THE CHI-CHI, TAIWAN EARTHQUAKE OF 21 SEPTEMBER 1999

Report of the NZSEE Reconnaissance Team

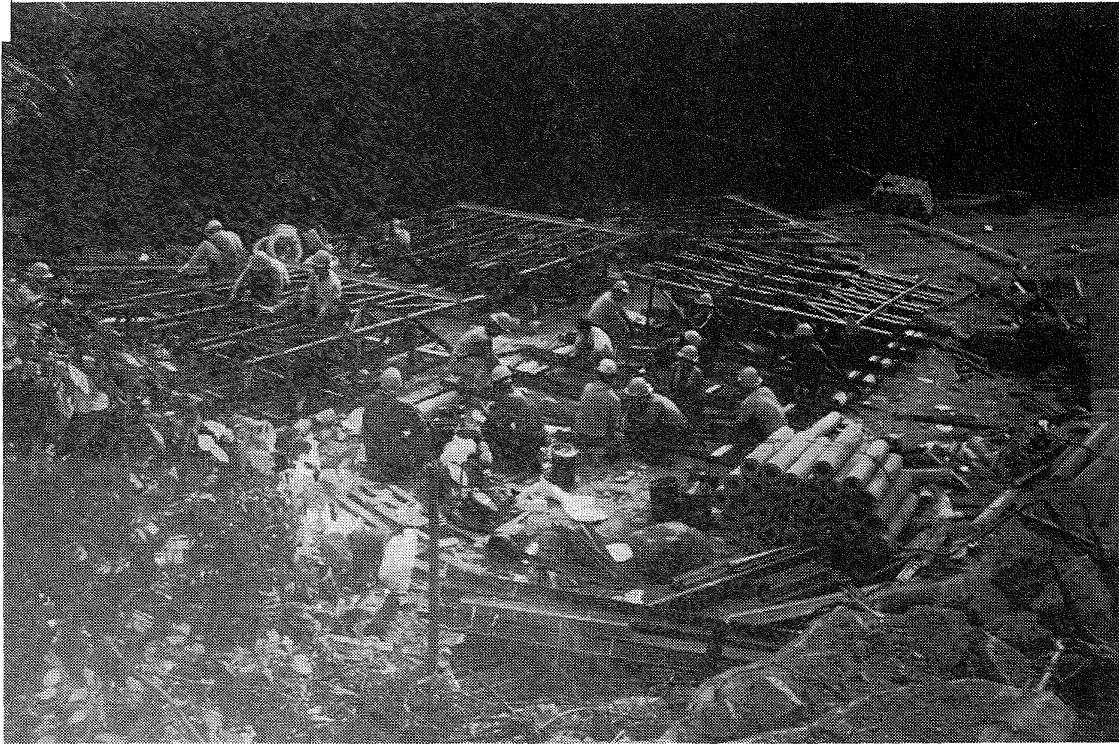
Figure 4.2: Assembling the elements for one of the temporary 345 kV Towers.

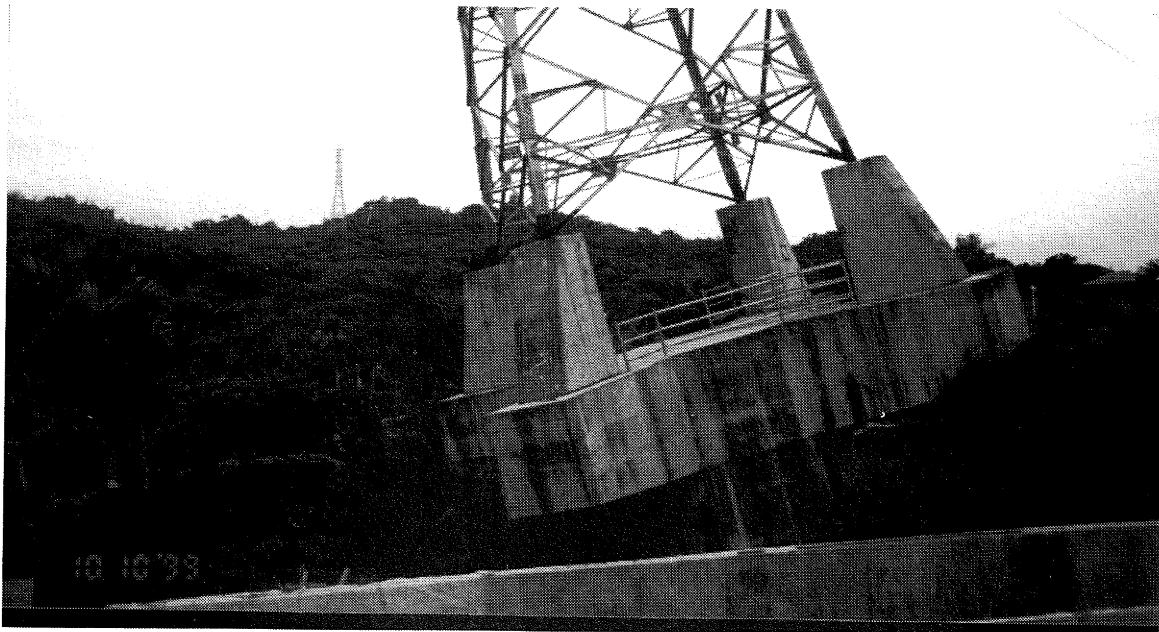
Figure 4.5: Typical Foundation Detail for 69 kV Pylons.

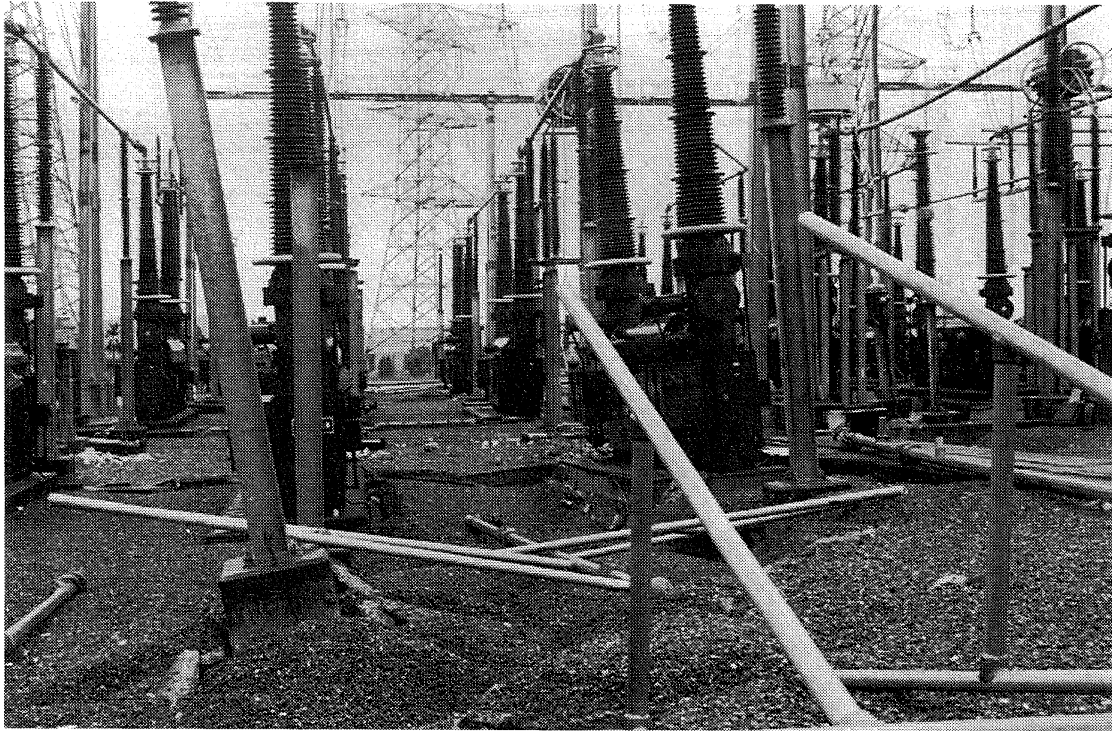
Figure 4.6: Chungliou Switchyard – Ground deformation and insulator damage.

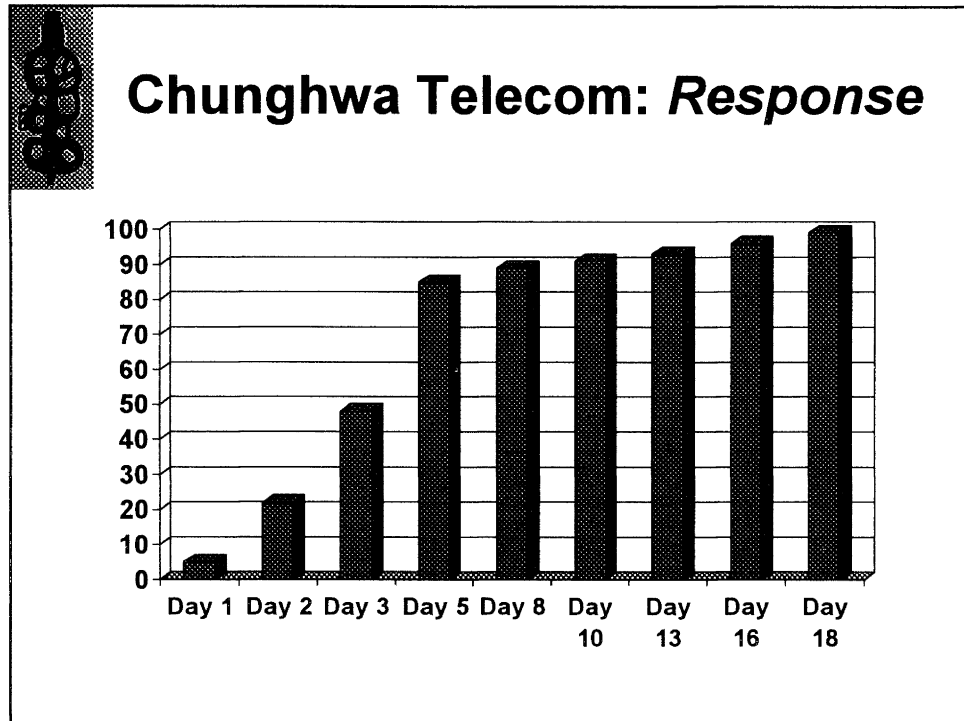
Figure 4.7: Restoration rate for affected Chunghwa Telecom subscribers.

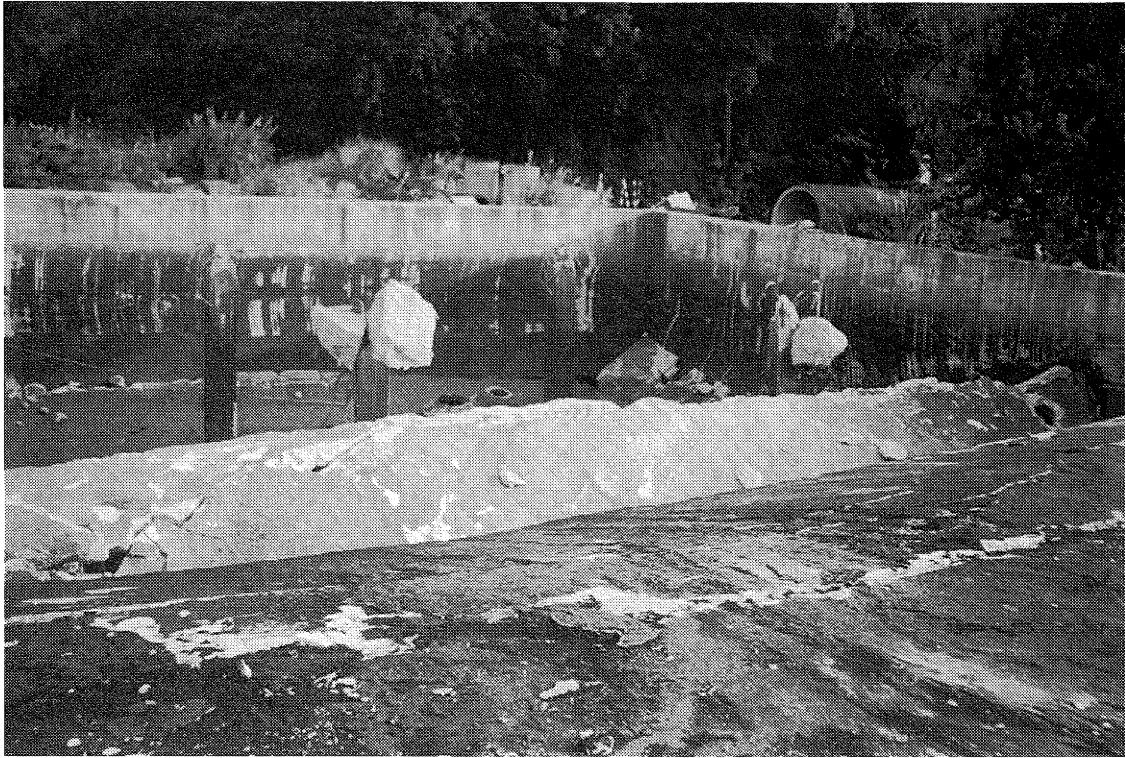
Figure 4.8: Failure of reservoir roof, Fengyuan Water Treatment Plant.

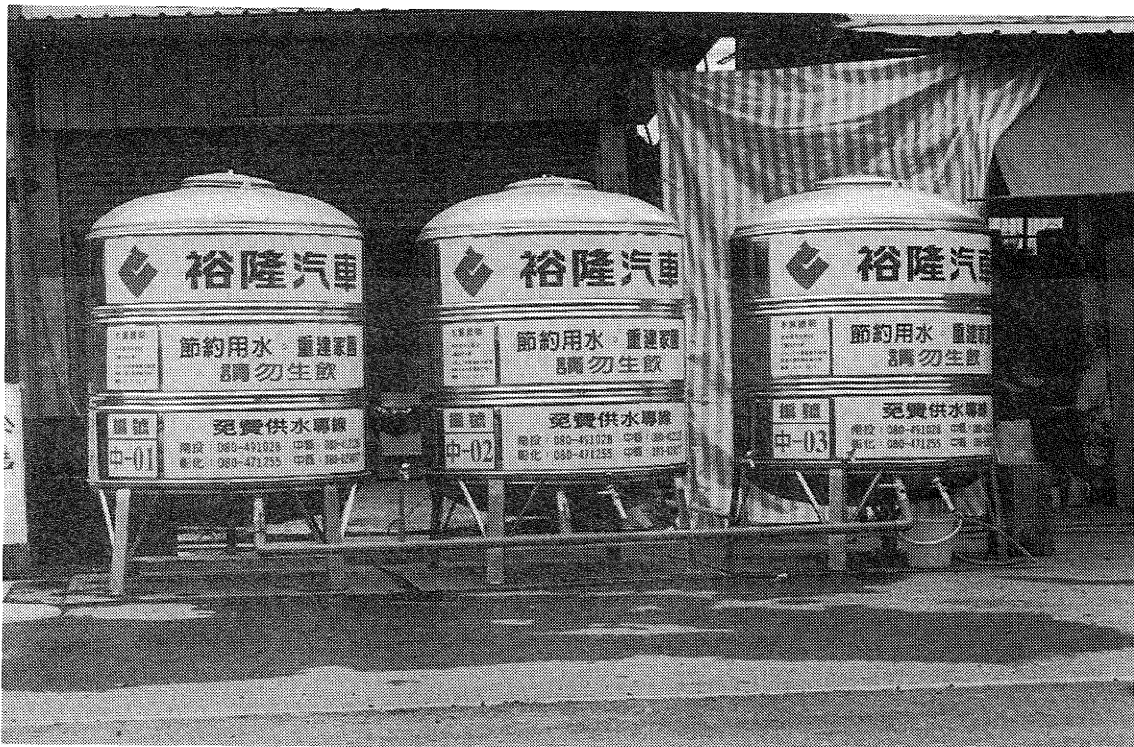
Figure 4.9: Common configuration of 2.5m² emergency water tanks.

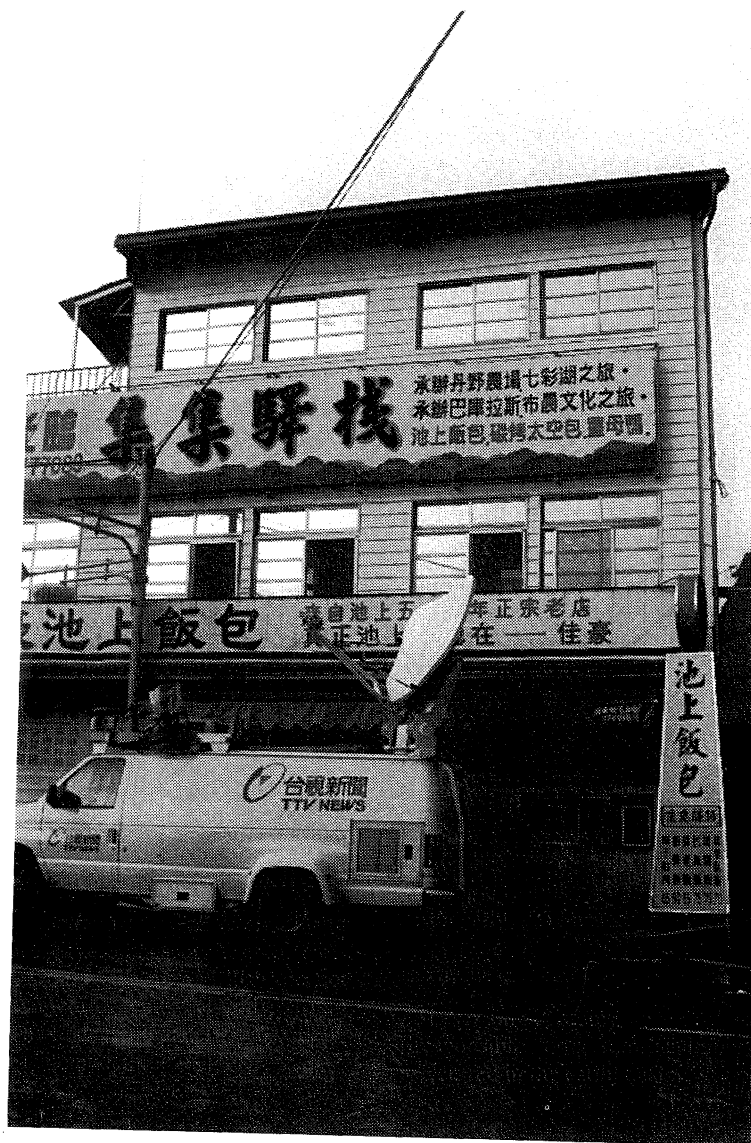
Figure 5.1: Undamaged light timber framed building, Chi-Chi.

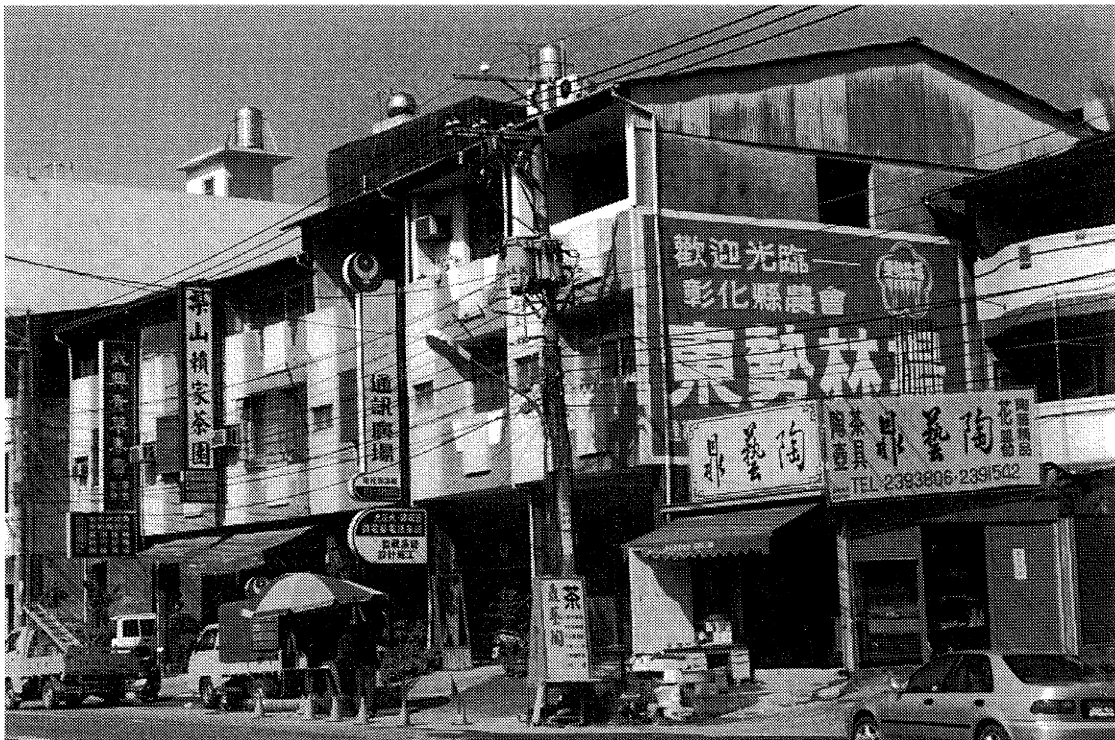
Figure 5.4: A typical streetscape consisting of a collection of "Up to Heaven Houses".

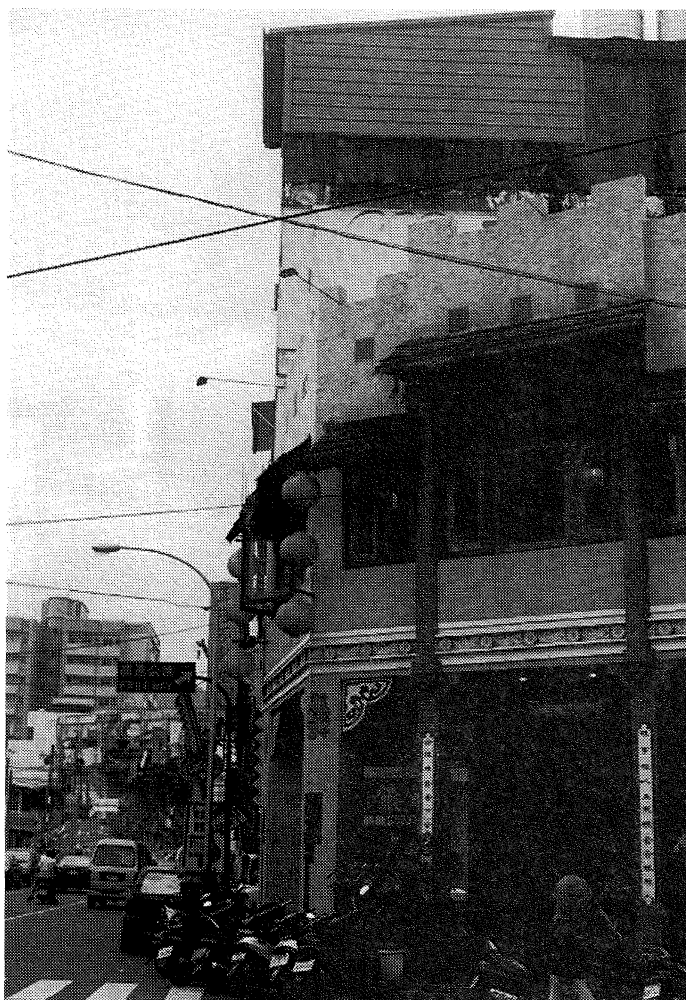
Figure 5.8: Fengyuan Streetscape in vicinity of toppled building. Buildings generally undamaged.

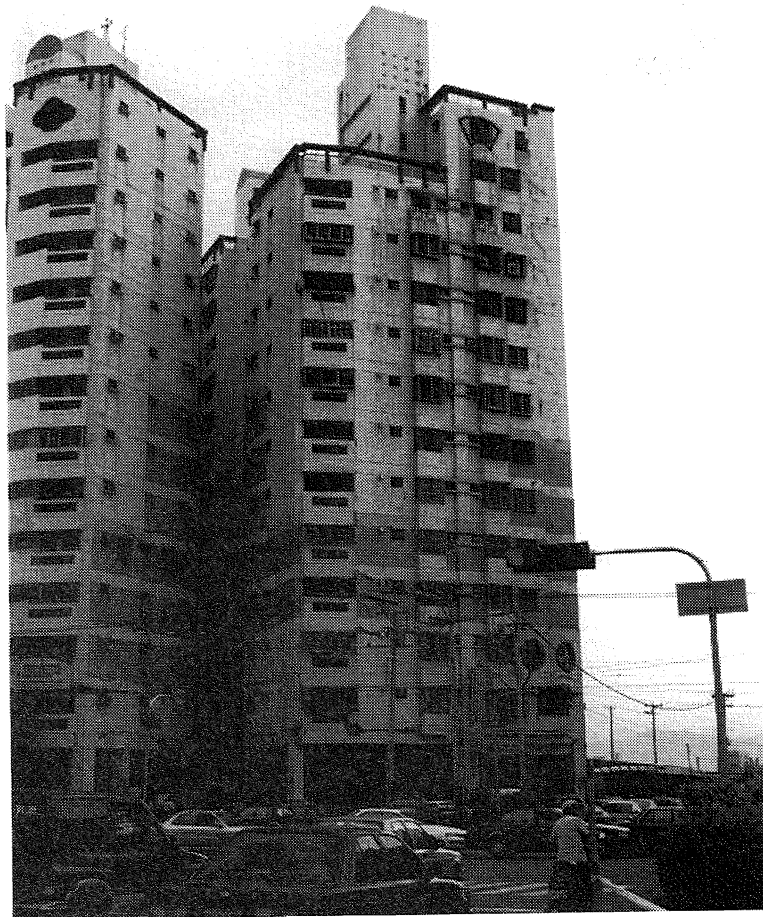
Figure 5.11: Overall view of damaged multistoreyed apartment building, Taichung.

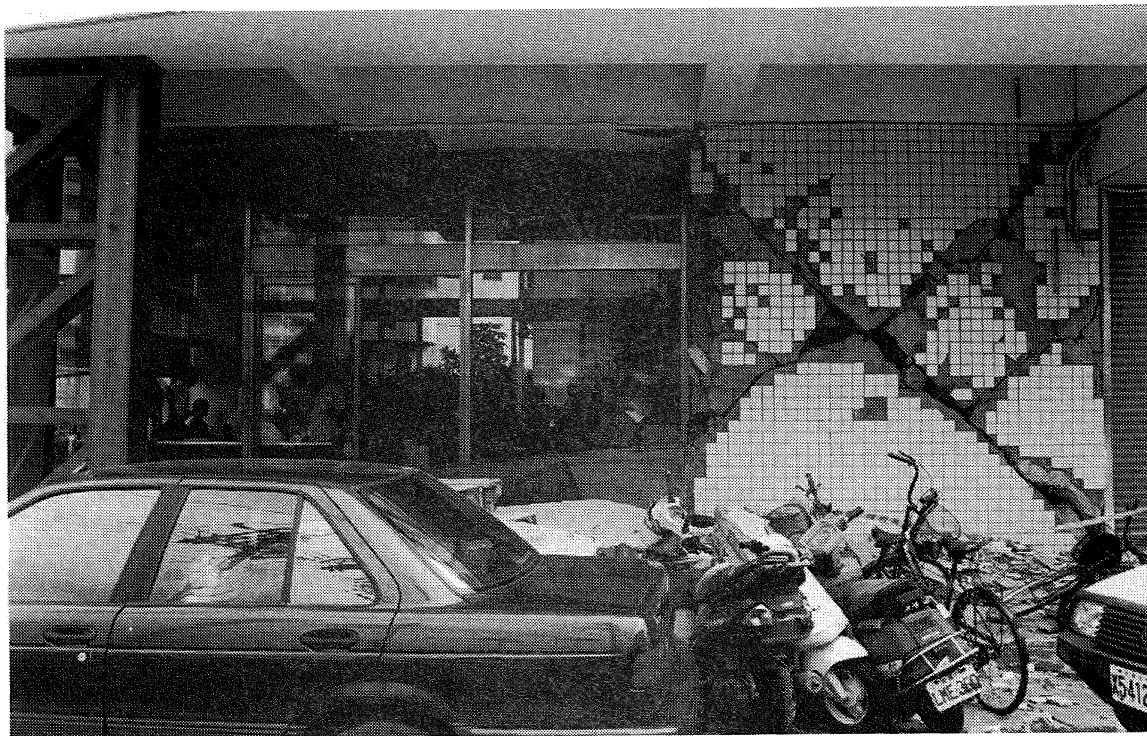
Figure 5.12: Detail of damage to single infill panel at ground level.

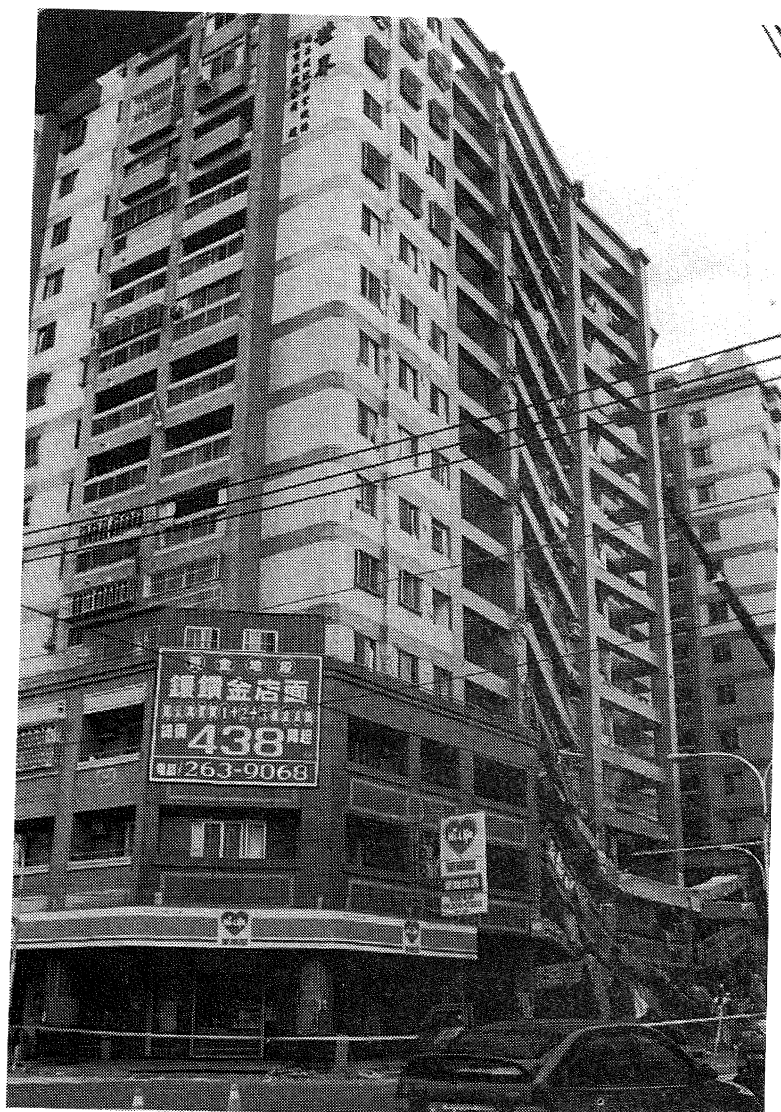
Figure 5.13: Overall view of "Oil Can Building" showing loss of storey over part of the building – Taichung.

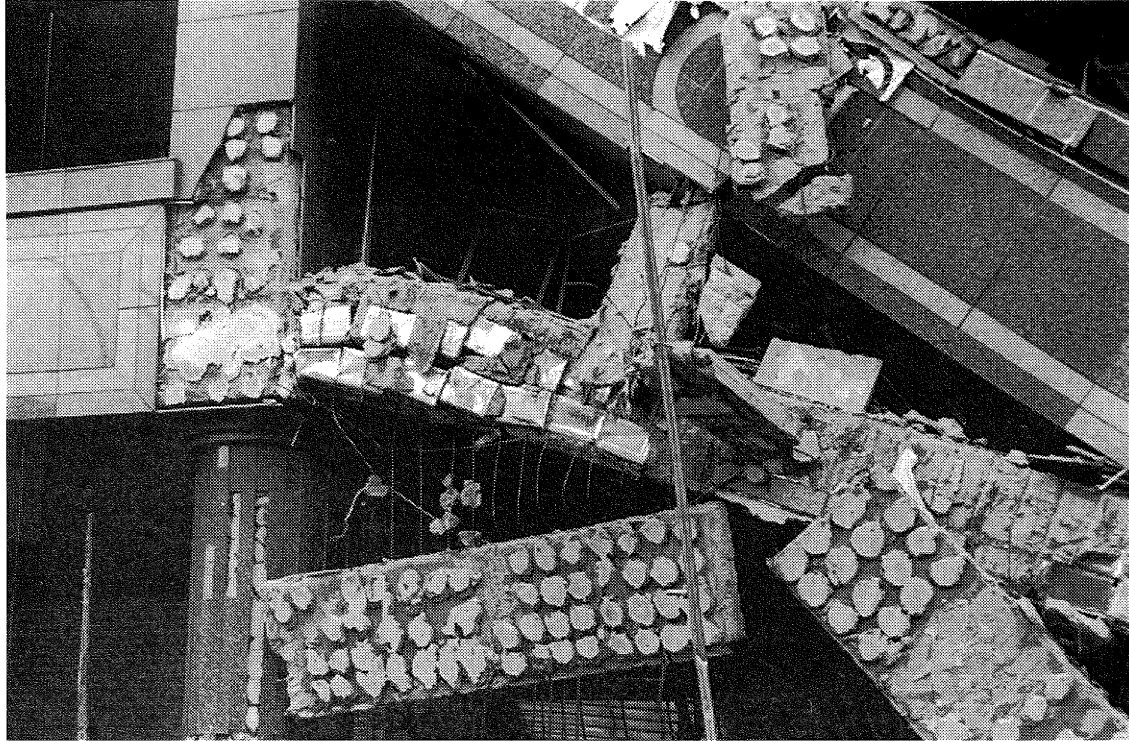
Figure 5.14: Detail of damage at first floor level of "Oil Can Building".

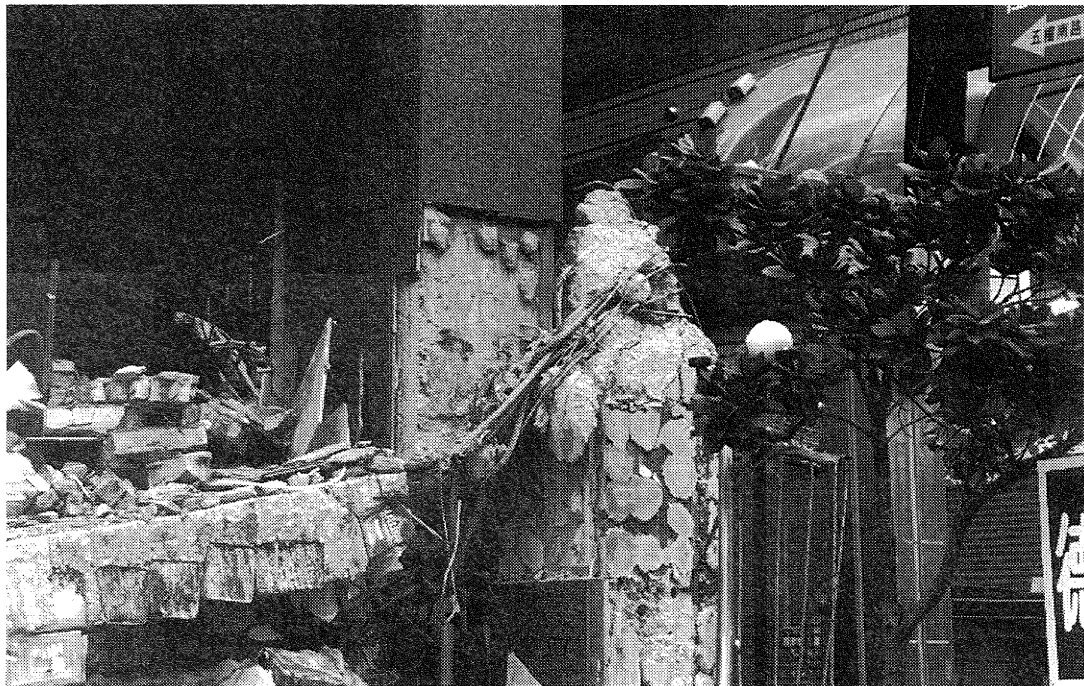
Figure 5.15: Detail of column offset in "Oil Can Building". Note lack of confinement reinforcement.

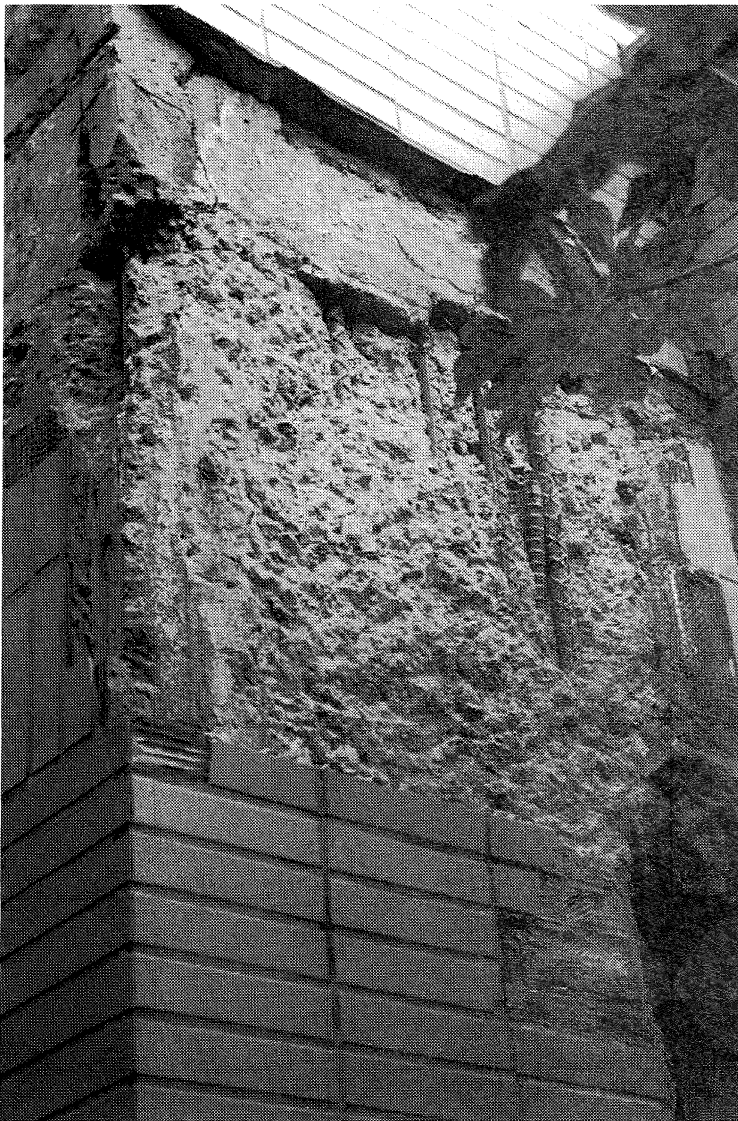
Figure 5.17: Damage to beam corner column junction at first floor level of complex shown in Fig 5.15. Inadequate joint ties and poor quality concrete evident.

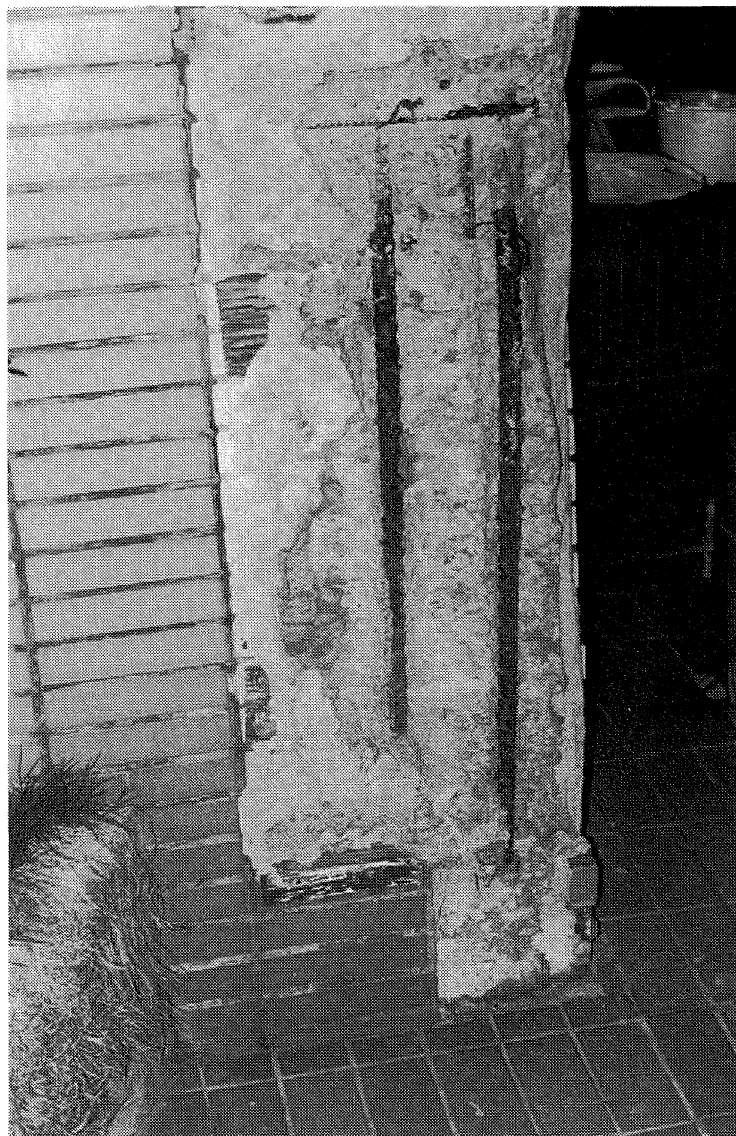
Figure 5.18: Same building as Fig 5.17 showing spalled cover to ground floor column at location of splice to longitudinal bars. Non confining reinforcement to the splice and inadequate cover.

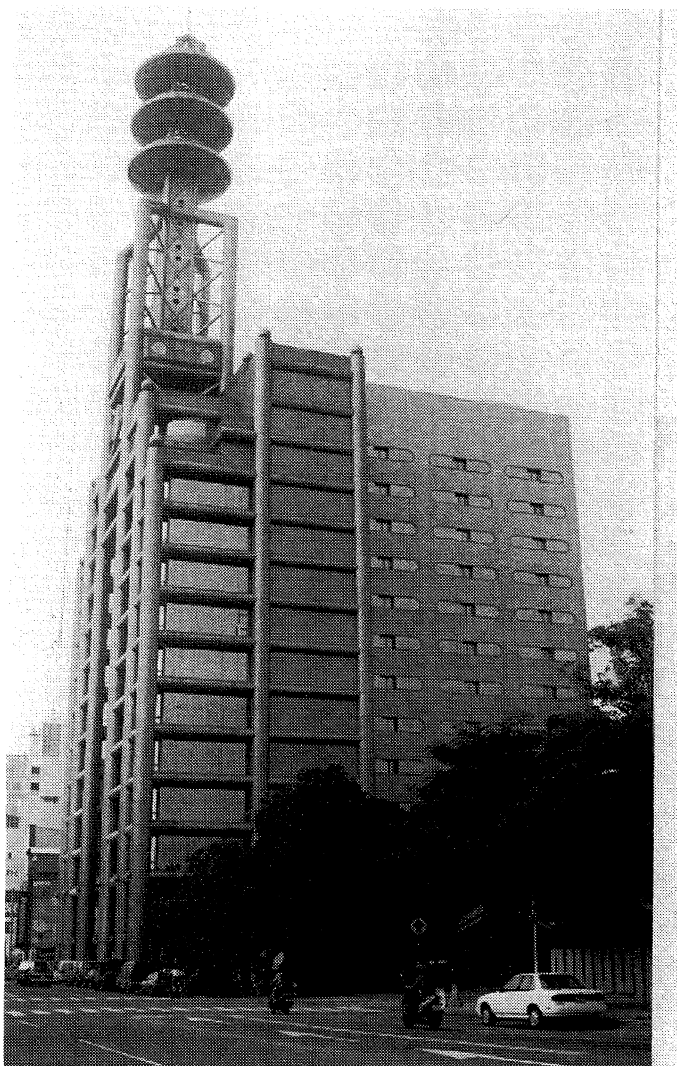
Figure 5.19: Commercial headquarters of Chunghwa Telecom in Taichung City.

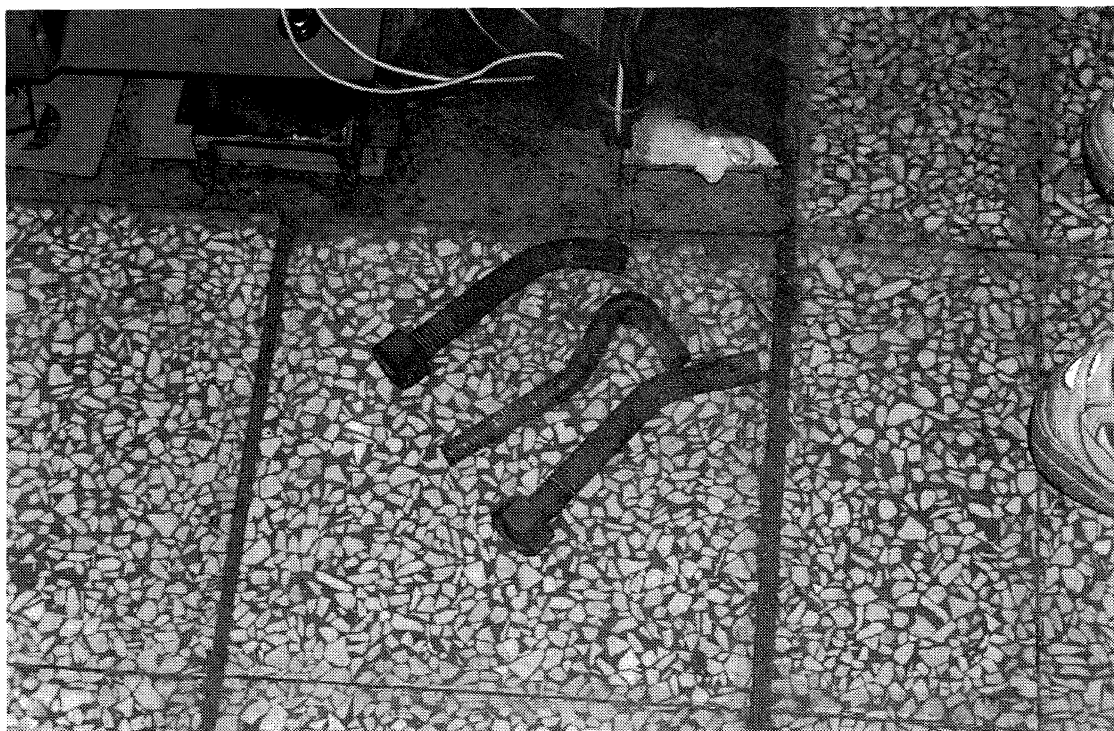
Figure 5.22: Detail of failed holding down bolts that allowed cabinets to topple.

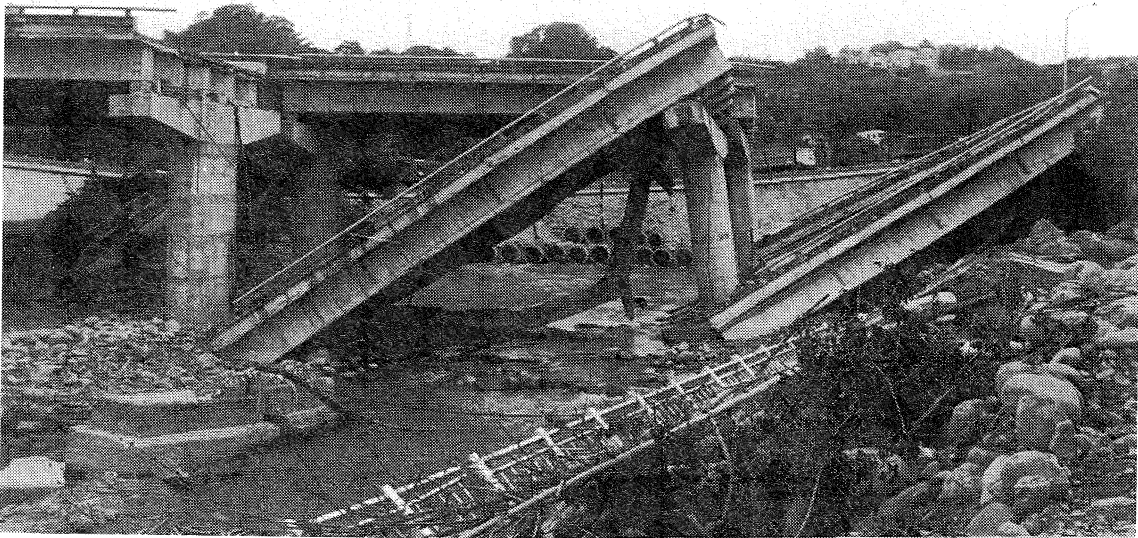
Figure 6.1: Collapsed spans of prestressed concrete I beam bridge crossing the Tachia Hsi river.

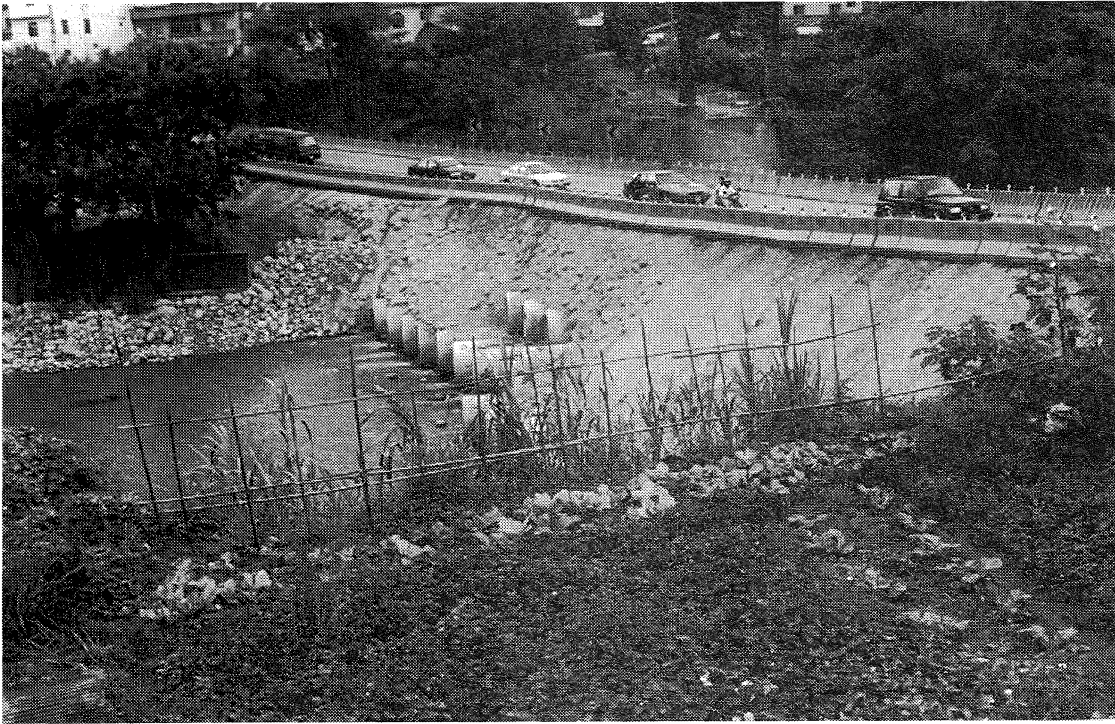
Figure 6.3: Temporary causeway constructed to establish a river crossing.

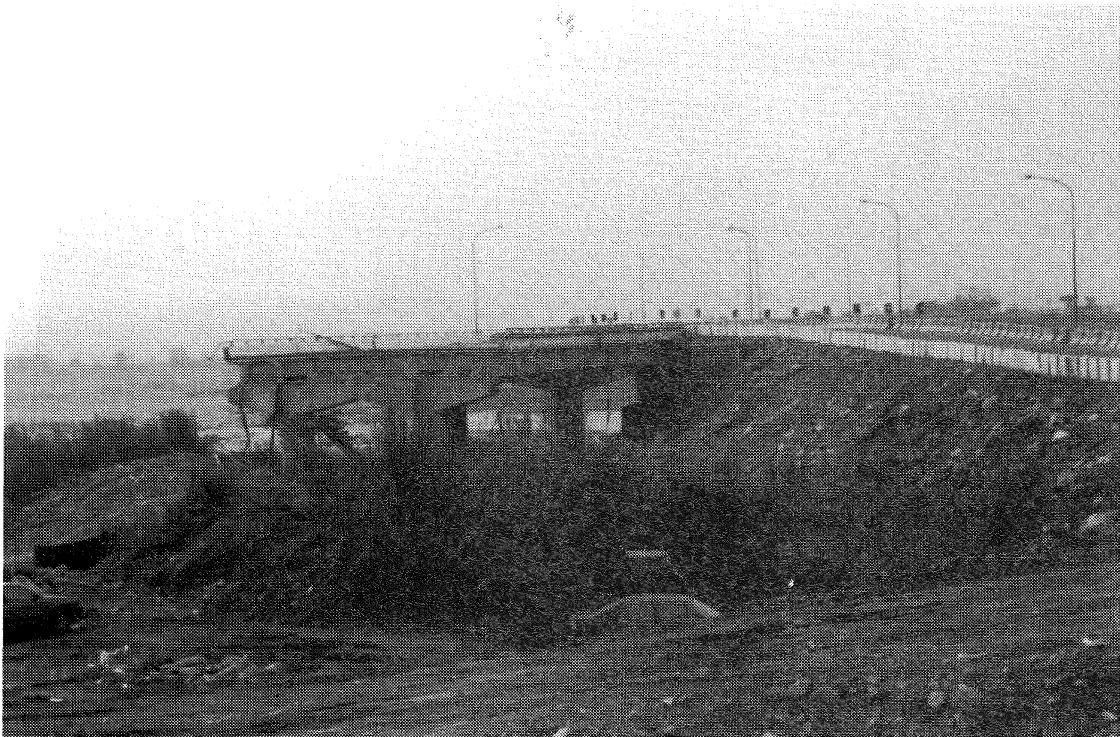
Figure 6.4: Damage to abutment span of bridge crossing the Chosui river.

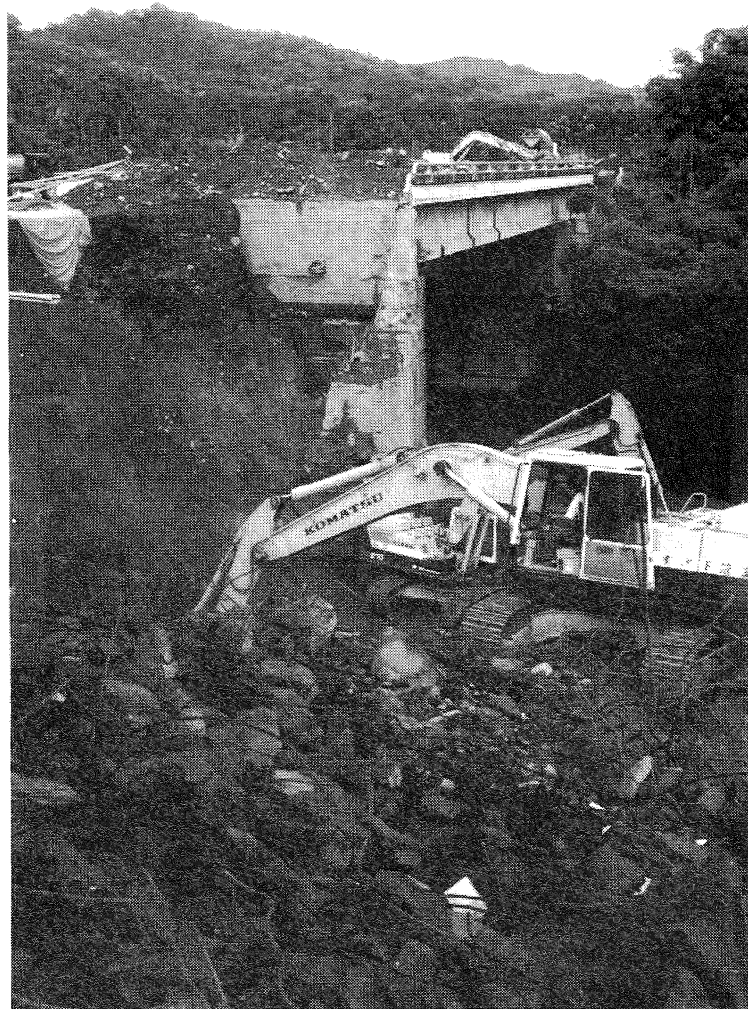
Figure 6.5: Failed retaining wall led to the loss of the abutment of this bridge near Shuli.

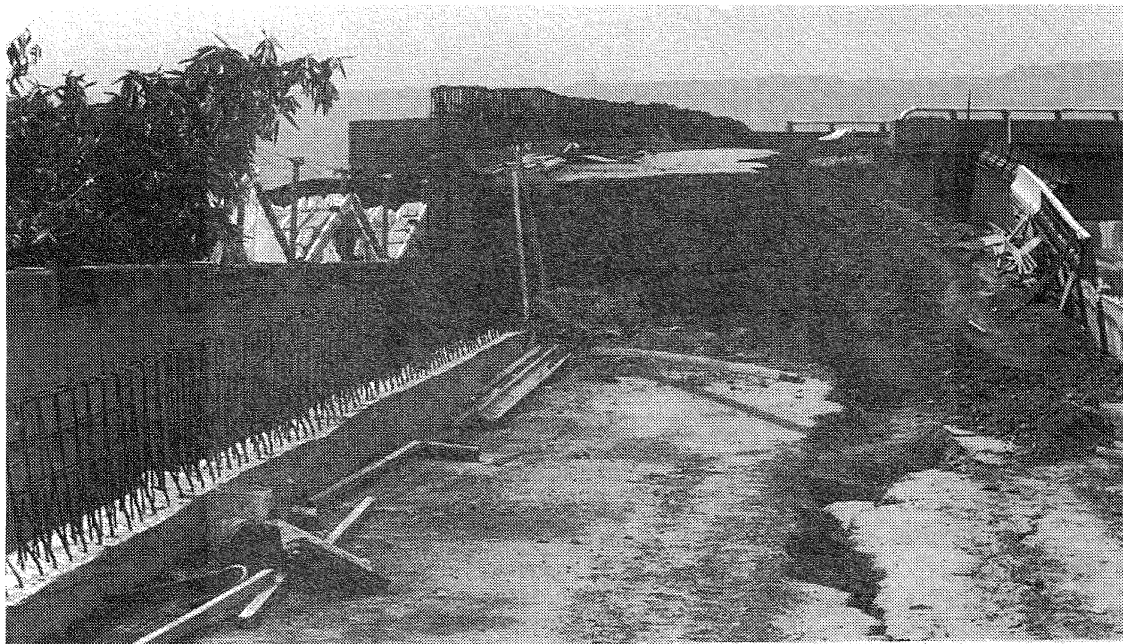
Figure 6.6: Slumping and lateral spreading of these canal walls allowed movement of the bridge abutment in the background causing settlement, Nantou.

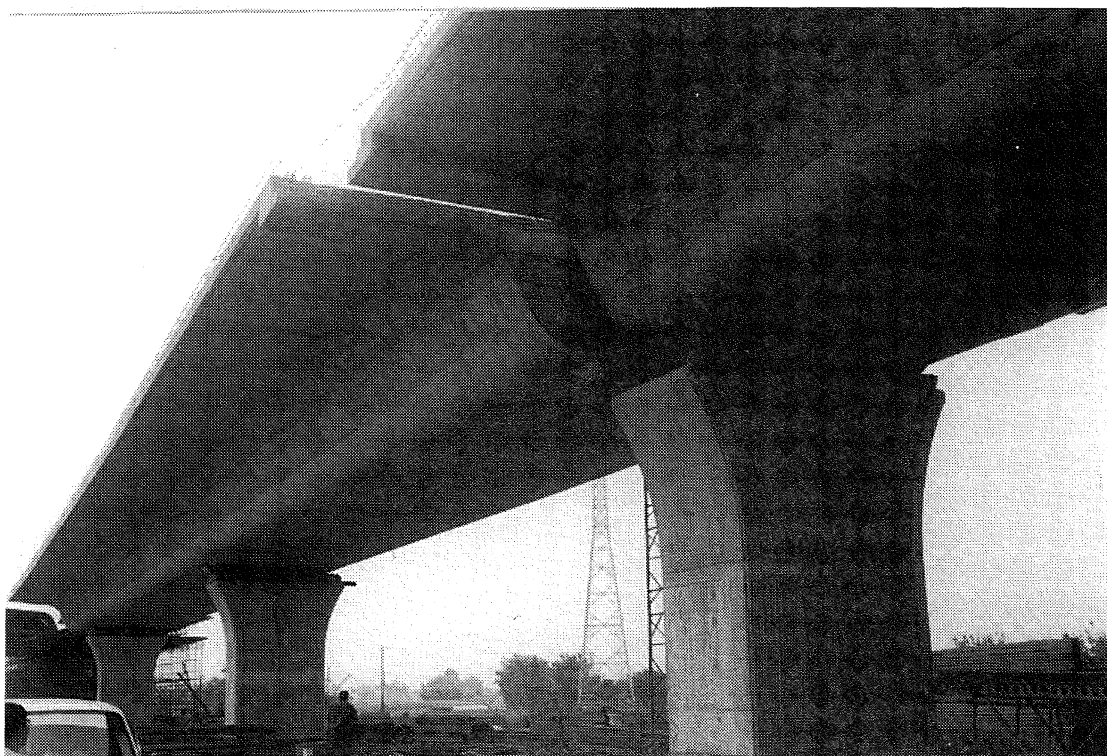
Figure 6.7: Failure of pot bearing on elevated expressway under construction near Fengyuan.

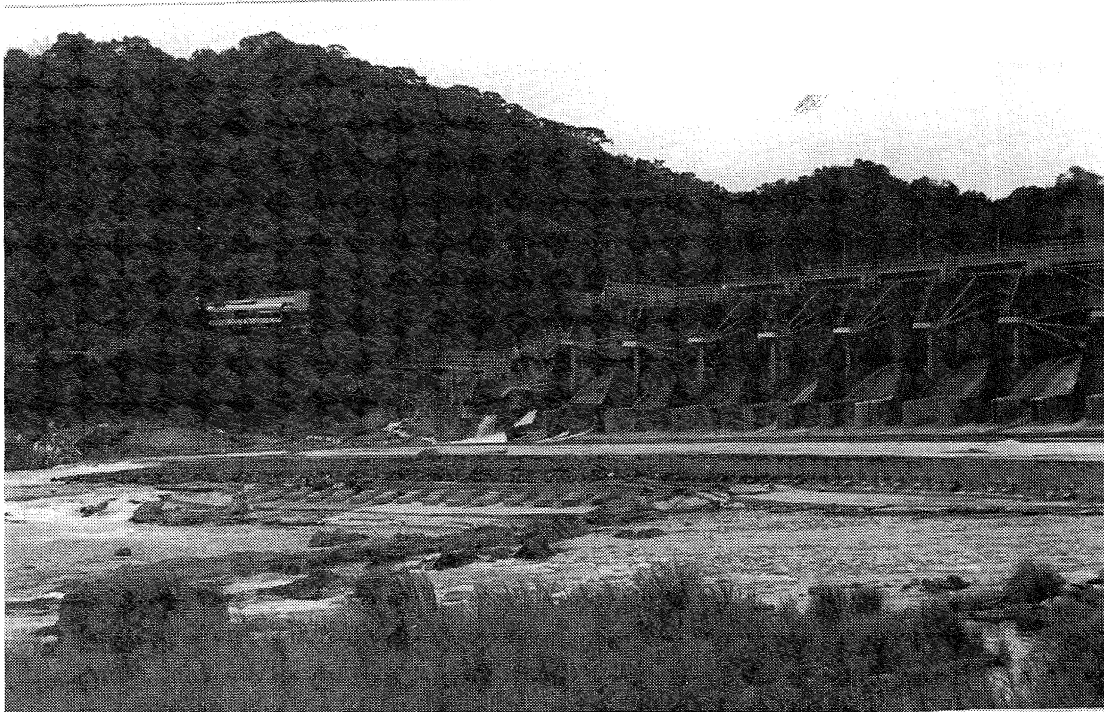
Figure 7.1: Damage to Shih-kang Dam.

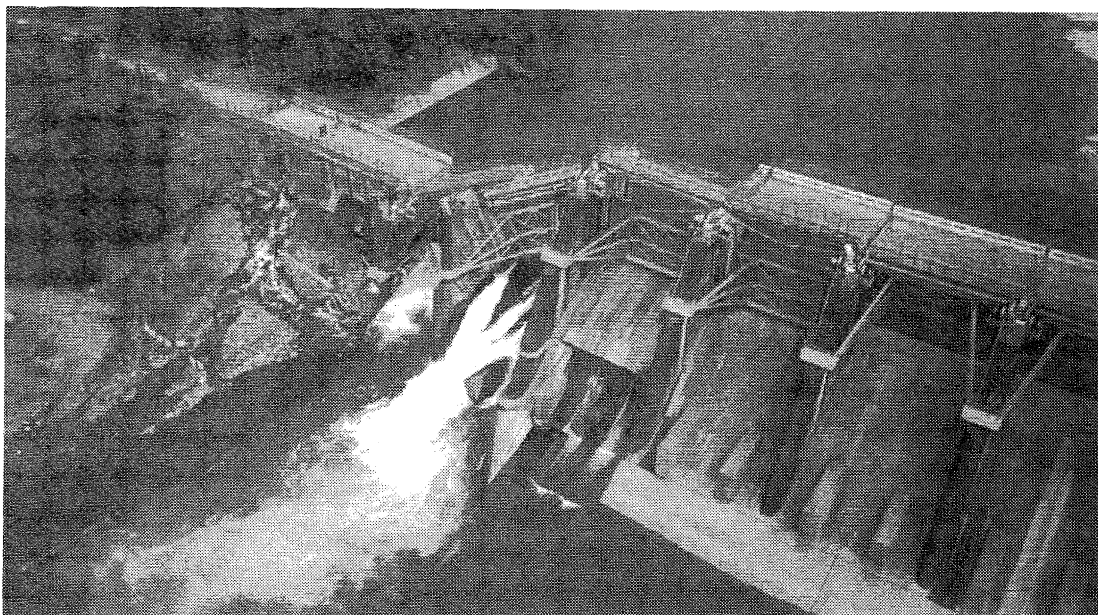
Figure 7.2: The fault cuts through the Shih-kang Dam, uplifting much of the dam by 8 m.

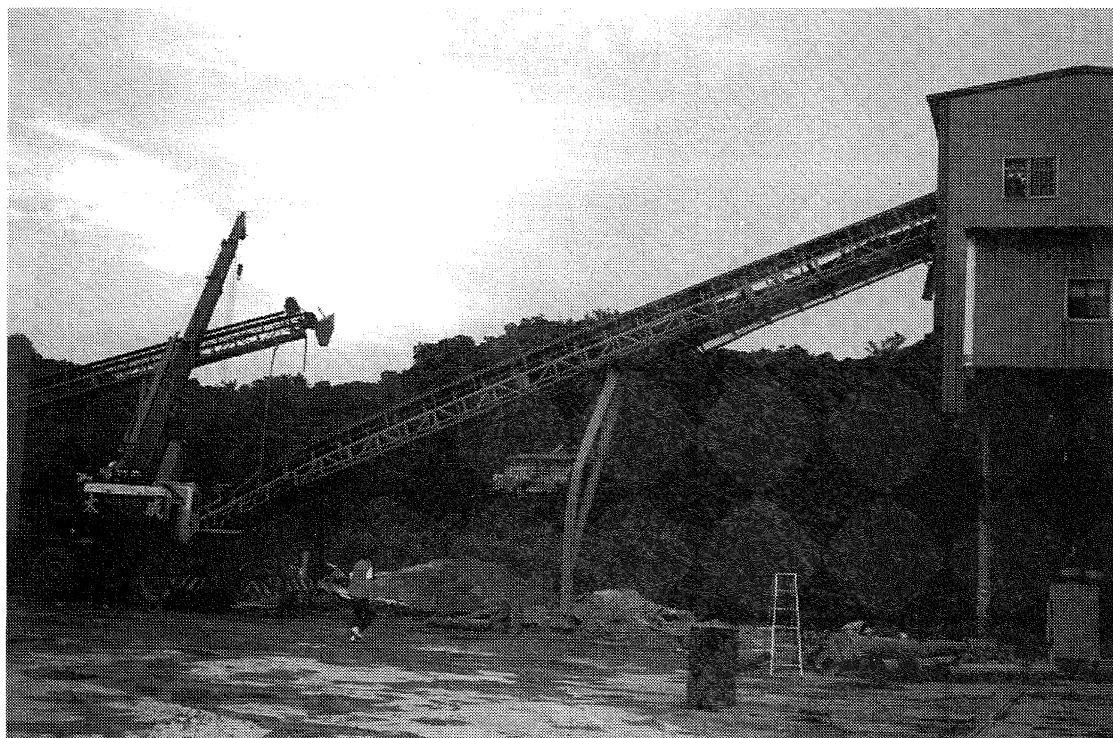
Figure 7.3: Damaged conveyors at concrete plant near Mingchien.
