**THE 1934 PAHIATUA EARTHQUAKE SEQUENCE:
ANALYSIS OF OBSERVATIONAL
AND INSTRUMENTAL DATA**

**Gaye Downes^{1,2}, David Dowrick^{1,4}, Euan Smith^{3,4}
and Kelvin Berryman^{1,2}**

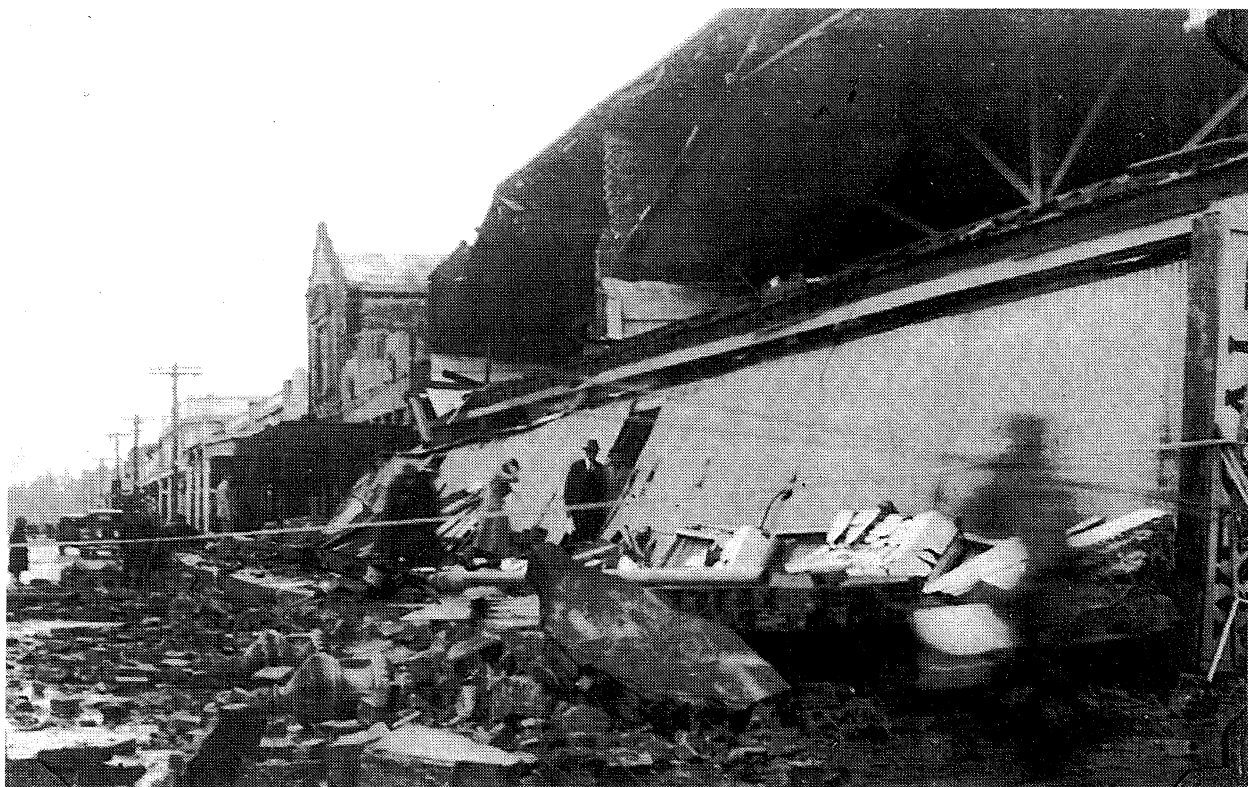
Non-domestic buildings in Pahiatua were either one or two-storeyed. Considerable damage occurred to many of the brick buildings, with walls wholly or partly falling in a number of buildings. The upper storey front facade of the Wairarapa Farmer's Cooperative Association's general store fell into the main street (Figure 4). Other business premises which suffered damage from falling brick walls, parapets or gables were the Tararua Electric Power Board's offices (1 storey), Oxley's buildings (2); Hall-Watson/Timms (2); Taylor tobacconist (2); Woodward's Chemist, *et al.* (2). Many other buildings had their brick walls cracked to some degree. The roofs of two brick buildings fell in, i.e. Yates' grocery and Hee's fruiterer, and both buildings were described as requiring complete rebuilding. There appear to have been few, if any, reinforced concrete or steel framed buildings in Pahiatua. If there were any, none were reported to be damaged, despite the very detailed listings of damage given in the *Pahiatua Herald*.

Overall the damage in Pahiatua clearly indicates that intensity MM8 was reached. As there were no signs of MM9, the intensity for the town is unequivocally MM8.

Figure 4. View along the main street of Pahiatua, showing the collapse of the brick facade of the upper storey of the Wairarapa Farmer's Cooperative Association store. (Reference no. P-A1 0832-021 -0, Alexander Turnbull Library, Wellington, New Zealand)

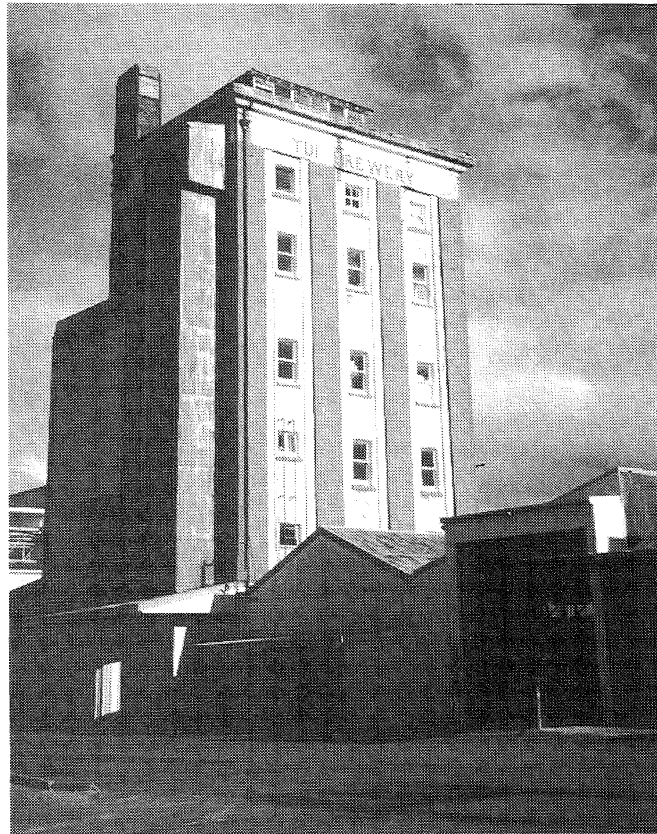
One of the largest buildings within the MM8 isoseismal was the five-storey Tui Brewery at Mangatainoka (Figure 5) (est. PGA 0.39g), a small town about 5 km northeast of Pahiatua and hence about the same distance from the major axis of the isoseismals (Figure 3b) as Pahiatua. The Brewery, a brick-clad reinforced concrete building, which had been completed shortly before the earthquake, withstood the shock well. An inspection of the building by R T Hefford in June 1997 showed no signs of its having been cracked at any time. Its construction drawings show the beams and columns to have been only lightly reinforced. Its good performance is presumed to result from the combined action of frame and brickwork, its symmetry, and the small size and good positioning of its wall apertures. Such buildings also tend to do better at higher levels of shaking than implied by the corresponding descriptions of intensity. A two-storey brick building, which is visible in an immediately pre-earthquake photograph but which no longer exists, was not reported as being damaged. Some of the other reinforced brick buildings at the Brewery (generally single storied) were cracked in the earthquake, but have remained in service until the time of writing, despite being subjected to strong shaking (probably MM7) again in the 1942 earthquakes.

Figure 5. A view of the five-storey Tui Brewery building at Mangatainoka, near Pahiatua. This brick clad, reinforced concrete frame building was undamaged. (Photograph by R. T. Hefford, 1997).

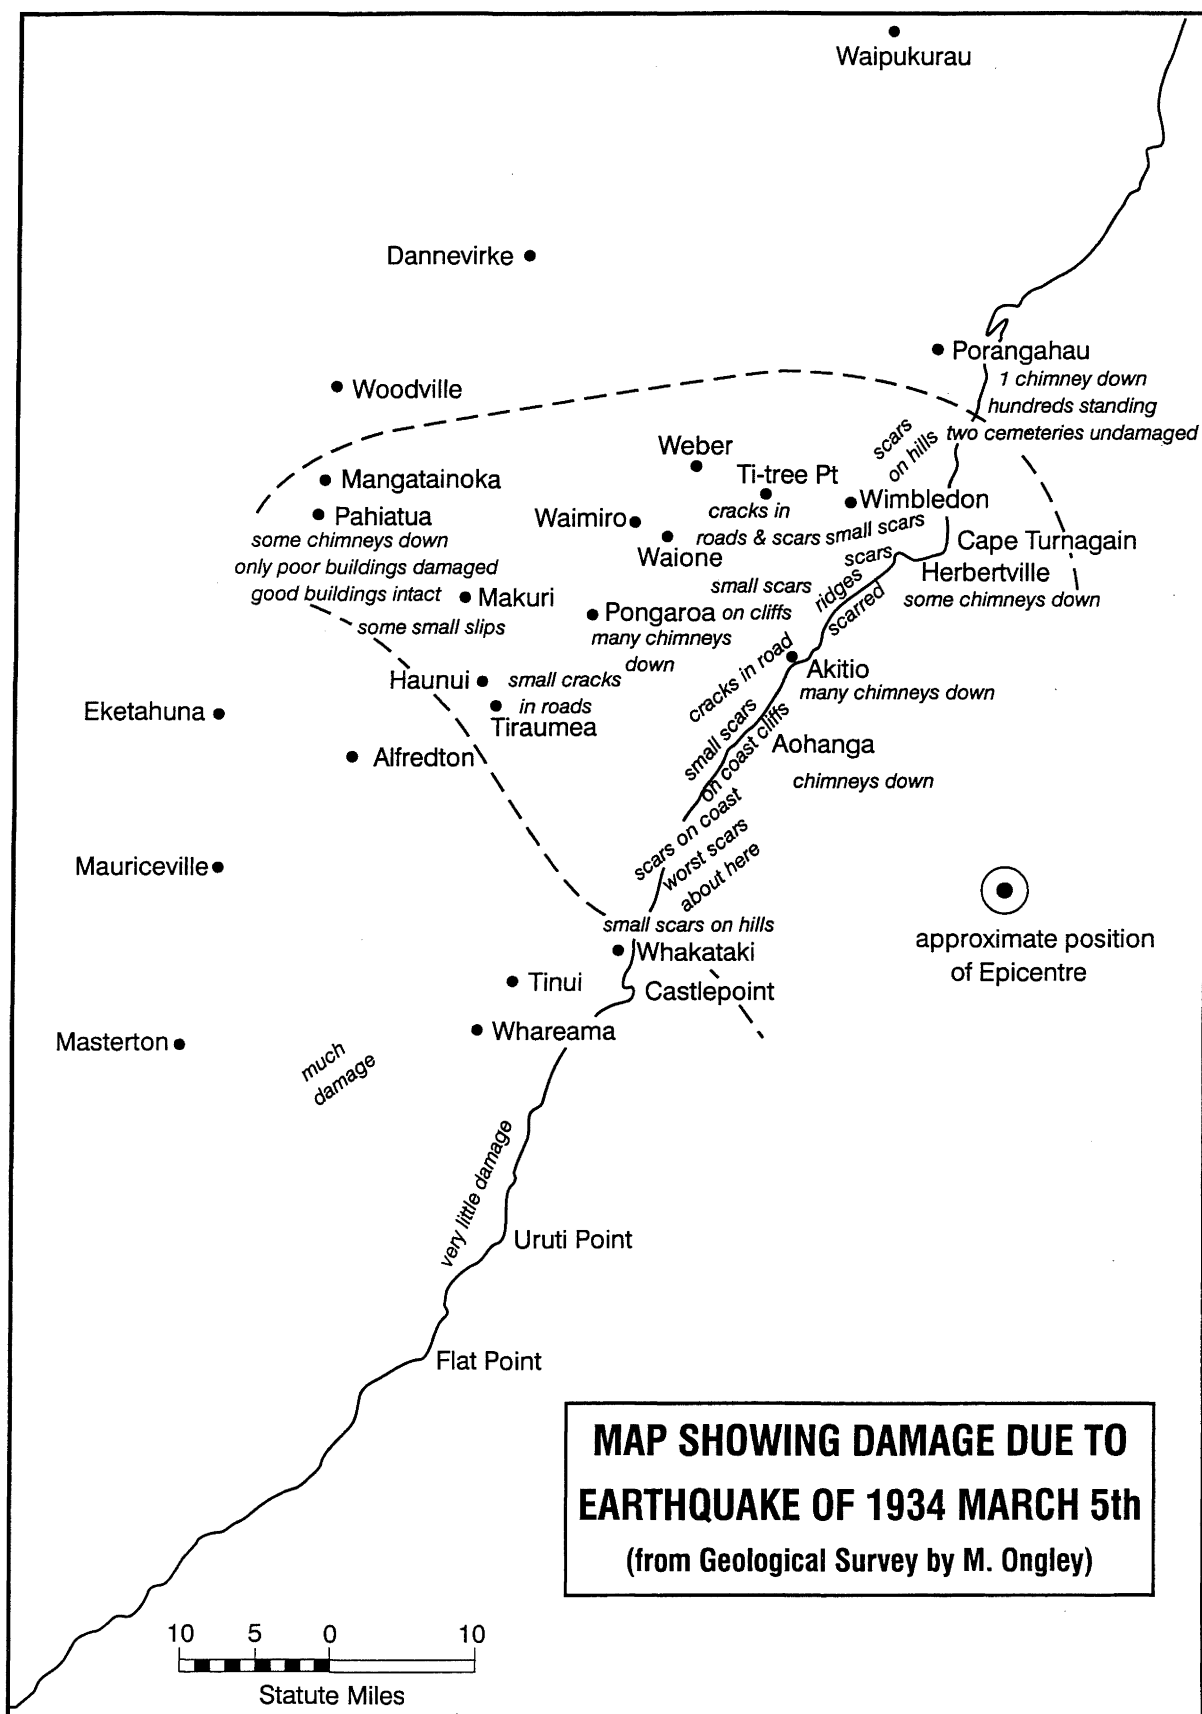
M. Ongley, one of the New Zealand Geological Survey's geologists on a field survey of the east coast from Cape Turnagain to Castlepoint, also provides some descriptive material and a sketch showing the distribution of landslides [14] (shown in Figure 6). According to Ongley, the damage was greatest to the east of Pahiataua, but everywhere it was less than that caused by the 1931 Hawke's Bay earthquake. Several newspaper articles written by special correspondents sent to survey the damaged area also recognised the greater severity of damage east of Pahiataua.

Figure 6. Scanned and redrafted sketch of the distribution of landslides in the epicentral area. Hayes probably drew the original from data supplied by Ongley [13] and located the epicentre shown in the sketch.

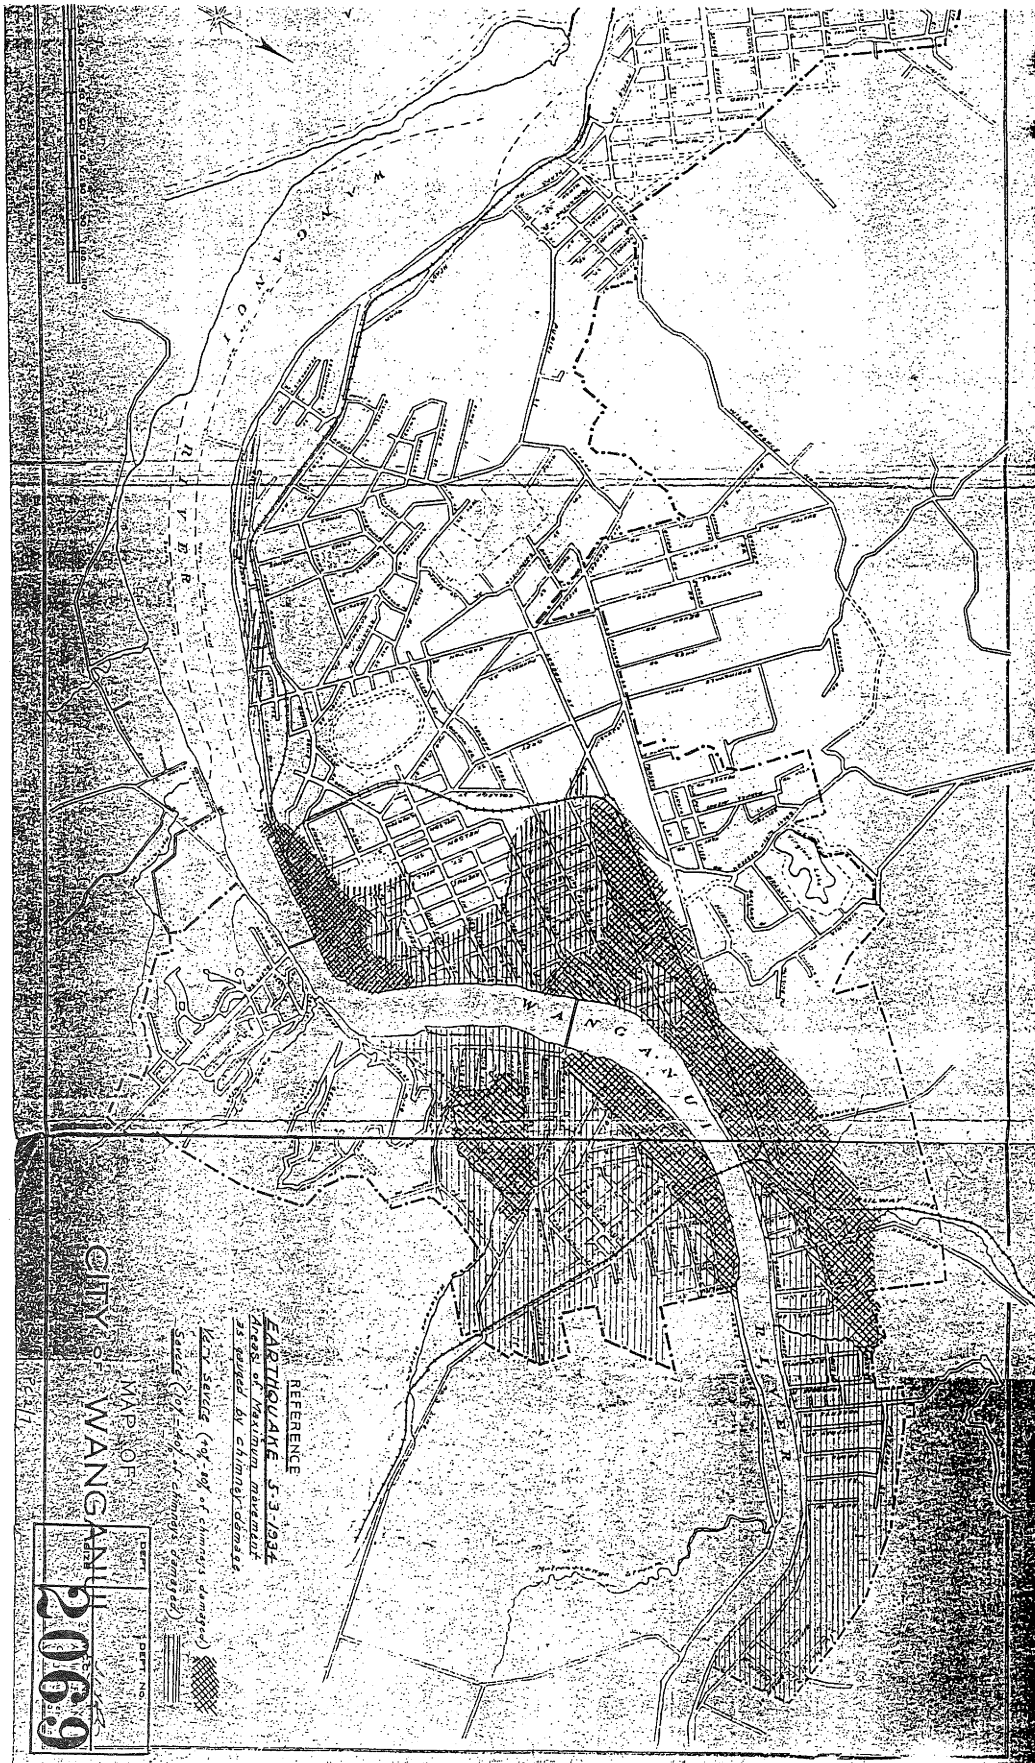
Figure 7. (a): Sketch of the distribution of chimney damage in Wanganui caused by the Pahiatua earthquake. The sketch was prepared for the Wanganui Council by the Council Engineer in March 1934. (Sketch courtesy of the Wanganui City Council Archives.)

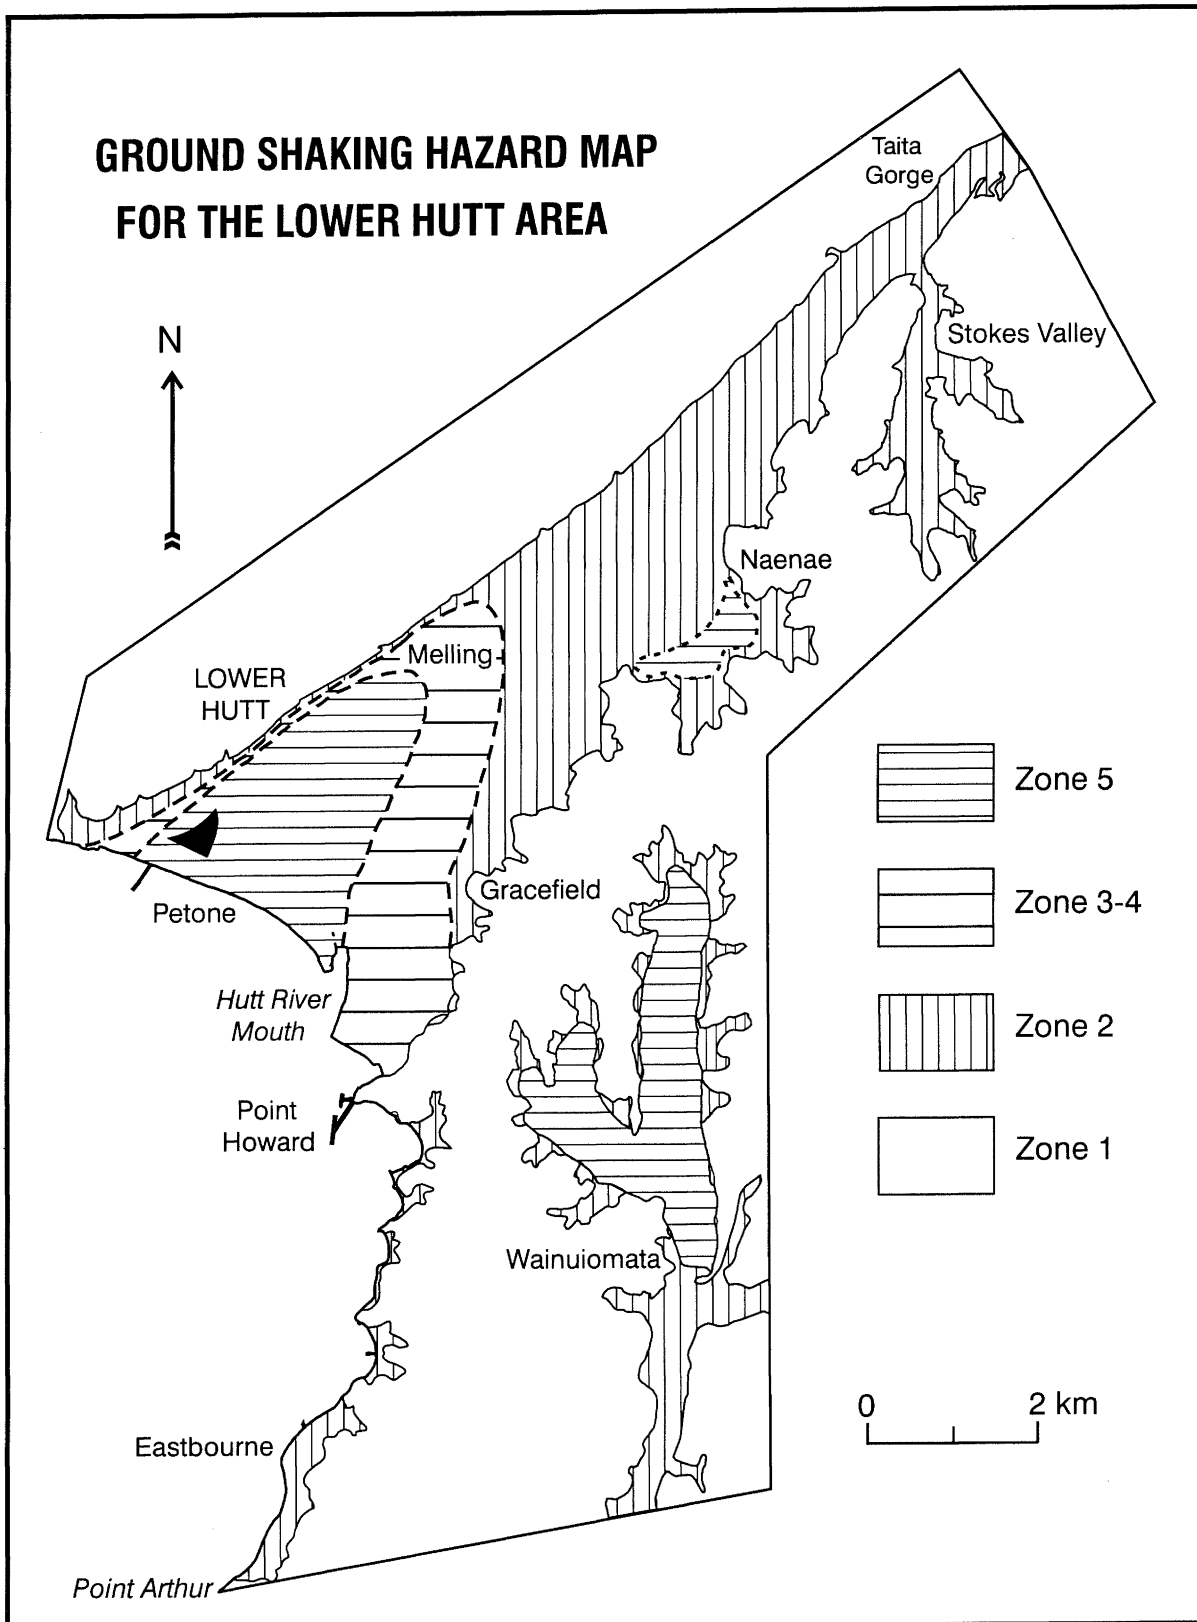
epicentre, 40 chimneys were damaged (i.e. MM7), 20 requiring demolition, in one small area of less than 0.5 km². Elsewhere in Petone, the intensity seems to have been MM6. In Lower Hutt a few chimneys were damaged or fallen and these were generally confined to a small area west of the Hutt River. This is in sharp contrast with Upper Hutt and Eastbourne where damage was slight and mostly confined to a few household items (MM5). Most of the Petone chimneys were reported to be old and built with lime mortar, but they were probably not the only ones of this type in Lower Hutt and Petone at this time. The areas of most damage in Petone and in Lower Hutt both lie in an area designated Zone 5, the highest shaking hazard zone, on the shaking hazard map of the Hutt Valley [19] (Figure 7b).

Figure 7. (b): Location of heavy chimney damage in Petone within Zone 5 of the Ground Shaking Hazard map for the lower Hutt Valley area (after Van Dissen et al [16]).
