## DAMAGE AND INTENSITIES IN THE MAGNITUDE 7.8 1931 HAWKE'S BAY, NEW ZEALAND, EARTHQUAKE

David J. Dowrick<sup>1</sup>

This paper is the result of a study of the shallow  $M_W = 7.8$  Hawke's Bay earthquake which occurred in the North Island of New Zealand, 2 February 1931(UT), and which was the final spur to the production of the first earthquake loadings code in New Zealand issued in 1935. This earthquake was a direct hit on two provincial towns (Napier and Hastings) and was the most damaging in New Zealand's history, causing the most casualties, major fires, and much damage to the built and natural environments. It gives the first overall description of the damage (to the buildings and lifelines) in this major event in modern earthquake engineering terms, and presents the first intensity map for the event determined directly in the Modified Mercalli (MM) scale. The zone which experienced the highest intensity (MM10) was confined to a modest area of onshore land (about 300 km<sup>2</sup>) above the centre of the rupture surface.

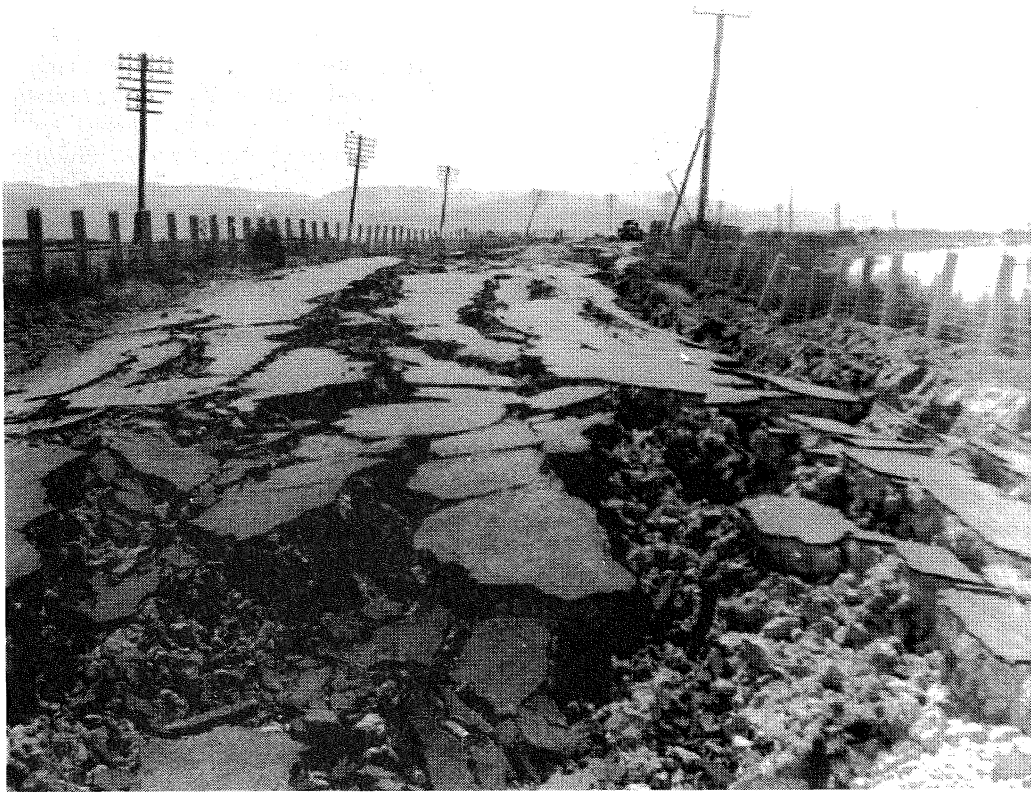
The damage to the roads and railways was dramatic on the man-made embankments across the harbour in the near-fault zone around Napier, as seen in Figure 4 and other contemporary photographs, e.g. References 22-24. According to Callaghan [12] the Napier-Wairoa road was blocked in many places by slips in road cuttings, while the Napier-Taupo road was much less affected, being open again within two or three days. In addition, embankment approaches to bridges subsided badly and spread laterally in many instances. The main road

**Figure 4:** *Photograph showing severe lateral spreading of embankment of road across Napier Harbour. (Courtesy of the Alexander Turnbull Library, Tyndall Collection, Wellington).*

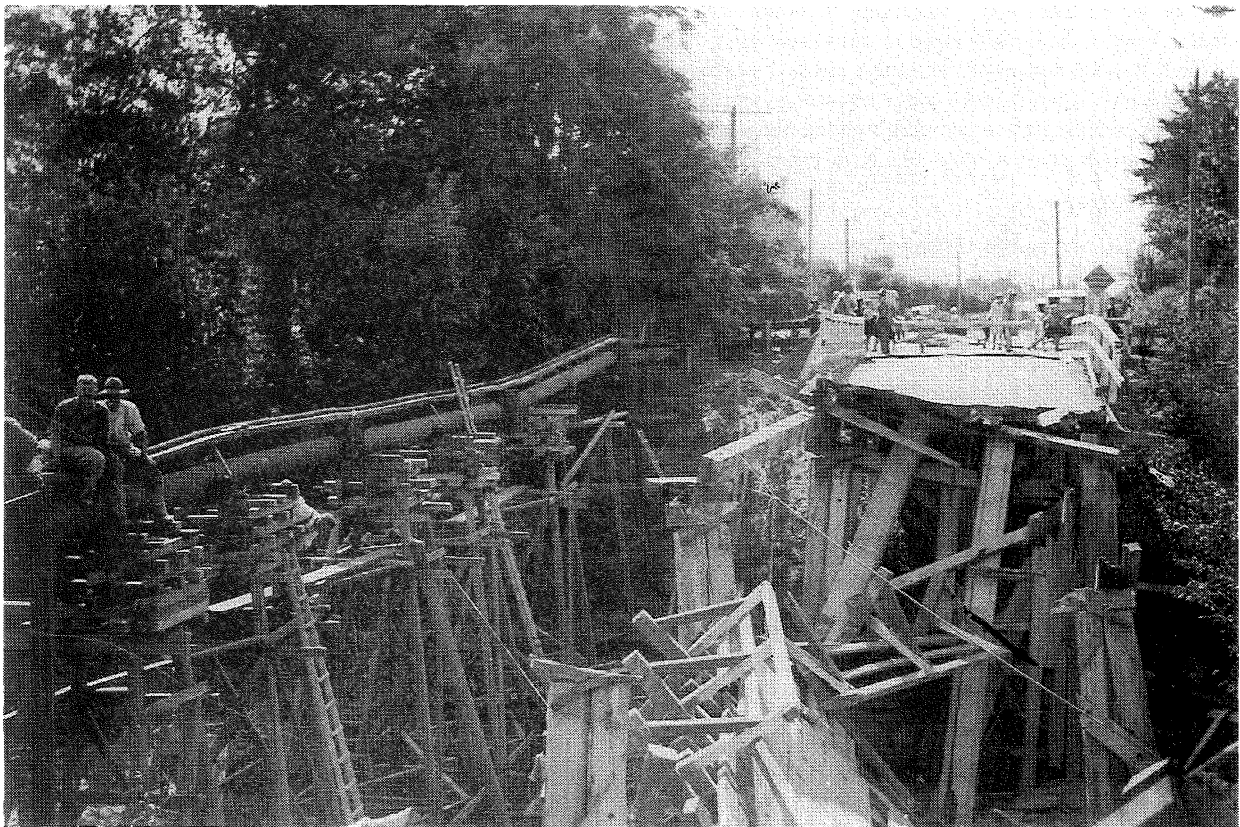
In Hastings the water mains sustained very little damage apart from subsidence at bridges and fillings. A section of the main supply pipe to Hastings supported by the Havelock North bridge was lost when that structure collapsed (Figure 5). Water supply was apparently generally restored within a day or two [Ref. 22, p. 112]. Artesian water from Hastings was temporarily pumped to the Havelock Hills reservoir to give more head. Hastings water supply was maintained by pumping artesian water directly into the mains. The pipe bridge was reinstated on the 10th of February, seven days after the main shock. The mains pressure was quite satisfactory at 100 lb/sq.in. [690 kPa] by 9th February.

**Figure 5:** *Photograph showing destruction of Hastings-Havelock North road bridge and temporary restoration of water main. (Courtesy of the Alexander Turnbull Library, P.A. Ashcroft Collection, Wellington).*

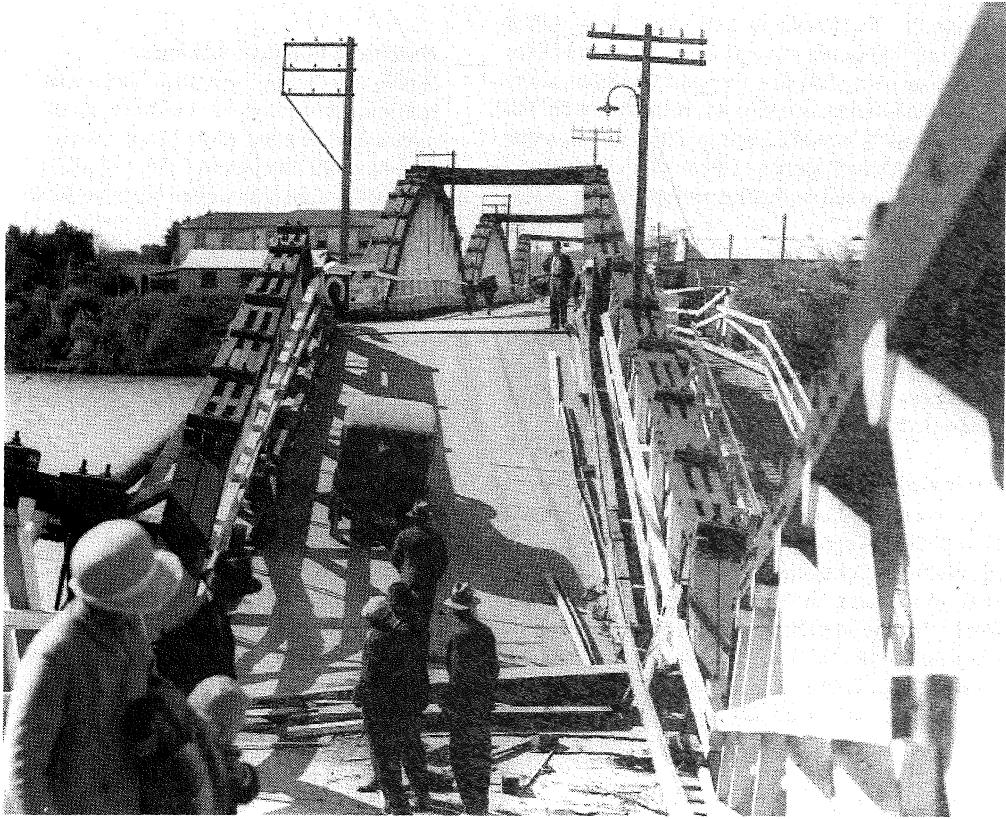
Damage to some of the road and rail bridge structures has been described in contemporary terms by Furkert [9], who discussed the nature of the damage to a number of road and railway bridges. Photographs of the notable incidents appear in various publications [22-24], including the Havelock North - Hastings road bridge (Figure 5). Another example is the Wairoa road bridge (Figure 6) which lost two adjacent 60 foot (18.3 m) spans at the southern end. According to Smith [25], the northern bank of the river slumped towards deep water, "with the result that the bottom of the nearest pier was pushed out from the bank". From Figure 6 and other photographs the pier that displaced the most was the third from the north, and as it was fully in the river it may also have been affected by liquefaction.

**Figure 6:** *View southwards of main road bridge at Wairoa, showing effect of failure of third pier from north abutment. (Courtesy of New Zealand Herald.)*

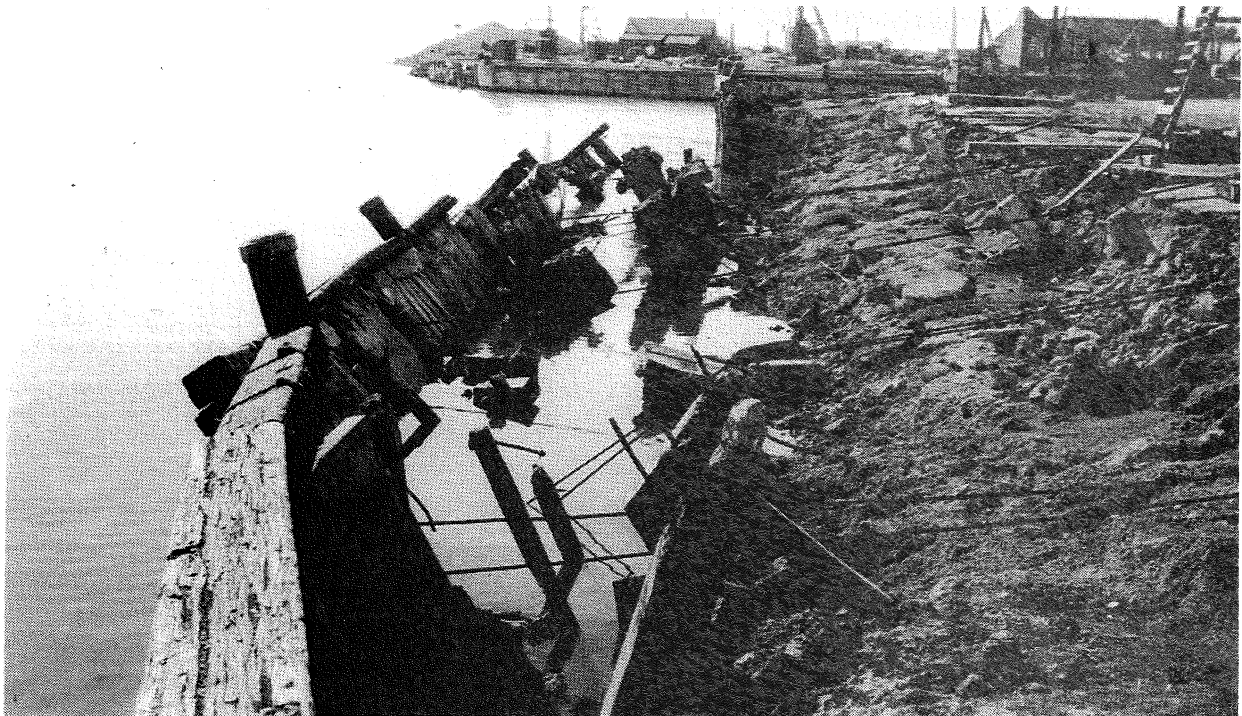
Ground shaking and liquefaction apparently combined to cause severe damage to wharves at Napier as seen in various photographs [22,23], an example of which is given here (Figure 7). In the *Remark Book* of H.M.S. "Veronica" (which helped in search and rescue operations), the damage was summarised thus:

- (1) All wharves in the Inner Harbour (Figures 3 and 7) are severely damaged and are at present unserviceable.
- (2) The breakwater is only slightly damaged.
- (3) Breakwater wharf is damaged beyond repair.
- (4) Glasgow wharf has suffered considerable damage, but is not beyond repair.

the piles. Practically no damage was done to the deck or bracing." In the above quotation Furkert was evidently referring to Glasgow wharf which was a finger wharf coming off the breakwater, an entirely concrete structure without rock or hydraulic fill. As might be expected, some of the worst damage was experienced by the wharf structures built parallel to and supporting land areas which were generally reclamations, e.g. as shown in Figure 7.

**Figure 7:** *View northwards along failed West Quay at Port Ahuriri, Napier. (Courtesy of the Alexander Turnbull Library, D.H. Jones Collection, Wellington).*

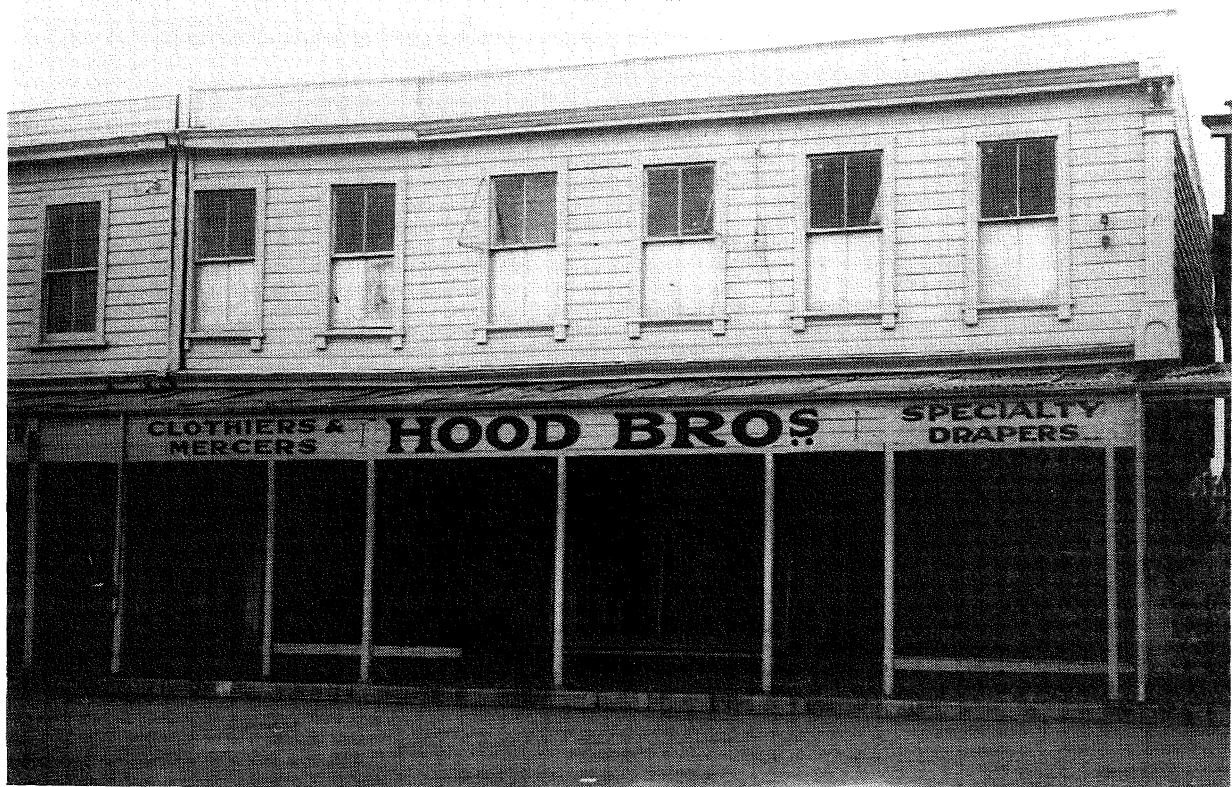
**Figure 8:** Example of racking destroying plate glass windows in the weak front wall of shops built of timber. Hood Brothers, Waipawa, in the MM8 zone. (Courtesy of the Alexander Turnbull Library, Insurance Council of New Zealand Collection, Wellington).

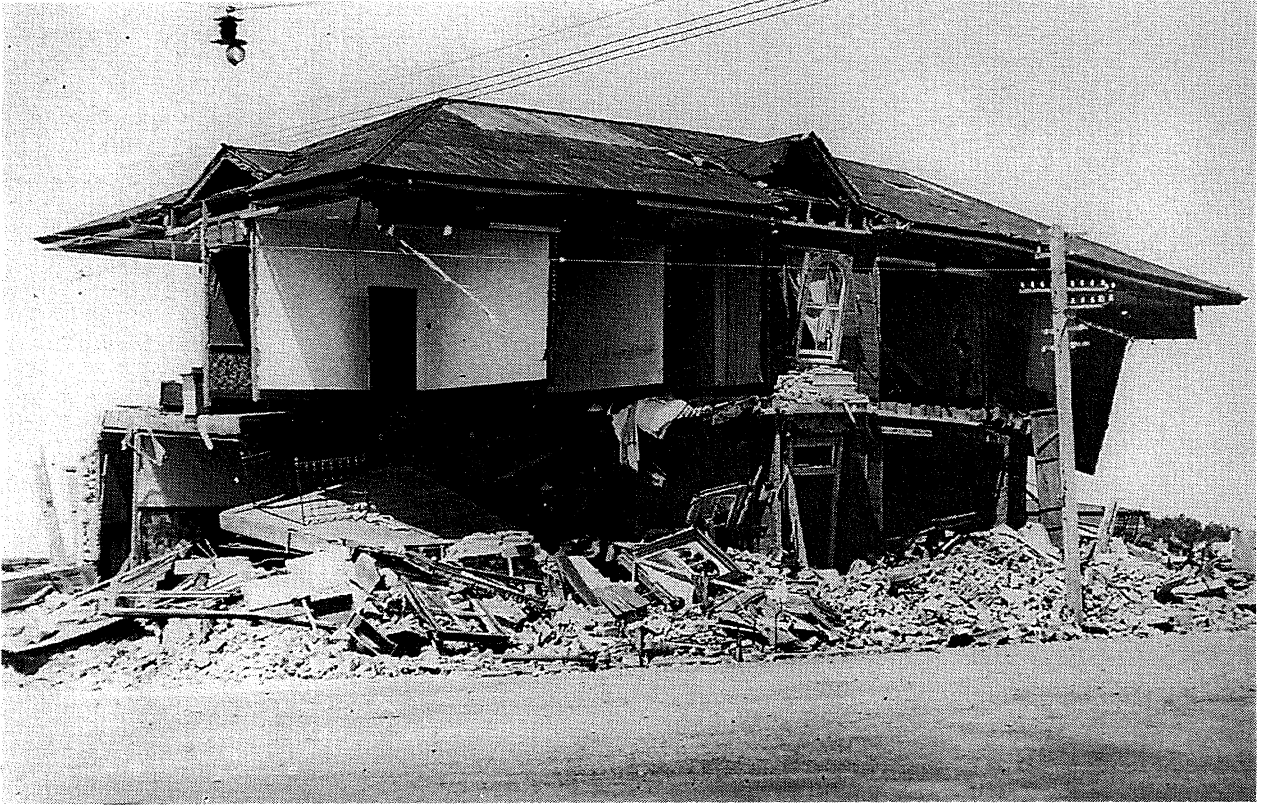
- (i) Permitting adjacent buildings of different heights to abut one another.
- (ii) Insufficient area of footings, where the subsoil was silt.
- (iii) Absence of ties across foundations [in silty ground?].
- (iv) Interior timber partitions inadequately fixed to the exterior brick walls (Figure 9(a)).
- (v) Poor mortar and inefficient band-course reinforcement (Figure 9(a)).
- (vi) Support of heavy roofs on piers or walls too thin to withstand the racking effects produced.
- (vii) Heavy brick shop fronts inadequately connected to the rest of the building.

**Figure 9:** (a) A poor brick building. The Taradale Hotel illustrating two weaknesses in brick construction: (i) external brick walls not fixed to partitions; (ii) weak mortar (cleanly separated bricks). (Courtesy of the Alexander Turnbull Library, Insurance Council of NZ Collection, Wellington).

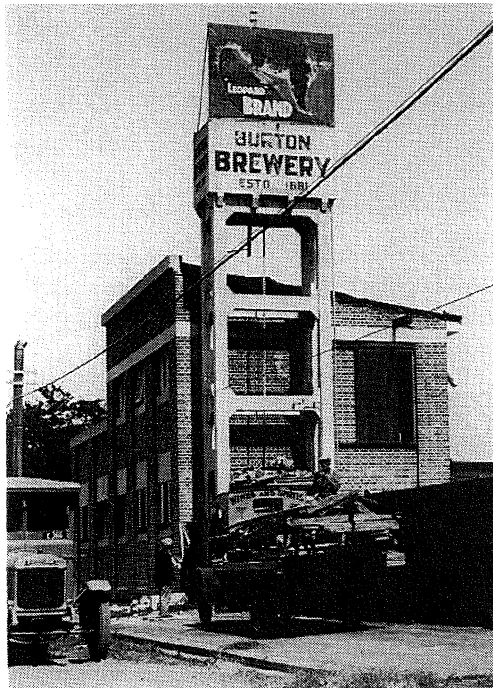
As noted earlier some brick buildings in the Hastings/Napier area suffered little damage. An example is the two-storeyed Burton Brewery in Hastings, as illustrated in Figure 9(b), which evidently was protected by the presence of reinforced concrete ring beams. It lost an unbraced brick parapet, but otherwise suffered only minor cracks.

**Figure 9:** (b) A successful brick building. The Burton Brewery, Hastings. (Courtesy of the Alexander Turnbull Library, Insurance Council of NZ Collection, Wellington).

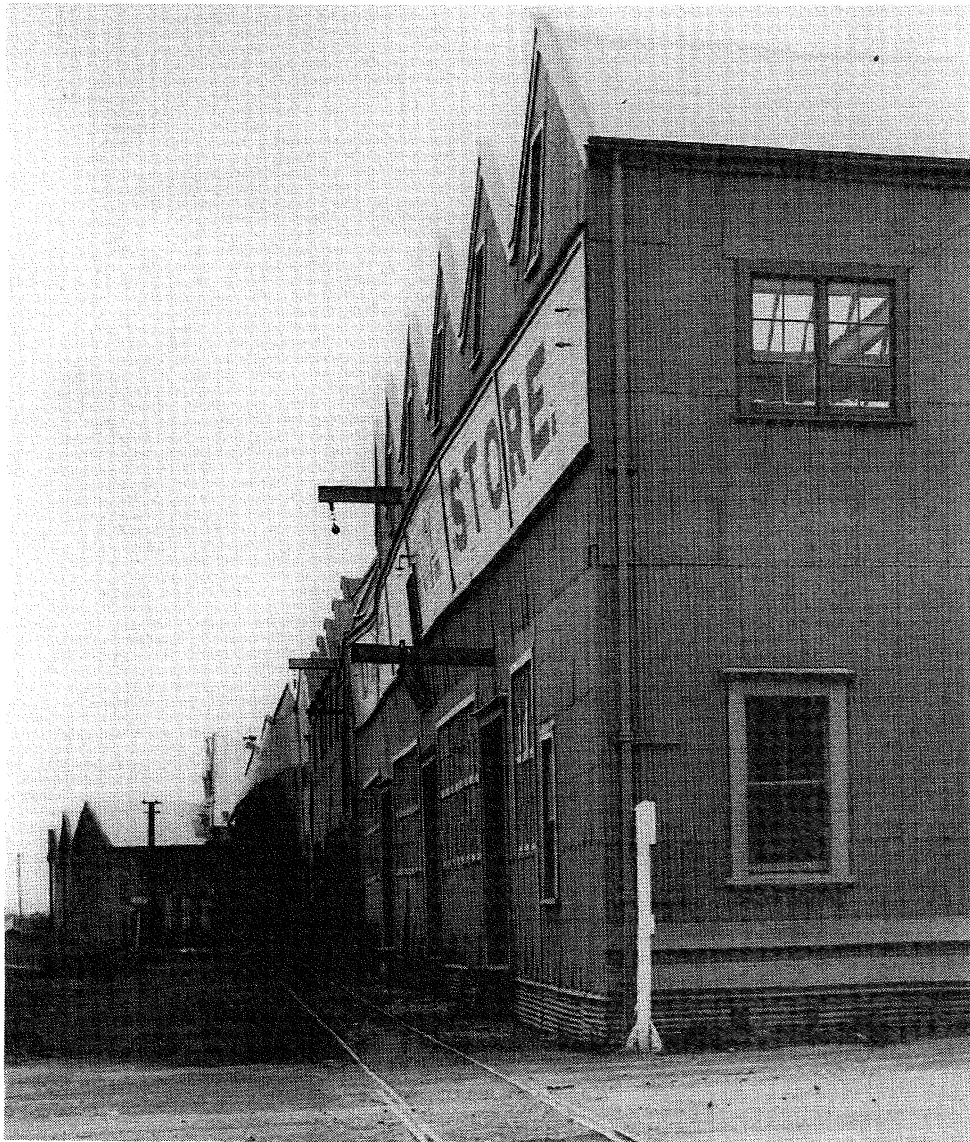
There were not many fully steel-framed buildings in Hawke's Bay in 1931. Furkert [9] notes that there was "no instance of a steel-framed building collapsing, although the brick and masonry work surrounding the steel frames were frequently much shattered." Brodie and Harris [8] stated that many of the timber-clad warehouses for wool at Port Ahuriri in Napier had structural steel (RSJs) beams and columns supporting the second floor, and were extensively damaged due to inadequate

**Figure 10:** *Dalgety's No. 2 Store, Port Ahuriri, Napier one of the few steel-framed buildings in the region, was inadequately braced.* (Courtesy of the Alexander Turnbull Library, Insurance Council of NZ Collection, Wellington).

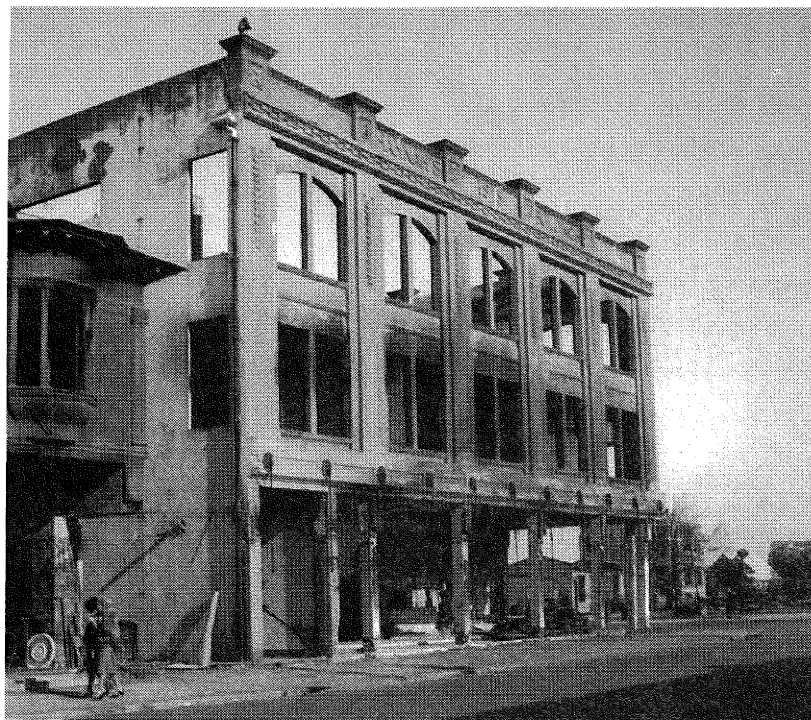
*Figure 11: (a) A successful reinforced concrete building. Hannah's shoe shop, Napier, a "corner building", MRF + concrete block infill. (Courtesy of the Alexander Turnbull Library, Wellington).*

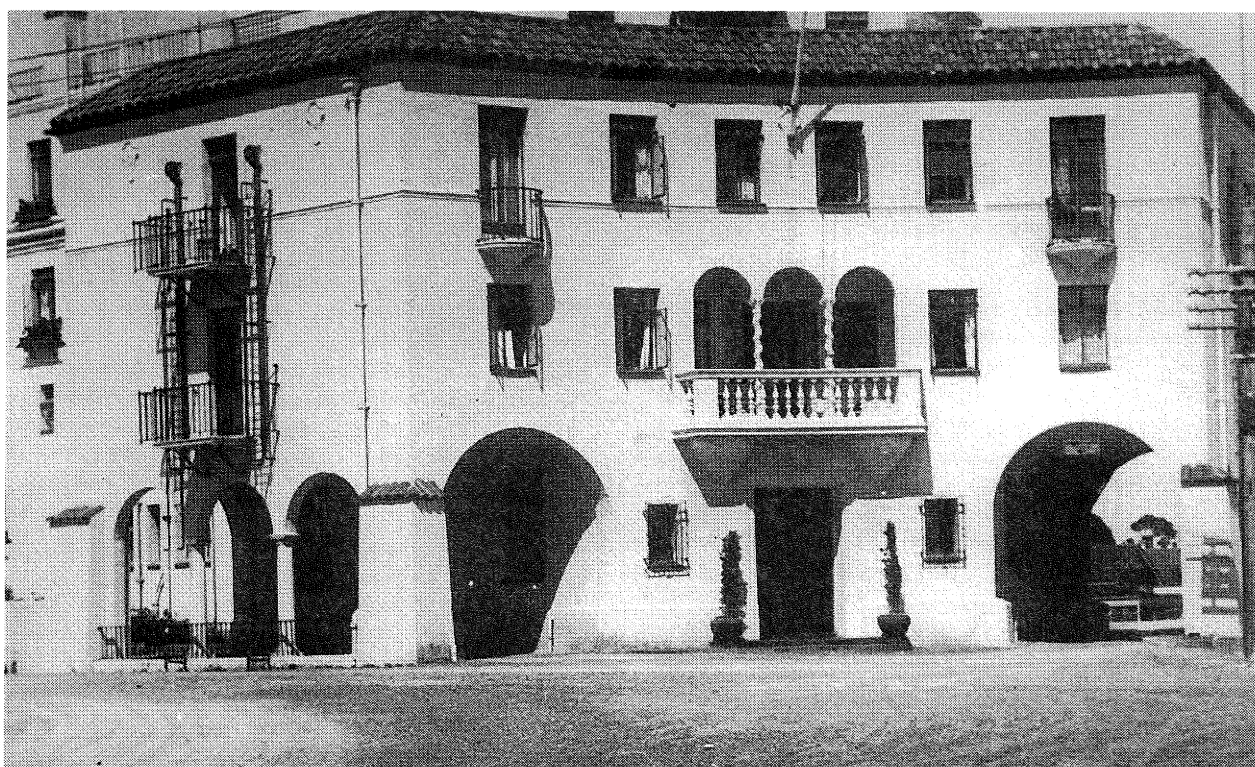
*Figure 11: (b) A poor reinforced concrete building. The Nurses' Home at Napier Hospital before the earthquake, the only r.c. building to collapse completely, due to a bottom storey weakened by large openings and little reinforcement (Courtesy of the Alexander Turnbull Library, Wellington).*
