EARTHQUAKE DESIGN AND PERFORMANCE OF STEEL STRUCTURES

H Krawinkler¹

This paper was presented as one of the keynote addresses at the Pacific Conference on Earthquake Engineering, PCEE 95, Melbourne, November 1995.

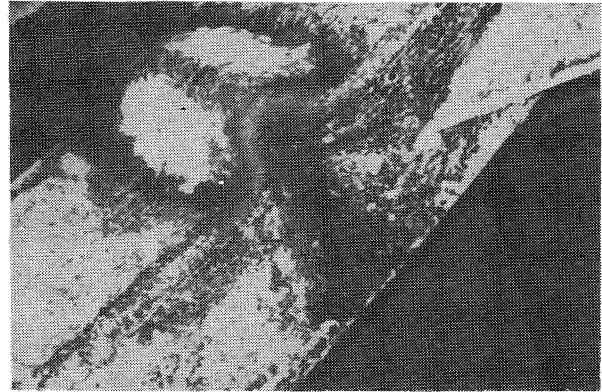
Most braced frames performed as expected in severe earthquakes. Several instances of brace buckling were reported but no case is known in which brace buckling by itself brought the structural system close to failure. There is one case, however, in which brace and brace connection performance had very undesirable consequences that did cause concerns about structural integrity. This is the case of a 4-story office building in which primary lateral load resistance was provided by thin-walled tubular braces in a concentric chevron arrangement. Several of the tubular braces buckled globally, causing severe local buckling with very large local strains as shown in Figure 1. This severe local buckling occurred at three places in a brace; at the two ends close to the gusset plates and in the middle of the brace. Under cyclic load reversals cracks formed at the corners of the tubes where the strains due to local buckling are highest and large residual strains exist due to the

FIGURE 1. *Severe local buckling in a tubular brace*

cold-forming process. The cracks must have propagated rapidly under load reversals and led to several brace fractures. Some of the braces fractured in the middle and others fractured near the gusset plate. This type of failure has been observed in several experimental studies (e.g., [6, 9]) and points out the need for strict limitations on the allowable width/thickness ratio of walls in tubular sections. The recommendation made in [9] is to limit the width/thickness ratio in tubular braces to a value of 18.

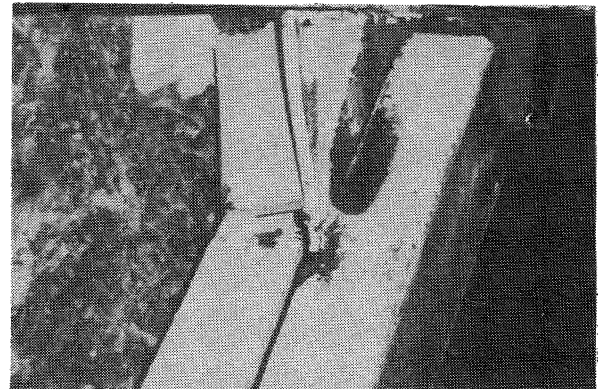
FIGURE 2. *Fracture at welded brace connection*

In the same structure a second type of failure was observed that had equally severe consequences. The braces were slotted at the ends and fillet welded to gusset plates which in turn were welded to the bottom flange of the beams (in the middle of the chevron). Weld fracture of the type shown in Figure 2 was observed. It is not known to the writer whether this type of fracture occurred because of insufficient fusion or because of insufficient length or size of welds. The latter would be possible without violating the present seismic code, which limits the maximum force that must be transferred through a connection to a certain fraction (usually in the order of 3/8) of the force due to the elastic spectral strength demand. This may be inadequate in cases in which the braces are strong and attract high story shear forces. Thus, more effort needs to be devoted to a more accurate determination of the maximum force that can be attracted in a brace and to detailing that assures that this maximum force can be transferred safely through the brace connection.

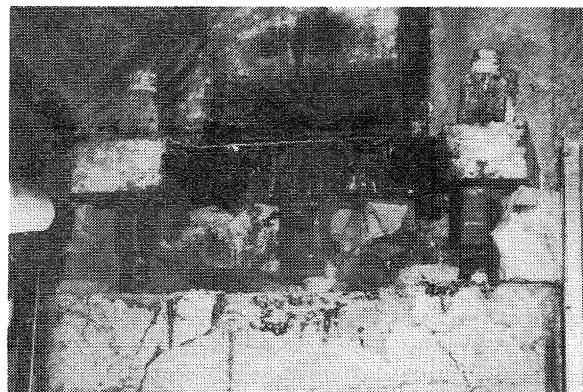
Several cases of cracks in welds connecting columns to base plates have been reported. In general, these cracks propagated horizontally along the welds and led to partial separation between a column and the supporting base plate. Such local failures have been observed in other earthquakes and cannot be considered surprises. In one case, however, dramatic vertical fractures were seen in many heavy base plates of slender single-bay x-braced frames that were provided around the perimeter of a 4-story building located not far from the epicenter of the earthquake. A photo of a typical column base connection is shown in Figure 3. The column was welded to the base plate, and on one side a diagonal brace was welded to a gusset plate which in turn was welded to the column web and the base plate. The base plate was connected to a concrete pedestal by means of four long anchor rods. A shear key was welded to the bottom of the base plate, as can be seen below the torch-cut section of the plate.

FIGURE 3. Base connection for column and brace

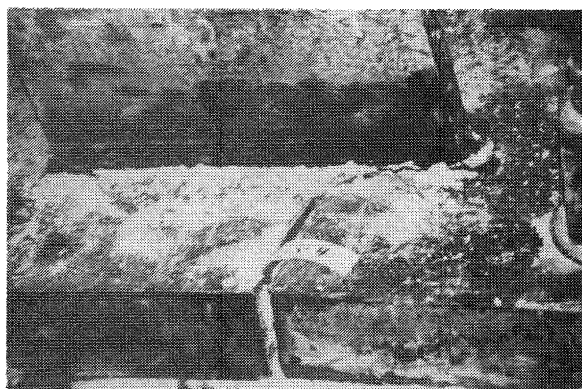
Many of the 10 cm thick base plates fractured in a very consistent pattern as shown in Figures 4 and 5. The fracture was usually close to vertical and extended all across the width and through the thickness of the base plate. It occurred always at the side opposite the brace connection and usually several centimeters in from the edge of the column flange. In addition to the base plate fractures, horizontal cracks were usually observed along the welds connecting the two column flanges to the base plate, extending from the edge of the column flanges to or beyond the fracture surface in the base plate (Figure 4).

The following scenario is postulated for these failures. Most of the braced bays were slender (height to width ratio of about 4) and had to support relatively light gravity loads but large seismic inertia forces since bracing was provided only at the perimeter of a large floor area. Since the braces were relatively strong, large story shear forces and therefore large overturning moments were generated. The overturning moments did generate large tensile forces in the columns, which in turn caused significant bending moments in the base plates. The critical spots were the welds at the edges (tips) of the column flanges, where cracks initiated. The cracks propagated horizontally along the column flanges towards the column web, thus increasing the distance between the tensile stress resultant in the column and the anchor rods, which further increased the bending moments in the base plate. The cracks likely turned into the base plate when the horizontal tensile stresses due to plate bending exceeded a certain threshold.

After the base plate fractured, other events happened that led to more damage. Since only part of the base plate was connected to the column, the whole uplift force had to be resisted by the two anchor rods on the side of the diagonal brace. This led to pull-out or yielding of the anchor rods, as was evident in a clear separation noticed between several of the anchor rod nuts and the base plates. The portion of the base plate still connected to the column uplifted and bounced back on the concrete pedestal, causing damage to the pedestal and widening of the crack.

FIGURE 4. Crack propagation in weld and base plate

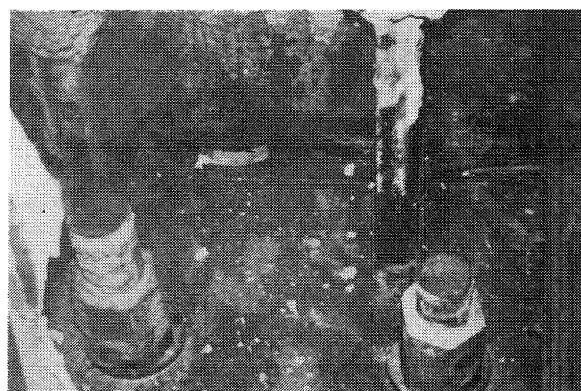
FIGURE 5. Fracture across base plate

The question to be answered is why plates made of apparently ductile steel fractured in such a dramatic fashion. Material studies performed after the earthquake did show that the plate material fulfills the ASTM strength and chemical composition requirements for A36 steel. The question needs to be answered from the viewpoints of fracture mechanics and welding technology. A crack, once it has formed (in this case as a horizontal crack at the column flange to base plate weld), can easily change direction in conformance with the orientation of

the principal tensile stress and the fracture mechanics properties of the materials. Significant tensile stresses may have pre-existed near the surface of the plate since a relatively thin flange was welded to a thick plate that acted as a heat sink and cooled rapidly compared to the column flange. The rapid cooling may also have caused surface embrittlement in the base plate, which degraded the fracture properties.

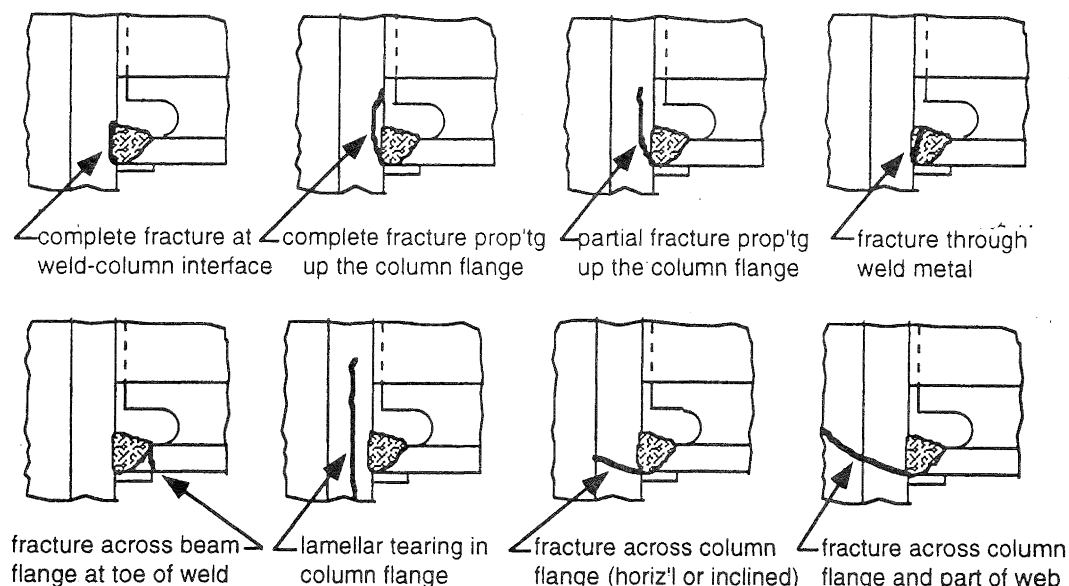
Failure modes observed at and around the beam bottom flange weld are illustrated in Figure 7. Very common was the type of fracture shown at the top left of the figure, in which the weld separated cleanly from the column flange. It is quite likely that there are many instances in which the crack did not propagate all the way up the weld-column interface; unfortunately these cracks cannot be detected through visual inspection. In many cases the fracture initiated at the intersection of the backup bar and the column and propagated into the column flange material taking out a piece ("nugget") of the column flange as shown in the second sketch from the left in the top row of the figure. Sometimes the crack stopped within the column flange as illustrated in the third sketch from the left. Fracture through the weld material, as shown in the top right sketch, was also observed frequently. The type of fracture illustrated in the lower left of the figure, in which a crack initiated at the toe of the weld and propagated through the heat affected zone in the beam flange, was seen in only a few of the Northridge

FIGURE 7. Fracture modes observed at welded beam bottom flange to column flange connection

structures but has been observed frequently in experimental studies. Lamellar tearing of the type shown in the second sketch from the left in the bottom row was observed in a box column. The third sketch from the left in the bottom row illustrates frequently observed horizontal or inclined fracturing of the column flange. In some cases the crack extended into the column web as illustrated in the last sketch. At least one case was reported in which horizontal column fracture extended all the way across the column width, causing complete column separation.

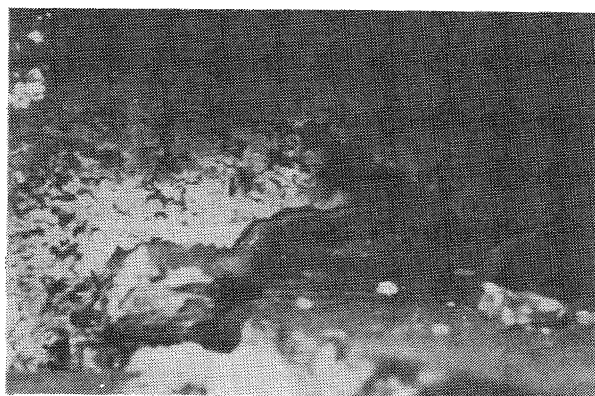
An example of a fracture of the type illustrated in the second sketch from the left in the top row of Figure 7 is shown in Figure 8. The surface of such a fracture is shown in Figure 9. The fracture surface extends over the full width of the beam flange and is bounded by the backup bar below the flange, two run-off tabs that acted more like dams on the left and right, and column flange material on the top. Based on the striation markings it is likely that cracking in this case initiated at the two edges of the flange and propagated inward towards the center of the flange. Significant imperfections on the fracture surface can be noted at the two ends, along the interface of the weld and the

FIGURE 8. Nugget type fracture

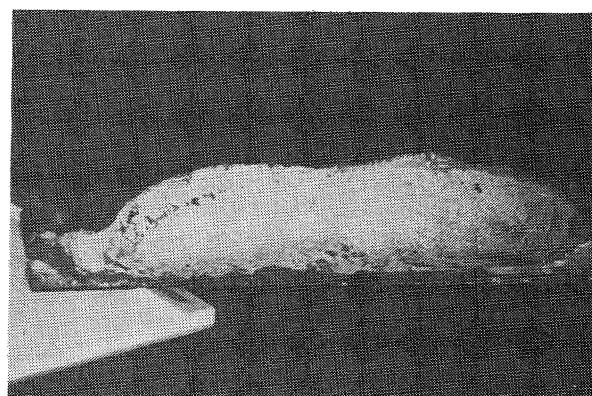
back-up bar, and in the upper portion where the fracture went through the column material. The imperfections at the interface of the weld and the backup bar have been noted in many fractures, particularly at the center of the weld where welding had to be interrupted because of the presence of the beam web. These imperfections are caused by slag inclusions along the root pass of the weld, which are equivalent to initial cracks.

FIGURE 9. Surface of a nugget type fracture

- Inadequate run-off tabs. In many of the fractured connections it can be assumed that cracking started at the ends of the weld and propagated towards the center (see Fig. 9). This assumption is based on the observation that run-off tabs were turned up in a way that they acted as dams rather than run-off tabs. The likelihood is high that large amounts of slag collect behind these dams. Even though these slag inclusions may be outside the edges of the beam flange, they act as stress risers and are triggers for crack propagation.

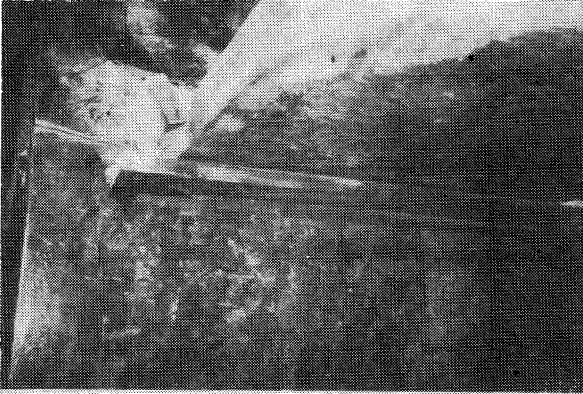
Examples of fractures extending into the column are shown in Figures 10 and 11. Figure 10 shows a case in which the column flange fractured horizontally but the crack did not extend into the column web. Figure 11 shows a case in which the column flange fractured at an angle of about 45 degrees and the crack propagated deep into the column web.

FIGURE 10. Fracture across column flange

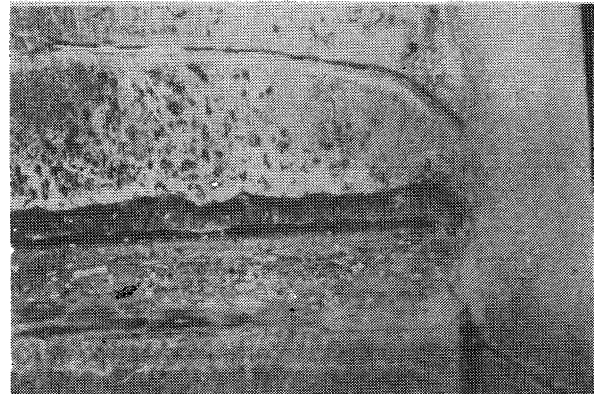
FIGURE 11. Fracture extending into column web

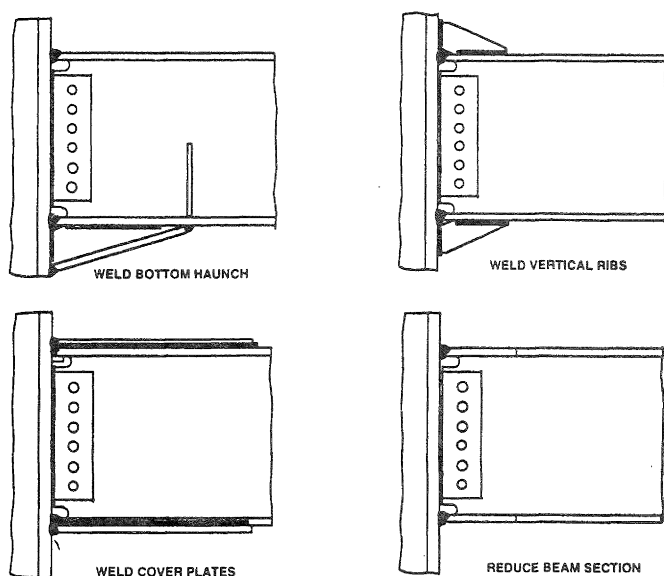
The four most widely advocated alternatives are illustrated in Figure 12. All of them have undergone limited testing that has shown good performance.

The bottom haunch connection shown at the top left of Figure 12 is very attractive in concept but poses difficulties in welding. The advantage is that it provides a smooth transfer of bottom flange forces to two welds spaced a distance apart. This reduces the stress level at the bottom welds and provides redundancy. It also reduces the stress level at the top flange weld, but to a much smaller degree. Great difficulties exist in welding the web of the haunch section to the bottom flange of the beam because of access problems. These problems are reduced if the slope of the haunch is increased. However, a steep slope (in the order of 45 degrees) is detrimental to the load path and will require much additional depth if the beam plastic hinge is to be moved clearly away from the connection. The vertical stiffener at the end of the haunch is needed to prevent beam flange distortion that may lead to stress concentrations at the center of the weld connecting the haunch flange to the beam flange.

FIGURE 12. Widely advocated alternatives to standard welded connection

Vertical ribs, as illustrated in the top right sketch of Figure 12, have been used in several repairs of damaged Northridge structures. Limited testing with two ribs welded at the third points of the beam flange has shown satisfactory performance. However, these tests were performed on specimens with very thick column flanges, and it remains to be seen whether stress concentrations, which have to be expected in columns with thinner flanges, will allow satisfactory performance for all cases. The use of a single rib at the web level is not recommended because of the potential for cracking of the weld connecting the rib to the beam.

Much experimental work has been performed on connections with cover plates, the alternative illustrated in the bottom left sketch of Figure 12. The most widely used configuration employed a wide rectangular bottom cover plate to which the beam bottom flange was fillet welded, and a tapered top cover plate which was fillet welded to the beam top flange. The majority of the tests were successful, but some failed prematurely at the welds connecting the flange and cover plate to the column or at the fillet weld connecting the beam bottom flange to the cover plate. The behavior depends strongly on the quality of the welds and on the through-thickness properties of the column flange material. This alternative is cost effective, but it remains to be seen whether it provides the reliability desirable for structural safety.
