# LESSONS FOR NEW ZEALAND LIFELINES ORGANISATIONS FROM THE 17 JANUARY 1995 GREAT HANSHIN EARTHQUAKE

This report outlines the observations and findings with regard to lifelines and other infrastructural items from each of the various New Zealand post-earthquake visits to Kobe subsequent to the NZNSEE reconnaissance team visit. The preliminary assessments on lifelines aspects made in the NZNSEE reconnaissance team report are developed further. Lessons and recommendations for New Zealand are presented.

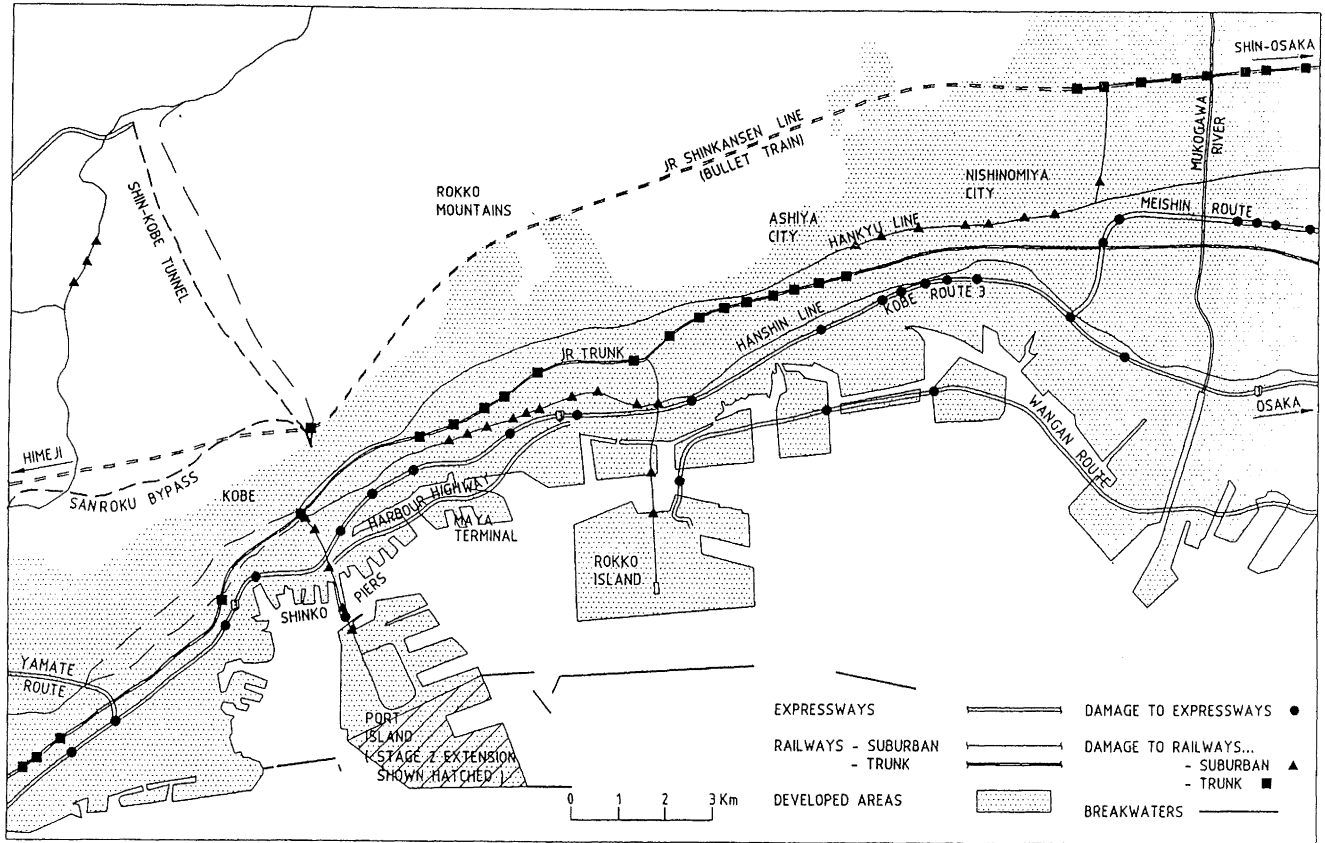
FIGURE 5.1 Damage to primary transportation routes in the Kobe area [Billings, 1995] and port layout

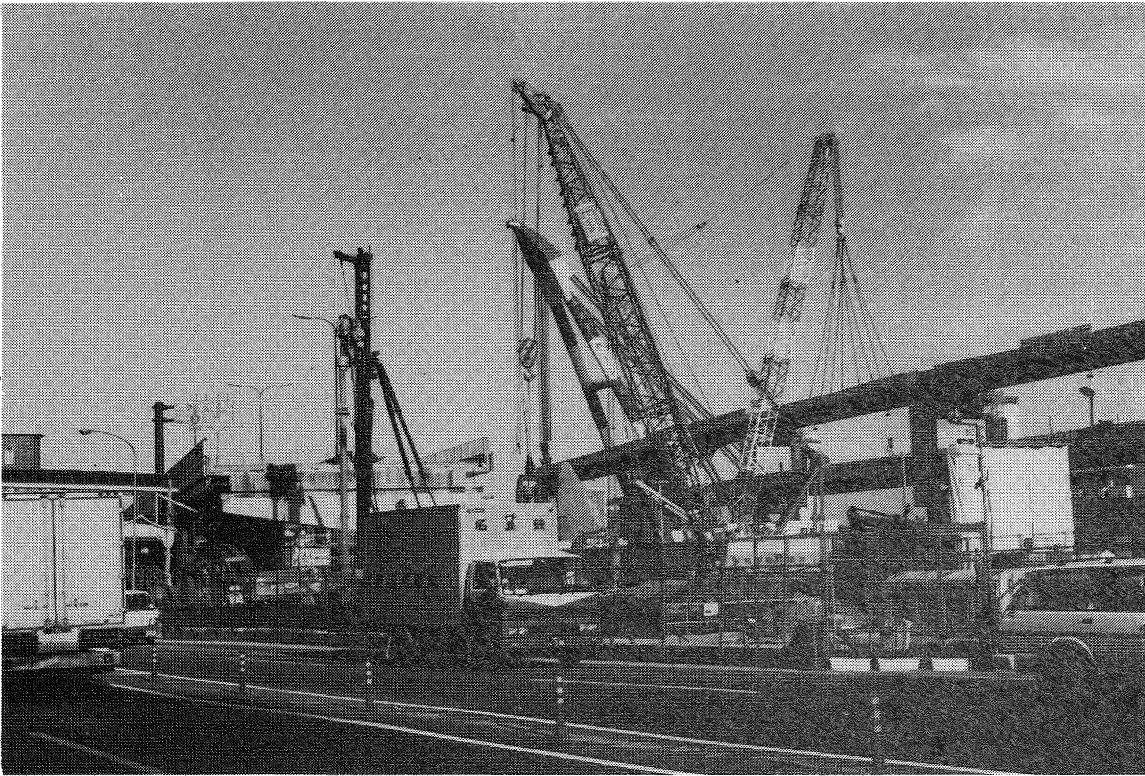
*FIGURE 5.2 Restoration work underway on Kobe Route 3. Highway 43 is at grade with the elevated Kobe-Yamate bypass in the background*

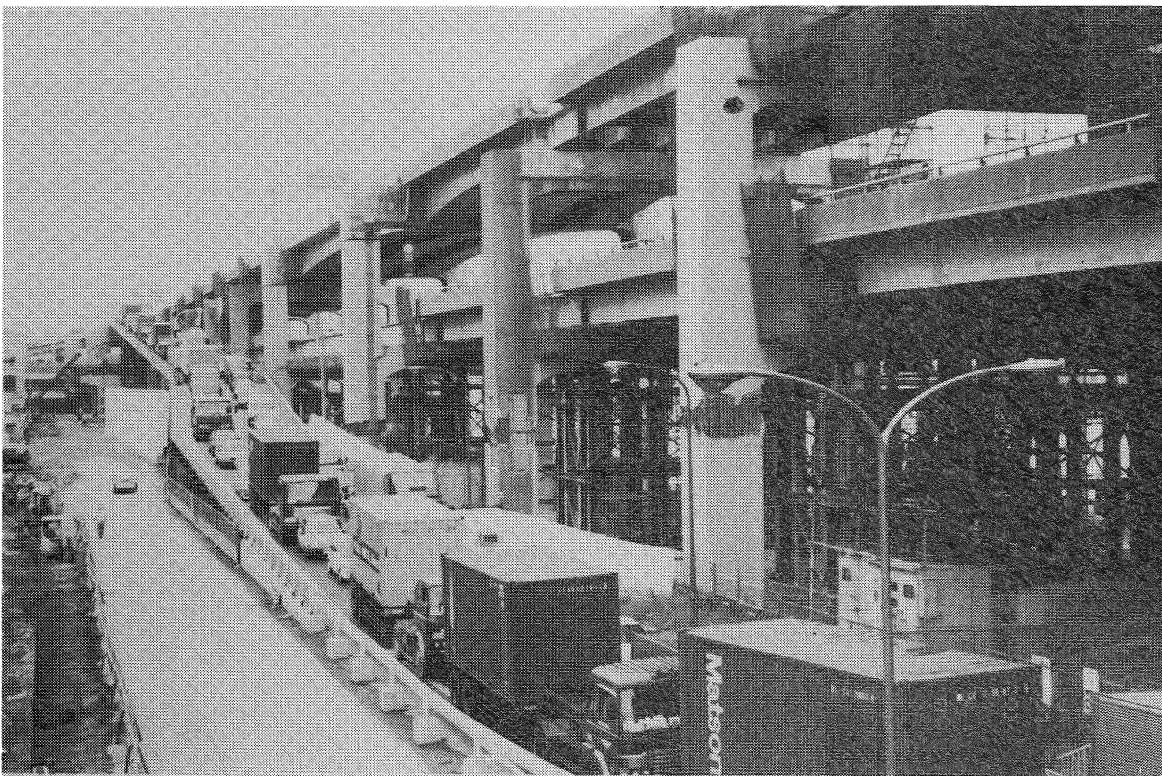
*FIGURE 5.3 Repair work underway on road linkages to Port Island, noting the severe congestion on the temporary route.*

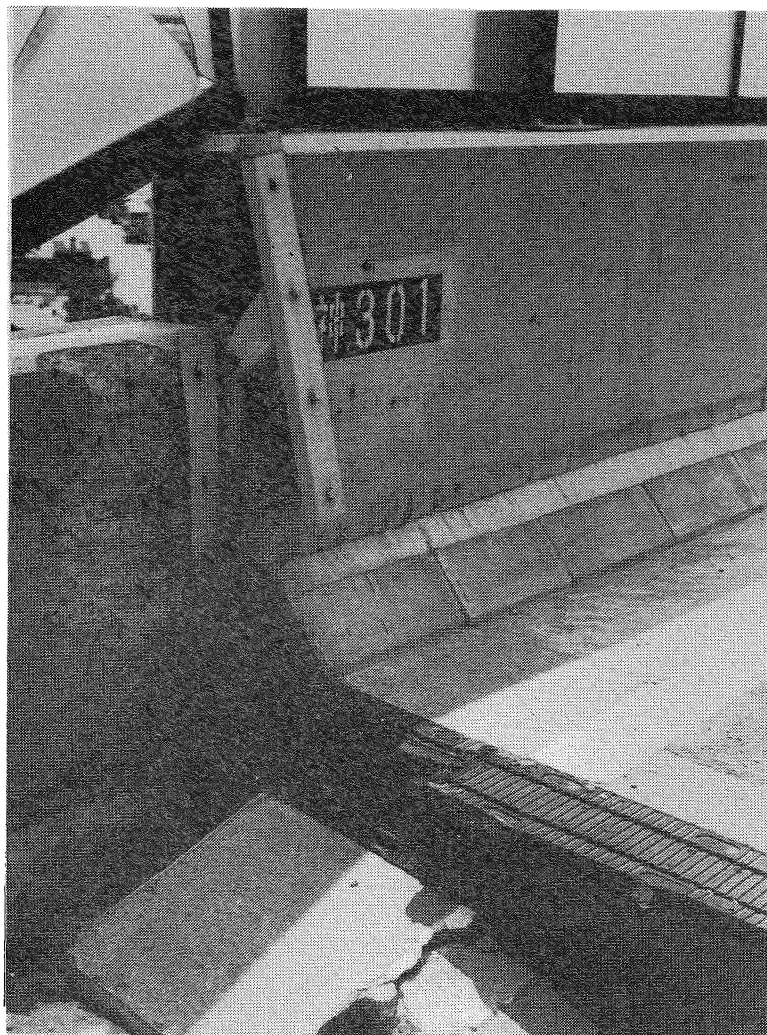
*FIGURE 5.4* Damage at bridge deck connections, Kobe Route 3

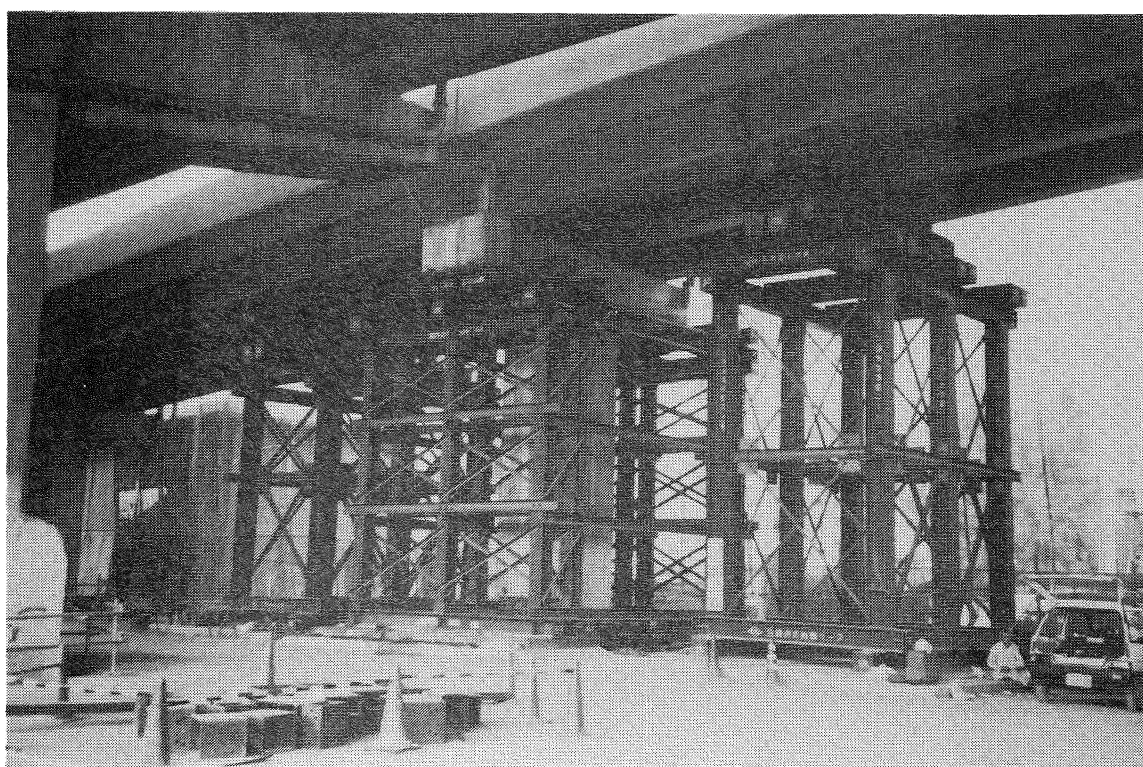
*FIGURE 5.5* Propping of Kobe Route 3 expressway

Typical measures adopted for the strengthening of reinforced concrete bridge piers to current earthquake standards include:

- Removal of damaged concrete and reinstatement of original longitudinal and transverse reinforcement.
- 30mm longitudinal reinforcing bars grouted into the existing foundation outside the existing column, and full strength welded to bars above for the height of the pier.
- Transverse reinforcement consisting typically of D16 bars at 150 mm centres added to confine new and existing concrete.

- A 6 mm steel jacket and new concrete of average thickness 300 mm (depending on geometry of pier) added around the existing pier.

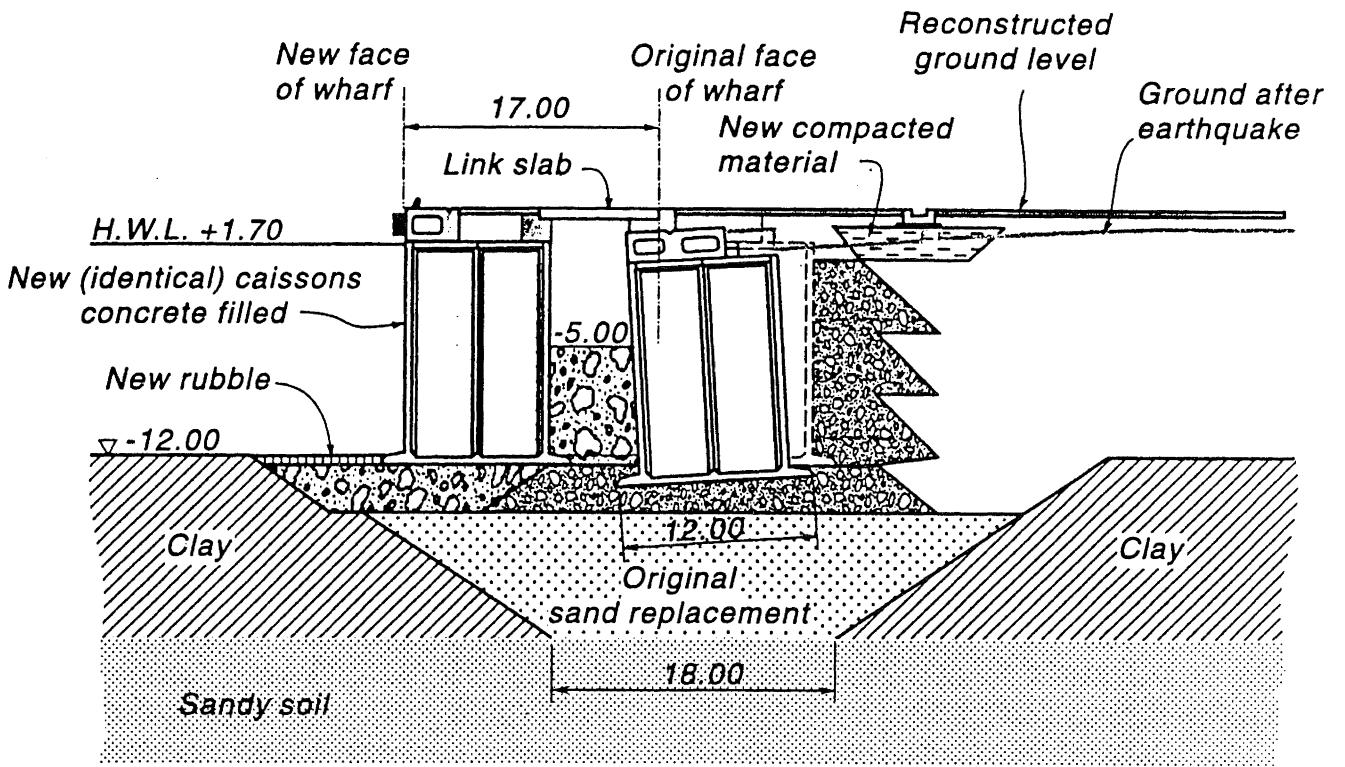
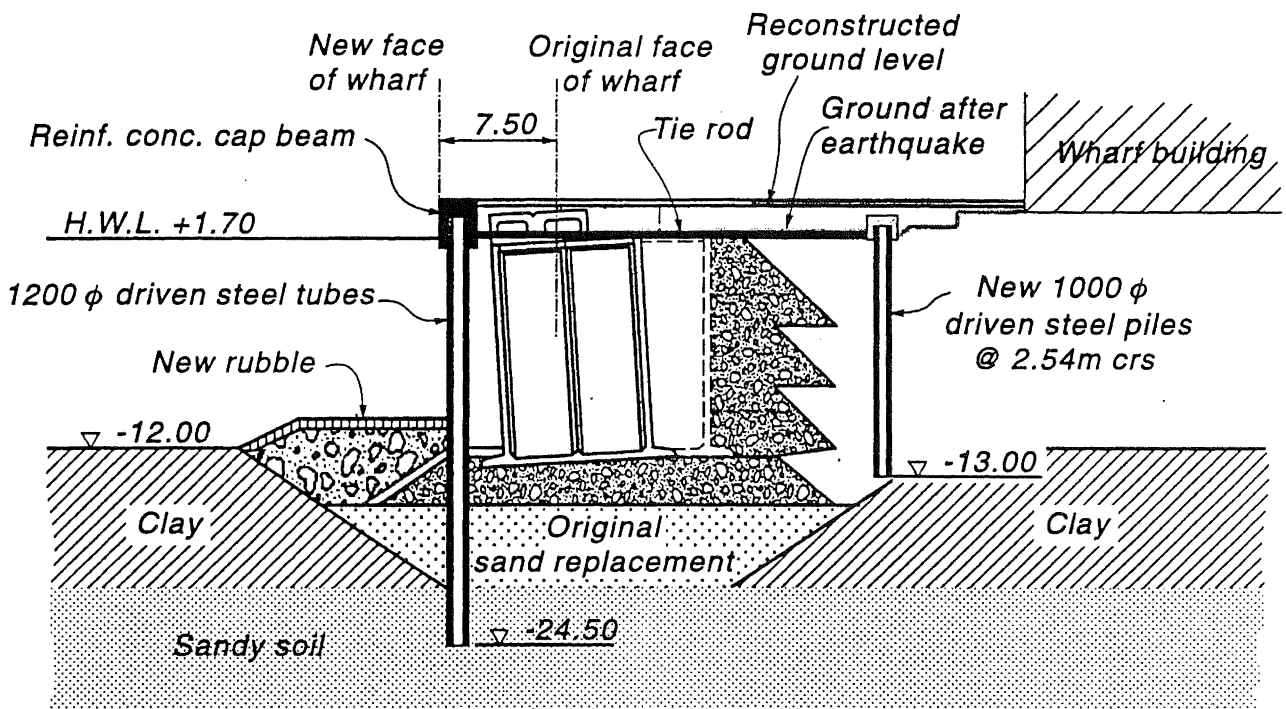
(a) Placement of New Caissons

(b) Driving of Steel Piles

FIGURE 6.1 Repair methods for rotated sea wall caissons

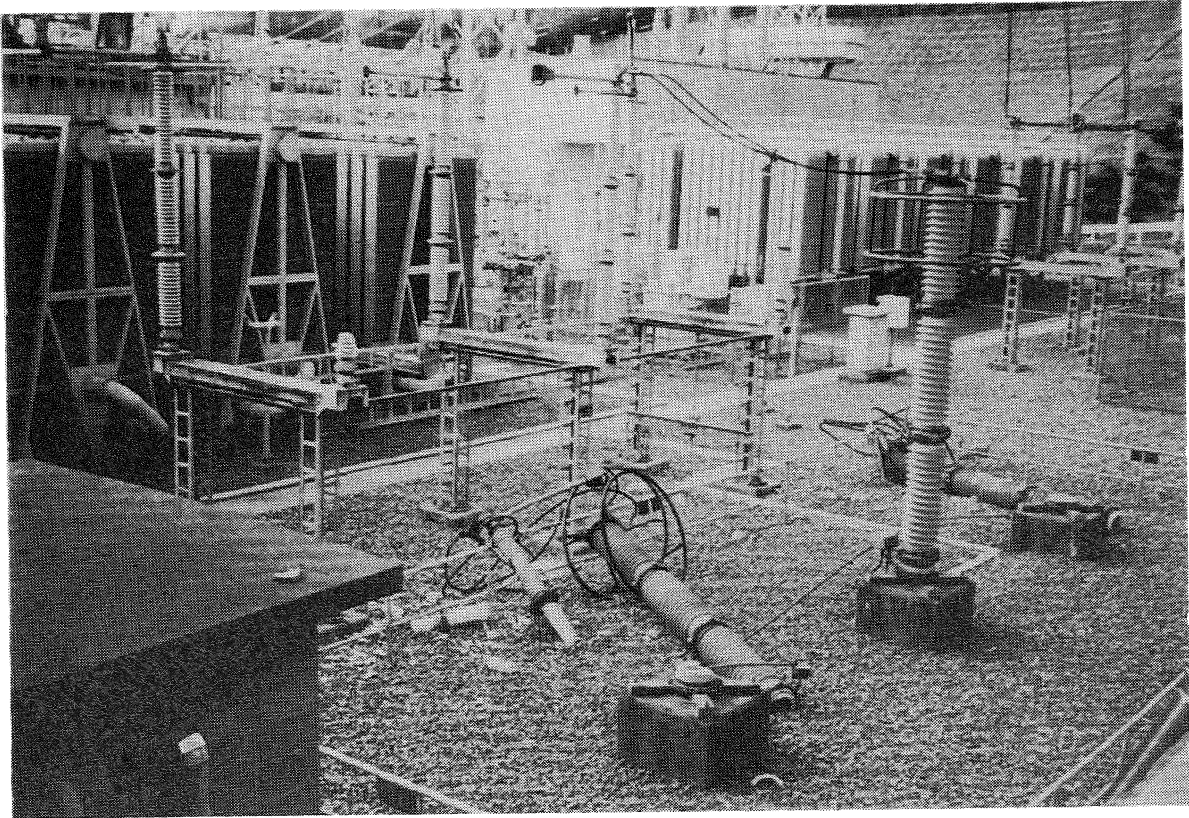
*FIGURE 8.1 Collapse of a 275 kV arrester*

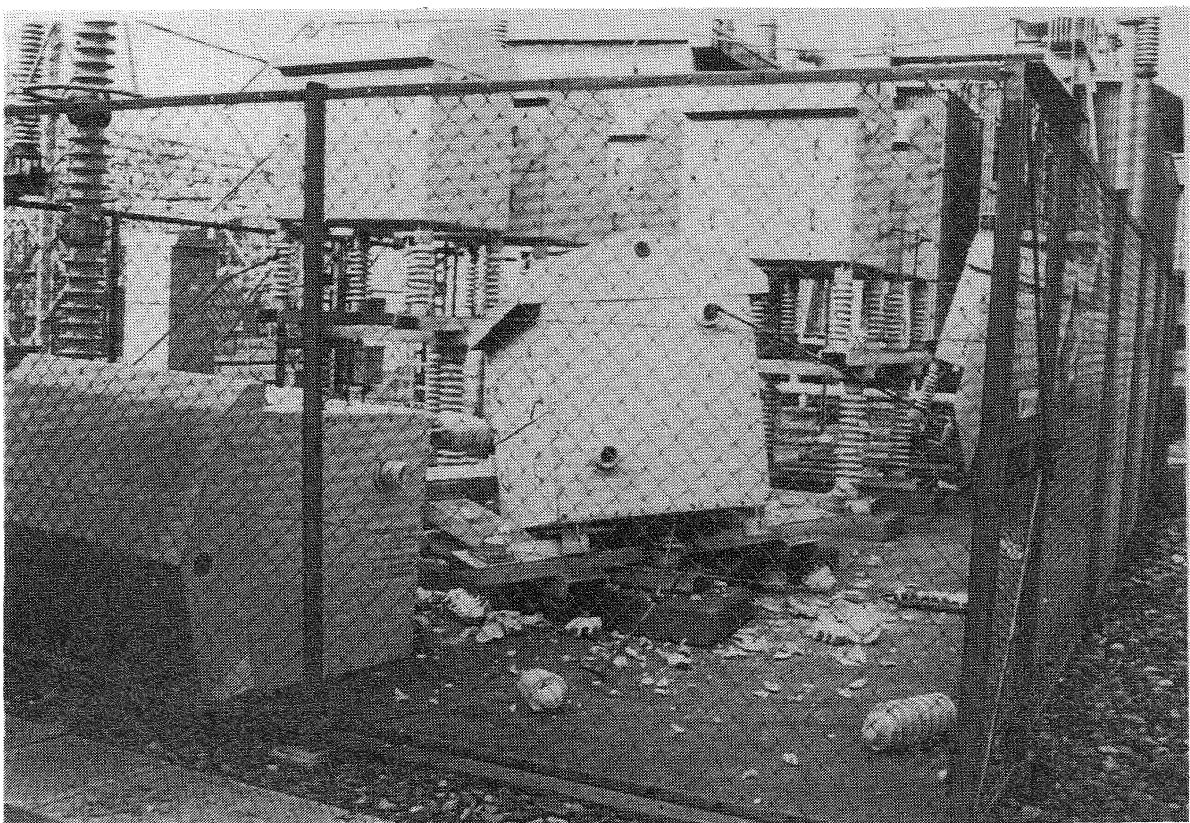
*FIGURE 8.2 Collapse of a neutral resistor*

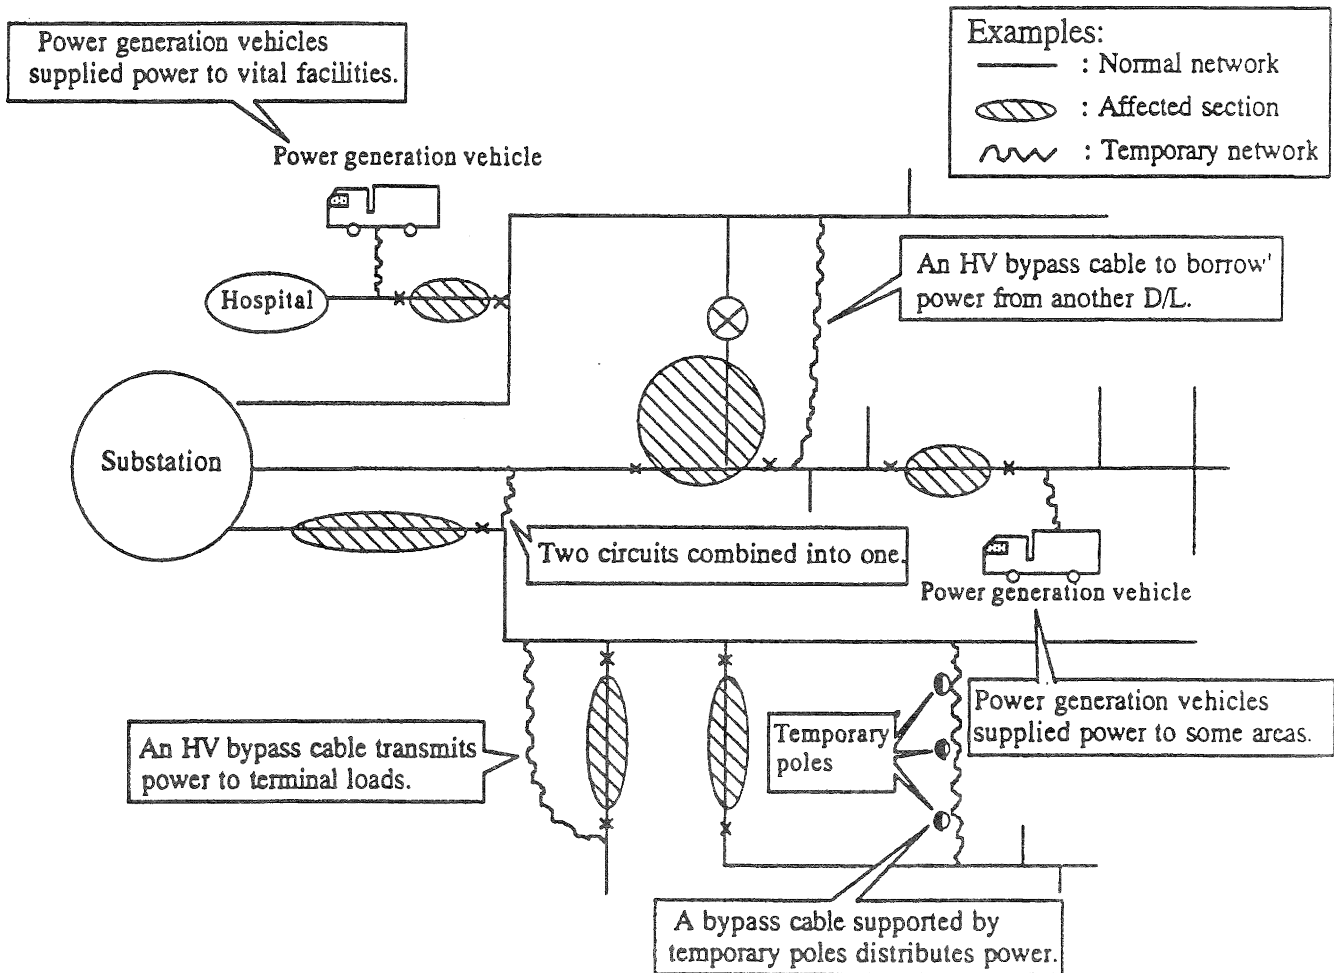
FIGURE 8.4 Temporary Repairs to an HV network
