PERFORMANCE OF REINFORCED CONCRETE BUILDINGS IN THE 2016 KUMAMOTO EARTHQUAKES AND SEISMIC DESIGN IN JAPAN

Mehdi Sarrafzadeh¹, Ken J. Elwood², Rajesh P. Dhakal³, Helen Ferner⁴, Didier Pettinga⁵, Mike Stannard⁶, Masaki Maeda⁷, Yoshiaki Nakano⁸, Tomihisa Mukai⁹ and Takuya Koike¹⁰

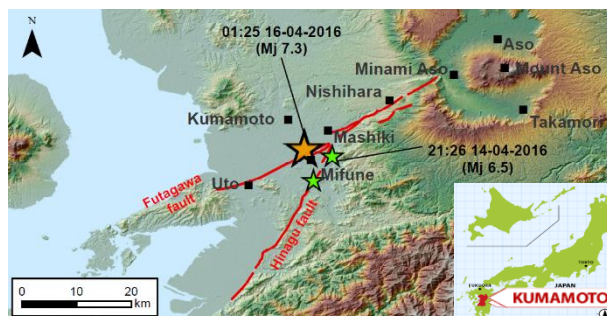
Figure 1: Epicentre and fault map of Kumamoto Prefecture. Adapted from Chiaro et al. (2017) [2]. Inset map of Japan obtained from <https://www.kumagaku.ac.jp/english/> (accessed June 2017).

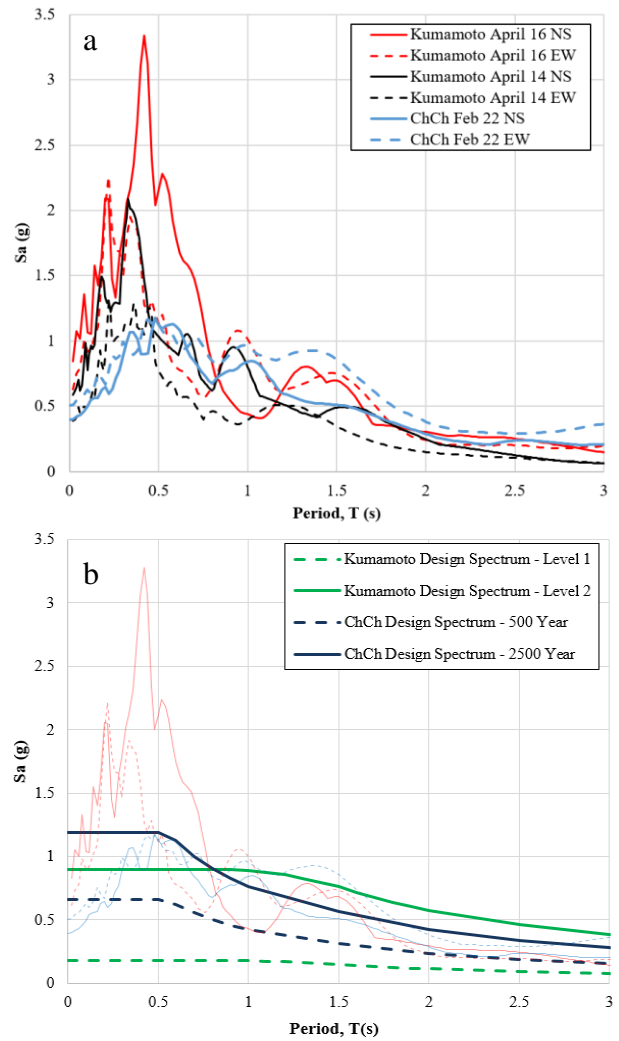
Figure 2: (a) Kumamoto vs. Christchurch response spectra. (b) Kumamoto vs. Christchurch design spectra (based on $Z=0.22$ – pre 2011 hazard factor). Response of April 16 Kumamoto and Feb. 22 Christchurch event included. Japanese design Level 1 represents the ‘Damage Limit State’ (similar to NZ SLS) and Level 2 represents the ‘Safety Limit State’ (similar to NZ ULS). Kumamoto response spectra obtained from data recorded at K-net station KMM006. Christchurch response spectra represent average response of data from CanNet stations CCCC and CHHC as well as NSMN stations CBGS and REHS.

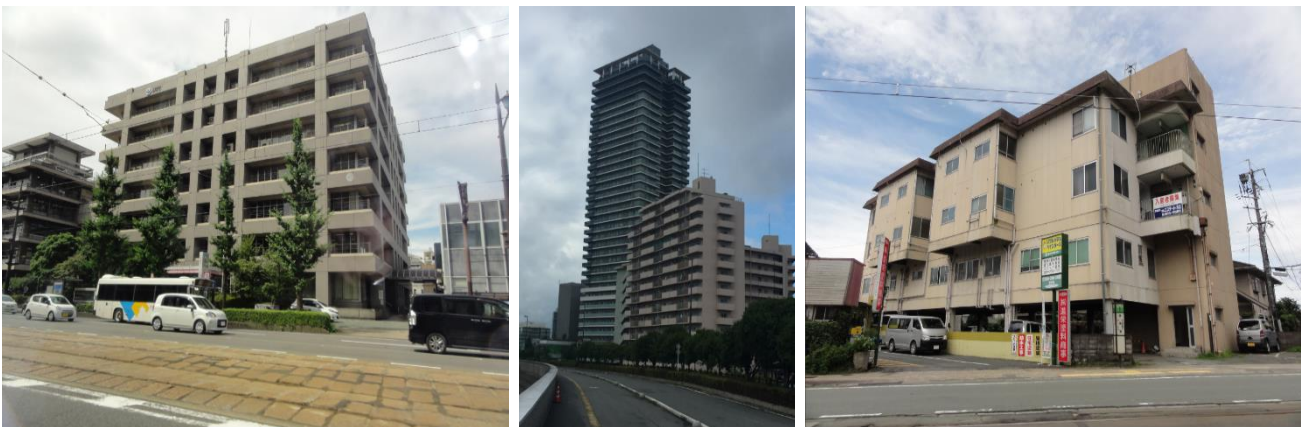
Figure 3: Example of multistory buildings with no damage.

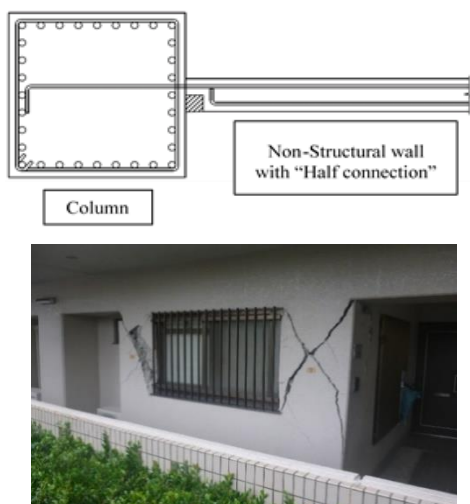
Figure 4: Typical non-structural wall connection and example of damage to non-structural wall (see Appendix A2).

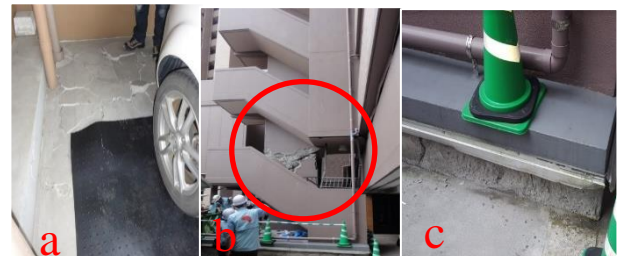
Figure 5: External damage to base isolated buildings (a) Base Isolated Building No.1 (Appendix A5) (b) & (c) Base Isolated Building No.2 (Appendix A6).

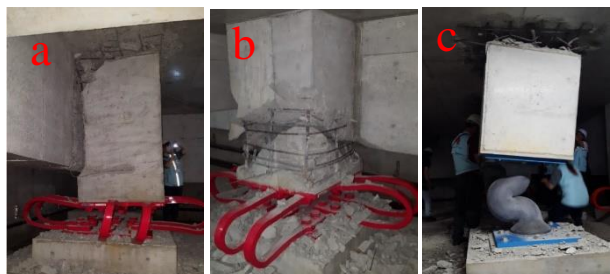
Figure 6: Damage sustained to Steel (a) & (b) and lead (c) dampers below Base Isolated Building No. 1.

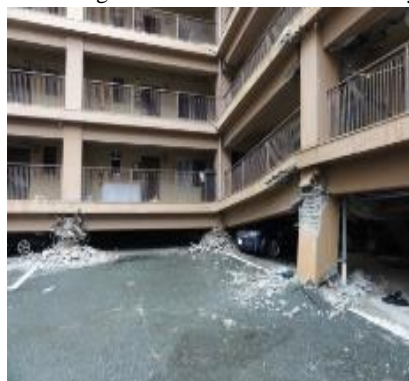
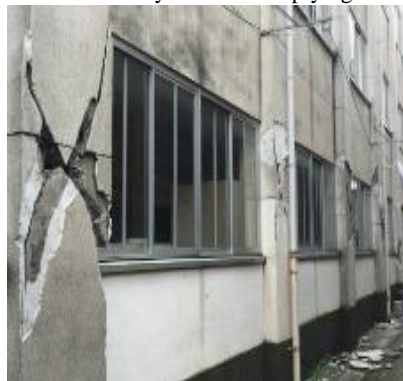
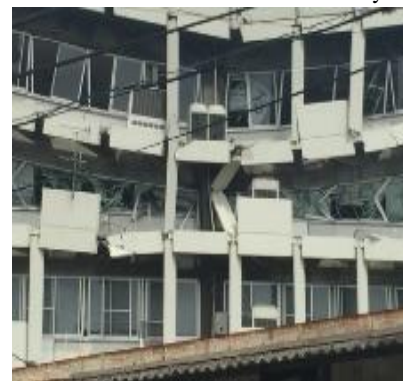
Figure 7: Examples of damage to pre-1980s concrete buildings.

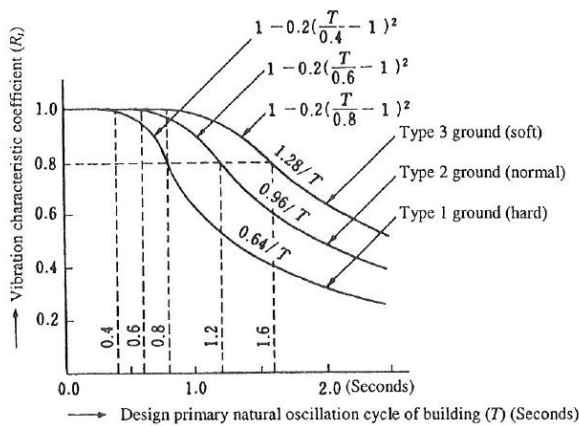
Figure 9: R_t values for buildings of different natural period founded on different soil types. Figure adapted from BSL seismic loading guidelines [6].

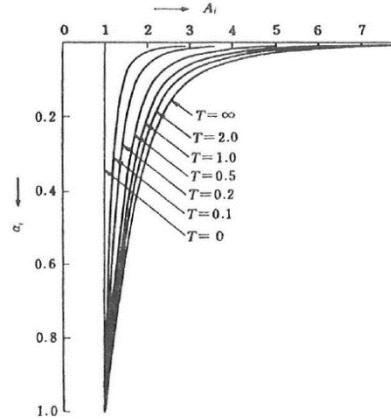
Figure 10: Sensitivity of A_i to different values of α_i . Figure adapted from BSL seismic loading guidelines [6].

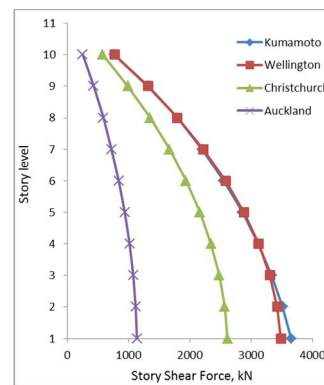
Figure 13: Story Shear Force for Kumamoto (Damage Check, Soil Type 3) vs NZS1170 SLS (Ductility 1.25, Soil Type E).

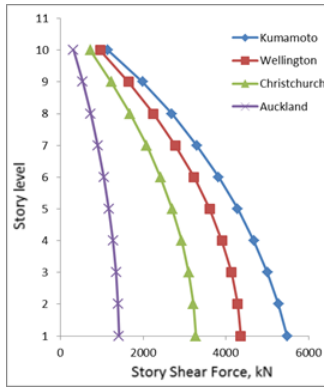
Figure 14: Story Shear Force for Kumamoto (Safety Check, Soil Type 3, $D_s=0.3$) vs NZS1170 ULS (IL2, Ductility 4, Soil Type E).

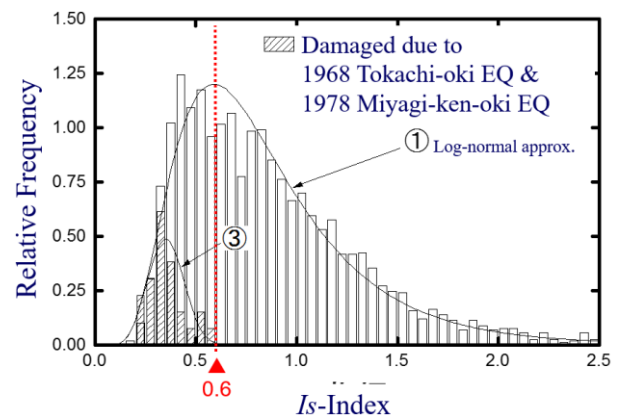
Figure 16: Statistics of I_s index values of public RC structures in comparison to damaged RC structures in Shizuoka, Japan – Figure adapted from Nakano & Teshigawara [12].

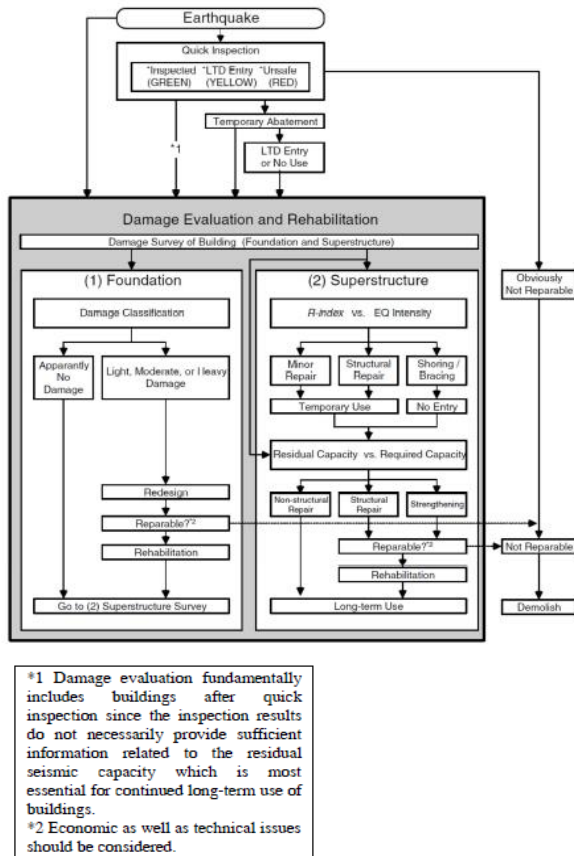
Figure 17: Flow diagram summary of Japanese Damage Evaluation and Rehabilitation Guideline. Adapted from Maeda et al. 2014 [12].

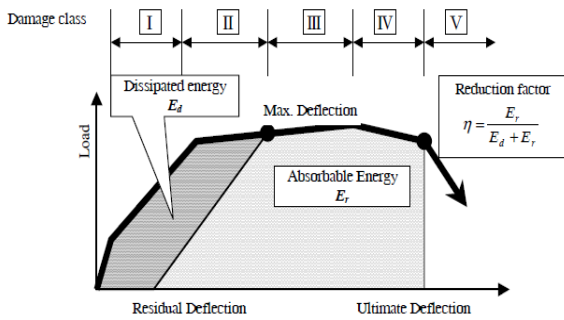
Figure 18: Seismic Capacity Reduction Factor. Adapted from Maeda et al. [13].

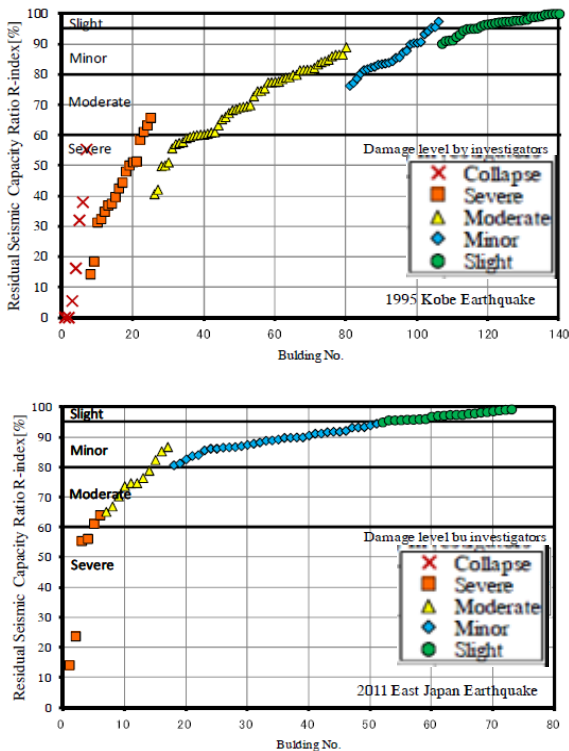
Figure 19: R-index evaluation results vs Engineer's expert judgment for RC school buildings damaged in 1995 Kobe Earthquake and 2011 East Japan Earthquake. Figure adapted from Maeda et al. [13].

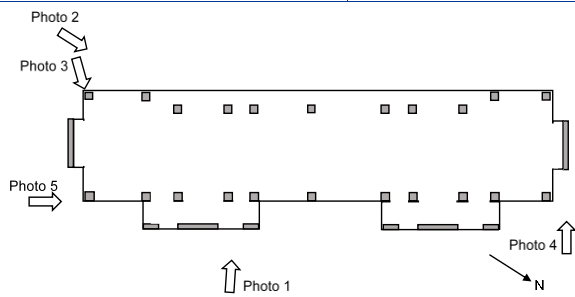
Plan showing floor slab outline and full-height structural elements and photo locations.

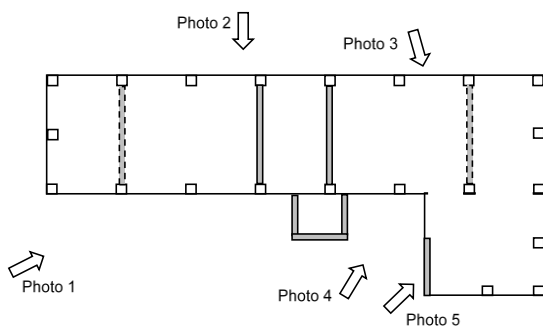
Plan showing floor slab outline with known full-height structural elements and photo locations.

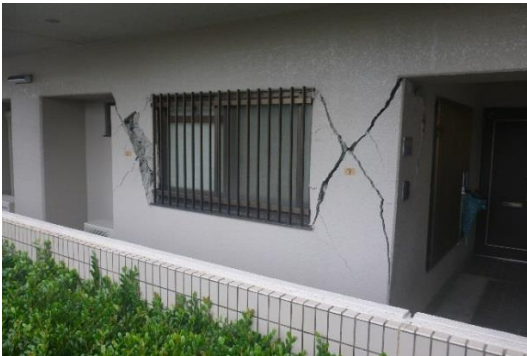
Photo 3: Typical infill concrete wall shear cracking due to interaction with moment frame beams.

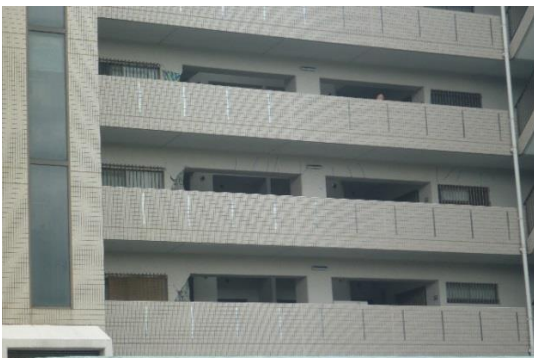
Photo 4: Moment frame beam flexural hinging in regions not affected by infill walls.

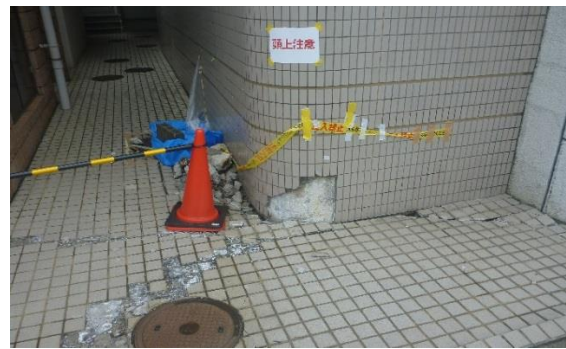
Photo 5: Foundation settlement at base of shear walls due to rocking.

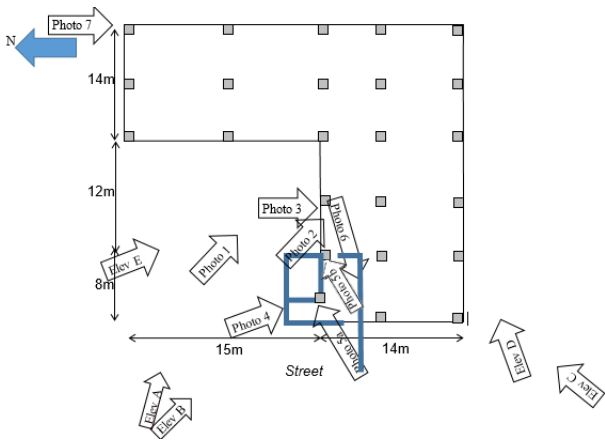
Plan showing building layout with known full-height structural elements and photo locations
 (note walls shown in blue were not clearly structural walls)

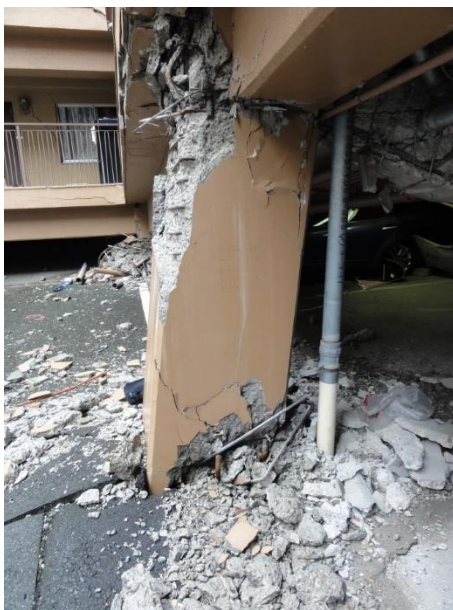
Photo 4: Uplift of wall (does not appear to be structural wall).

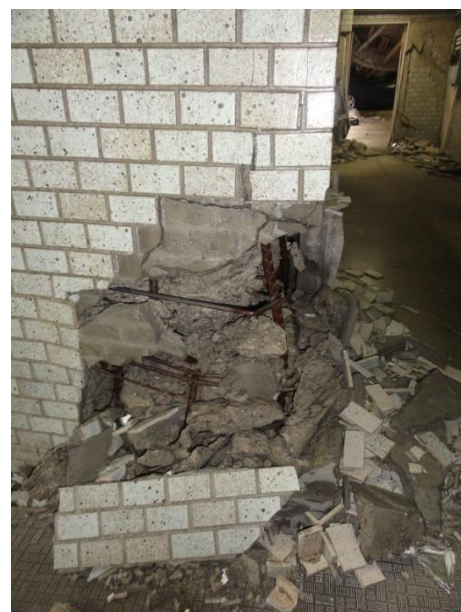
Photo 5a: crushed columns at corners of walls around core.

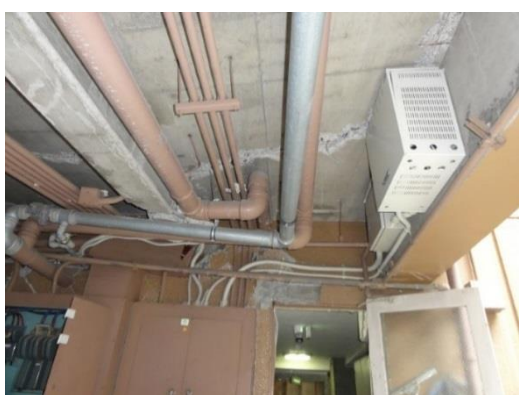
Photo 6: Damage to first floor diaphragm at wall (similar damage not apparent on other levels).

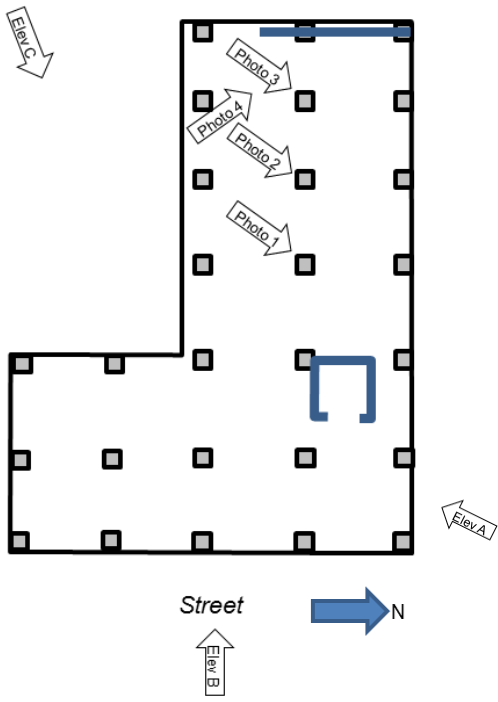
Plan showing building layout with known full-height structural elements and photo locations (walls shown in blue – uncertain if core is structural)

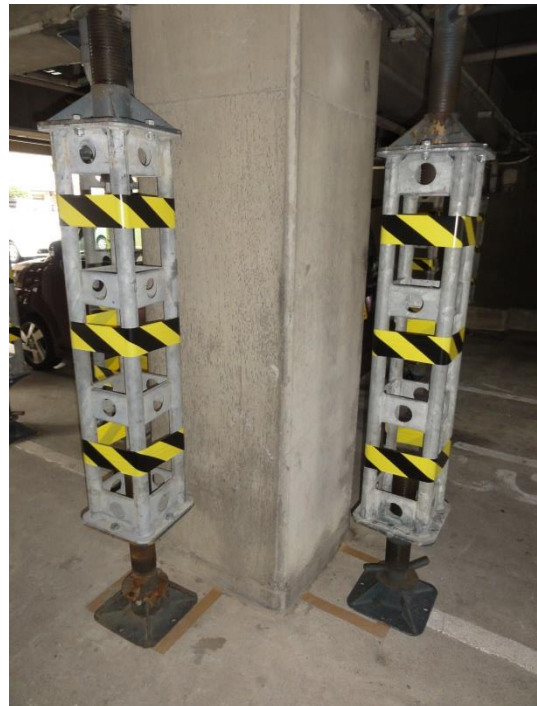
Photo 1: Bidirectional shear cracks.

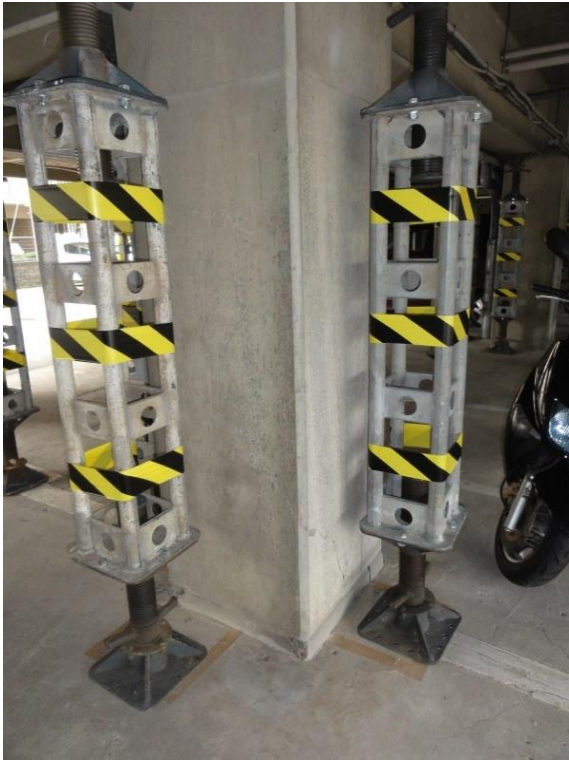
Photo 2: Bidirectional shear cracks.

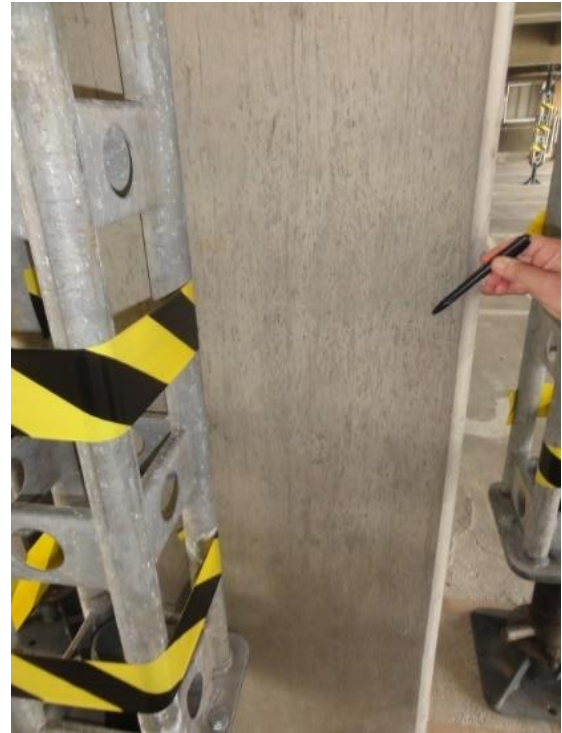
Photo 3b: Apparent torsional cracks.

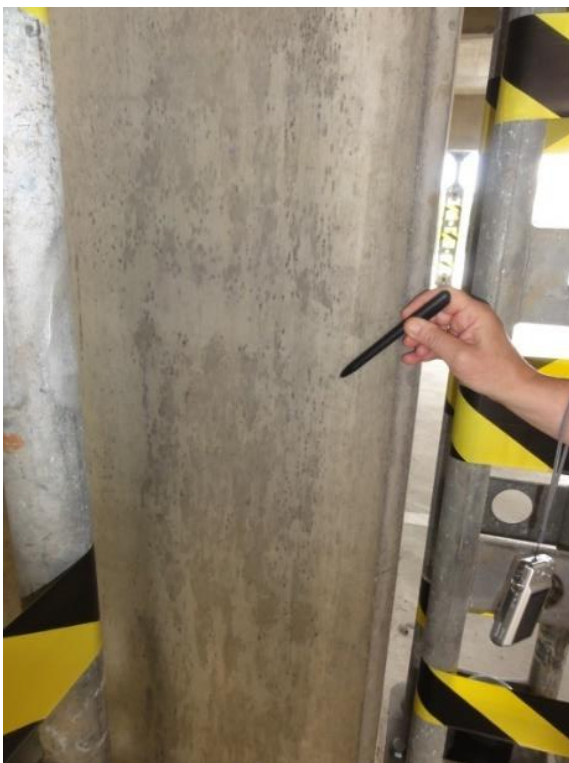
Photo 3a: Apparent torsional cracks.

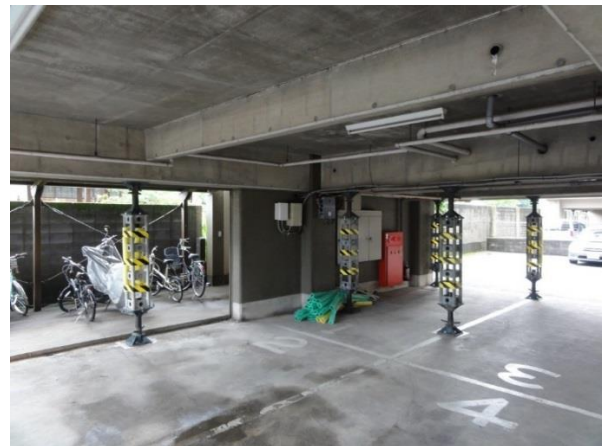
Photo 4: Wall on west end of building.

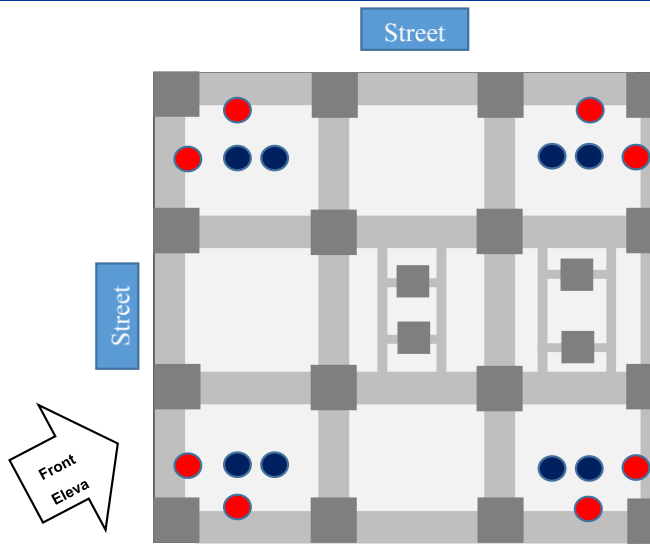
- Base Isolation System – Large Bearings
- Steel Dampers
- Lead Dampers
- Base Isolation System – Small
- Concrete Beams

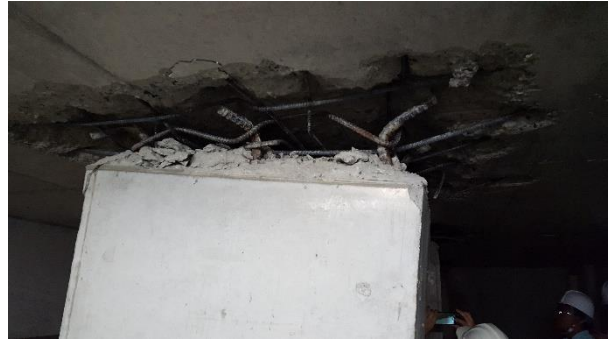
Photo 7: Failure at joint between floor slab & lead dampers.

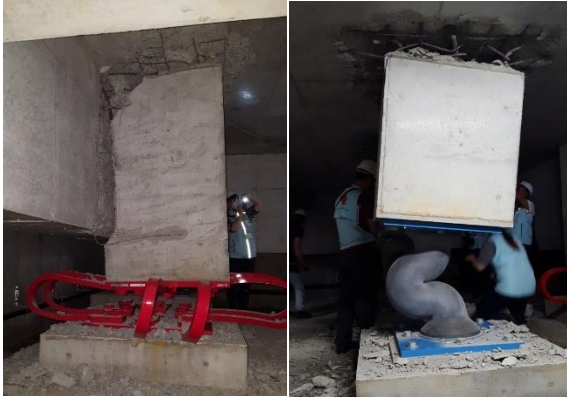
Photos 3 & 4: Separation of steel dampers from concrete beams.

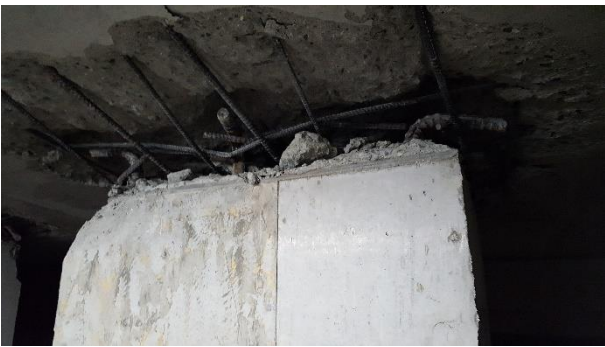
Photo 5: Failure at joint between floor slab & lead dampers.

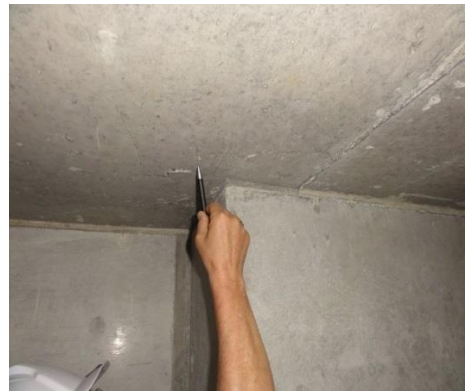
Photo 9: Visible signs of cone failure like cracking in base slab where small base isolator is connected.

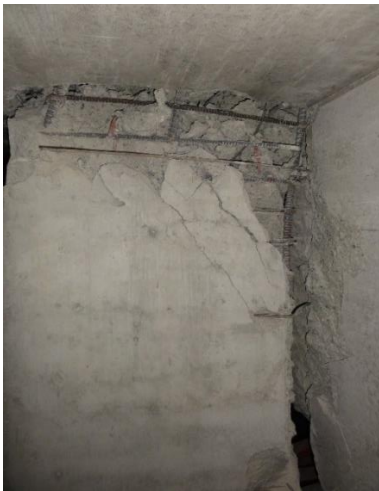
Photo 6: Failure at joint between floor slab & lead dampers.

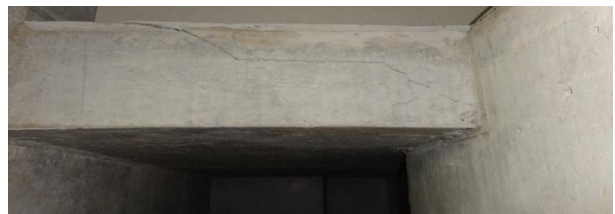
Photo 10: Cracking in deck slab where connected to small base isolator

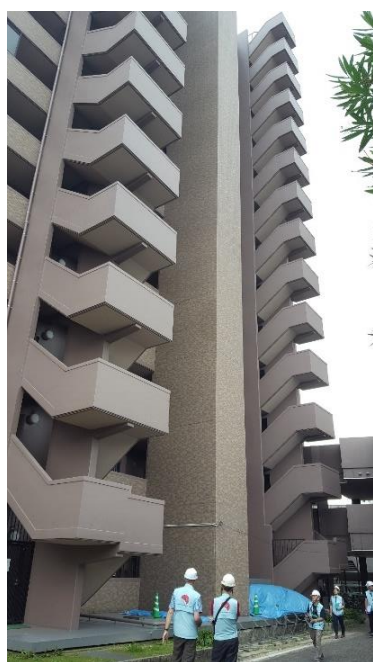
Building front elevation for Building No.3

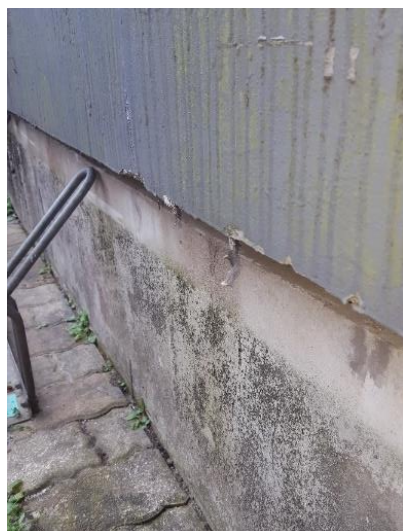
Photo 2: Damage to the first level of stairs on Building No.2 with multi-level isolation

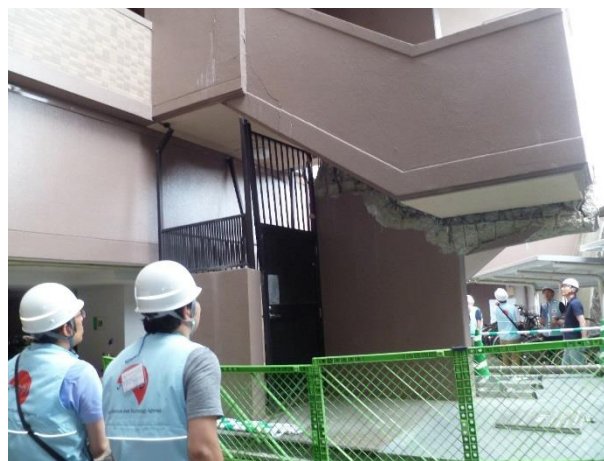
Photo 4: Damage to the first level of stairs on base isolated Building No.2. Staircase isolated at ground level while isolation plane of main structure was at level 1.

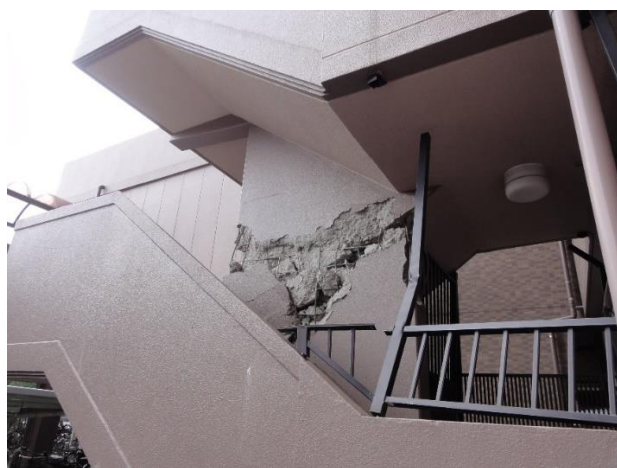
Photo 3: Damage to the first level of stairs on base isolated Building No.2. Staircase isolated at ground level while isolation plane of main structure was at level 1.

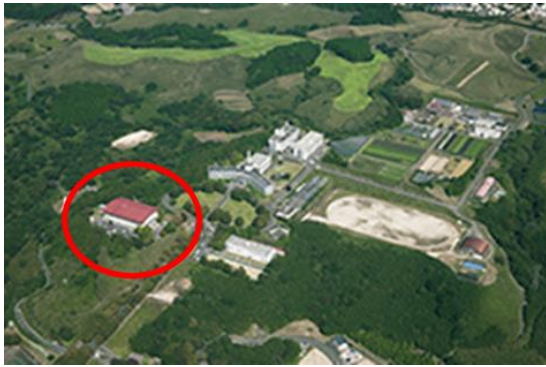
Photo 1: Aerial view of campus indicating location of Gymnasium.

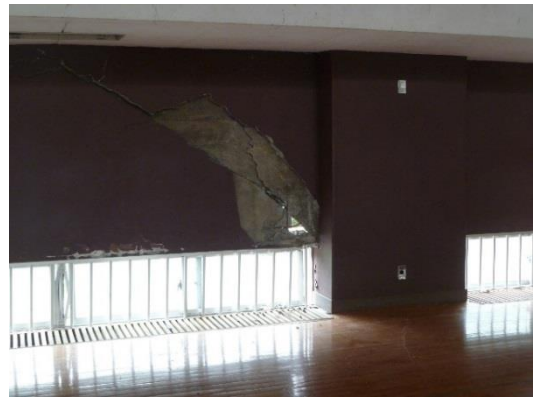
Photo 4: Shear cracking damage to concrete beam supporting mezzanine on side wall.

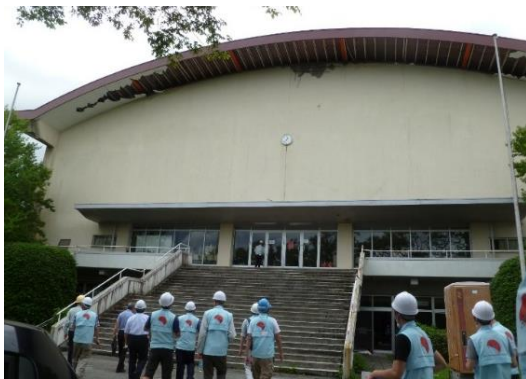
Photo 2: Building front exterior elevation (note damage to infill concrete walls and ceiling at roof interface).

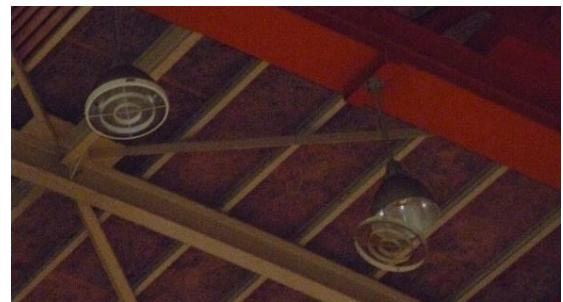
Photo 5: Light fitting partially unclipped.

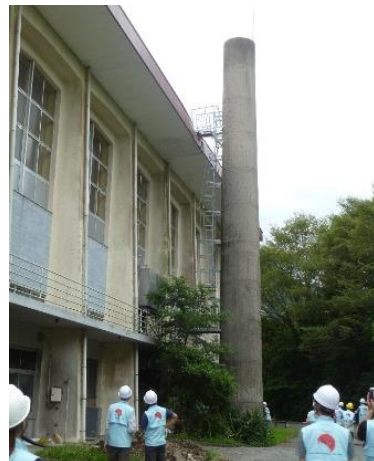
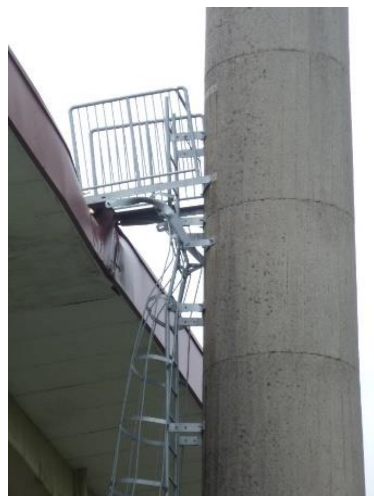
Photos 6 & 7: Chimney adjacent to building (note pounding damage at roof interface).

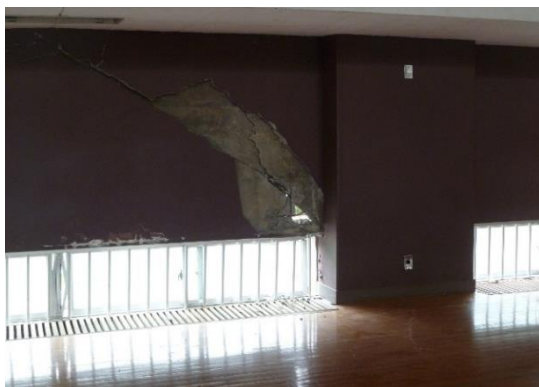
Photo 4: Shear cracking damage to concrete beam supporting mezzanine on side wall.

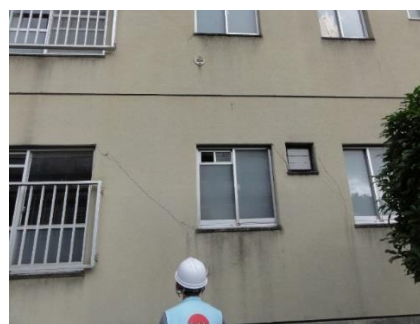
Photo 1: Cracking of non-structural walls due to differential settlement of building.

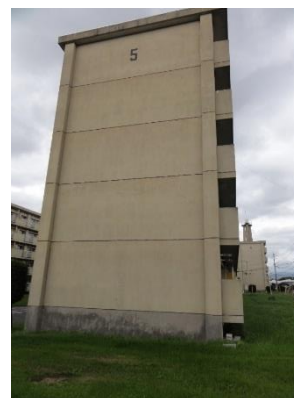
Photo 2: Visible leaning of Building No. 5 (One side noticeably lower than other).

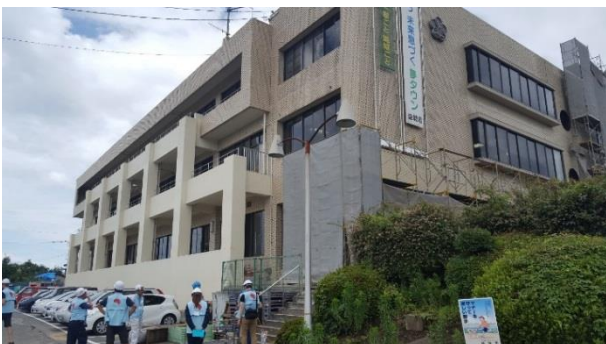
Building elevation. Additional exterior RC moment frame added as a seismic retrofit shown.

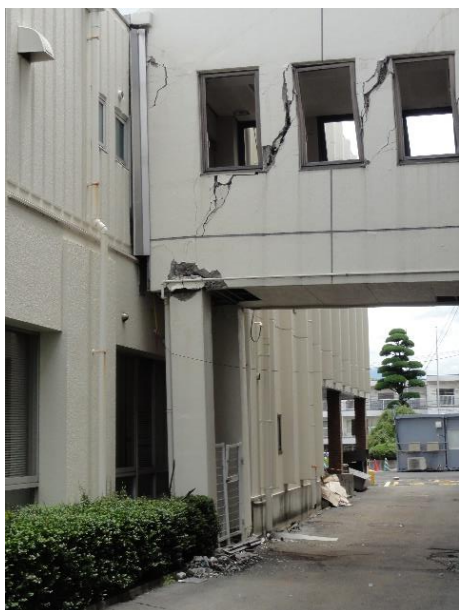
Photo 3: Damage to bridge between two buildings.

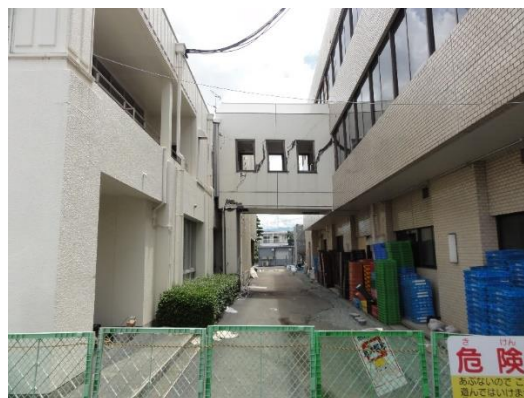
Photo 4: Damage to bridge between two buildings

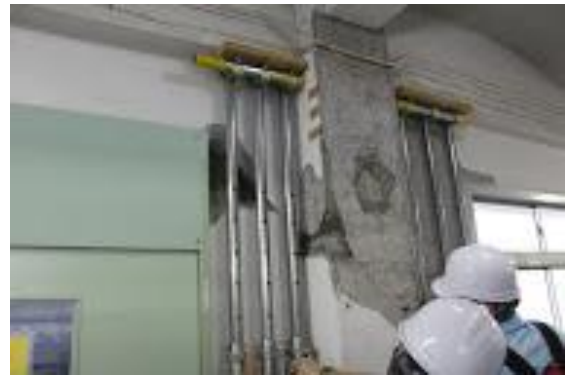
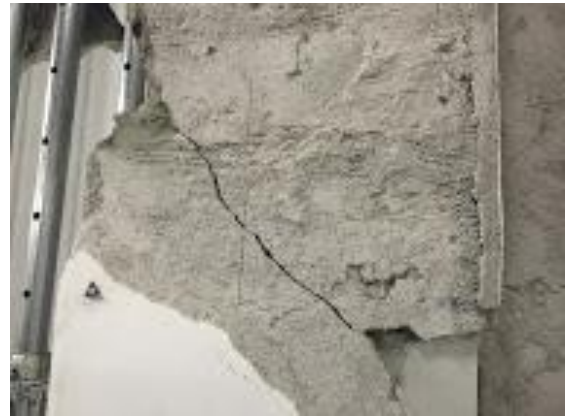
Photos 6 & 7: Shear damaged column (damage class IV) located in corridor 1st floor level.

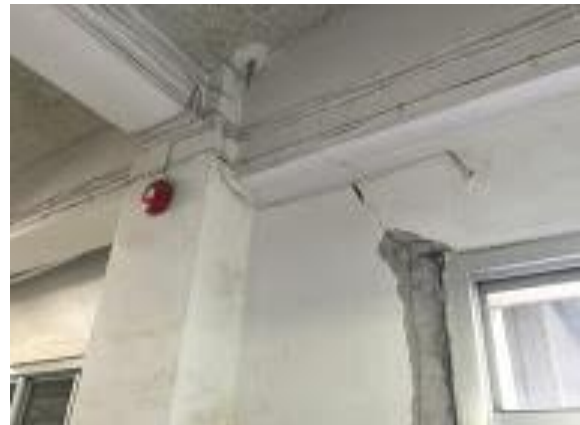
Photo 8: Typical damage to concrete “non-structural” walls between concrete moment frames.

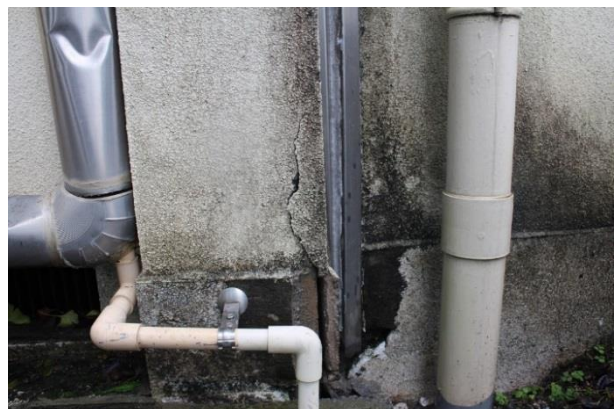
Photo 9: Pounding damage at seismic joint between classroom blocks.

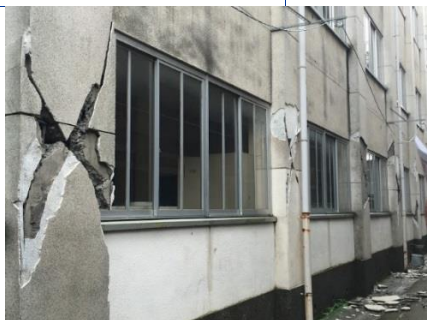
Photo 1: Damaged columns from outside the building

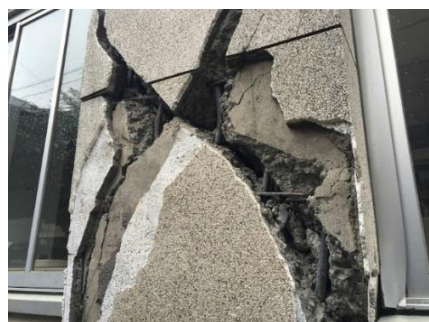
Photo 2: Close up view of typical columns failed in short column induced shear failure.

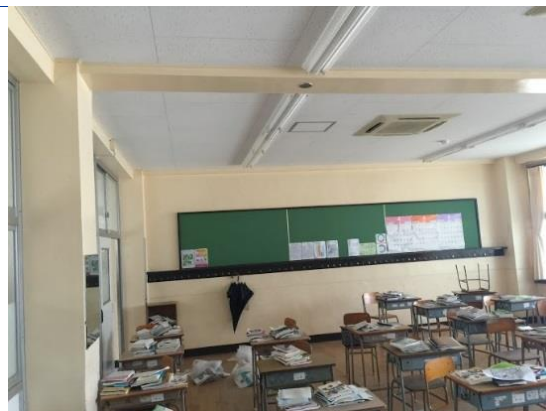
Photo 3: A typical classroom (Internal longitudinal frame can be seen at the left end of the room, transverse frame without wall can be seen in the middle of the room and transverse frame infilled with structural wall can be seen at the far end of the classroom).

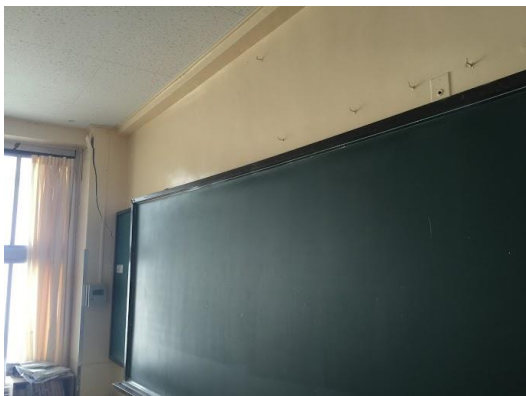
Photo 4: A rare instance of damage to the classroom side external columns.

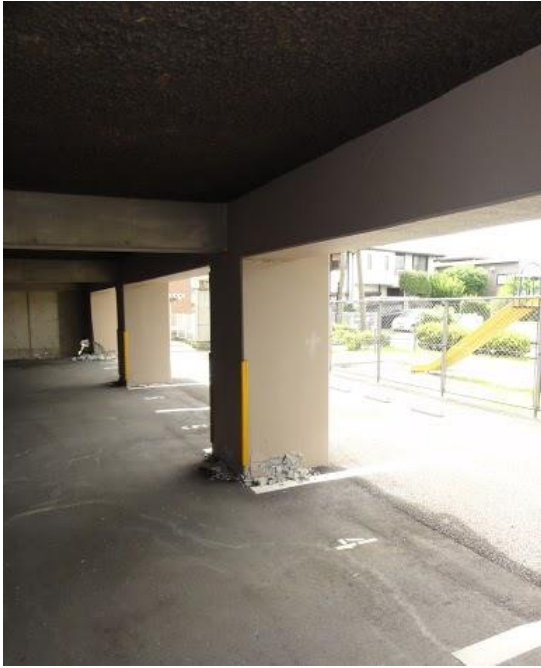
Photo 3: Damage to the columns on South side (most severe damage was to the far-east end column).

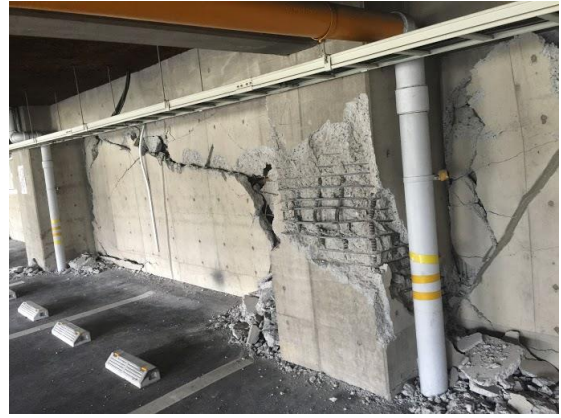
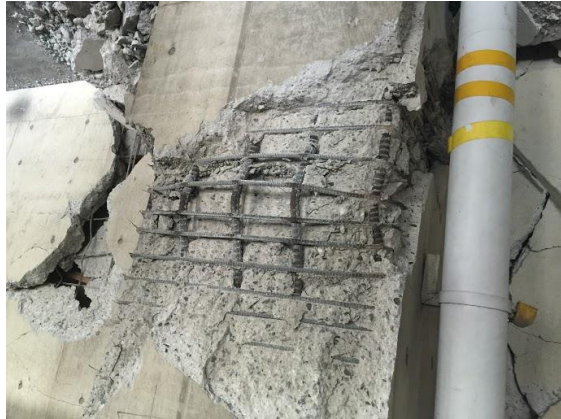
Photos 6 & 7: Close up view of typical columns failed in short column induced shear failure.

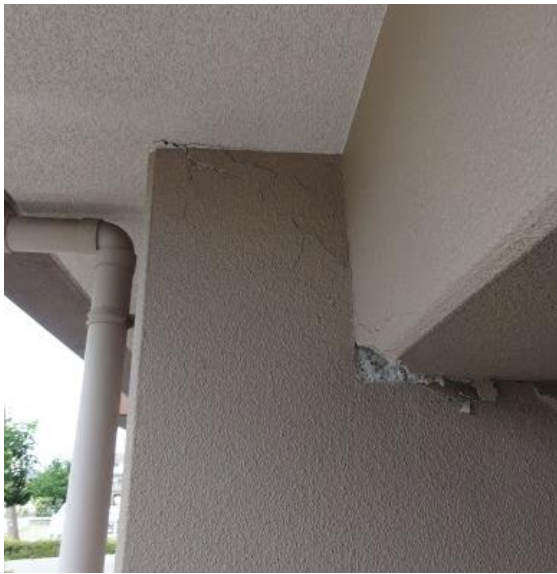
Photo 4: Damage to the central beam-column connection on the south frame.

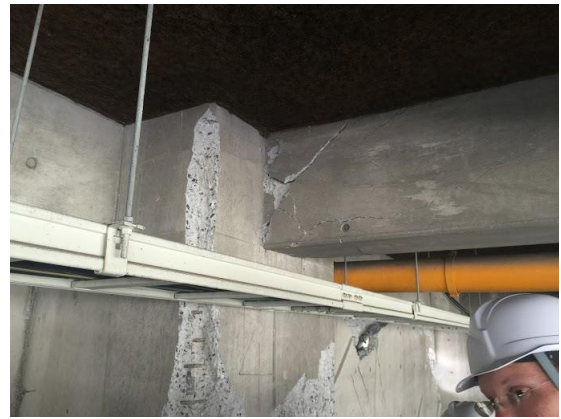
Photo 8: Beam-Column connection at the top of the shear damaged column.

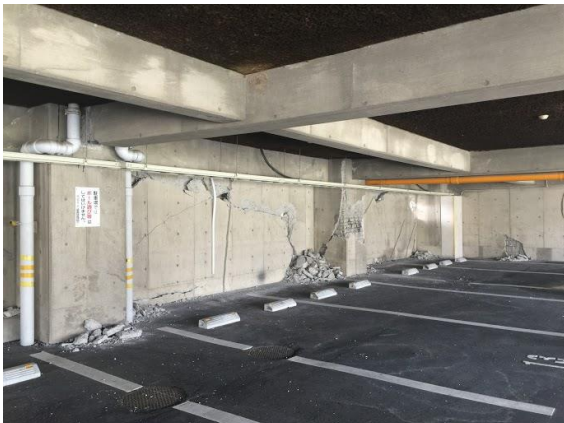
Photo 5: Damaged walls and column on the north side.

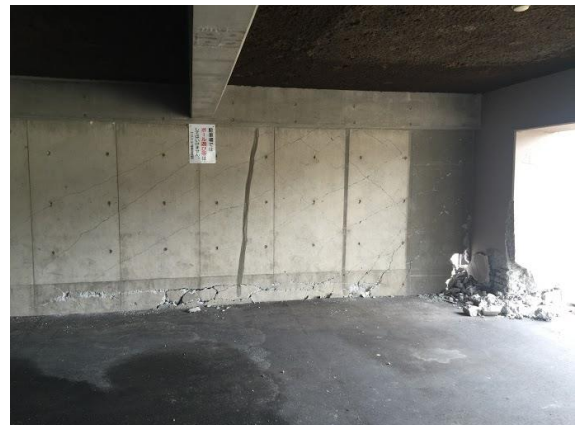
Photo 9: Shear cracks on the east side wall and damage to the south-east corner column.

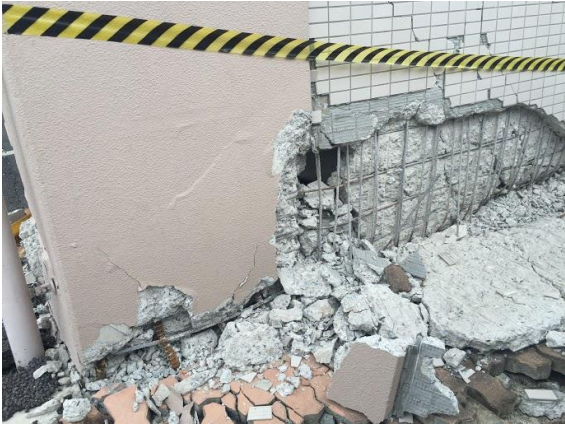
Photo 10: Damage to the SE Corner column and its connection to the adjacent East face wall (Photo taken from outside the building).

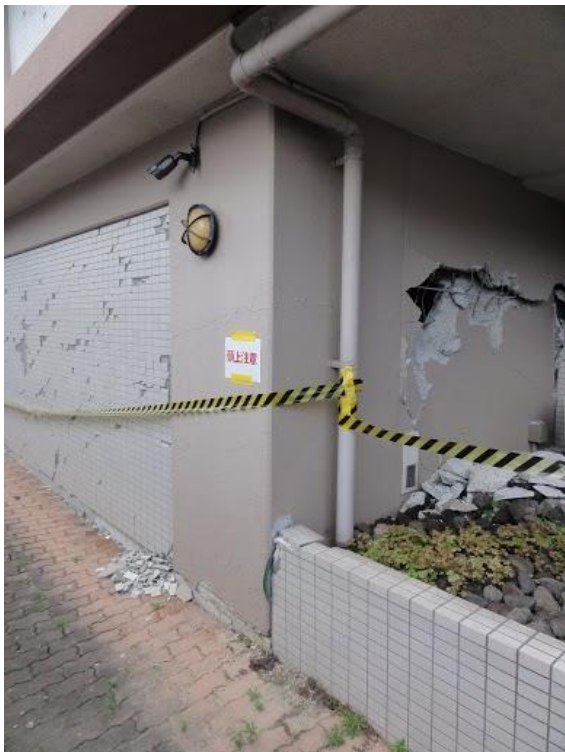
Photo 11: Damaged orthogonal walls at the NE corner (Photo taken from outside the building).

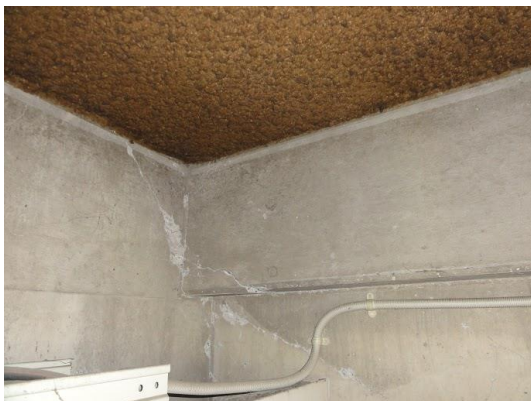
Photo 12: Close up view of the beam column joint at the NE corner from outside.

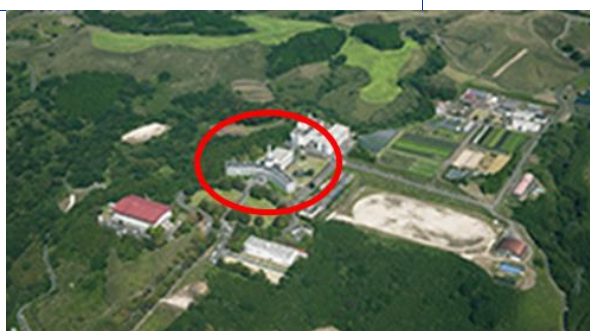
Photo 1: Aerial view of campus indicating location of building.

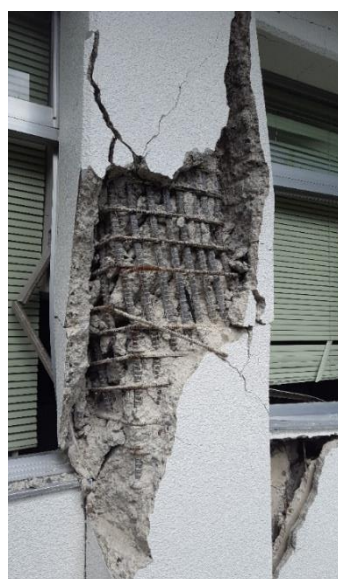
Photo 6: Shear failure of column at centre of building due to short column effect.

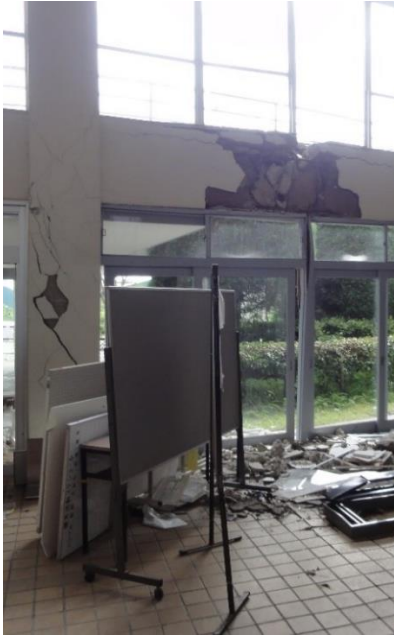
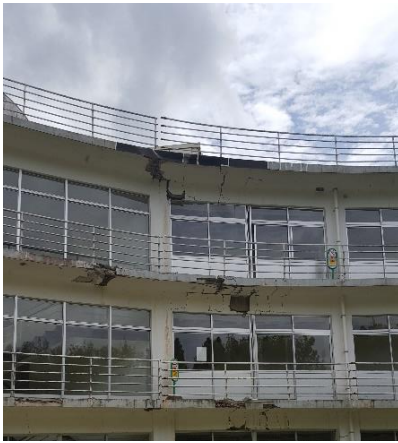
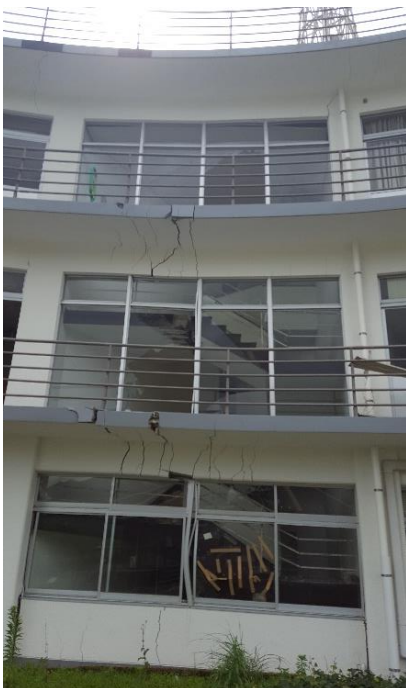
Photos 7, 8 & 9: Visible signs of damage at “Y” juncture of building.

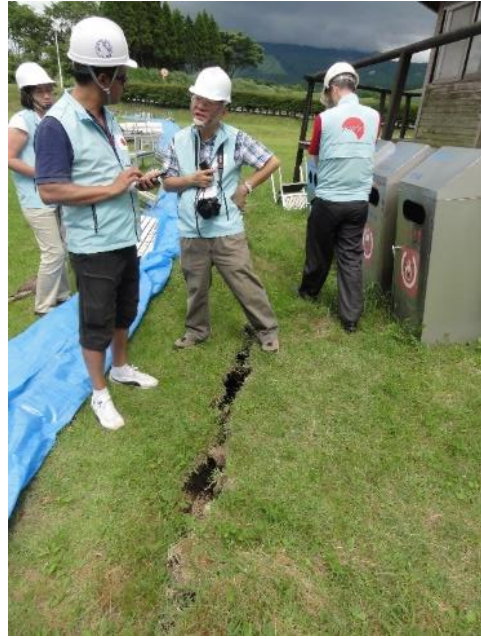
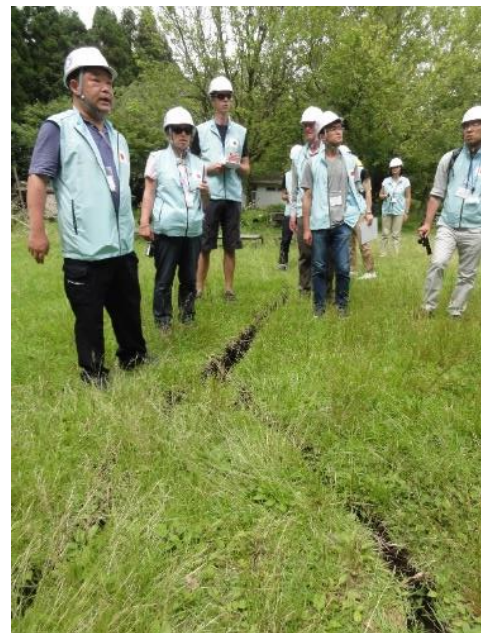
Photos 10 & 11: Cracks found throughout ground on both sides of the building.

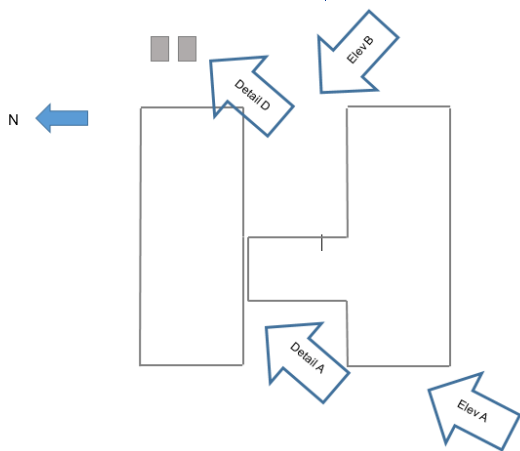
Sketch plan of building layout

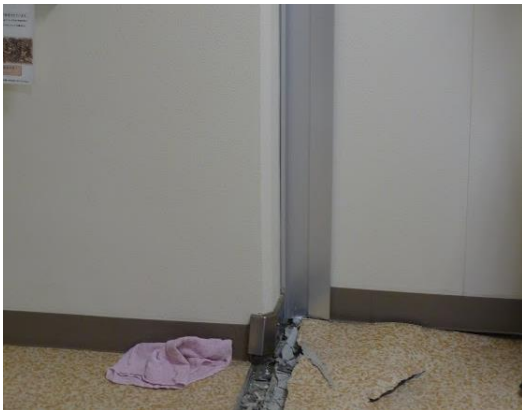
Detail B: Seismic joint between four storey block and interconnector at building interior showing some damage to floor at joint.

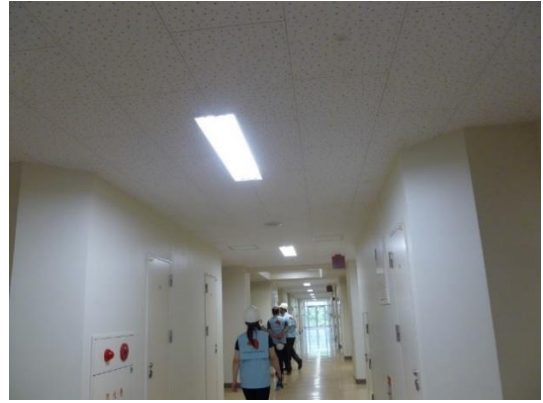
Detail C: Interior view of south four storey block at ground level. Note no damage to interiors including ceilings.

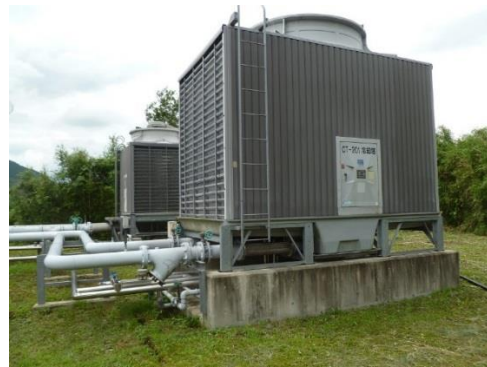
Detail D: Chiller plant located exterior to building. Note ground rupture adjacent to foundations.

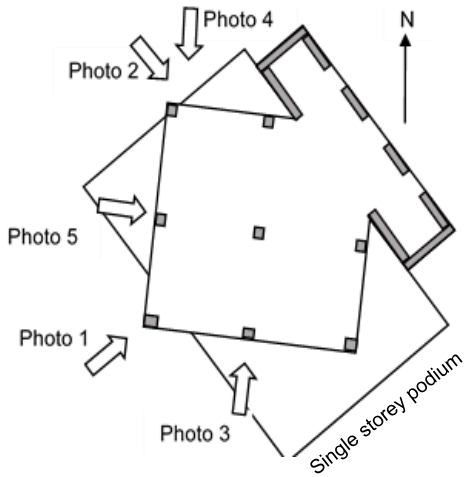
Plan showing floor slab outline, full-height structural elements and photo locations

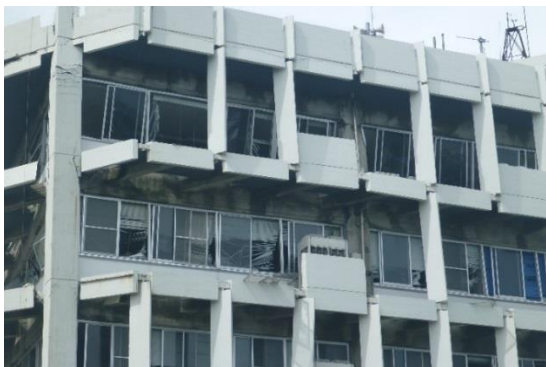
Photo 3: Column plastic-hinge at underside of roof beam and shear failure at Level 4 beam-column joint.
