PERFORMANCE OF REINFORCED CONCRETE BUILDINGS IN THE 2016 KUMAMOTO EARTHQUAKES AND SEISMIC DESIGN IN JAPAN

Mehdi Sarrafzadeh¹, Ken J. Elwood², Rajesh P. Dhakal³, Helen Ferner⁴, Didier Pettinga⁵, Mike Stannard⁶, Masaki Maeda⁷, Yoshiaki Nakano⁸, Tomihisa Mukai⁹ and Takuya Koike¹⁰

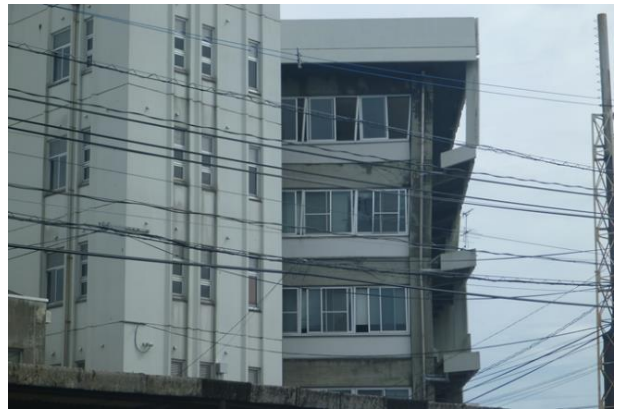
Photo 4: Beam plastic-hinges and permanent offset of upper floors.

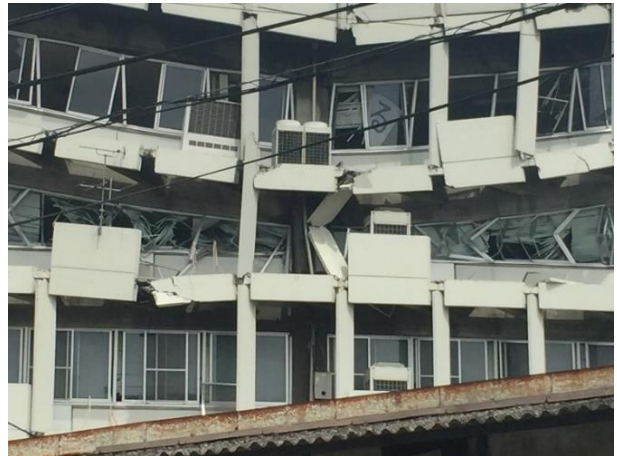
Photo 5: Beam-column joint shear failure and dislocation of beam from column.

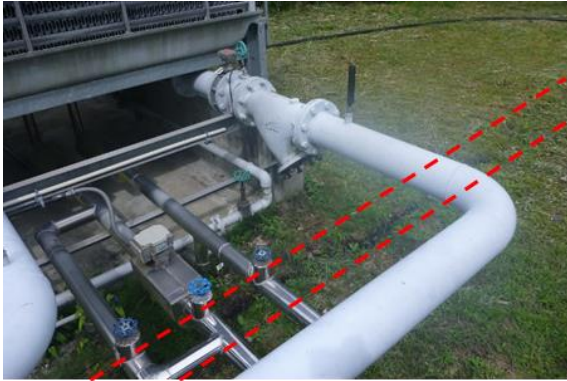
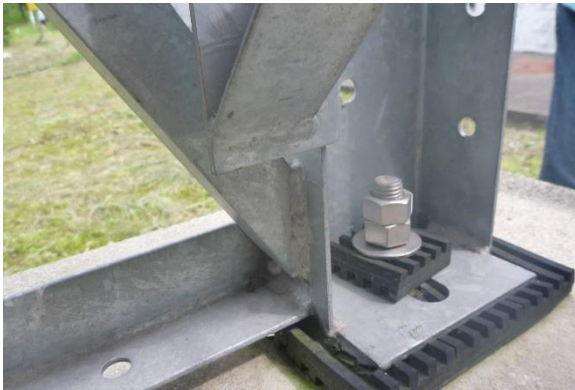
Photos 1 & 2: Building A14 major plant items located behind the teaching / office building.

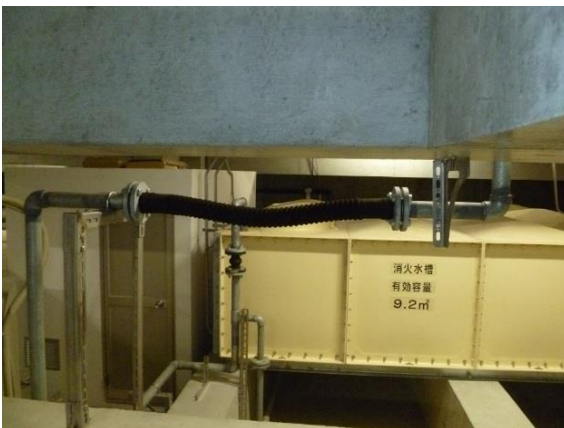
Photo 3: Building A5. Plant and piping in the basement located below the plane of isolation and flexible connectors across the plane of isolation.

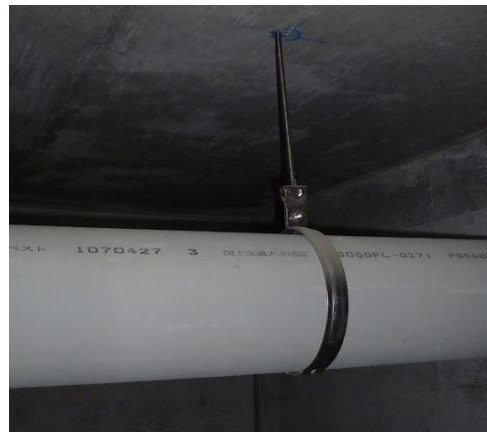
Photo 5: Building A5. Supports for storm water piping located immediately hung from ground floor above the plane of seismic isolation.

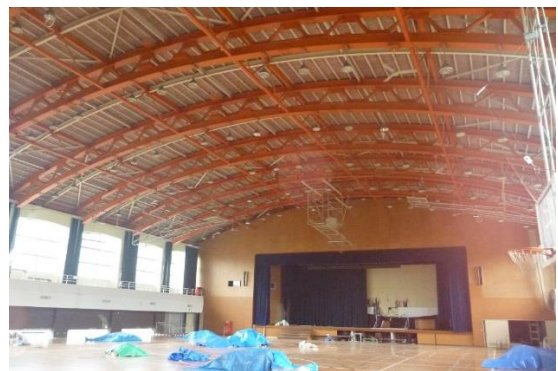
Photo 6: Building A7 designed with no ceiling thus avoiding damage

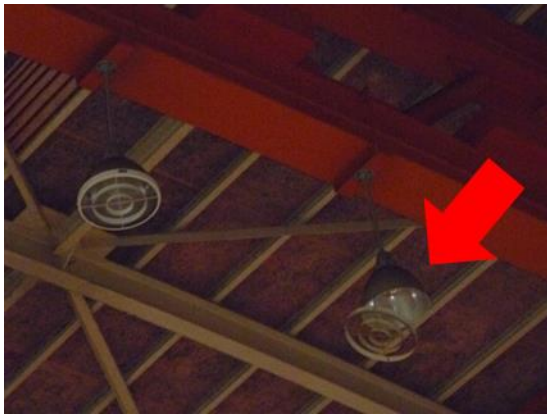
Photo 7: Building A7 detail of ceiling.

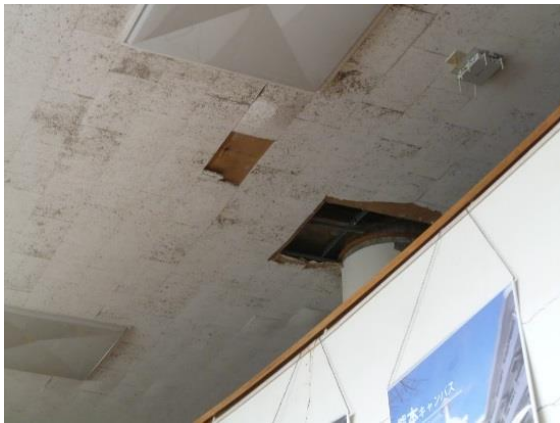
Photo 8: Building A13 interior ceiling damage.

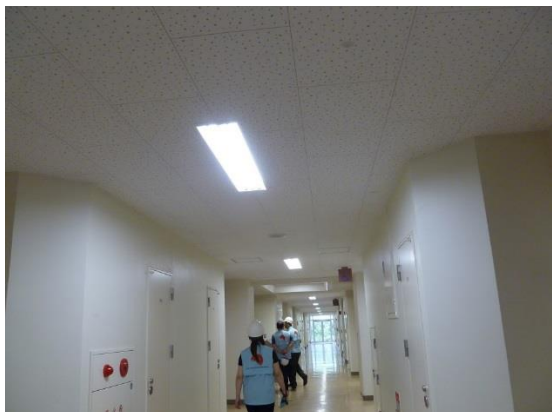
Photo 9: Building A14 building internal ceiling, no damage observed

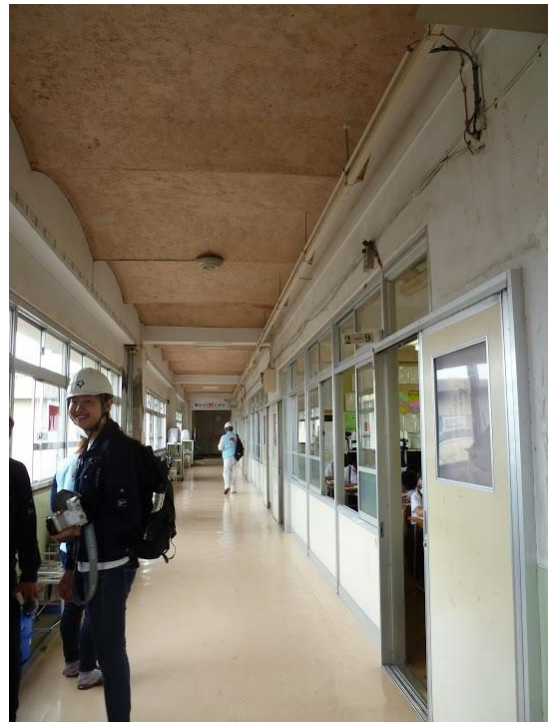
Photo 10: Building A10 classroom corridor.

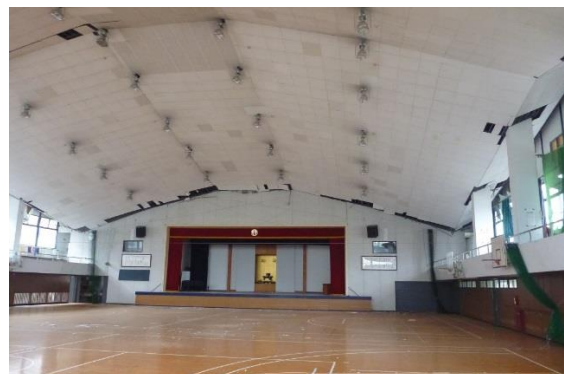
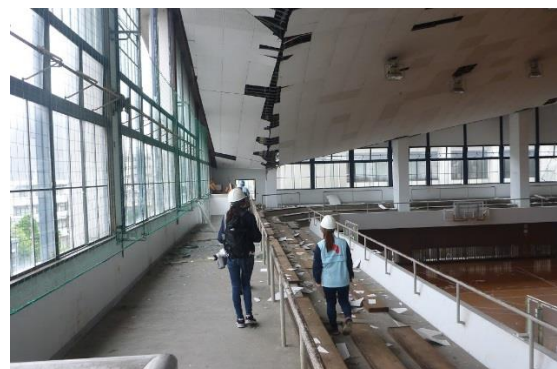
Photos 11 & 12: Gym close to Building A10.

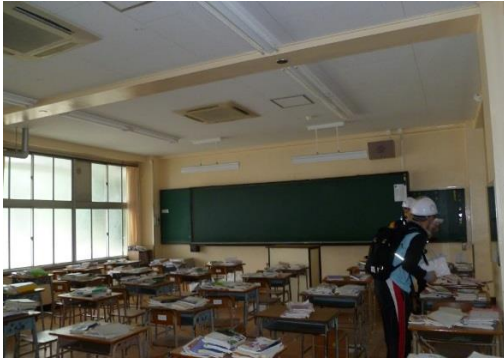
Photo 13: Building A11.

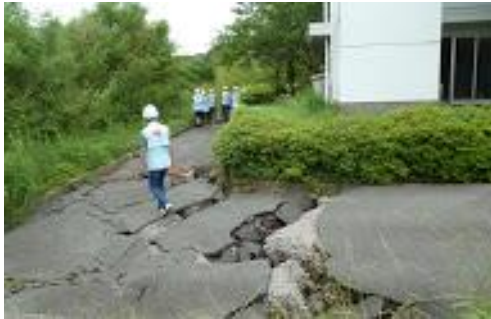
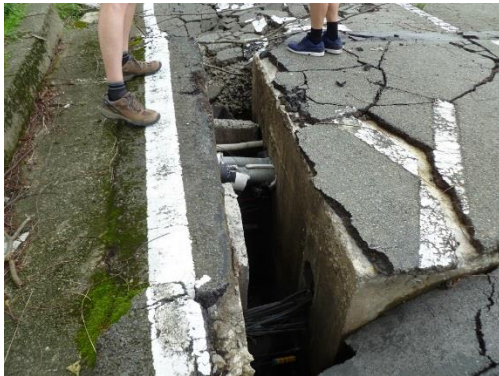
Photos 14 & 15: Ground and underground services disruption Building A13.

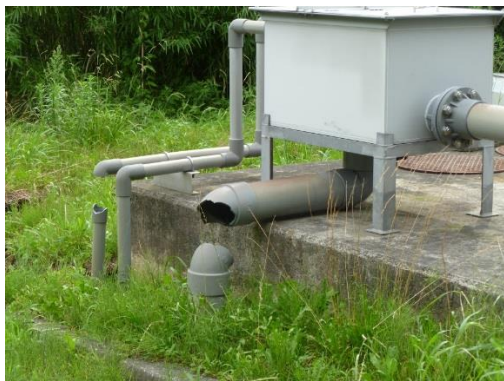
Photo 16: Broken piping adjacent to Building A13.

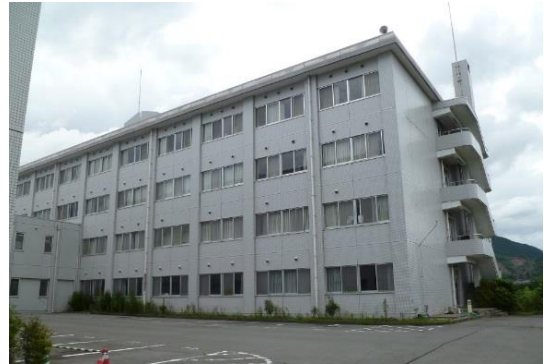
Photo 17: Building A14. Exterior covered in ceramic tiles applied directly to the concrete structure. A typical Japanese cladding system

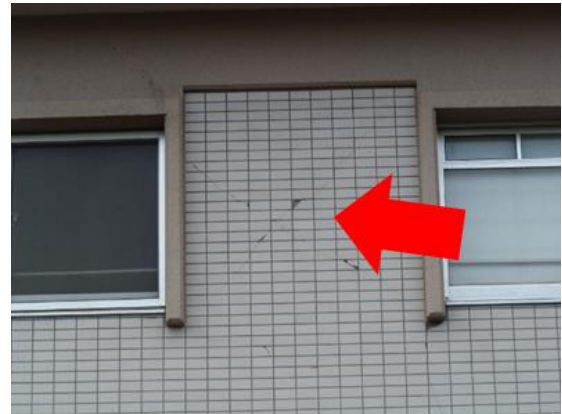
Photo 18: Building A12, Exterior tiled cladding.

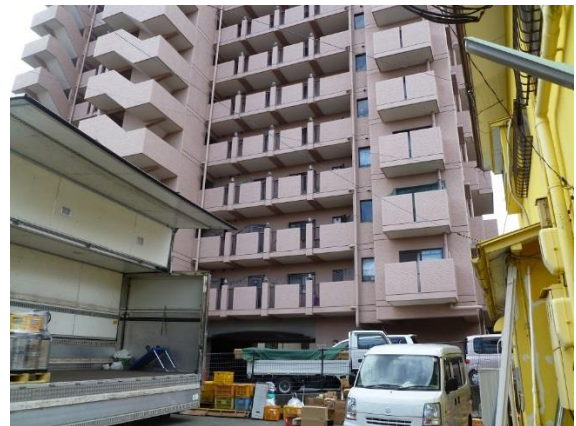
Photo 19: Apartment buildings Kumamoto. Undamaged buildings.

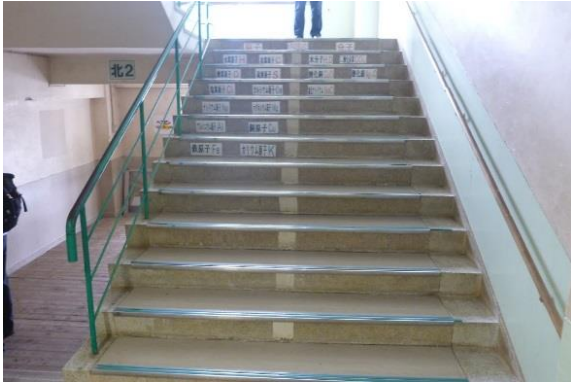
Photo 20: Building A10 no damage observed to stairs.

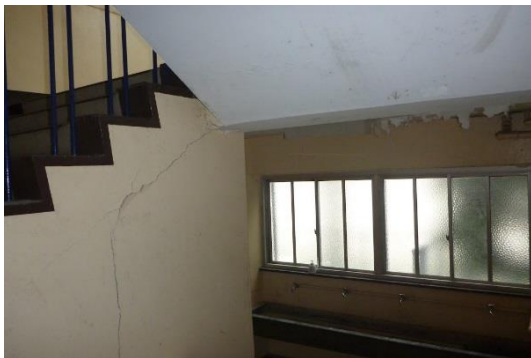
Photo 21: Building A11.

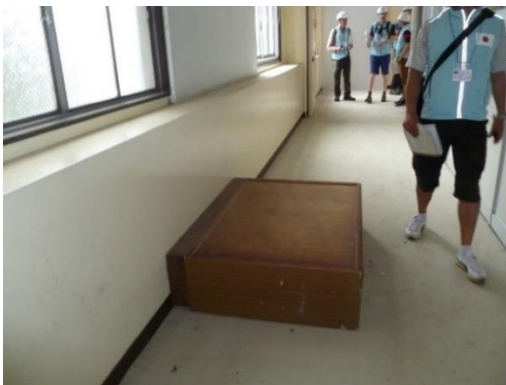
Photo 22: Building A10.

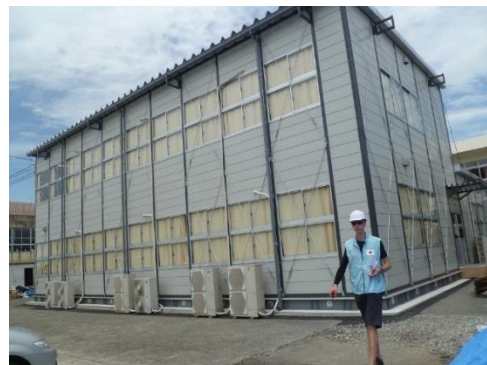
Photo 25: Building A15, City Hall temporary office block erected on carpark adjacent to the damaged buildings they are temporarily replacing

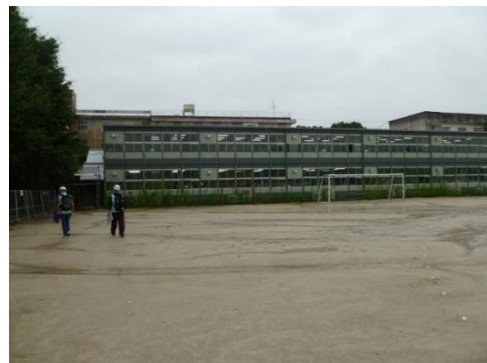
Photo 38: Building A11,, Temporary class room block erected in school playing field
