DAMAGE AND INTENSITIES IN THE MAGNITUDE 7.8 1929 MURCHISON, NEW ZEALAND, EARTHQUAKE

David J. Dowrick¹

SUMMARY

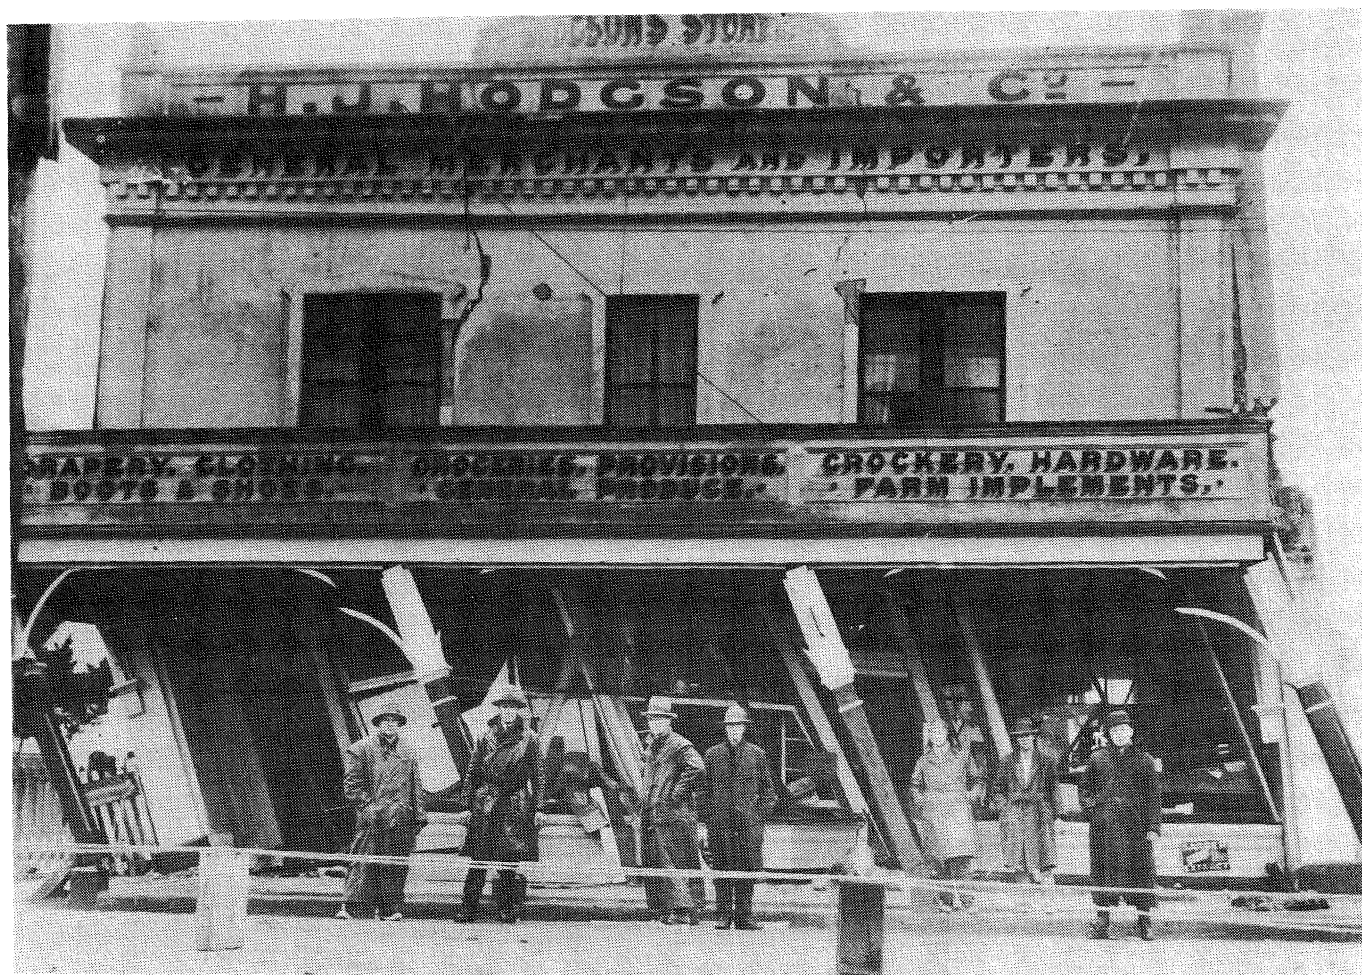
FIGURE 2 *Hodgson's store, Murchison, reinforced concrete, showing soft storey effect due to absence of lateral load resisting frame in shop's frontage. (Reproduced by courtesy of the Alexander Turnbull Library, Wellington, New Zealand).*

- (i) the soft-storey effect of the openings of large shop windows (e.g. Figure 2),
- (ii) unrestrained parapets and gables, and
- (iii) the inherent difficulty of tying brick and timber together adequately.

Near collapse: Hodgson's store (1 and 2). Concrete, no reinforcing bars, a few bed ends acting as haphazard reinforcement. The two storey portion was beyond repair due to large sway deflection of the soft storey front wall (c. 1m drift) (Figure 3). The rear single storey portion was essentially undamaged and was still in use in 1993. This part of the building on its own would be classified Bldg Type III*. There were no other Type I buildings in Murchison.

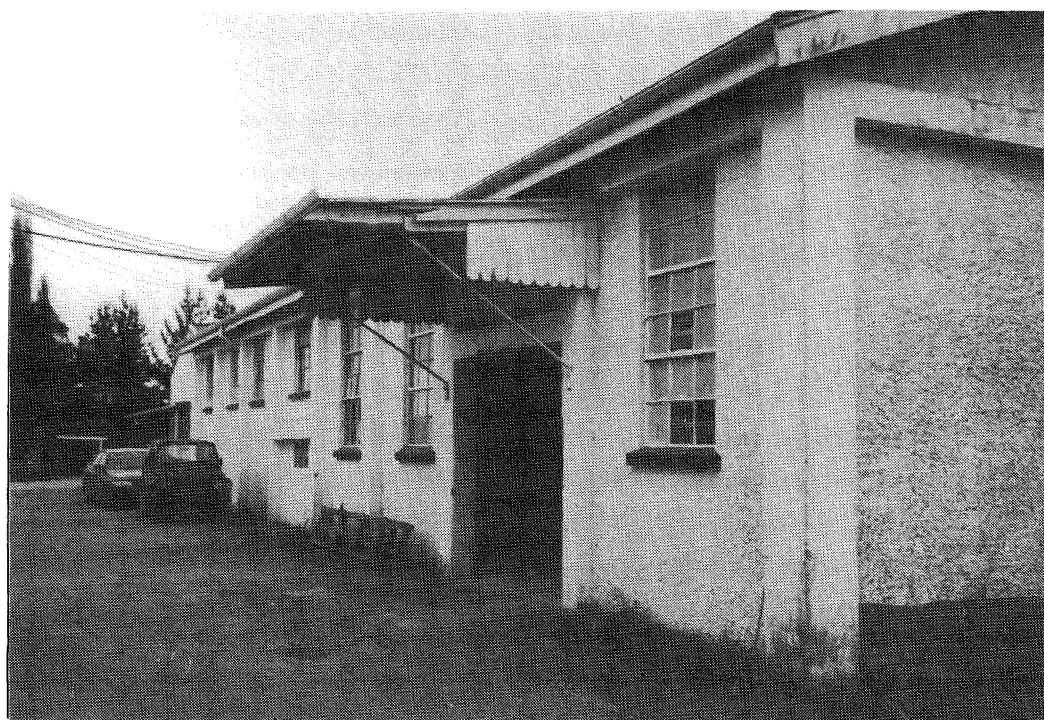
FIGURE 3 *Dairy factory, Murchison, reinforced concrete, undamaged due to having large amounts of structural wall and symmetry in plan.*

Few buildings within the MM8 isoseismal were made of concrete. By today's standards, the concrete was low in strength and was under-reinforced. However most of the concrete buildings performed well, apparently because (a) they were low-rise buildings with plenty of structural wall area, and (b) they were reasonably symmetrical in plan. Both these good attributes are illustrated by the dairy factory at Murchison (Figure 3).

crack in floor and i) pediment over doorway. *Undamaged:* Dairy factory (1), reinforced concrete (Figure 3); McNee's store (1), reinforced concrete.

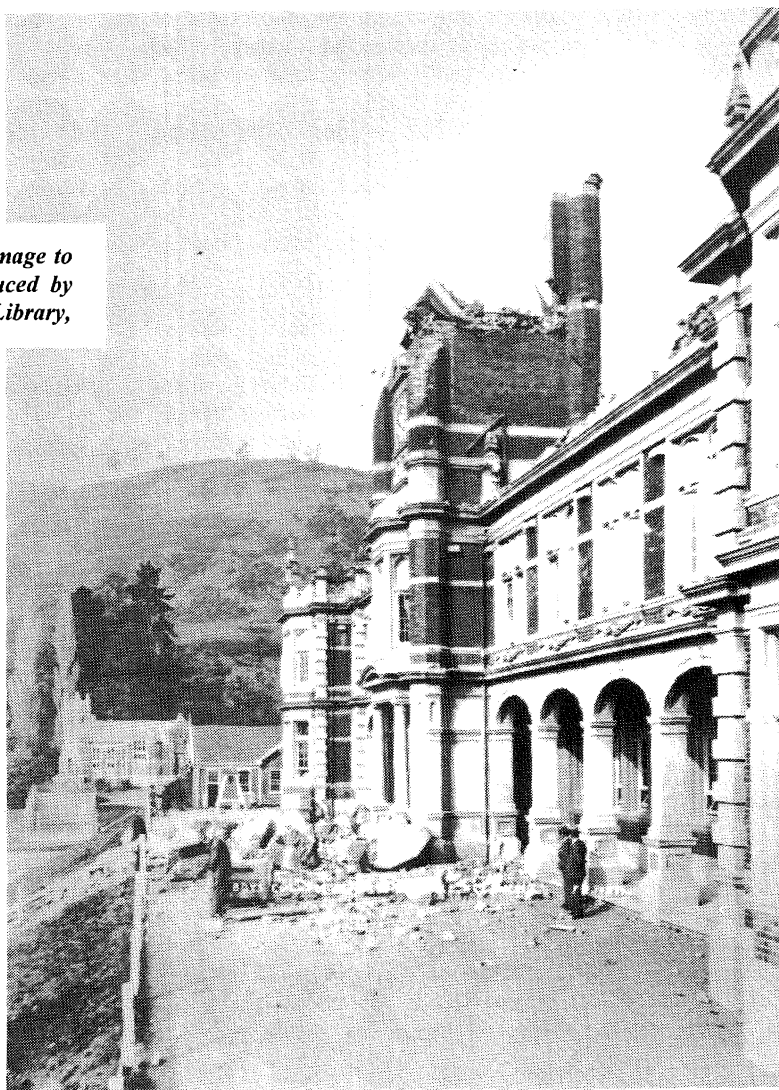
Two of these towers fell. At the Westport Post Office the complete tower fell, while at Nelson College Main Block the soft storey top portion of the tower fell (Figures 4 and 5). Also in all four cases the structure below the tower was damaged much more than it would have been if no tower had been present. This raises the question as to what masonry grade such buildings should be classified as, for intensity assignment purposes? These four buildings all conformed fully to the definition of Masonry C, i.e. Buildings Type II* (Appendix 2), as regards materials quality, workmanship and detailing. But the towers made them much more vulnerable to ground shaking than comparable buildings without substantial towers. The two buildings whose towers fell were the most seriously damaged buildings in their respective towns, despite being as well built as any of the other brick buildings. Thus for intensity assignment purposes, such buildings should be regarded effectively as Masonry D, i.e. Buildings Type I.

In addition, the main block of Nelson College was a long building in which the internal cross-walls were timber not brickwork. This was reported [6] to be unsatisfactory, as the internal and external walls were not effectively tied together resulting in a loss of vital out-of-plane stiffening of the longitudinal brick walls.

FIGURE 5 Nelson College Main Block showing damage to tower and unbraced parapets. (Reproduced by courtesy of the Alexander Turnbull Library, Wellington, New Zealand).

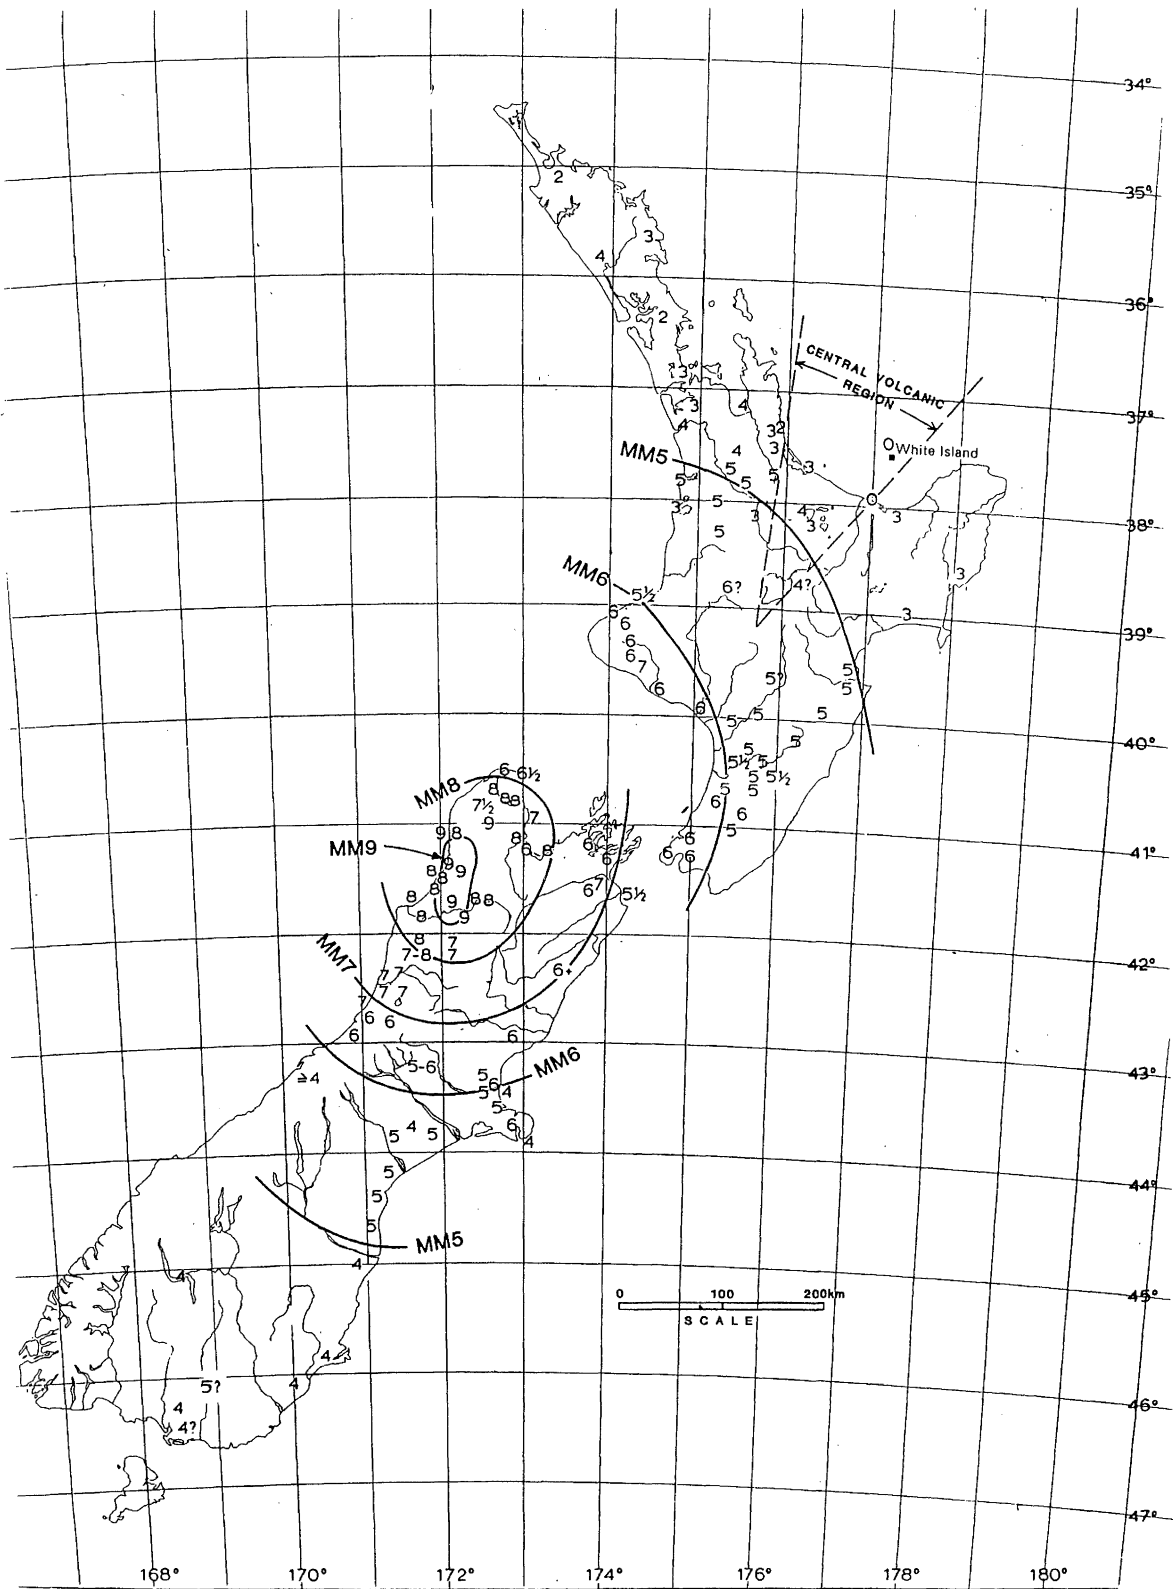
FIGURE 6 Map showing Modified Mercalli intensity observations and isoseismals of the 1929 Murchison earthquake, as assigned in this study (6½ indicates MM6-7).

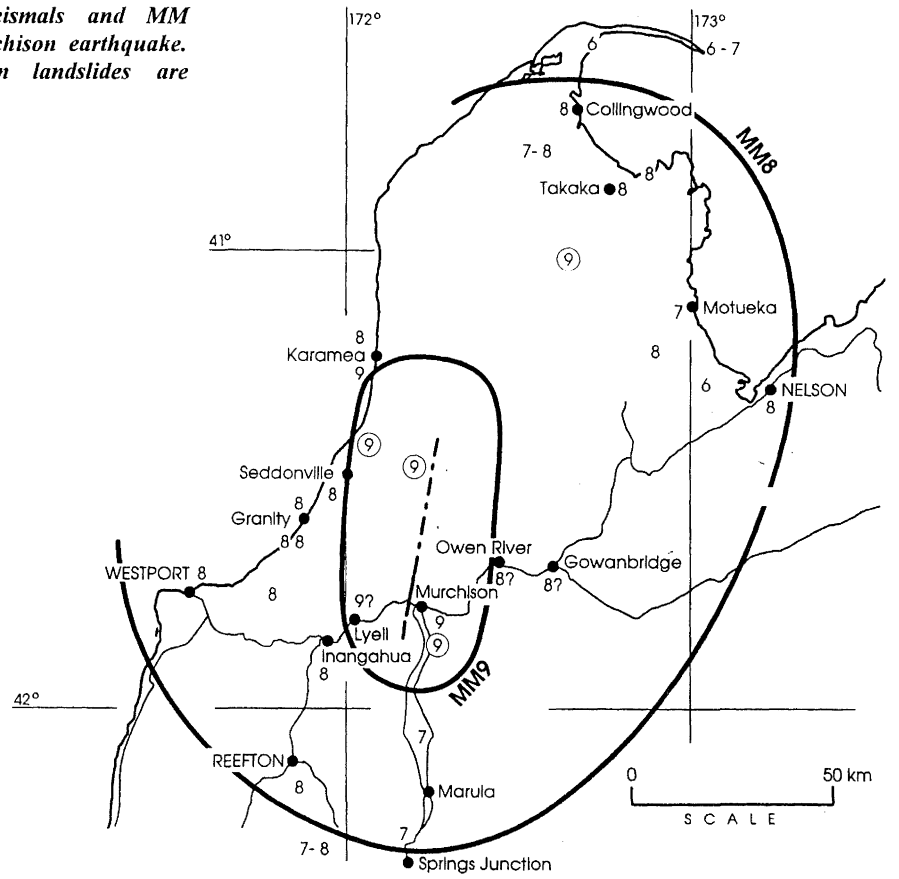
A key feature of Figures 6 and 7 is the absence of any observations of intensity MM10. It is reasonable to suppose that the intensity could have reached MM10 close to the fault rupture, (if MM10 can be achieved in New Zealand). But there were no buildings in that area, so that no damage criteria arose that would be suitable for assigning MM10. There is room on Figures 6 and 7 for a narrow MM10 zone close to the fault. This is consistent with Freeman's observations [18] that in large earthquakes the high damage zone is confined to an area very close to the fault rupture (major microzoning effects excepted). Housner [19] also gives a narrow zone of maximum intensity.

FIGURE 7 Map showing inner isoseismals and MM intensities of the 1929 Murchison earthquake. Intensities based only on landslides are enclosed in circles.

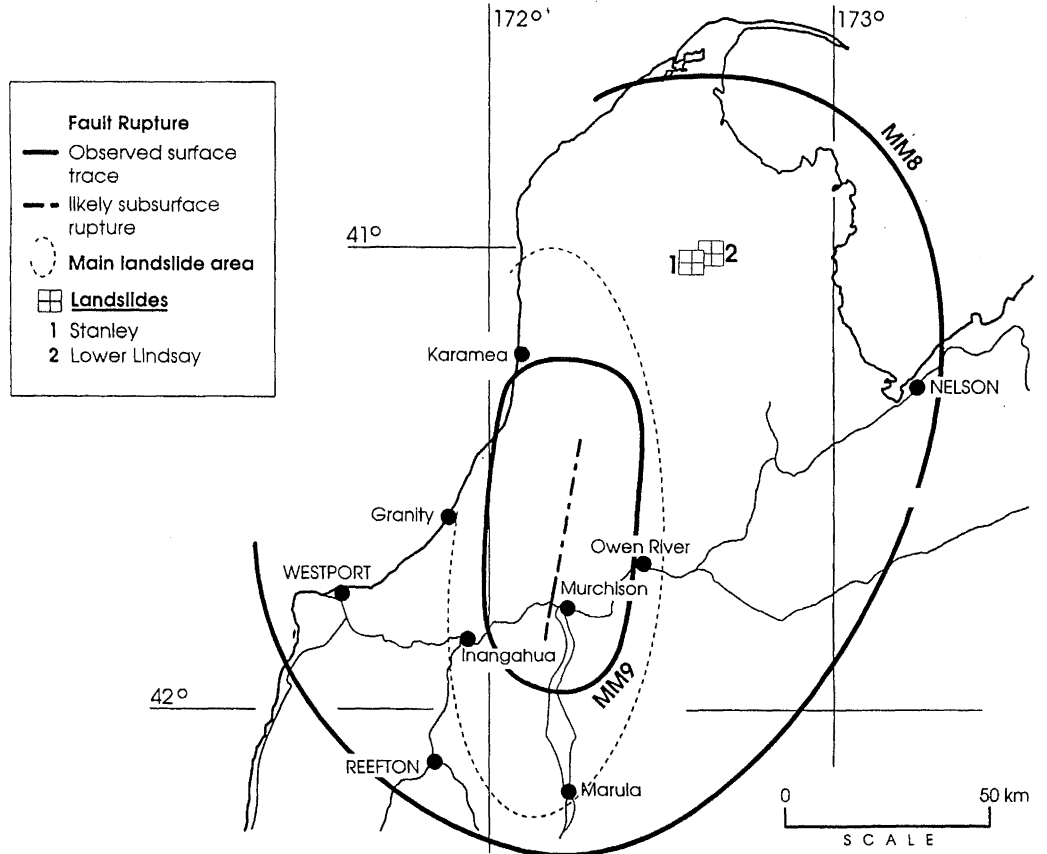
Likewise the MM9 isoseismal is fairly narrow, and it is nearly symmetrical about the likely *maximum* fault rupture. In addition the MM9 isoseismal is nearly symmetrical with respect to the main landslide area (Figure 8).

FIGURE 8 Map showing relationship of the MM8 and MM9 isoseismals to the main landslide area of the 1929 Murchison earthquake.
