# RECONNAISSANCE REPORT ON HIGHWAY DAMAGE FROM THE 18 JUNE 1994, ARTHURS PASS EARTHQUAKE

B.R. Paterson<sup>1</sup> and P.J. Bourne-Webb<sup>2</sup>

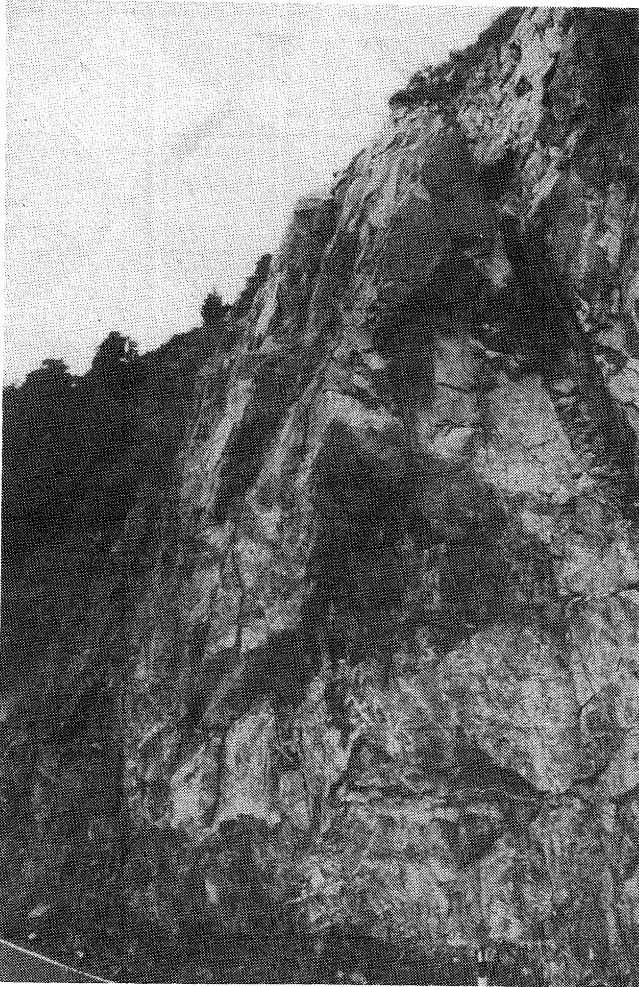
Between Cass and the Waimakariri Bridge where the highway follows the southern side of the broad Waimakariri Valley, the effects of the earthquake were restricted to debris and rockfalls, which occurred mainly towards the eastern end where the highway sidles across steep, glaciated slopes of greywacke and greywacke-derived colluvium. Slope instability in this area is a function of the relaxed nature of the highly folded and fractured greywacke sandstone and siltstone, which strikes subparallel to the highway and dips steeply into the slope. Numerous blocks of rock up to about 1 m diameter were dislodged from the steep batters by earthquake shaking, and impacted on the highway. Release of the blocks, as well as the effects of earthquake shaking, loosened the rock mass to the degree that further rockfalls could be expected to occur at any time, but particularly during aftershocks and heavy rainfall (Figure 2). Because these blocks could impact directly on the highway, it was recommended that they be removed.

**FIGURE 2** *Destressed greywacke sandstone and argillite loosened by earthquake shaking . Locality on State Highway 73 near Paddy's Bend.*

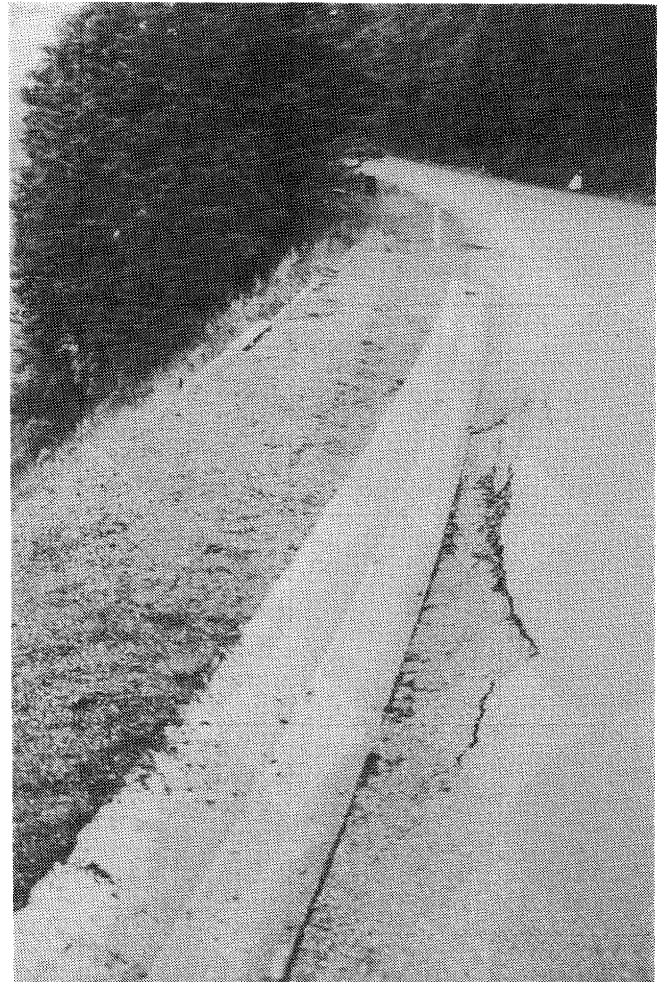
**FIGURE 3** *Slumping along the outer edge of an embankment retained by a crib wall. Locality south of Athurs Pass.*

From the Waimakariri Bridge to Arthurs Pass township, where the highway follows the western margin of the more-confined, north-south trending Bealey Valley, the incidence of minor rockfalls and the severity of embankment slumping increased. Minor rockfalls occurred at most road cuts, interspersed with debris slides/flows from unstable slopes high above the highway, and numerous individual blocks of rock - these effects are similar to those experienced during rainstorms. Slumping of the outer edge of the highway extended to the centre-line in some locations, but commonly was restricted to the poorly-compacted material adjacent to the sealed carriageway. Minor settlement occurred at crib-block retaining walls, without noticeable damage to the structures (Figure 3).

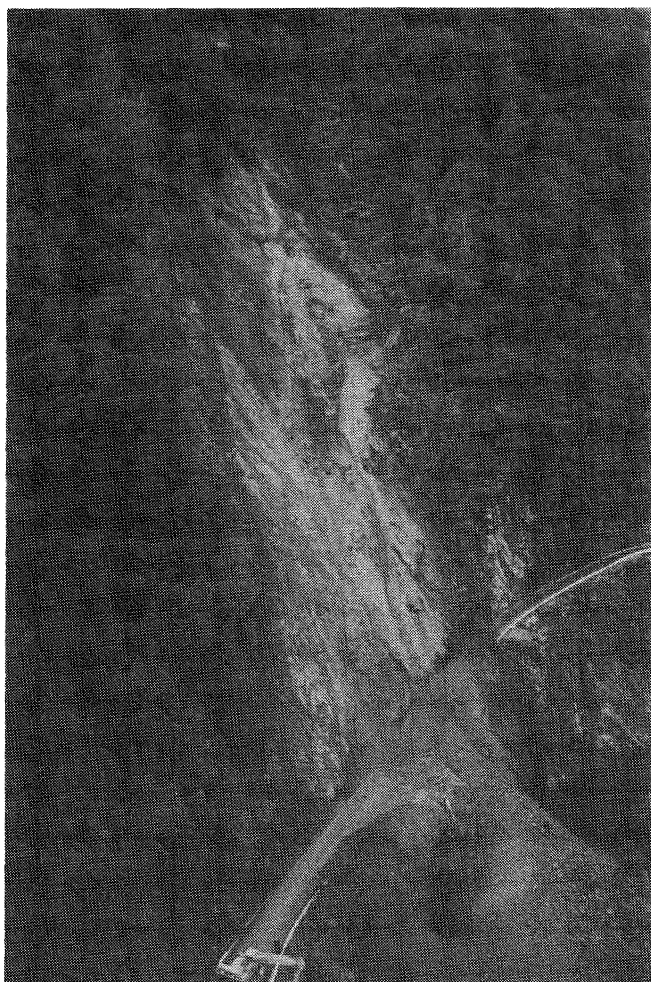
The largest slope failures that affected the highway were located in the Otira Gorge. A large rock slide on the eastern side of the valley, in the upper, narrow section of the gorge, partially dammed the Otira River (Figure 4). Several large debris slides/flows and numerous minor rockfalls occurred throughout the gorge (Figure 5), and the rock mass in numerous steep road cuts was loosened by earthquake shaking. Rock slopes at

**FIGURE 4** Rock slide above SH 73 partially damming the river in the upper Otira Gorge.

The main rock slide is a classical wedge failure, delineated by undulating shear zones which form a shallow wedge, the intersection of which has a plunge (angle of declination) similar to the slope angle ( $55^\circ$ ). The failure surfaces are curved, daylighting at the top and bottom of the vertically-orientated wedge. This feature was identified previously as a potentially unstable wedge and was recommended for removal or stabilisation prior to upgrading of this section of highway [2]. The wedge failure extends to a height of 60-80 m, and has a width of approximately 20 m. The volume of slide debris is estimated to be 5-10,000 m<sup>3</sup>. Because of continuing risk of rockfall from material loosened by the slope failure, considerable effort was made to dislodge this material by sluicing it with water carried by two helicopters equipped with monsoon buckets.

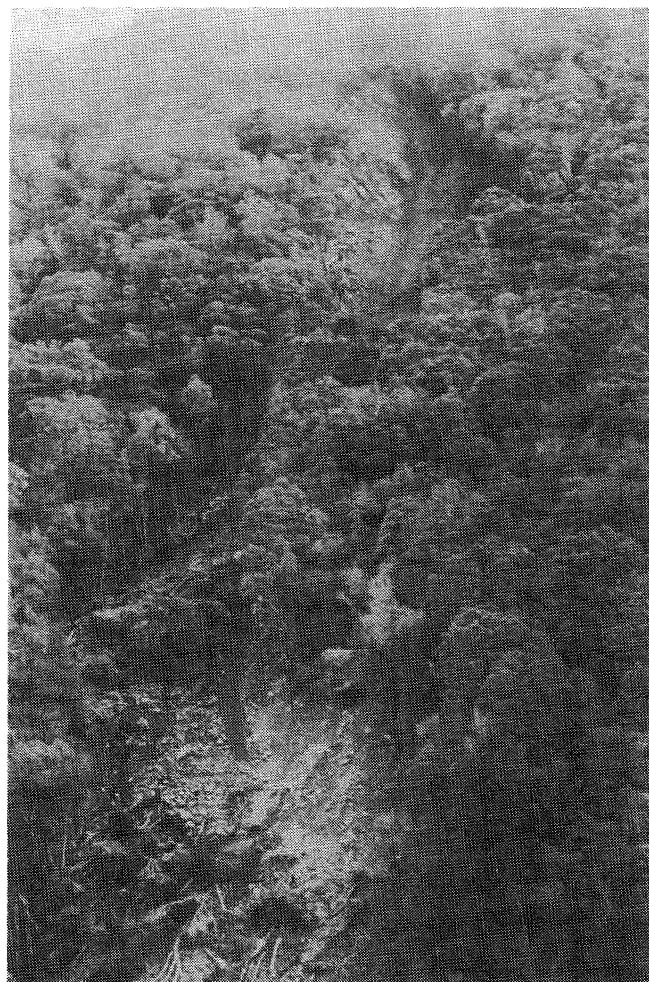
**FIGURE 5** Debris slide on the western side of the Otira Gorge, opposite SH 73.
