GROUND SHAKING INTENSITY AND DAMAGE AT LAKE COLERIDGE POWER STATION IN THE 18 JUNE 1994 AVOCA RIVER EARTHQUAKE

A. Pattle¹ and J.H. Wood²

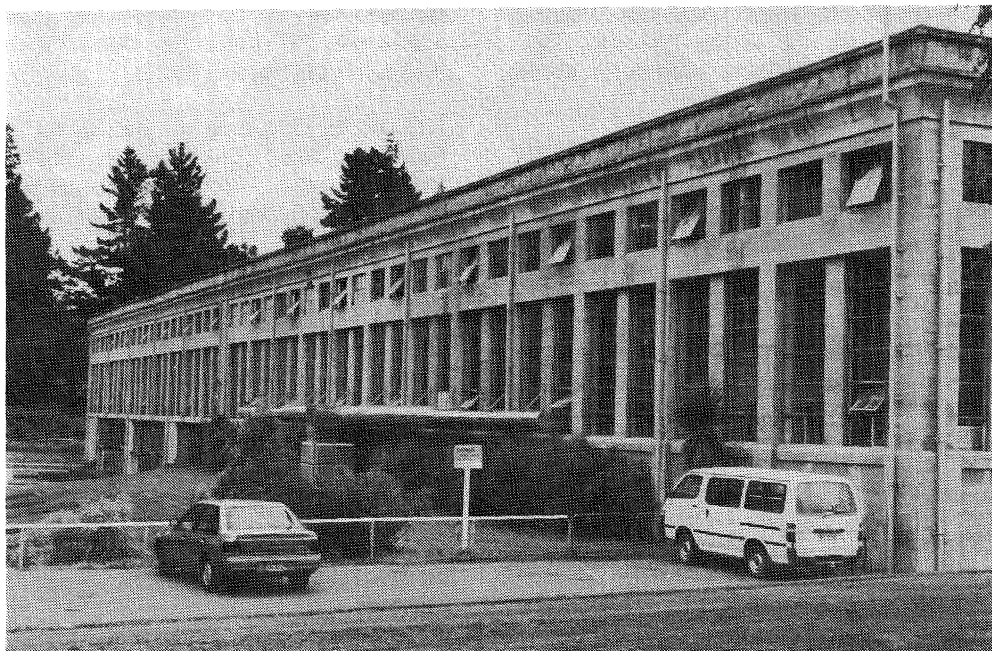
Typical details of the buildings are shown in Figure 1. Both buildings are of similar reinforced concrete frame construction with concrete beams supporting a 100mm thick reinforced concrete roof. The original concrete roofs were later more securely weather proofed by the addition of galvanised steel roofing placed on a light weight structure over the top of concrete.

- There were approximately 100 broken or cracked windows. Loss of glass was predominantly from the west end wall of Building 'B'.
- Concrete was spalled by clashing of the buildings at the joint between them but the damage was superficial.
- An offset of 10 mm occurred at the joint in the crane rails where they join between the two buildings.
- A number of fine cracks were observed in the concrete walls and typically extended from the lower window sills to the floor. Many of the cracks were related to repaired pre-existing cracks that were caused by shrinkage, settlement or possibly previous earthquake activity but some new cracks formed. However, most of the cracks that opened had widths considerably less than 1 mm.

Figure 1. Lake Coleridge power station buildings (tailrace side).

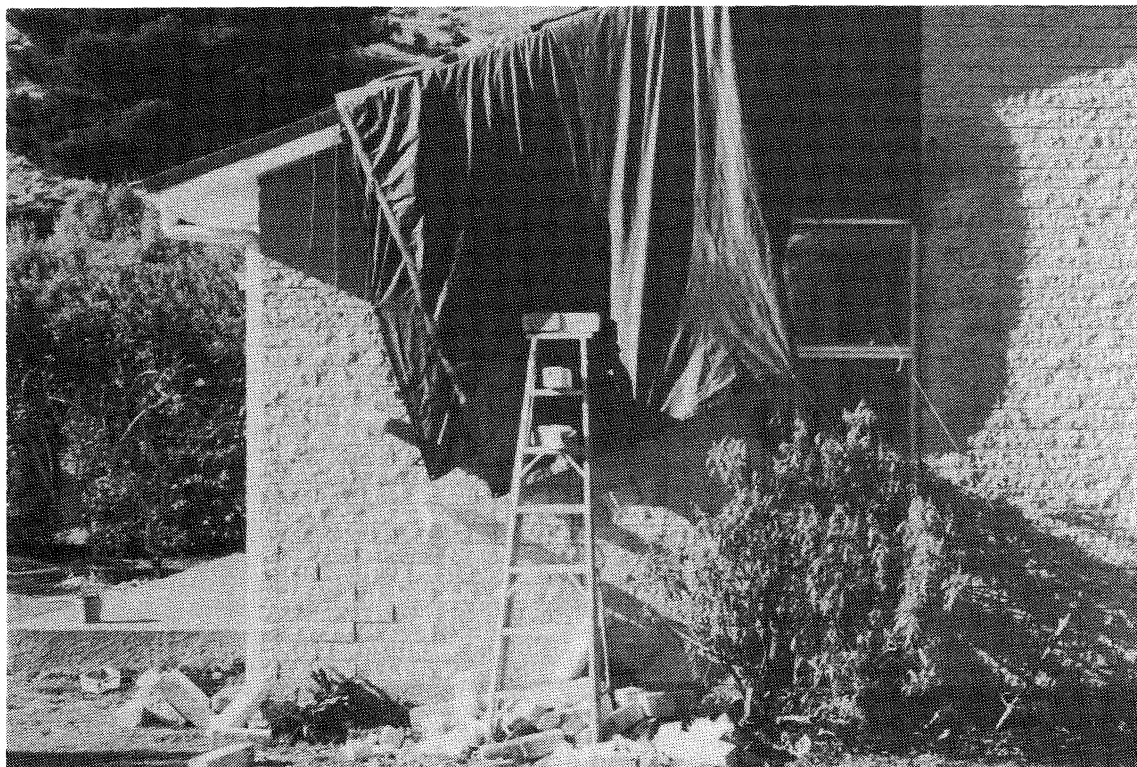
In the main shock the house occupied by the Harper Plant Operator received very minor damage to a brick veneer gable. The contents of the house were not greatly disturbed. In the magnitude 5.8 aftershock a large section of the gable end was dislodged as shown in Figure 2. A wood burner fireplace was also dislodged with the flue movement resulting in damage to the ceiling.

Figure 2. Section of gable end dislodged at the Plant Operators residence, Harpers Village, in the magnitude 5.8 aftershock.

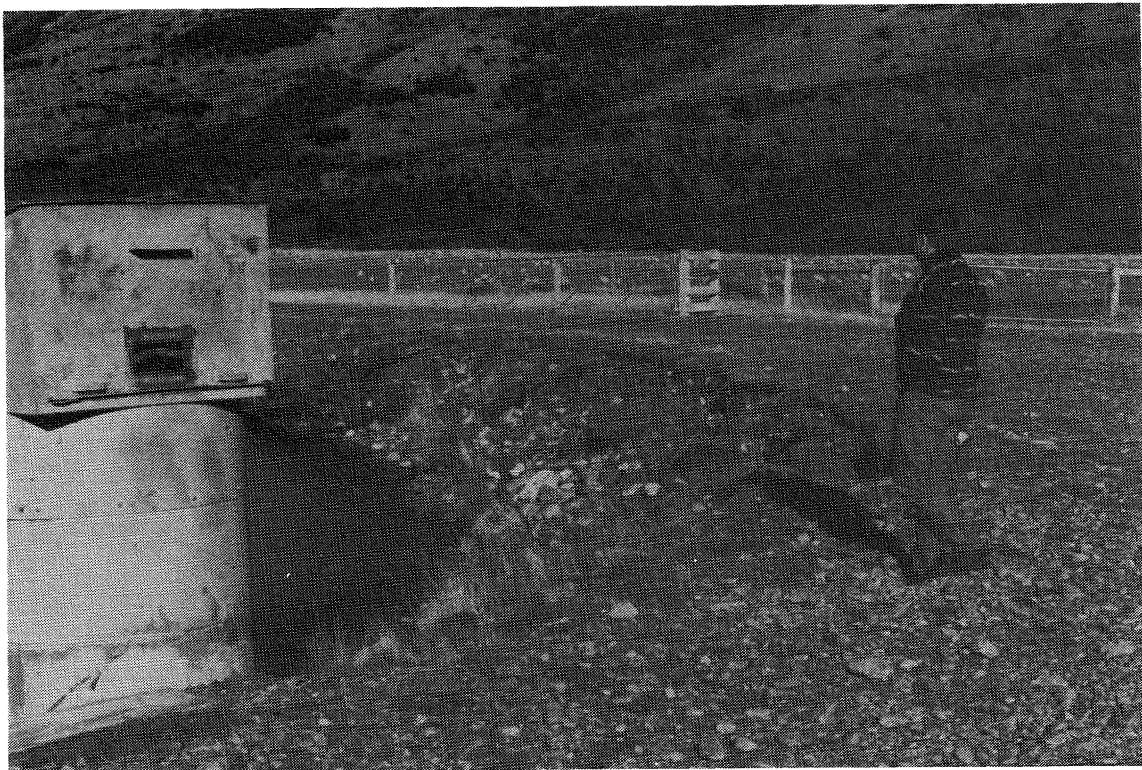
In the main shock a number of canal slopes suffered minor slumping. In the aftershock, additional slumping occurred and there was some minor differential settlement in the fill covering a corrugated steel culvert structure. Some of the damage is illustrated in Figure 3. The canal slope slumping and settlement was the only observed damage to ECNZ structures at this location.

Figure 3. Embankment slumping at Oakden Culvert, Wilberforce Diversion.
