## THE 2016 MEINONG TAIWAN EARTHQUAKE: LEARNING FROM EARTHQUAKES REPORT

**Richard S. Henry<sup>1</sup>, Bo-Yao Lee<sup>2</sup>, David McGuigan<sup>3</sup>,  
John Finnegan<sup>4</sup> and Gordon Ashby<sup>5</sup>**

### ABSTRACT

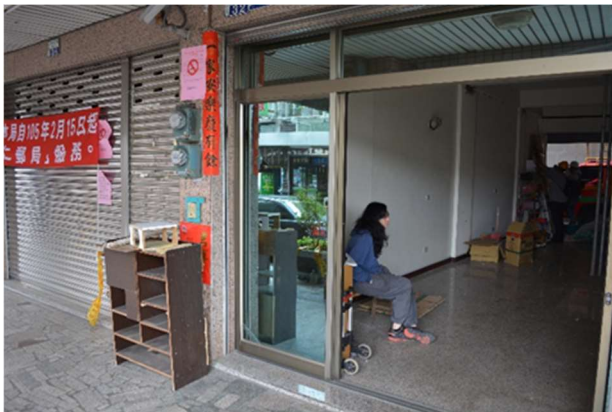
Several buildings with red placards visited were still occupied, such as that shown in Figure 9. This may have been due to the damaged buildings having already been temporarily stabilised and the placard not being updated or removed. However, this may also indicate a lack of alternative accommodation provided to relocate residents of damaged apartment buildings. For typical mixed-use buildings, a single title is often both the family business (ground floor) and residence (upper floors). Occupants are therefore less likely to relocate at the risk of losing both their home and business and may be willing to tolerate a higher level of risk by remaining in the damaged building.

**Figure 9: Occupied red placard building.**

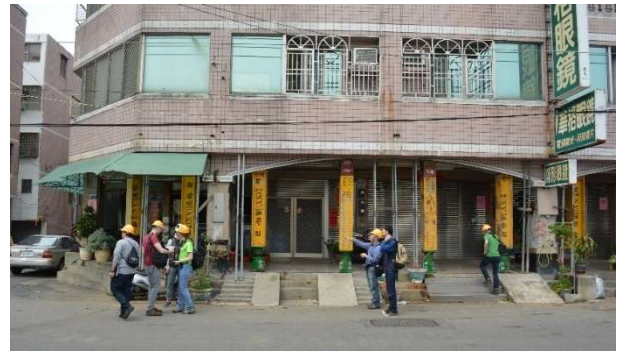
The use of barricading around damaged buildings was not widespread. The lack of barricading observed may have reflected the quick recovery and demolition or stabilisation of severely damaged building. However, a number of red placard buildings visited had either no or poor barricading despite being a potential collapse risk. The red placard building shown in Figure 10a had severely damaged columns on the front of the ground floor and although temporary props had been installed, no barricading was in place. Another district office building, shown in Figure 10b, had severely damaged columns at the front of the building and hazard tape had been placed around the entire building. No temporary stabilisation had been installed in this district office and the taped area would not have provided adequate protection if the building did collapse during an aftershock.

**a) Lack of barricading around a red placard building**

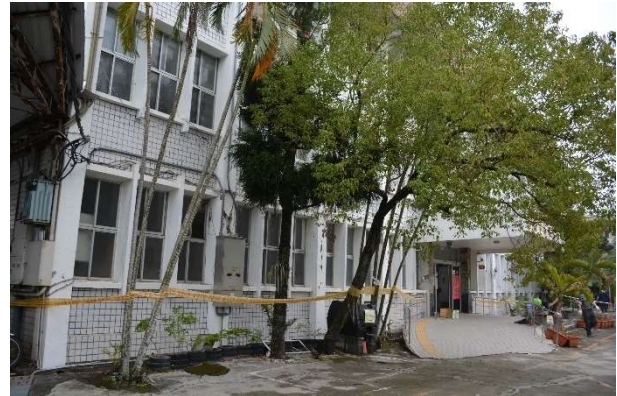
**b) Hazard tape surrounding severely damaged building**

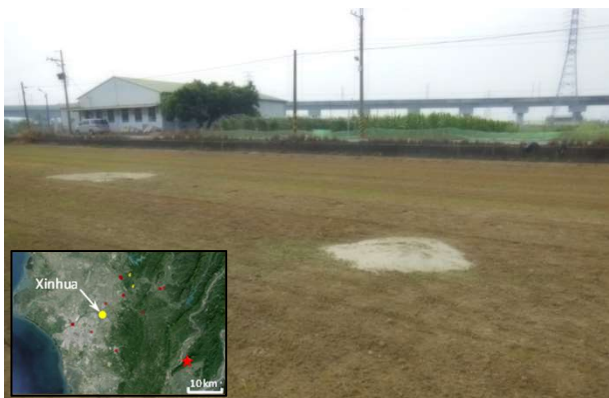
Sporadic localised sand boils were observed in open ground within the lowland district of Xinhua, which is located approximately 4 km to the south of Xinshi, refer to Figure 11. These are also visible on Google Earth with photography date of 7th February 2016.

Figure 11: Xinhua sand boils (GEER [20])

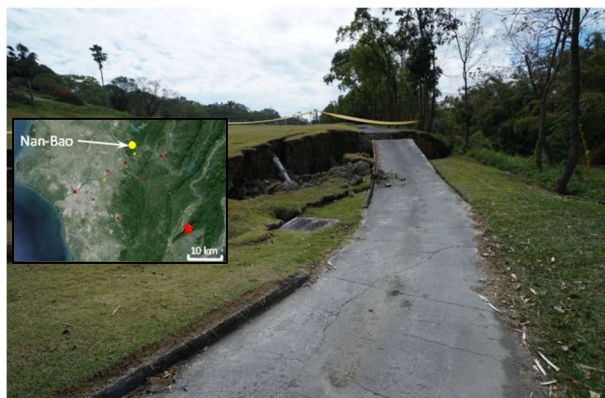
Slope failure also occurred as a result of this earthquake at the Nanbao golf course, as shown in Figure 12. At this site the slide mass moved in a relatively coherent manner towards a creek bank with relatively low level translational movement in more of a rotational failure mode.

Figure 12: Slope failure at Nanbao golf course (Source: NCREE).

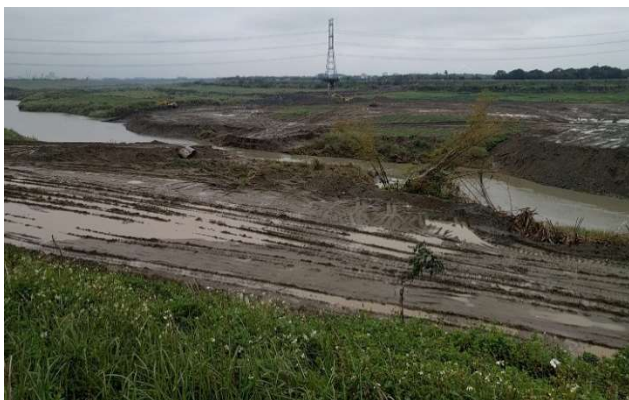
c) Failure #3

The slope instability of the Rixin Levee is considered to result from a particular saturated cohesionless fill layer at or below the base of the levee that liquefied during the earthquake, resulting in slope failure and lateral soil displacement (runout) of between approximately 30 m and 135 m. The fill is presumed to directly overlie a naturally occurring low permeability silty clay soil, which was identified in soil investigations associated with a pipeline bridge located approximately 500 m downstream from the adjacent Freeway bridge. Discussions with a local engineer indicated that there was most likely no subsurface investigation information associated with the levee (or its repair) away from any bridge structures. It is also understood that piles have been placed beneath the levee immediately adjacent to the upstream side of the right bridge abutment and opposite the factory structure visible in Figure 13. No instability was observed within this part of the levee. Some

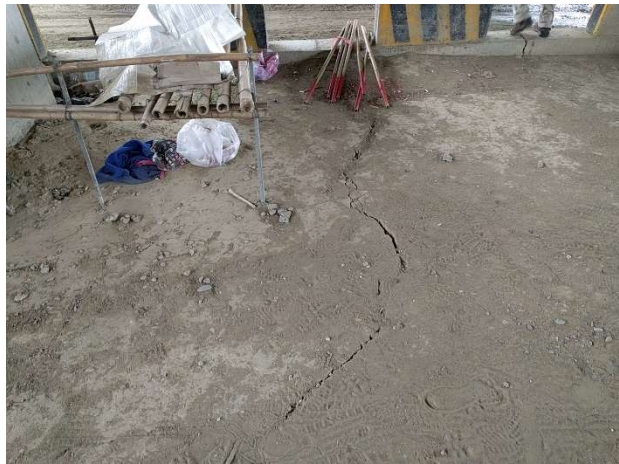
ground surface settlement of the order of 100 mm and surface cracking was observed adjacent to the bridge pier on the right abutment of the Freeway bridge at an elevation coincident with the top of the river levee, as shown in Figure 14.

**Figure 14: Ground surface settlement and crack adjacent to Freeway bridge pier on the right abutment.**

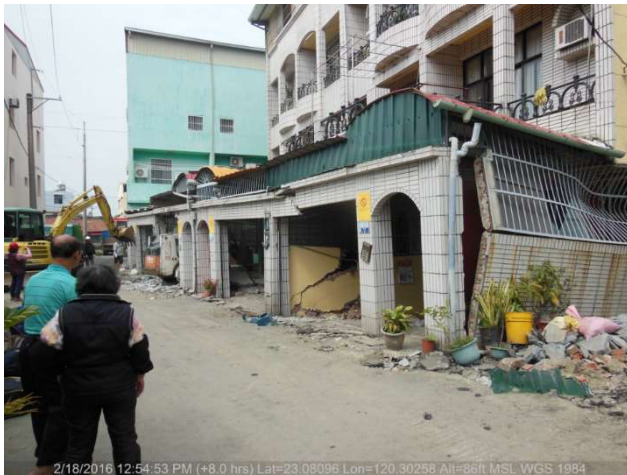
a) Damaged ancillary buildings (GEER [20])

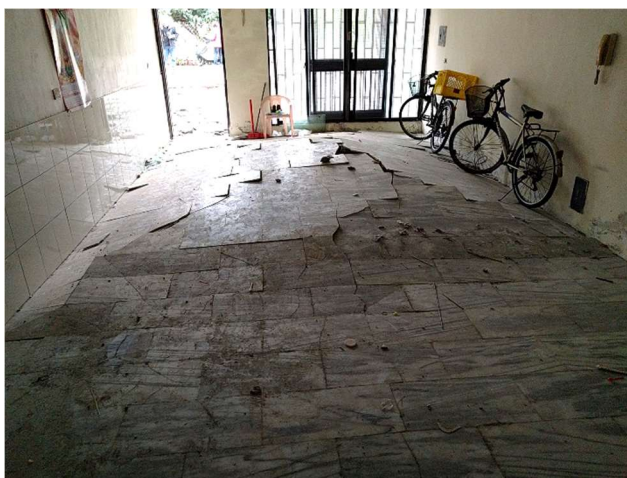
The photos within Figure 15 illustrate several points, including the relatively uniform settlement of the main residential building. In this case there is little tilting of the overall structure indicating that the foundation essentially punched into the underlying soil vertically. The settlement of the foundation ground beams, which are carrying the building loads, has resulted in the hogging of the ground floor slab. At the time of the NZSEE visit there was very little liquefaction ejecta evident

c) Hogging of the unreinforced floor slab within dwelling

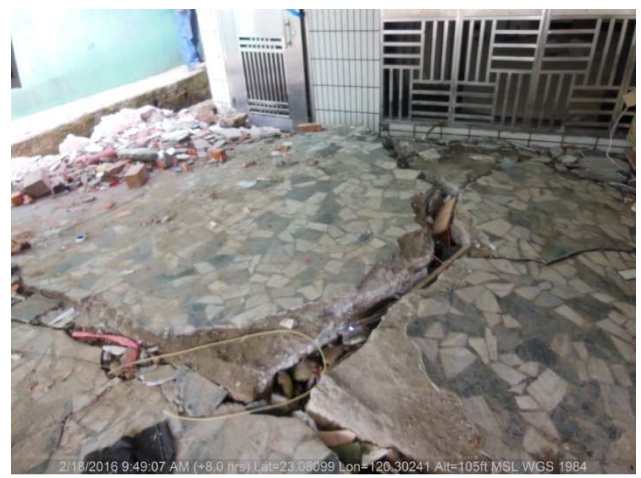
d) Damaged ground slab in front of dwelling (GEER [20])

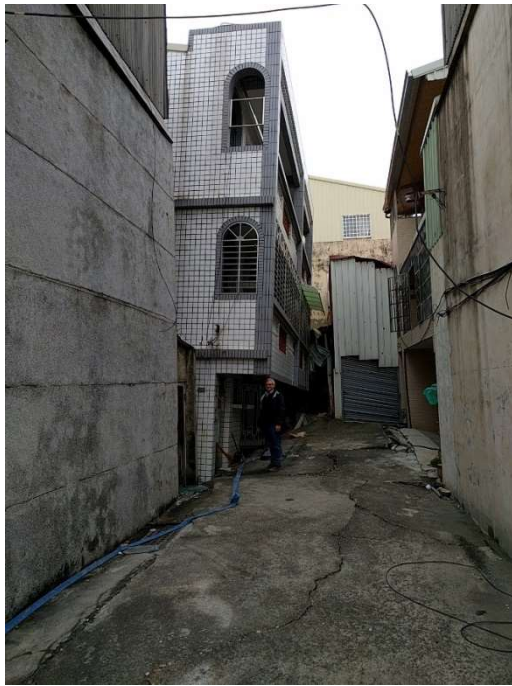
Figure 17 provides an example of liquefaction-related land damage and associated residential building damage. In this case, which is located in the Annan District and again associated with historical backfilling of a former fish pond, the building has punched and tilted as a result of liquefaction of the underlying soil. Vertical settlement is of the order of 1.0-1.2 m and the building has tilted by approximately 8 degrees. The building superstructure appeared to have held together well despite the obvious foundation movement. Figure 17b shows a liquefaction ejecta-filled drainage trench immediately adjacent to the building.

*a) Tilted residential building*

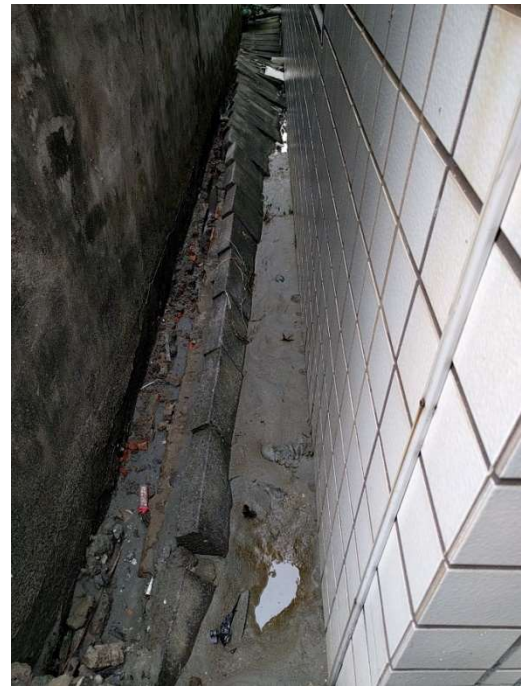
*b) Drainage trench*

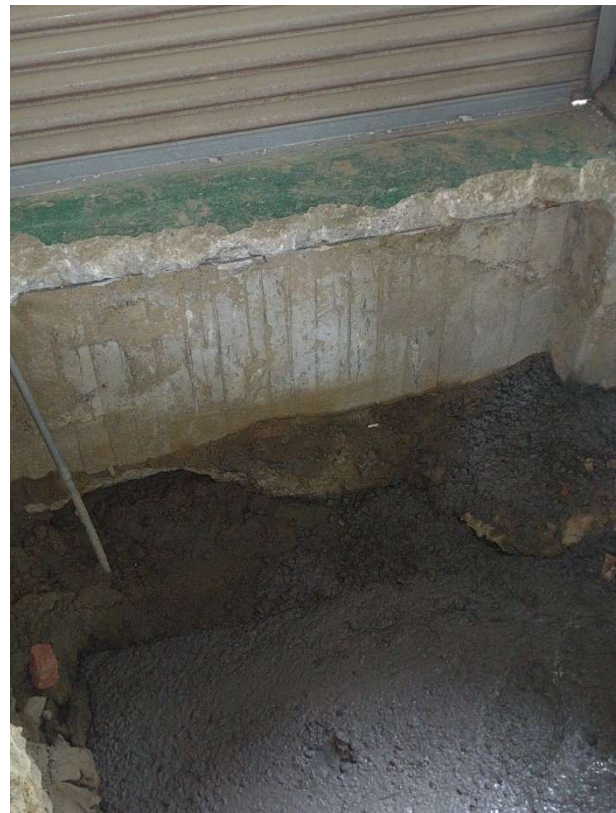
*c) Perimeter foundation beams*

At the time of the NZSEE team visit a building in this area was undergoing repair involving jacking and re-levelling of the foundations. The photos in Figure 18 show the building and the nature of the foundation ground beams that had been exposed to enable positioning of the jacks. The perimeter foundation beams (Figure 18c) are approximately 0.8 m deep and 0.4 m wide. Dewatering was also carried out to facilitate the repairs and the plastic pipework is evident (Figure 18b). The unreinforced slab-on-grade floor is clearly shown along with nominal tie bars between the slab and the ground beams. At the time of the team visit the re-levelling had just been completed. Discussion with the owner indicated that the building had settled approximately 150 mm, although this was an estimate as no measurements were believed to have been taken of building settlement or tilt.

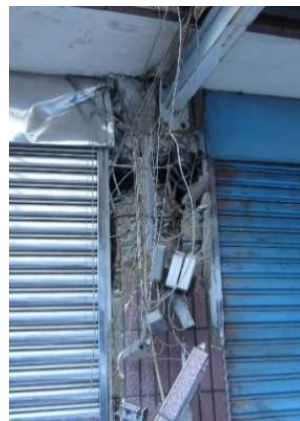
*b) Damaged column*

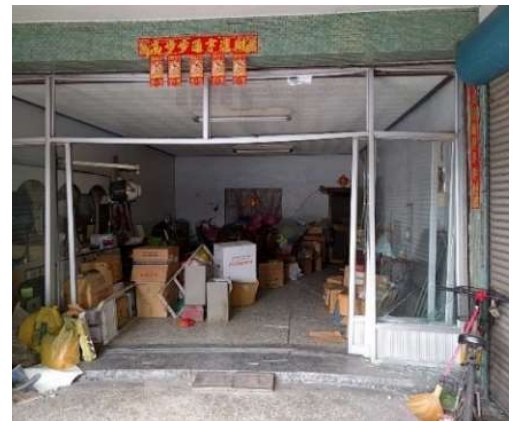
*c) Hogging of floor slab*

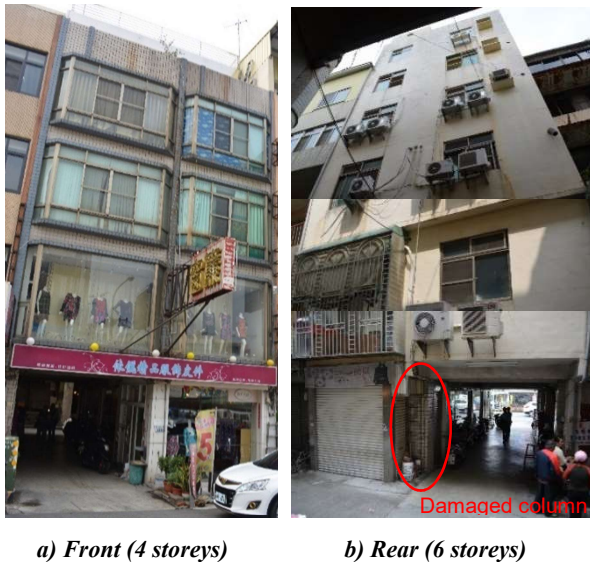
these heavy additional storeys may lead to overloaded columns. The building shown in Figure 22 appeared to be four storeys from the front, but was actually six storeys at the rear. The building addition at the rear of the building was not original and the increased weight may have contributed to the damaged observed in a central column that had steep inclined cracking characteristic of an axial-shear type failure.

**Figure 22: Added storeys on top of building.**

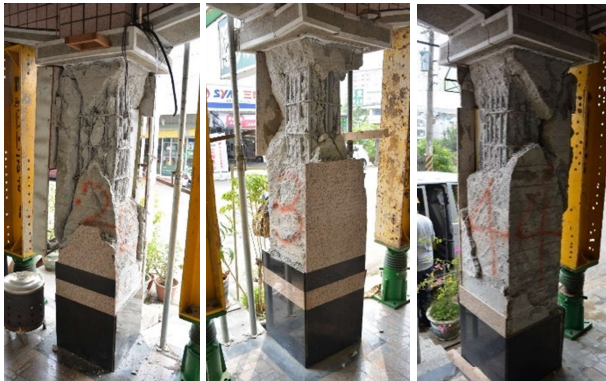
The 5-storey building shown in Figure 24 was located in Guiren District, southeast of central Tainan and was constructed in approximately 1992. The columns on the side of the building adjacent to the street were all severely damaged with significant cover loss, inclined shear cracks, and crushed core concrete. Temporary props had been added to provide gravity load support and the building had a red placard, although occupants were still living in the building. In addition to the structural

- Lap splices of all of the longitudinal reinforcement at the base of the column resulting in a weak section above (similar to short column effect).
- Widely spaced transverse reinforcement.
- 90-degree anchors in stirrups opened up at the corners.
- Fractured stirrups (possibly due to bending quenched and tempered steel).
- Large concrete cover depth (~100 mm).
- Electrical boxes embedded in the front of columns.
- Rainwater downpipes located within the column core.

b) Column damage

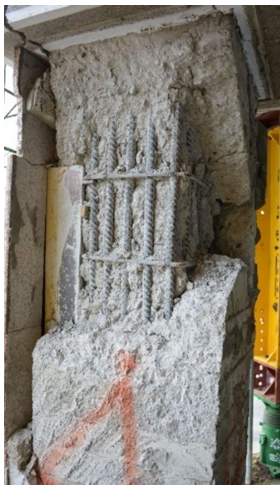
c) Electricity box, large cover, stirrup spacing

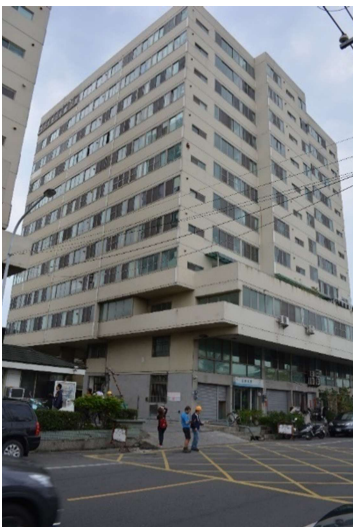
a) Front view of damage tower

The building had been given a yellow placard and was in the process of being repaired when team members visited. The proposed repair consisted of installation of steel columns either side of the damaged column in the basement. The repair strategy had been proposed by an engineer and requires approval from the local district council.

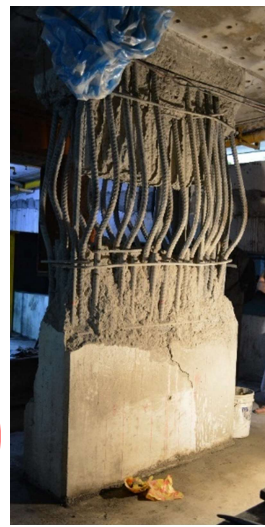
c) Basement column

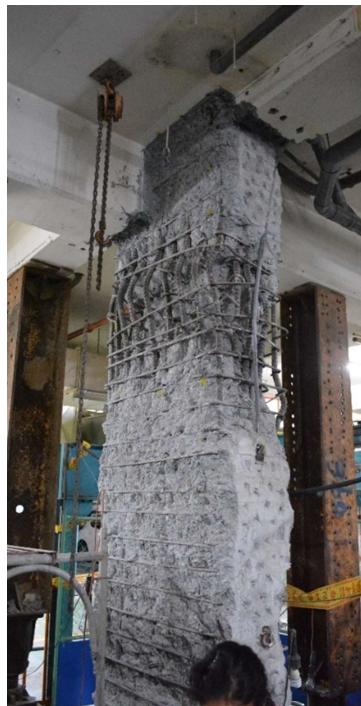
Nearby to the building described above was a block of 14 storey apartments built in 1998 and shown in Figure 30. The four towers were constructed above a single basement carpark with the weight of the upper storeys being transferred to columns with large spans up to 12 m. There was visible distress to the columns and infill walls at ground level, such as that shown at the corner column in Figure 30b. In the basement there was diagonal cracking in most of the reinforced concrete walls (Figure 30e), but most of the columns were not significantly damaged with the exception of one. The column under one of the corners of the building above was severely damaged with axial-shear failure along a 45-degree plane, as shown in Figure 30c. Despite closely spaced stirrups and ties (~120 mm centres), the 90-degree hooks in the stirrups and ties had opened up and a number of stirrups had fractured as well (Figure 30d).

*c) Damaged column in basement*

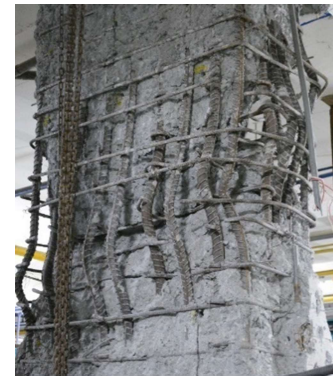
*d) Poor reinforcement detailing*

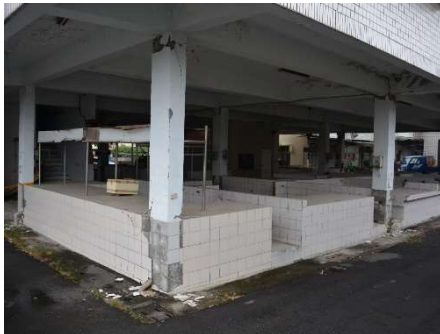
The old market in Nanhua (north of the epicentre) shown in Figure 31 is an example of a common local market with open plan ground floor with a heavy box like structure above. This market was damaged during the 2010 Kaohsiung Jiasian earthquake and subsequently strengthened with the installation of steel columns on either side of damage columns (Figure 31c). The market was subsequently closed in 2014. The ends of the columns sustained fresh damage during the Meinong earthquake, but the building did not collapse.

b) Column damage

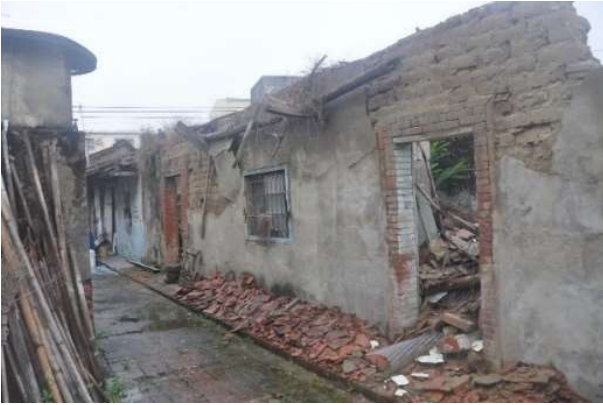
*a) Damaged adobe and URM house*

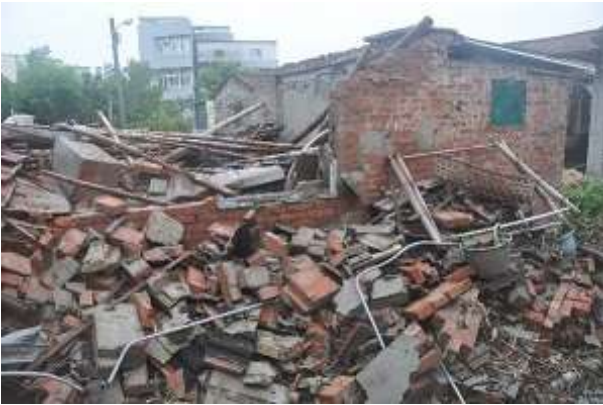
*b) Collapsed URM house*

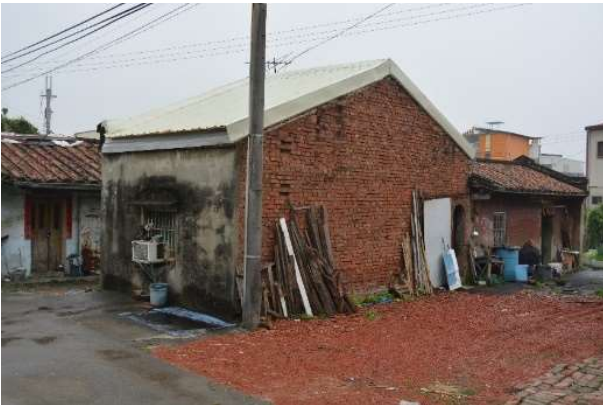
*c) Repaired roof that collapsed*

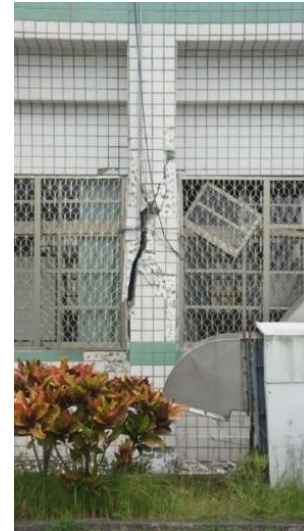
The Yujing Junior High School classroom block shown in Figure 34 is a three storey reinforced concrete building that was built in 1998 and had not been seismically retrofitted. The lateral load resistance in the long direction of the building is provided by reinforced concrete frames, but the impact of the reinforced concrete infill walls has not been fully considered. The front support columns are short columns, or “captive columns” as described in Taiwan. A downstand spandrel and an upstand concrete sill have restrained the column deformation resulting in a short column effect and shear failure, as shown in Figure 34b. The cantilevered front face of the building has also induced demands that damaged a feature wall with a circular hole. Non-structural damage consisted of a large area of ceiling tiles falling.

*b) Damaged column*

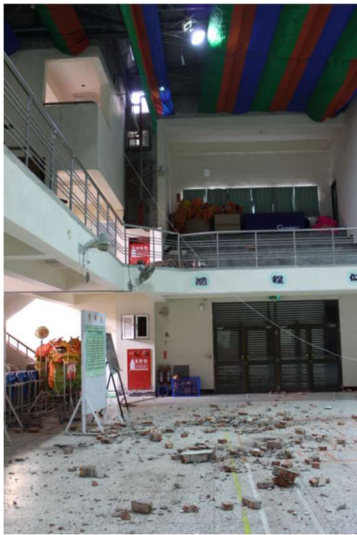
*a) Falling bricks inside*

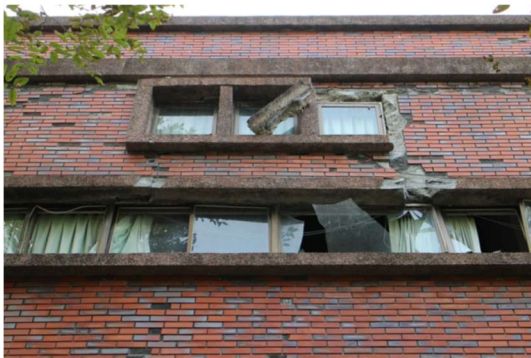
*b) Damaged wall*

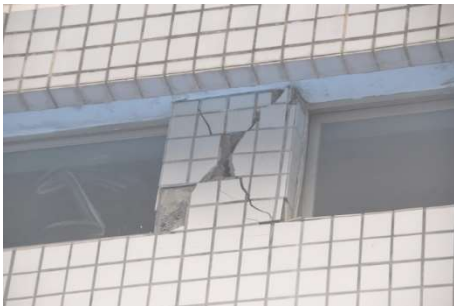
*a) Damaged short column*

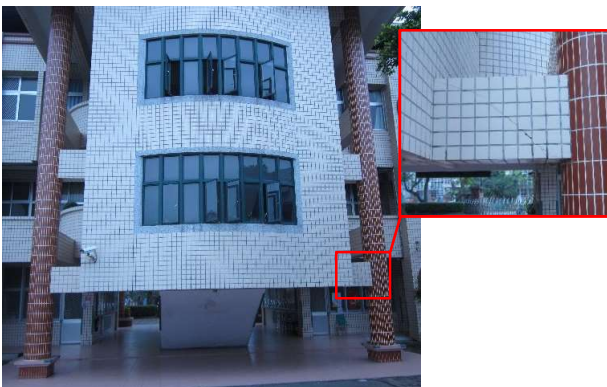
*b) Shear crack in support beams*

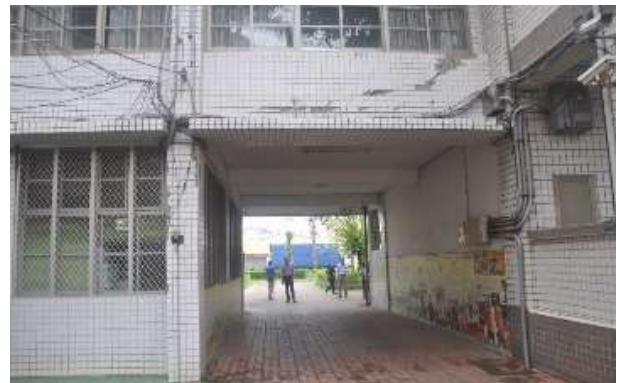
*b) Building pounding*

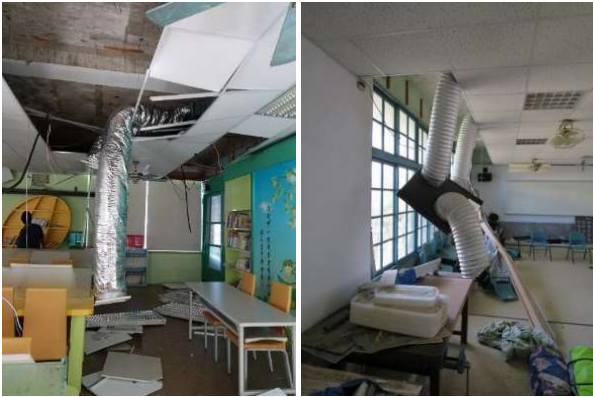
A reasonable amount of non-structural damage was observed to school buildings. The typical failures involved ceiling tiles and mechanical equipment and ducting in the classrooms, halls and administration buildings, as shown in Figure 39 and Figure 40. Non-structural damage to school buildings was investigated during post-earthquake reconnaissance [24]. Of interest were the stainless steel water containers that are common all over Taiwan as a means of emergency preparedness. They are of a typical make and form and the tank legs typically failed, resulting in overturning of the tanks, as shown in Figure 41. In some instances, the tanks did not overturn, but failed through punching of the supports into the tanks.

**Figure 39: Mechanical ducting support failure (Source: NCREE).**

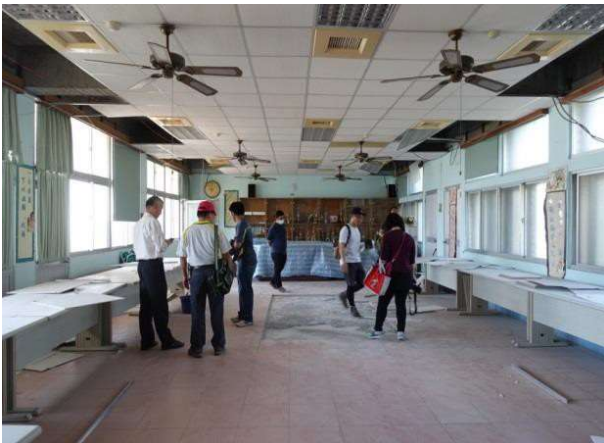
**Figure 40: Ceiling tile failure (Source: NCREE).**

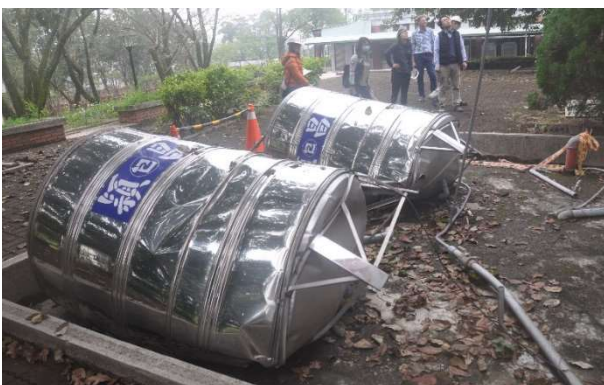
**Figure 41: Typical water tanks that were damaged during the earthquake.**
