BRIEF REPORT ON THE JANUARY 17 1994 NORTHRIDGE EARTHQUAKE IN LOS ANGELES

SUMMARY

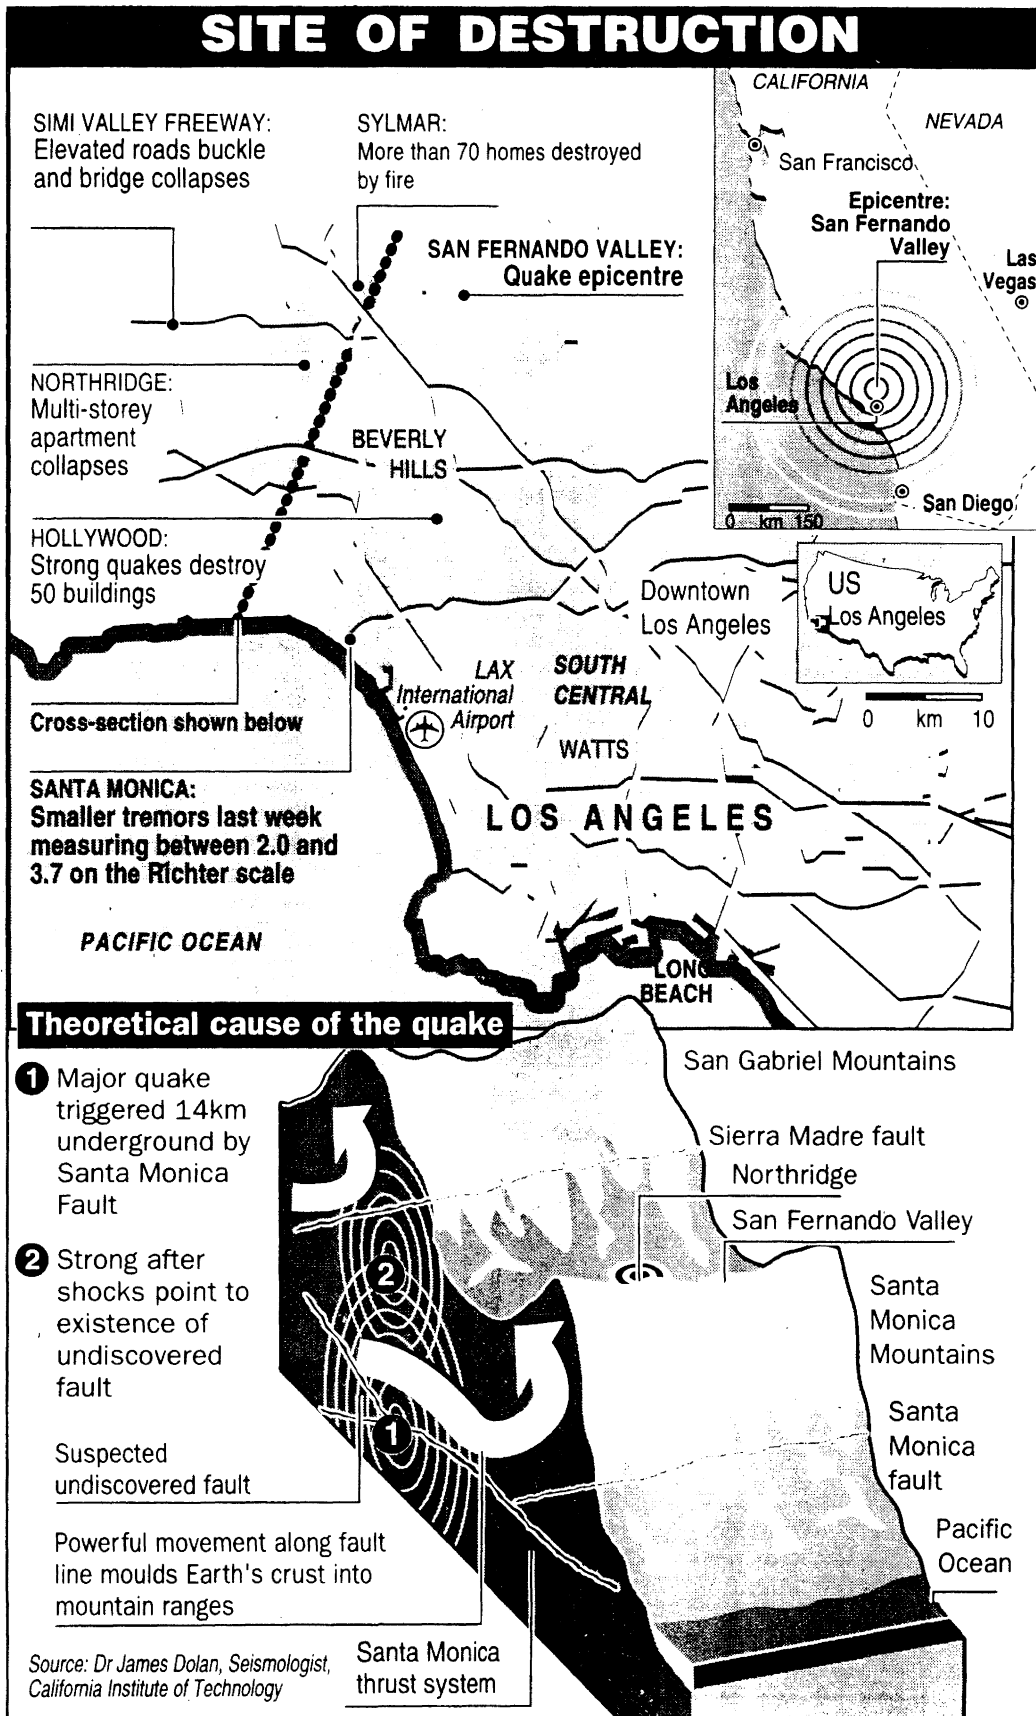
Figure 1 Newspaper summary of damage and the cause of the earthquake.

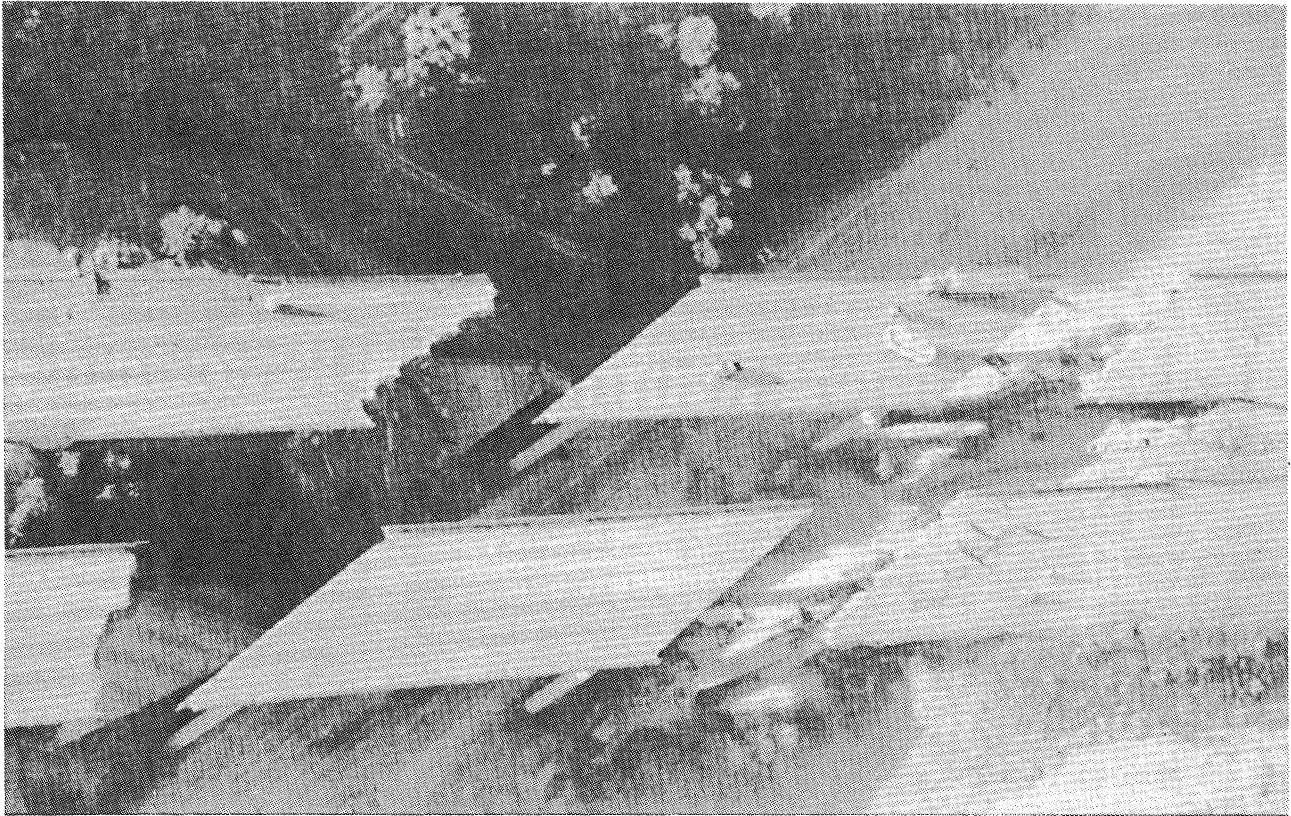
Figure 5 Vehicles are stranded on the centre section of a bridge on Interstate Five (Reuter/Christchurch Press).

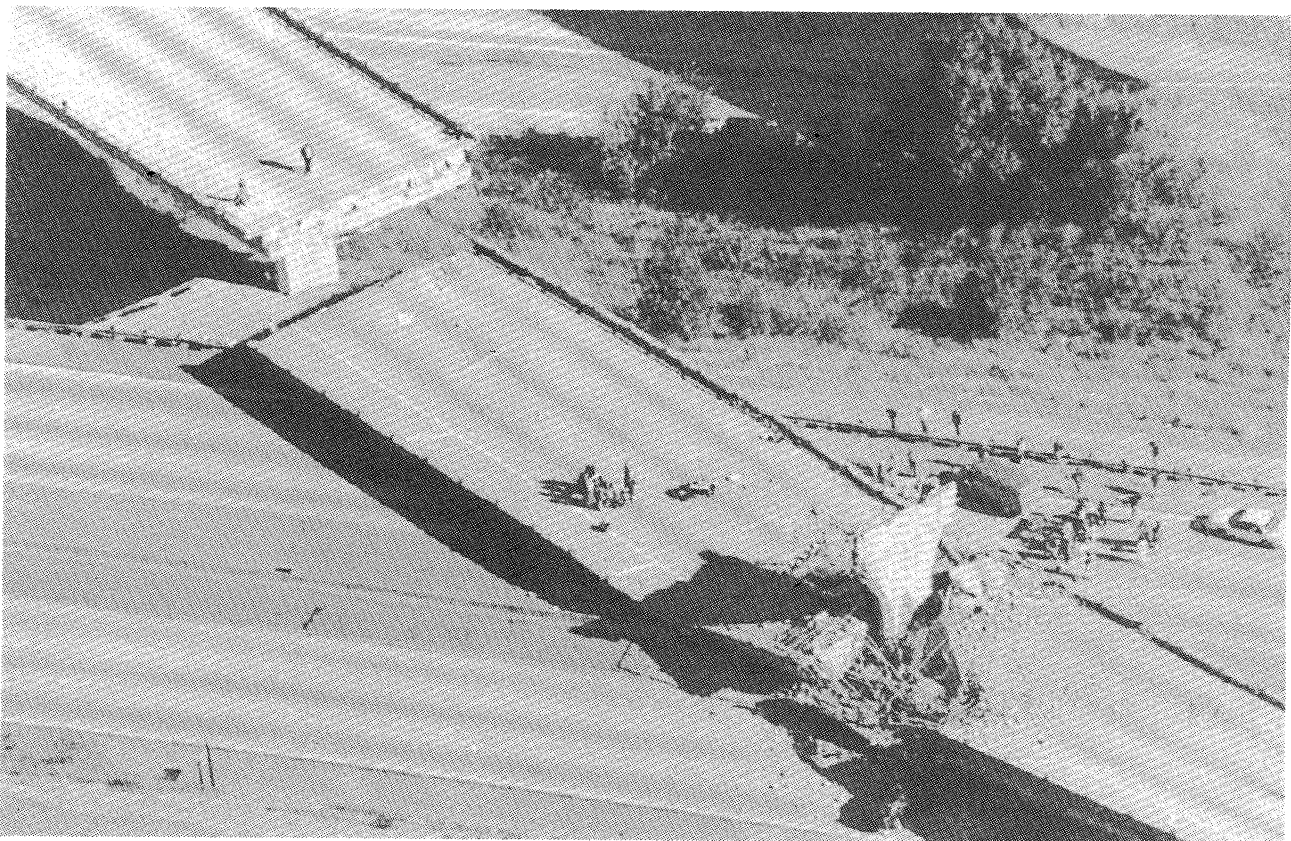
Figure 6 Collapsed Freeway overpass (Reuter/Christchurch Press).
