## EARTHQUAKE OF 7 DECEMBER 1988, SPITAK, ARMENIA REPORT OF THE NZNSEE TEAM VISIT OF 1989

P.R. Wood<sup>1</sup>, J.B. Berrill<sup>2</sup>, N.R. Gillon<sup>3</sup>, P.J. North<sup>4</sup>

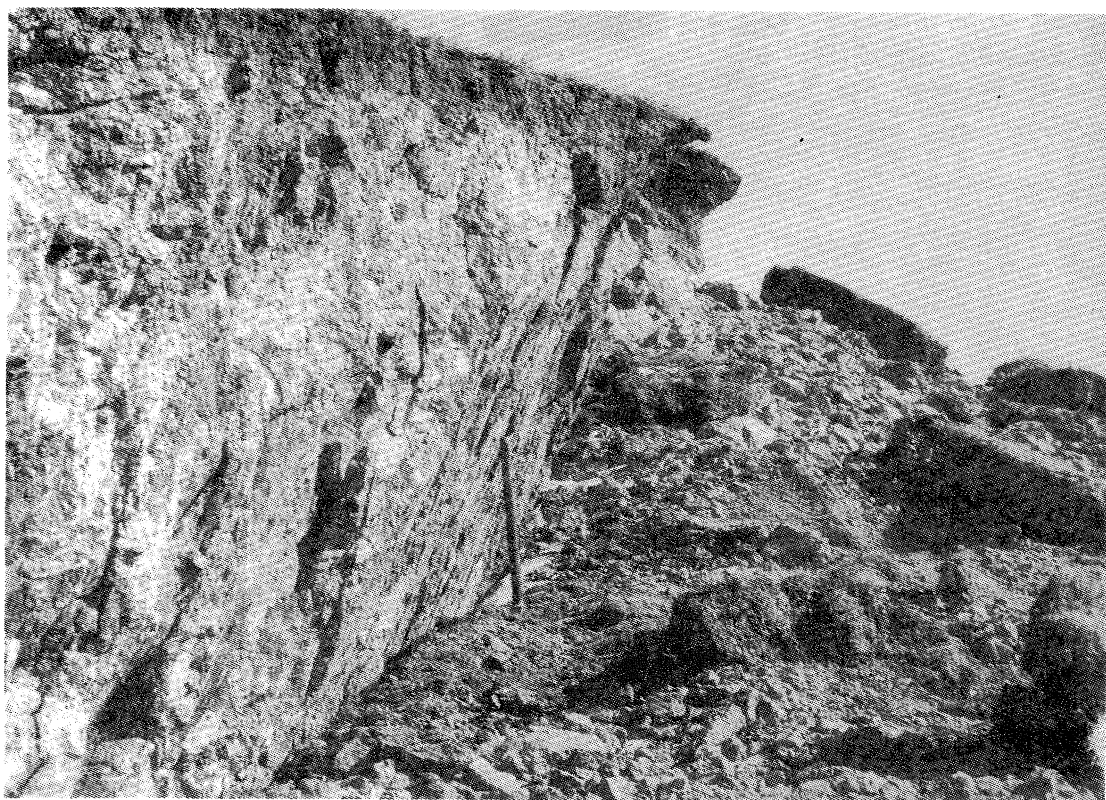
*Figure 10* Fault scarp produced by the Spitak earthquake (with hammer for scale). [from Trifonov et al. (1989)]

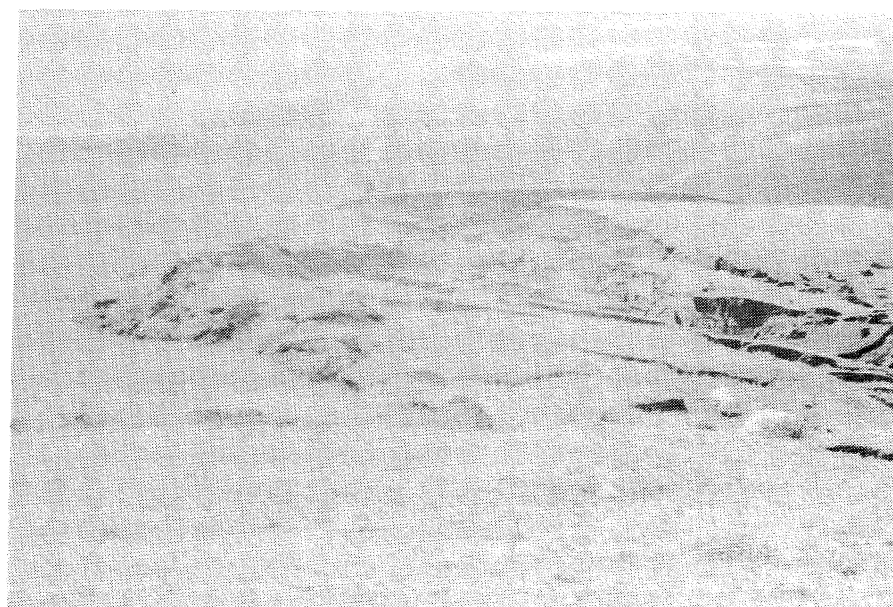
Slope failures were triggered by the earthquake [A. Karakhanian, pers comm.]. They include rockfalls from cuts, block slides (Figure 18), and earthflows.

Figure 18 Landslide near NW end of fault rupture. [A. Karakhanian]

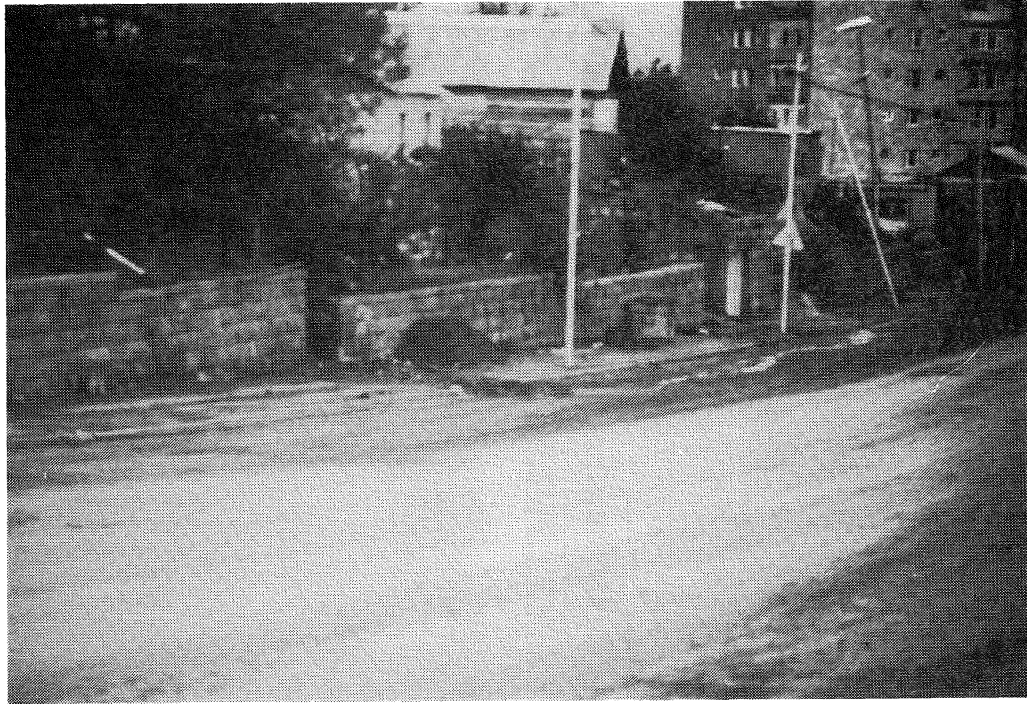
Apart from bridge abutments, no mass concrete retaining walls were identified in the epicentral area. A number of low cut-stone walls were seen at Spitak and most of these were undamaged or had at most one or two capping stones missing. Figures 20 and 21 show typical examples. The only wall that we saw to have suffered serious damage was found at the northern end of the precast concrete highway bridge under construction over the Pemback River at the time of the earthquake. Here, an old masonry wall, shown in Figure 22, about 2 m high, about 500 mm deep at the top and about 50 m long, retaining a horizontal backfill, had moved out of plumb by about 5 degrees over most of its length. At its highest point, a length of about 12 m had collapsed.

*Figure 20 Stone wall, Spítak.*

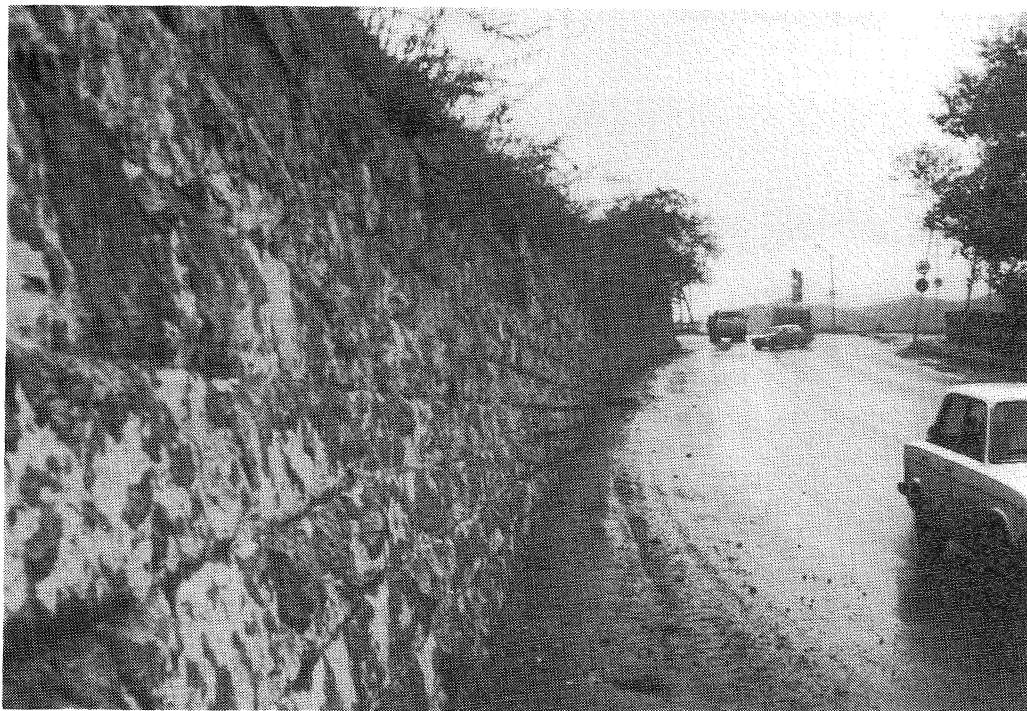
*Figure 21 Cut stone wall, Spítak.*

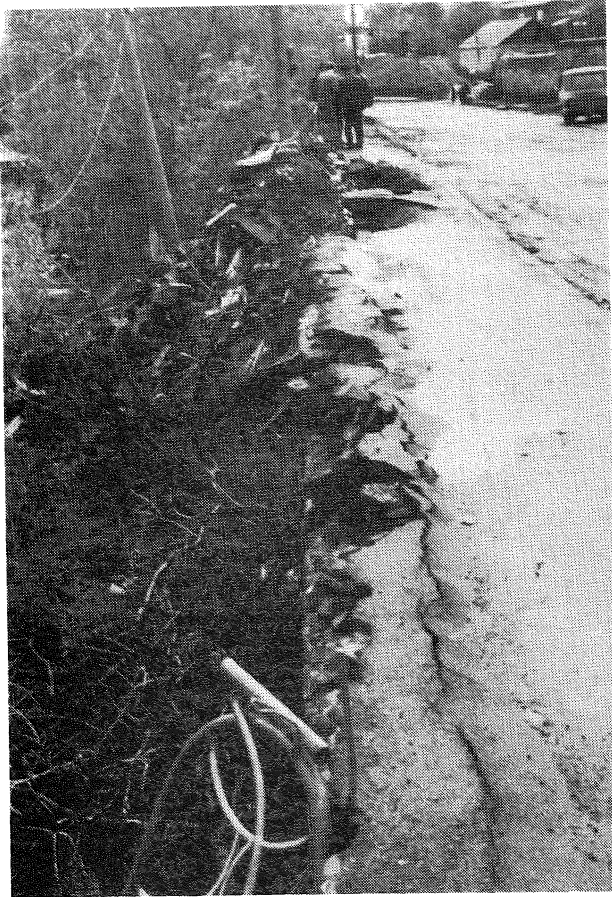
*Figure 22 Collapsed wall, Spütak.*

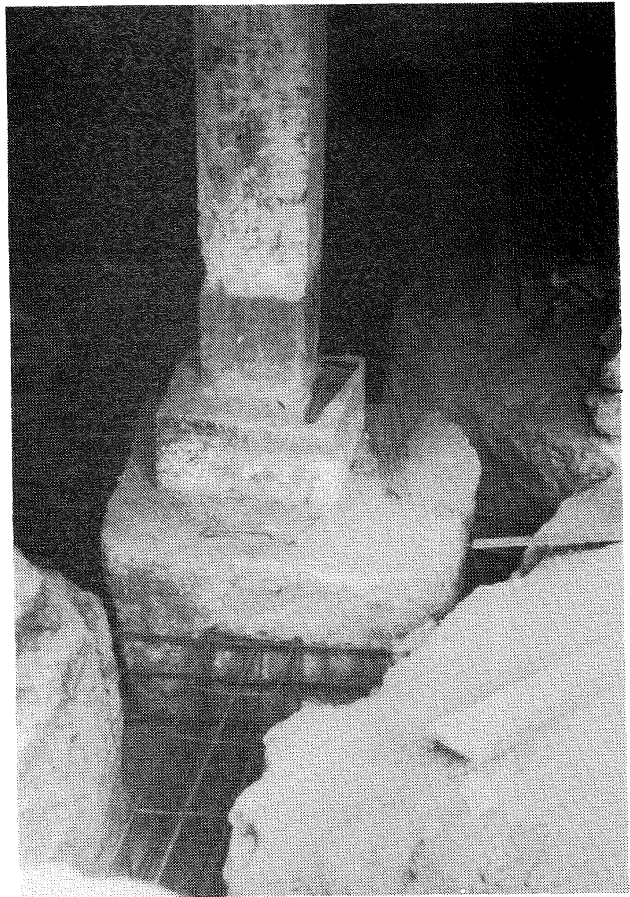
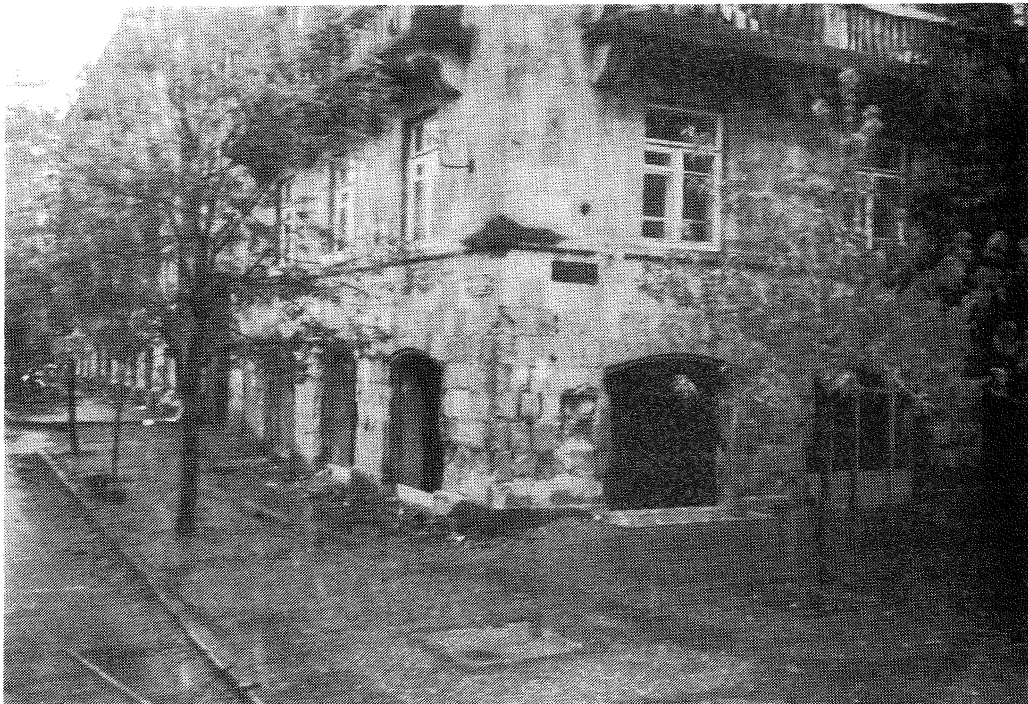
During our visit we observed a three storey masonry building in the old central section of Leninakan, one block from the Central Square, where pad foundations were being enlarged and tied together with ground beams (Figures 23 and 24). Excavation was also observed around the pad footings of a low rise steel-framed industrial building on the outskirts of Leninakan.

*Figure 23 Spread footings being extended and tied together in old quarter of Leninakan.*

*Figure 24 Building in which spread footings were being extended.*

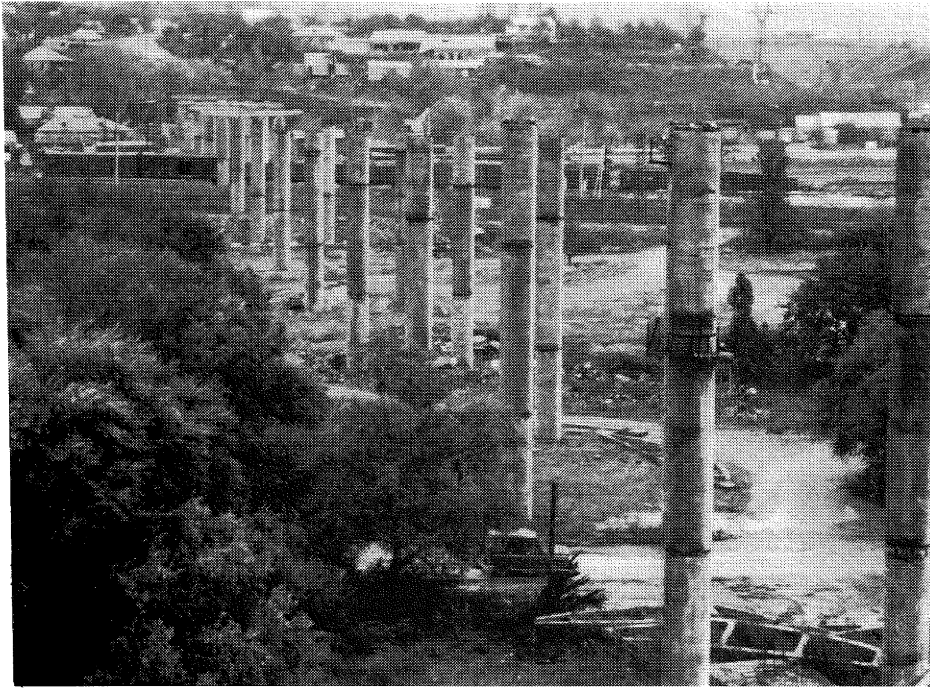
As a result of the earthquake, fault displacement offset the pier alignment at about pier 5. Some pier caps tilted on top of the shafts and some beams fell over, both in place and in stacks on the ground (Figures 26 and 27). Some of the pier shafts tilted slightly in the ground (Figures 26 and 27). The damage can be attributed to the effects of soft alluvial soils overlying the rock, in addition to the effects of displacement of the fault running through the site.

*Figure 25* Precast, prestressed concrete highway bridge, under construction at Spitak at time of earthquake.

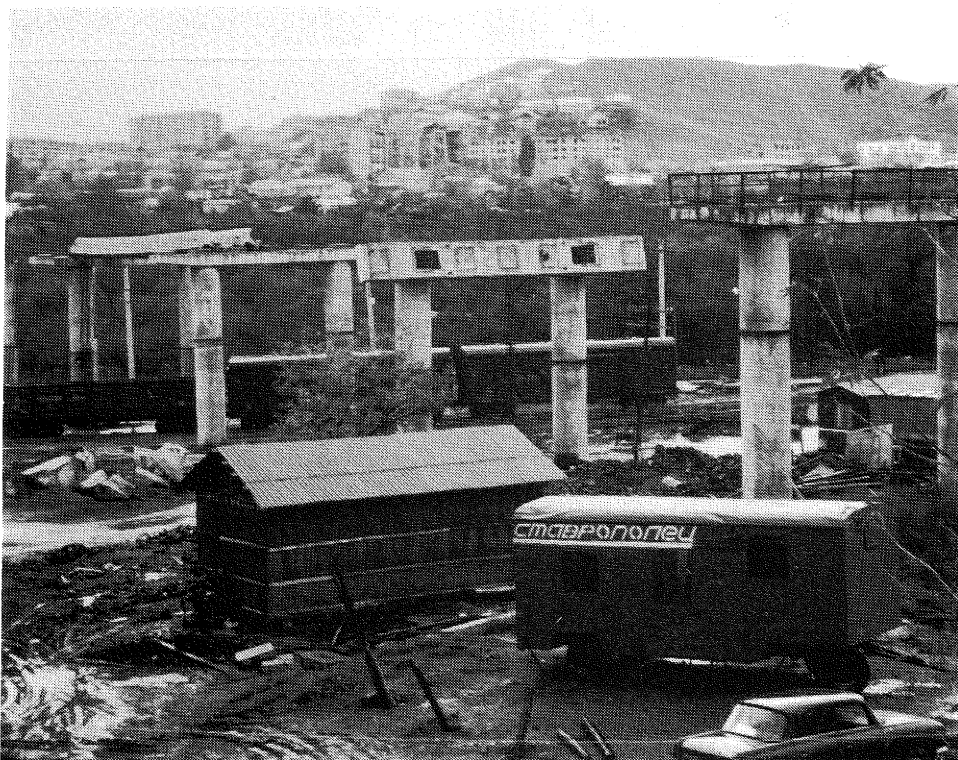
*Figure 26* View of Spitak bridge, looking in the other direction.

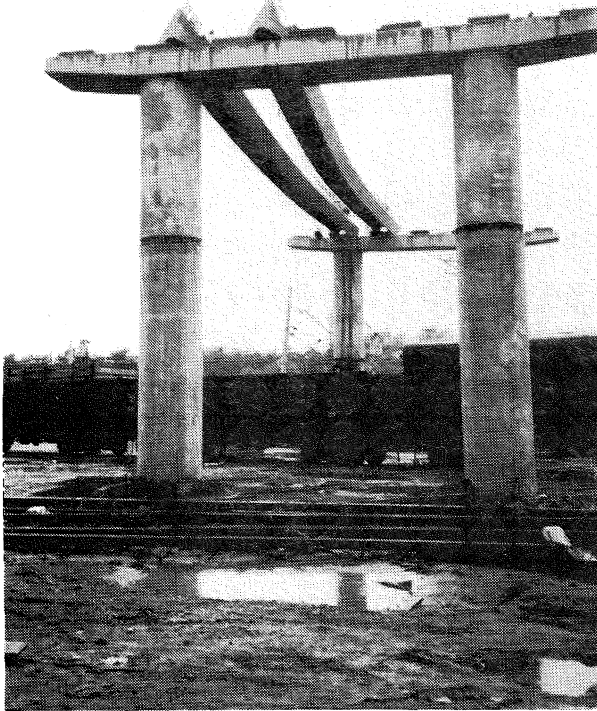
Figure 27 *Toppled precast beams, Spítak highway bridge.*

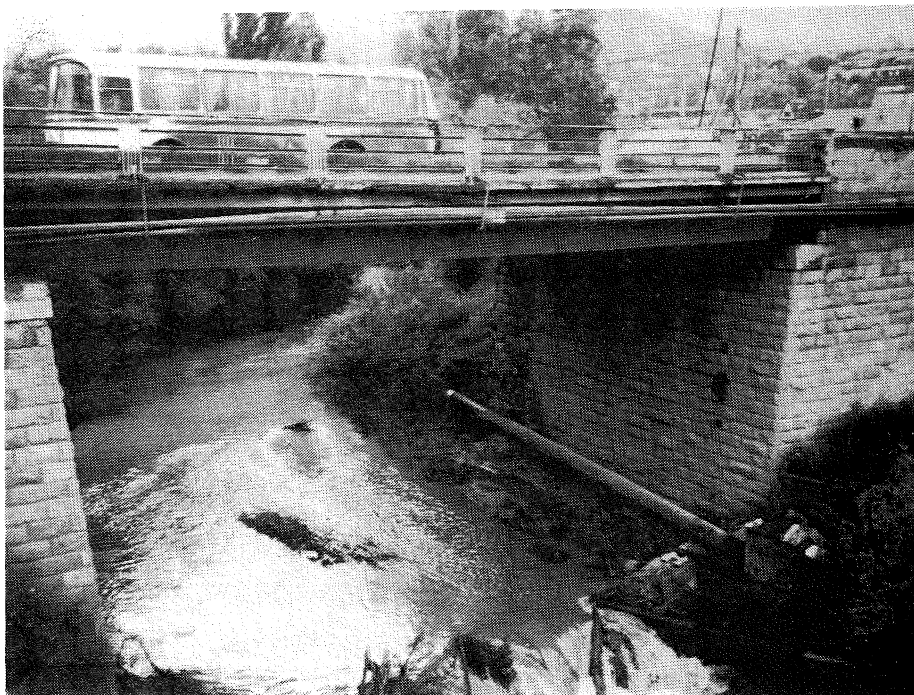
The authorities have decided to abandon the bridge although it is probably repairable at small extra cost. The other surprise was that the existing low level bridge at the site was apparently undamaged. It had high gravity retaining abutments and poor seismic detailing but it was founded directly on rock (Figure 28).

Figure 28 *Old bridge across Pembak River at Spítak, undamaged.*

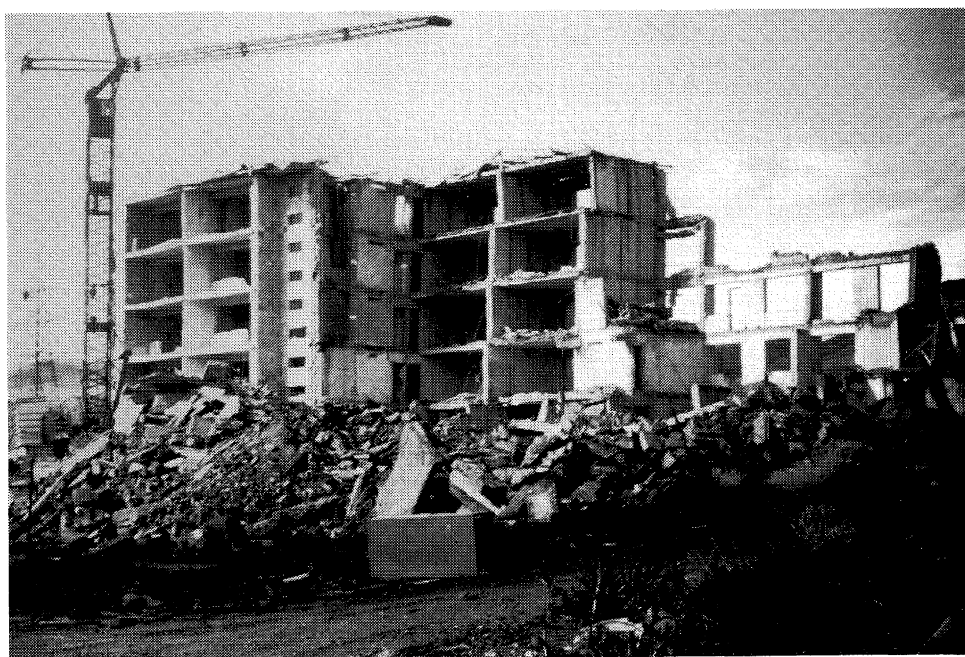
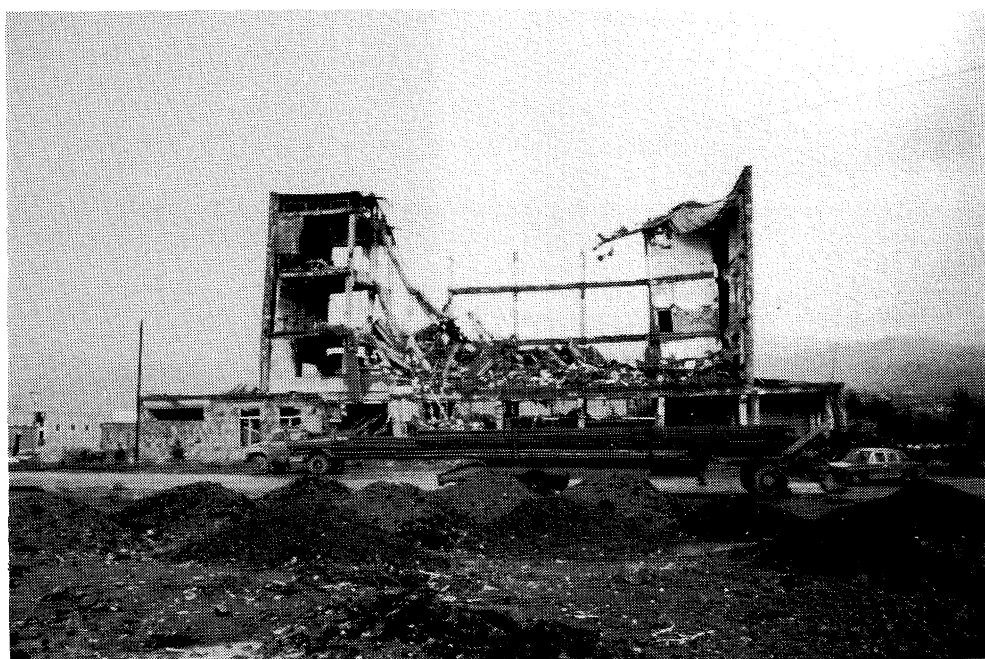
When our team visited the area, much of the damage had been cleared away but there were many severely damaged buildings left standing (Figures 29 and 30). Previous reconnaissance teams have recorded the damaged buildings well [e.g. Wyllie & Filson, 1989].

*Figure 29*    *Damaged reinforced concrete building, Spitak.*

*Figure 30*    *The main telephone exchange in Spitak after the earthquake.*

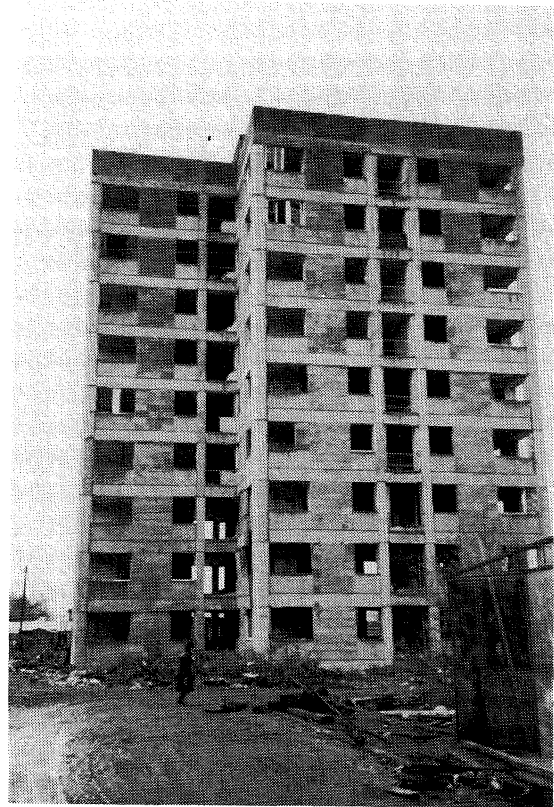
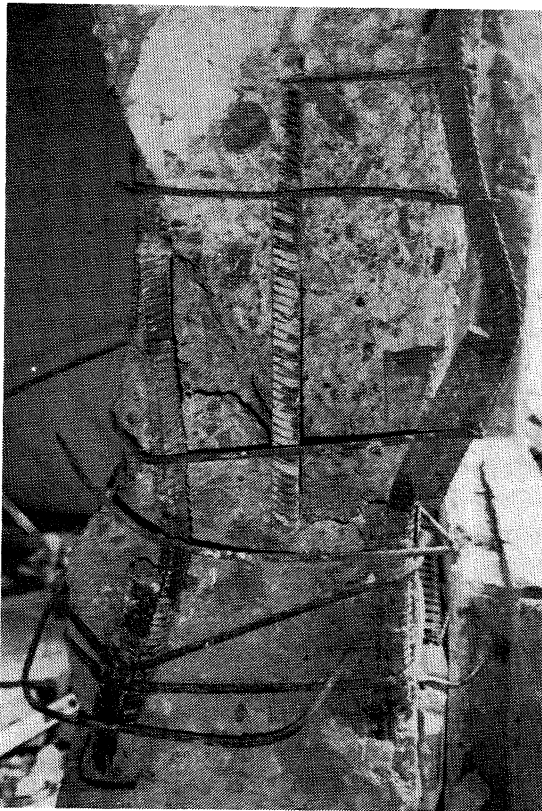
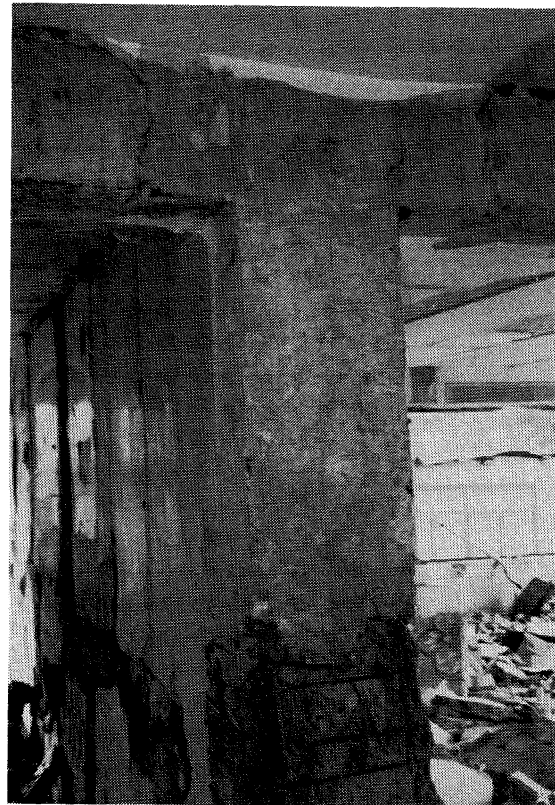
Most of the buildings that failed were of the Soviet Building Type 111 series, of 9 storey precast frame construction. Seventy eight had been built in Leninakan and only 6 survived the earthquake, but these, too, were damaged beyond repair. We examined the last one standing before it was demolished (Figures 31, 32 and 33).

*Figure 31 Type 111 building, heavily damaged but still standing, at Leninakan.*

*Figure 32 Details of the Type 111 building.*

*Figure 33 Details of the Type 111 building.*

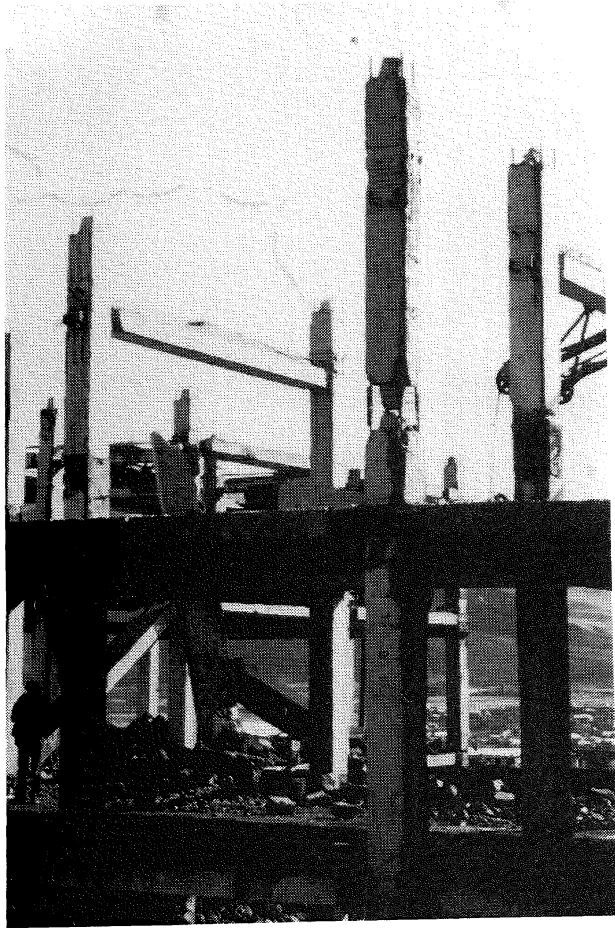
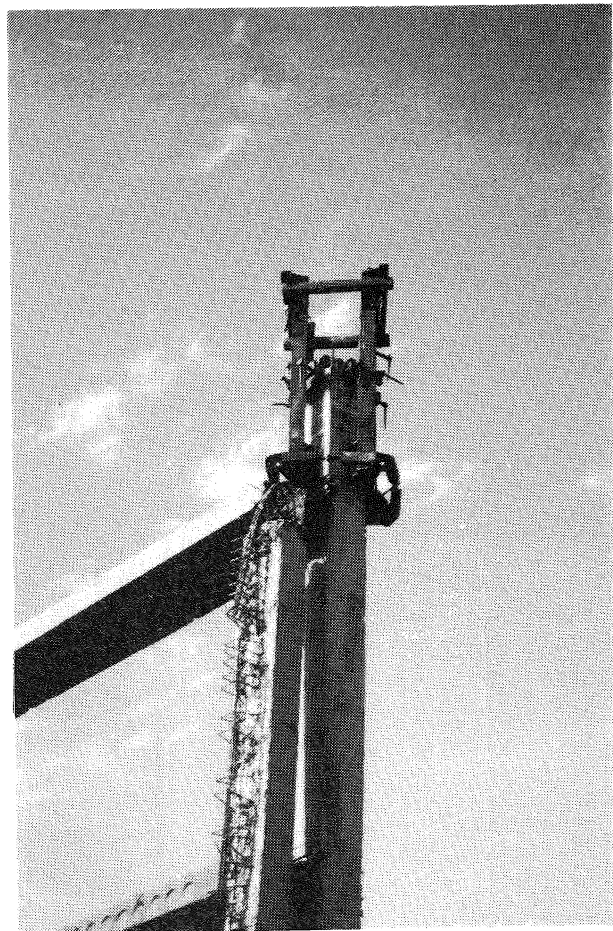
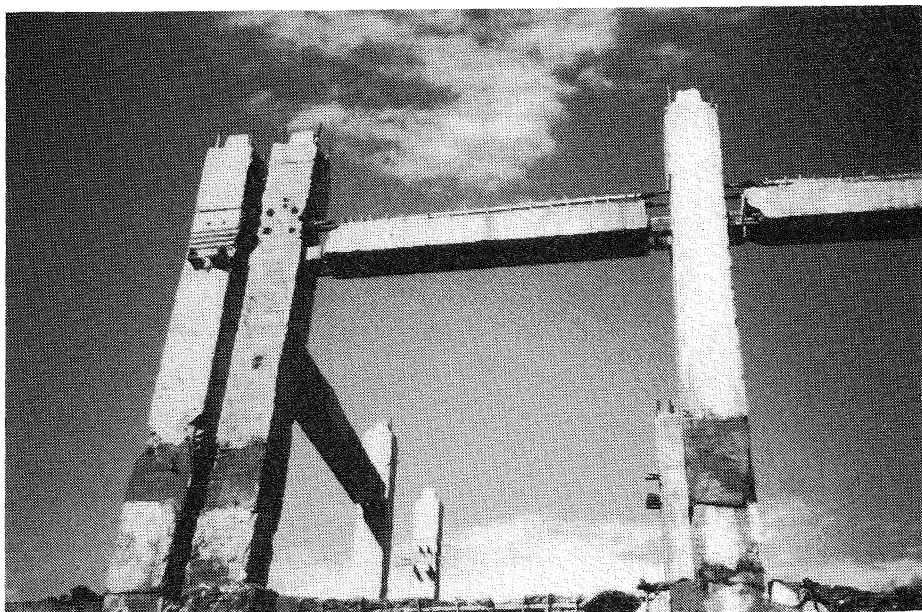
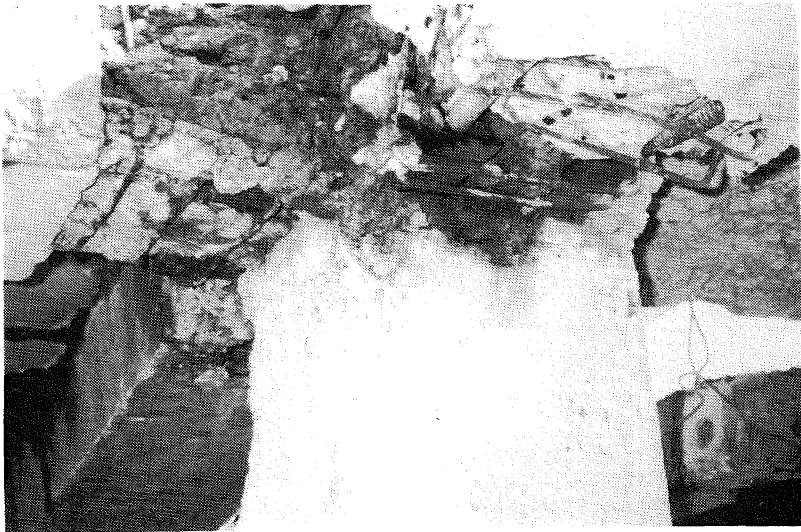
In Spítak the team also examined some frame buildings that had been under construction at the time of the earthquake and had not yet been demolished. They clearly indicated very low construction standards which exacerbated suspect joint details (Figures 34, 35, 36 and 37).

*Figure 34* Precast concrete frame building, under construction at Spítak.

*Figure 35* Precast concrete frame building, under construction at Spítak.

*Figure 36* Precast concrete frame building, under construction at Spítak.

*Figure 37* Precast concrete frame building, under construction at Spitak.

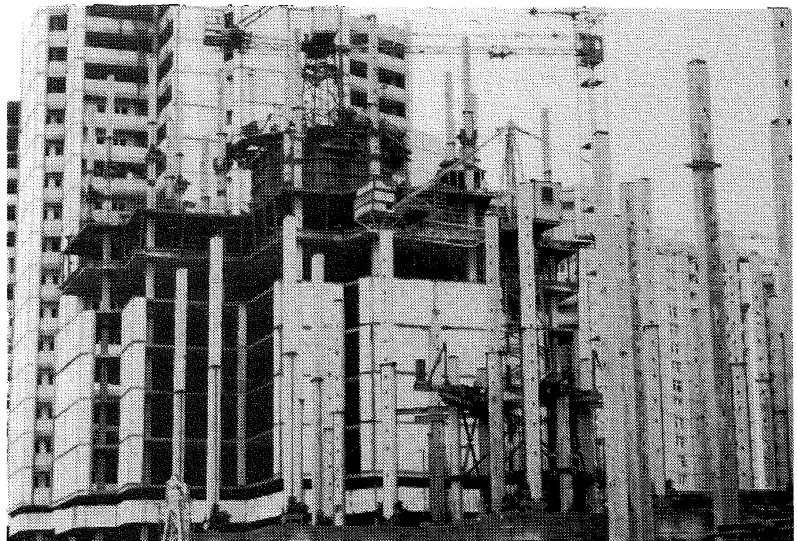
There were two high rise lift slab buildings in Leninakan and they both failed in the earthquake. One of 6 storeys stayed up but lost 30 cm in height because of crushing of the core at the first floor level. The second building, of 10 storeys collapsed completely. Many similar buildings could be seen under construction in Yerevan (Figure 38).

*Figure 38* Lift slab building under construction on the northern outskirts of Yesevan. Similar structures collapsed in Leninakan.

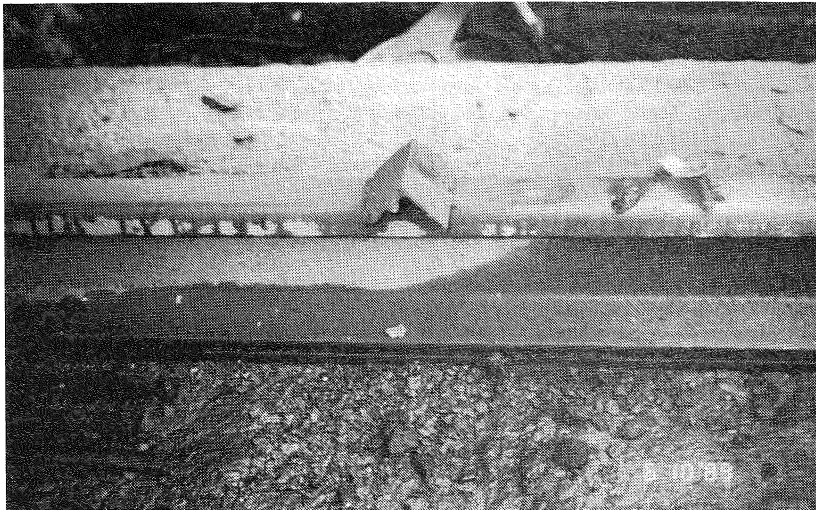
Many transformers are not anchored to the rails but are secured from rolling only by steel chocks welded to the rails (Figure 40). In one case, a transformer, in Spitak, jumped off its rails. The chocks intended to prevent the transformer from rolling failed to restrain it when the welds failed (Figures 41, 42 and 43).

*Figure 40 Transformer support rail showing failure of wheel chocks.*

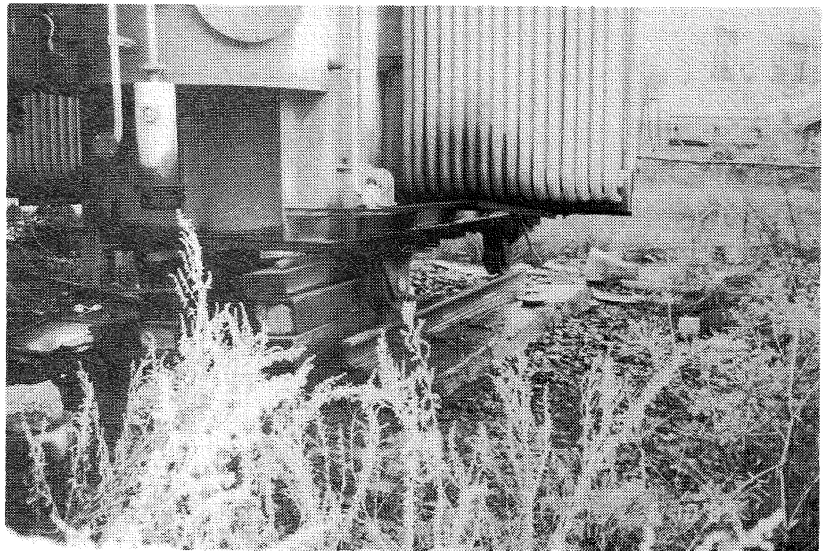
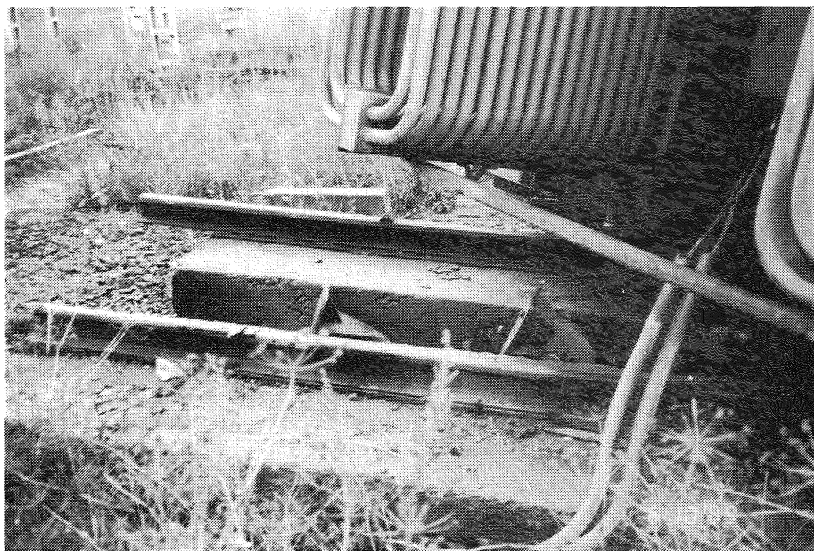
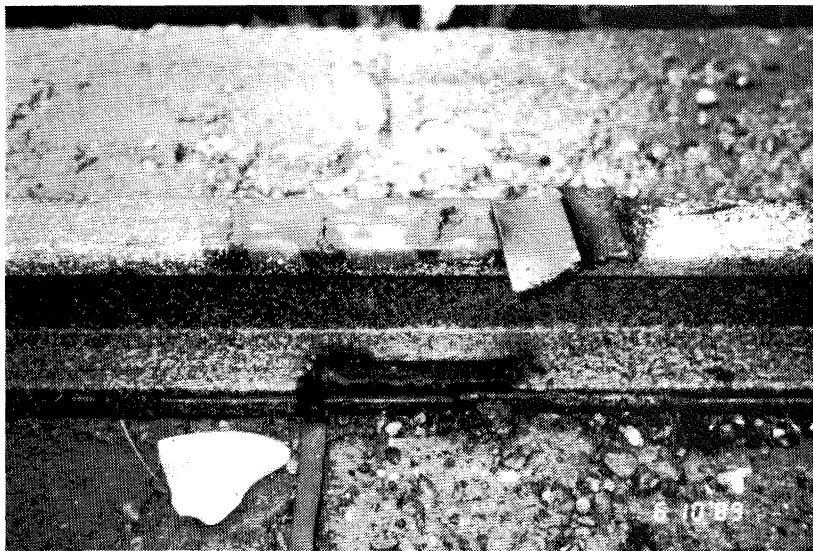
*Figure 41 Transformer at Spítak jumped off track.*

*Figure 42 Transformer support failure at Spítak.*

Figure 43 Failed wheel chocks on transformer support rail at Spítak.

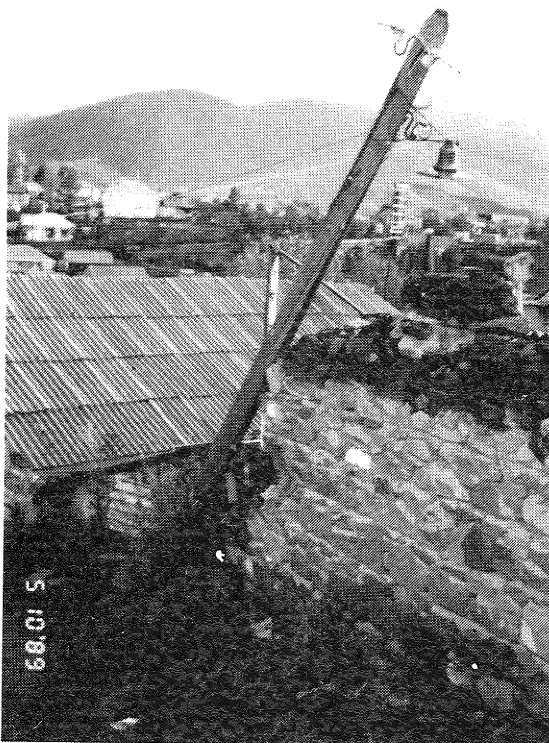
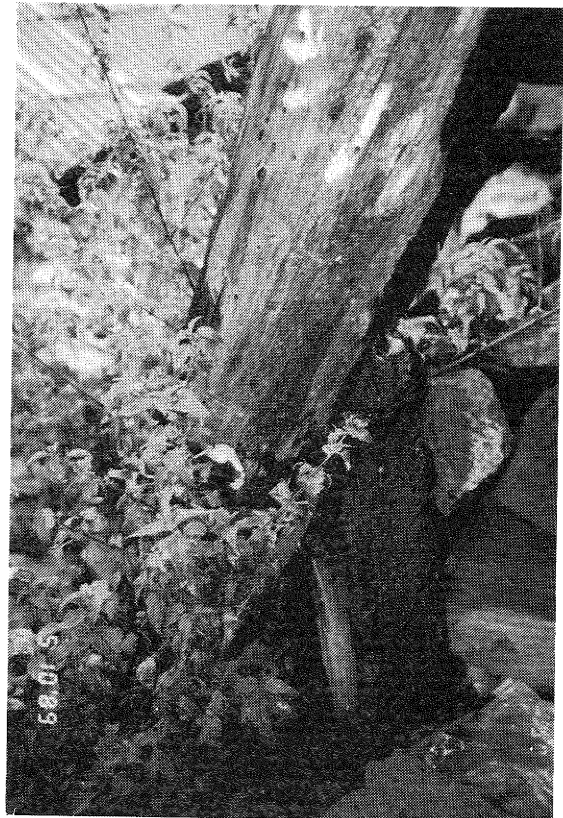
reinforced concrete, timber or rail iron ground posts (Figures 44, 45 and 46) and an A-frame pole with timber or reinforced concrete ground posts (Figure 47). Both types have wooden poles secured to the ground posts with wire ties. In Spitak a pole was observed to have failed, but it could not be identified as being a direct result of the earthquake shaking (Figures 48 and 49). High voltage transmission lines are supported on steel lattice type pylons anchored in concrete; these appear to have performed well. A number of power lines were supported on towers fixed to building roofs. Obviously these survived only when the building structures remained standing.

Figure 48 Power pole fixing failure at Spitak.

Figure 49 Close up view of power pole fixing failure at Spitak.
