RECONNAISSANCE REPORT ON THE ORMOND EARTHQUAKE — 10 AUGUST 1993

S.A.L. Read^{1,2} and S. Sritharan^{1,2}

ABSTRACT

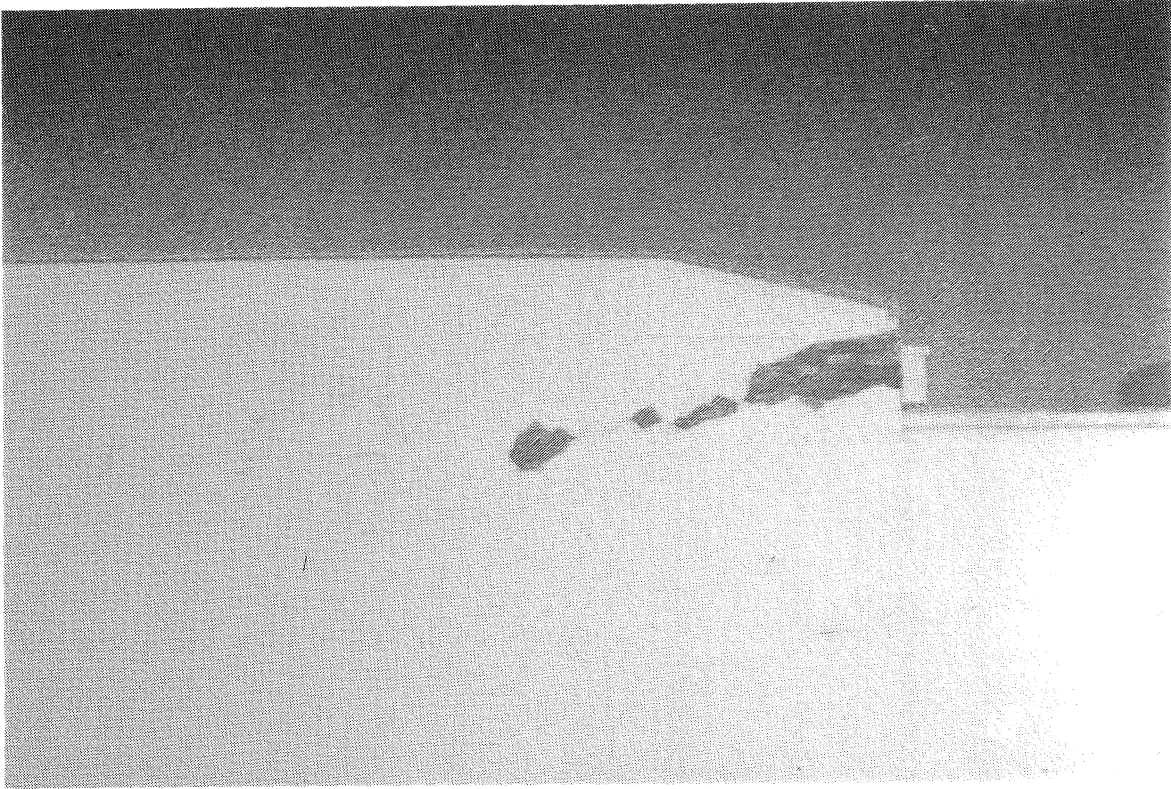
- (i) badly cracked wall from face loading in a two-storey unreinforced brick masonry building (Figure 5)
- (ii) six cases of shifted or dislodged parapets (Figure 6)
- (iii) several instances of cracking in walls (Figure 7)
- (iv) cracking and spalling of plaster in several buildings
- (v) window breakage in several buildings (Figure 8).

Apart from the damage to the wall in (i), no other major structural damage was seen during the reconnaissance.

Figure 5 Cracking in southwest wall of two-storey unreinforced brick masonry building in Lowe Street, Gisborne. The cracking was more extensive in the upper storey and parapet above.

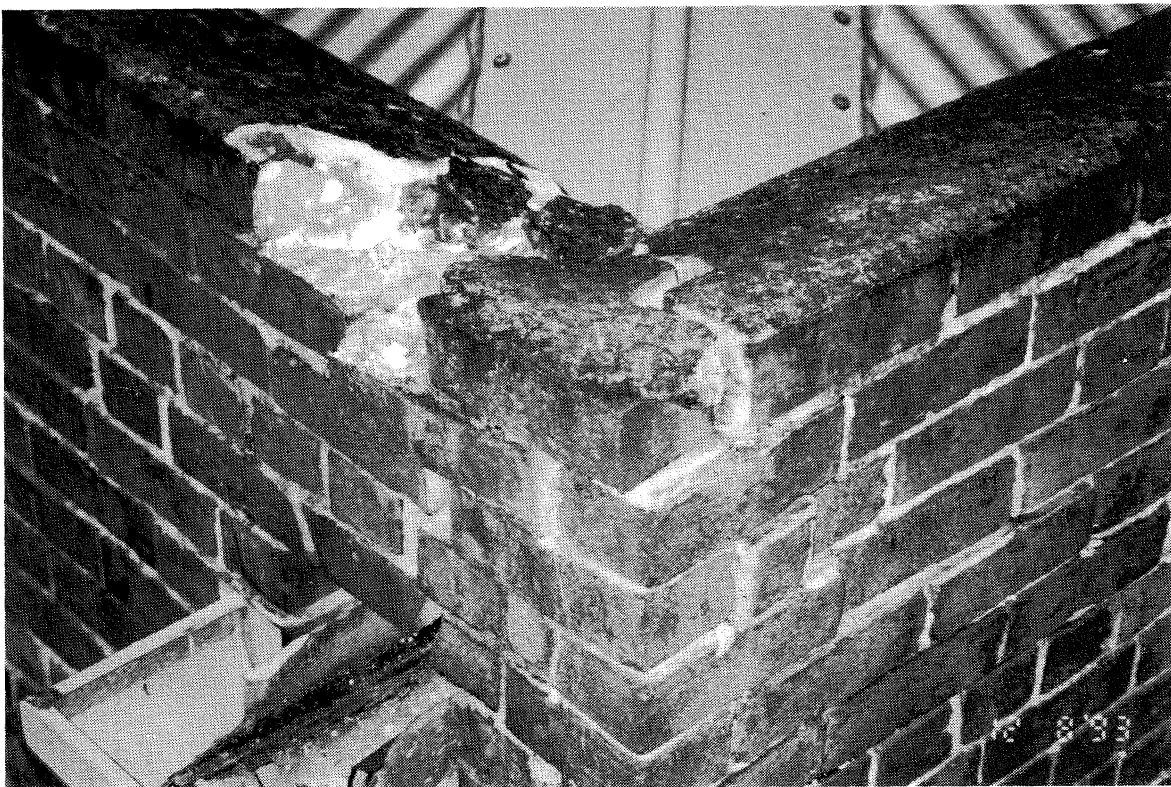
Figure 6 Close up view of cracking in parapet corner of the building in Figure 5.

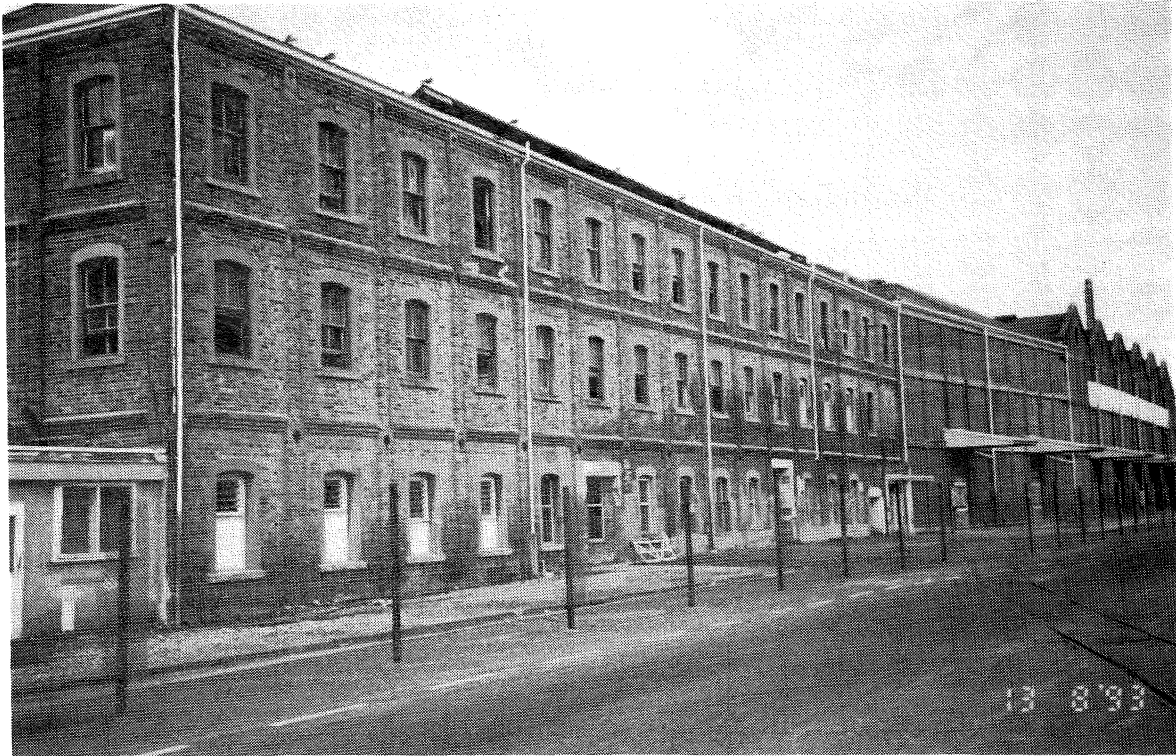
Figure 7 Part of the freezing works buildings in the Esplanade, Gisborne. Built in the mid-1920s and at the end of its operational life, the structure sustained little damage. Minor cracking in the walls was more apparent at the rear of the building.

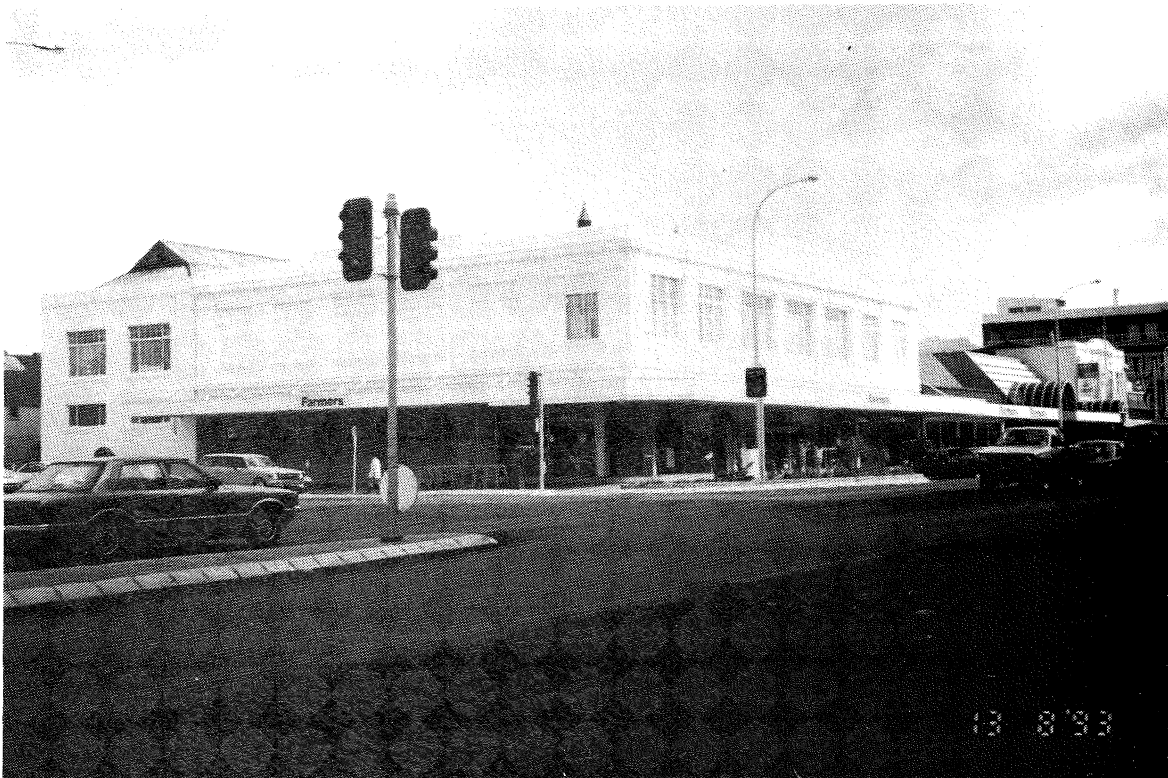
Figure 8 Farmers building on the corner of Gladstone Road and Customhouse Street, Gisborne. Plate glass windows in the bottom storey were broken during the earthquake, but otherwise there was no significant damage.

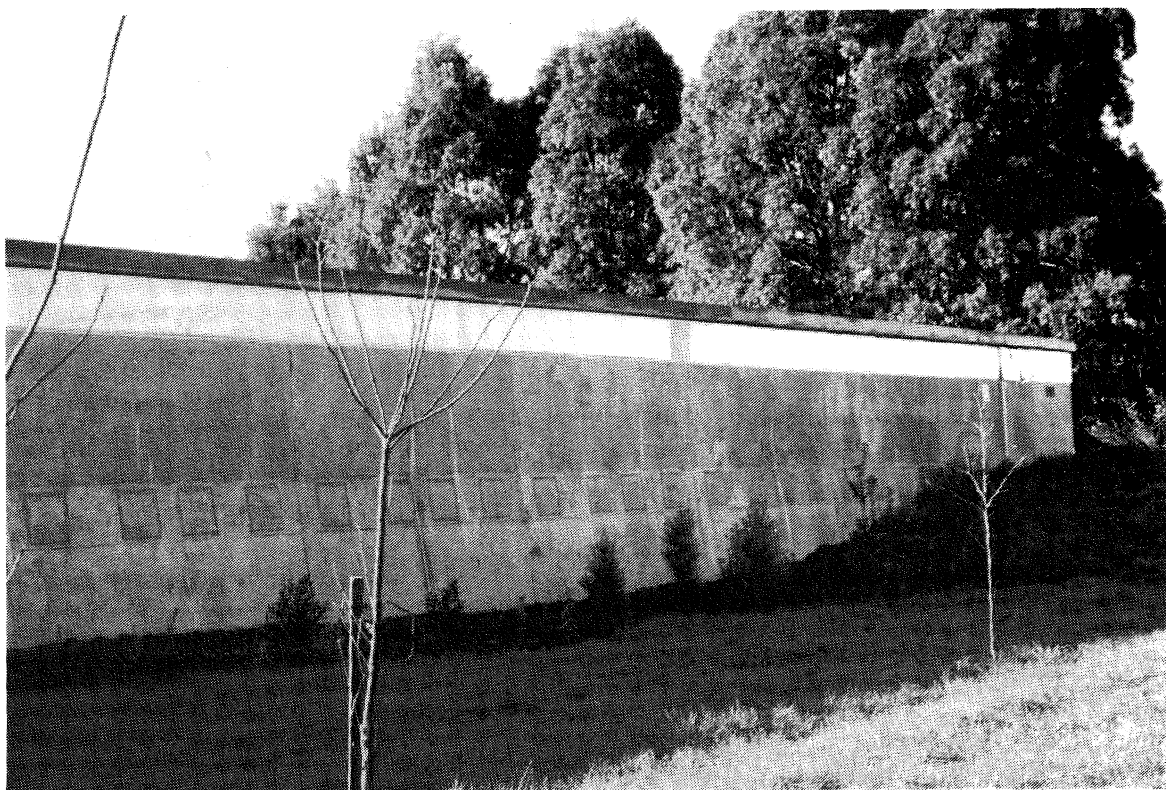
No damage was reported from the water supply dams near Waingake 20km southwest of Gisborne (Figure 2), or along the pipeline to Gisborne City. The recently completed (1990) 38,000m³ reinforced concrete water supply reservoir on Hospital Hill was 90% full at the time of the earthquake. The reservoir, with a floating slab roof and divided into two storage cells, suffered no structural damage, although there was some minor damage to the protective covers between the walls and roof slab due to water movement (Figures 9 and 10).

Figure 9 General view of part of the 38,000m³ water supply reservoir on Hospital Hill, Gisborne. The 140m by 70m reservoir is divided into two cells, and the flashing is in the gap between the external wall and floating slab roof.

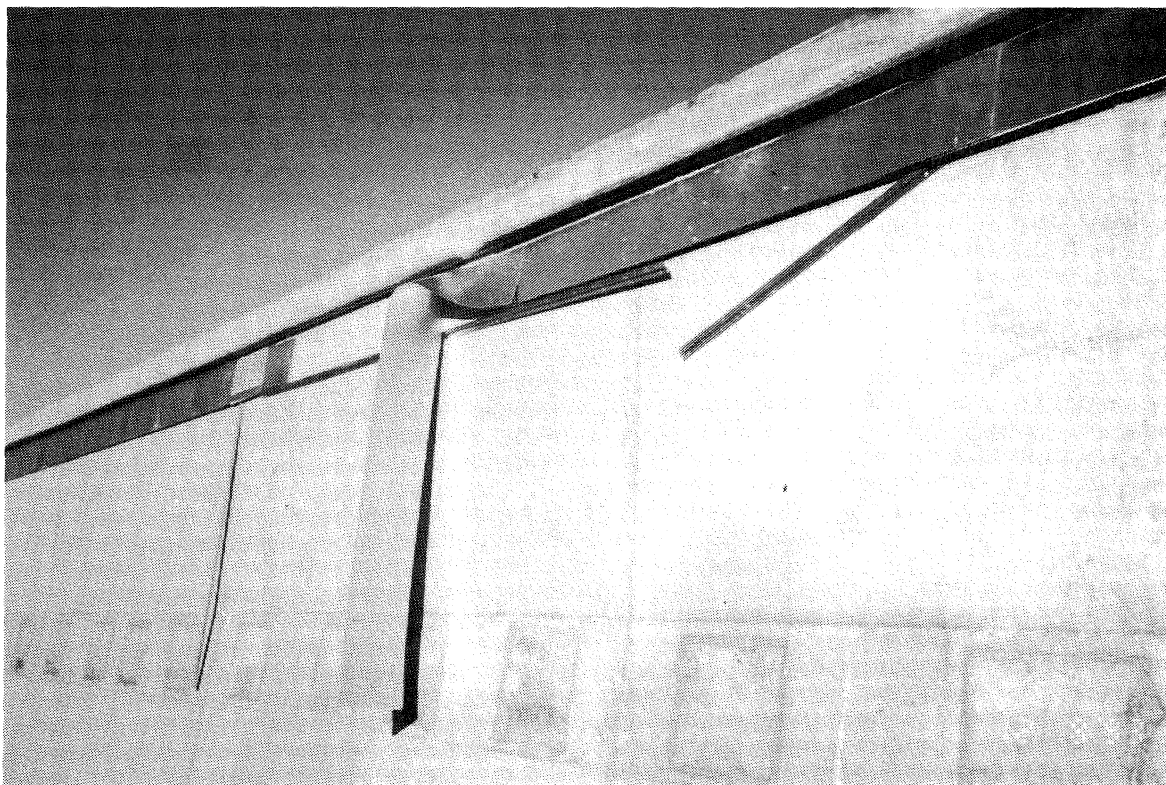
Figure 10 Close-up view of 'popping' of flashing on the southwest side of Hospital Hill reservoir, caused by water motion within the reservoir during the earthquake.

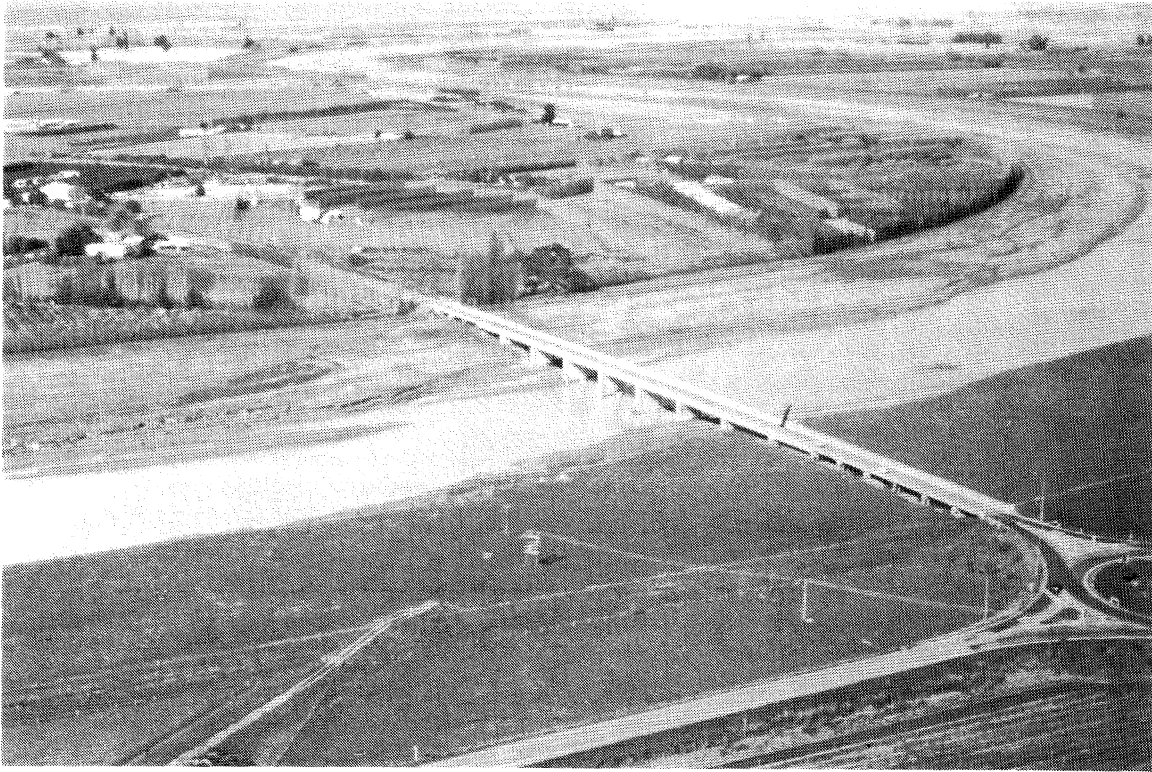
Traffic on two SH2 bridges was reduced to one lane by damage caused by the earthquake. The Waipaoa bridge, which is 8km west of Gisborne and was completed in 1956, suffered spalling of a pier cap near the east abutment (Figures 11, 12 and 13). The Kaiteratahi bridge, which is 1 km north of Kaiteratahi and was completed in 1986, was not damaged, but there was up to 50mm of settlement under one lane of the north abutment fill (Figure 14). No other significant structural damage to bridges was reported, although there was some lateral spreading adjacent to the eastern pier and west abutment of the Puha bridge, 5km west of Te Karaka. Chapman [1993] discusses the performance of bridges in more detail.

Figure 11 Aerial view of the Waipaoa Bridge, 8km west of Gisborne, looking southwest or obliquely downstream. Damage was to the last main pier on the far (eastern) bank, as shown in Figure 12.

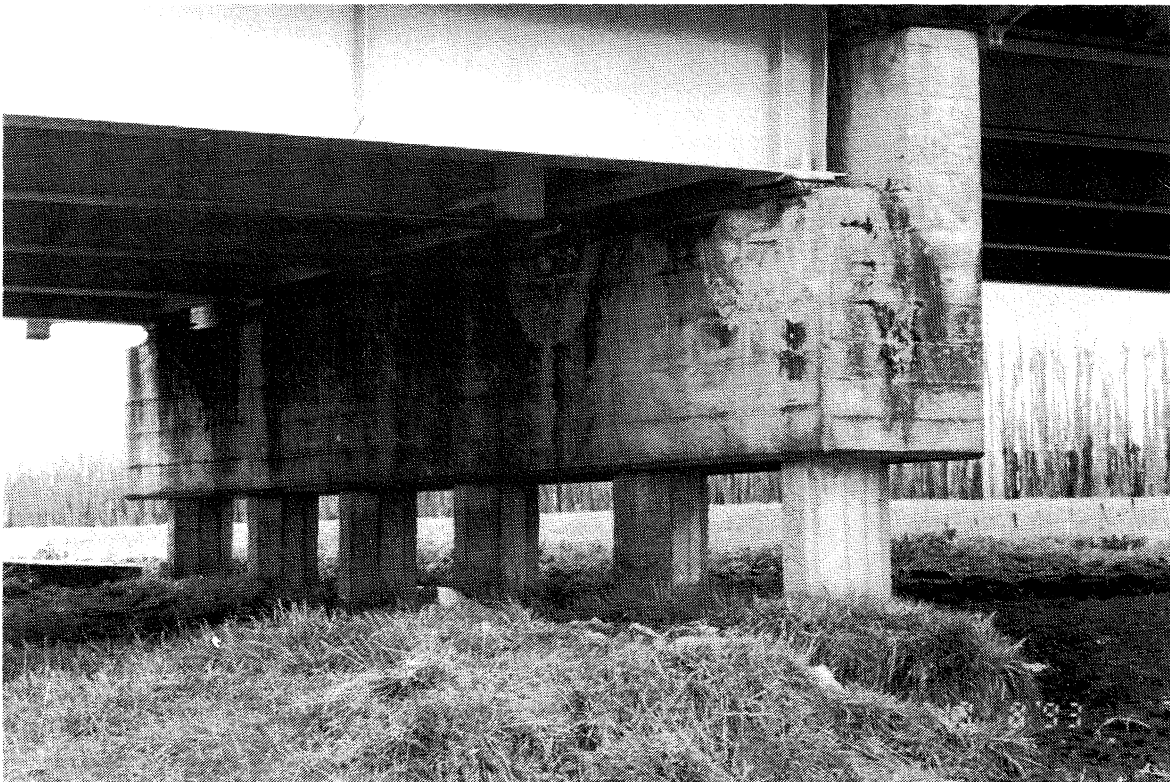
Figure 12 Waipaoa Bridge pier on the east bank of the Waipaoa River looking obliquely upstream. In addition to the spalling of pier concrete under two of the steel girder bearers, cracking under the most distant (upstream) girder on the other side of the pier indicated a similar incipient failure.

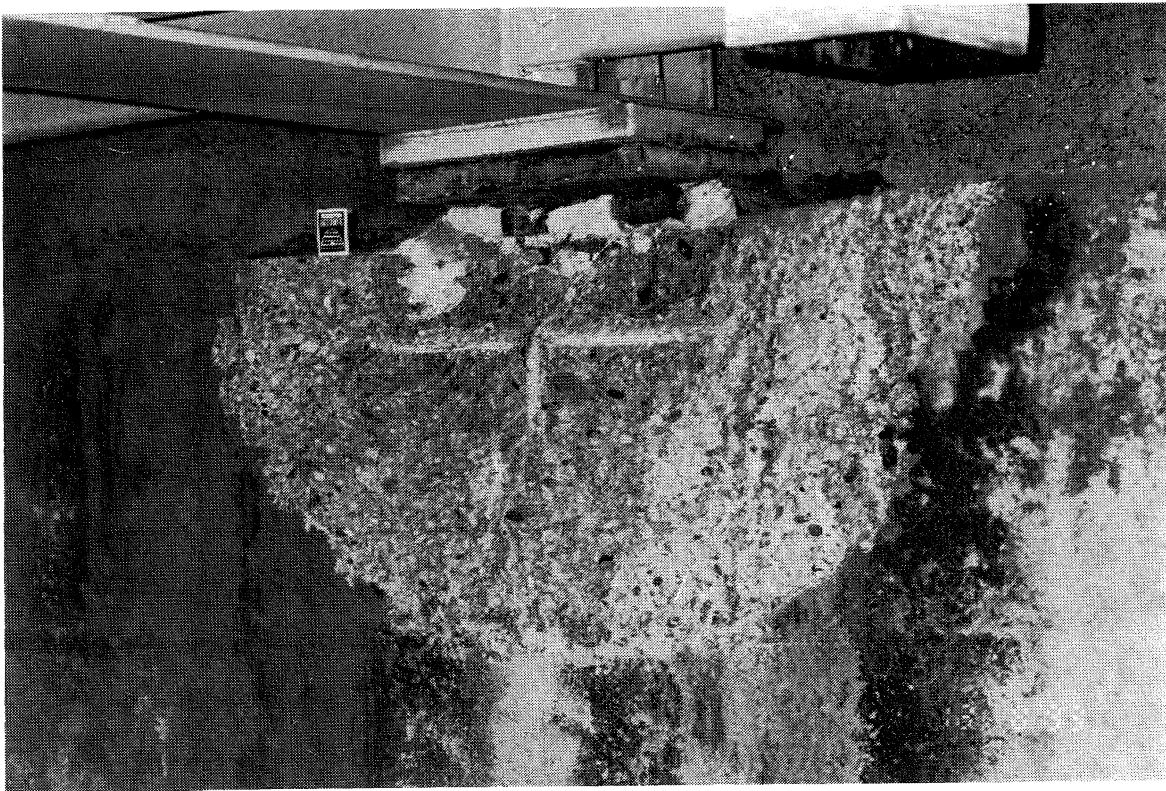
Figure 13 Close-up view of the spalling in the centre of Figure 12, illustrating the reduction of bearing area for the girder.

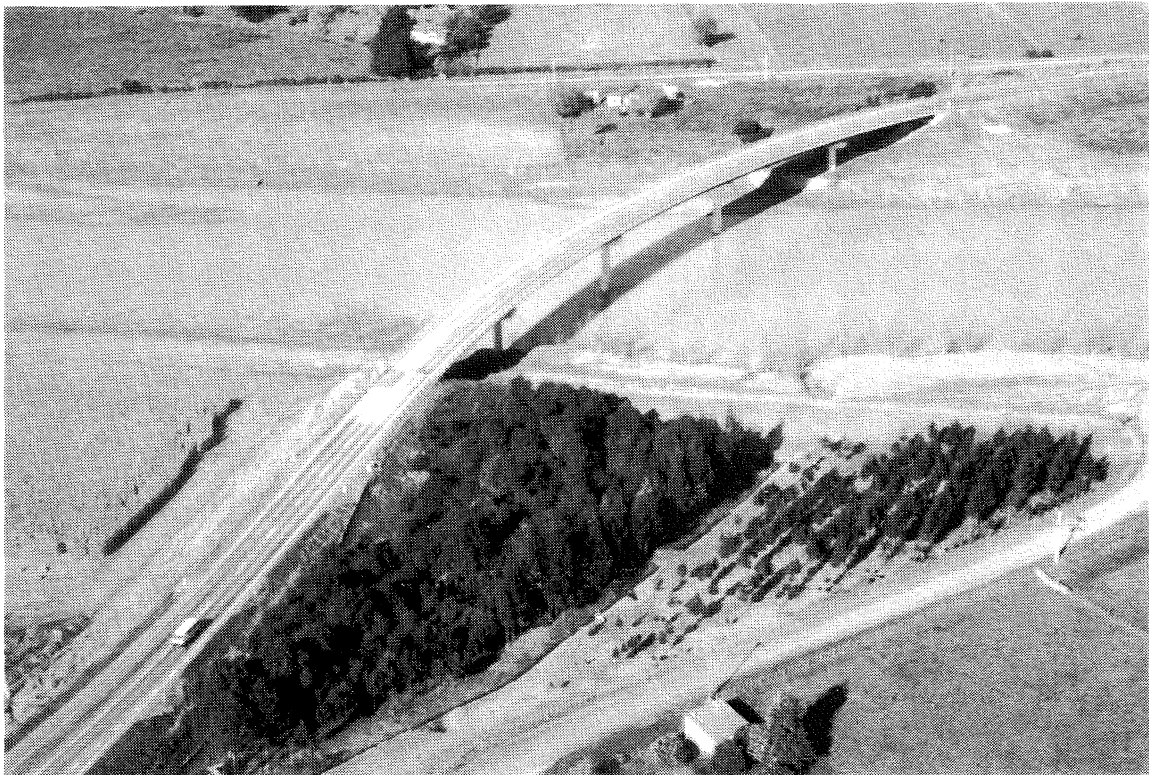
Figure 14 Aerial view of Kaiteratahi bridge, 1km north of Kaiteratahi. The box girder bridge structure was not damaged during the earthquake. The repairs to one lane of SH2 surface delineate the area of settlement on northern (near) abutment approach.

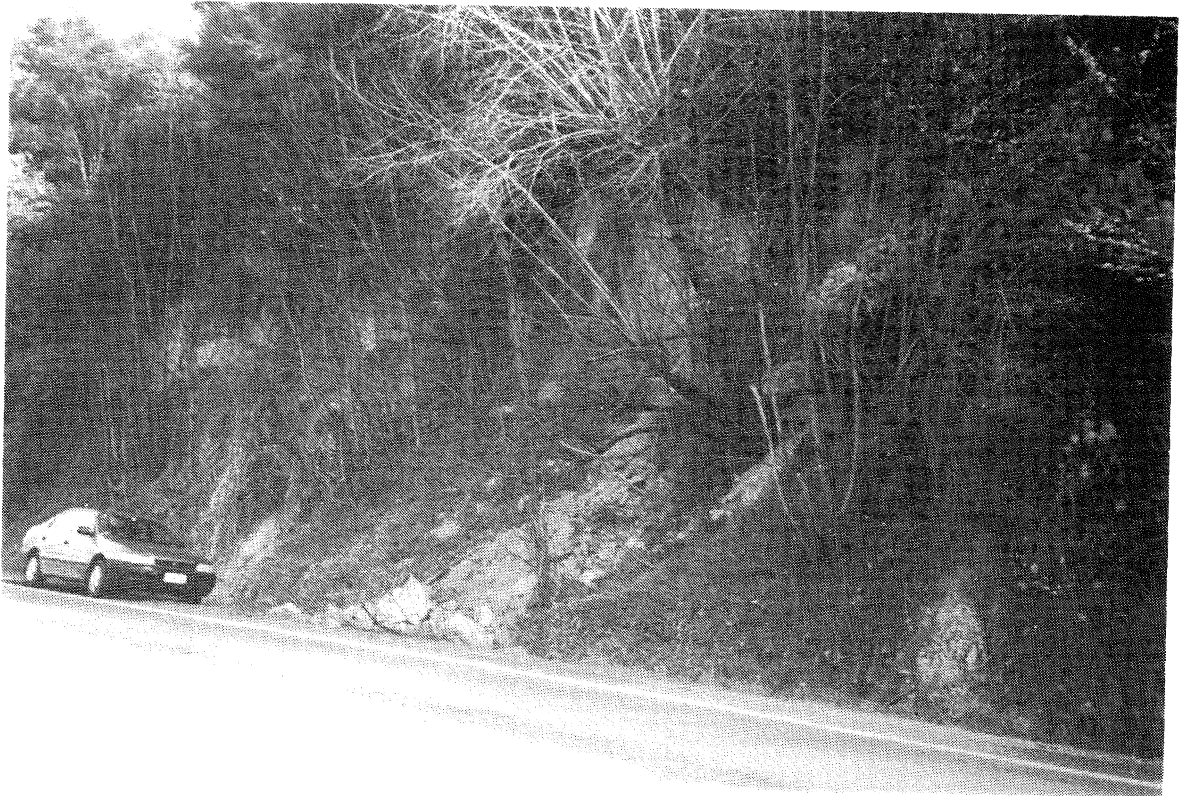
Damage to roading was minor. There were no major failures in cut slopes, both in Tertiary bedrock, or in overlying colluvial or alluvial deposits. Minor falls and failures occurred from the steeper cut slopes (Figure 15) over the wider (\approx MMVI isoseismal) area covered in Figure 2. Minor displacements of fills occurred in several places (e.g. SH2 5km north of Kaiteratahi), with cracking and settlement of the road pavement. In particular, sidling cuts and fills not founded on bedrock were damaged, for example Ngakaroa Road east of Kaiteratahi (Figure 16). Overall the level of damage was similar to that experienced during a large rainstorm.

Figure 15 Typical small fall from a steep cut slope beside SH2, 3km north of Kaitaratahi. Fall volumes were typically up to 20m³, while other failures which involved bedrock and colluvium were up to 100m³.

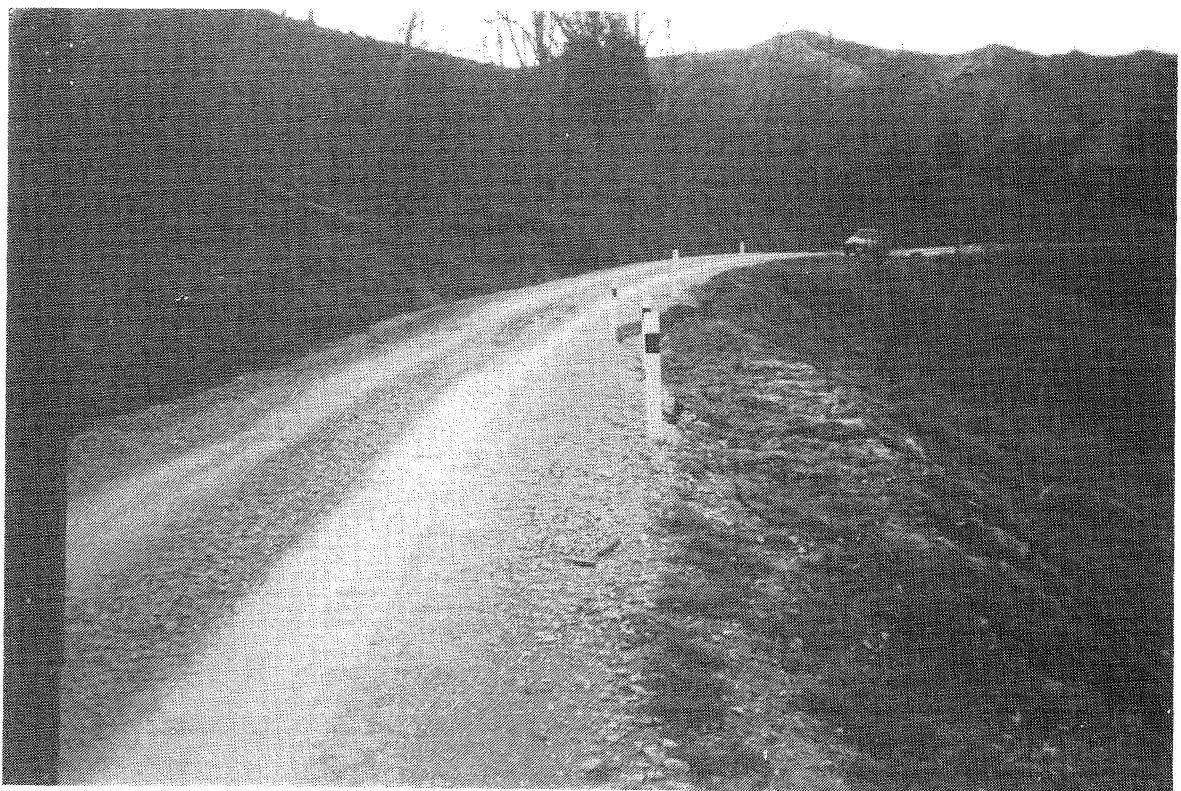
Figure 16 Typical failure involving road surface on Ngakaroa Road, 5km east of Kaitaratahi. Slumping typically occurred on slopes between 15° and 20°, where there was either a veneer of colluvium above bedrock or fill materials.

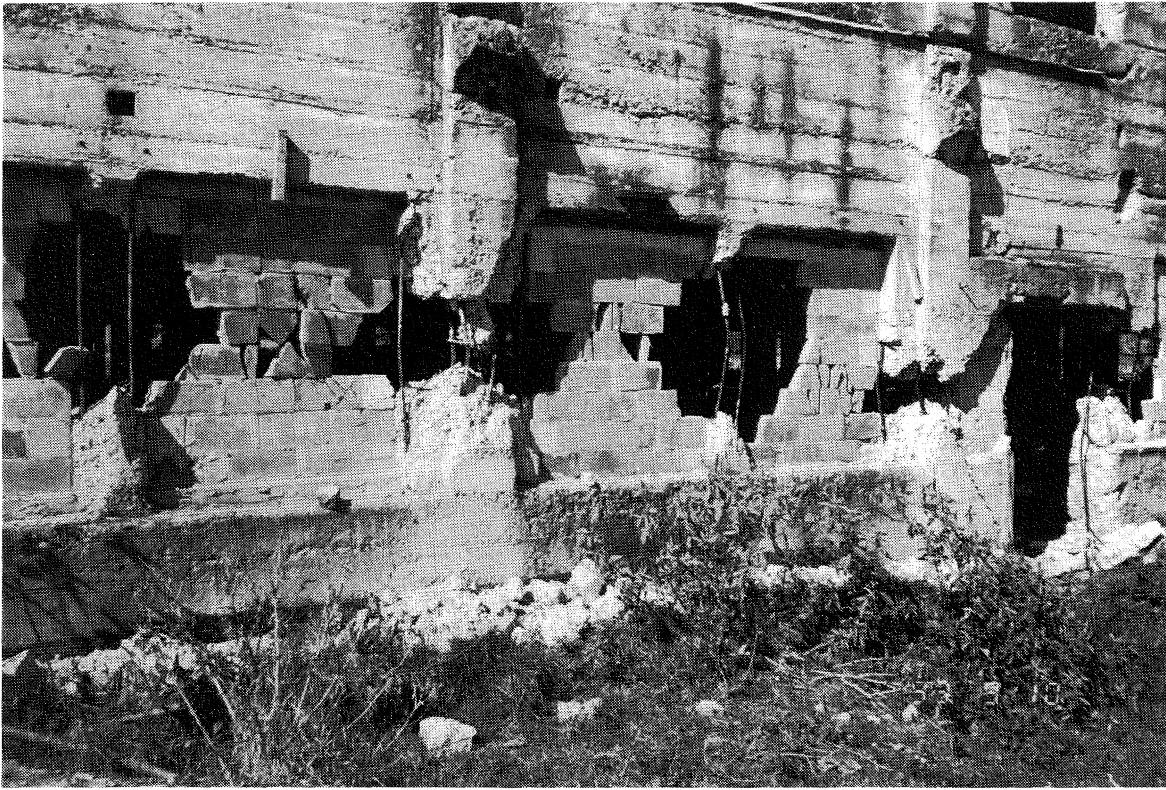
Reports of damage to brick chimneys were widespread. Although chimneys were damaged in Gisborne City, and as far afield as Waerengaokuri and Kanakanaia (ie extending at least over the \approx MMVI isoseismal area on Figure 2), the greatest concentration of such damage was in the area between Ormond and Te Karaka. Collapses and movements of unsupported domestic water tanks were also reported. The most striking evidence of damage to a structure was to the old freezing works building in Waipaoa. The three-storey building, which was built of reinforced concrete in about 1915 and abandoned in 1931, suffered extensive shear failures to the bottom-storey columns (Figure 17).

Figure 17 Failure in shear of columns in the southwest wall of the abandoned three-storey freezing works built in about 1915 at Waipaoa. Disused since 1931, only the northwest wall of the building was not damaged.

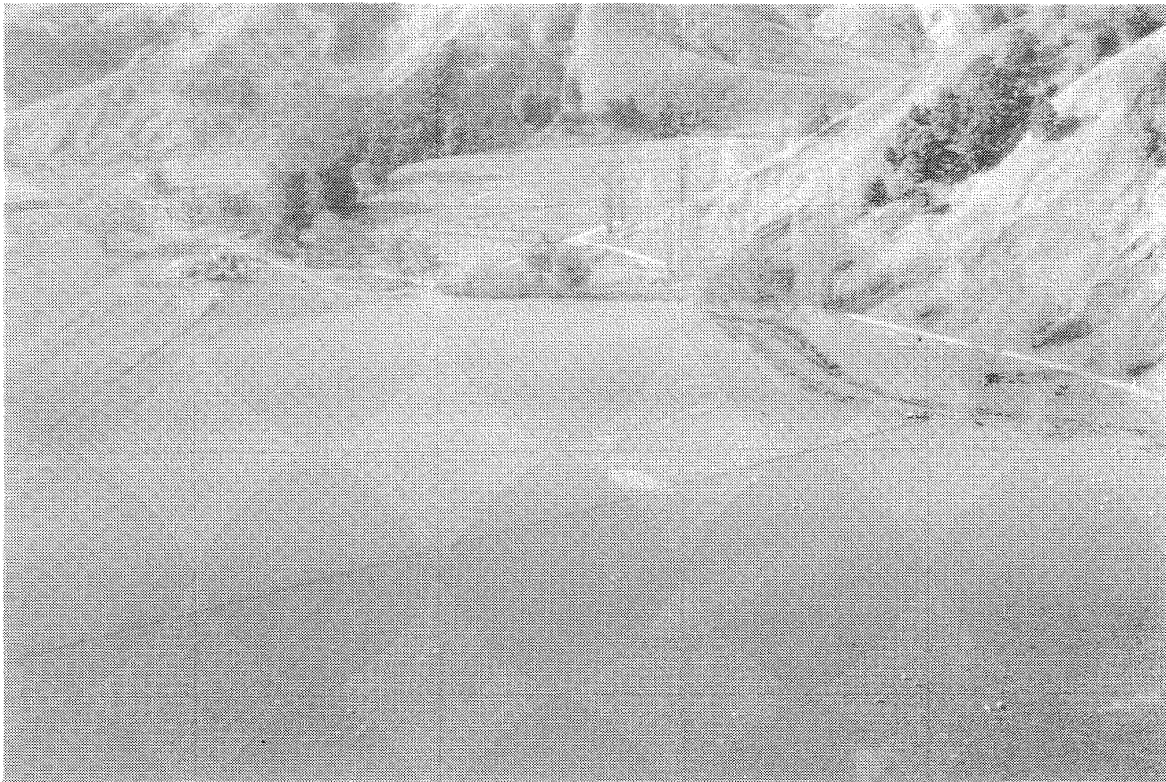
Figure 18 Aerial view of sand boils on eastern side of the Waipaoa River valley, 5km southeast of Te Karaka, showing variation in the trends of linear vents. Northern end of site 3 in Christensen (1993).

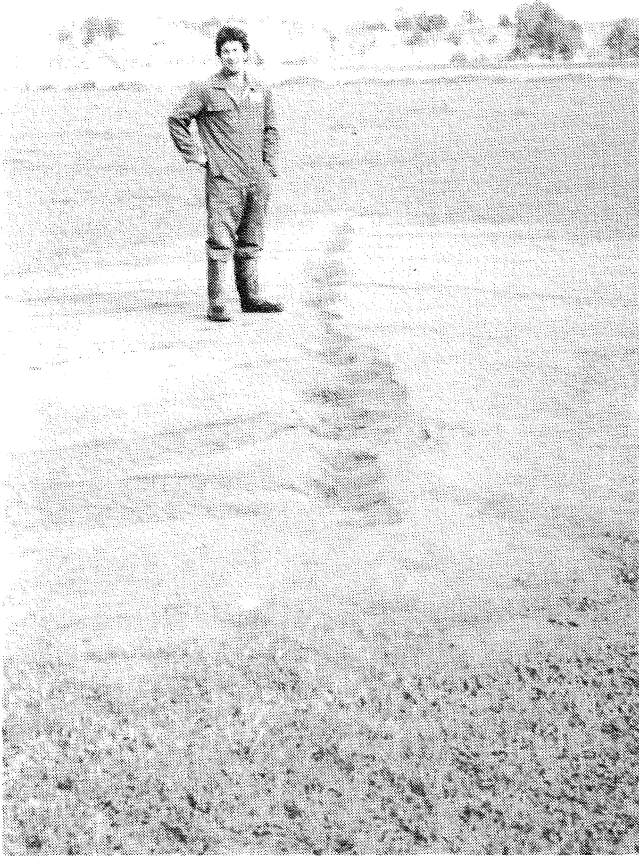
Figure 19 Typical sand boil, 3km south east of Te Karaka, showing linear vent and ejection of fine to medium sand. Boil 8 in Area 1 of Christensen (1993).

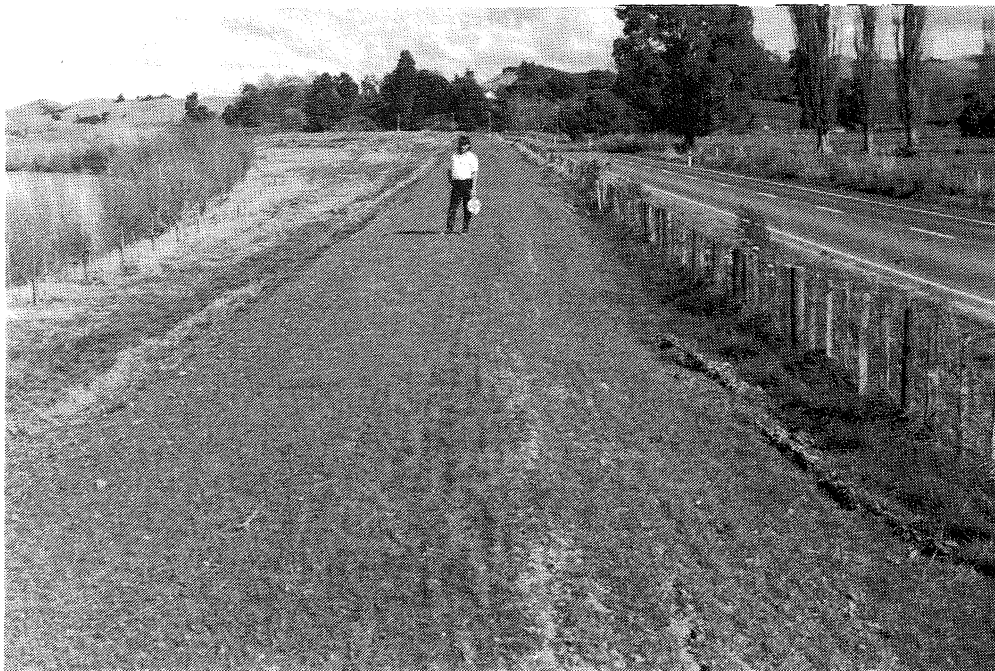
Ground cracking associated with lateral spreading was apparent in several places between Kaiteratahi and Te Karaka (Figure 2), mainly close to 3 to 5 metre high steep (20°) banks adjacent to the Waipaoa River. The cracks generally had vertical and/or horizontal (spreading) displacements toward the river channel of less than 150mm, over distances up to 200 metres. In one place they were associated with a settlement of up to 300mm over a 150m length of the stopbank on the right (west) bank of the Waipaoa River (Figure 20).

Figure 20 Cracking behind the stopbank on the right (west) bank of Waipaoa River, 2.5km north of Kaitaratahi. Close to a steep bank beside the river, the stopbank has settled by up to 300mm.

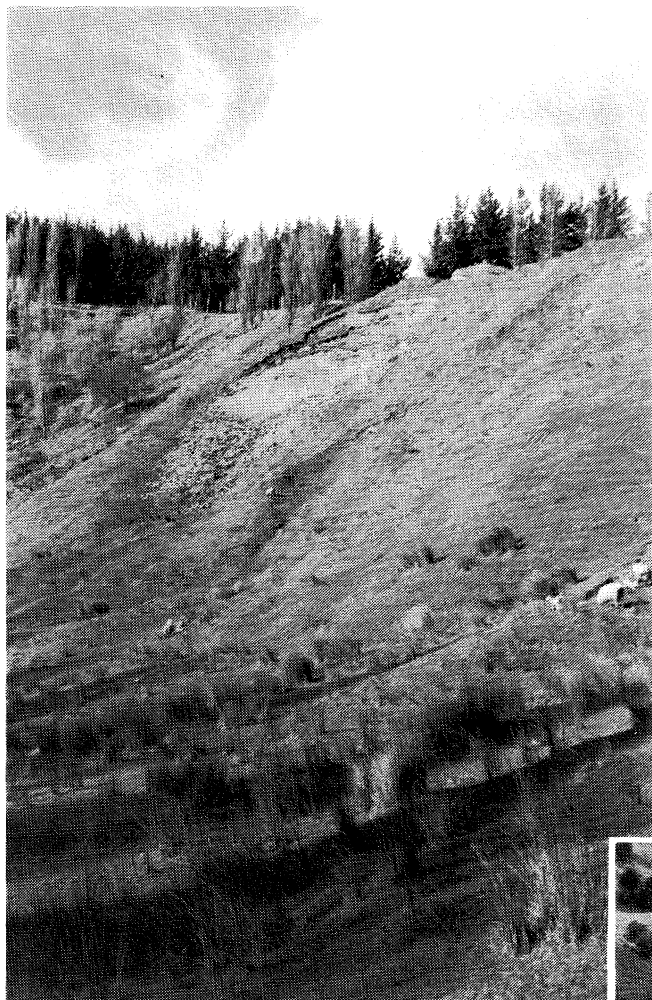
Figure 21 Small shallow landslide on steep (34°) northwest facing slope close to Newmans Road, 7km southeast of Te Karaka. The overall slope has scars from previous failures, typically those that have occurred in storm events such as Cyclone Bola.

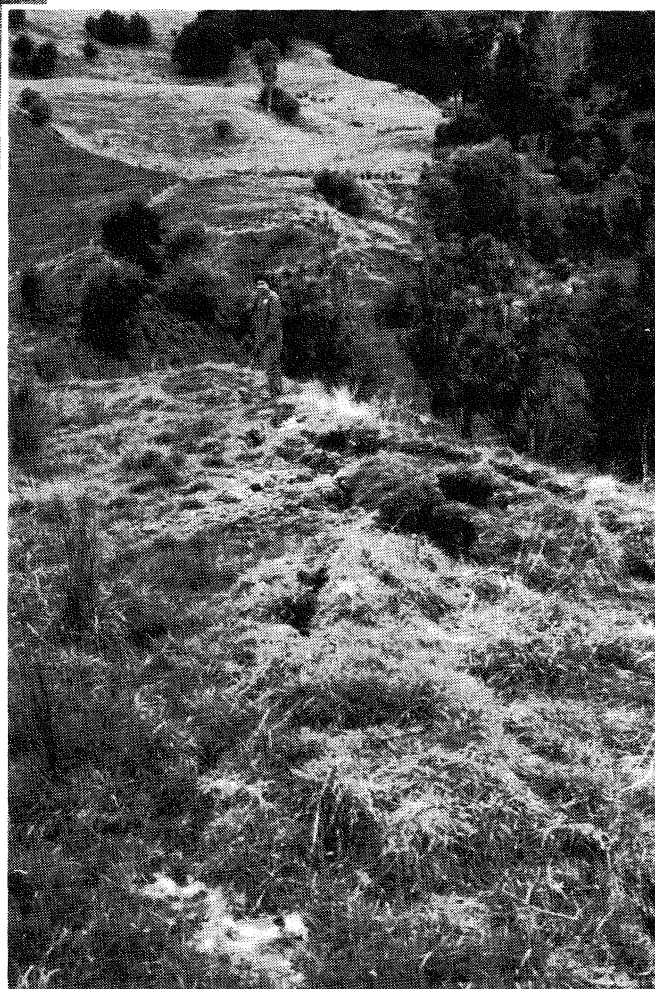
Figure 22 Damage to top of steep west trending ridge crest, 2km east of Te Karaka. Note that soil has been thrown to one side of the crack indicating a significant vertical component of movement during the earthquake.

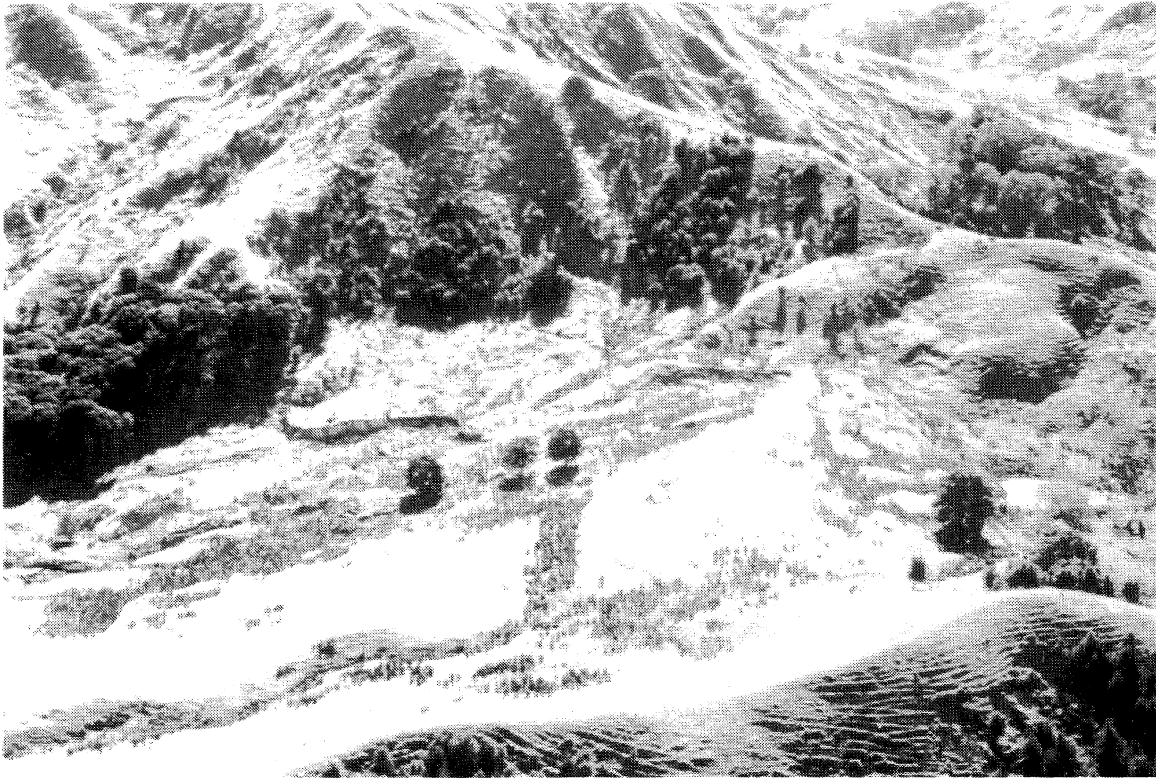
Figure 23 Aerial view of a 200m long earthflow 3km southeast of Te Karaka. Twin headscarps are visible in the colluvial debris at the base of steep slopes, and movement of the earthflow was down an 8° slope.
