RECONNAISSANCE REPORT ON THE WEBER EARTHQUAKE — 13 MAY 1990

P. G. Johnstone¹ and R. Potangaroa²
(edited by P. J. Moss³)

SUMMARY

On 13 May 1990, an earthquake of magnitude 6.7 occurred near Dannevirke and caused damage both there and in the surrounding area.

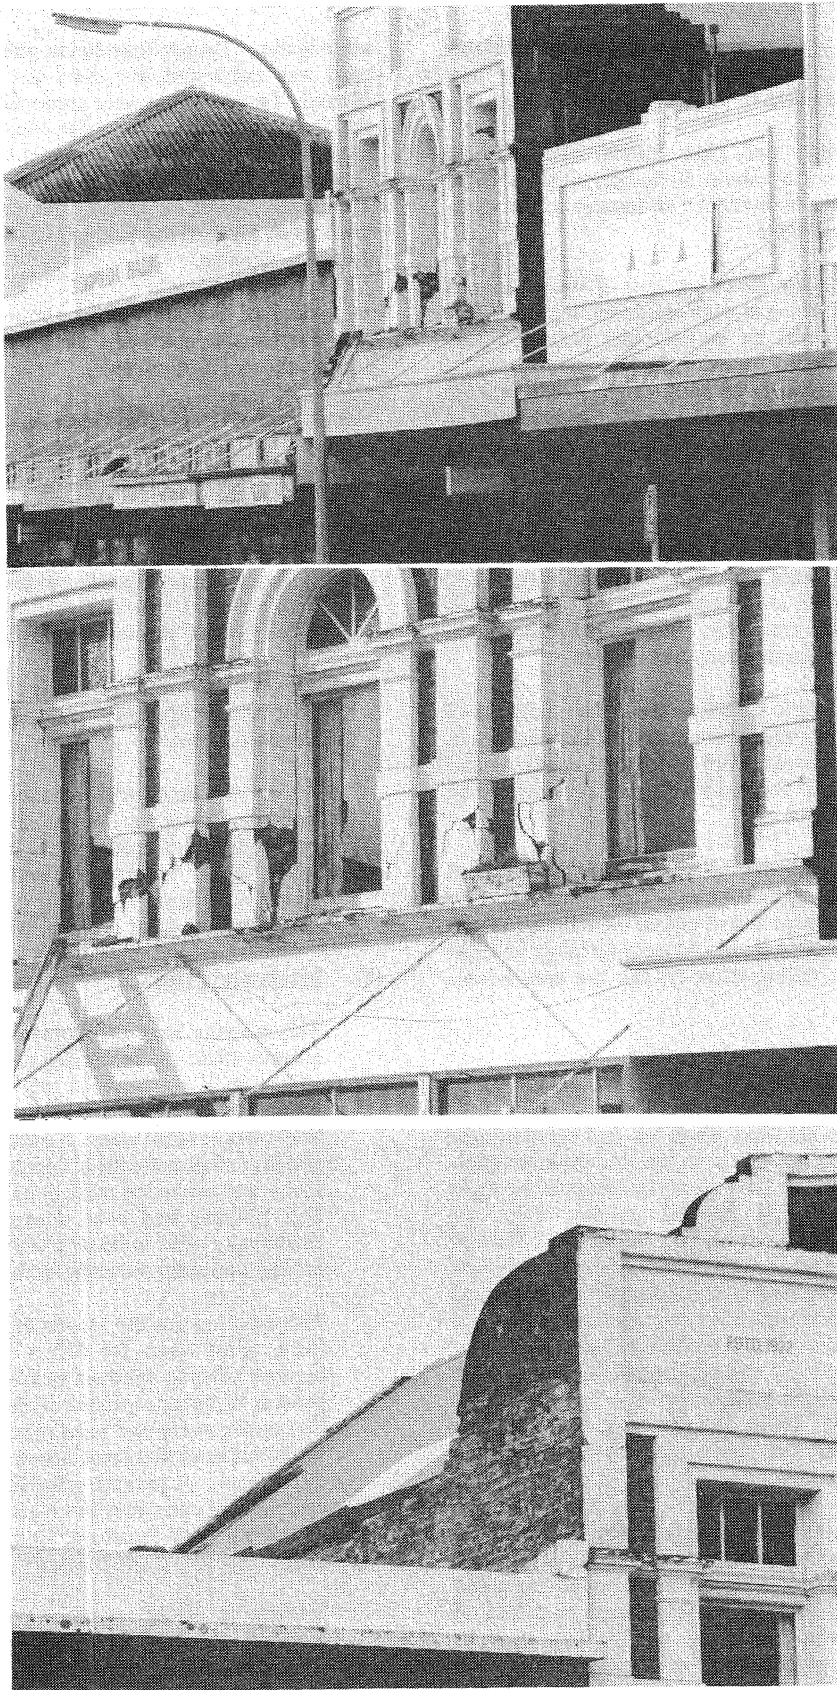
There was little new to learn from this particular building, being a typical high, heavy, and not particularly well constructed building, built around 1910. Shear failures occurred in the brickwork as shown in Figure 5. The sarked roof no doubt prevented the front parapet falling into the street.

Figure 5 *Damage to Shires building.*

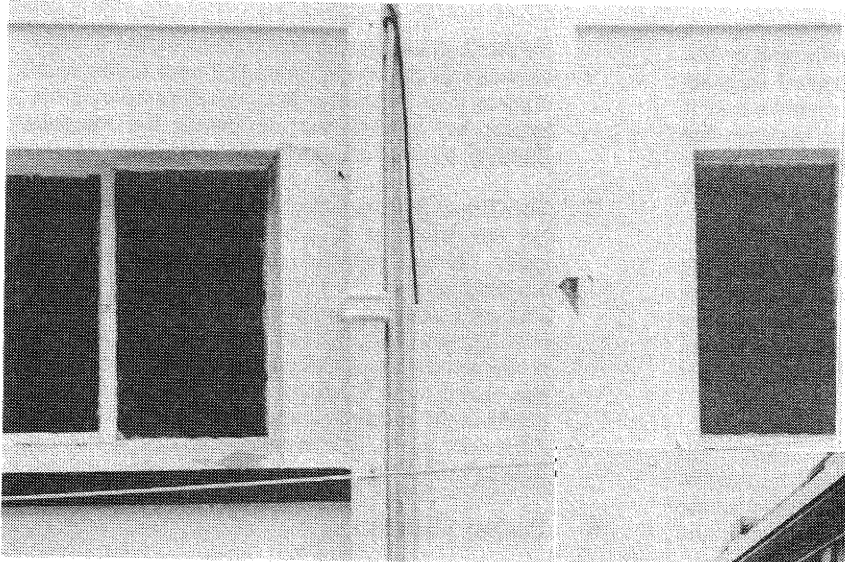
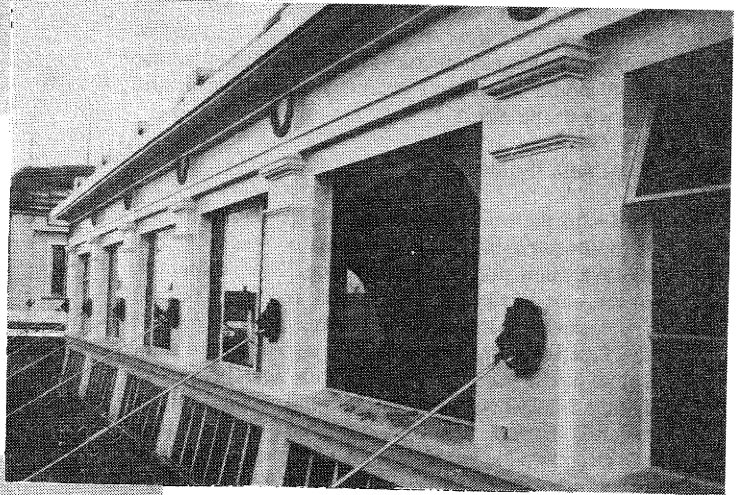
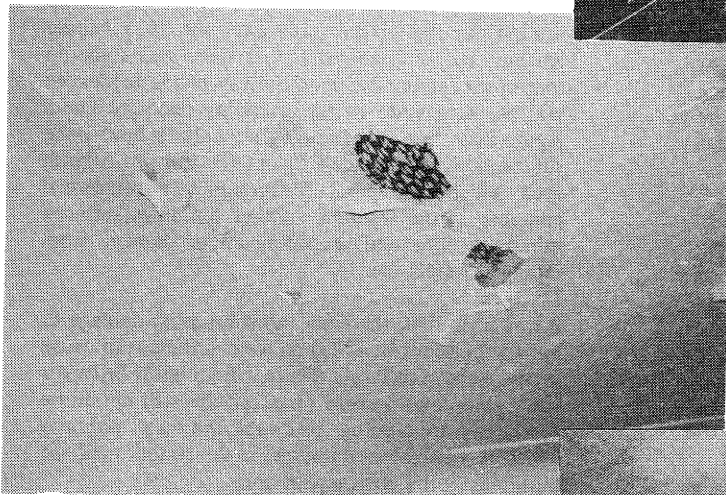
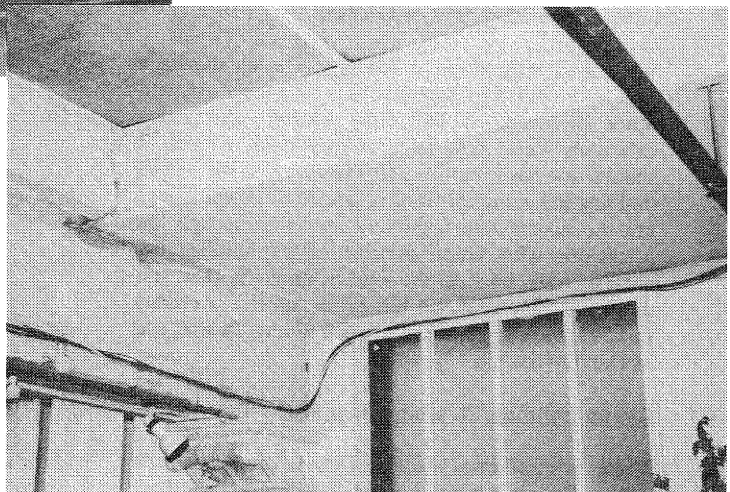
Damage to the Margrethe Building is illustrated in Figure 6. Again, there is nothing specific to be learnt from this building because it performed fairly much as expected in a moderate to severe earthquake. An interesting factor was that the rear wall adjacent to the railway had been strengthened with vertical steel members tied at the roof level, obviously the ground level, and probably at first floor level. This wall

Figure 6 *Damage to Margarethe Plaza.*

showed no signs of distress. The exterior wall on the side street (Station Street) showed typical diagonal cracking at the piers between the windows and it should be noted that this building does not have any other substantial walls running at right angles to the main road apart from that adjacent to the Trustbank Building.

The wall whose parapet collapsed into the Trustbank site had a concrete band above it, and one suspects that the direction of collapse, which did run counter to all other parapet collapses, was dictated by the roof of the Margrethe Plaza behind the parapet pushing the wall to the east.

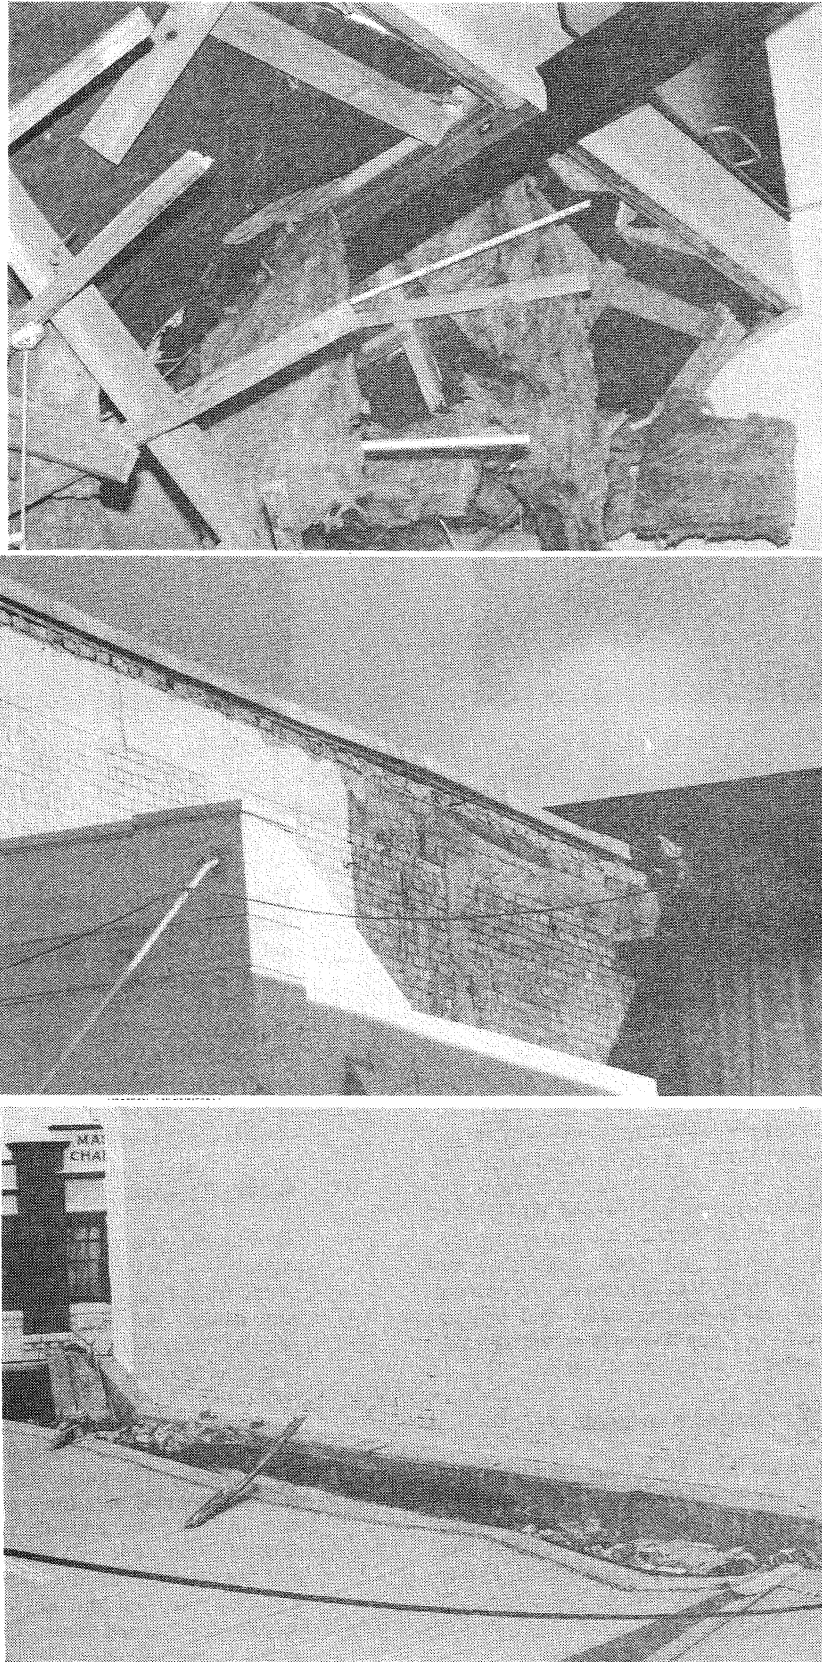
Figure 7 *Damage to the Trustbank building.*

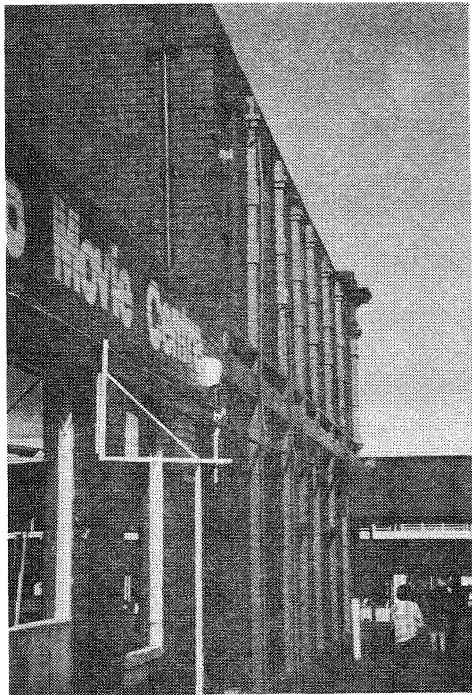
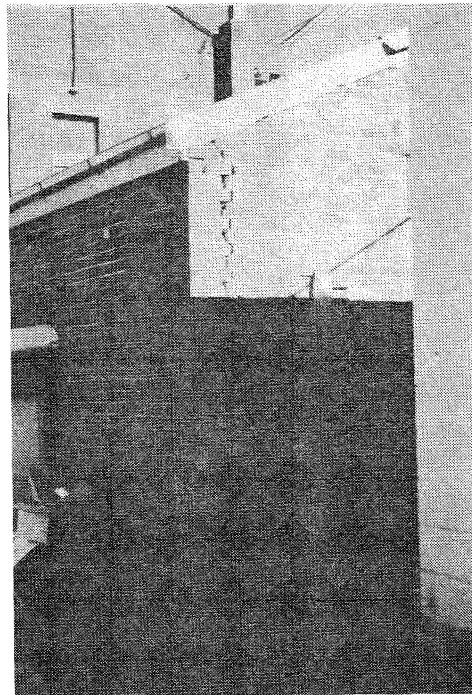
This was a blue and pink painted building, two storeys high, on the corner of High Street and Ward Street which outwardly showed little sign of damage (Figure 8). However, close inspection showed that the Ward Street brickwork was in grave danger of collapse since there had never been any connection between the inner and outer wythes of brickwork.

Also, there was severe cracking visible on the back wall of the building, together with its annex. As with other buildings, it had lime mortar which was extremely weak, and using conventional wisdom, it should not have survived to the extent it did. The building has a timber floor at first floor level. There are the normal old fashioned tie bolts through the brickwork with large circular plates holding the parapet walls back to the roof at both the rear and the front. The roof is a full gable and it is probably sarked, as are most of the other buildings of that era in Dannevirke.

Figure 8 Damage to the Cats Pyjamas building.

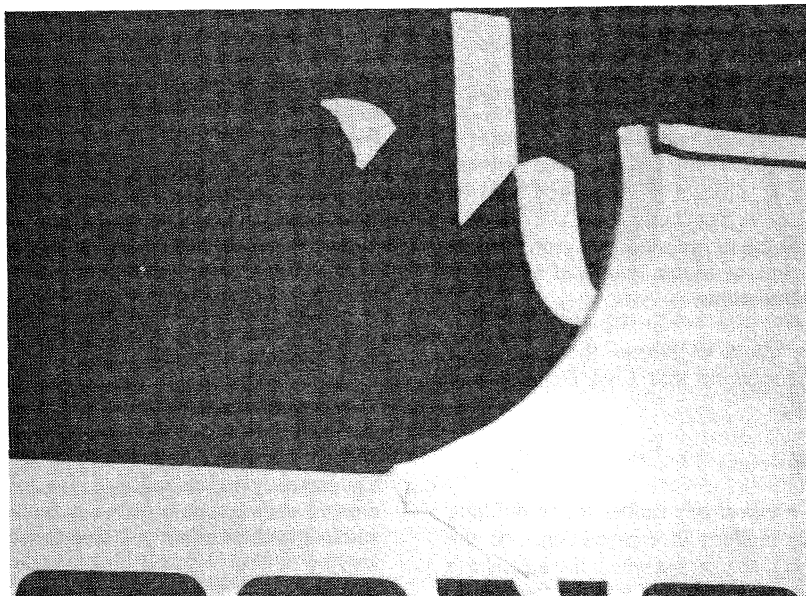
This is a big open warehouse type building, one storey high, with a very steep roof and a high parapet truss at the front (street) of the building (Figure 9). The roof of the building is supported by a tied rafter system, each rafter being a queen post beam. The long steel bar eaves ties which connect the queen post rafter feet, have, of course, no capacity to resist compression. The timber roof purlins frame into holes in the brickwork behind the high gable above the footpath. The gable wall was pulled away from the roof, opening up quite a gap between the roofing iron and flashing, and the roof face of the gable parapet. The gable end did not move far enough to pull the purlins ends out of their housings and therefore the roof did not collapse though it has moved at least 100 mm. The side walls, at right angles to the side street but running parallel to the main street of Dannevirke, have severely bowed and at a rough estimate it would have moved at the top by at least 200 mm. The building did not collapse but was in fairly unstable condition. The interior of the

Figure 9 *Damage to Davidson's Engineering building.*

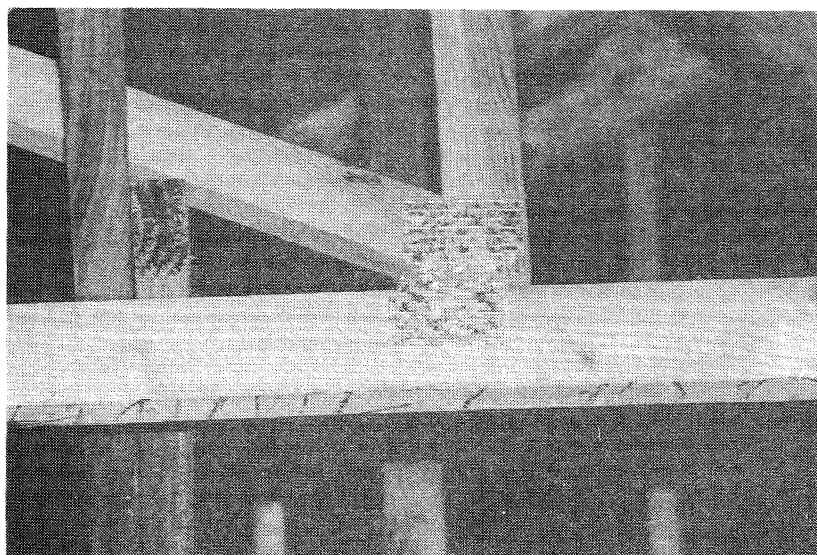
Figure 10 *Regent Theatre - damage to timber truss node due to impact from masonry debris falling on the roof.*

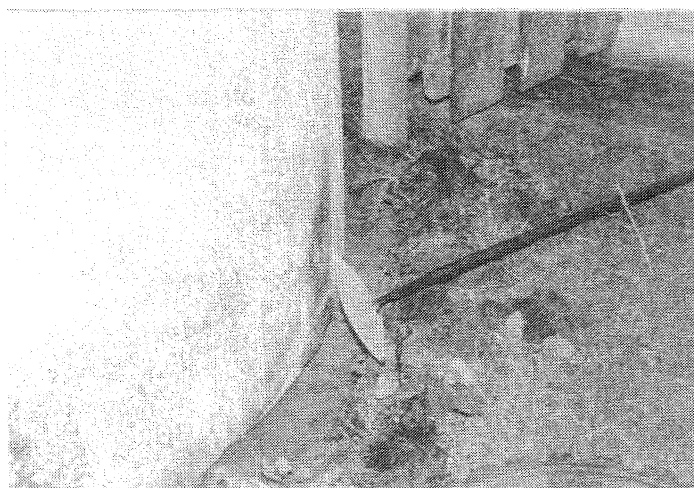
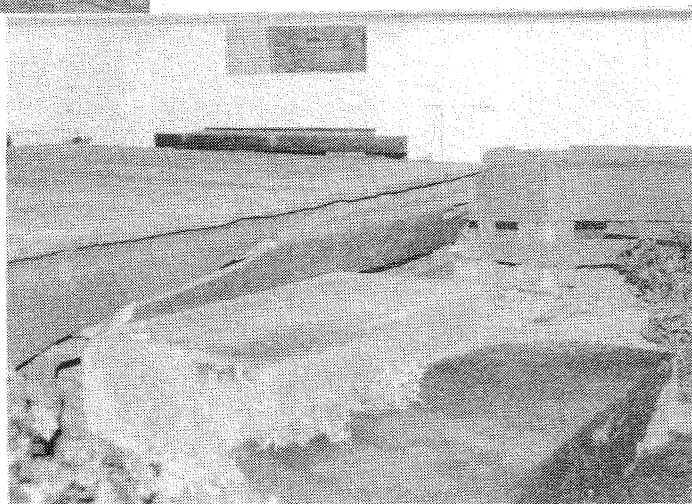
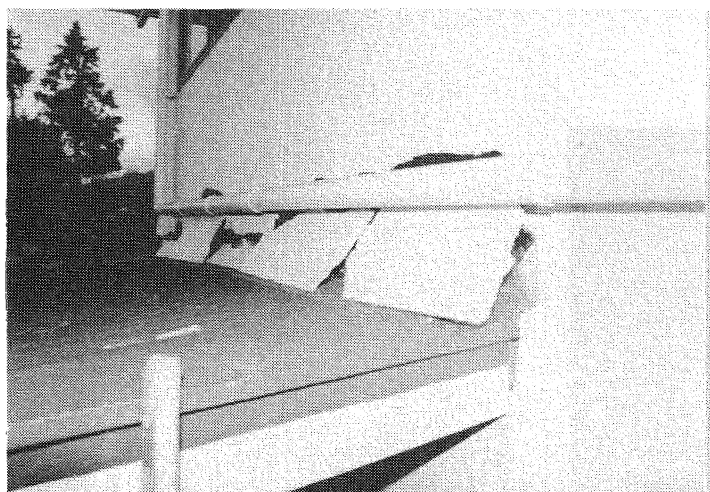
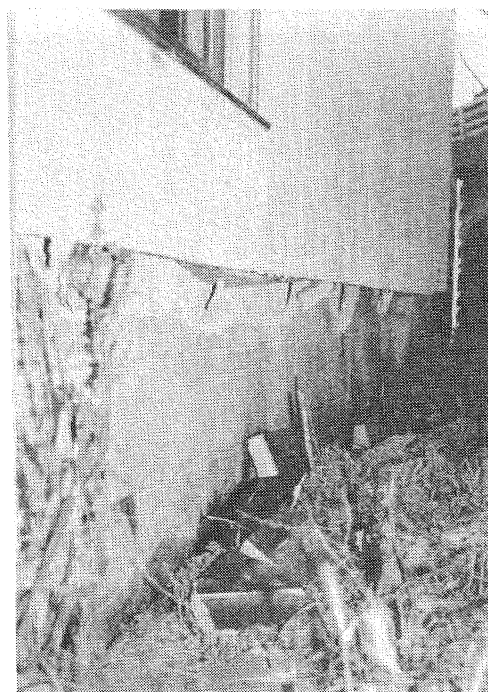
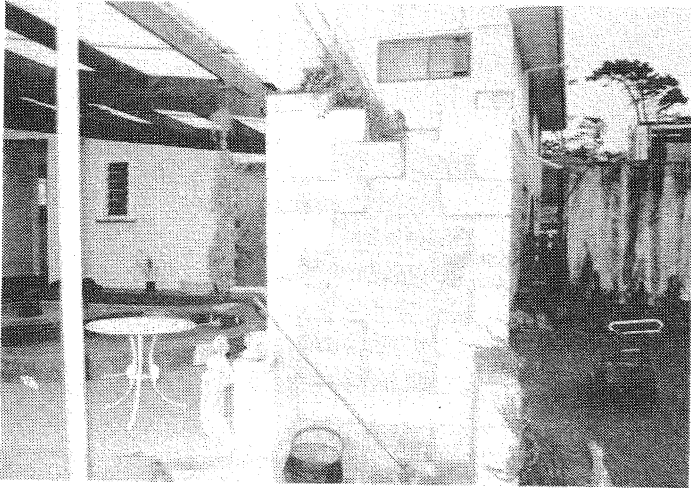
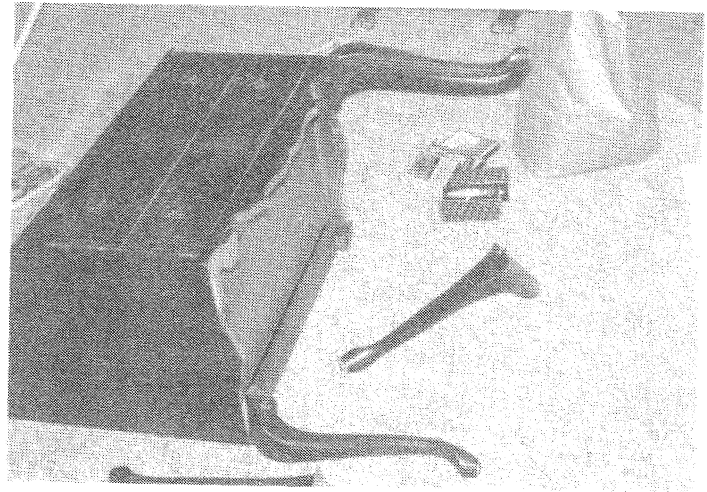
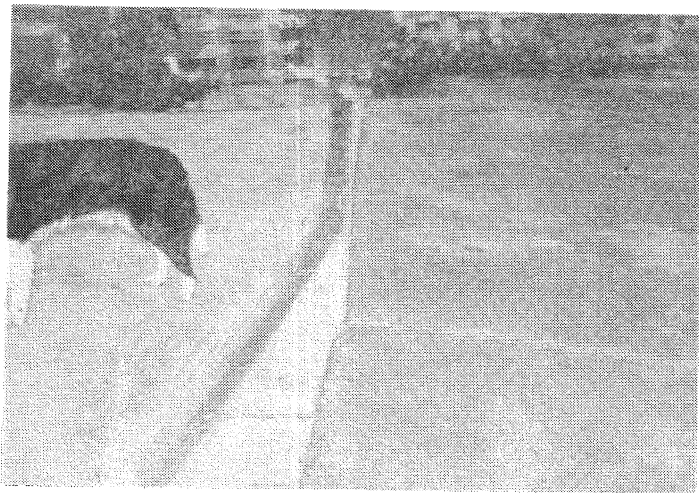
The Duncan house comprises a colonial single storey house with a two storey garage. The lower level of the garage is in concrete block while the upper level is of stucco construction. Damage to the house was extensive below the floor level (Figure 11). The house had moved in an east to north-east direction by approximately 200mm. There were no cantilever or braced piles and the house was sitting just on ordinary piles. In the eastern corner, the progress of the house was stopped by the concrete deck area. However, when the house hit this concrete slab, it knocked out the ranch sliders. Also, at the eastern end of the house, a sunroom floor area became detached from the remaining part of the house and fell completely off the piles. Inside, there was extensive damage to the furniture. Legs to much of the antique furniture were snapped off, windows were

cracked, doors and windows were all jammed, cupboards were jammed, and everything that was in cupboards was thrown on to the floor. A verandah on the western side was ripped away from the house as it moved in the easterly direction. A small changing area adjacent to the spa pool was also ripped away from the house. One of the chimneys in the house fell through this adjoining roof and broke some of the timber framing members. The new fireplace which had been replaced after the February earthquake showed less damage but still suffered cracking. The associated hot water cylinder pipes had also been flexed but not cracked.

The concrete block walls of the garage sustained quite extensive damage. The southern end of the garage was acting as a retaining wall. The dynamic earth pressures against this, plus the buffing of the building against the bank, created a discontinuity between the side and end wall. The stucco structure above remained rigid but followed the side wall by pulling out and blowing the side cover of the top block of the end wall. This top structure also disconnected itself from the joining roof to the main house.

It was difficult to check whether there was any reinforcing steel tying the two corners together. The vertical cracking pattern suggests that there was no reinforcing between these two walls. Certainly, there was no steel in the top course anchoring the bottom plate bolts into the top of the wall.

Figure 11 *Damage to the Duncan house, Motea*

Figure 11 (cont.) Damage to the Duncan house, Motea.
