THE 1989 NEWCASTLE, AUSTRALIA, EARTHQUAKE: THE FACTS AND THE MISCONCEPTIONS

J.M.W. Rynn¹, E. Brennan², P.R. Hughes³, I.S. Pedersen⁴
and H.J. Stuart⁵

ABSTRACT

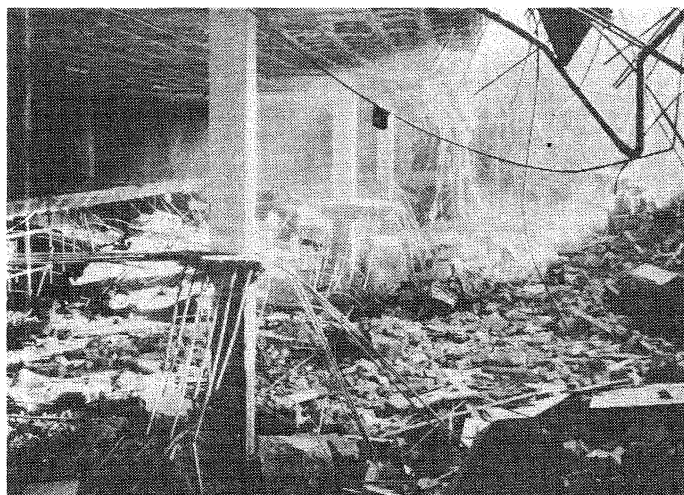
FIGURE 7 DESTRUCTION OF THE NEWCASTLE WORKERS' CLUB, KING STREET, NEWCASTLE CBD WHEREIN NINE PERSONS WERE KILLED: CLASSICAL PANCAKE SHEAR FAILURE EXPOSES NEGATIVE MOMENT REINFORCEMENT OVER COLUMNS AFTER FLOORS COLLAPSED (29.12.89; J.M.W. RYNN)

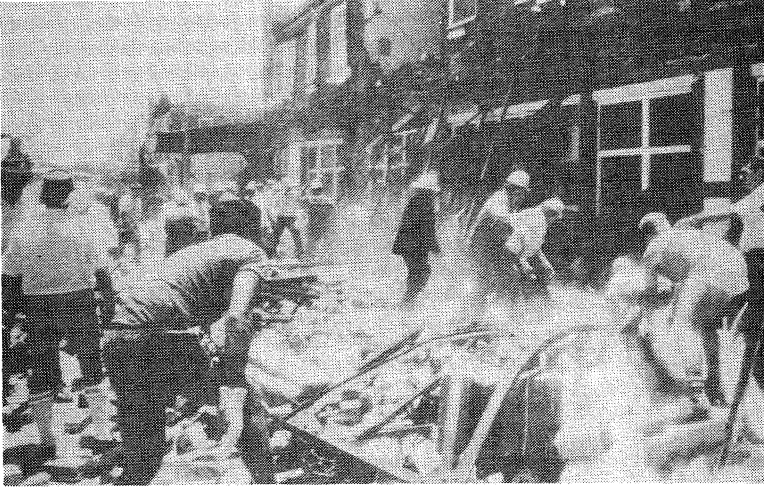
FIGURE 8
 DEVASTATION AT THE KENT HOTEL,
 BEAUMONT STREET, HAMILTON WITHIN
 MINUTES OF EARTHQUAKE: AFTERMATH
 OF PARAPET AND AWNING COLLAPSE
 ONTO FOOTPATH - ALL HANDS TO THE
 RESCUE:
 (28.12.89; "NEWCASTLE HERALD")

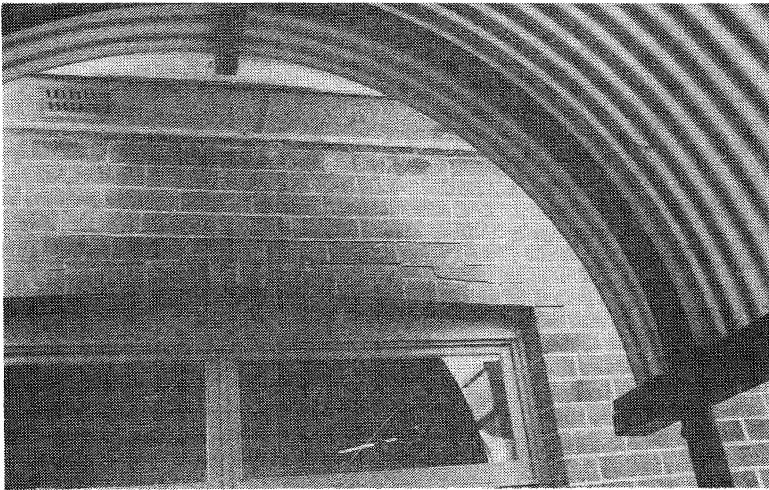
FIGURE 9
 ST. LUKE'S PARISH CHURCH HALL,
 SCONE, 110 km NW OF NEWCASTLE:
 TYPICAL DIFFERENTIAL MOVEMENT AT
 LINTEL OVER WINDOW ABOVE
 ENTRANCE DOOR SHOWN BY TENSION
 CRACKING FROM POINT OF
 DISCONTINUITY
 (23.1.90; E.BRENNAN)

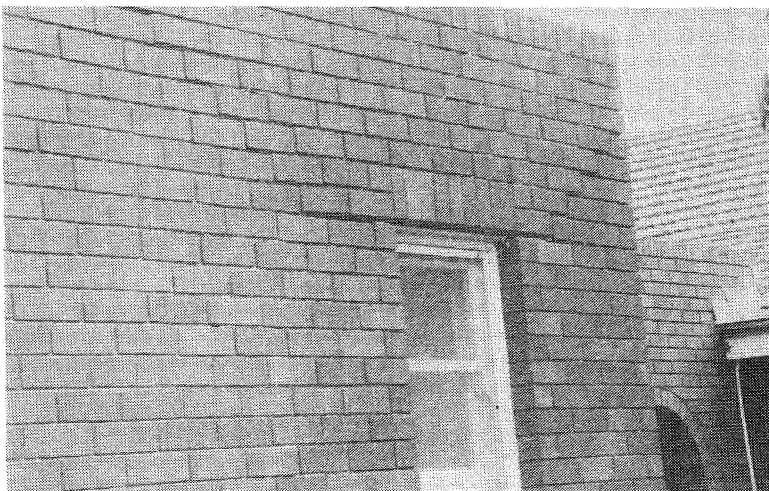
FIGURE 10
 LIVERPOOL CHILDREN'S HOSPITAL,
 SYDNEY, 150 km SW OF NEWCASTLE:
 TYPICAL MASONRY DIAGONAL SHEAR
 FAILURE FROM WINDOW LINTEL
 (22.1.90; E. BRENNAN)

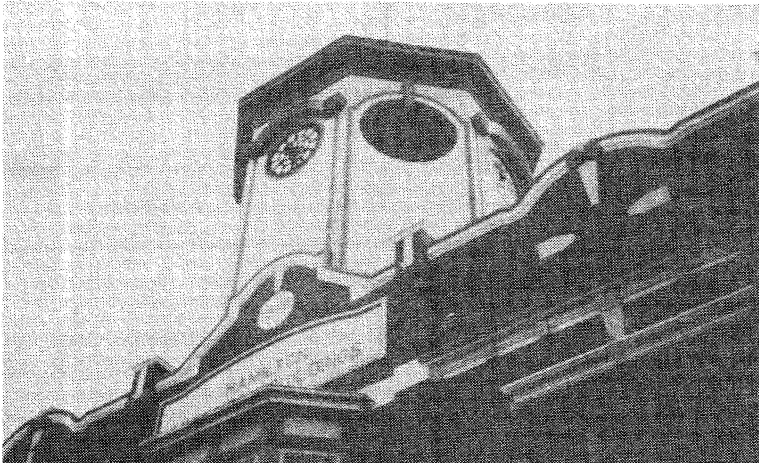
FIGURE 11
HAMILTON COUNCIL CHAMBERS CLOCK TOWER, BEAUMONT STREET, HAMILTON, AFTER RESTORATION. UNREINFORCED MASONRY BRICK PARAPETS AND CLOCK TOWER SO BADLY DAMAGED THEY HAD TO BE DESTROYED.
(24.10.91; H.J.STUART)

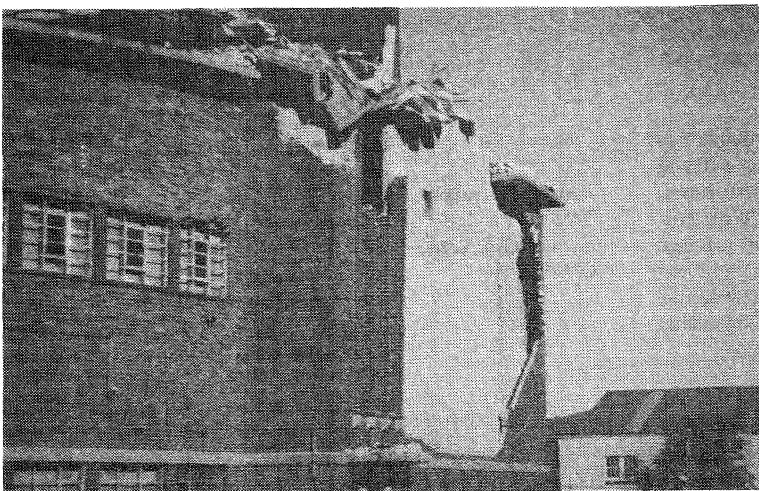
FIGURE 12
NEWCASTLE CITY COUNCIL MUNICIPAL INCINERATOR IN PARRY STREET, NEWCASTLE CBD: OUTER SKIN OF MASONRY BRICK WALL DISCONNECTED FROM INNER SKINS (COLLAPSE THREE STOREYS HIGH, WITH COLLAPSE OF BRICK PARAPET AND ROOF. THIS DAMAGE SUFFICIENT TO WARRANT ITS DEMOLITION.
(30.12.89; J.M.W. RYNN)

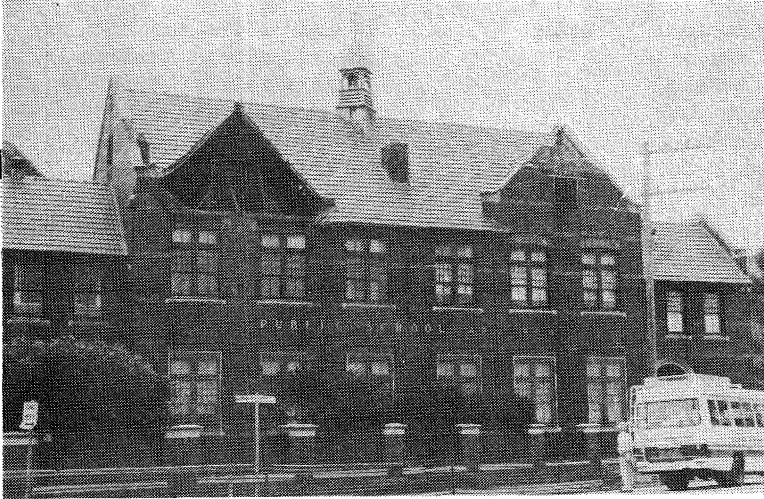
FIGURE 14
 WICKHAM PUBLIC SCHOOL,
 HANNELL STREET, WICKHAM:
 TYPICAL MASONRY GABLE ROOF
 ENDS, PARAPETS AND OUTER
 BRICK SKIN FAILURES. NO
 LATERAL SUPPORT OF
 UNREINFORCED MASONRY TO
 ROOF FRAMING. TYPICAL GABLE
 DETAIL
 (5.1.90; J.M. FENWICK)

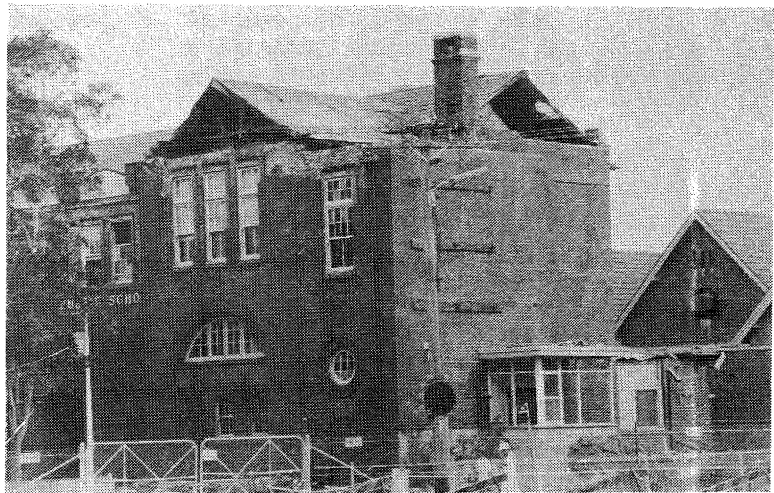
FIGURE 15
 THE OLD JUNCTION SCHOOL (NOW
 TAFE COLLEGE), GLEBE ROAD, THE
 JUNCTION; SHOWS TYPICAL
 SCHOOL CONSTRUCTION. FAILURE
 OF UNREINFORCED CAVITY
 MASONRY GABLE ROOF ENDS,
 LATERALLY UNSUPPORTED TO
 ROOF FRAMING. FAILURE IN ROOF
 CHIMNEY AND BRICK WALLS.
 MASONRY DEBRIS IN SCHOOL
 YARD AND DAMAGE TO ADJOINING
 BUILDING.
 (4.1.90; E.BRENNAN)

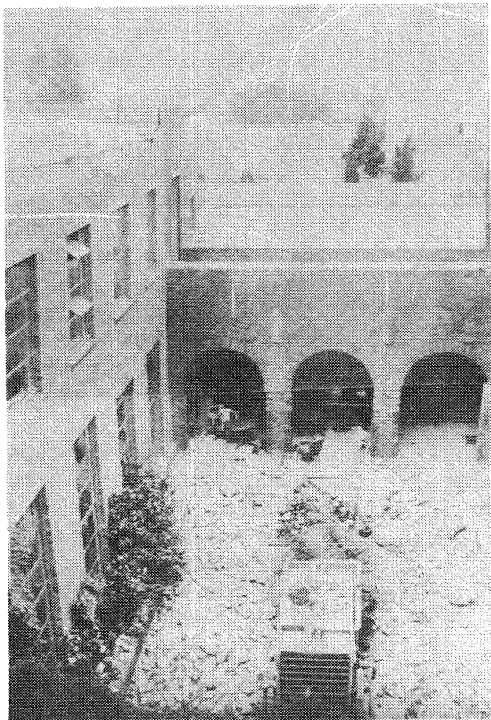
FIGURE 16
 NEWCASTLE TAFE COLLEGE,
 TIGHES HILL, INNER COURTYARD
 OF H.G. DARLING BUILDING:
 COMPOSITE PHOTOGRAPH OF
 COURTYARD FILLED WITH
 MASONRY DEBRIS FROM COLLAPSE
 OF THREE SURROUNDING
 UNREINFORCED AND
 UNSUPPORTED MASONRY PARAPET
 WALLS (LEFT VISIBLE ONLY),
 CONCRETE AND MASONRY
 LINTELS AND ARCHITECTURAL
 FEATURES
 (4.1.90; J.M. FENWICK)

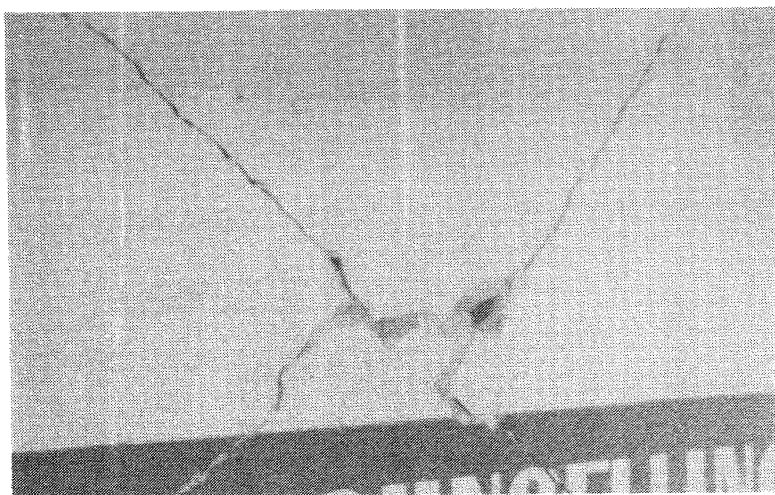
FIGURE 18

NEWCASTLE TAFE COLLEGE,
TICHES HILL, CHANDLER
BUILDING: DIAGONAL SHEAR
CRACKING. TYPICAL FRACTURING
OF INTERNAL CEMENT RENDERED
BRICK WALLS OF MULTISTOREY
BUILDINGS

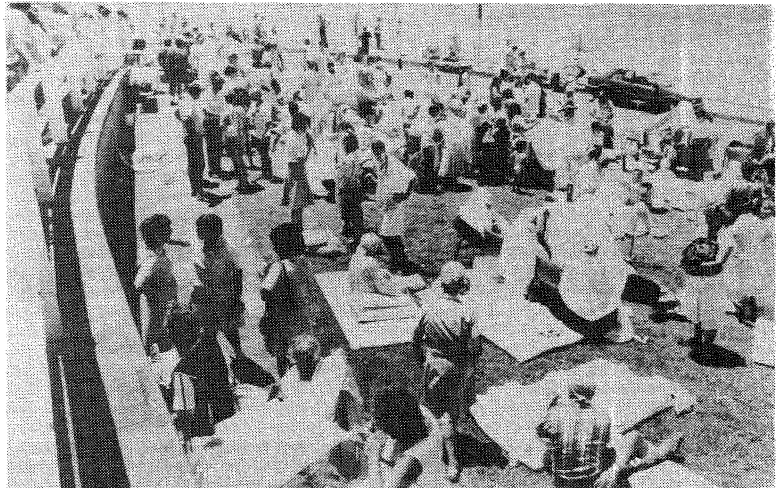
FIGURE 20

ROYAL NEWCASTLE HOSPITAL,
NEWCASTLE EAST: EVACUATION
OF ALL PATIENTS ONTO BEACH
ESPLANADE AND PARK BECAUSE
OF PUBLIC DANGER IN DAMAGED
BUILDINGS
(28.12.89; NEWCASTLE "HERALD")

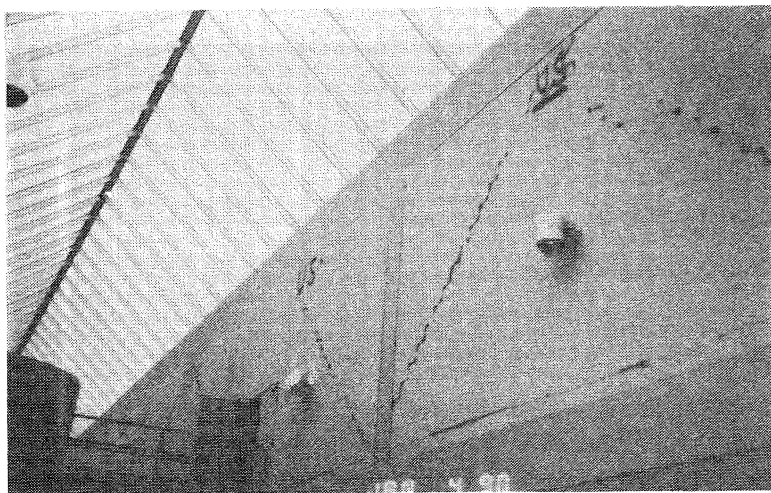
FIGURE 22

MATER MISERICORDIAE HOSPITAL,
EDITH STREET, WARATAH:
COLLAPSE OF UNREINFORCED
MASONRY PARAPET ENCLOSING
COVERED WALKWAY AT ROOF
LEVEL
(19.1.90; E. BRENNAN)

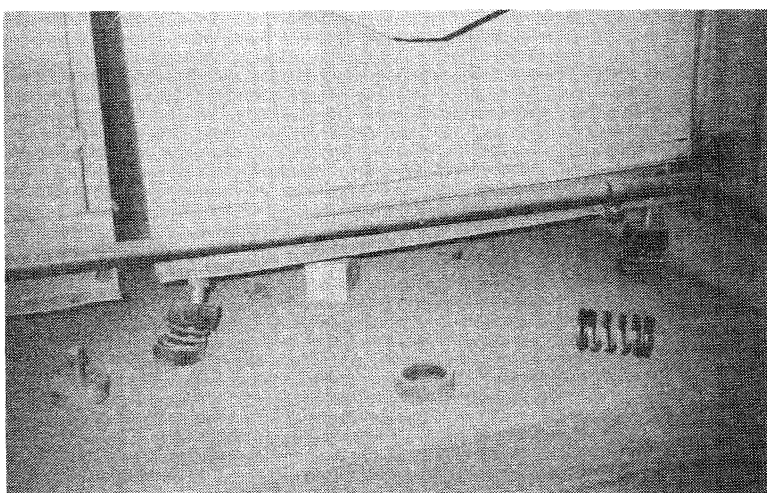
FIGURE 23

THE JOHN HUNTER HOSPITAL,
LOOKOUT ROAD, LAMBTON
HEIGHTS, SERVICES BLOCK:
DAMAGE OCCURRED TO
ELECTRICAL AND MECHANICAL
SERVICES WITH EXAMPLE HERE OF
ANTI-VIBRATION SPRINGS FROM
BASE OF AIR CONDITIONING UNIT -
"POPPED OUT" FOR LACK OF
HOLDING DOWN BOLTS
(29.12.89; J.M.W. RYNN)

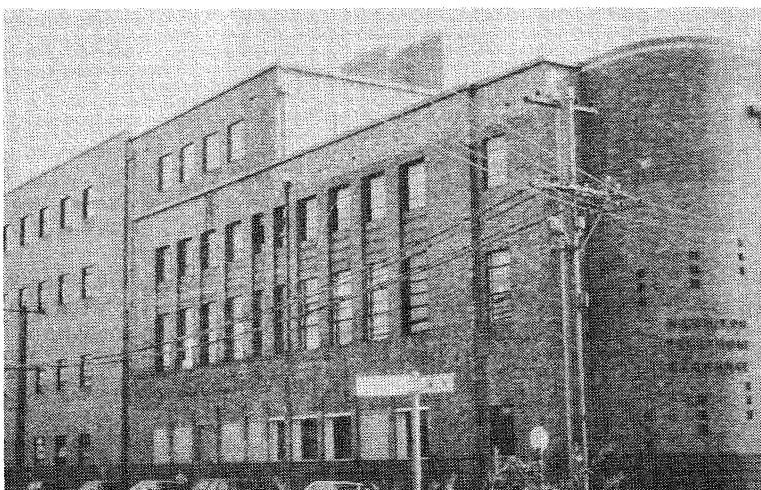
FIGURE 29
ROAD TRAFFIC AUTHORITY
BUILDING, PACIFIC HIGHWAY,
CHARLESTOWN: SHORING OF
UNREINFORCED CAVITY MASONRY
FEATURE END WALL WHICH WAS
NOT TIED LATERALLY TO AND
BECAME SEPARATED FROM SIDE
WALLS (20.1.90; E. BRENNAN)

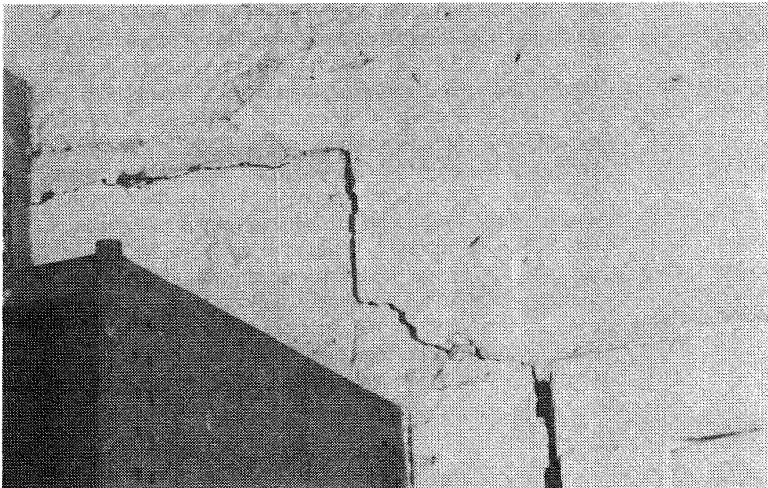
FIGURE 32
NORAH HEAD LIGHTHOUSE, OPERATIONS
ROOM: MASONRY SHEAR FAILURE IN
CONCRETE BLOCK WALLS WITH
CRACKING AROUND CONCRETE MAIN
FRAME
(20.1.90; E. BRENNAN)

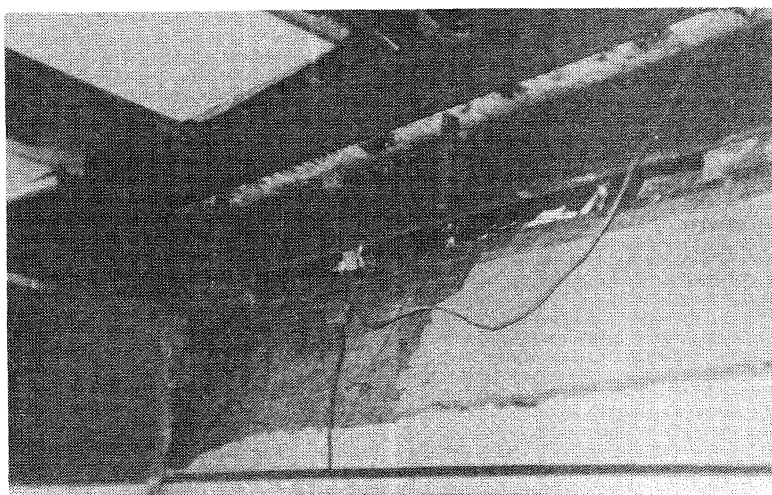
HAMILTON RSL CLUB, TUDOR AND CHAUCER STREETS, HAMILTON: SEVERE BUCKLING OF CHAUCER ST. (WESTERN) WALL - OUTSIDE BRICK SKIN FAILURE DUE TO LACK OF LATERAL SUPPORT. WALL STILL CONNECTED TO LOAD BEARING INSIDE SKIN BY BRICK TIES (5.1.90; C.R. FEATHERSTONE)

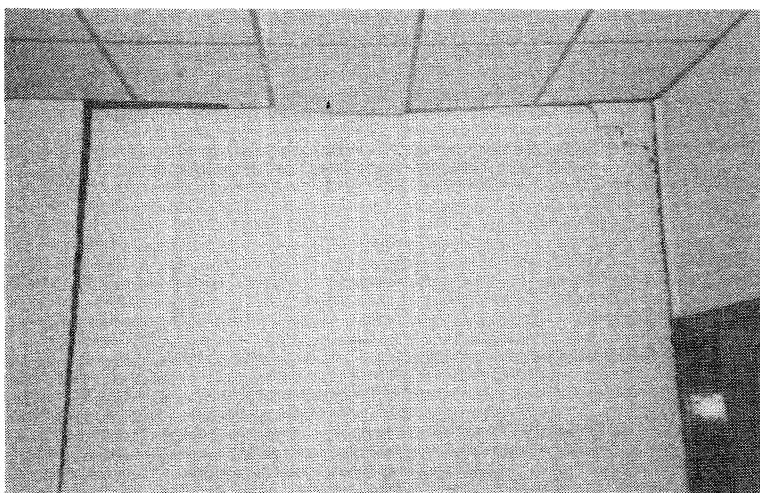
FIGURE 34

HAMILTON RSL CLUB, TUDOR AND CHAUCER STREETS, HAMILTON: FAILURE OF INTERNAL BRICK WALL - TYPICAL DIAGONAL SHEAR CRACKING IN MASONRY WALLS. NOTE LACK OF CONNECTION OF INFILL BRICKWORK TO CONCRETE FRAME (5.1.90; C.R. FEATHERSTONE)

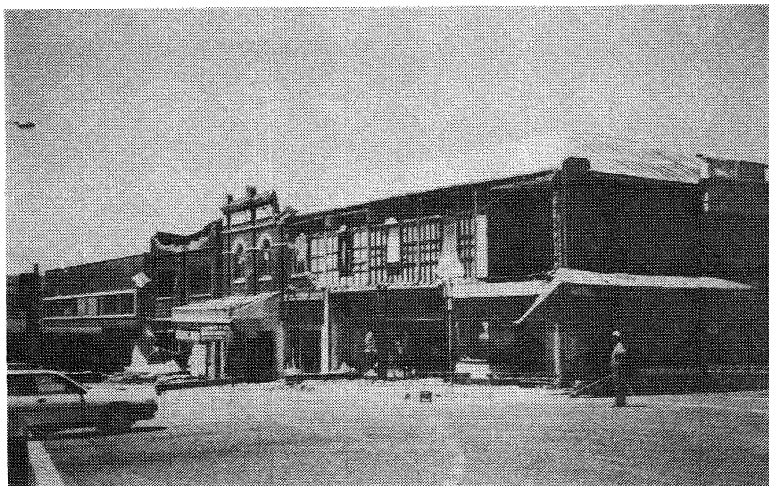
FIGURE 36
COMMERCIAL BUILDINGS, KING AND UNION STREETS, NEWCASTLE CBD: OUTER SKIN OF BRICKWORK COLLAPSED ONTO AWNING - INSIDE TIMBER FRAME SUPPORTING ROOF REMAINED IN PLACE (29.12.89; J.M.W. RYNN)

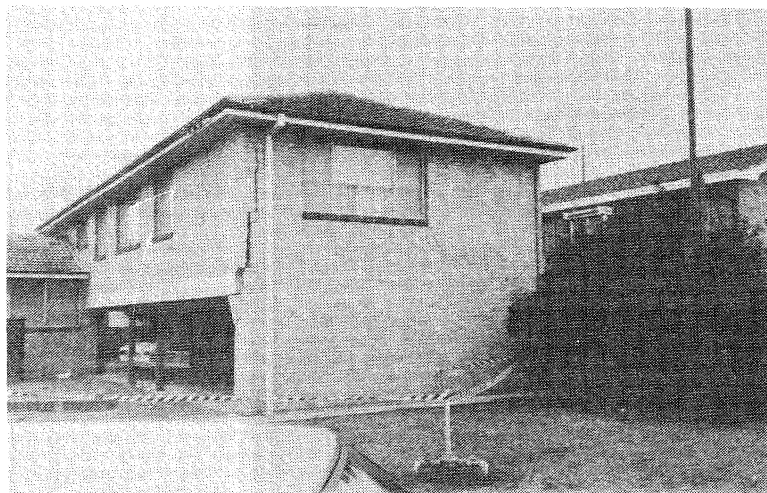
FIGURE 39 BLOCK OF UNITS, WILTON STREET,
MEREWETHER: TYPICAL SOFT STOREY
FAILURE - NO LATERAL BRACING
WALLS
(4.1.90; C.R. FEATHERSTONE)

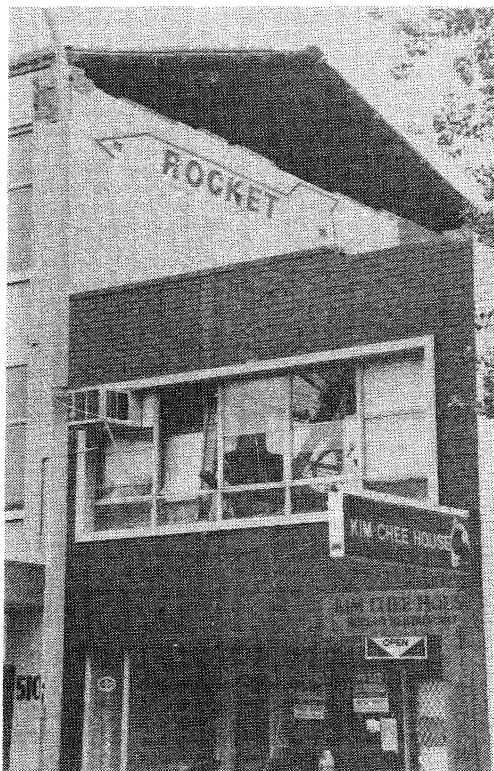
← FIGURE 40 HUNTER STREET, NEWCASTLE CBD:
CONSEQUENTIAL EFFECTS WHERE
DEBRIS FROM UNREINFORCED MASONRY
GABLE ROOF END OF HIGHER BUILDING
COLLAPSED ONTO ROOF OF UNDAMAGED
LOWER BUILDING UNDEAMAGED BY THE
INITIAL SHOCK OF THE EARTHQUAKE.
DAMAGE CAUSED TO ROOF, CEILING AND
INTERNAL FITTINGS OF THE LOWER
BUILDING
(4.1.90; E. BRENNAN)

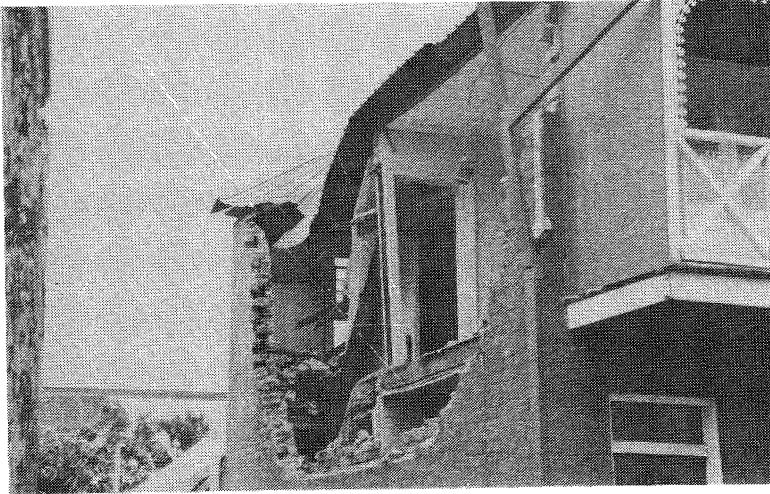
FIGURE 41
TERRACE HOUSE, LAMAN STREET, COOKS HILL: COLLAPSE OF DOUBLE SKIN BRICK WALL AND BRICK GABLE END WITH NO LATERAL SUPPORT OF TWO-STOREY PRIVATE DWELLING, TYPICAL DAMAGE FOR THIS TYPE OF CONSTRUCTION (5.1.90; C.R. FEATHERSTONE)

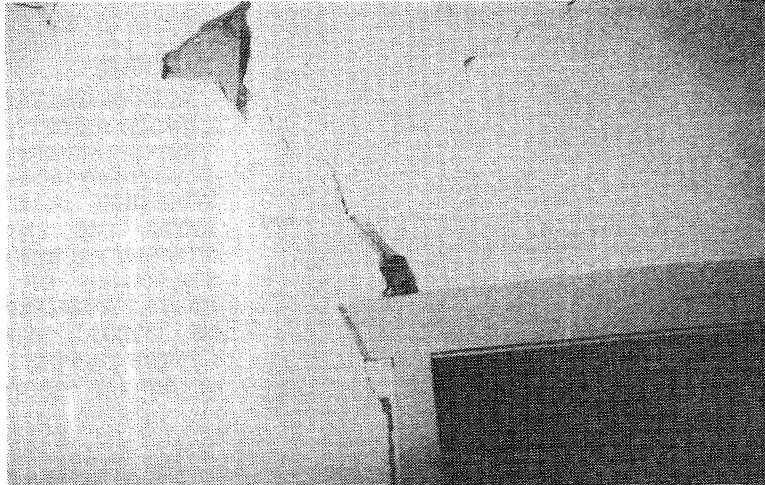
FIGURE 44 INTERIOR OF SINGLE STOREY PRIVATE DWELLING, 91 MEREWETHER STREET, MEREWETHER: TYPICAL DIAGONAL SHEAR FAILURE IN UNREINFORCED MASONRY WALLS (BRICK AND CEMENT RENDER) FROM DOOR OPENING IN INTERNAL WALL SHEETING (4.1.90; B. GREEN)

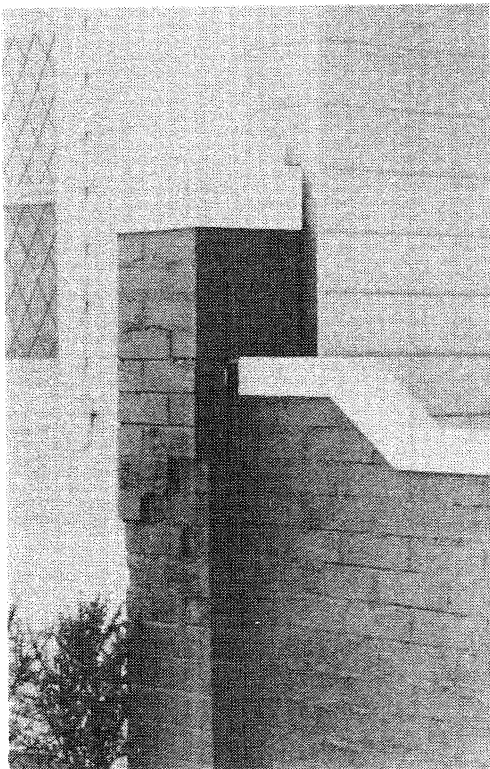
← FIGURE 45 EXTERIOR BRICK VERANDAH OF PRIVATE SINGLE STOREY DWELLING, 151A OLD MAITLAND ROAD, HEXHAM (APPROX 14 km NW OF NEWCASTLE CBD): DISCONNECTED UNSUPPORTED BRICK PIER FAILURE WITH SEVERE CRACKING OF MORTAR JOINTS AND DISPLACEMENT OF BRICK BASE (21.1.90; E. BRENNAN)

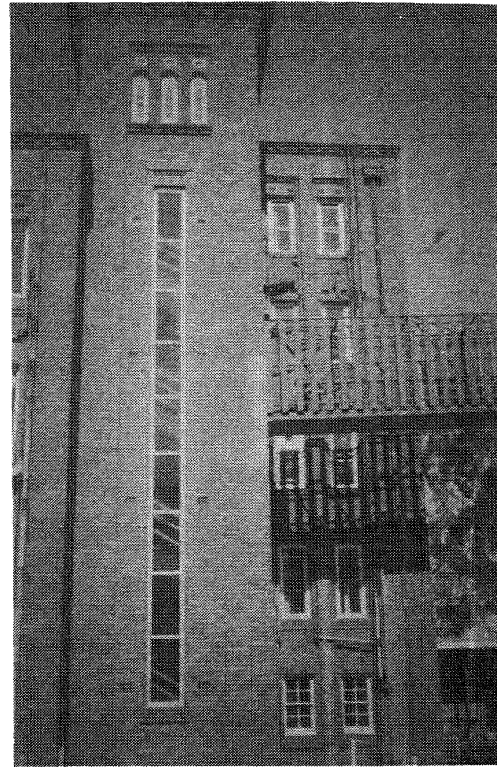
FIGURE 48 ST MARY'S CATHOLIC HIGH SCHOOL REDGAMMON BUILDING, MAITLAND (CIRCA 1930's): BRIDGE DISCONNECTED AND PARAPET MOVED 30-80 mm (WEST VIEW) (JANUARY 1990; J. NICHOLS)

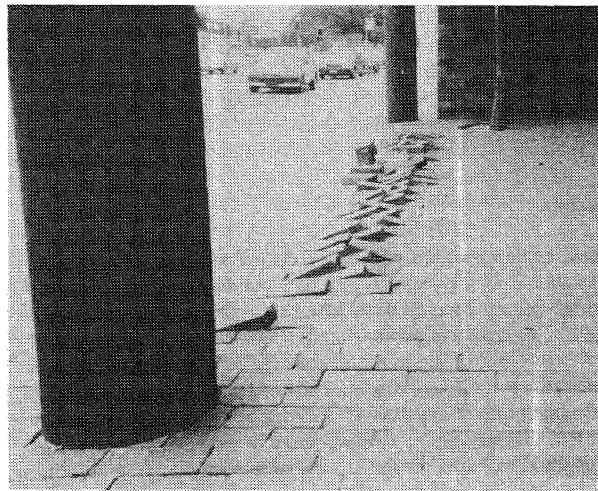
FIGURE 52 EVIDENCE OF APPARENT COMPRESSIVE GROUND MOTION IN BRICK PAVEMENT OUTSIDE DEPT OF SOCIAL SECURITY BUILDING IN KING STREET, NEWCASTLE CBD
(5.1.90; W.H. BOYCE)

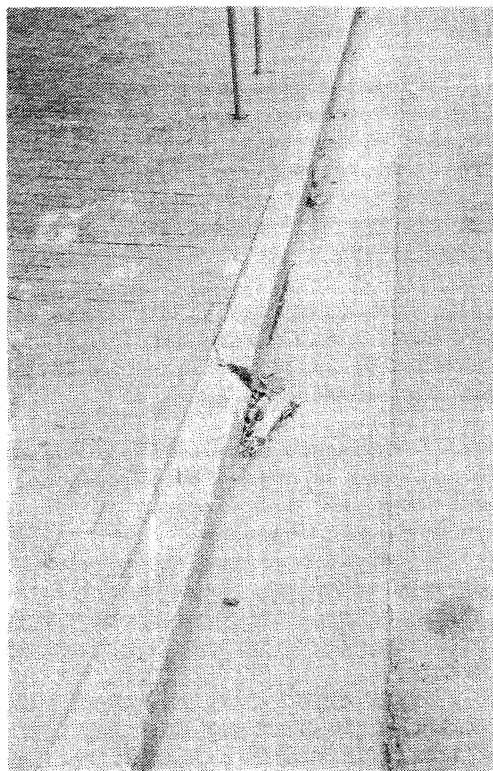
FIGURE 53 FURTHER EVIDENCE SHOWING COMPRESSION FAILURE (CRACK) IN STREET GUTTER AND SPALLING OF CONCRETE ON KERB EDGE OF BRICK PAVEMENT OF FIGURE 52 (5.1.90; W.H. BOYCE)

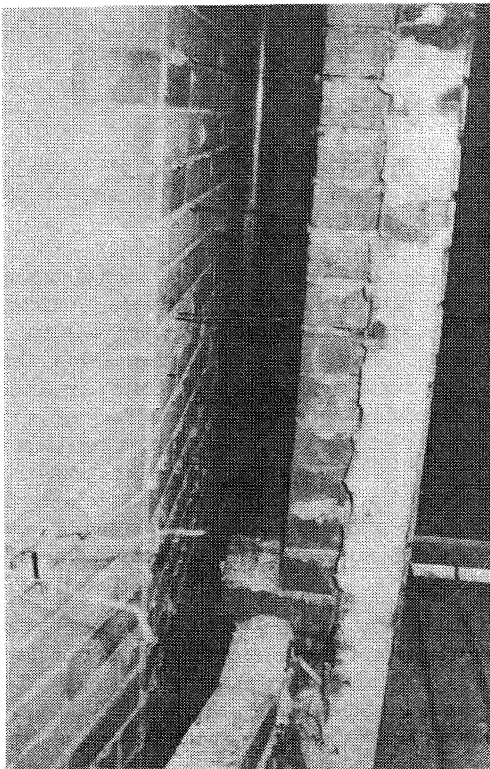
FIGURE 69
INADEQUATE SIZE OF MASONRY
CAVITY TIES FOR SPACING OF
BRICK SKINS IN BUILDING.
CONSTRUCTED IN 1970's. SMALLER
GAUGE BRICK TIES THAN NORMAL,
TIES DO NOT CONNECT AND THE
SKINS AND CONSTRUCTION AT
CHANGE OF CAVITY WIDTH WITH
UPPER BRICK WALL RESTING ON
UNSUPPORTED BRICK ATOP LOWER
BRICKWORK
(JUNE 1990; I.S.PEDERSEN)

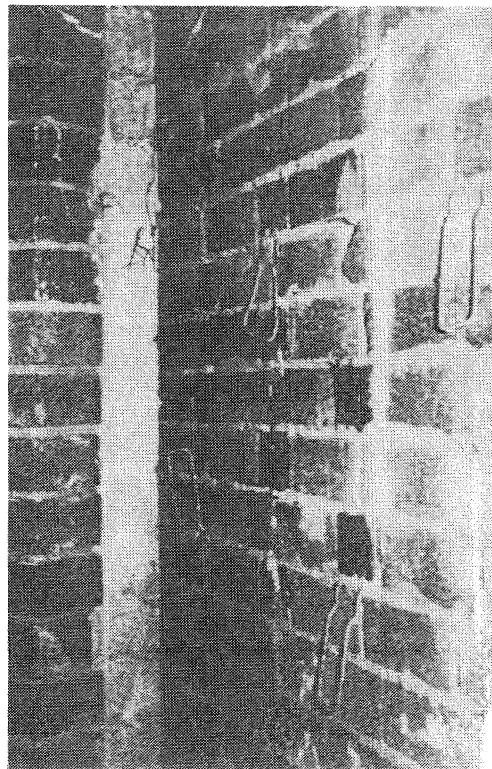
FIGURE 70
BRICK TIES BENT DOWN AND NOT
ENGAGED
(FEBRUARY 1990; A.W.PAGE)

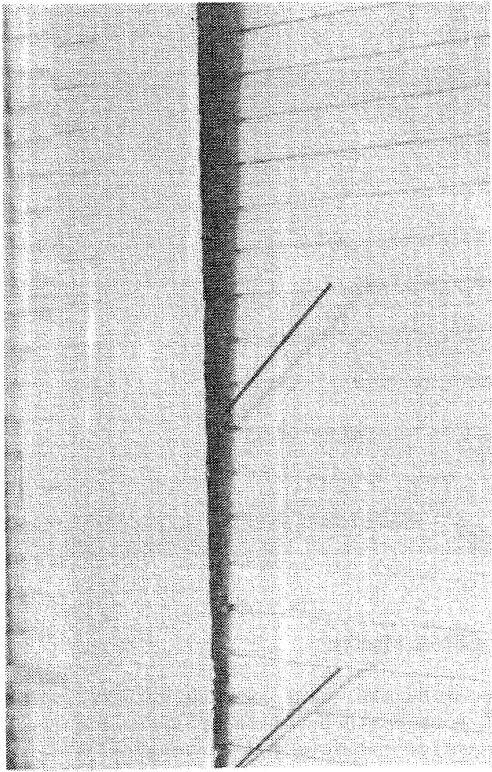
FIGURE 71 COMMON EXAMPLE (THIS CASE FROM HAMILTON RSL BUILDING), OF WALL TIES NEVER CONNECTED BY BUILDER AT TIME OF CONSTRUCTION RESULTING IN RELATIVE FAILURE OF MASONRY WALL SECTIONS (TIES SHOWN WERE EMPLACED IN ONE SECTION AND SIMPLY BENT UP PARALLEL TO THIS SECTION WITHOUT ATTACHMENT TO ADJOINING SECTION. TIES WERE PULLED OUT FROM BEHIND WALL TO SHOW THIS PROBLEM). (5.1.90; E.BRENNAN)

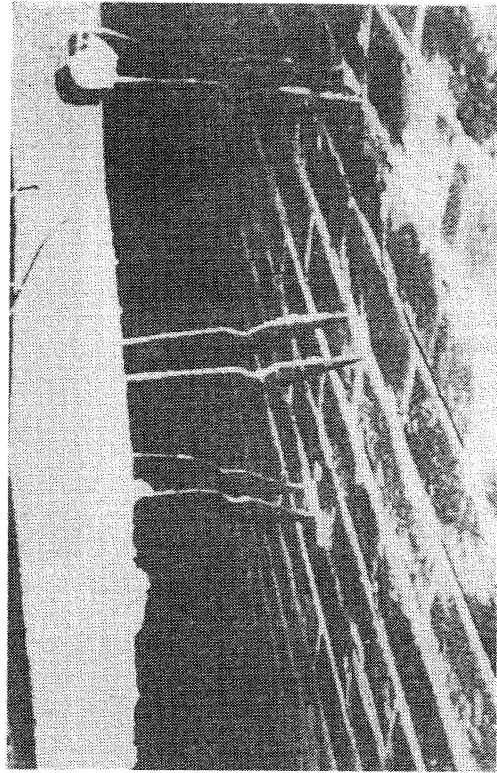
FIGURE 72 BRICK TIES TOO FLEXIBLE (FEBRUARY 1990; A.W.PAGE)

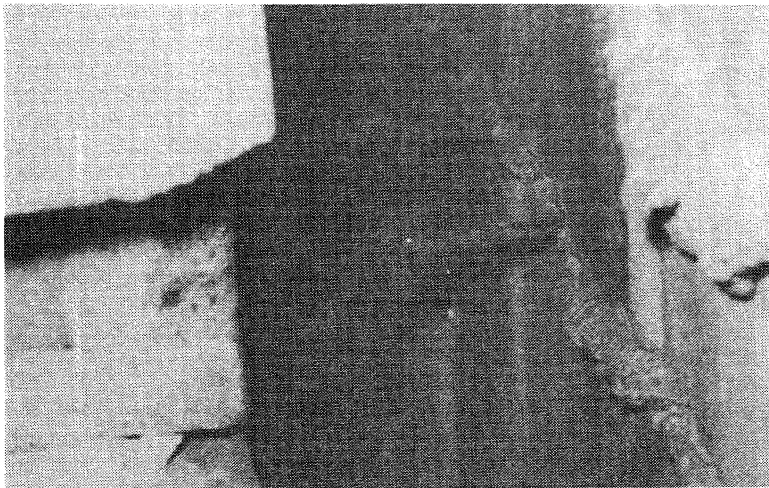
FIGURE 73 CORRODED BRICK TIES FOUND IN OLDER BUILDING, NEWCASTLE (27.11.90; I.S.PEDERSEN)
