# EARTHQUAKE RECONNAISSANCE REPORT

## Damage to the Power Generation and Transmission Facilities in the Loma Prieta Earthquake of 17 October 1989

Tan Pham<sup>1</sup>

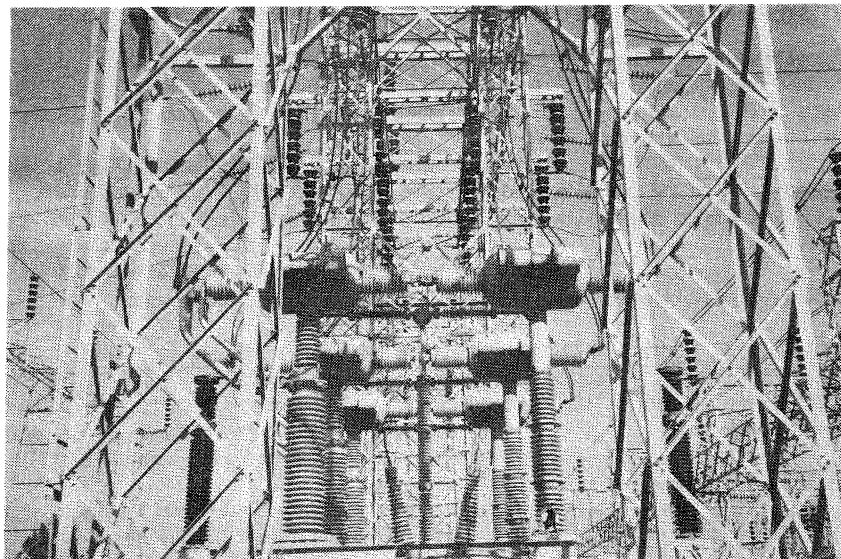
The major damage at San Mateo was to one General Electric (GE) model ATB4 and three GE model ATB4 and three GE model ATB7 live-tank 220 kV circuit breakers. The breaker support insulators were cracked at the base as shown in Figures 2 & 3, in a classic bending failure mode of a weak column supporting a heavy interrupter head at the top. These breakers were replaced with dead tank breakers (Fig.4).

Figure 2 - DAMAGED 230kV AIR BLAST CIRCUIT  
BREAKER AT SAN MATEO SUBSTATION

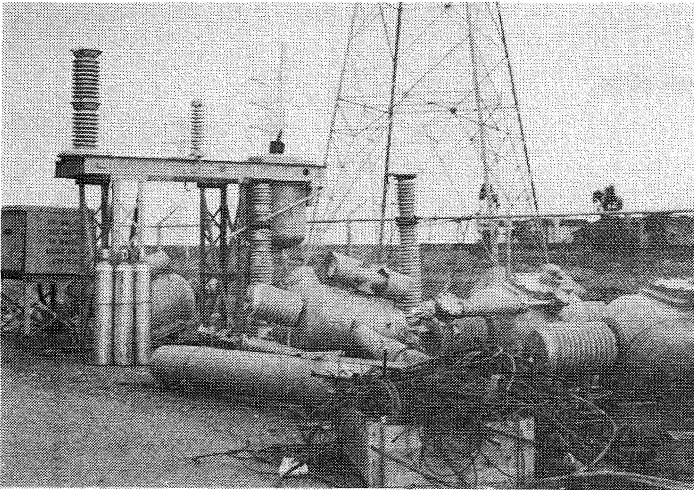
Figure 3 -  
REMAINS OF DAMAGED CIRCUIT  
BREAKER - SAN MATEO

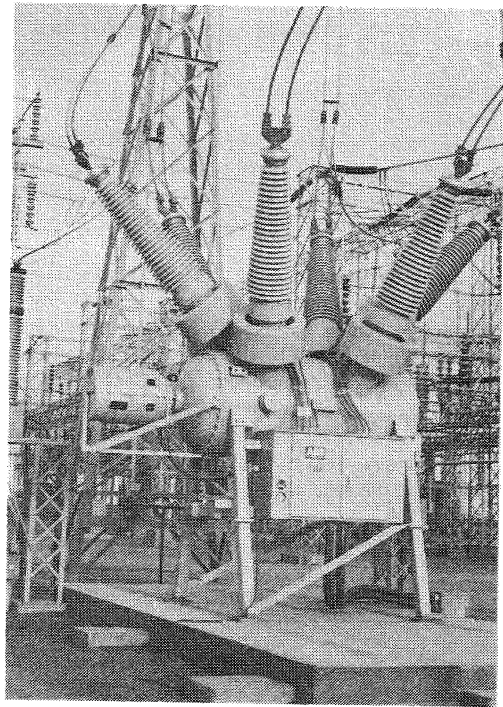
Figure 4 - DEAD-TANK 230 kV CIRCUIT BREAKER  
INSTALLED AFTER THE EARTHQUAKE,  
SAN MATEO.

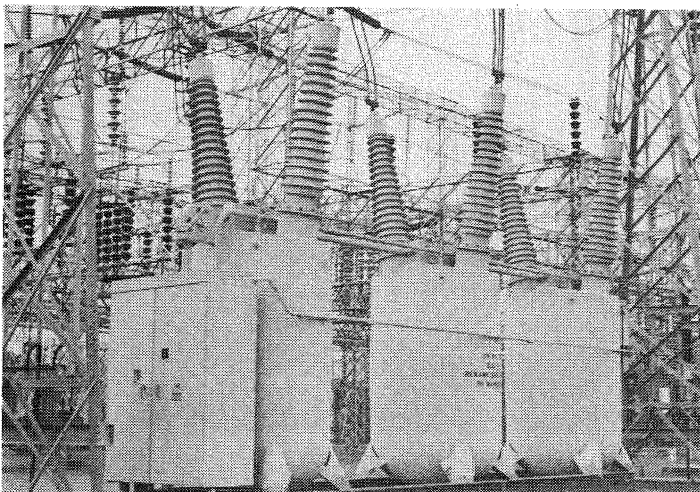
There was other minor damage as described in Ref.1. However, most items of the equipment, including 230 kV bulk oil circuit breakers (Fig.5), withstood the earthquake.

Figure 5 -  
230 kV BULK OIL CIRCUIT BREAKER DID  
NOT EXPERIENCE ANY DAMAGE -  
SAN MATEO.

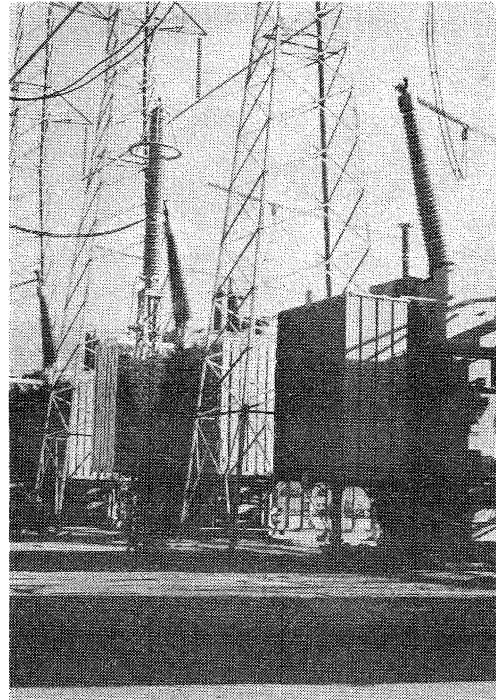
- i) A 500 kV bushing on transformer 11C shifted on its support which put it out of service (Fig.6). This transformer was replaced by the spare unit.
- ii) Severe oil leaks at the flange joining the top header of the radiator to the main tank of transformer 12C (Figures 7 & 8). This occurred as the radiators swayed during the earthquake.
- iii) Two out of seven 230 kV transformer-mounted lightning arresters associated with bank 11 cracked at the base and fell to the ground (Fig.9).

Figure 6 - THE 500 kV BUSHING ON THE RIGHT-HAND SIDE OF THE PHOTOGRAPH WAS REPLACED AFTER THE EARTHQUAKE - METCALF.

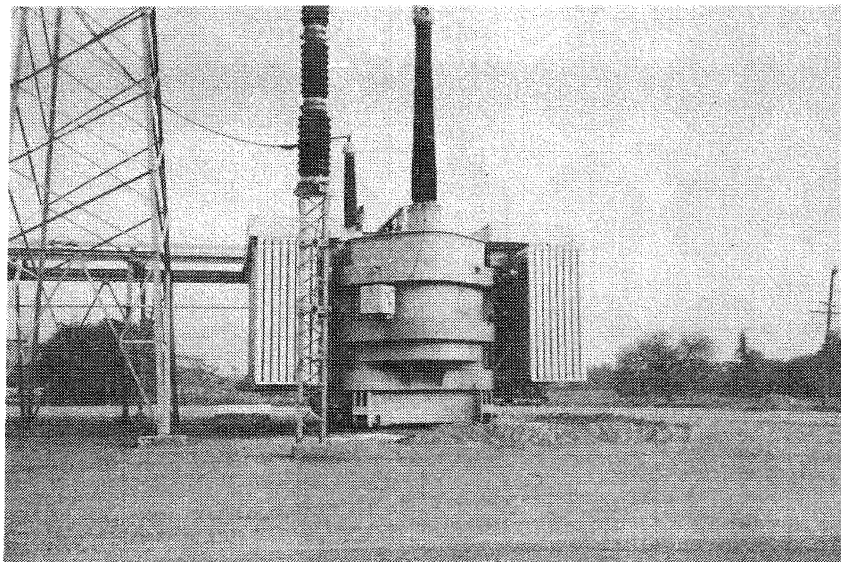
Figure 7 - TRANSFORMER 12C (BANK 12, C PHASE) LOST OIL DURING THE EARTHQUAKE - METCALF.

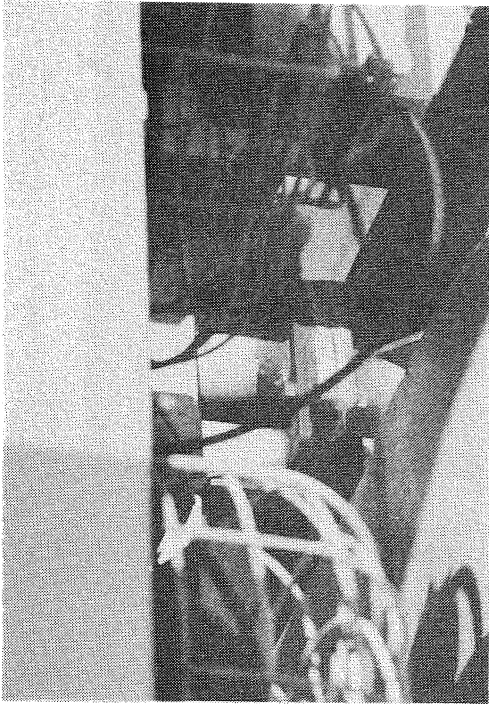
Figure 8 - A CLOSE-UP VIEW OF THE JOINT WHERE THE OIL WAS LEAKED DURING THE EARTHQUAKE - METCALF.

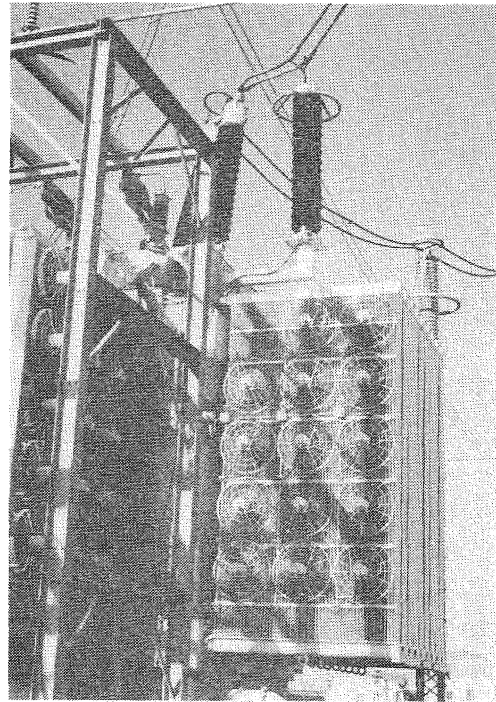
Figure 9 - 230 kV SURGE ARRESTER SUCH AS THIS ON BANK 11 WAS DAMAGED - METCALF.

They were replaced by the units from Bank 12.

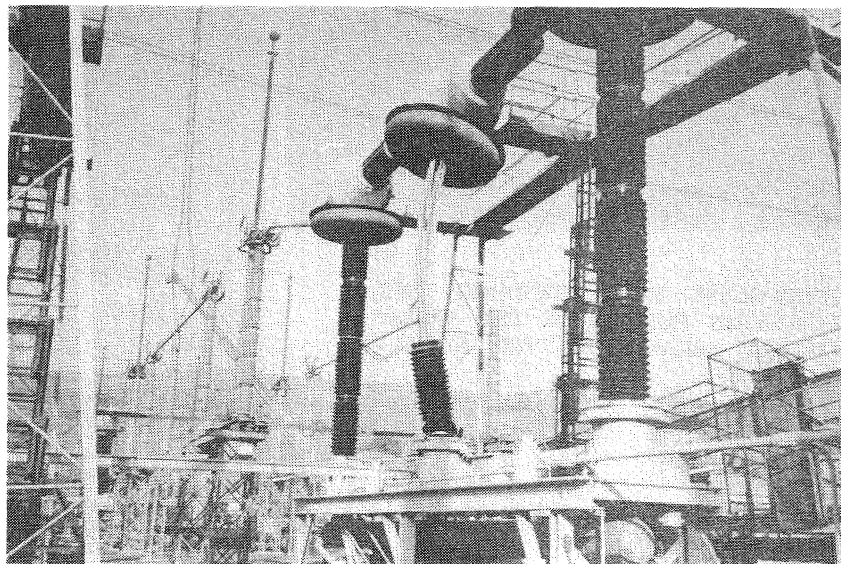
All three of the air blast WE circuit breakers were damaged at the base as shown in Figures 10 & 11. The hold down clamps also failed and allowed the circuit breakers to shift up to 250 mm horizontally (Fig.11).

Figure 10 - DAMAGED 500 kV CIRCUIT BREAKER - METCALF.

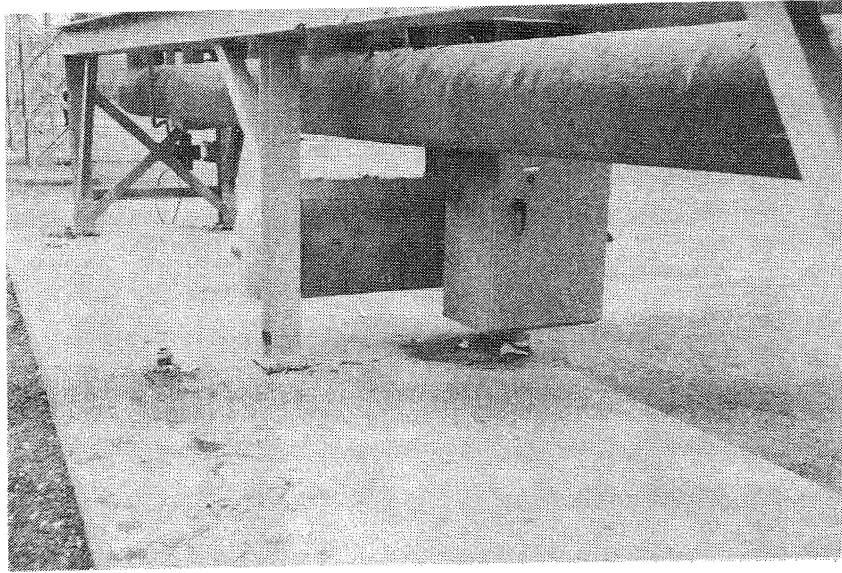
Figure 11 - THE FAILURE OF THE HD BOLT CAUSED THE SUPPORT STAND OF THE 500 kV CIRCUIT BREAKER TO BE SHIFTED. SEE ALSO FIGURE 15 - METCALF.

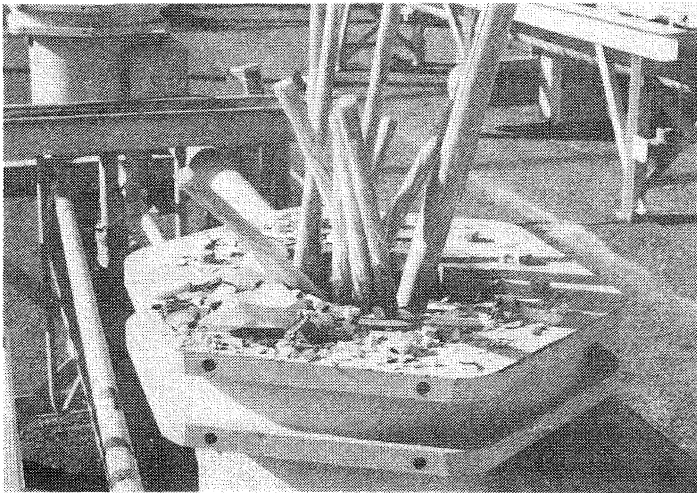
There were three columns per circuit breaker. Each consisted of four porcelain cylinders, stacked on top of each other, separated by rubber gaskets (1) and an interrupter head at the top. The whole assembly was held together and secured to the support base by post-tensioned fibreglass rods. These rods replaced the original wooden rods as an attempt to strengthen the circuit breakers (Fig.12). Unfortunately, this did not prevent the porcelain bushing from extensive cracking despite the fact that the rods were not damaged.

Figure 12 - FIBRE-GLASS RODS SECURING THE PORCELAIN COLUMN OF THE 500 kV CIRCUIT BREAKER TO THE BASE - METCALF.

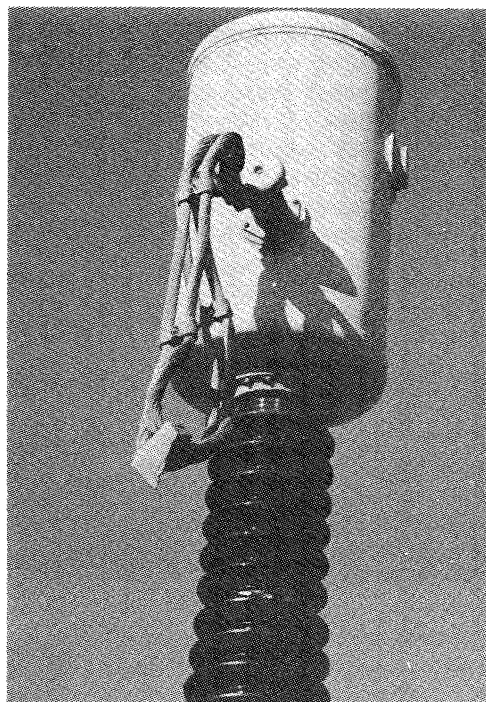
There were nine Westinghouse's HDR-2138 ACT 1800 CT's associated with the three circuit breakers. Most suffered oil leaks. Between 757 and 1135 litres (200 and 300 gallons) of oil were lost per unit. A few were damaged as shown in Fig.13. These CT's were very old and did not meet PG&E's present seismic design requirements.

Figure 14 - A CLOSE-UP VIEW OF THE DAMAGED 500 kV CURRENT TRANSFORMER - METCALF.

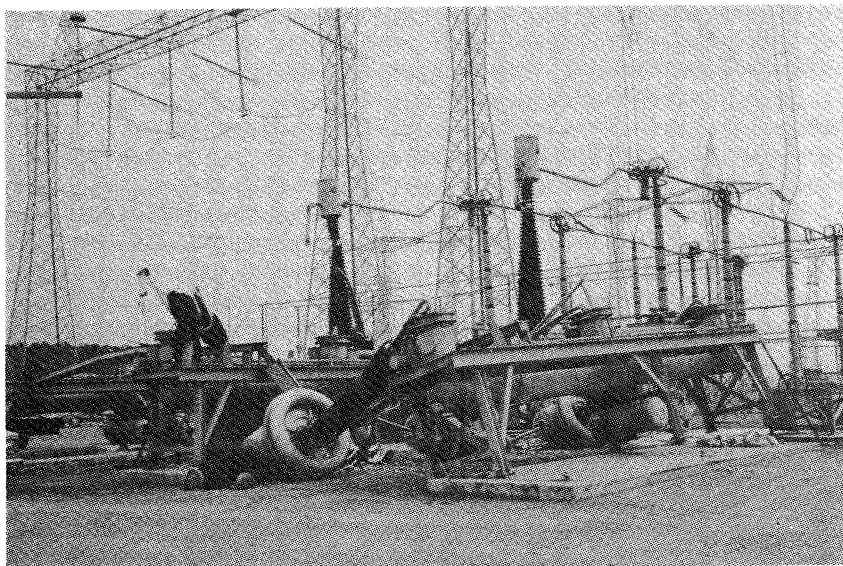
Figure 15 - DAMAGED 500 kV CIRCUIT BREAKER - METCALF.

There were five 500 kV circuit breakers at the site. Four of those, which were similar to those at Metcalf substation, suffered extensive damage. The damage included failure to holding down bolts and failure of support columns as shown in Figures 15 & 16. The fifth one, a modern dead-tank circuit breaker, similar to that in Fig. 13, survived the earthquake.

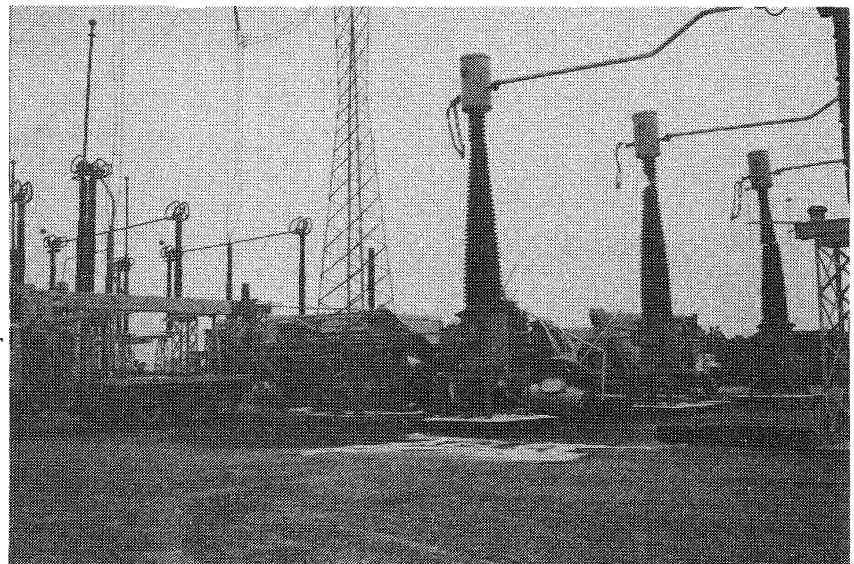
Figure 17 -

Ten out of twelve CT's (similar to those at Metcalf substation) suffered damage (Figures 16 & 17).

DAMAGED 500 kV CURRENT  
TRANSFORMERS - MOSS LANDING.

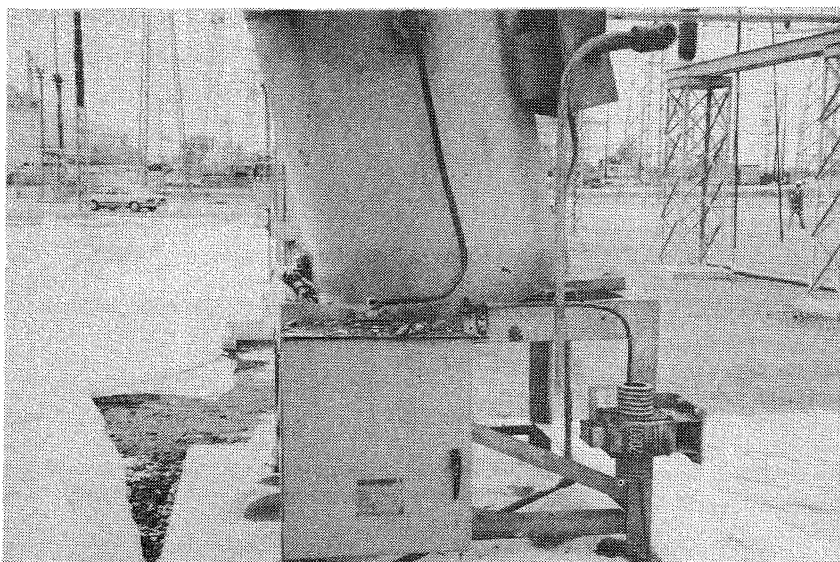
Figure 18 -

DAMAGE TO 500 kV CURRENT  
TRANSFORMER SUPPORT STAND -  
MOSS LANDING.

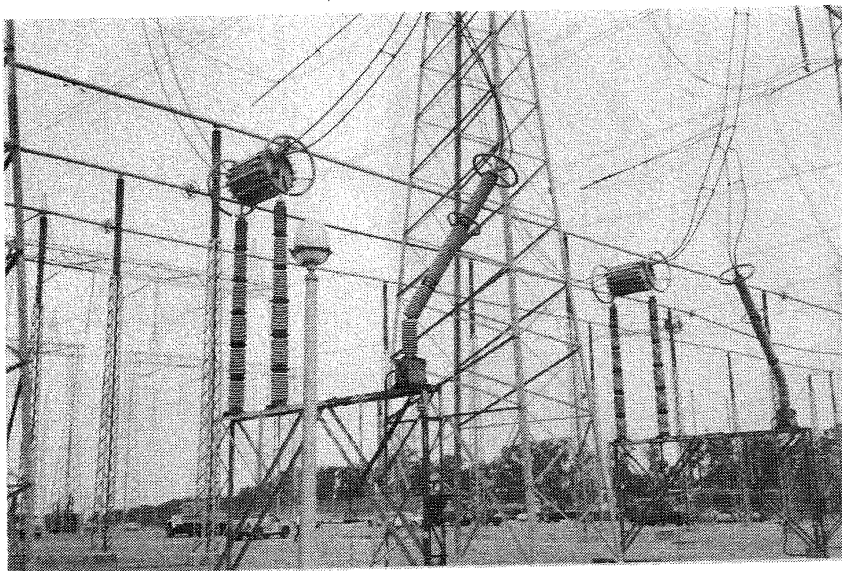
One line trap out of four and all four CCVT's associated with the linetraps failed when the support porcelain bushings broke at their base (Fig. 19).

Figure 19 -  
DAMAGED CCVT - MOSS LANDING.

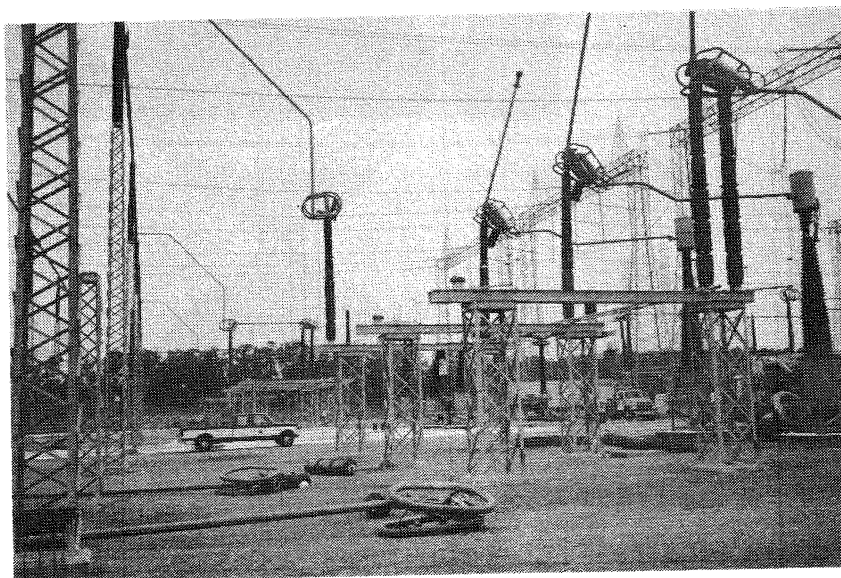
Out of a total of 14 three-phase disconnecter switches units, 12 (three-phase units) were damaged. (Figures 20 & 21).

The two three-phase units connected to the surviving dead-tank circuit breaker did not experience any damage. This suggested the damaged units were pulled down by the damaged CT's and circuit breakers connected to them.

Figure 20 - DAMAGED 500 kV DISCONNECTOR SWITCHES. NOTE THAT NOT ALL SUPPORT INSULATORS WERE BROKEN - MOSS LANDING.

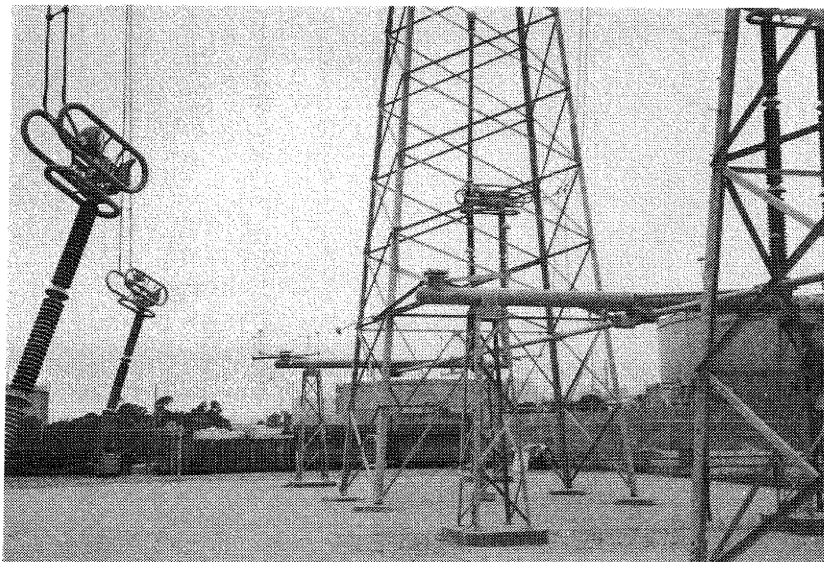
Figure 21 -

DAMAGED 500 kV DISCONNECTOR SWITCHES - MOSS LANDING.

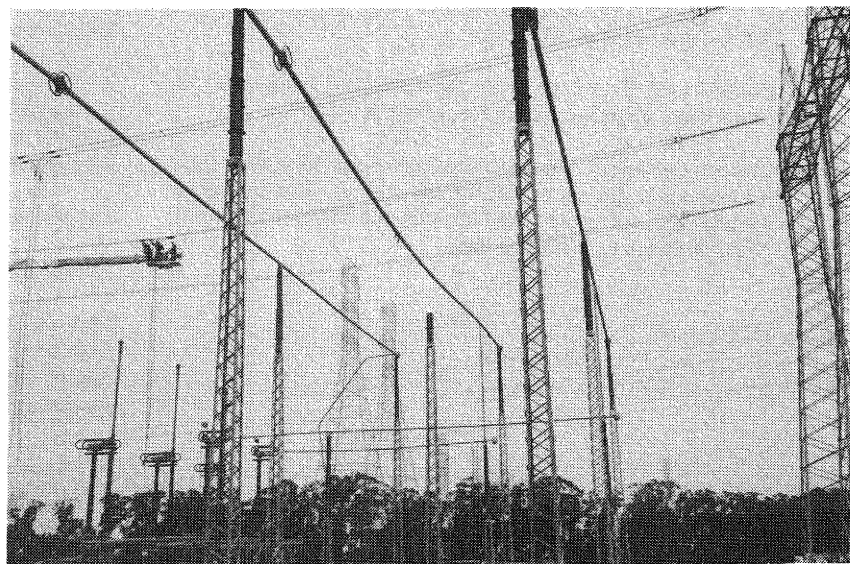
Figure 22 -

A long span of the 500 kV aluminum busbar came down during the earthquake (Fig. 22). This took place because the support insulator broke at the base and the fitting attaching the bus to the top of the insulator also failed.

DAMAGED 500 kV BUSWORK - MOSS LANDING.

The buswork was repaired within two days.

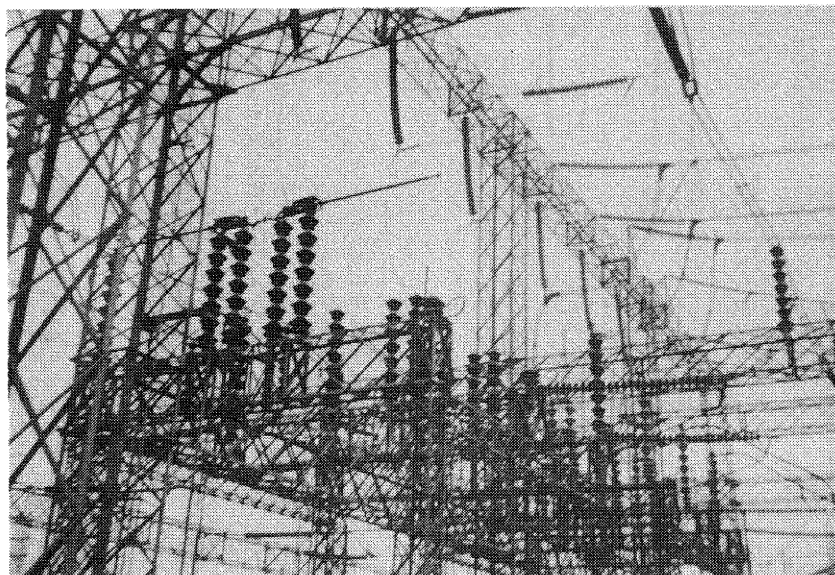
Figure 23 -

Most of 230 kV disconnecter switches supported on gantries were found to be misaligned after the earthquake. On one bay (out of 10), a few disconnecter switches were damaged. The support porcelain broke at the base (Figures 23 & 24).

DAMAGED 230 kV DISCONNECTOR SWITCHES - MOSS LANDING.

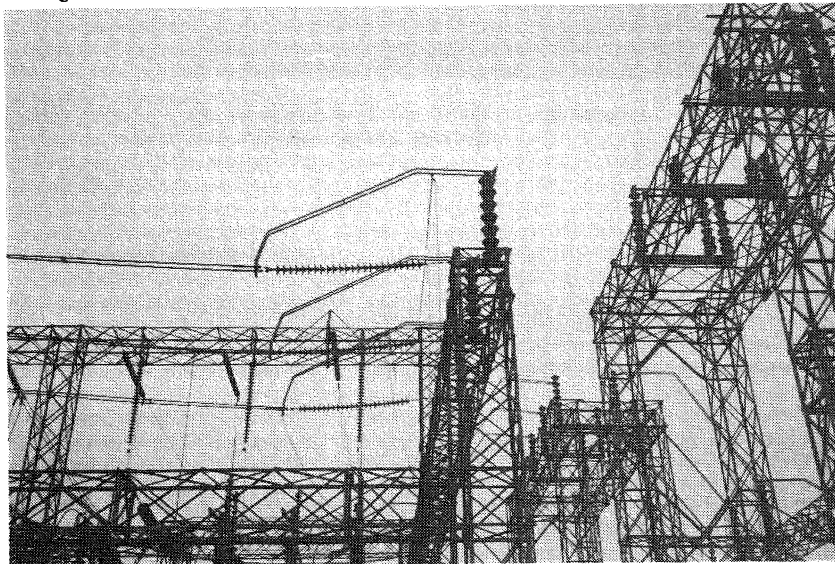
Figure 24 - DAMAGED 230 kV DISCONNECTOR SWITCHES - MOSS LANDING.

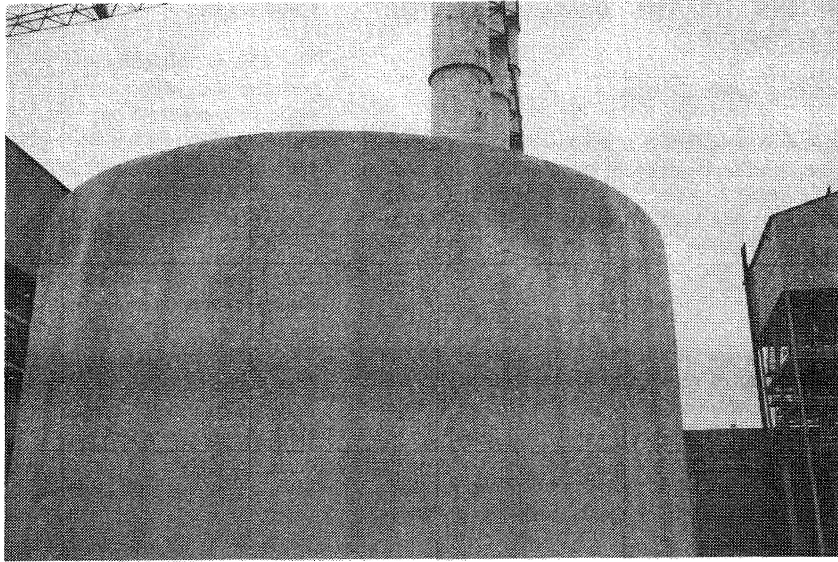
One 1,135,500 litres (300,000 gallon) tank of approximately 16 m in diameter and 12 m high, fabricated from steel plates, was badly damaged. The damage occurred at the base, which was corroded, and allowed water to escape. This created a drop in pressure inside the tank and caused the tank plate to buckle (Figures 24 & 25). The internal roof structure was also damaged.

In itself, the damage of this free-standing tank was not serious. However, as it stored water for fire fighting, the consequence of its damage would have been much more serious if fire had broken out at the site.

Figure 25 - DAMAGED WATER TANK - MOSS LANDING.

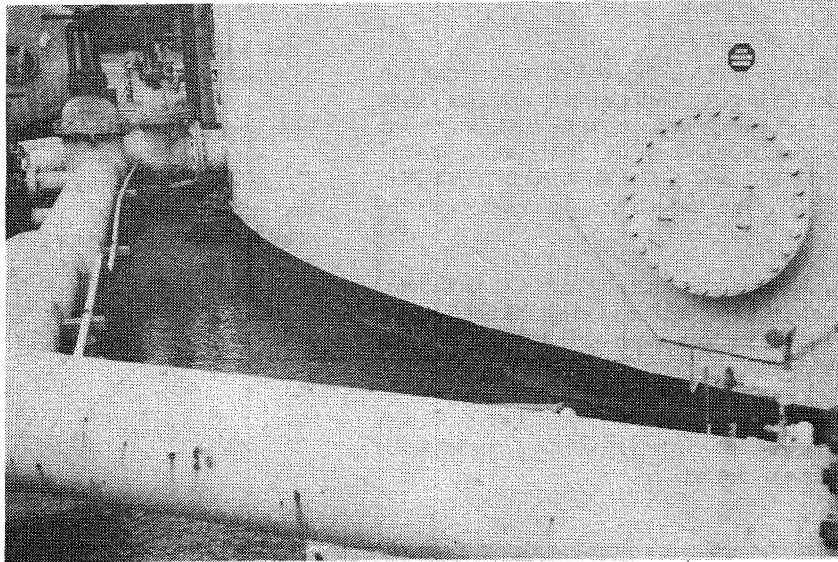
Figure 26 - VIEW OF THE BASE OF THE DAMAGED WATER TANK - MOSS LANDING.
