STRUCTURAL DAMAGE ASPECTS OF THE APRIL 22, 1991 COSTA RICA EARTHQUAKE

M. J. Nigel Priestley¹

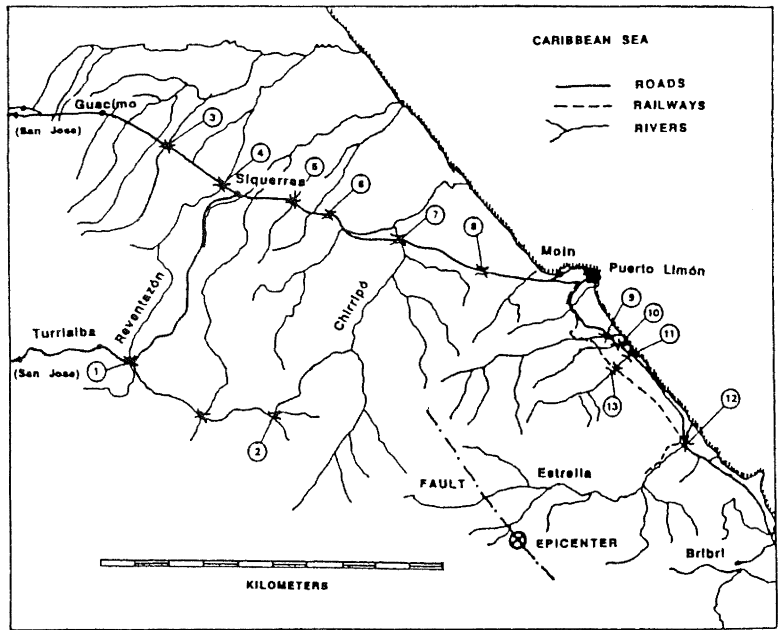
FIGURE 1: Location of Epicentre and Sites of Damage.

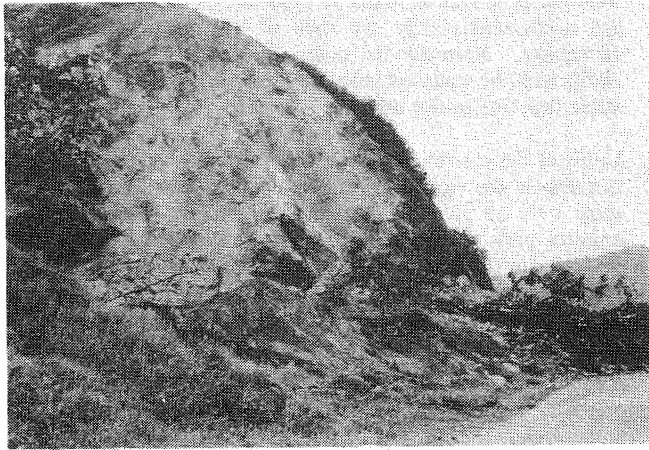
FIGURE 2: Landslide Near Epicentral Region.

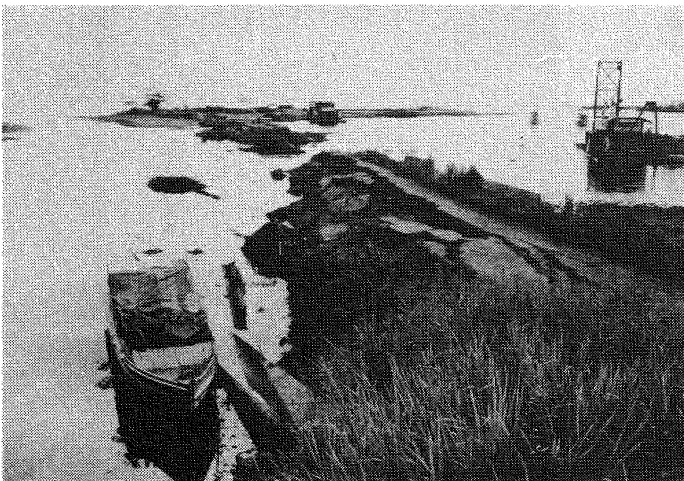
FIGURE 6: Dike Destroyed by Outflow of Water from Tortuegas Canel, Following Upsurge into Canel.

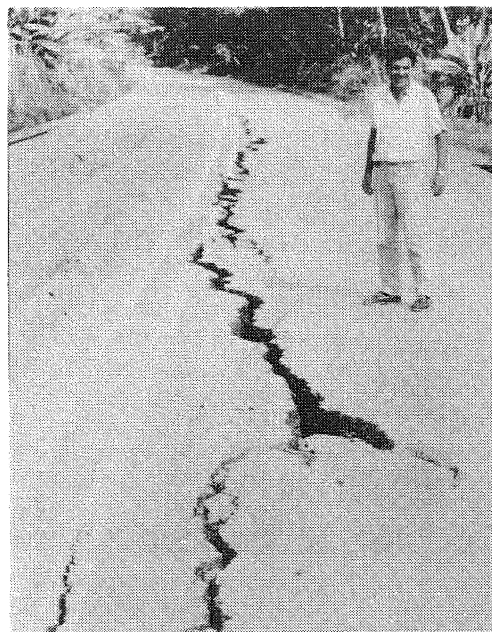
FIGURE 7: Typical Road Damage North of Limón, Caused by Abutment Spreading.

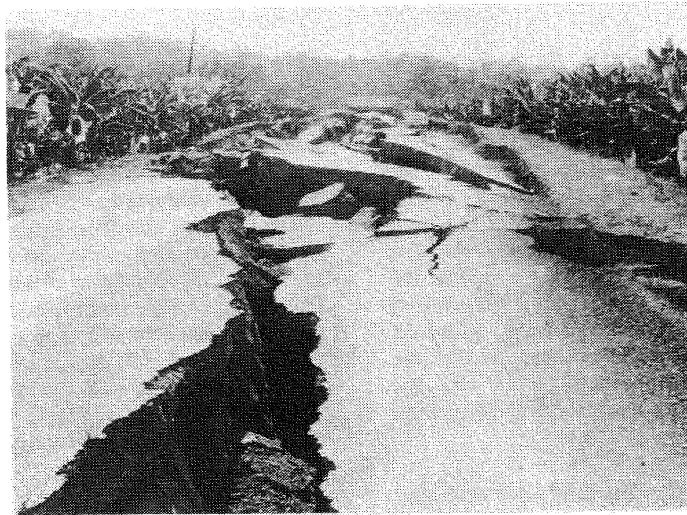
FIGURE 8: Extreme Damage to Embankment Approach to Rio Estrella Bridge.

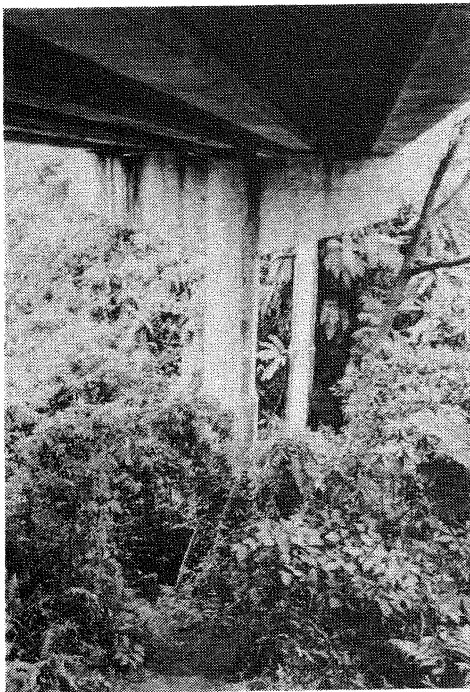
← (a) Structural Form: Simply Supported Precast I-Beams.

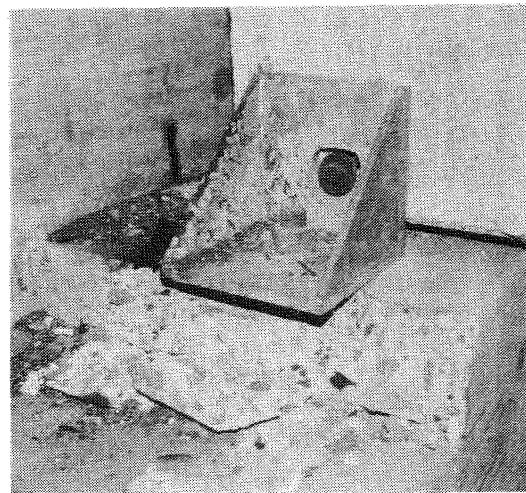
(b) Spalling of Abutment Support Block from Transverse Response.

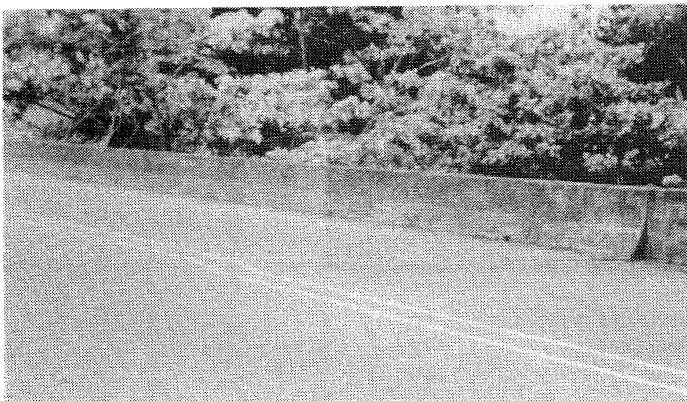
← (c) Abutment Fill Settlement.

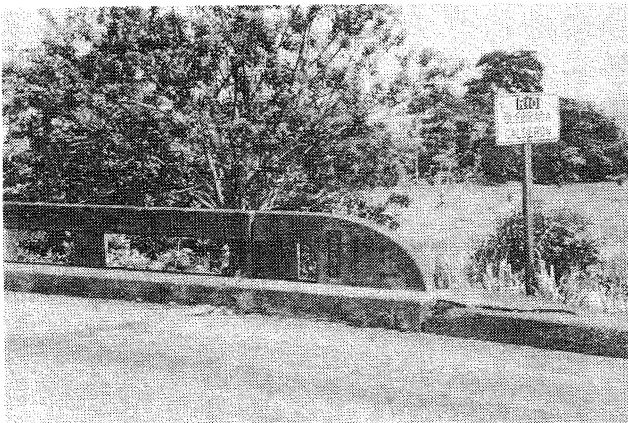
(a) Rio Quebrada Calderon Abutment Slumping (300 m). Note effectiveness of settlement slab, but damage to curb.

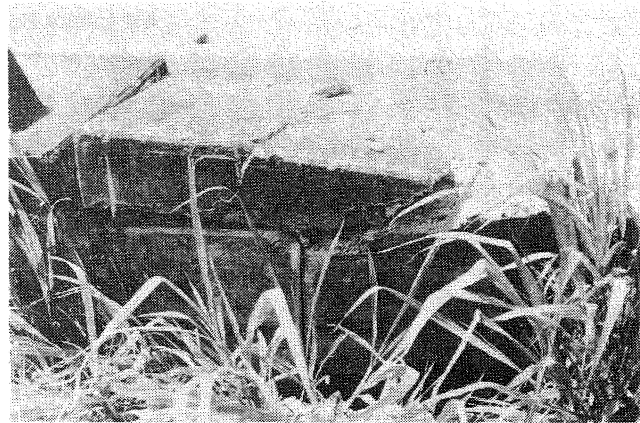
(b) Detail of above. Curb is integral with settlement slab but supported on abutment wing wall, causing failure when slab settles.

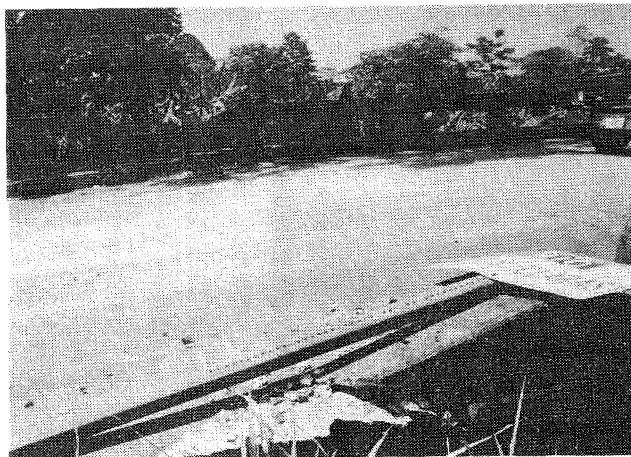
(c) Rio Aguas Claras. Same detail as above, with the same consequence.

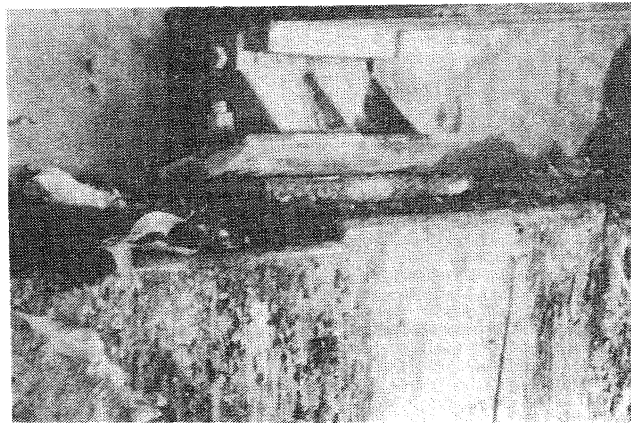
(c) Rotation of pier away from fallen end span, shown by rocker support rotation.

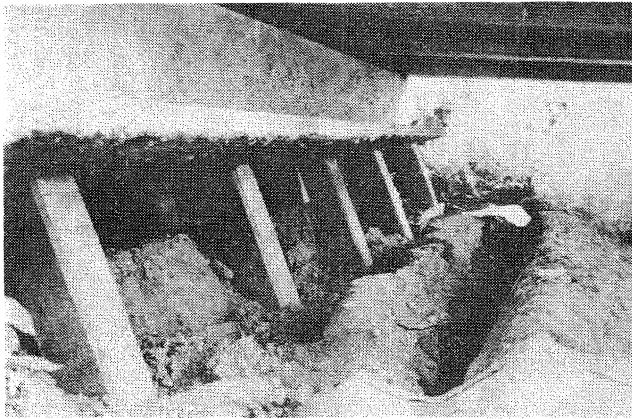
(a) Abutment rotation and foundation material slumping. Lack of damage to piles indicates the base of these have moved with the soil.

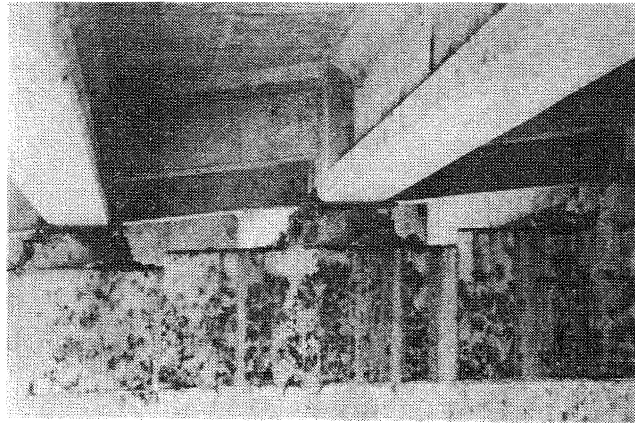
(b) Girder Seat Damage at Interior Pier.

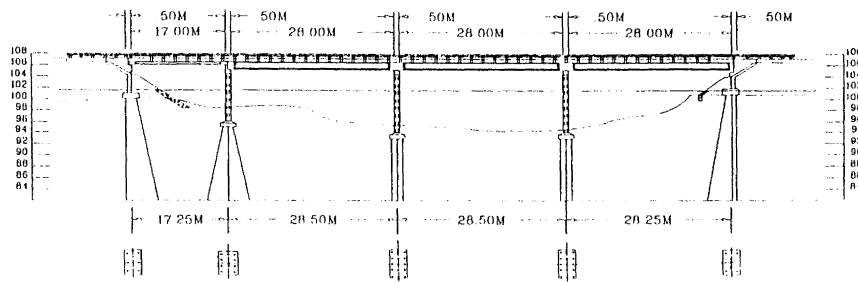
(a) General Dimensions of Bridge⁽¹⁾.

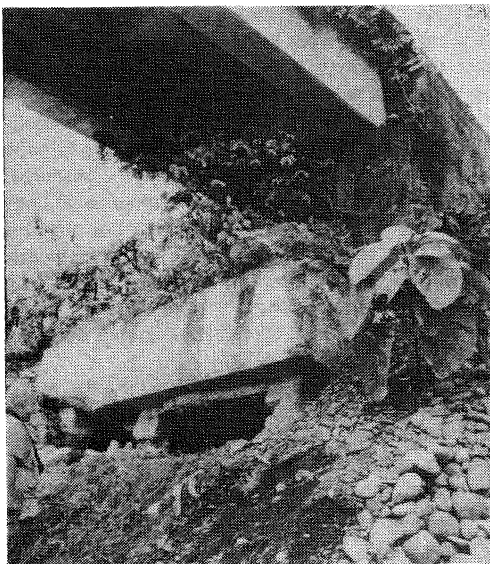
(d) Settlement and Pier Damage.

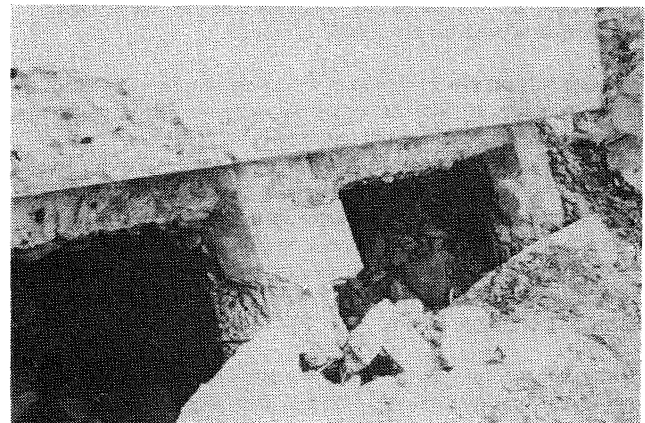
(e) Pile Failure (front raked piles were more heavily damaged than rear vertical piles).

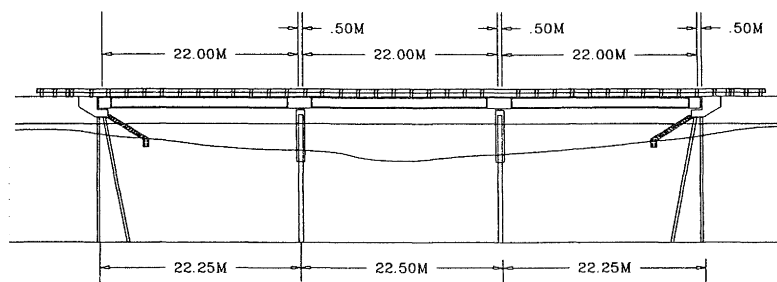
(a) General Dimensions⁽¹⁾.

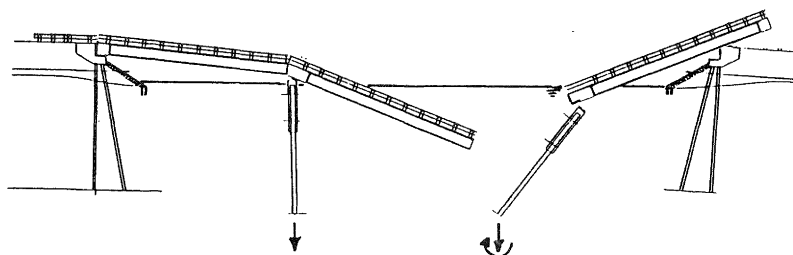
(b) Inferred Failure Mode.

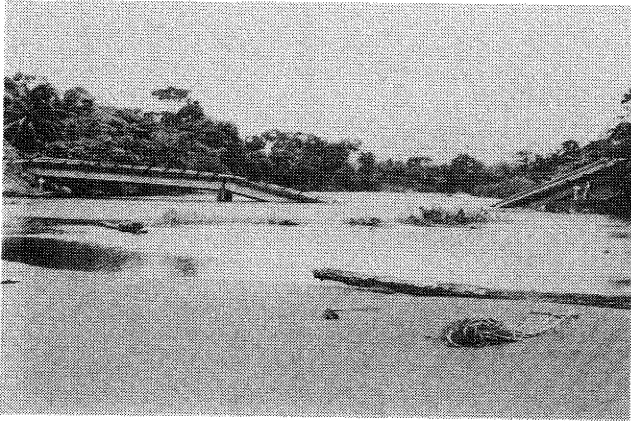
Two hotels in Limón were extensively damaged: the Hotel International in downtown Puerto Limón, and the Hotel Las Olas, some 4 km north on the road to Puerto Moin. Both were reinforced concrete frame structures reputedly designed by the same engineer in about 1971 for the Hotel International, and 1976 for the Hotel Las Olas.

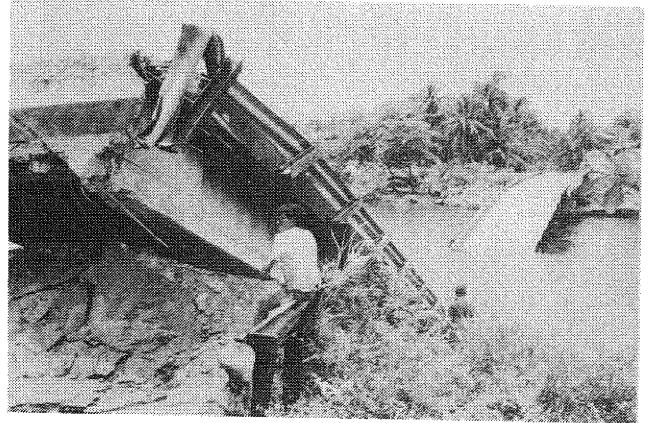
(b) General View showing North Abutment Damage.

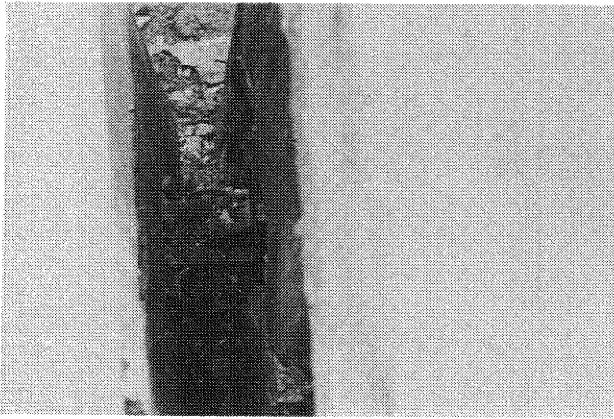
(c) Detail of Linkage Restrainer Connecting Spans over Pier 2.

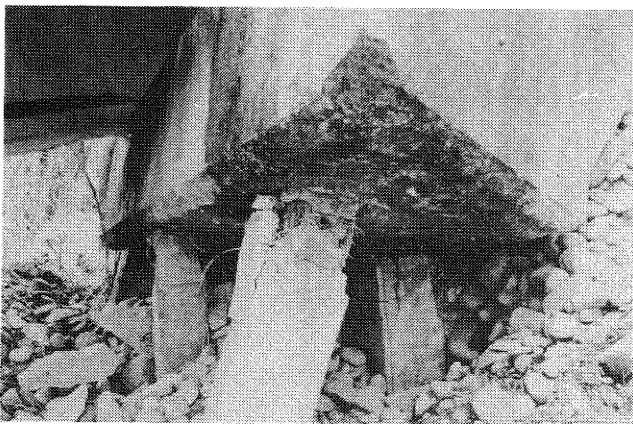
(e) Rotation of North Abutment and Pier Failure. Note compression failure of rear pile.

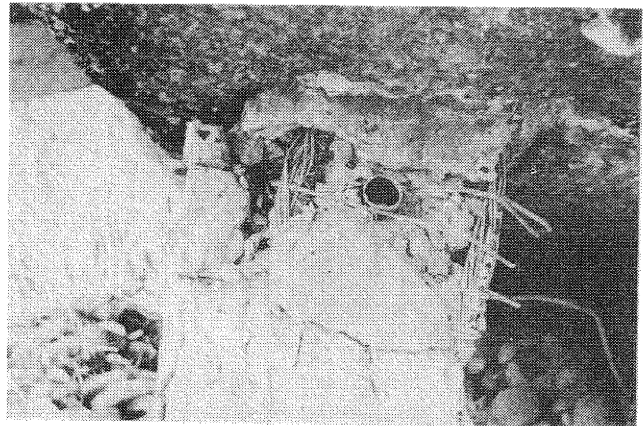
(f) Detail of Pile Flexural Failure. Note poor detailing transverse reinforcement.

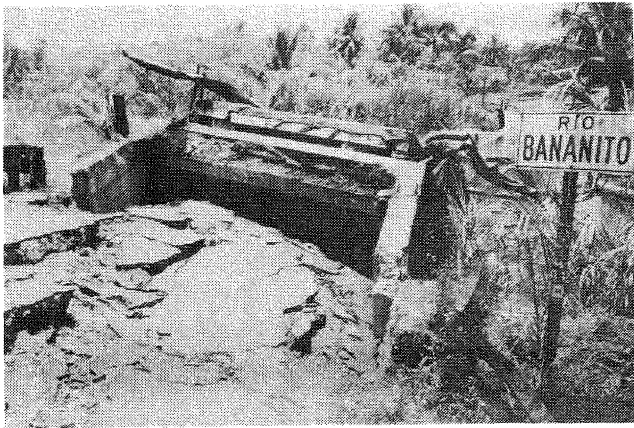
(a) Abutment Slumping and Rotation.

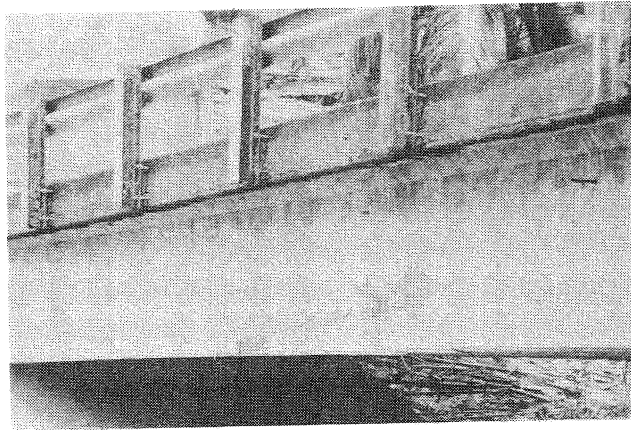
(c) Compression - Shear Failure of I-Girder.

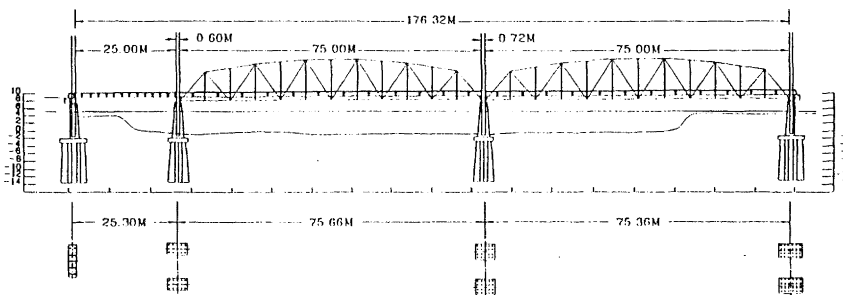
(a) General Dimensions.

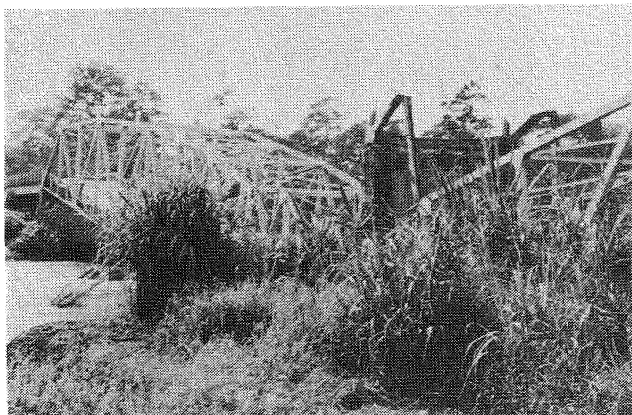
(a) General View from South-West.

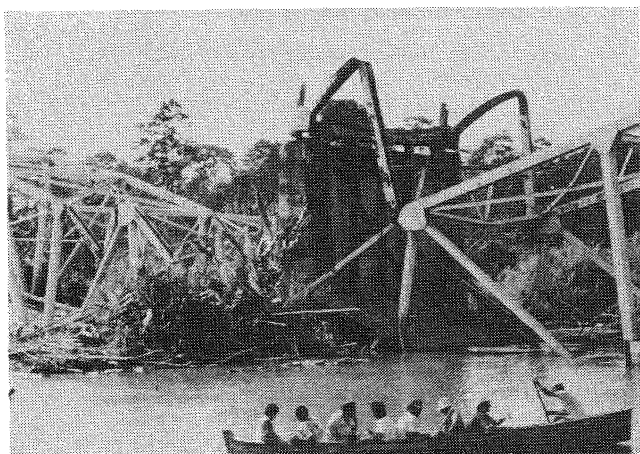
(c) Failure at Central Pier, Viewed from South-West. Note failure of bottom tension chords.

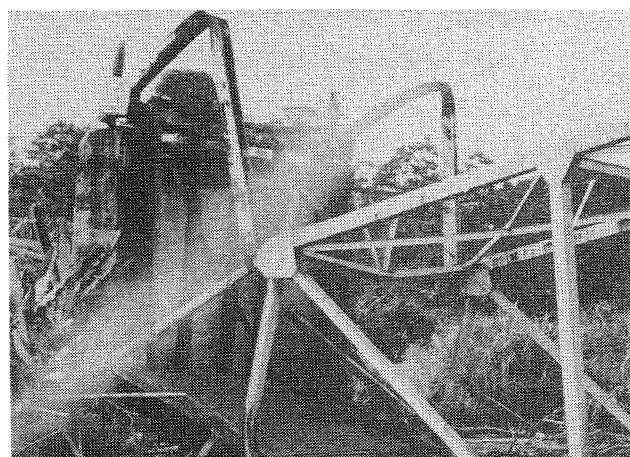
(d) Detail of South Span Collapse.

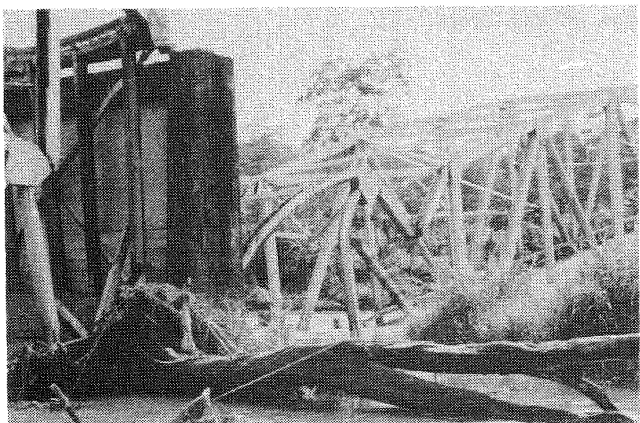
(e) North Span Failure - Damage to truss apparently caused by impact after unseating.

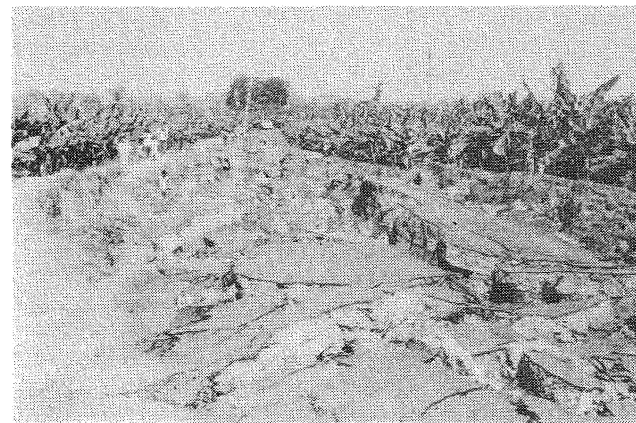
(f) Road Embankment Damage at Rio Estrella Bridge South Approach, looking South.

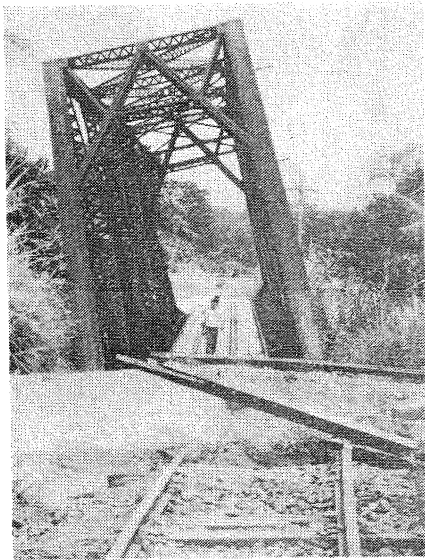
(a) Rotation of Truss to the West.

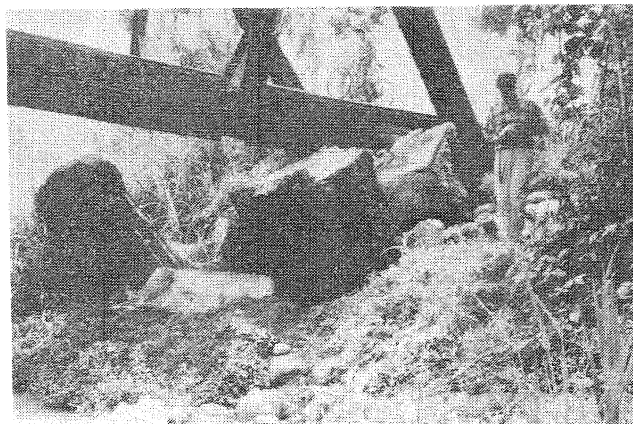
(c) Caissons Rotated Towards River with Support Block Fallen off and behind. (North abutment).

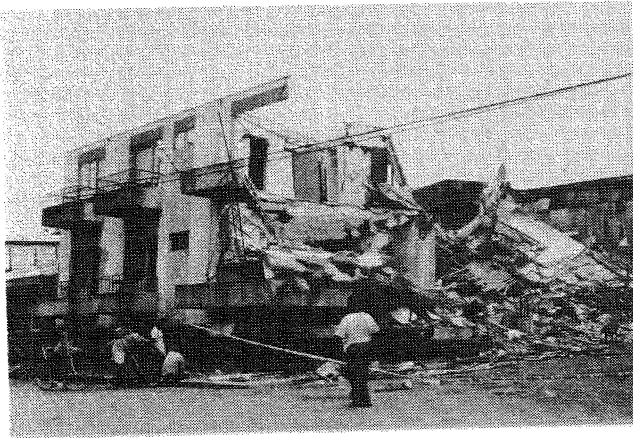
The Hotel Las Olas is a considerably larger building, four stories high, consisting of two similar, though not identical structures, each one bay transversely by about 10 bays longitudinally, linked by a central foyer/administration/stairs area of considerable structural irregularity. The wings are founded on concrete pads on the coral, which originally was underwater (hence the name 'Las Olas', which means 'the waves'. The current nickname is Las Rocas, since the uplifted coastline has exposed about 1 m of coral reef). The south wing had a lower level walkway which was not present in the north wing.

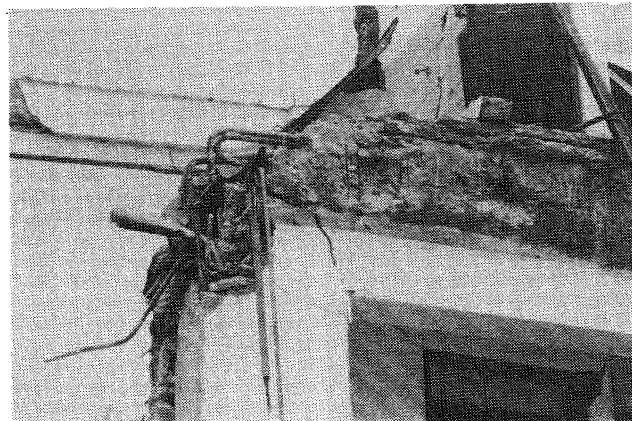
(c) Beam-column Joint Details.
Note discontinuous reinforcement at outside of joint.

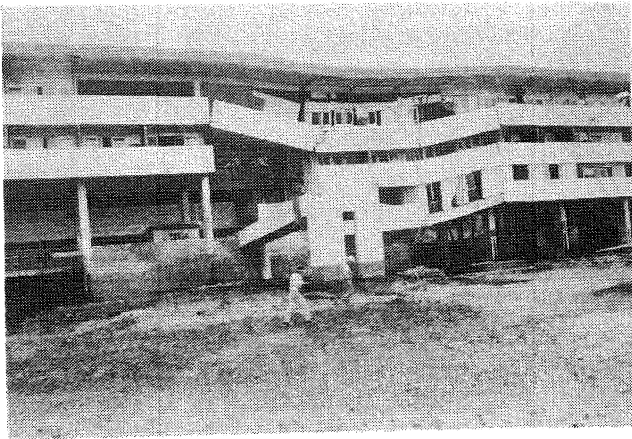
(a) View of Collapsed Portico, also showing uplifted coral reef, formerly below sea level.

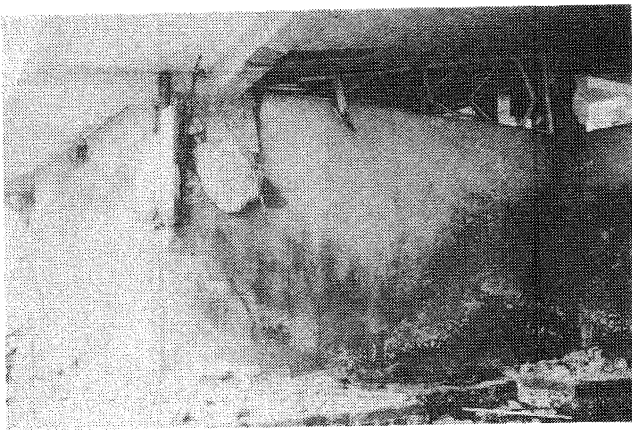
(b) Cause of Collapse - Short Columns at Centre of Building.

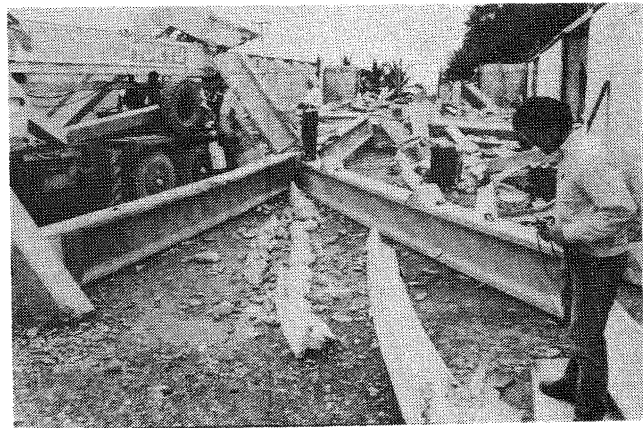
(b) Details of Collapsed Units.

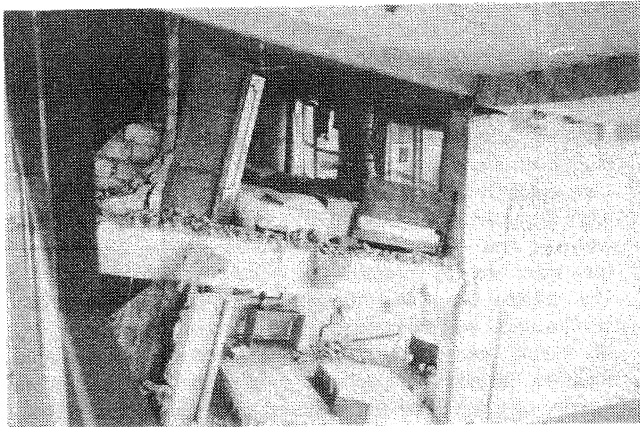
(c) Failure of Masonry Infill Walls.

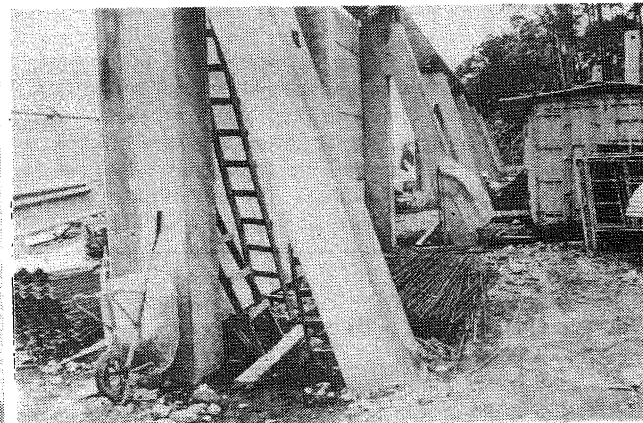
(c) Precast Wall Supports.

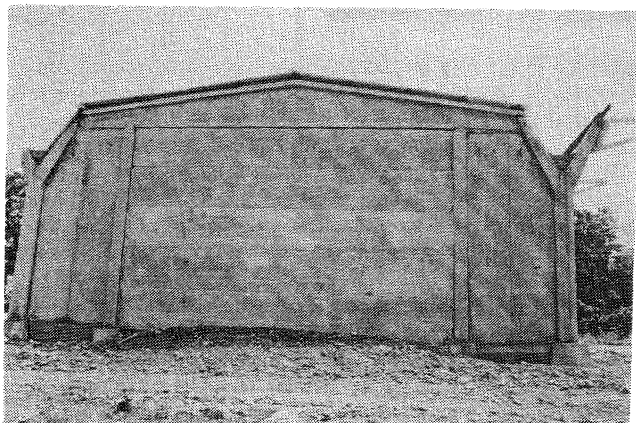
FIGURE 22: Precast Warehouse at Moin. Under construction at time of earthquake.

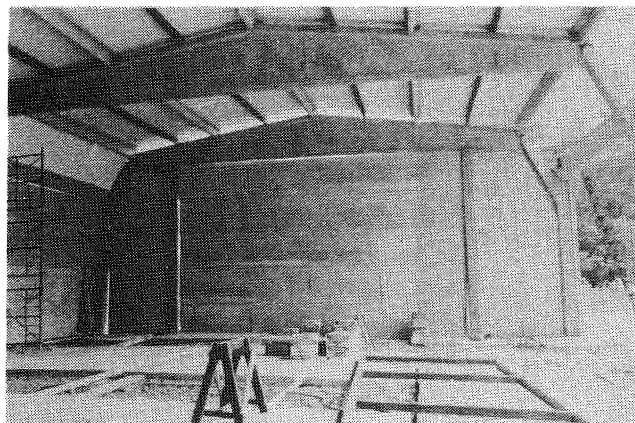
(b) Interior View. Note spreading at foundation level.

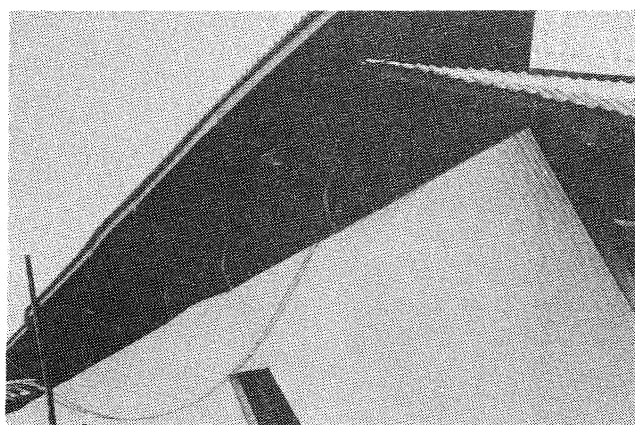
(b) Buckling of Exterior Steel columns.

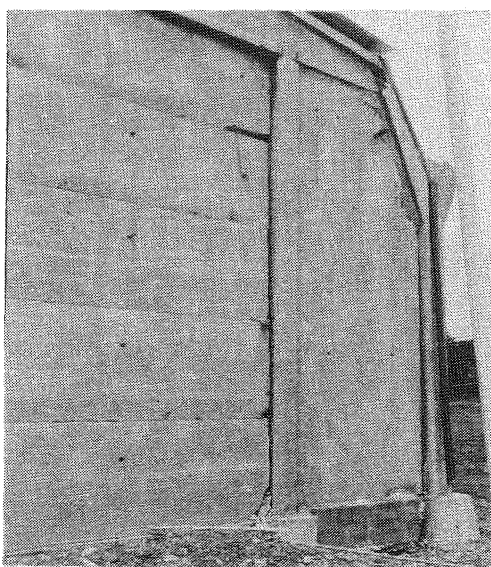
(c) Shear Failure of Precast End Panels.

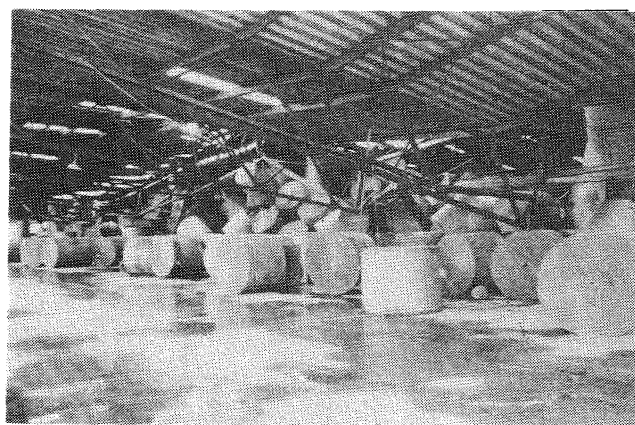
(c) Collapsed Paper Roll Stock Caused Collapse of Internal Columns.

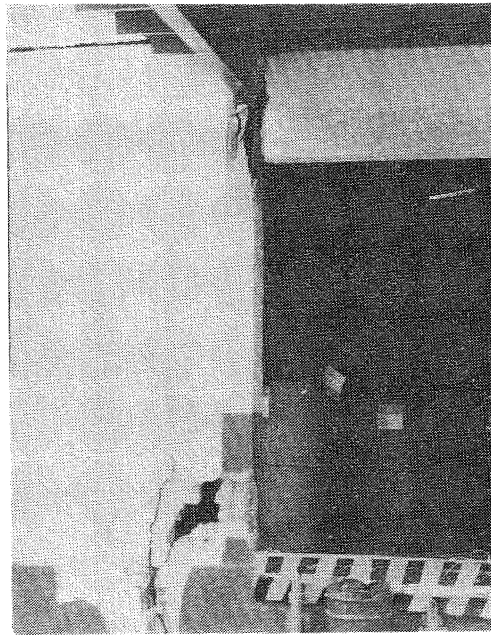
(a) Non Load-Bearing End Wall with Loading Dock.

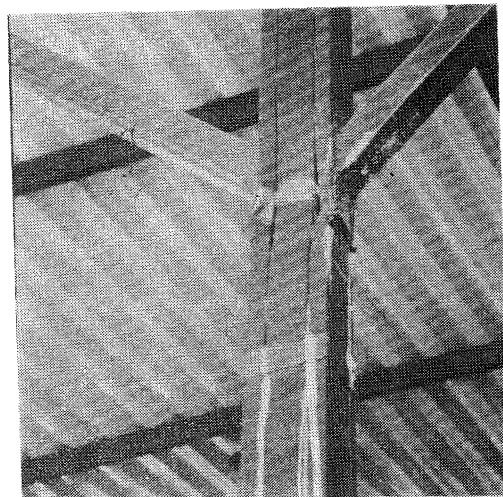
(c) Buckling of Light-Gauge Steel Columns.

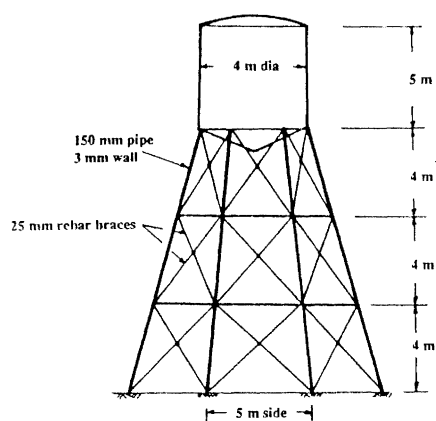
(a) Dimensions - Elevation.

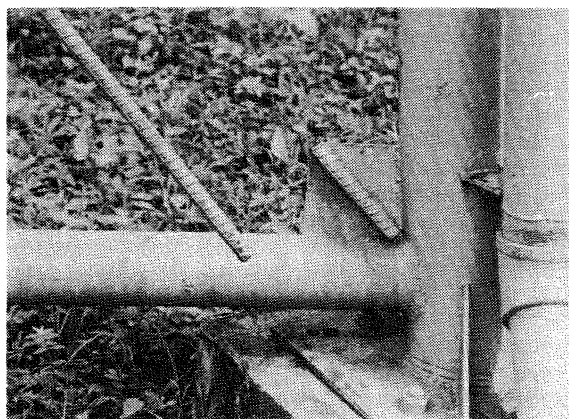
(c) Brittle Fractured Rebar Brace at Weld.

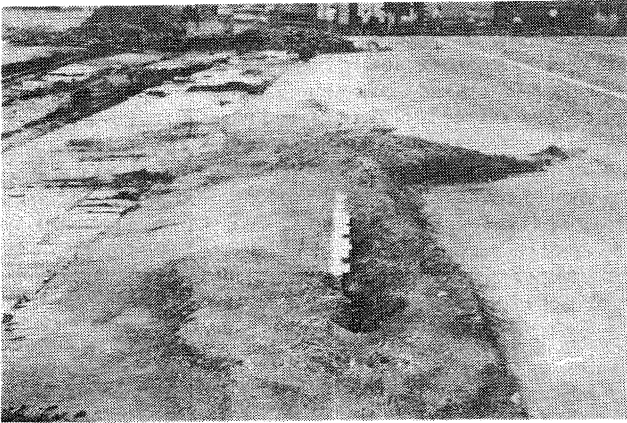
FIGURE 27: Liquefaction Damage to Muelia Alemaigne (German Wharf) - Puerto Limón.

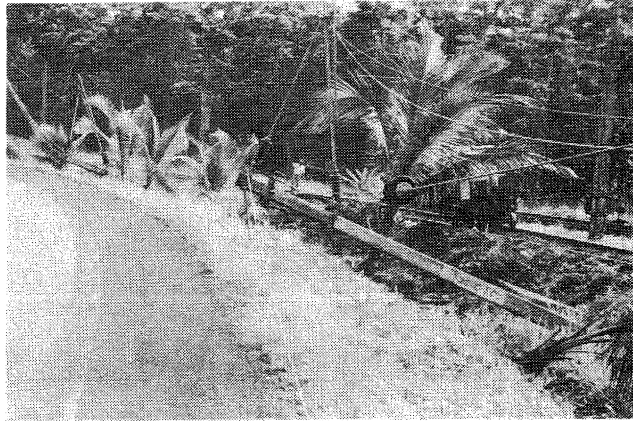
FIGURE 28: Overturned Electricity Standards by Railroad Track at Moin.

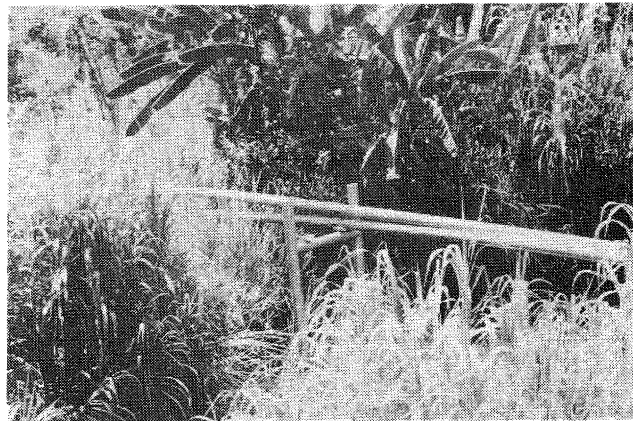
FIGURE 29: Buckling of Elevated Oil Pipeline. (Fracture would probably have happened if the pipeline had been buried).
