# GROUND PERFORMANCE IN WELLINGTON WATERFRONT AREA FOLLOWING THE 2016 KAIKŌURA EARTHQUAKE

(Submitted *March 2017*; Reviewed *April 2017*; Accepted *April 2017*)

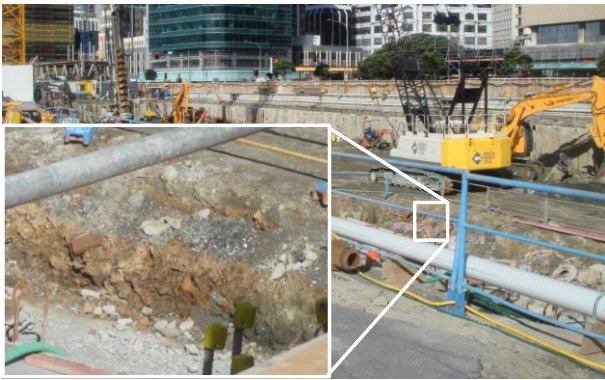
Figure 3: An excavation site at the waterfront for a building, showing the exposed gravel fill.

As a result of the reclamation work, the ground in the reclaimed sites vary from soft silts and loose sands (dredged seabed material placed hydraulically) to loose silty gravel comprising weathered greywacke rock. The depth of reclamation varies up to 17 m. Typical soil profile is illustrated in Figure 2. The reclaimed land is approximately flat with ground surface levels varying between 1 – 3 m above the mean sea level [3]. During the reconnaissance work, there was an excavation for a building being constructed in the waterfront, where the gravel fill was exposed (see Figure 3).

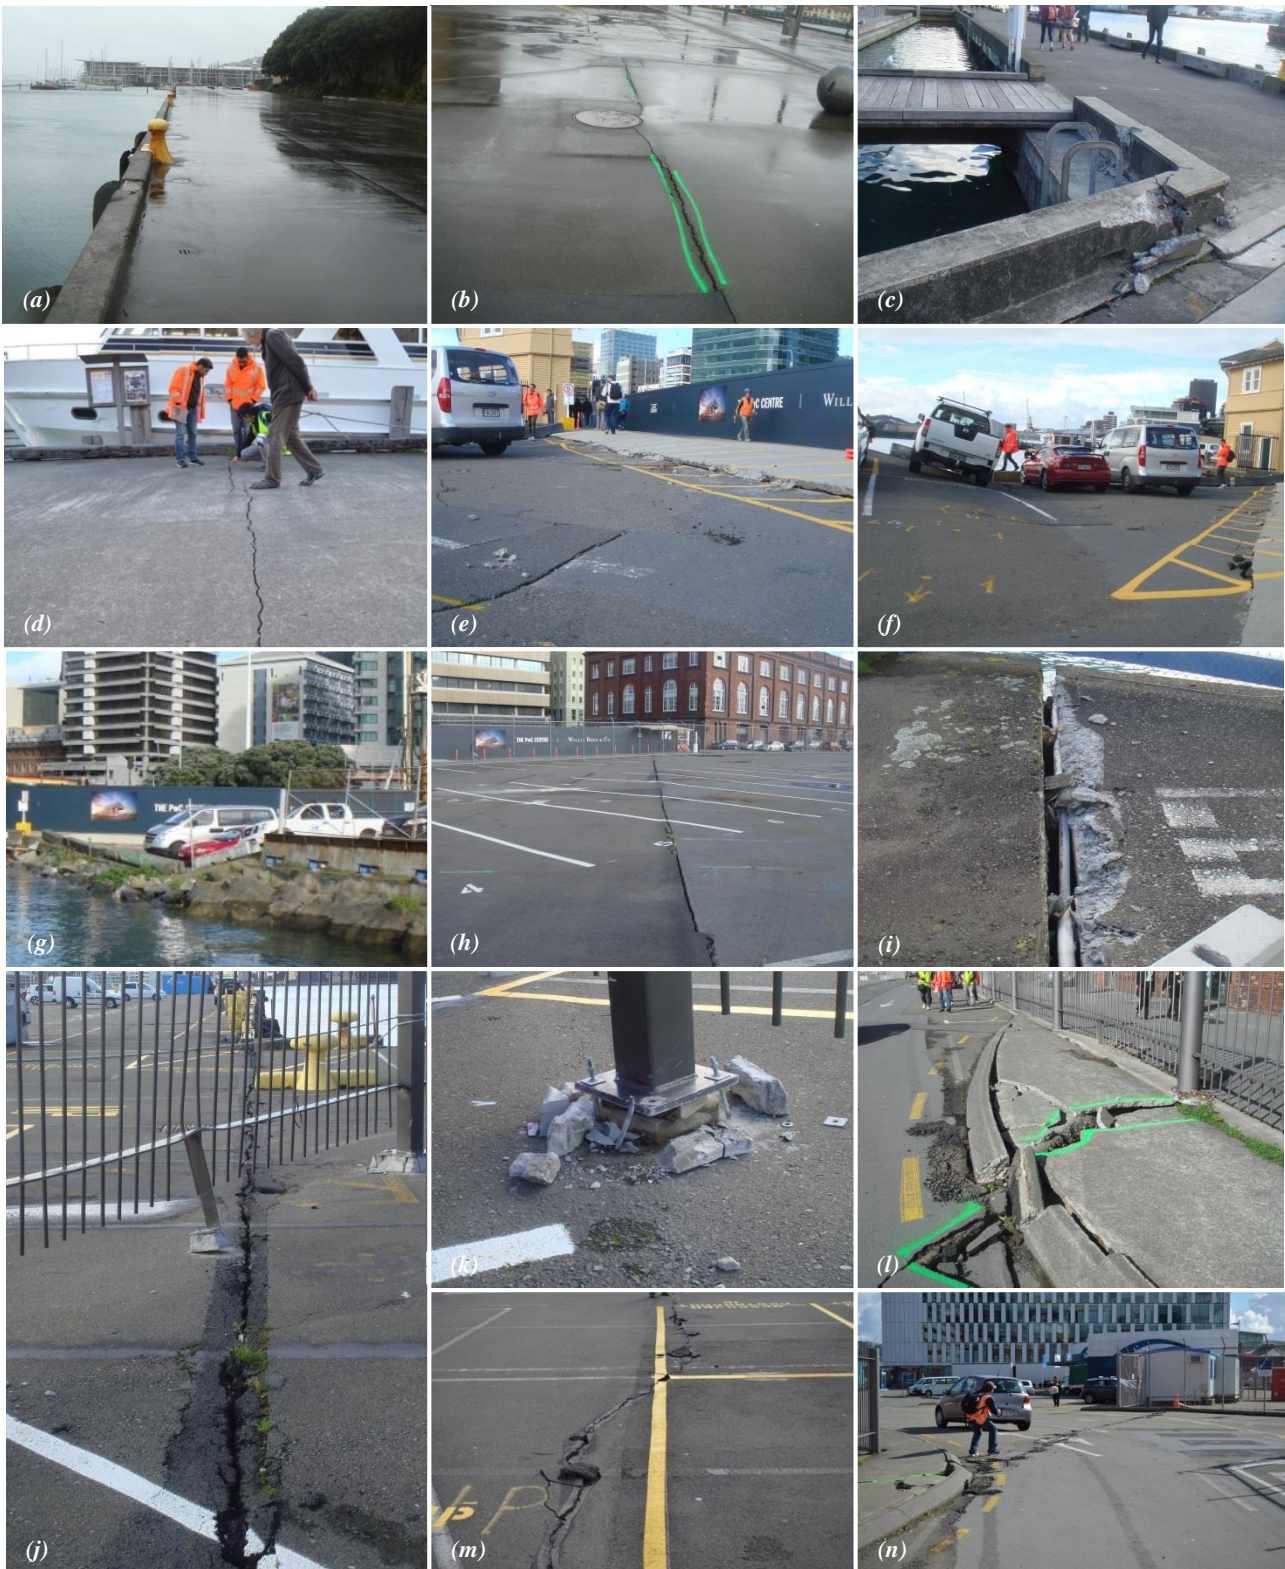
In the zone southeast of the TSB Bank Arena (designated as Zone A in Figure 6), the effect of earthquake shaking was minimal to non-existent. There was practically no damage observed in the paved areas adjacent to the sea wall, as depicted in Figure 7(a). Occasionally, minor cracks, about 2-5 mm wide and highlighted by spray paints, were observed in some sections, as portrayed in Figure 7(b). Unlike the occurrence of sand boils and ejected sandy/silty materials reported in Christchurch following the 2010-2011 Canterbury earthquake sequence (e.g. Orense et al. [8], Pender et al. [9]) and in Tokyo following the 2011 Great East Japan Earthquake (e.g. Orense et al. [10]), there was no manifestation of liquefaction adjacent to these cracks. Thus, it can be surmised that the damage was mainly the result of ground oscillation of the fill, although possible liquefaction-induced softening cannot be discounted. Referring to Figure 1, these zones were reclaimed in 1968; however, as discussed later, some parts of Zone A, such as the ground where the Te Papa Museum is located, have been improved to prevent liquefaction occurrence.

Going north from the TSB Bank Arena Building/Queens Wharf area (referred to as Zone B in Figure 6), earthquake-induced ground damage became more noticeable. For example, Figure 7(c) shows a concrete barrier wall protruding from the retaining structure on the walkway which cracked as a result of the ground shaking. The crack exposed the steel reinforcement. Figure 7(d) illustrates a crack, 5-8 mm wide, running perpendicular to the walkway.

A significant number of moderate damages were observed in the parking area north of the Queens Wharf. In the area adjacent to a construction site (for location, see Figure 6), the ground subsided, resulting in 50-80 mm vertical gap between the walkway and the parking area, as shown in Figure 7(e). The subsidence is more noticeable in Figure 7(f), where the right section of the photo appears to be much lower (by about half a metre) compared to the left. Closer inspection revealed that a section of the wharf underwent significant settlement, as illustrated in Figure 7(g), and the backfill also subsided. Such subsidence may be attributed to the vertical compression of the weak embankment fill, although liquefaction may have also contributed (there are no reports that this section has been stabilised).

The pavement of the parking area north of the Queens Wharf was criss-crossed by many cracks. For example, Figure 7(h) shows a very long compressional crack, possibly induced by the shaking of the ground. In Figure 7(i), a section of a wharf was laterally displaced towards the sea, resulting in 60-80 mm crack opening and exposing a pipe underneath. Similar observation was noted in a section of another wharf, described in Figure 7(j). Note however that the location of the crack has asphalt sealant, indicating that this section may have cracked before (possibly after the 2013 Cook Strait Earthquake), and

re-opened again following the ground shaking induced by the 2016 event. The intensity of ground shaking in this zone is described by the damaged foundation connection of a column supporting a fence, shown in Figure 7(k); the concrete base totally collapsed and the anchor bolts were exposed.

Proceeding north towards the Bluebridge Ferry Terminal building, which remained operational, cracks were observed on the sidewalk (Figure 7(l)); in addition, re-cracking of repaired pavement was evident, as shown in Figures 7(m) and 7(n). These cracks generally have no dominant orientation, although most of the cracks generally run parallel to the waterline.

**Figure 7: Various observations of ground condition in the waterfront area: (a) no visible damage at the back of Te Papa Museum; (b) minor crack on pavement, highlighted by spray paint; (c) broken concrete barrier on the waterfront walkway near Queens Wharf, with reinforcement exposed; (d) pavement crack perpendicular to the walkway; (e) ground settlement adjacent to construction site; (f) significant ground subsidence resulting in noticeable deformation; (g) another view of the ground subsidence in the parking area adjacent to the wharf; (h) long compressional crack on the parking area; (i) lateral movement of a section of a wharf, resulting in crack; (j) reoccurrence of crack on re-paved section of the wharf; (k) close-up view of the foundation connection failure of a fence column; (l) cracks on the sidewalk; (m) pavement crack on the parking area; and (n) crack on the parking area adjacent to the Bluebridge Ferry Terminal.**

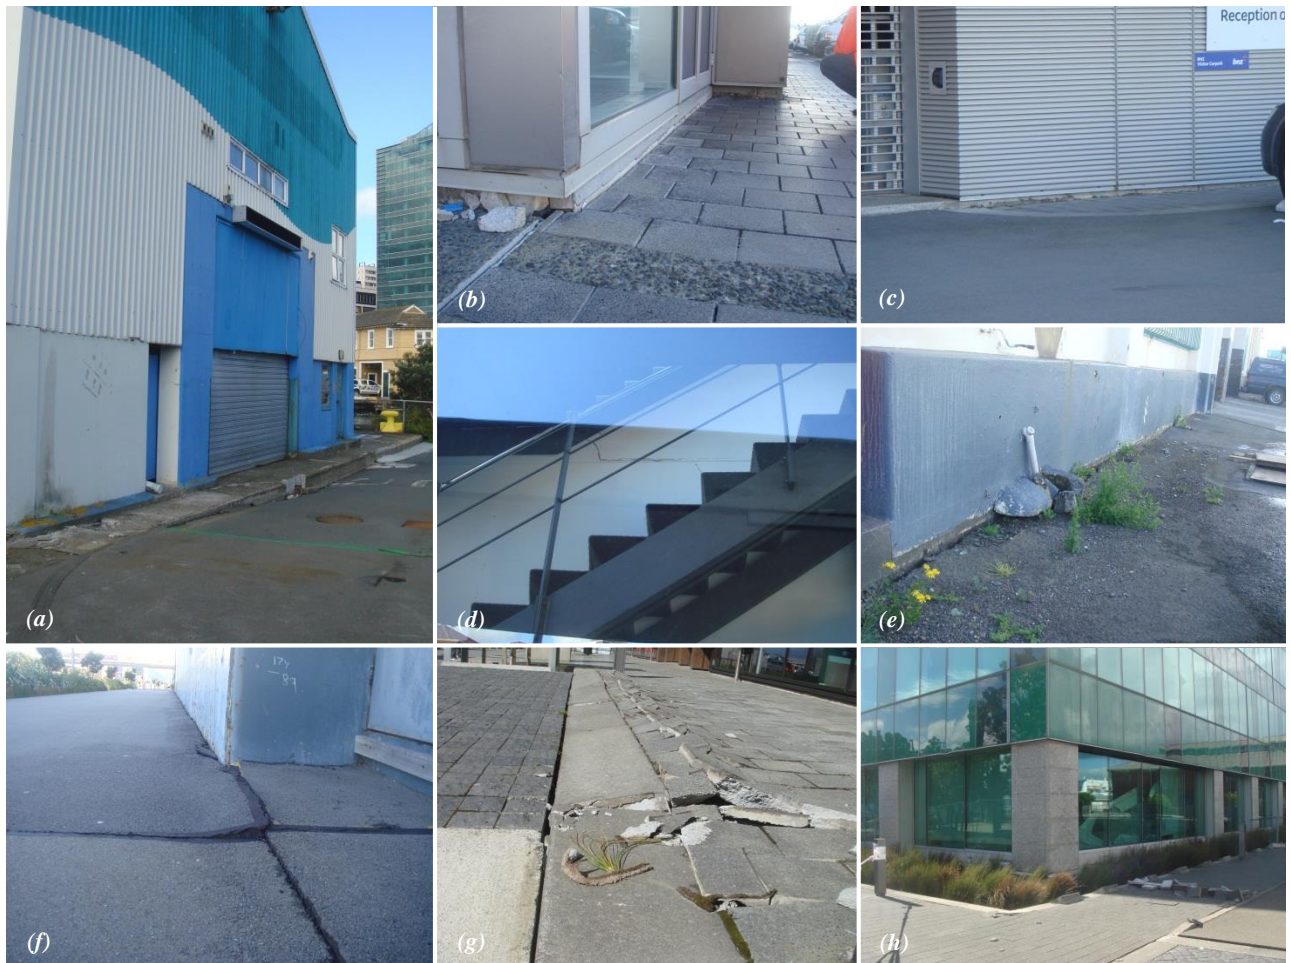
Figure 8(a) shows the settlement of the ground adjacent to a shed building located in one of the wharves in the waterfront. The settlement induced a vertical gap of 30-60 mm near the shed opening. Although the ground settled, there appears to be no damage to the structure itself.

The ground adjacent to the southwest corner of the BNZ building settled by 50-80 mm, resulting in a noticeable gap between the building and the ground, as described in Figures 8(b) and 8(c). The building itself, which was evacuated after the quake, appeared to have no major structural damage but the interior showed damaged partition wall, ceiling, etc., mostly non-structural, as illustrated in Figure 8(d).

**Figure 8: Various states of ground adjacent to structures: (a) ground settlement near a wharf shed; (b) settlement of the ground adjacent to BNZ building; (c) another section of BNZ building showing differential settlement between ground and structure; (d) non-structural damage to the interior of the BNZ building; (e) settlement of ground adjacent to the Customhouse building, resulting in vertical and horizontal offset; (f) cracked pavement and ground settlement near Customhouse building; (g) damaged brick pavement between Customhouse and Statistics NZ building; (h) destroyed pavement in front of Statistics NZ building.**

Ground settlement, in the order of 20-60 mm, was continued to be observed in the area adjacent to the Customhouse building, located north of BNZ building. In the north section of the building, both vertical and horizontal offsets were observed (see Figure 8(e)); in addition, 10-20 mm cracks resulting from both horizontal and vertical ground movements re-appeared in sections which may have been repaired before, i.e. in areas filled with asphalt sealant, as illustrated in Figure 8(f).

East of Customhouse building, the Statistics NZ Wellington Office building was damaged by the earthquake; details of the structural damage are reported by Henry et al. [11]. Sand boils appeared intermittently in some locations adjacent to the building, while damaged brick pavements between the Customhouse building and the Statistics NZ building were observed (see Figures 8(g) and 8(h)), giving an indication of the possible strength of ground shaking in the area. Palmer [12] reported that the building is supported by piles; the foundation ground was described as consisting of gravel and sand as fill materials with SPT N-value between 10-20, which overlay a loose deposit of hydraulically filled sand and silt layer with SPT N value of 2-10. Based on this information and the indicated strength of ground shaking, soil liquefaction is the major cause of the ground settlement in the area. However, it is not clear how the softening of the ground induced by soil

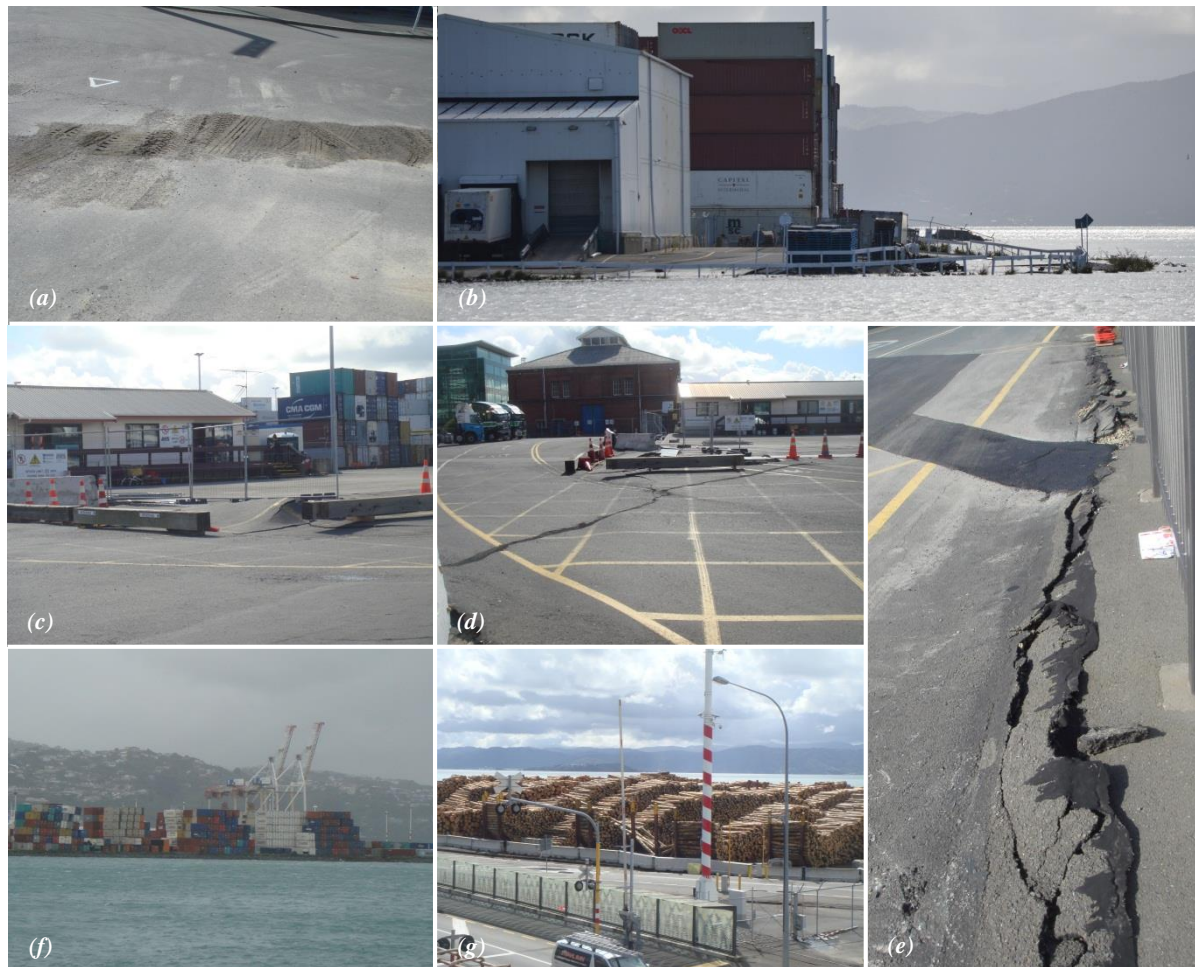
**Figure 9:** Damage observed from outside the CentrePort: (a) ejected sand and gravel near the entrance to the port; (b) south edge of Kings Wharf appeared to have settled and submerged under water; (c) subsidence within the port area; (d) longitudinal cracks on the pavement; (e) compressional ground cracks near the fence; (f) unstable stacking of containers in the yard; and (g) some logs falling off possibly due to shaking.

underground services and buildings were reported. Lateral spreading was also significant. One of the noticeable manifestations of liquefaction occurrence along the port boundaries was the sporadic presence of sand boils and cracks in the area. Figure 9(a) shows the ejected materials, consisting of coarse sand and gravelly material, at the port gate near the Customhouse building.

The south edge of the Kings Wharf settled and was under water, as illustrated in Figure 9(b). As mentioned earlier, the southern edge of the container yard underwent slumping following the 2013 earthquake; this time, the western end of the yard suffered the same fate. Other obvious damage was localised ground subsidence (Figure 9(c)), longitudinal cracks observed on the pavement (Figure 9(d)) and compressional cracks near the fence (Figure 9(e)).

Figure 9(f) shows the unstable stacking of the containers within the storage yard (as seen from Clyde Quay Wharf side), while Figure 9(g) illustrates some of the stacked timber logs falling off due to the ground shaking (as seen from Westpac Stadium).

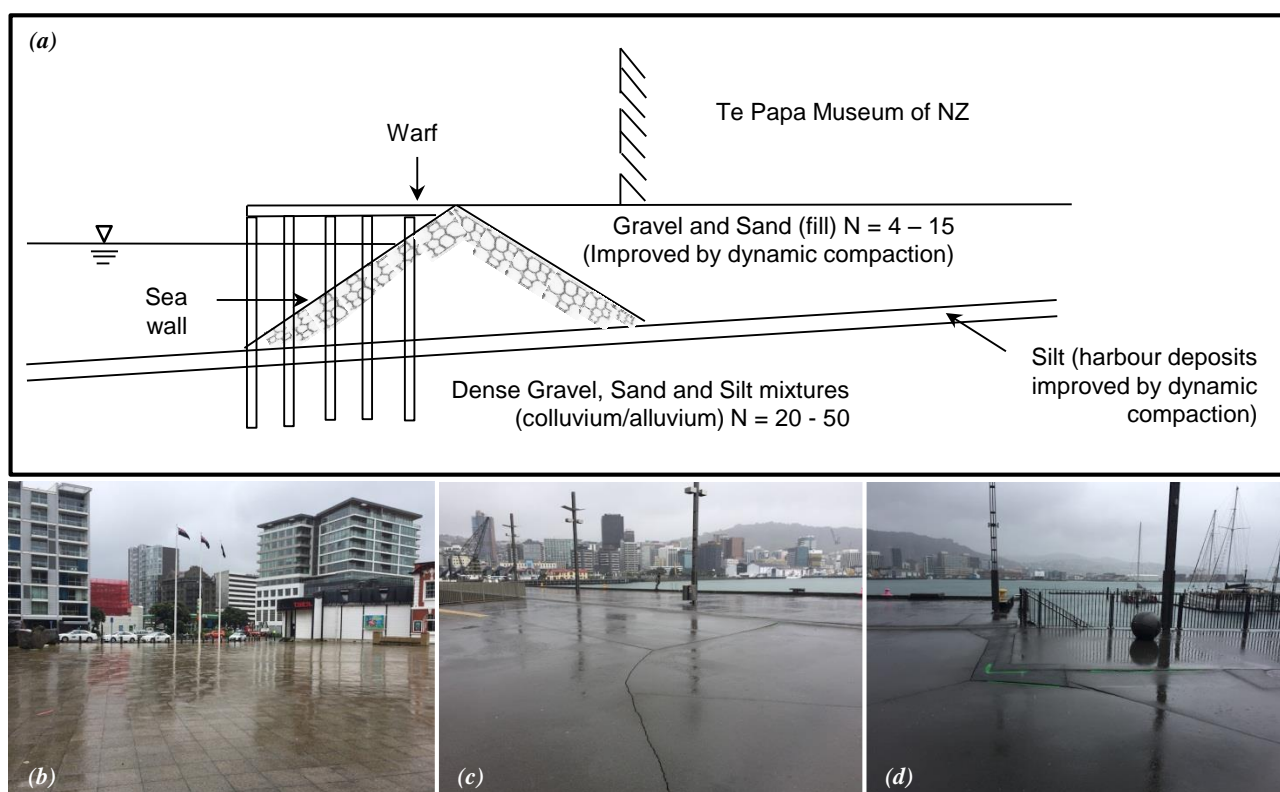
**Figure 10: Condition near Te Papa Museum: (a) improvement of foundation ground by dynamic compaction (after Palmer 2006); (b) condition of pavement in front of the museum; (c) crack on the pavement at the back of the museum; and (d) minor slumping, resulting in vertical offset, near the seawall.**

densify the reclamation fill and increase the strength of the underlying soft silt layer. The site profile as well as extent of improved ground is illustrated in Figure 10(a).

Following the 2016 earthquake, minor damage was observed on the pavement in front of the museum, which appeared to become wavy, which was confirmed by some inspectors interviewed by the team during the visit (see Figure 10(b)); at the back of the museum, minor cracks and slumping were noted at the wharf promenade, as illustrated in Figures 10(c) and 10(d).

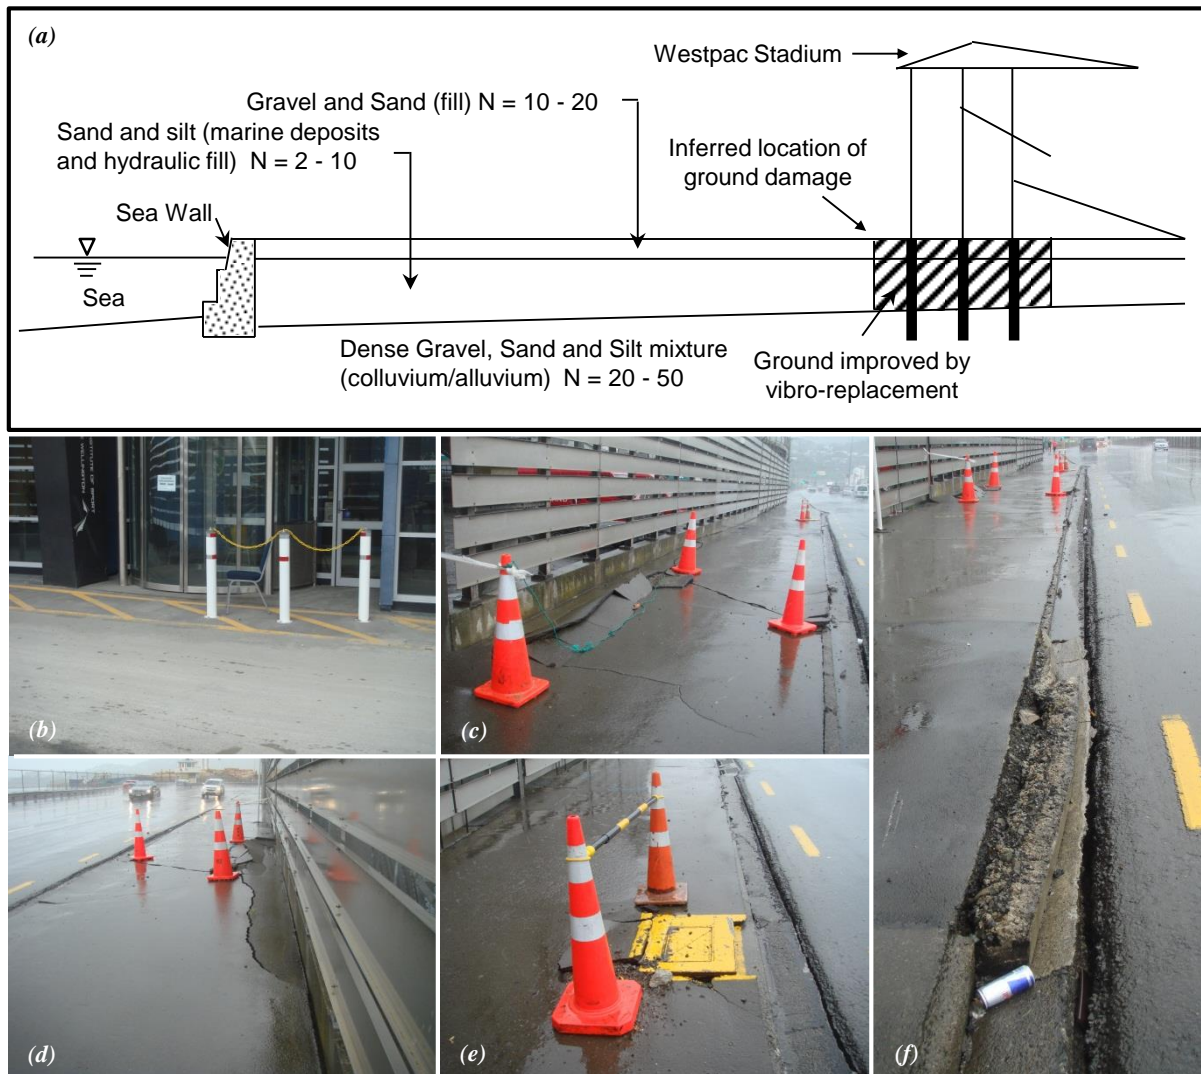
Following the 2016 earthquake, the stadium escaped unscathed and no ground damage was observed in the foundation ground, as seen in Figure 11(b). However, a portion of the sidewalk on the eastern side of the stadium (along Waterloo Quay Street) buckled (see Figures 11(c) and

11(d)) and underground utilities may have been compromised (Figure 11(e)). In addition, a 60 mm gap between the sidewalk and the roadway can be seen, as described in Figure 11(f). This isolated damage occurred at a section opposite the CentrePort, possibly at the boundary between the improved and the unimproved ground; the inferred location is indicated in Figure 11(a).

**Figure 11: Condition near Westpac Stadium: (a) improvement of foundation ground by vibro-replacement method (after Palmer 2006); (b) no visible foundation ground damage at the stadium; (c) buckling of the sidewalk adjacent to the stadium; (d) another view of the deformed sidewalk; (e) ground damage adjacent to utility cover; and (f) wide crack between sidewalk and road.**
