THE JUNE 28, 1991 SIERRA MADRE CALIFORNIA EARTHQUAKE

R. Shepherd¹

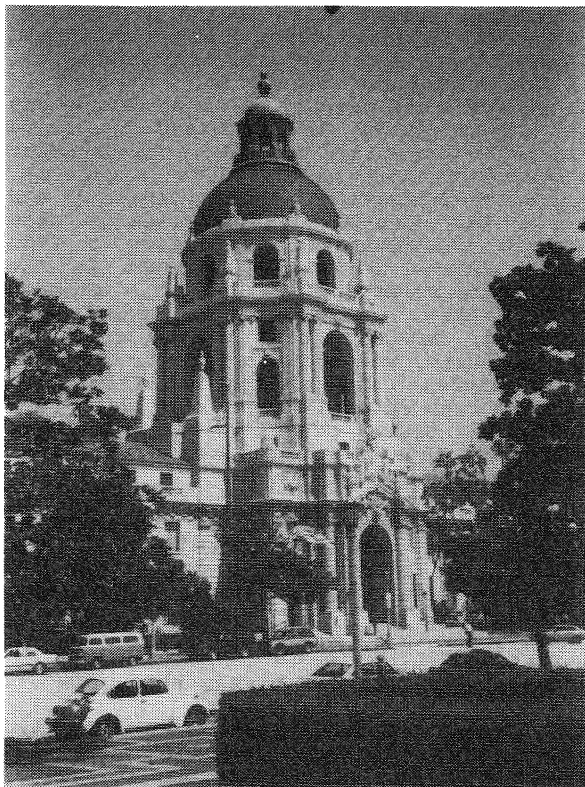
obvious damage was sustained by several historic buildings in Pasadena. The east wall of the Spanish-style City Hall (Figure 2) was cracked and the dome was tilted. Hollow clay tiles forming a veneer over a concrete masonry wall fell from the 1924 vintage Pasadena Playhouse (Figure 3) onto an adjoining property. Several churches suffered damage, including the 60-year old Westminster Presbyterian Church in Pasadena (Figure 4). Stained glass windows collapsed (Figure 5) and architectural components fell off the structure (Figure 6). Typical of the unreinforced masonry building damage was that sustained by 877 Colorado Boulevard (Figure 7) where lack of anchors contributed to severe cracking of the walls (Figure 8). Many brick chimneys collapsed (Figure 9) and even a few code-compliant buildings were rendered uninhabitable, including a 1963 design Motel-6 structure adjacent to the Santa Anita racetrack (Figure 10). Windows were broken, wastewater pipes were fractured, bottom plates parted from the concrete slab, and much structural cladding was shattered. One of the two fatalities resulted from an angle section falling from the steel truss covering the racetrack grandstand onto a woman working an early-morning exercise session.

FIGURE 2. PASADENA CITY HALL

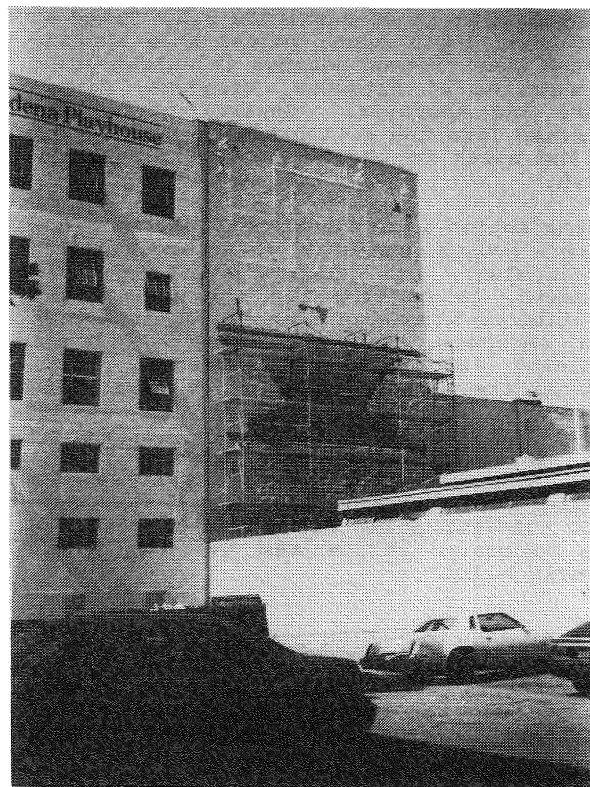
FIGURE 3. REAR OF PASADENA PLAYHOUSE

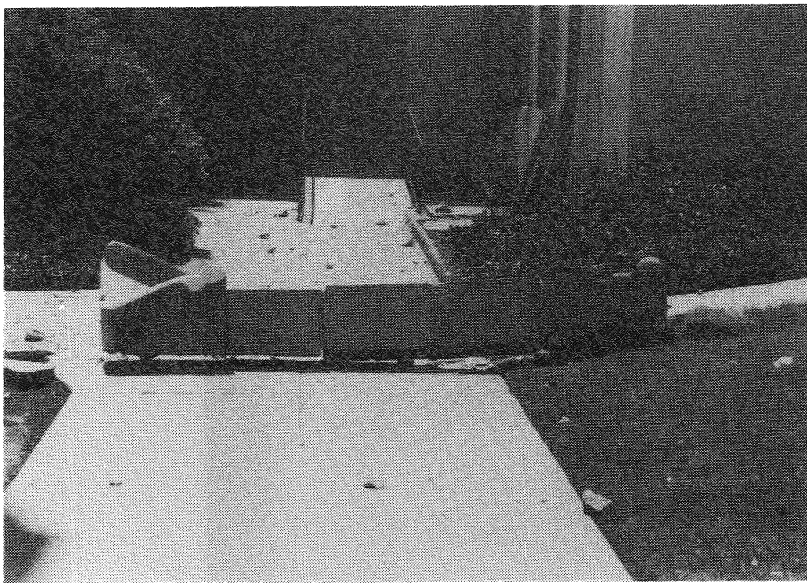
FIGURE 6. TOPPLED PINNACLE, WESTMINSTER PRESBYTERIAN CHURCH

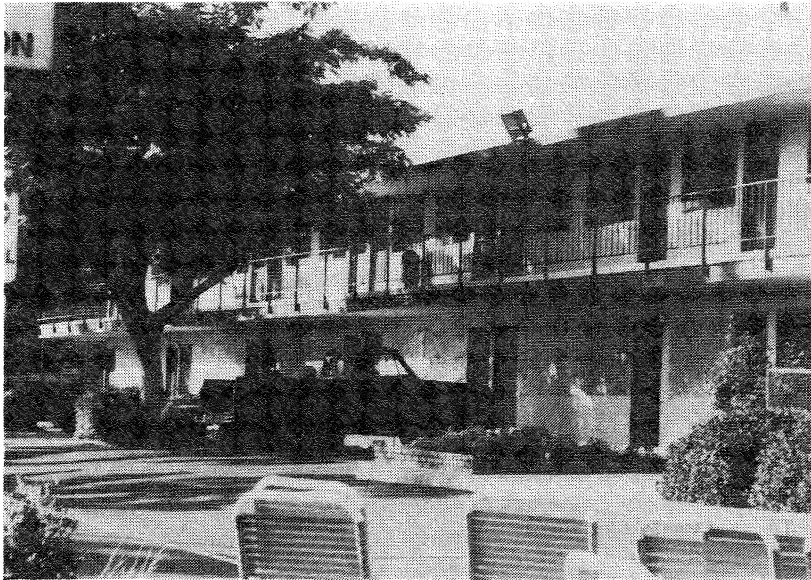
FIGURE 10. BOARDED-UP MOTEL 6 BUILDING, ARCADIA

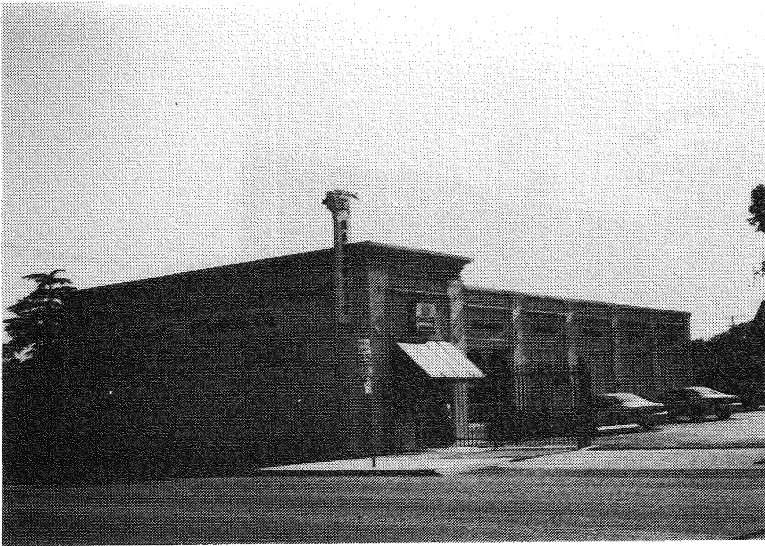
FIGURE 11. CROWN CITY HARDWARE BUILDING,
1047 NORTH ALLEN, PASADENA

In some instances, voluntary seismic upgrading had been undertaken by property owners with notable success. An example is the Crown City Hardware store in Duarte (Figure 11). This more than fifty-year old single storey unreinforced masonry building of approximately 6,500 square feet footprint had been seismically upgraded in 1990 at a cost of \$50,000 (Figure 12) essentially by tying the parapet back to the bowstring roof trusses at two levels. It survived the June 28 shaking unscathed, whereas the building directly across the street (Figure 13) suffered significant damage.

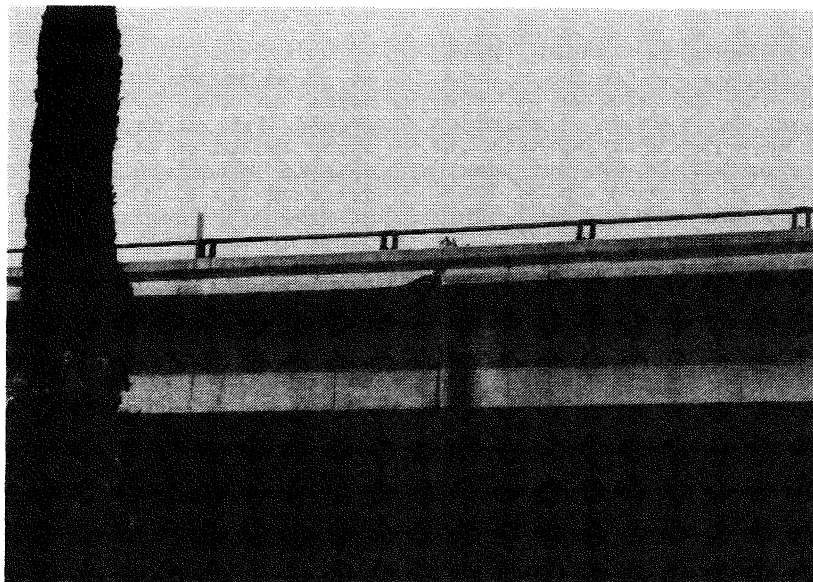
FIGURE 14. 210 FREEWAY OVERPASS AT SECOND AVENUE, ARCADIA

Very little structural damage occurred to the freeway system and no routes were affected other than by short-term restrictions to allow inspections to be made. Typical of the minor damage recorded was that observed on the 210 Freeway overpass at Second Avenue in Arcadia (Figure 14) where longitudinal compression at a joint caused spalling of some concrete.
