## VULNERABILITY AND SEISMIC RISK ASSESSMENT OF BUILDINGS FOLLOWING THE 1989 NEWCASTLE, AUSTRALIA EARTHQUAKE

A.M. Chandler<sup>1</sup>, J.W. Pappin<sup>2</sup>, and A.W. Coburn<sup>3</sup>

### ABSTRACT

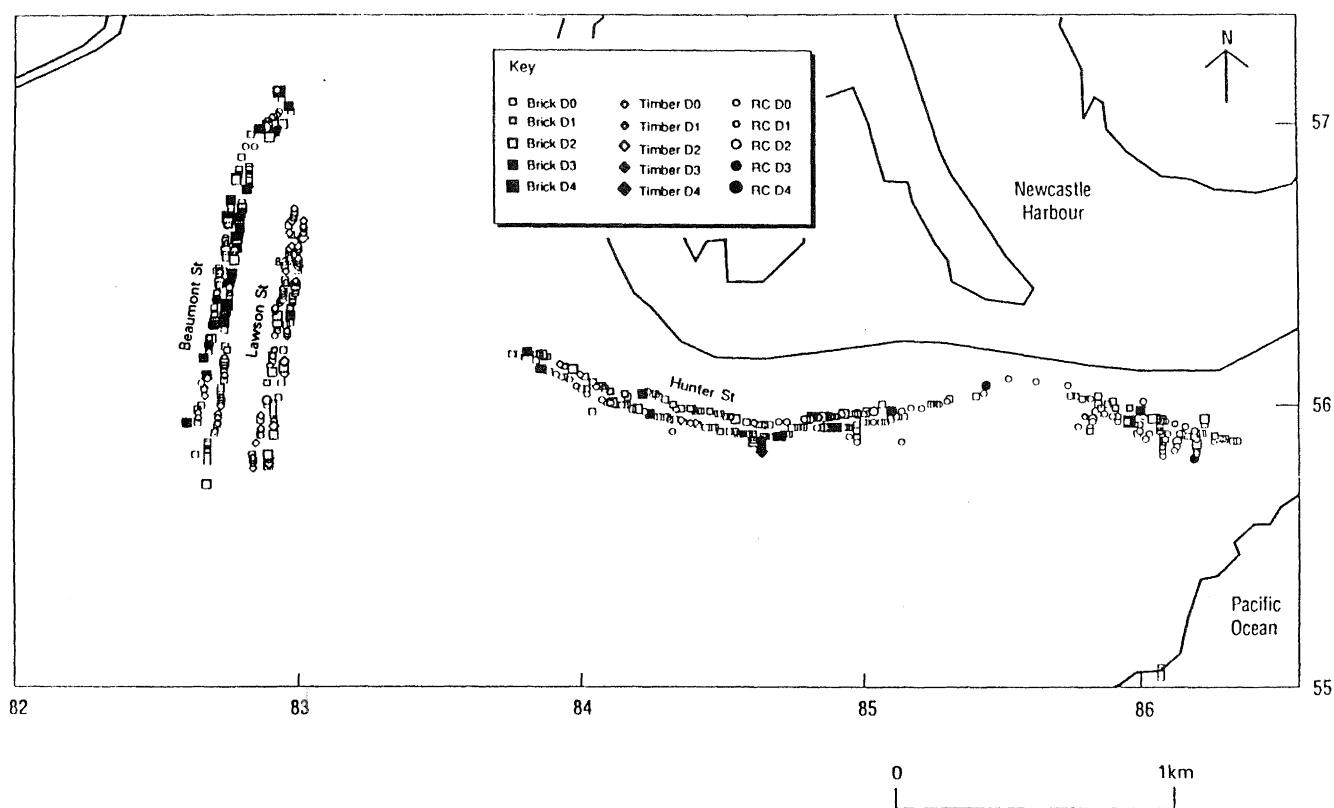
FIGURE 3 LOCATION OF DETAILED PHOTOGRAPHIC SURVEY AND SUMMARY OF RESULTS

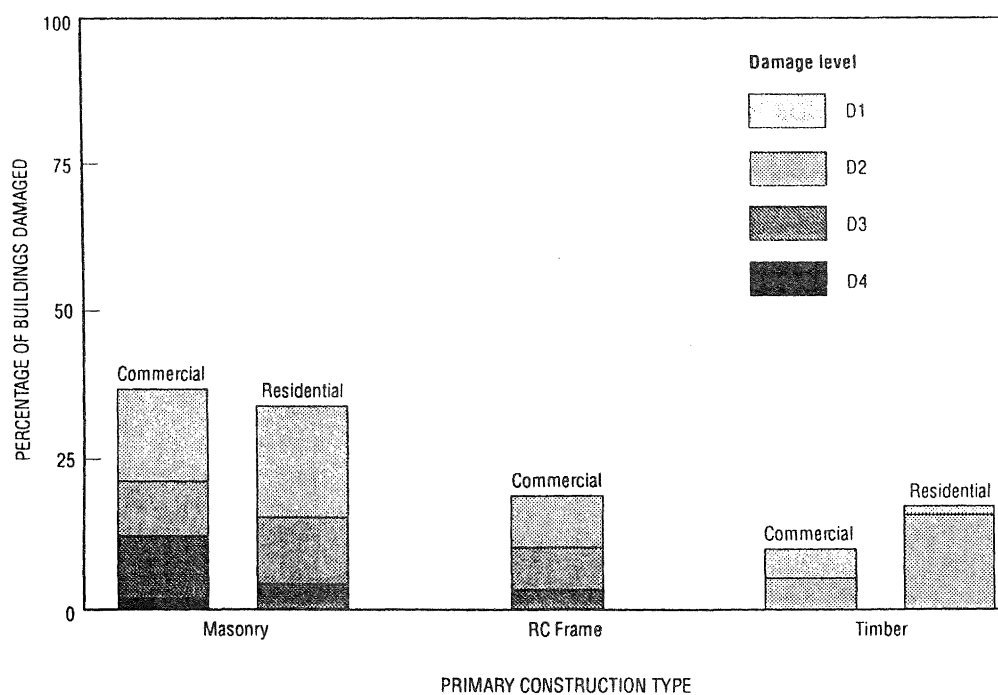
FIGURE 7 VARIATION OF DAMAGE LEVELS WITH PRIMARY CONSTRUCTION TYPE AND USE

The effectiveness of sub-dividing the data to analyse the effects of other characteristics of the building stock is limited by the size of the data sample. Figure 7 shows the distribution of damage levels by commercial or residential usage, within each primary building type. For brick masonry construction, there were considerably higher proportions of commercial buildings with heavy damage or partial destruction than for residential buildings of similar construction type. The proportions suffering light or moderate damage, however, were very similar. As expected, the reinforced concrete frame buildings were almost entirely commercial and hence the damage distribution was representative of this construction type as a whole. Timber frame buildings, however, were primarily residential and these suffered considerably more light to moderate damage than commercial timber buildings.

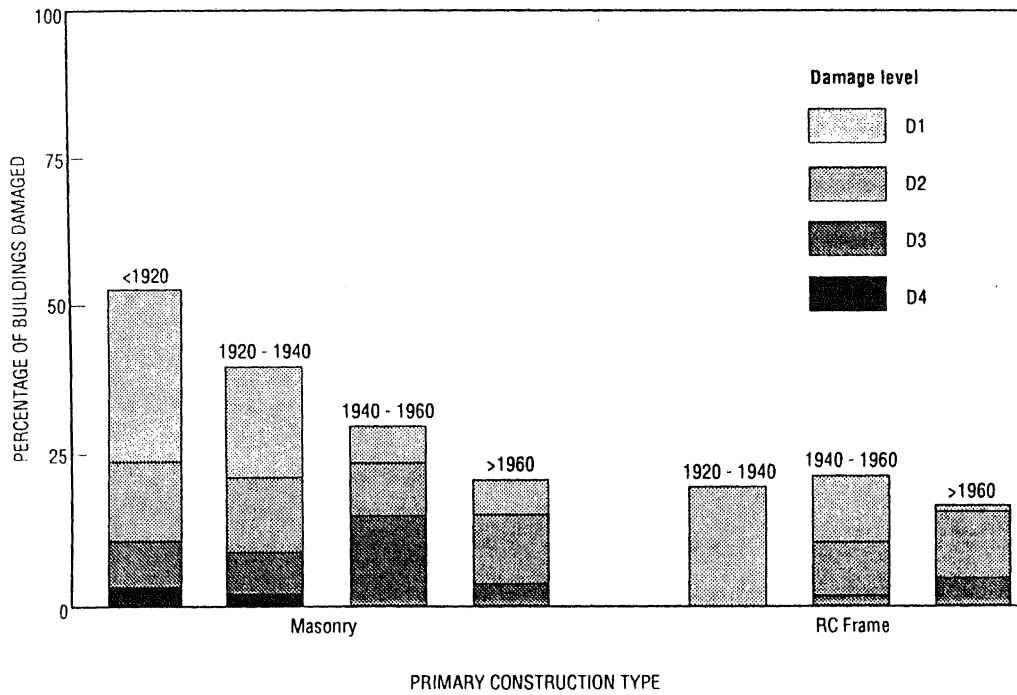
Figure 8 shows the vulnerability of brick masonry and reinforced concrete frame buildings according to their age of construction. There is a clear trend towards greater light or moderate damage in the older brick masonry buildings, with over half of the pre-1920 buildings suffering some damage. Conversely, 79% of the post-1960 buildings escaped without externally visible damage. For reinforced concrete frame buildings, the proportion of buildings with some damage is about 20% for all ages, but surprisingly no buildings constructed in the period 1920-1940 suffered more than slight damage, whereas for more recent

buildings there was significant moderate to heavy damage, the effect being noticeably worse in the buildings of recent (post-1960) construction, possibly due to reduced conservatism in design codes.

FIGURE 8 VARIATION OF DAMAGE LEVELS WITH AGE OF CONSTRUCTION

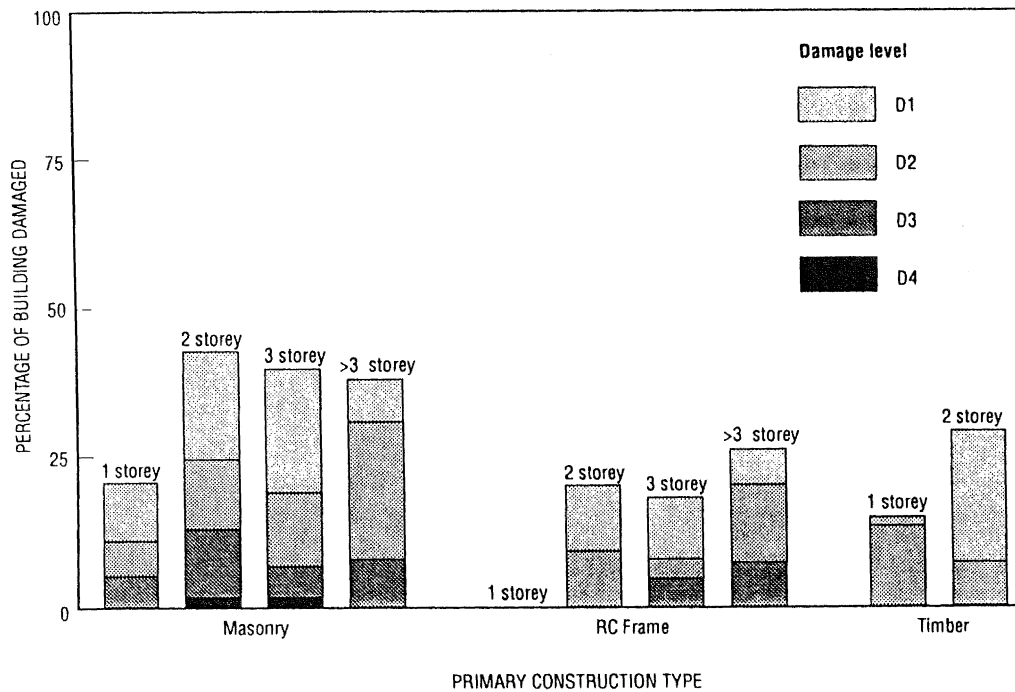
Finally, Figure 9 shows the effect of building height on the extent and distribution of damage. For brick masonry buildings, those with more than one storey showed about twice as much damage overall than the single storey buildings, with consistency for damage  $\geq D1$  for those with 2, 3 and  $>3$  storeys. For buildings with moderate or heavy damage ( $\geq D2$ ), those with  $>3$  storeys were about 4 times more vulnerable than single-storey buildings and about twice as vulnerable as buildings with 2 or 3 storeys. None of the single storey reinforced concrete frame buildings suffered any noticeable damage, but about 20% of the multi-storey buildings showed at least slight damage. This value is about half that for brick masonry buildings. Single storey timber framed buildings were found to be only half as vulnerable to damage  $\geq D2$  as compared with two-storey timber framed buildings. One two-storey building was damaged to level D4, but no single-storey buildings were observed in this category.

FIGURE 9 VARIATION OF DAMAGE LEVELS WITH HEIGHT IN STOREYS

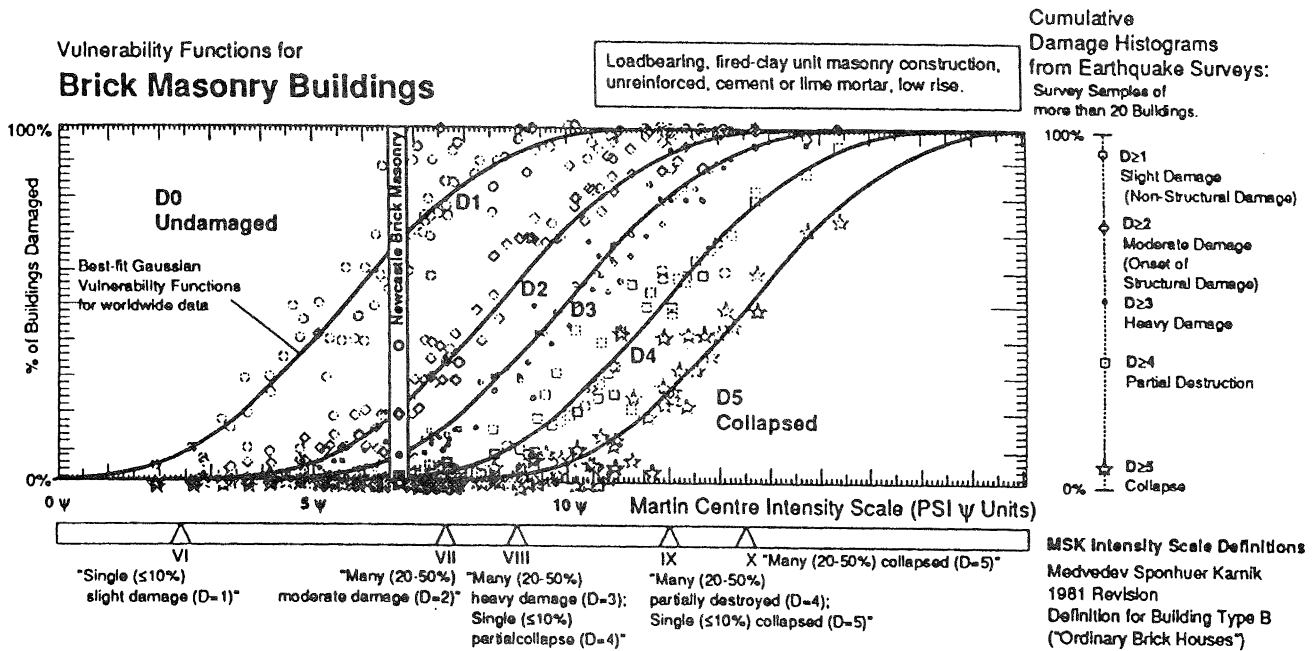
FIGURE 10 DISTRIBUTION OF DAMAGE TO NEWCASTLE BRICK MASONRY BUILDINGS COMPARED WITH SIMILAR BUILDING STOCK IN OTHER EARTHQUAKES WORLDWIDE (FROM MARTIN CENTRE VULNERABILITY DATABASE, REF. [11])

The general distributions of damage, particularly to brick masonry buildings, suggest that the damage level is at the low end of MSK Intensity VII ("Many [20 to 50%] brick buildings suffering moderate damage D2"), see Figure 10. Fitting the Newcastle distributions to the average Gaussian vulnerability functions derived from the Martin Centre database suggest a best fit at around an intensity level of 6.7  $\psi$  units (Martin Centre Intensity Scale, see Reference 13 for further details). Damage distributions of this order surveyed around strong motion instruments, such as at Bisaccia in the Italian earthquake of 1980 (16% D2 or worse for brick masonry structures) correlate with a peak ground acceleration around 100cm/s<sup>2</sup> (0.1g) [13]. It should be noted that this comparison with Bisaccia is for the effects of an earthquake at distance from a larger magnitude event rather than, as in Newcastle, close to the epicentre of a smaller magnitude event, so other characteristics like duration, frequency content and vertical components may be significantly different.

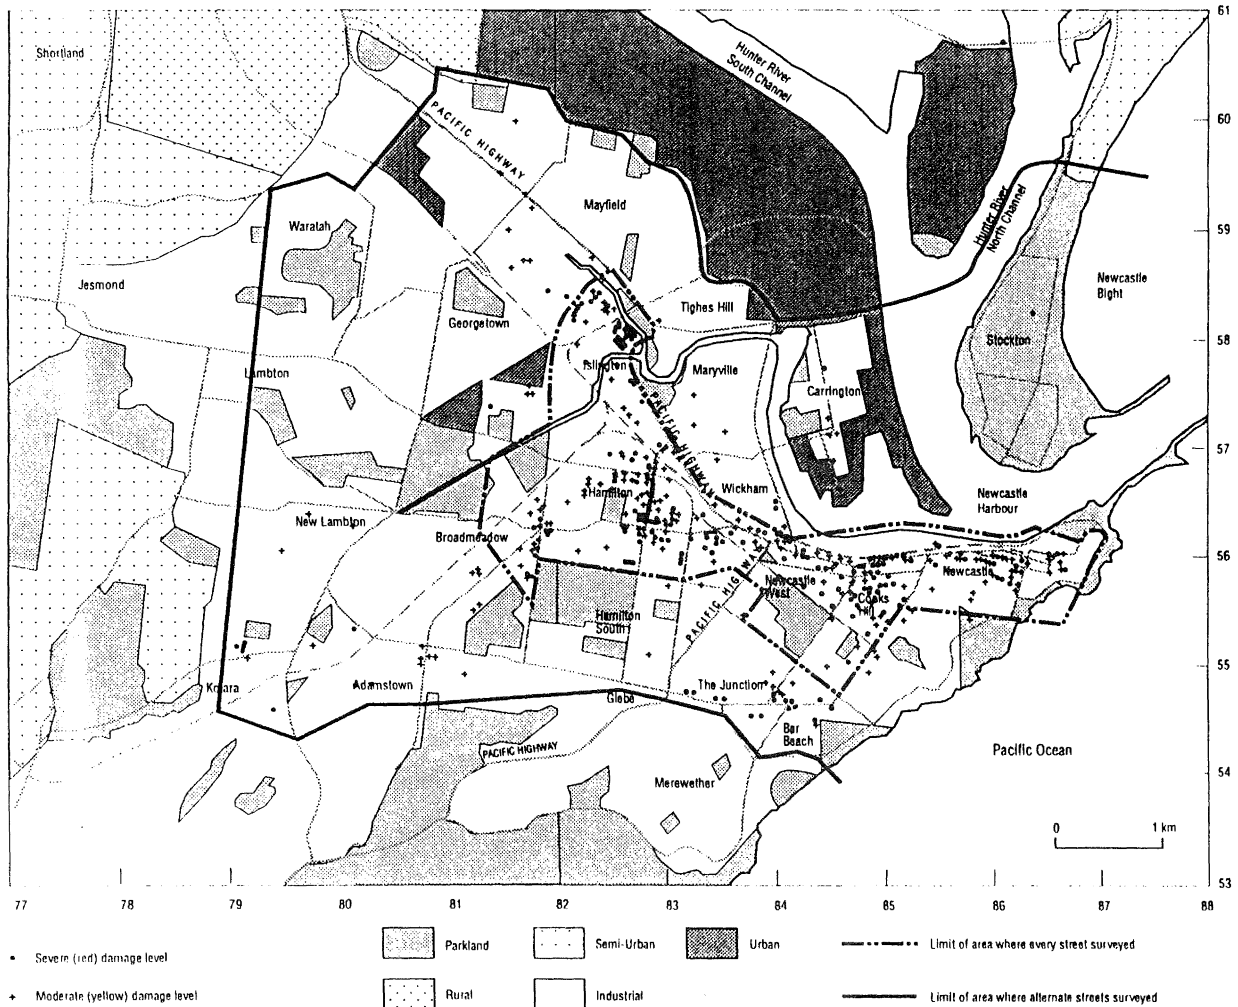
Figure 11 shows the locations of buildings with moderate or heavy damage observed in the EEFIT general survey. Whilst it can be seen that the areas of heaviest damage are in the vicinity of the detailed photographic survey, there is also considerable damage in the areas of The Junction, Tighes Hill and Broadmeadow. This correlates well with the data collected by the Newcastle City Council in their damage survey, as described below.

**FIGURE 11 LOCATIONS OF STRUCTURES WITH MODERATE OR HEAVY DAMAGE FROM EEFIT GENERAL SURVEY**

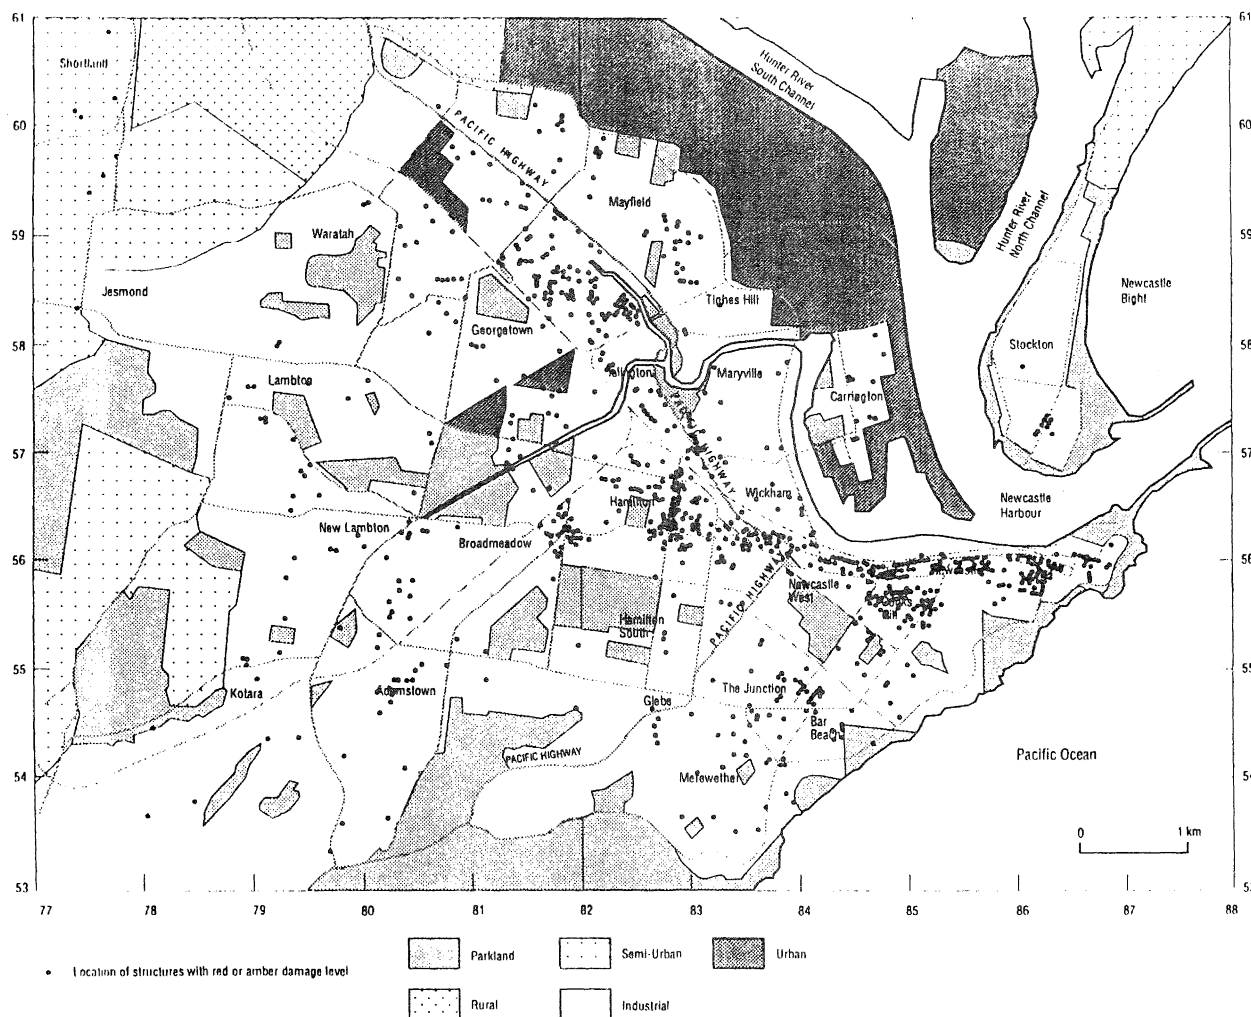
**FIGURE 12 LOCATIONS OF STRUCTURES WITH MODERATE OR HEAVY DAMAGE FROM NEWCASTLE CITY COUNCIL DATA**

approximately to the Yellow classification used by EEFIT. It must be noted that there will be considerable variability in the assessments between different inspectors and, as for the EEFIT survey, not all damage is recorded. In addition, damage to schools, colleges, churches, and so forth does not appear to have been reported. The Newcastle City Council map showing the locations of all residential buildings damaged in the Red and Amber categories is reproduced in Figure 12. The pattern of damage is similar to the EEFIT survey, except for Merewether which was not surveyed by EEFIT, and in Mayfield where the density of damage recorded by EEFIT was much less than that indicated in Figure 12.

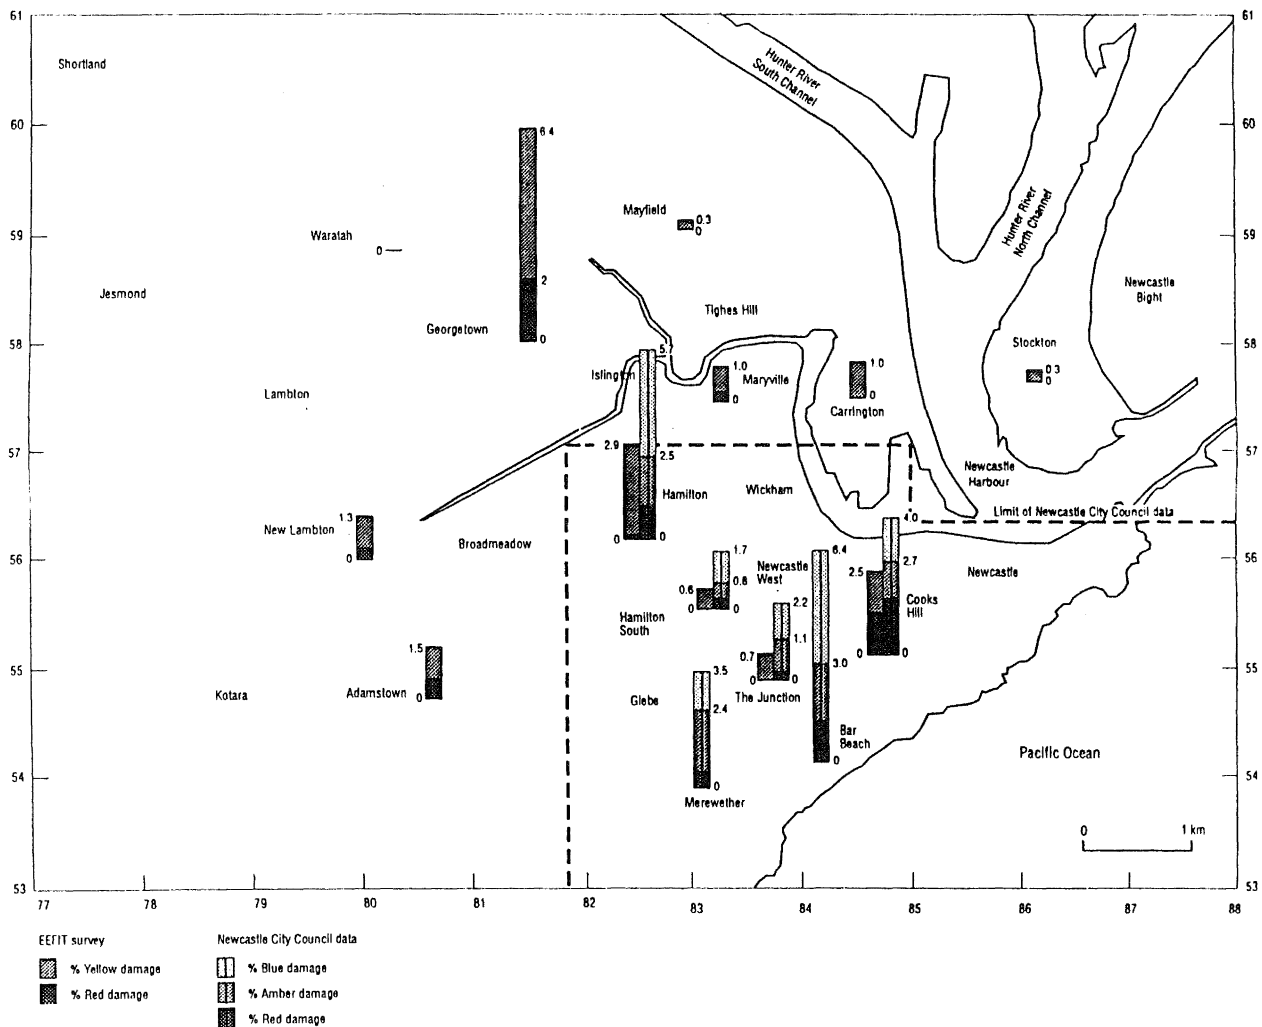
Percentage damage levels for the residential areas using the EEFIT data and the Newcastle City Council data are shown in Figure 13. The levels of damage are much lower than that observed in the EEFIT detailed photographic survey (Figures 3 and 7), and are believed to reflect a combination of:-

FIGURE 13 PERCENTAGES OF DAMAGE TO RESIDENTIAL BUILDINGS

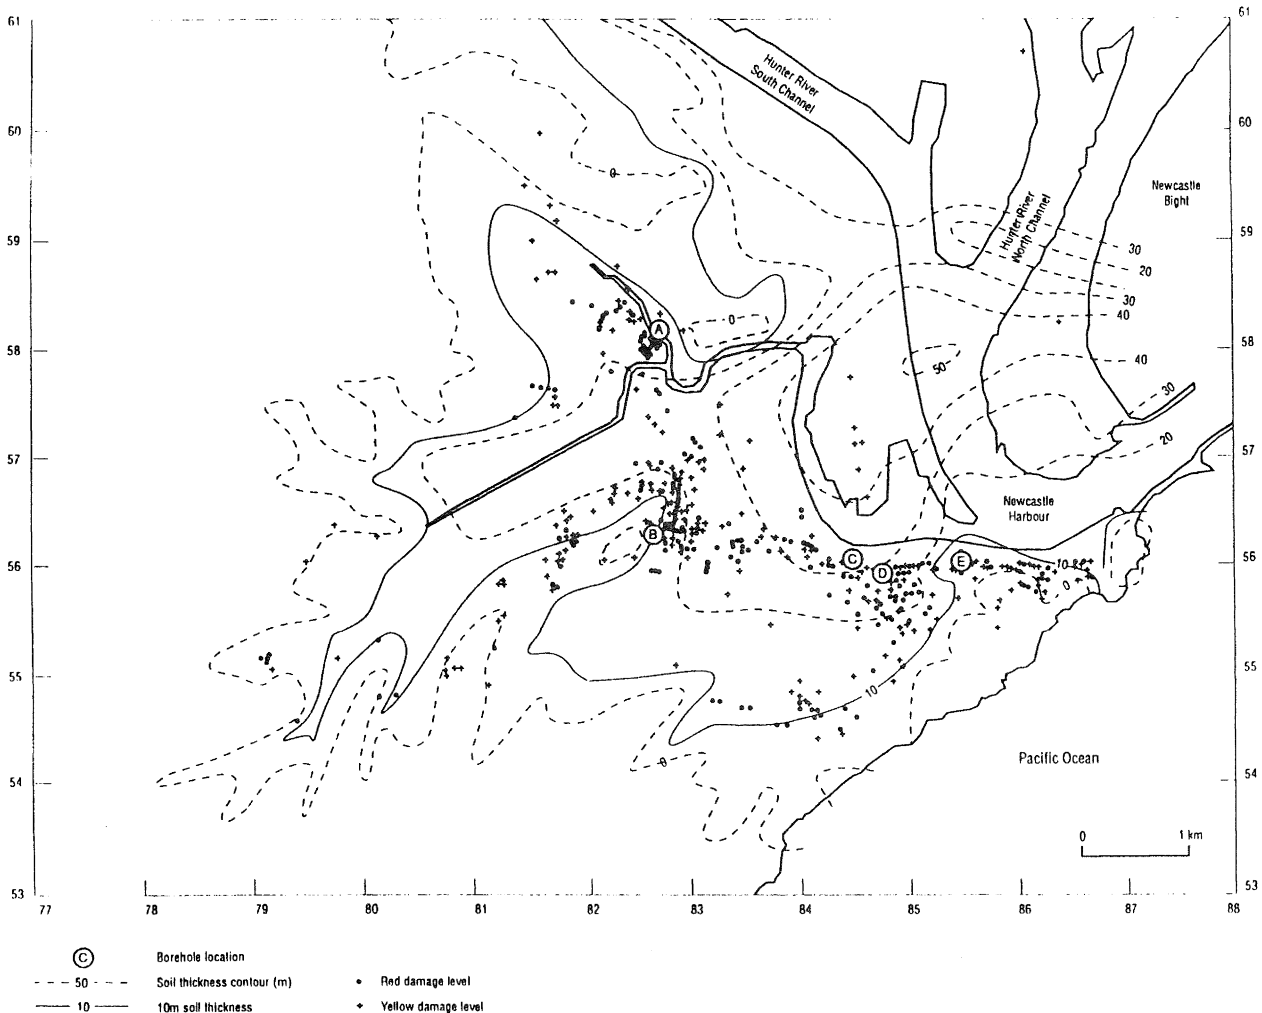
Figure 14 shows the damage distribution from the general survey superimposed on the soil thickness diagram. Generally, there is seemingly no correlation between damage distribution and soil thickness. The damage recorded in the detailed photographic survey in Hunter Street in the City centre (Figure 3) seems to confirm this. A fairly uniform distribution of damage was observed, even though the soil thickness varies from near zero at the eastern end to about 30m at the western end. The extent of damage in Hunter Street is comparable to that in Beaumont Street, Hamilton where the soil thickness is between 10 and 20m. In these areas, with a high concentration of the more vulnerable multi-storey older brick masonry buildings,

**FIGURE 14 DISTRIBUTION OF DAMAGE IN RELATION TO SOIL THICKNESS**

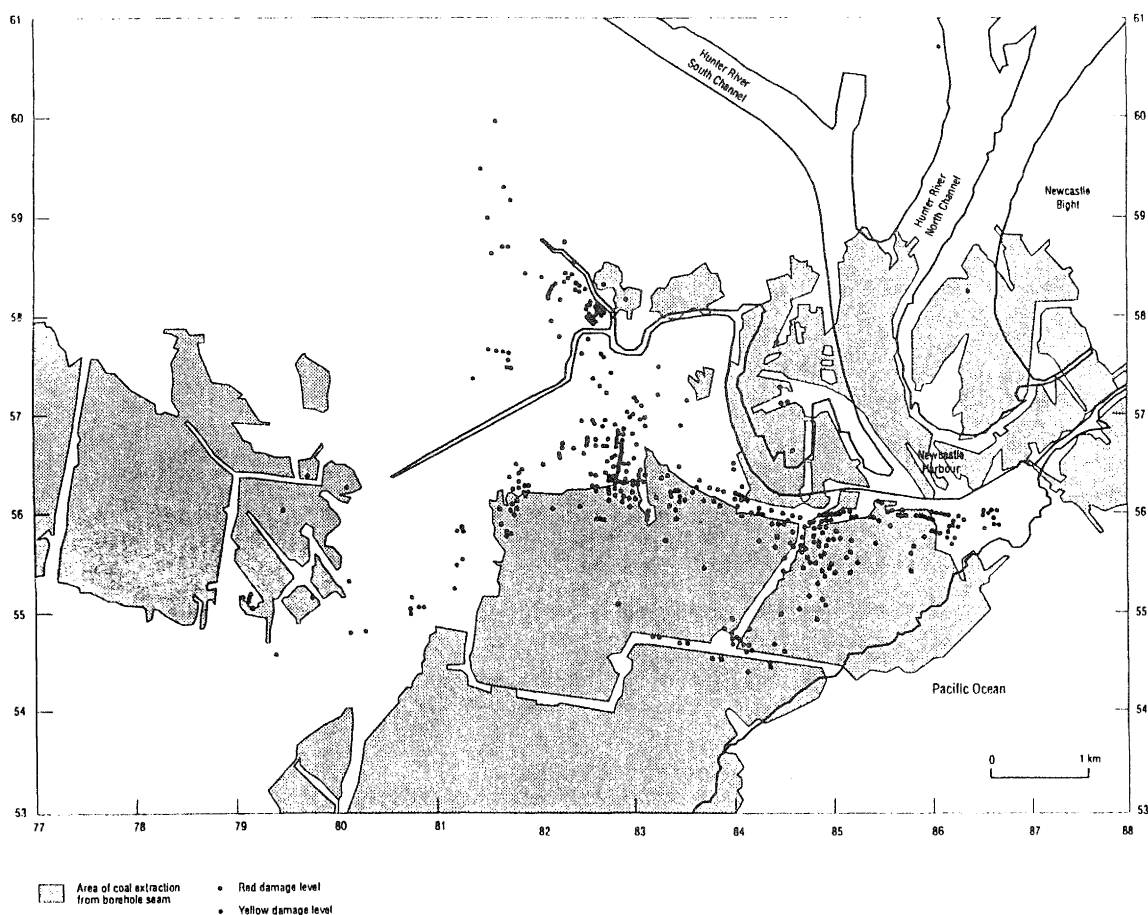
FIGURE 18 DISTRIBUTION OF DAMAGE IN RELATION TO AREAS OF COAL EXTRACTION
