Report on Field Visit

On July 16 1990, an earthquake of magnitude 7.8 caused widespread damage, disruption and loss of life in Central Luzon, north of Manila.

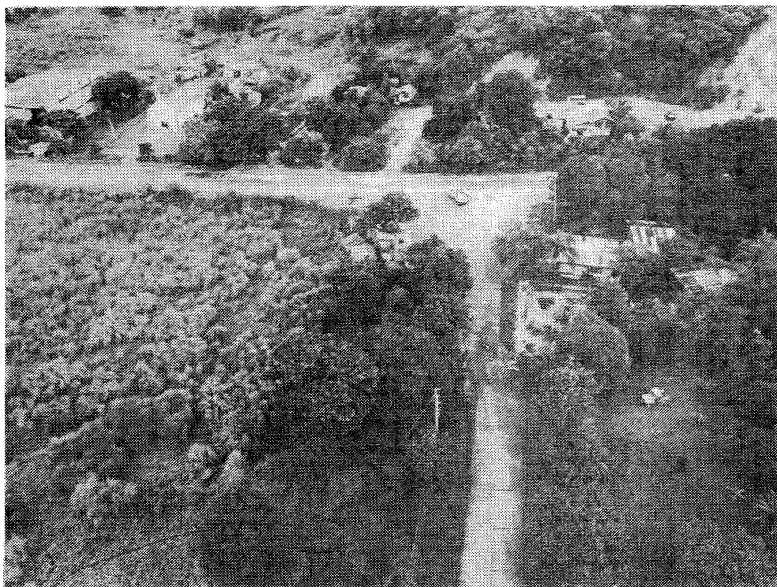
Figure 4.2: The 3 metre left lateral offset of the Digdig fault trace is clearly visible from the air - Carrangian Road, off main highway 20 km north of San Jose (Photo: Dodong Teves, PNOC)

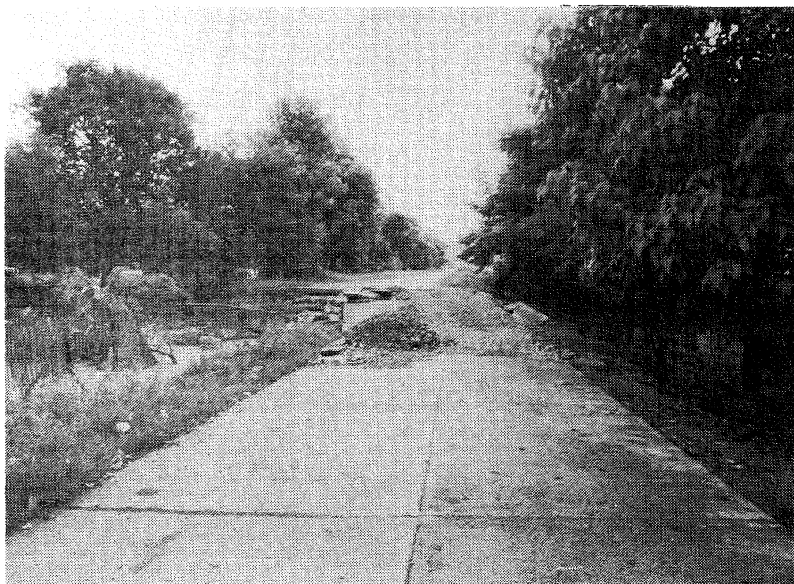
Figure 4.3: From the ground, both the 3 m left lateral, 1.5 m vertical displacement are obvious, as is the damage to the road (Photo: Dodong Teves, PNOC)

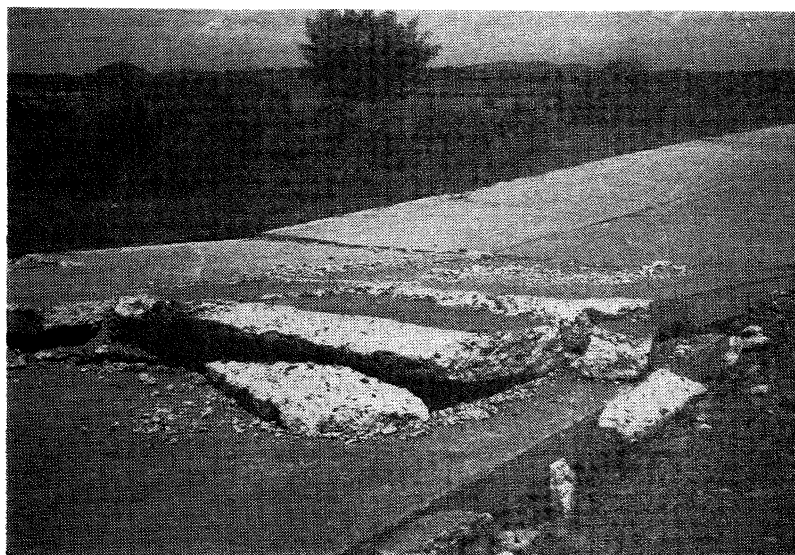
Figure 4.4: Damage to road pavement due to offset of Phillipines fault trace 3.5 km west of Rizal

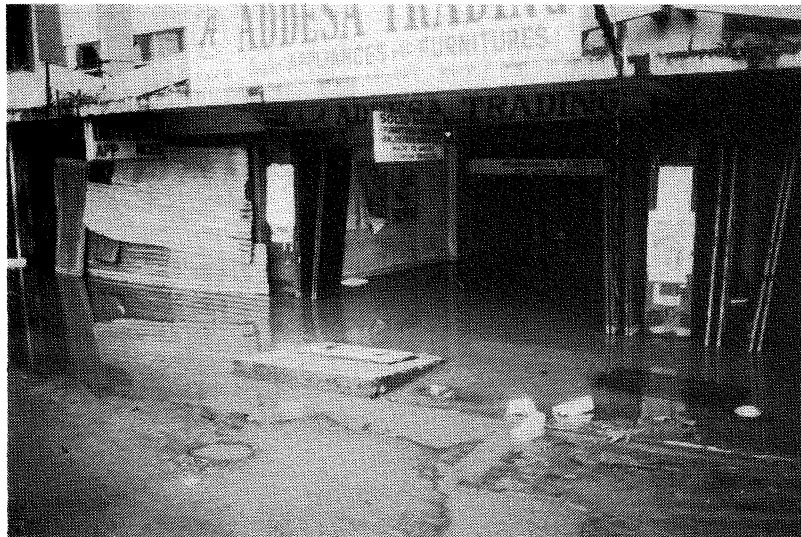
Figure 5.1.4: Dagupan City, Perez Blvd, building settlement with ground floor flooding

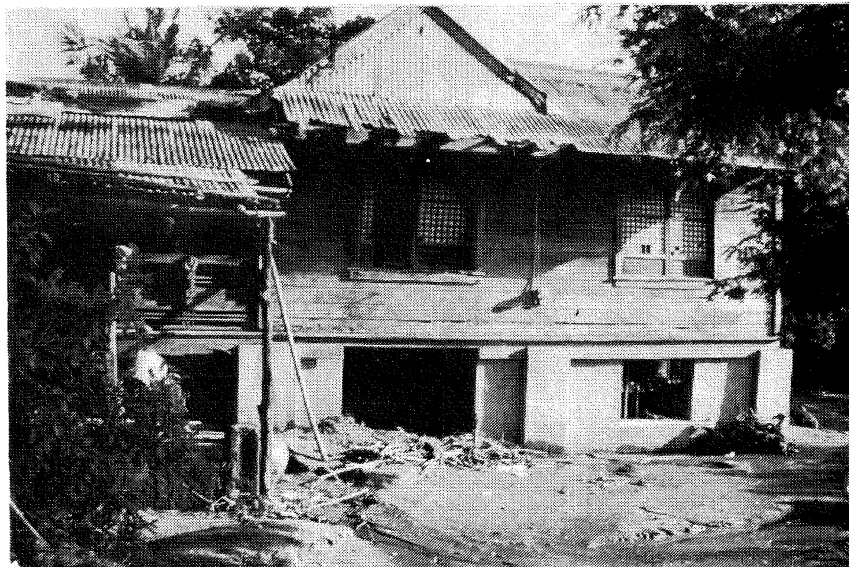
Figure 5.1.9: Settlement of house at Aringay due to liquefaction of foundation soils. The house has settled approximately 1 metre

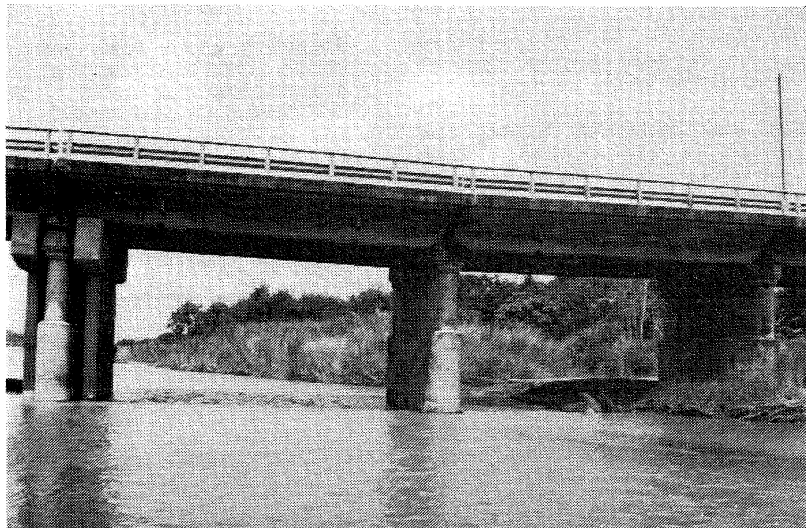
Liquefaction contributed to the damage of several other bridges due to lateral spreading of the riverbanks and settlement of the piers. Figure 5.1.10 shows settlement of the central pier of the Binalonan Bridge. The Carmen Bridge across the Agno River collapsed due to liquefaction of the foundation soils and closed the primary north-south route through the Luzon Central Plains. Liquefaction resulted in numerous fissures up to 0.3m wide parallel to the riverbank with quantities of ejected fine sand (Figure 5.1.11). On the north side of the channel, slump scarps up to about 0.75m high were evident. (Figure 5.1.12). Some piers were rotated towards the river channel suggesting lateral spreading but others were rotated the other way. Details are given in Case Study C.6. Because the floodplain is relatively flat, lateral spreading is not considered to have been the principal reason for collapse. It is postulated that failure may have been initiated due to out of phase oscillations of liquefied blocks of soil which led to inadequately anchored spans dropping off the

Figure 5.1.10: Binalonan Bridge, settlement of central pier by approximately 0.3 metre. Note previous work to pier on left

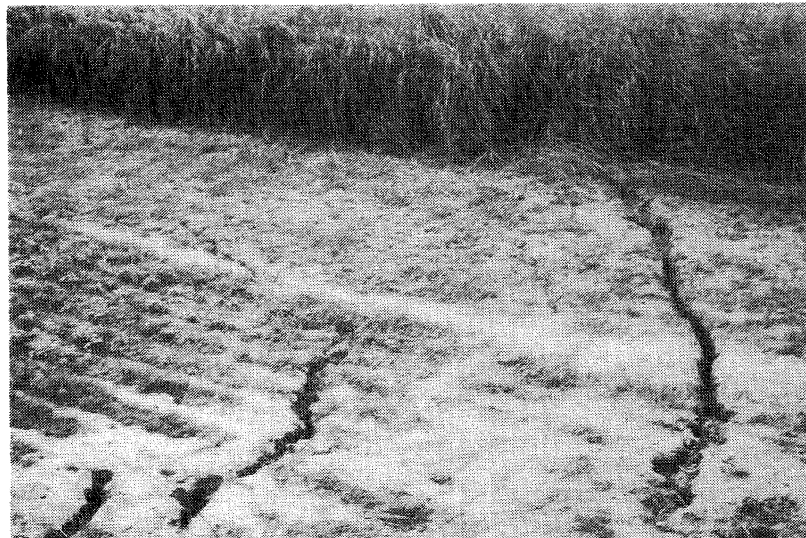
Figure 5.1.11: Fissures and ejected fine sand associated with liquefaction, Carmen Bridge (south river flood plain)

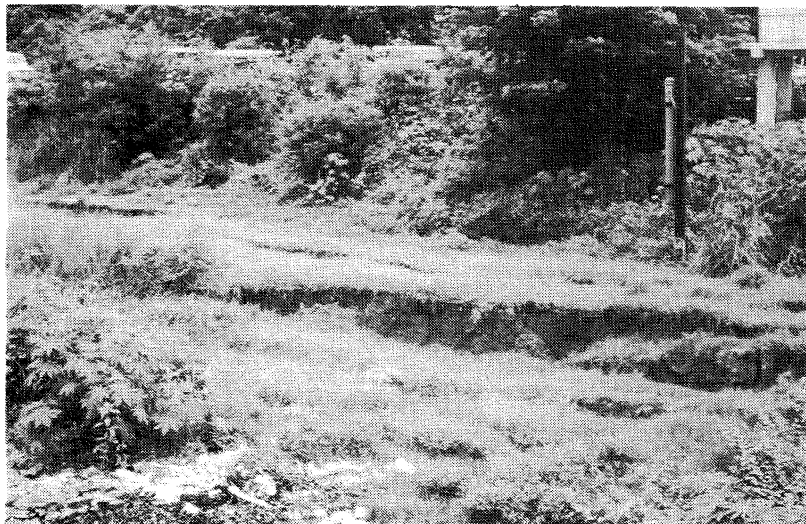
Figure 5.1.12: Slumping towards river channel, Carmen Bridge (north bank)

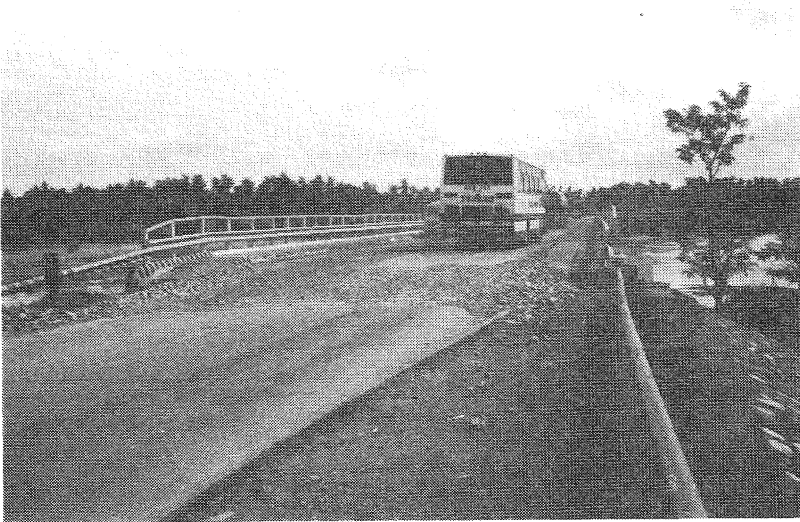
Figure 5.1.19: Cayanga Bridge north of Dagupan; approach fill settlement showing temporary reinstatement with a fill ramp to deck level

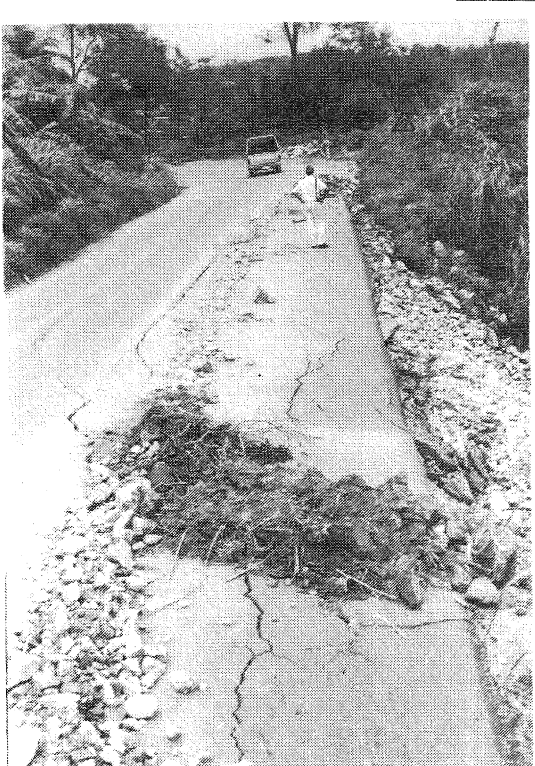
Figure 5.1.21: Road slumping due to failure of rock facing to retain fill

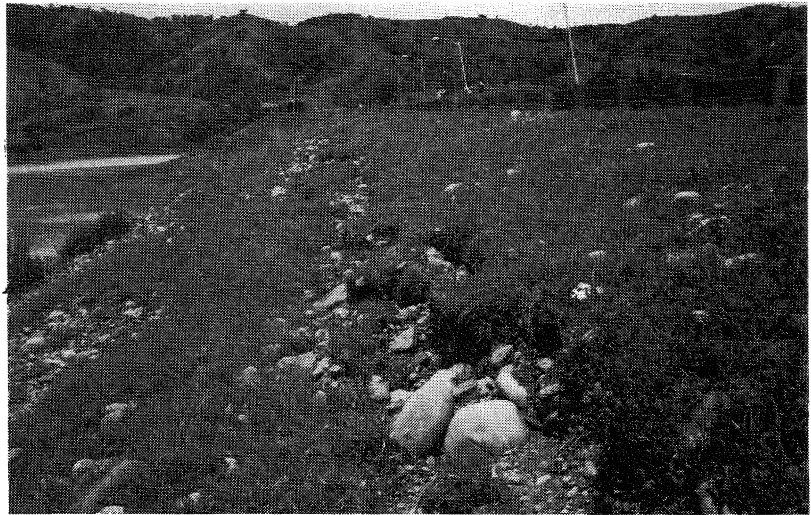
Figure 5.1.25: Masiway Dam; longitudinal cracking in upstream shoulder of rockfill dam

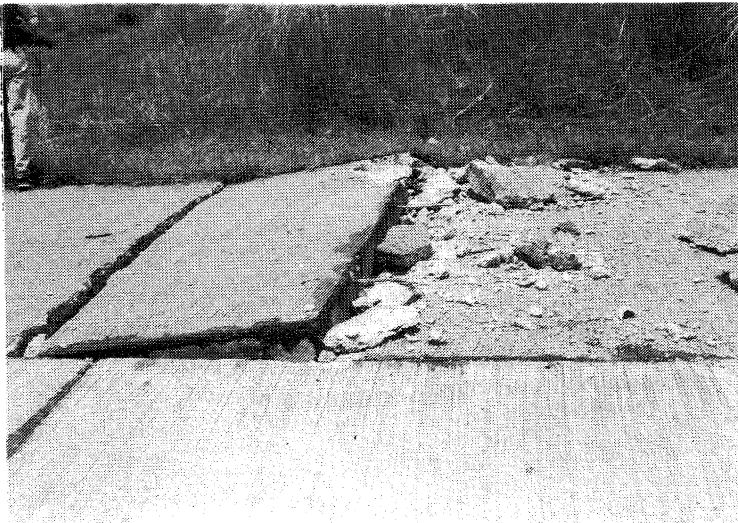
Figure 5.2.1: West of Rizal; compression failure of concrete road paving

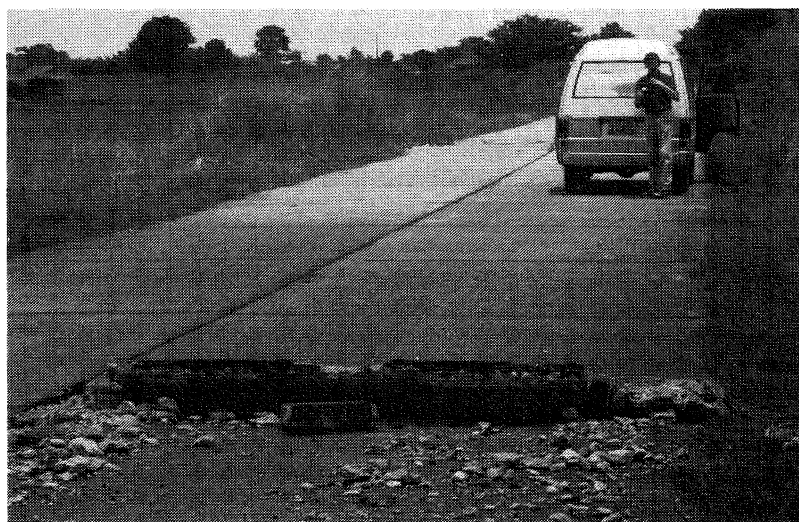
Figure 5.2.2: West of Rizal; compression failure of concrete road paving, typical offset of failure in each carriageway

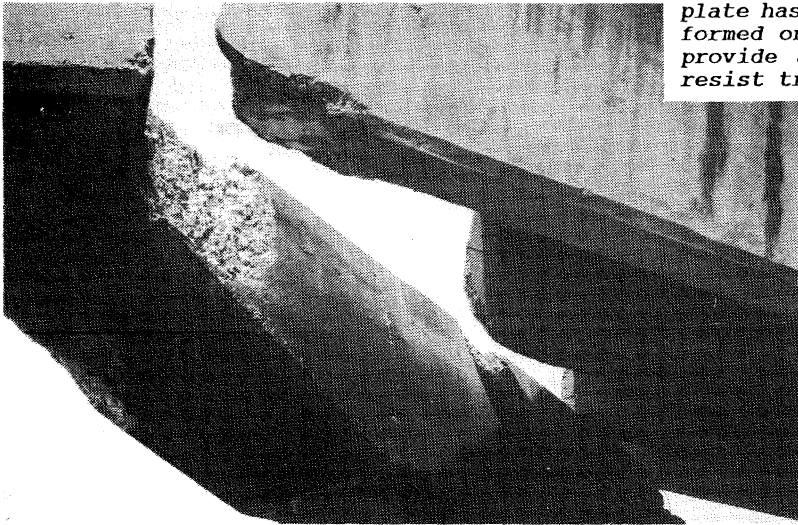
4km west of Rizal, a two-span bridge across an irrigation feeder canal was completely demolished due to fault movement through or close to the site. It would appear the bridge collapse, with liquefaction slumping, temporarily dammed the water flow. The water over-topped the collapsed bridge structure, cut through the canal embankment into the adjacent rice field, then scoured out any trace of surface faulting. At the time of the team's visit, the water supply to the feeder canal had been cut off. The two abutments and central pier had all tilted towards the east by varying degrees. The eastern span had dropped completely into the stream bed as the eastern abutment had tilted more than the pier. The abutment had moved back towards the approach carriageway and fill which had slumped away downstream, through the scoured out embankment, to a level below the 2.5m deep abutment apron wall. The western span had pulled off the western abutment due to greater easterly movement of the pier, but the pier was still supporting the second beam in from the southern side (there being four beams per span). Refer Figures 5.2.7 and 5.2.8

Figure 5.2.7: Rizal Canal Bridge; beams pulled away from the pier but still supported on far end cantilever section of pier. This cantilever section had failed in bending

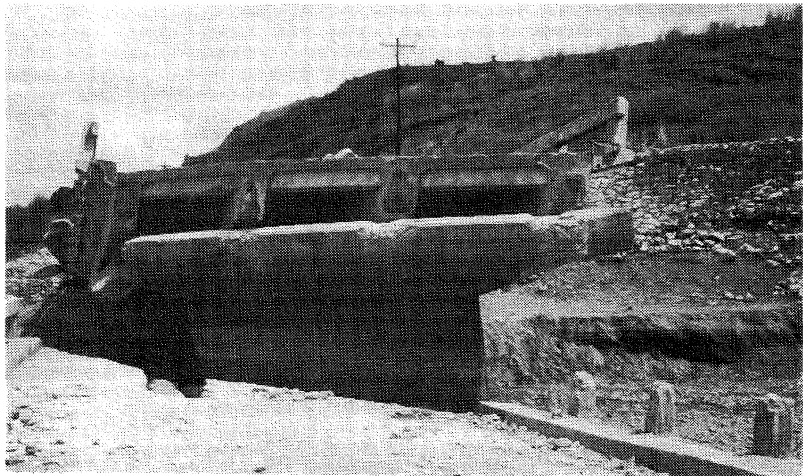
Figure 5.2.8: Rizal Canal Bridge; pier rotation and collapse of deck, view towards north west. Initial demolition work had commenced with removal of the handrail and cutting a slot in the deck

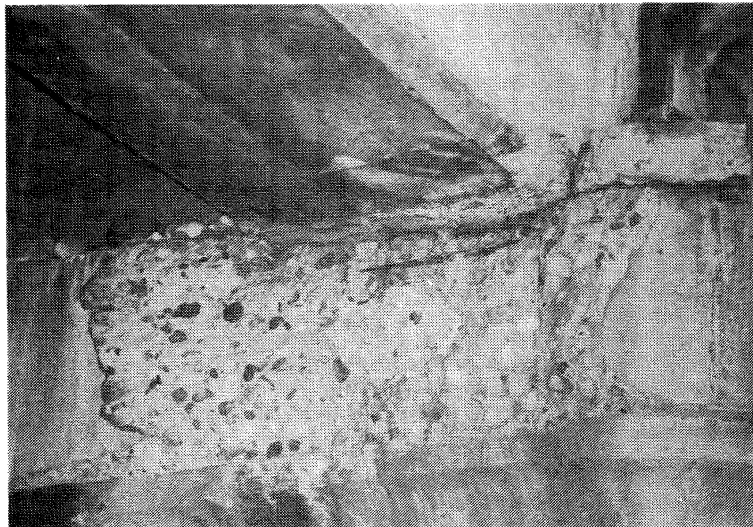
Figure 5.2.9: Spalling of pier cap due to deck beam bearing down on outer edge. The gap between pier cap and beam soffit had been packed with mortar to protect the bearing plate from corrosion

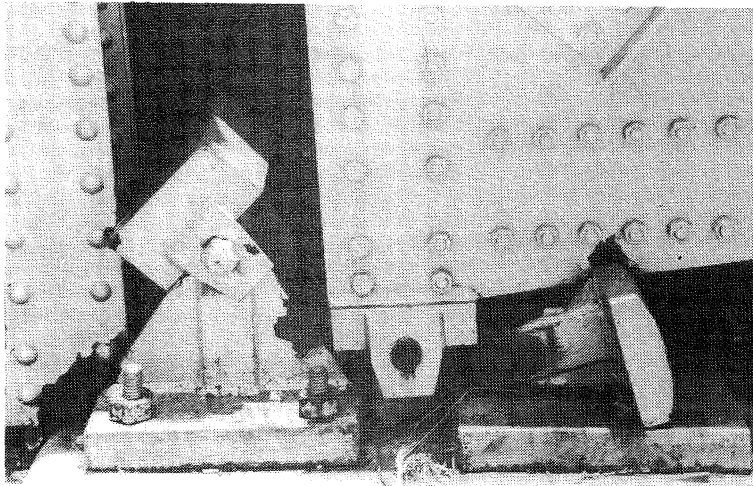
Figure 5.2.10: Carmen Bridge: pin and rocker bearing failure at the pier between spans 1 & 2. Refer Figure C6.1. There was no longitudinal tie between the girder spans

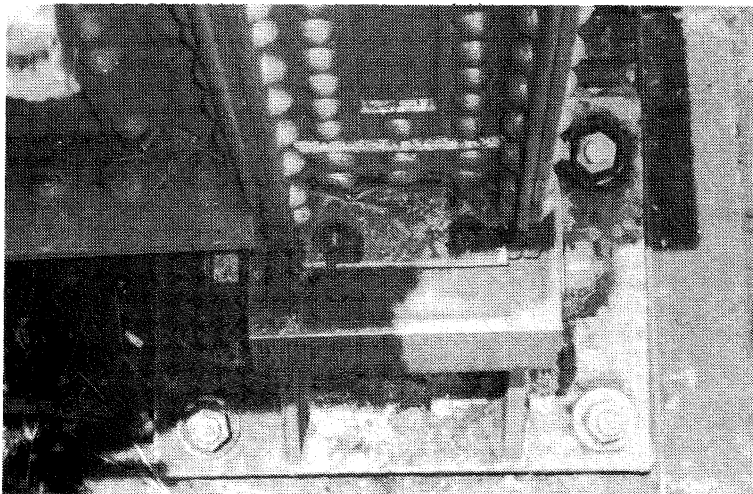
Figure 5.2.11: Shear failure of bolts at a girder support of the bridge shown in Figure 5.2.3

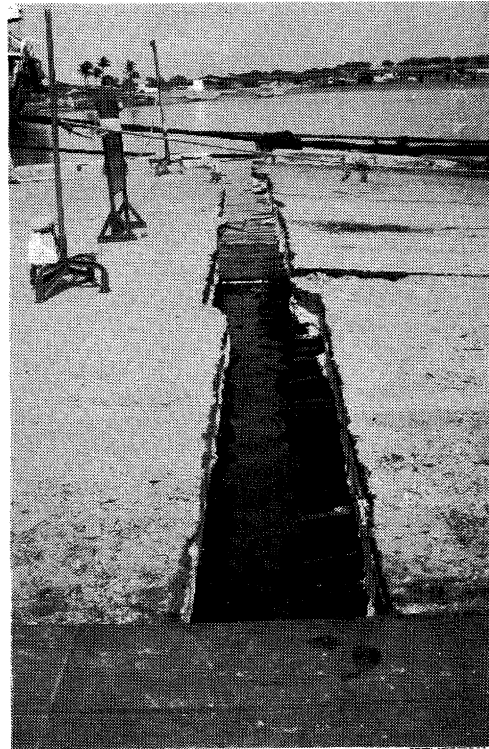
A number of raked piles had failed completely, with steel reinforcing breaking away from the longitudinal beam. Pile settlement of up to 400mm had occurred, particularly landwards of the deck tension failures. Severe corrosion had previously occurred to the pier steel reinforcing, particularly to the deck bottom bars and tidal section of the piles. The top surface of the 150mm thick deck was protected by a 70mm layer of asphaltic concrete topping. The corrosion of the longitudinal reinforcing had contributed to the tension failure of the deck and general

Figure 5.2.12: San Fernando port; tension failure of pier deck

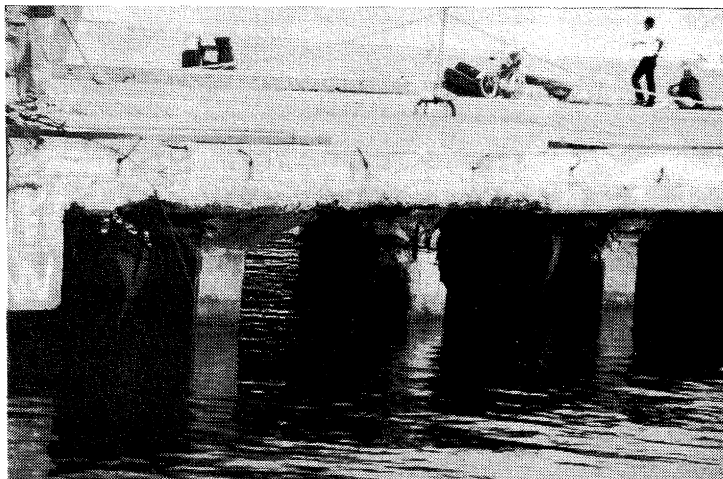
Figure 5.2.13: San Fernando port; failure of pier supports at the junction of vertical and raking piles

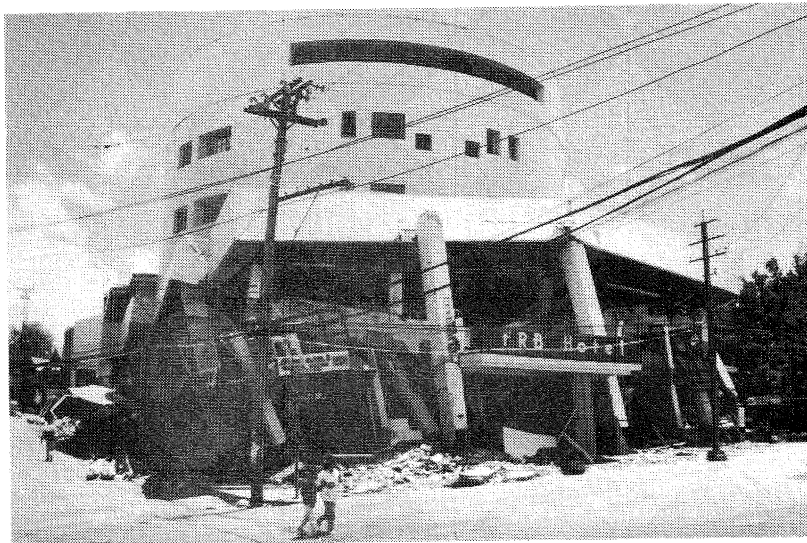
Figure 5.3.2: Two soft storeys at FRB Hotel, Baguio

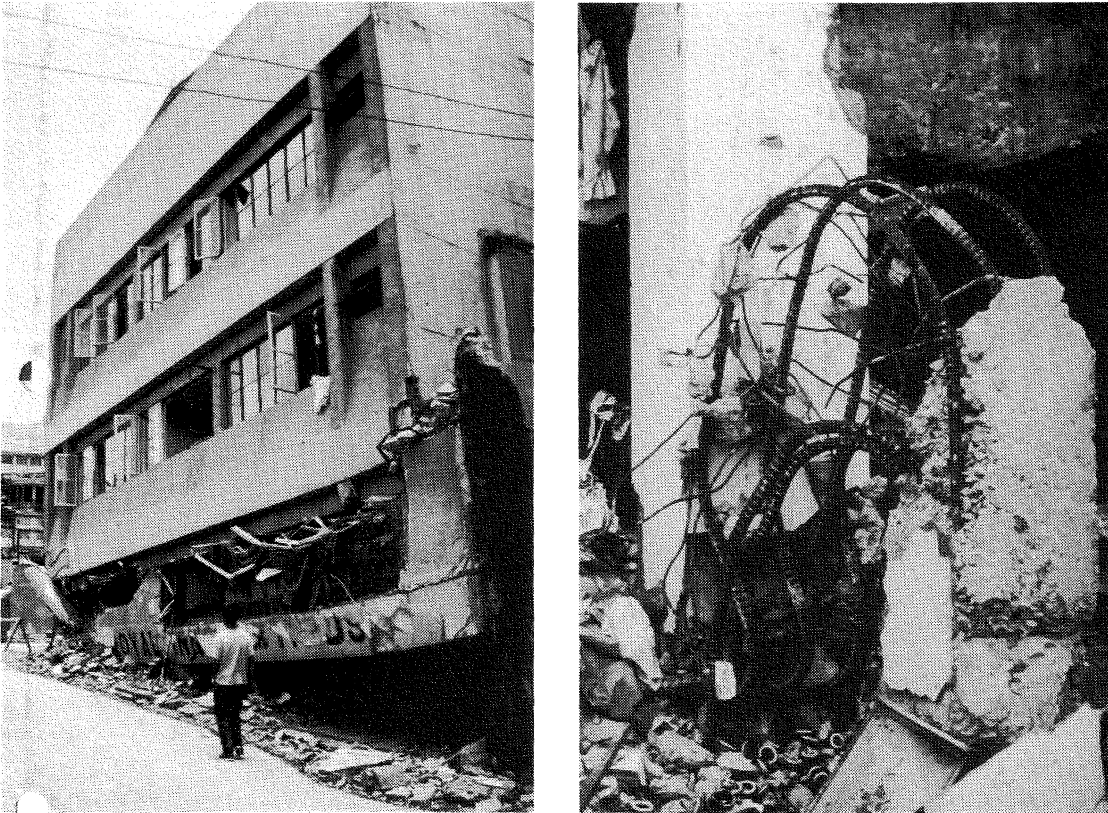
Figure 5.3.3: Soft storeys would test better reinforced columns than this one at the Royal Hotel, Baguio

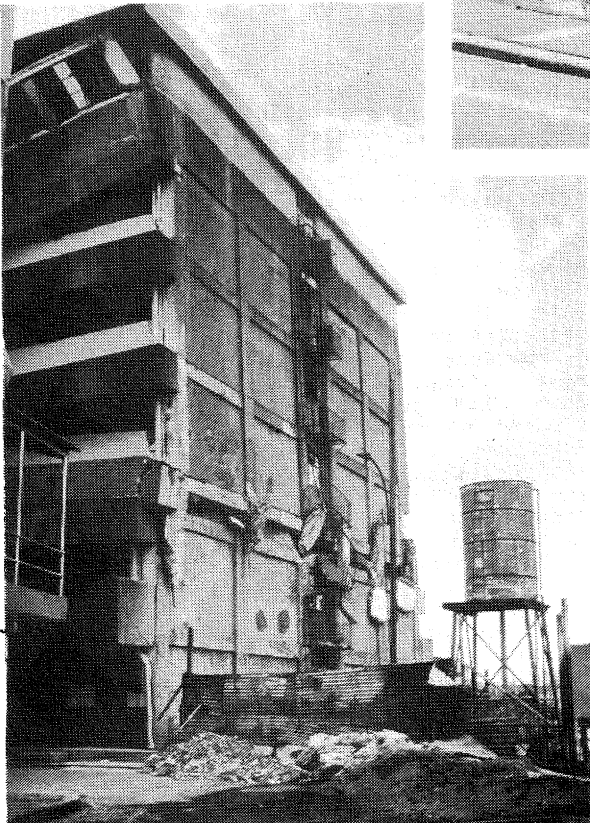
Figure 5.3.10: Loss of infill produces a soft storey - Science Building, Baguio University

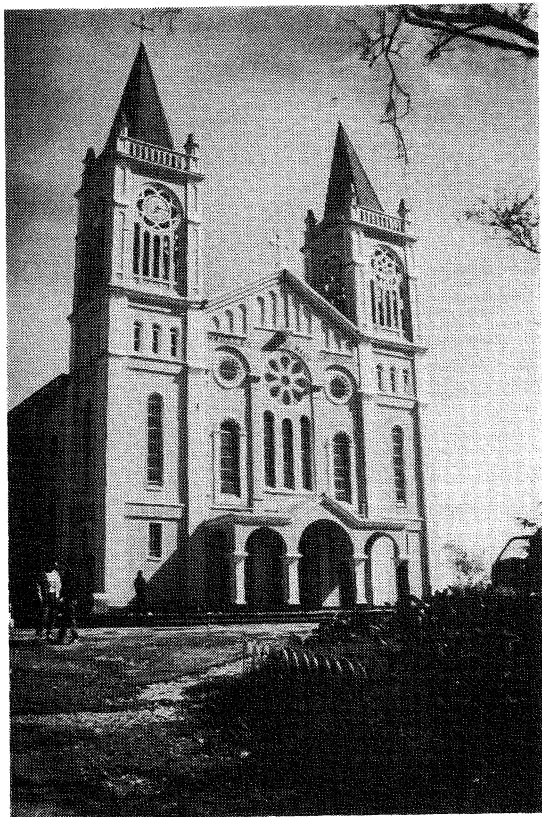
Figure 5.3.17: The reinforced concrete structure of Baguio Cathedral was virtually undamaged but the doors were firmly closed and services held outside. Note the tilt to the right hand tower roof

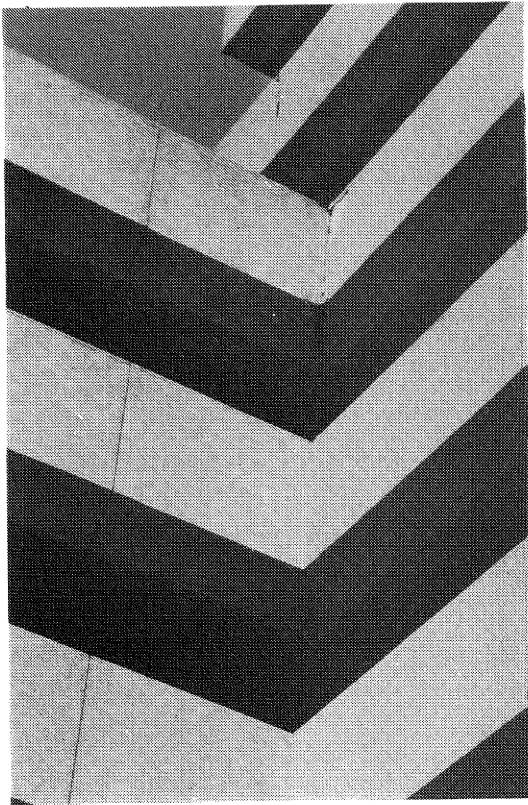
Figure 5.3.25: Manila office building; cracking at junction of sunscreen

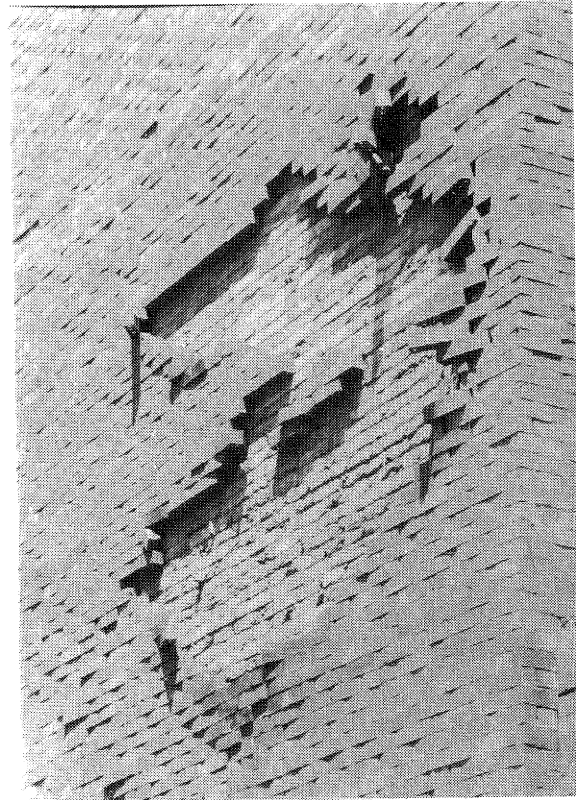
Figure 5.3.26: Loss of brick veneer - Baguio City

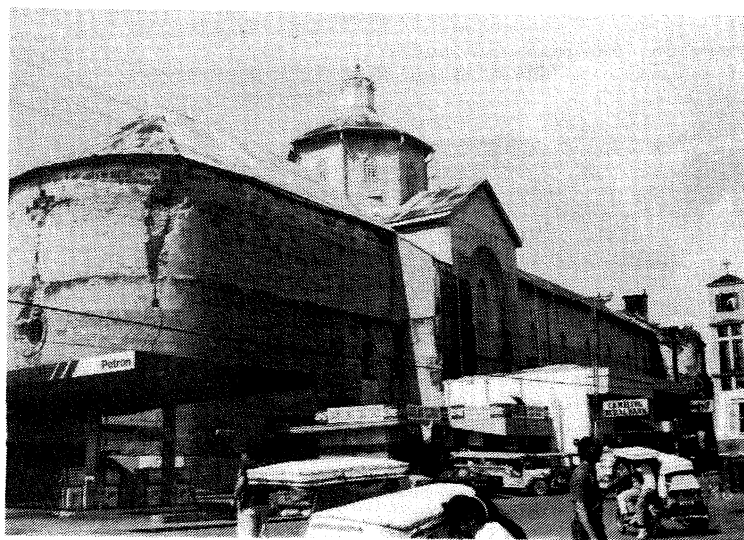
Figure 5.3.28: Camiling Cathedral; damage to nave as well as partial collapse of entrance tower (right hand end of church building)

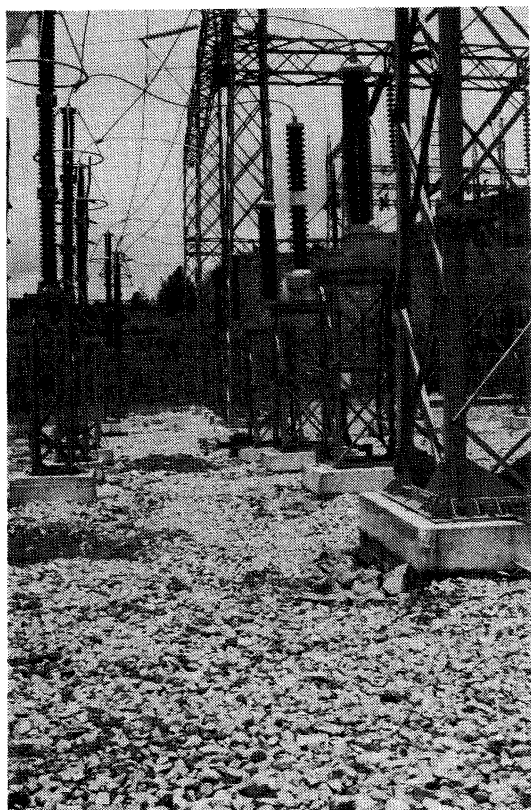
Figure 5.4.2: La Trinidad substation, Baguio; arrestor frames jacked back to level and foundation backfilled

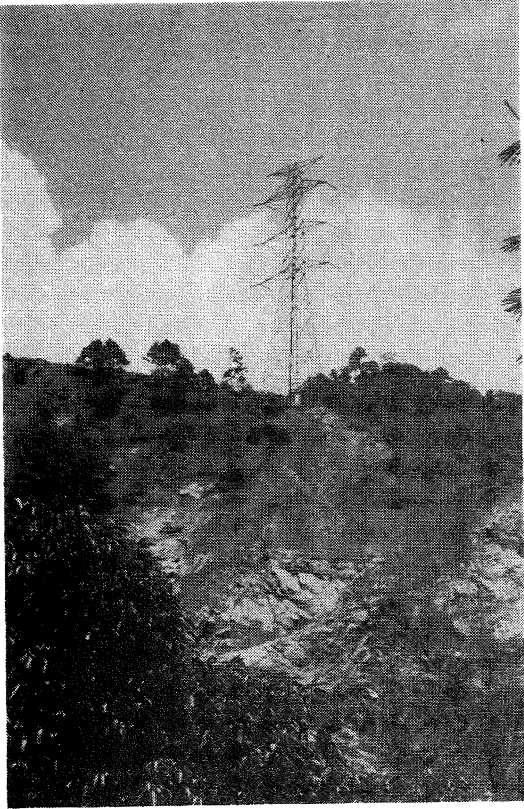
Figure 5.4.4: Power transmission line; east of Ambuklao Hydroelectric scheme. Being sited a spur, the tower is very vulnerable despite deep bored pile foundations, one of which is now exposed

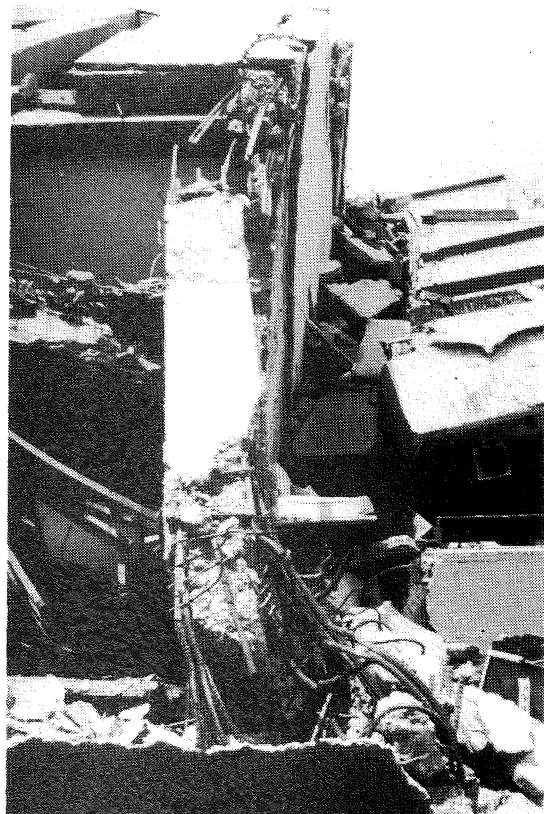
Figure C1.6: Tower block, Hyatt Terraces Hotel, Baguio; torsion/tension splice failure of column element at end of shear wall

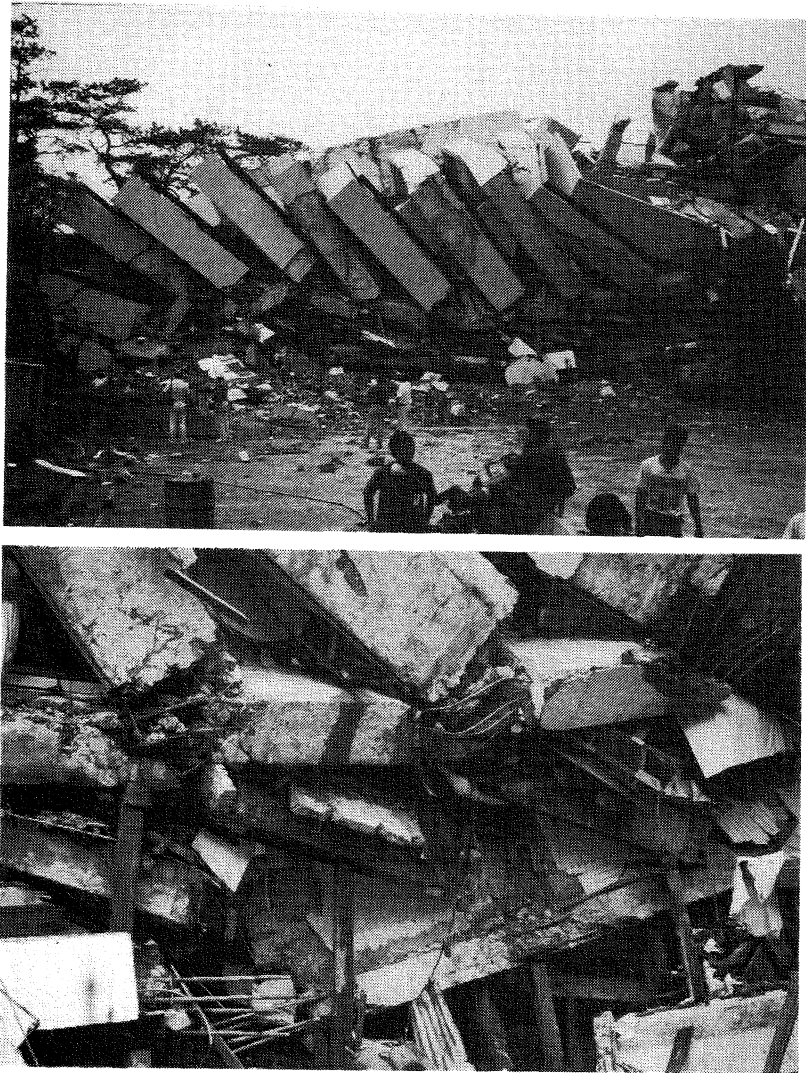
Figure C1.7: *(top)* Tower block, Hyatt Terraces Hotel, Baguio. The heavy balcony elements have collapsed back on themselves during impact due to failure of the joint with the column (now lying horizontal)

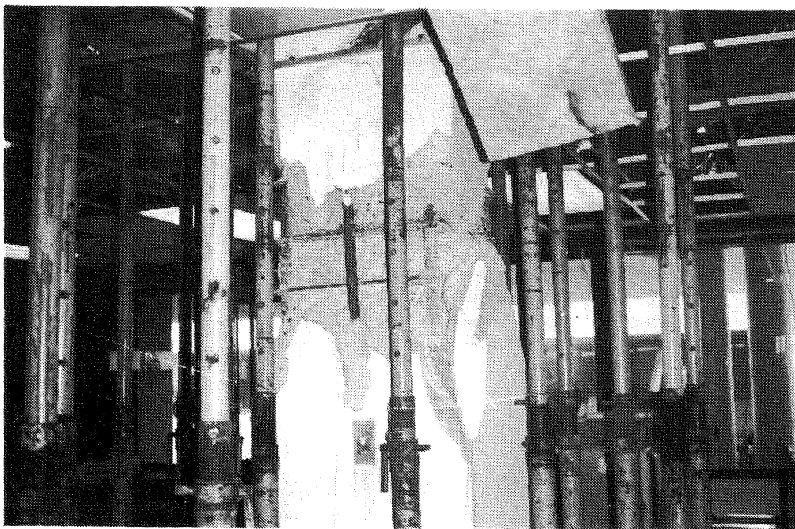
Figure C2.3: NPC Building, Quezon City, 3rd level; shear failure of column at mid height construction joint

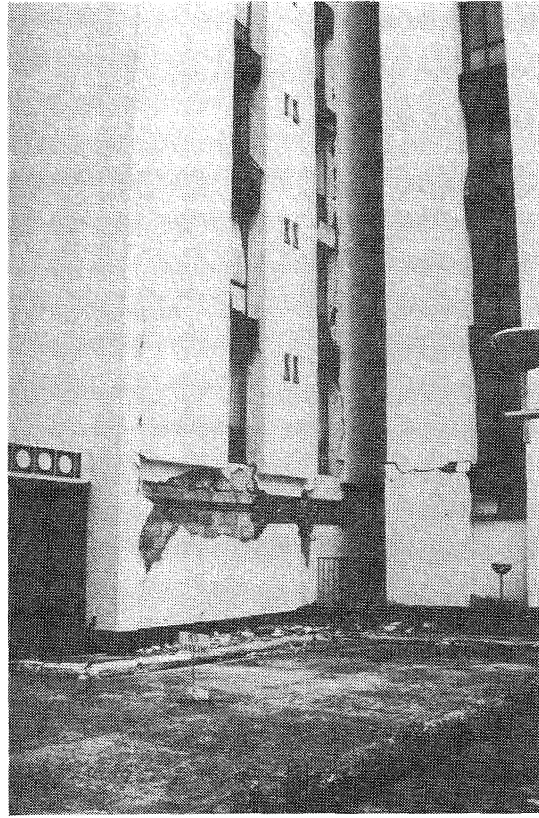
Figure C5.3: Montepinos Apartments, Baguio; windows broken due to structural movement

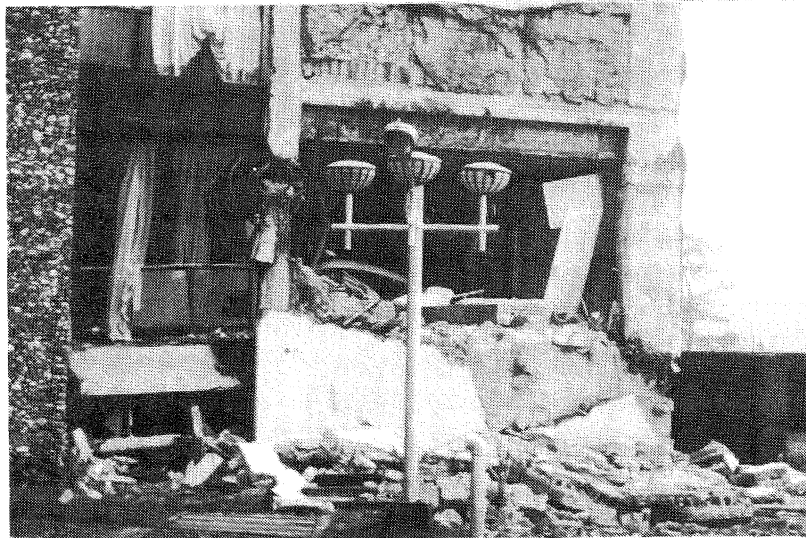
Figure C5.4: Montepinos Apartments, Baguio; failure of infill block panels and adjacent columns

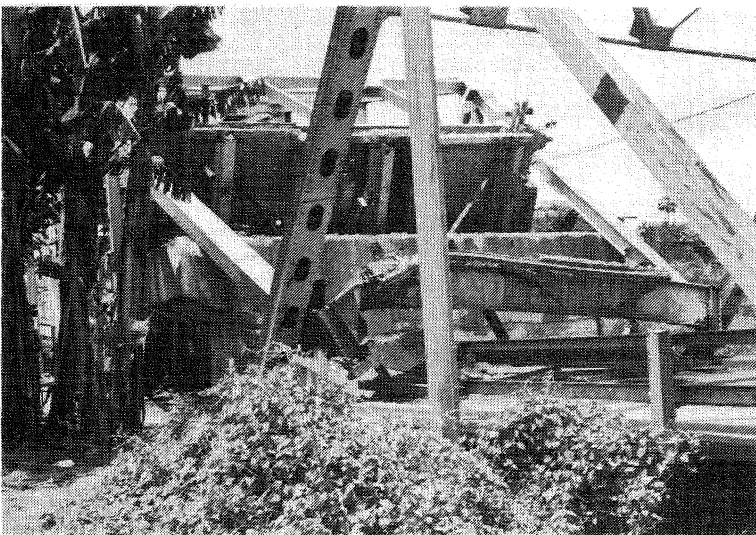
Figure C6.4: Carmen Bridge; pier between spans 12 and 13. Pier has broken up through bottom chord and deck of span 13 which has folded up - view towards the southwest

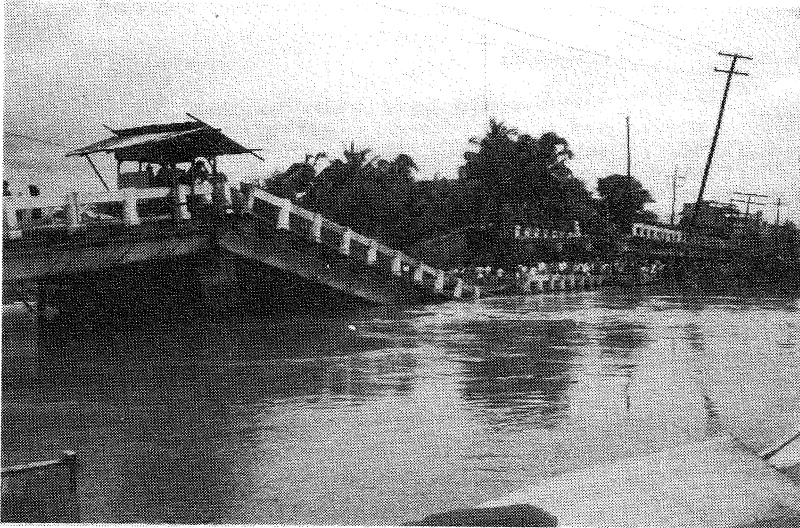
- . Total failure of the multispan steel and reinforced concrete, Magsaysay bridge in Dagupan due to liquefaction and lateral spreading of the river banks.

Figure C7.1: *Dagupan City, Magaysay Bridge on Perez Blvd.; collapse of bridge spans due to liquefaction and lateral spread of river bank*

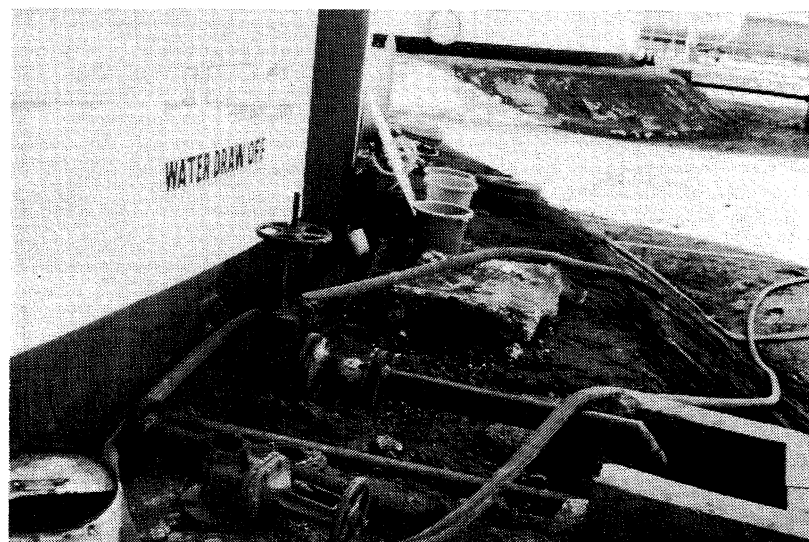
Figure C8.3: San Fernando Port - Oil Storage Facility. Storage tank settlement caused drainage valve to break because the outlet pipe was restrained by the concrete sump wall. Note the broken valve in the foreground
