## An Immediate and Preliminary Report on THE MANJIL, IRAN EARTHQUAKE OF 20 JUNE 1990

A. A. Moinfar<sup>1</sup> and A. Naderzadeh<sup>1</sup>

**Editorial Note:** This article is based on a brief English version of a fuller report by the authors originally published as Publication No. 119, July 1990 of the Building and Housing Research Centre.

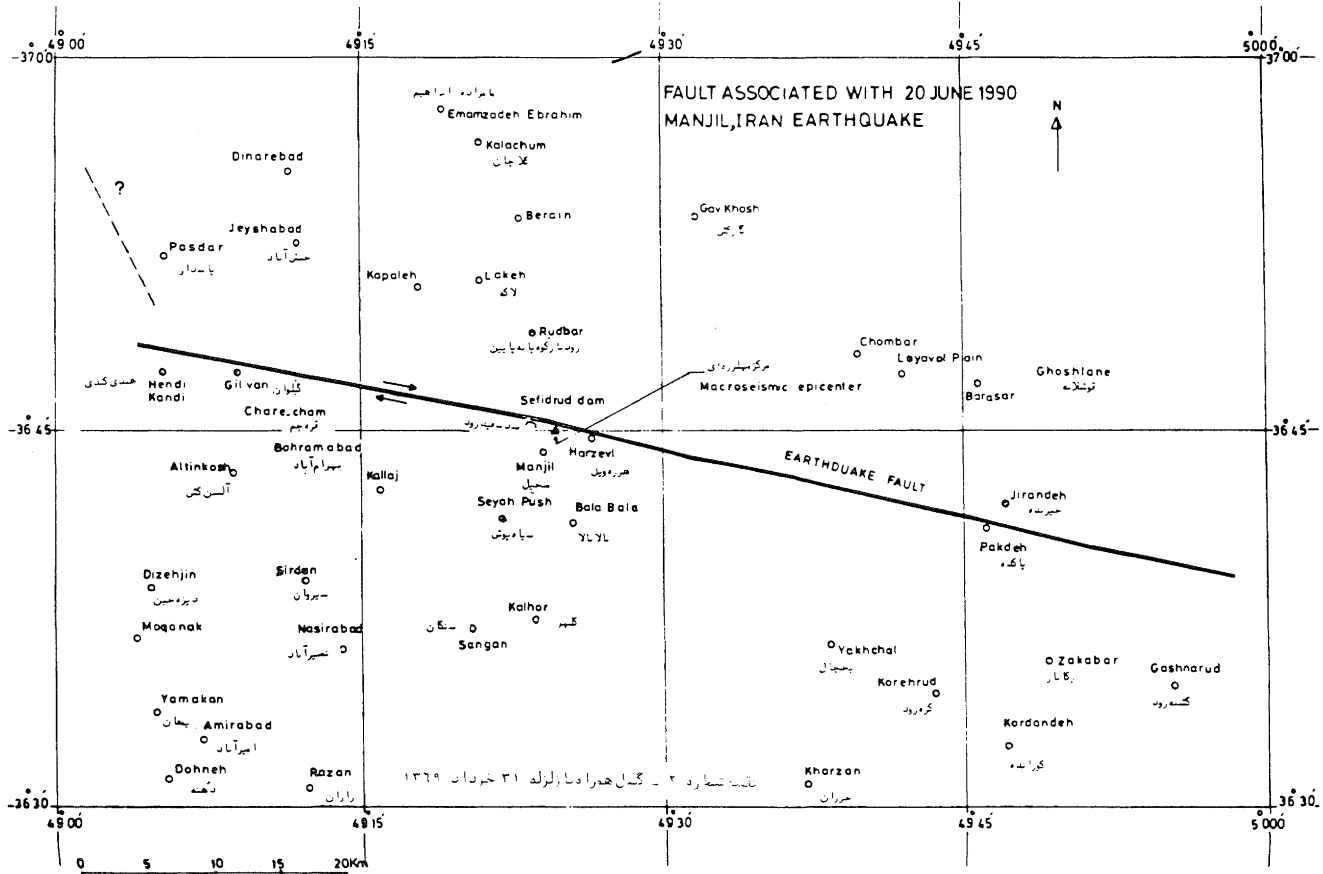
FIGURE 2: FAULT ASSOCIATED WITH THE 20 JUNE 1990 MANJIL, IRAN EARTHQUAKE.

Figure 2 shows the observed fault associated with the 20 June 1990 earthquake. A vertical displacement as large as 2.5 m was also seen in Pakdeh village which has divided the road into two parts. This movement seems to be due to a landslide rather than a vertical displacement of the fault.

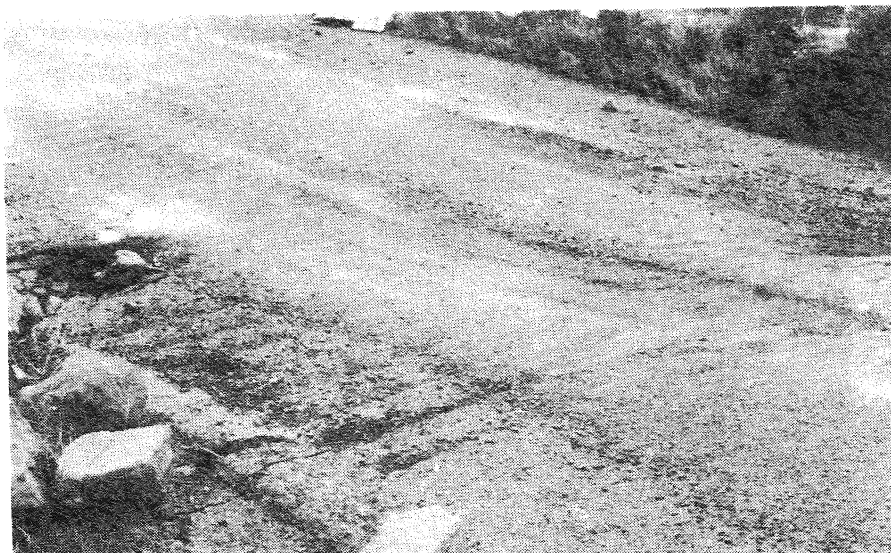
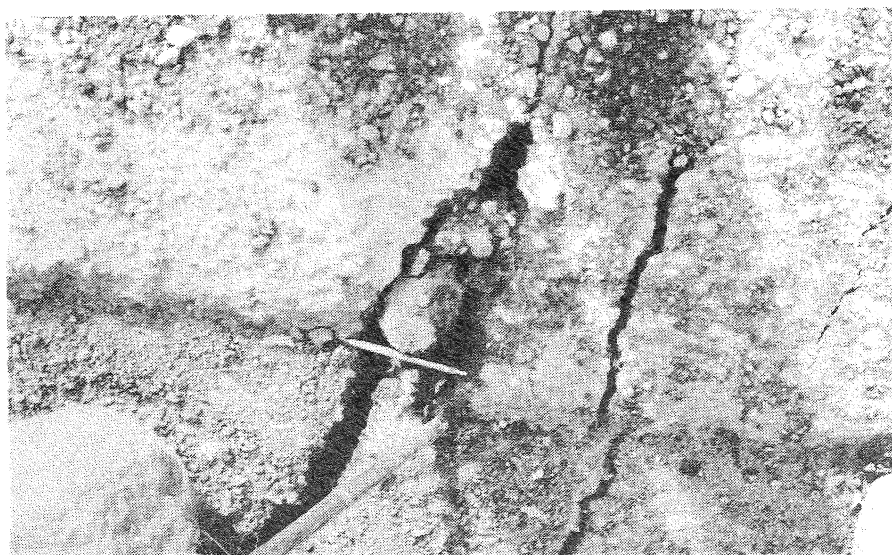
damage in the region, it was felt that the cause of the 20 June 1990 earthquake might be the Rudbar fault and the abovementioned gap. Local preliminary observation showed that there is evidence of faulting about 300 m north of the Sefidrud dam (Figures 3 and 4). Detailed study of the site showed that this fault is parallel to the mapped Rudbar fault. The fault intersects the downstream face of the dam and runs towards the west passing to the north of Gilvan and continues on to the west (Figures 5-6). The evidence of movement in Hendi Kandi village is clearly visible. In the Abbar area to the north of Hendi Kandi, cracks and ruptures are visible running north-south with an inclination to the west. The final judgement about these ground displacements will require more detailed study.

FIGURE 3: FAULT ON THE ROAD TO THE NORTH OF SEFRIDRUD DAM (TOP) WITH A CLOSE VIEW OF THE FAULT BREAK (BOTTOM).

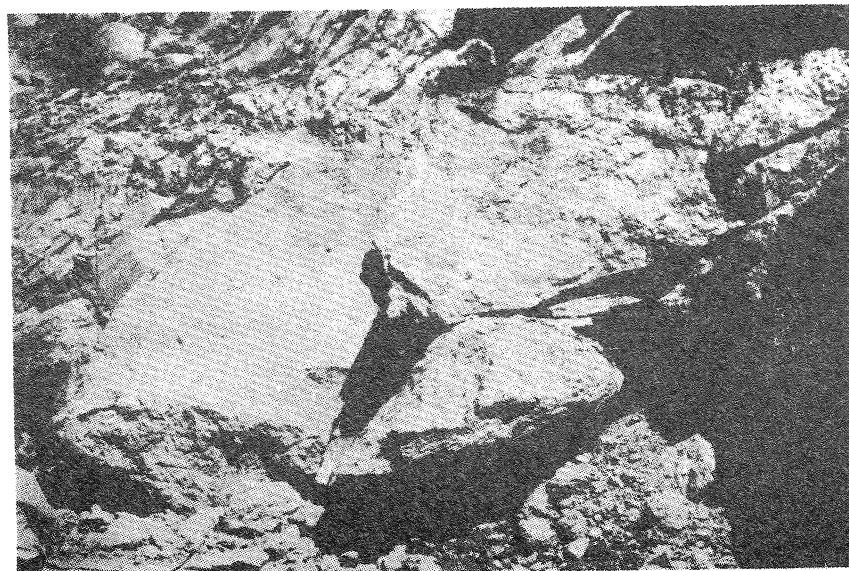
FIGURE 4: ROCK FALL NEXT TO THE SEFRIDRUD DAM.

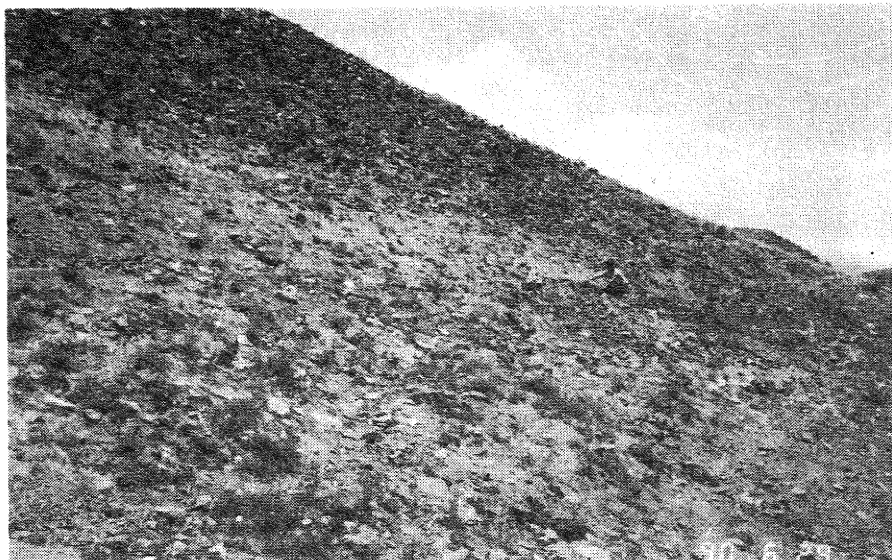
FIGURE 5: VERTICAL GROUND DISPLACEMENT (ABOUT 30 CM) TO THE NORTH OF GILVAN.

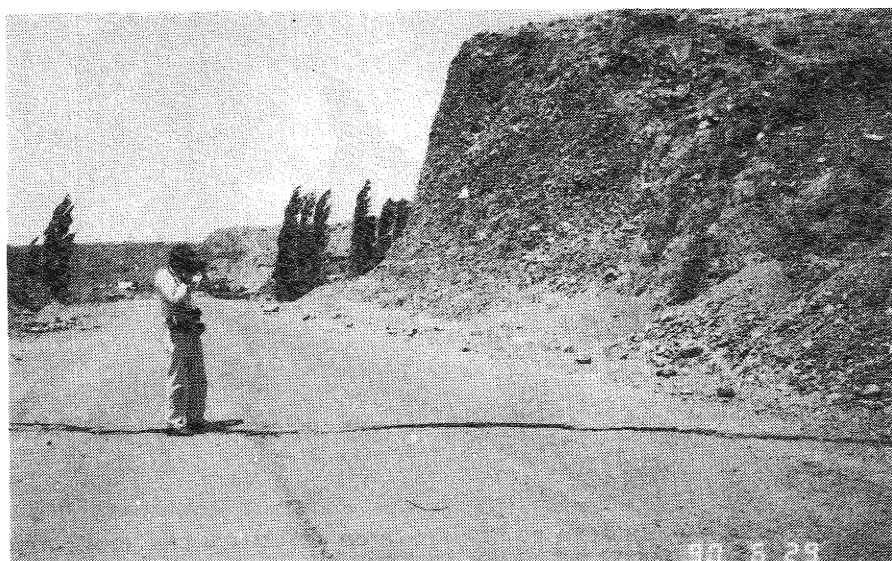
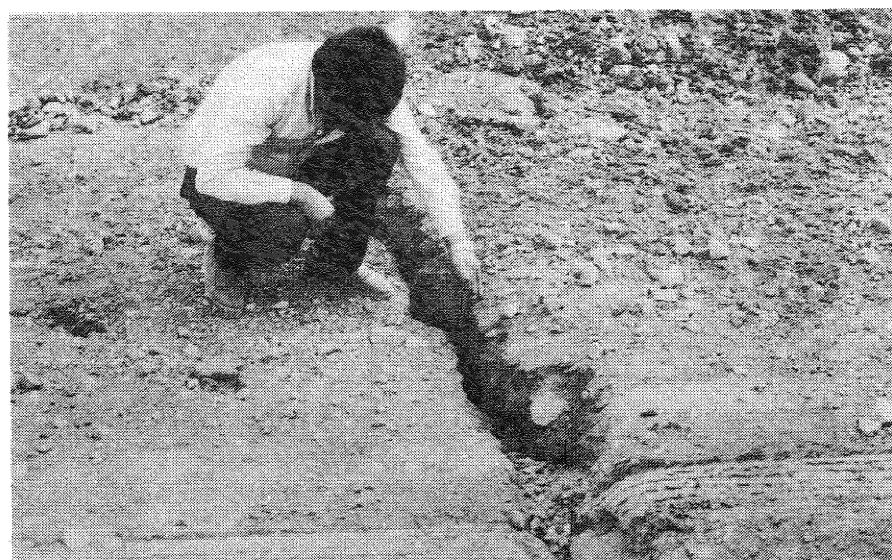
FIGURE 6: GROUND DISPLACEMENT TO THE NORTH OF GILVAN (TOP) AND IN HENDI KANDI VILLAGE (BOTTOM).

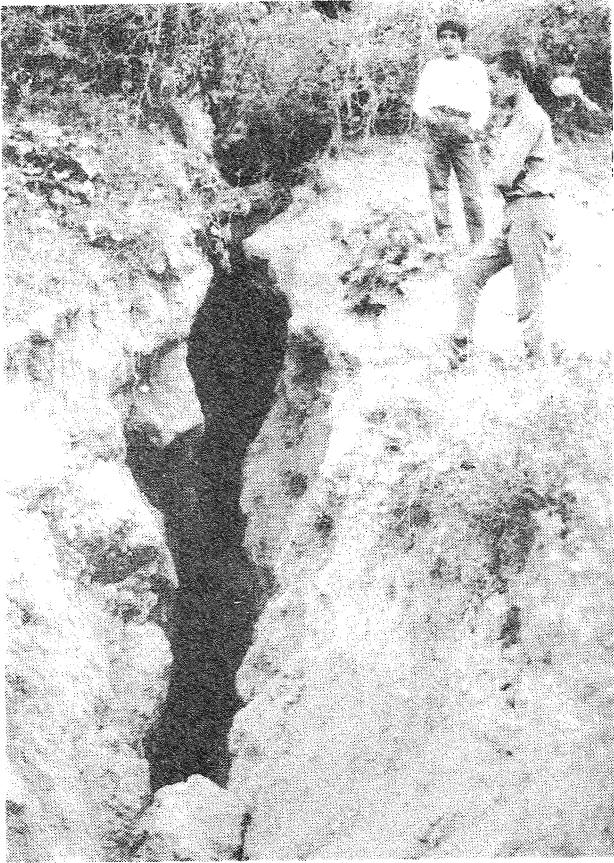
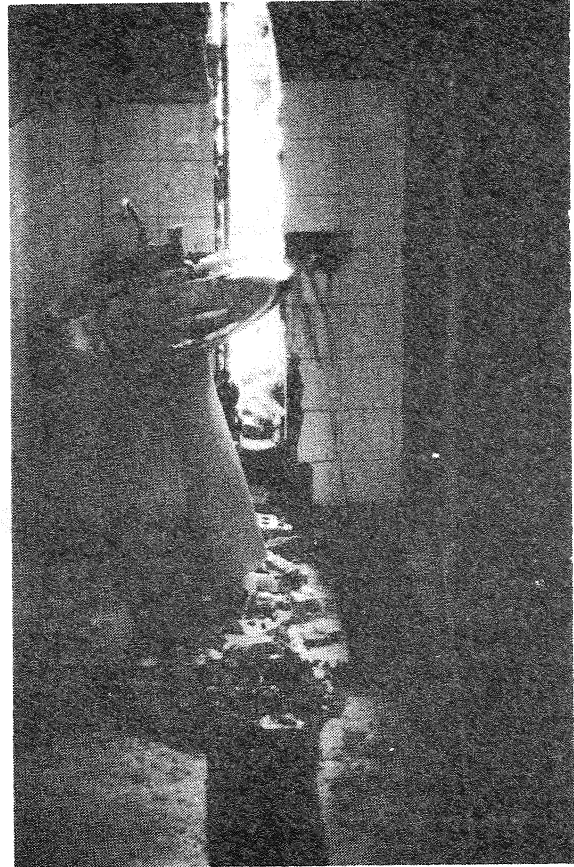
**FIGURE 7: GROUND RUPTURE IN PAKDEH VILLAGE (LEFT) WITH THE FAULT PASSING THROUGH A HOUSE (RIGHT). IN SPITE OF THE GROUND RUPTURE, THE BUILDING AND ITS ROOF REMAINED INTACT.**

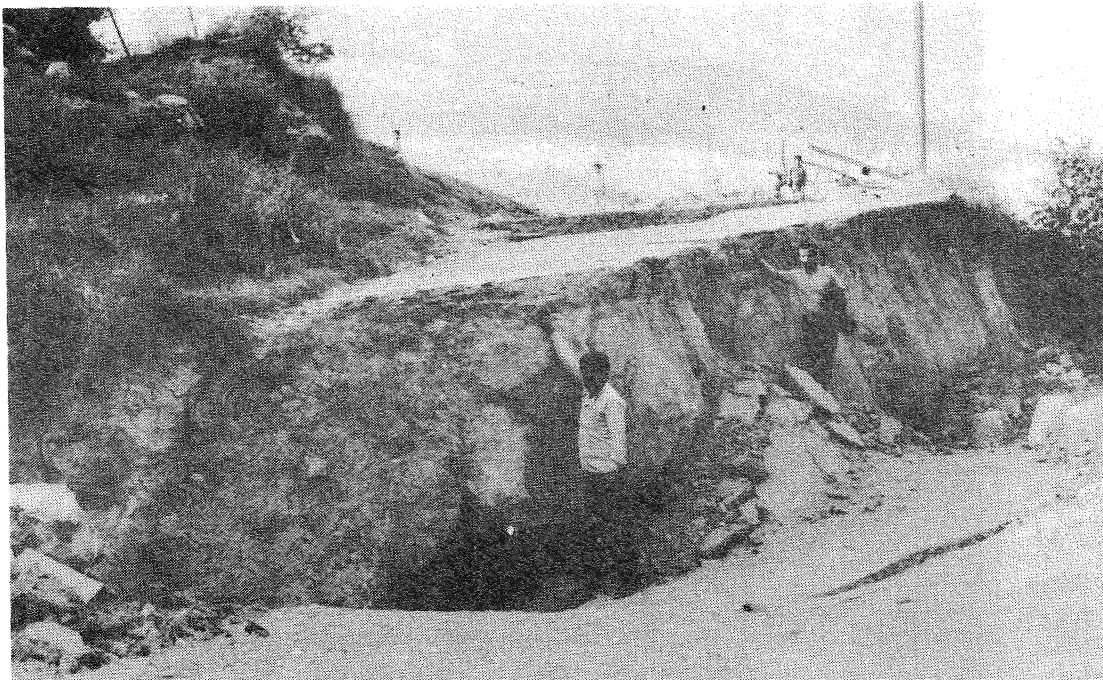
**FIGURE 8: VERTICAL DISPLACEMENT CAUSED BY A LANDSLIDE ON THE ROAD TO JIRANDEH IN THE VICINITY OF THE FAULT BREAK.**

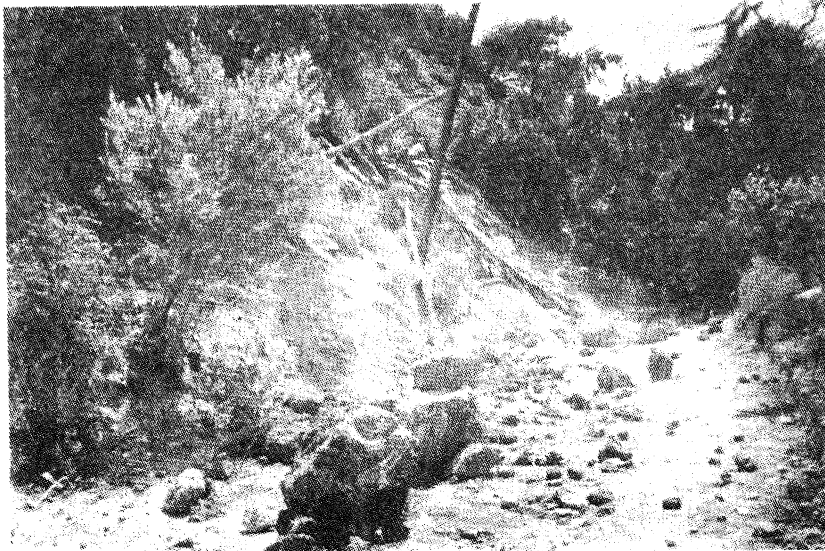
**FIGURE 9: A HUGE LANDSLIDE IN RUDBAR WHICH BLOKED THE ROAD (THIS LANDSLIDE IS STILL CONTINUING).**

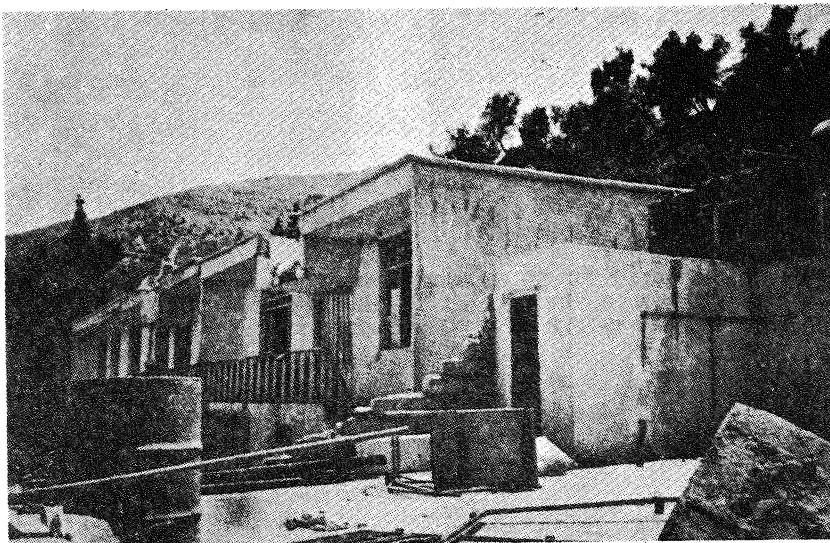
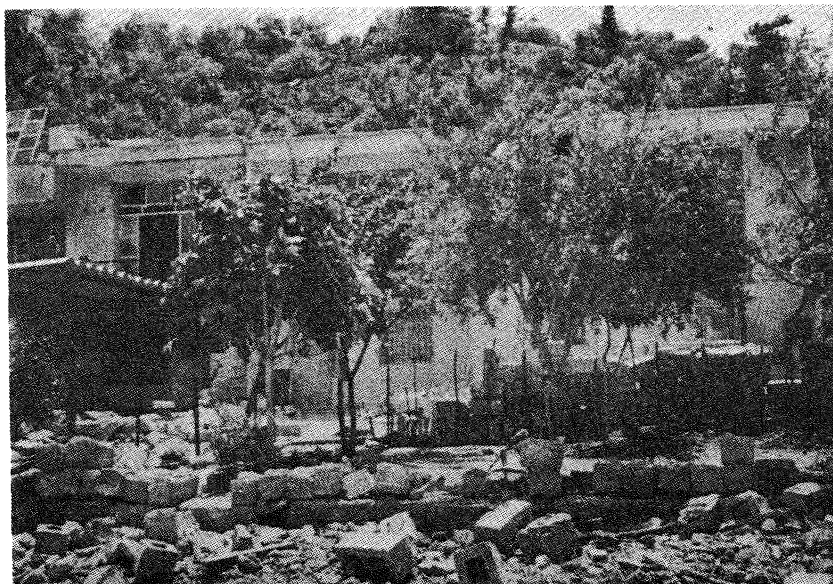
**FIGURE 10: LANDSLIDE DANGER TO BUILDINGS THAT SURVIVED THE EARTHQUAKE.**

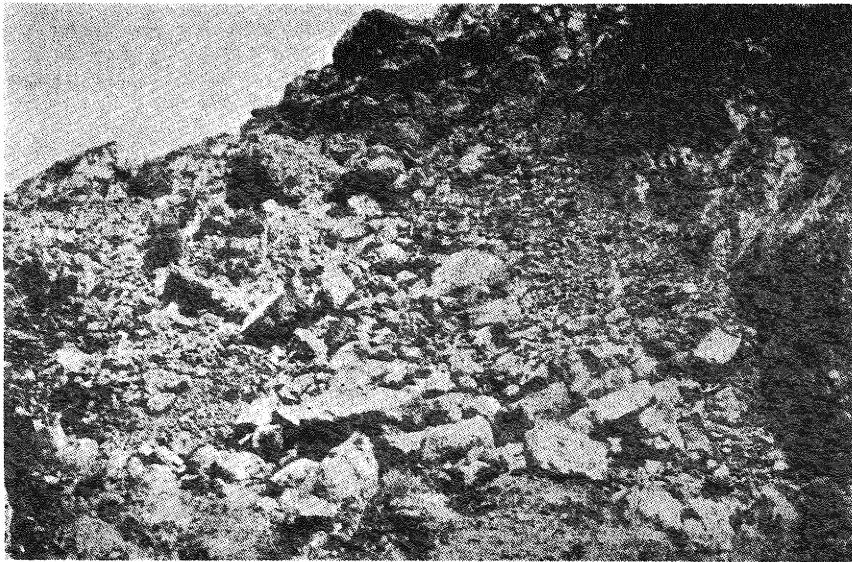
FIGURE 11: ROCKFALL IN HARZEVIL AREA.

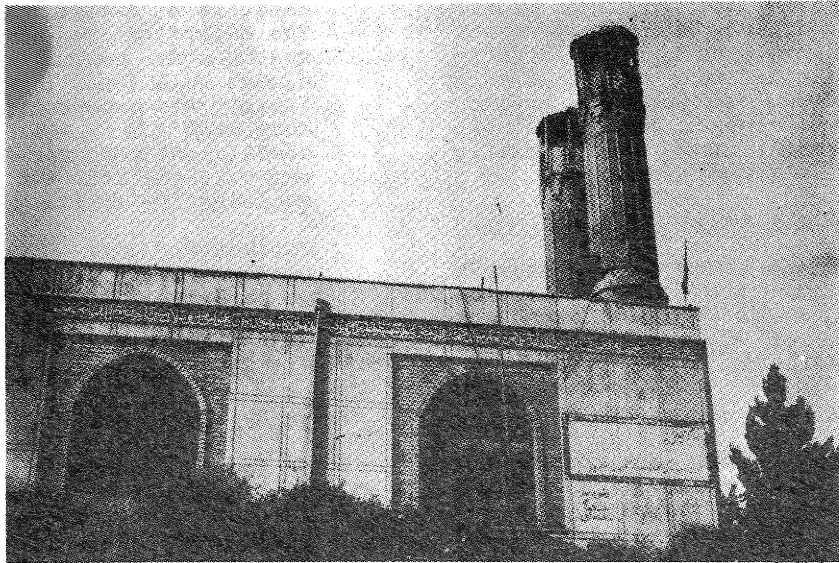
FIGURE 12: A HORIZONTAL CRACK AT THE BASE OF THE MOSQUE'S MINAR IN SANGRUD NEAR JIRANDEH.

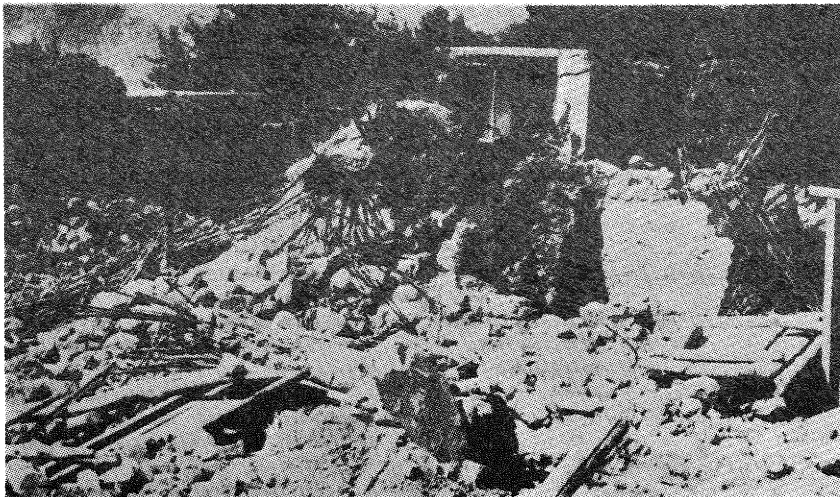
Traditional buildings which mainly consist of stone or sun dried mud brick walls with wooden pole roofs, suffered heavy damage and caused the death of many people in the villages (Figures 12-15).

FIGURE 13: COLLAPSE OF TRADITIONAL SUN DRIED BRICK HOUSES IN THE VILLAGE OF HENDI KANDI.

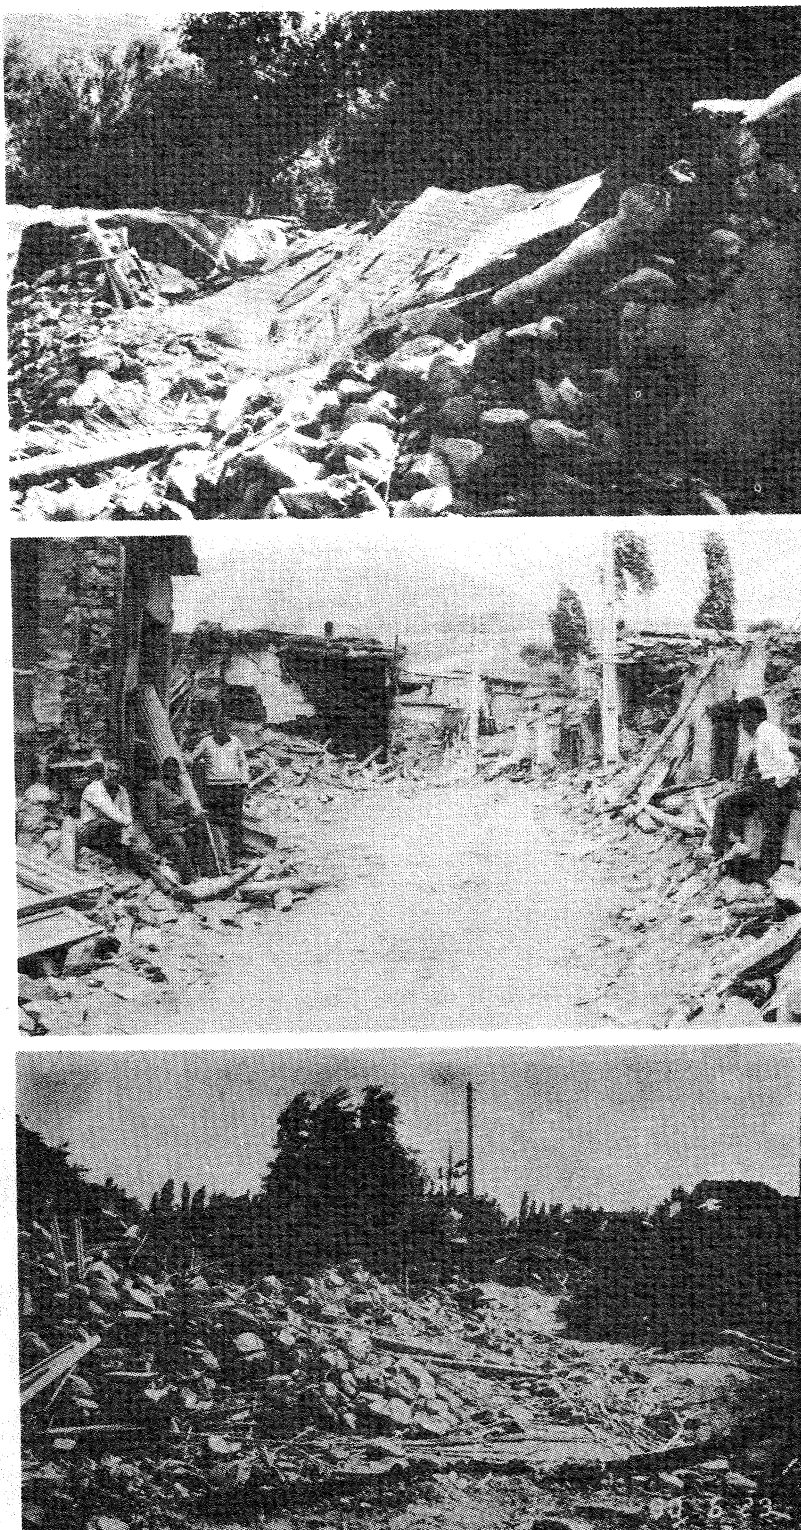
**FIGURE 14: COLLAPSE OF:**  
 (TOP) A TRADITIONAL RURAL HOUSE;  
 (MIDDLE) SUN DRIED MUD-BRICK HOUSES IN THE VILLAGE OF KELISHAM;  
 (BOTTOM) TRADITIONAL BUILDINGS WITH STONE AND SUN DRIED BRICK WALLS AND WOODEN POLE ROOFS IN THE VILLAGE OF HENDI KANDI.

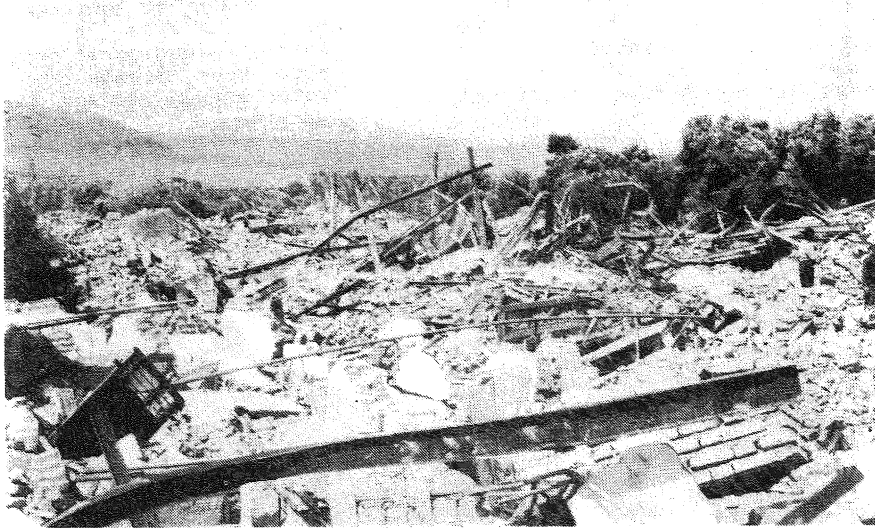
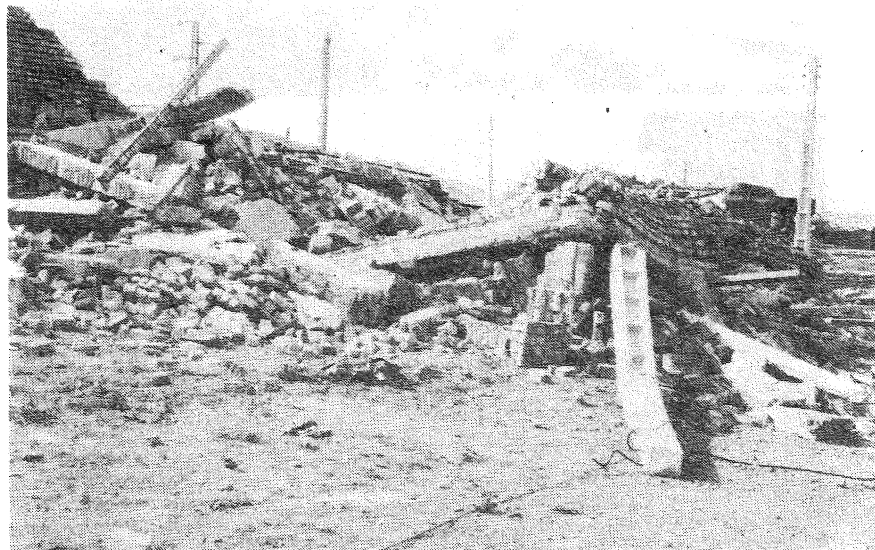
FIGURE 15: EXAMPLES OF THE DESTRUCTION IN MANJIL.

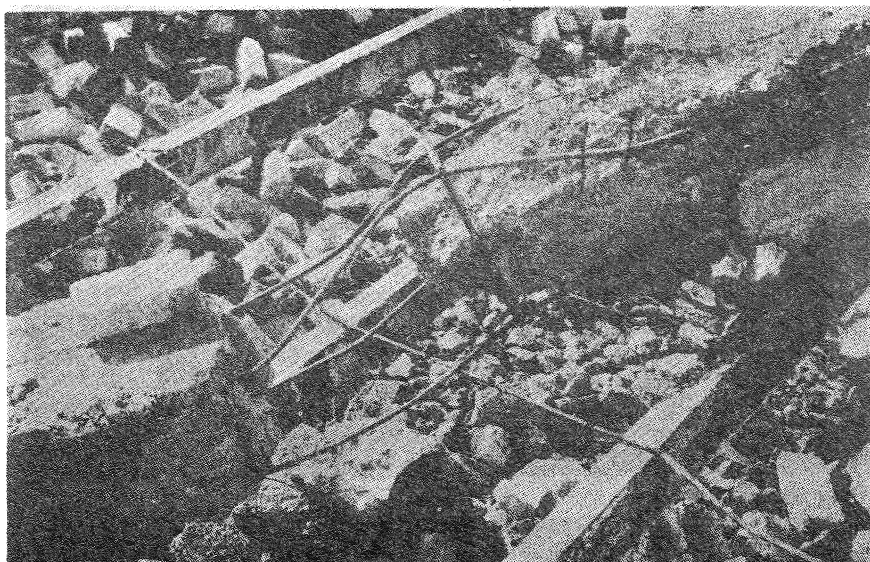
Generally, as has been experienced in similar earthquakes in the past in Iran, if reinforced concrete tie beams under roofs were constructed properly, they remained erect and in spite of collapse of masonry walls, the roofs did not collapse and remained as a unit and thus saved lives (Figures 16-22).

FIGURE 16: DISINTEGRATION OF A TIE BEAM IN A MASONRY BUILDING IN MANJIL.

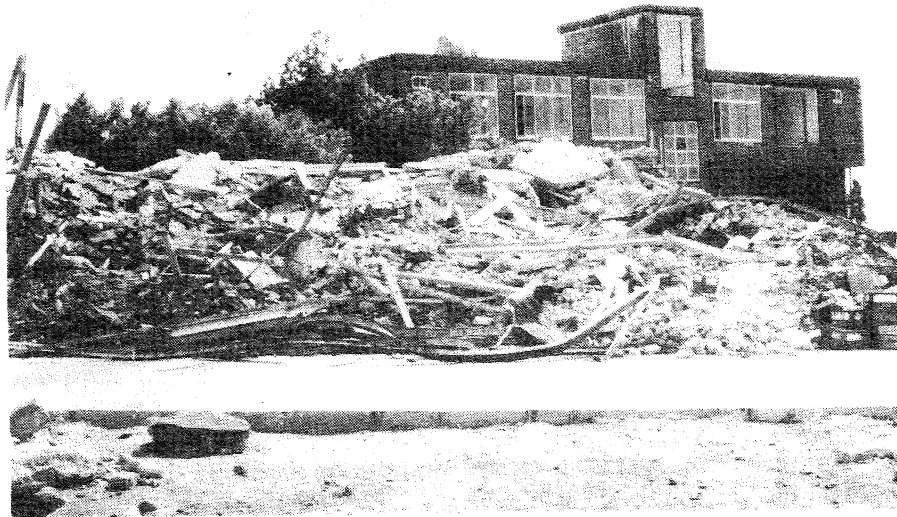
FIGURE 17: AN UNDAMAGED MASONRY BUILDING NEXT TO ANOTHER MASONRY STRUCTURE WHICH HAS COLLAPSED TOTALLY.

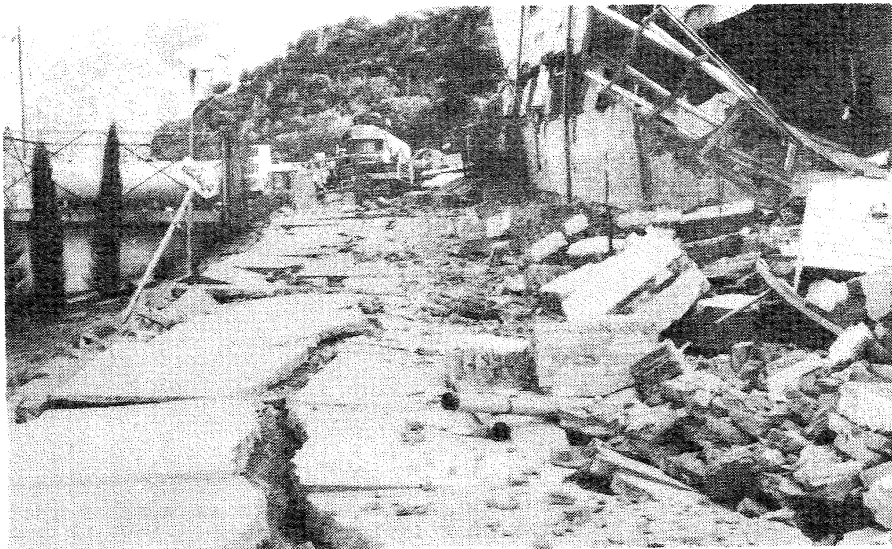
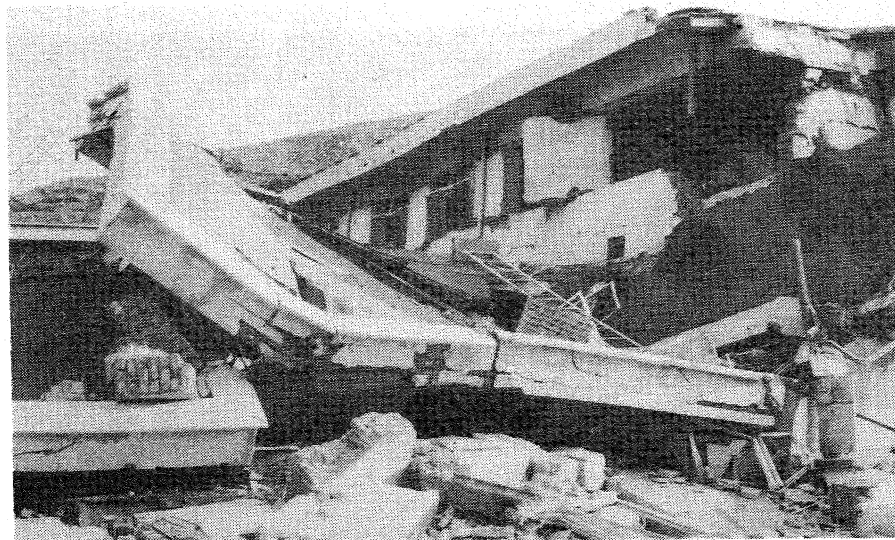
FIGURE 18: RUDBAR HOSPITAL AFTER THE EARTHQUAKE (TOP) WITH LONG CANTILEVER SPANS DAMAGED (BOTTOM).

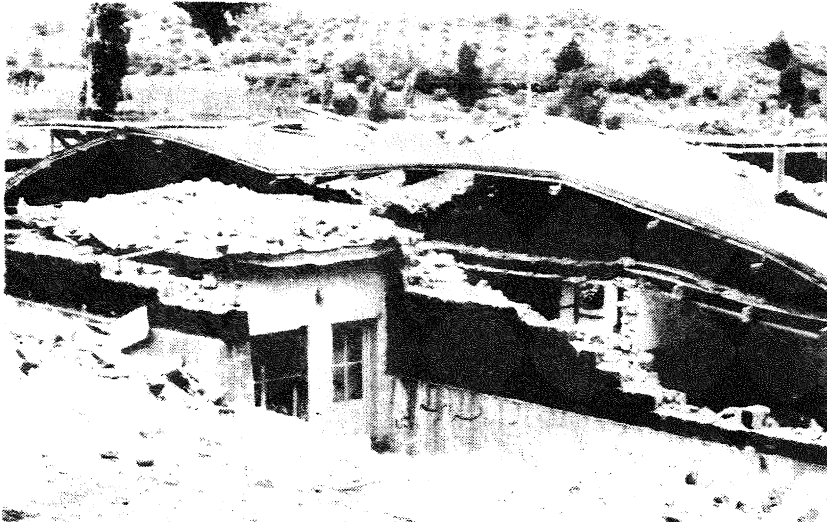
FIGURE 19: A SCHOOL BUILDING IN THE VILLAGE OF HARZEVIL TO THE EAST OF MANJIL WITH STONE WALLS AND LIGHT WOODEN TRUSS ROOF COVERED BY LIGHTWEIGHT IRON SHEETING.

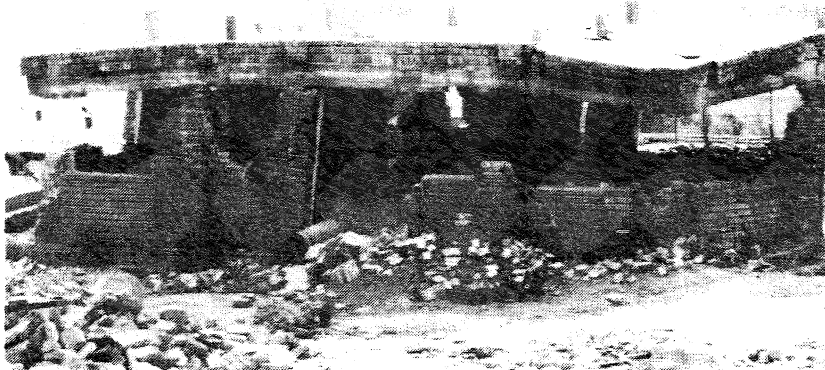
FIGURE 20: THE HORIZONTAL REINFORCED CONCRETE TIE BEAM UNDER THIS ROOF IN MANJIL HAS KEPT THE ROOF INTACT IN SPITE OF THE COLLAPSE OF THE SURROUNDING WALLS.

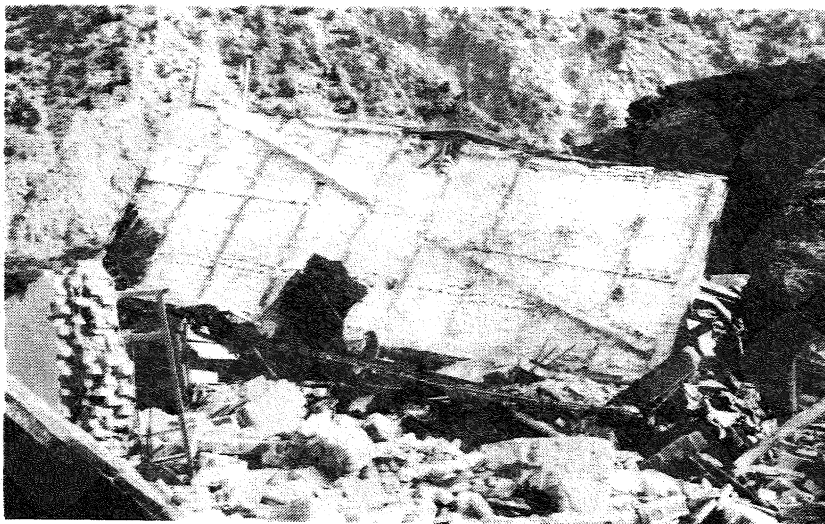
FIGURE 21: A TIED BRICK ARCH ROOF WHICH COLLAPSED AS A UNIT WITHOUT THE ROOF DISINTEGRATING.

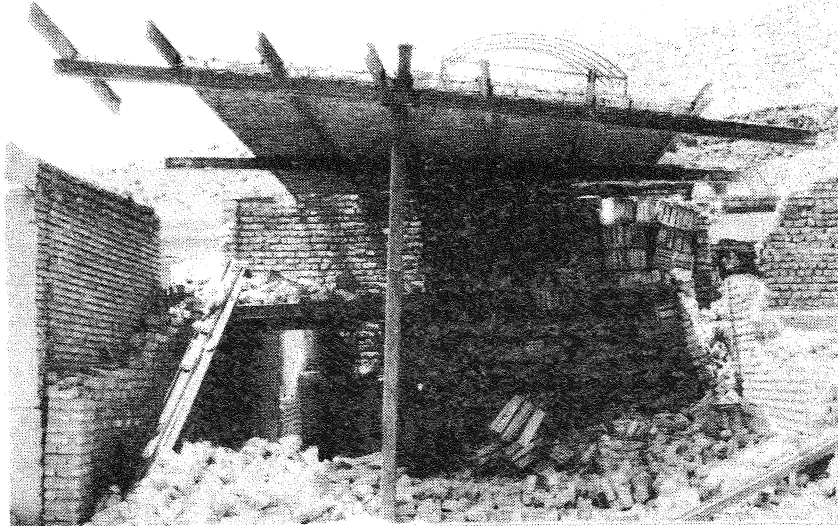
**FIGURE 22: THE BEARING WALLS LOCATED ON BOTH SIDES OF THIS BUILDING IN MANJIL COLLAPSED. THE PERFORMANCE OF THE MIDDLE COLUMN WAS SUCH THAT IT SAVED THE ROOF FROM COMPLETE COLLAPSE.**

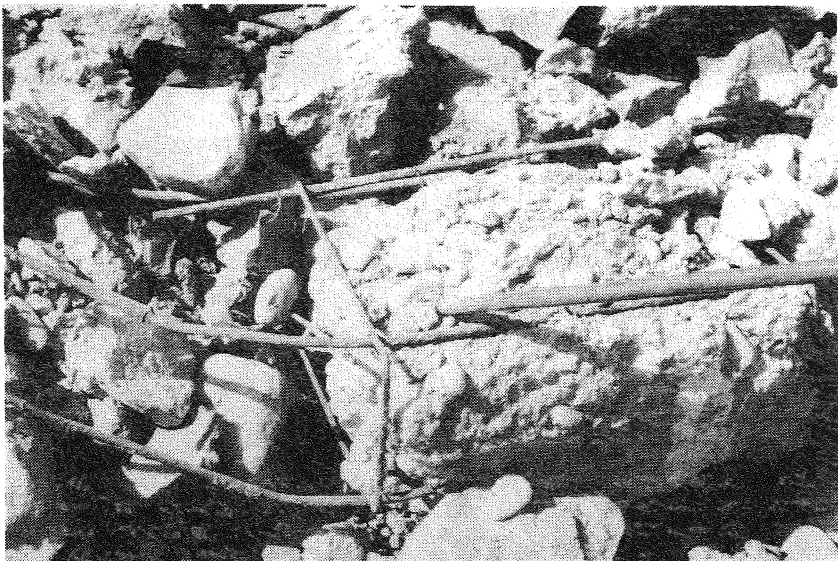
There were several steel and reinforced concrete buildings in the earthquake affected area (Figures 23-31). Some suffered damage on account of weak joints, low quality concrete and poor workmanship. The most damage has been to tall buildings (7 storeys and over) in the city of Rasht, 60 km from the epicentral area. The intensity in this city was about VI. The main reason for the extension of damage to such a relatively long distance from the epicentre, other than the problems stated above, is the

**FIGURE 23: DISINTEGRATION OF CONCRETE IN A REINFORCED CONCRETE TIE BEAM ( NO DUCTILE BEHAVIOUR).**

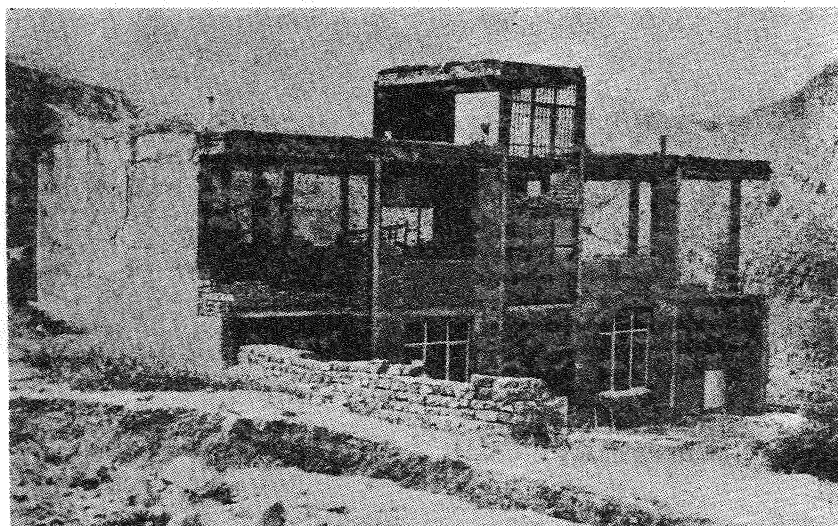
**FIGURE 24: A STEEL FRAMED BUILDING NEXT TO THE GROUND RUPTURE.**

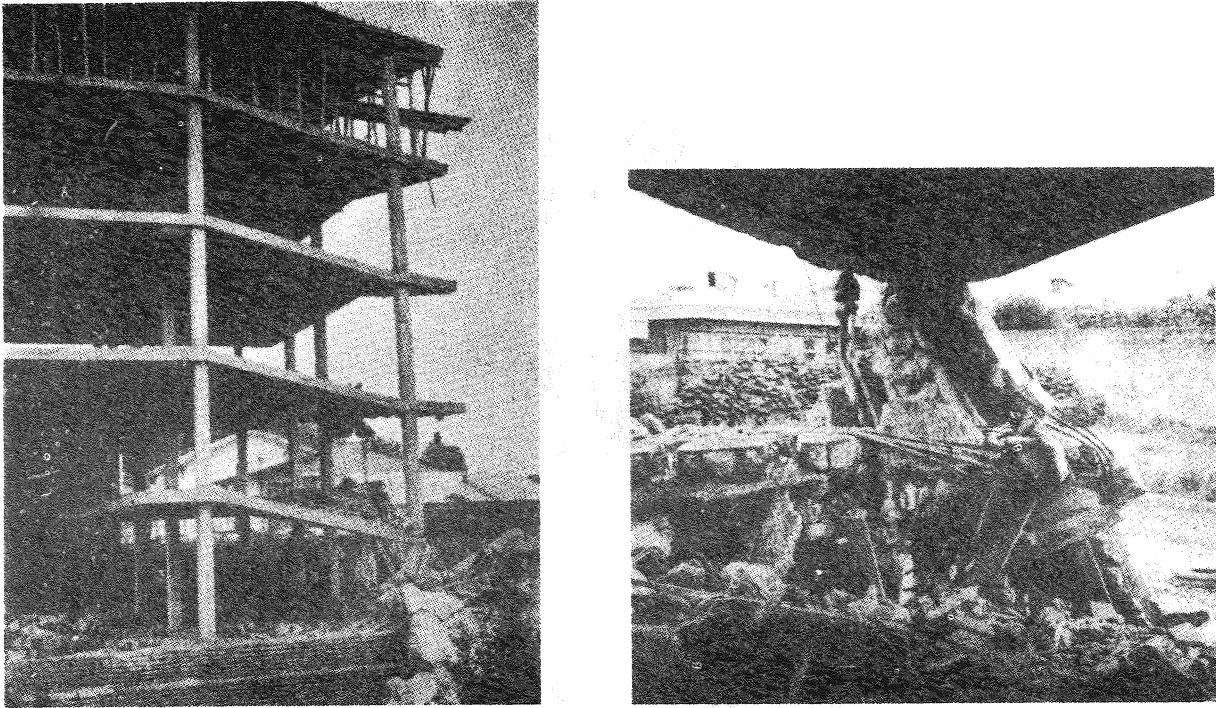
**FIGURE 25: A FIVE STOREY REINFORCED CONCRETE BUILDING UNDER CONSTRUCTION IN RASHT (LEFT) WITH A CLOSE-UP VIEW OF A FAILED REINFORCED CONCRETE COLUMN (RIGHT).**

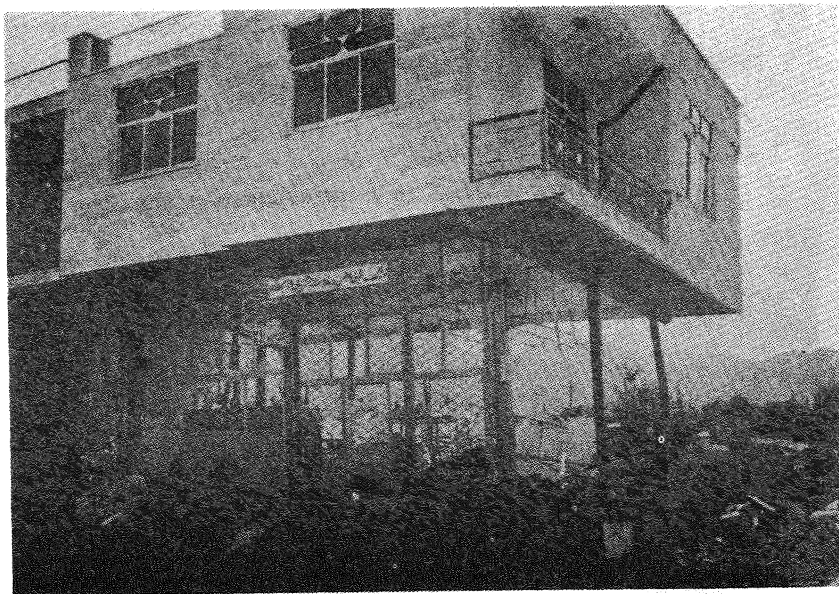
**FIGURE 26: THE STEEL COLUMNS OF THIS BUILDING IN MANJIL WERE LEFT BUCKLED BY THE EARTHQUAKE.**

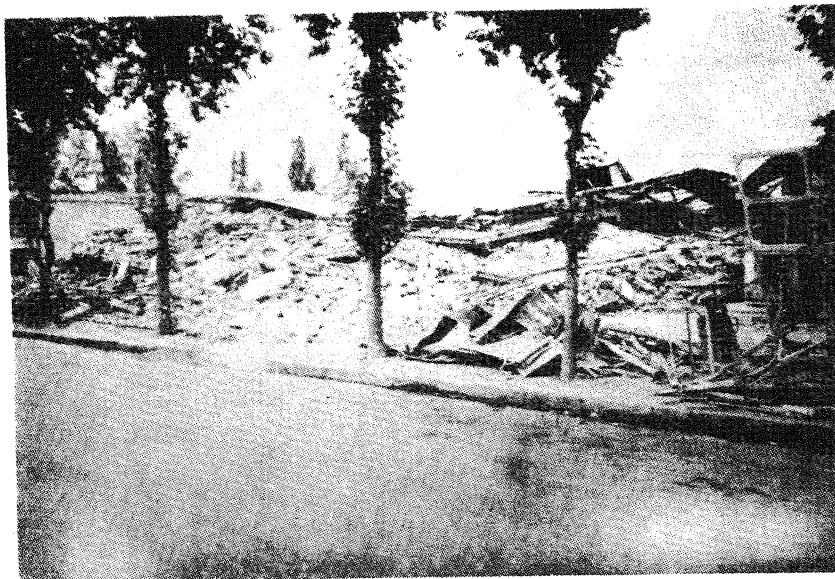
FIGURE 27: COLLAPSE OF A SIX STOREY STEEL BUILDING IN RASHT.

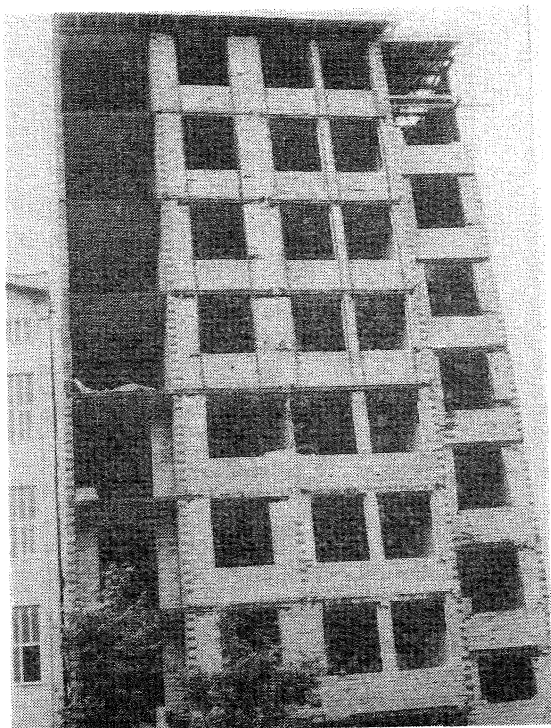
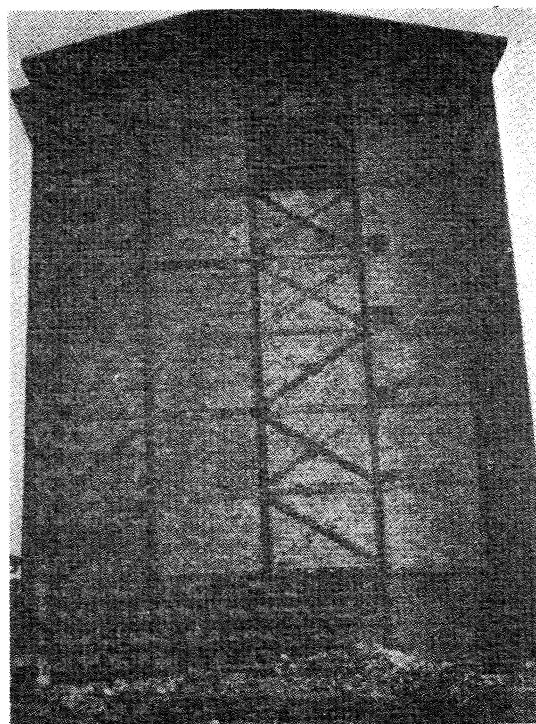
The effects of pounding were also observed and resulted in damage to a few buildings in Rasht. Several buildings were also tilted as much as 30 cm.

FIGURE 28: A FRONT (LEFT) AND SIDE VIEW (RIGHT) OF AN EIGHT STOREY STEEL FRAME BUILDING UNDER CONSTRUCTION IN RASHT. THIS BUILDING HAS TILTED OVER 30 CM. THE EFFECT OF POUNDING BETWEEN THIS BUILDING AND THE ADJACENT FIVE STOREY BUILDING WAS NOTICEABLE.

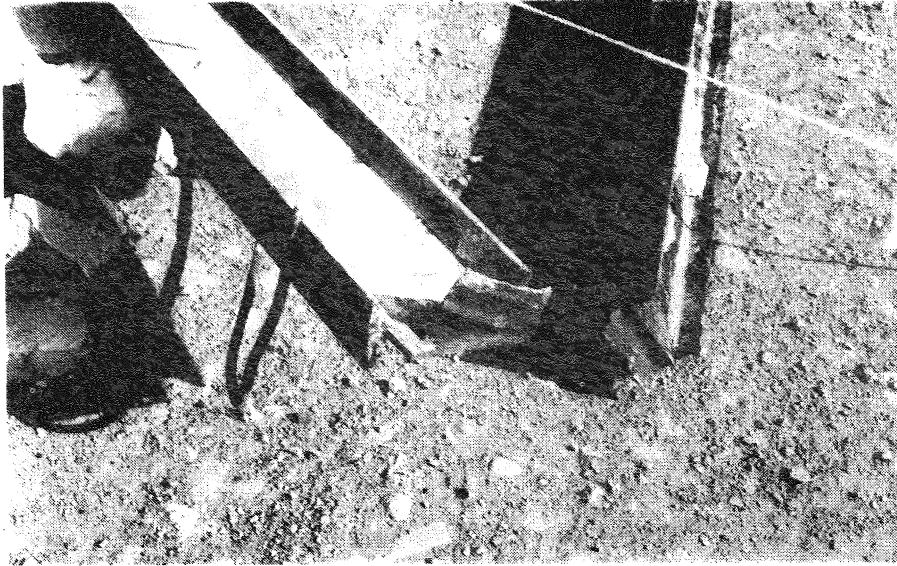
**FIGURE 29: POOR WELDING OF THIS STEEL ELEMENT LED TO FAILURE.**

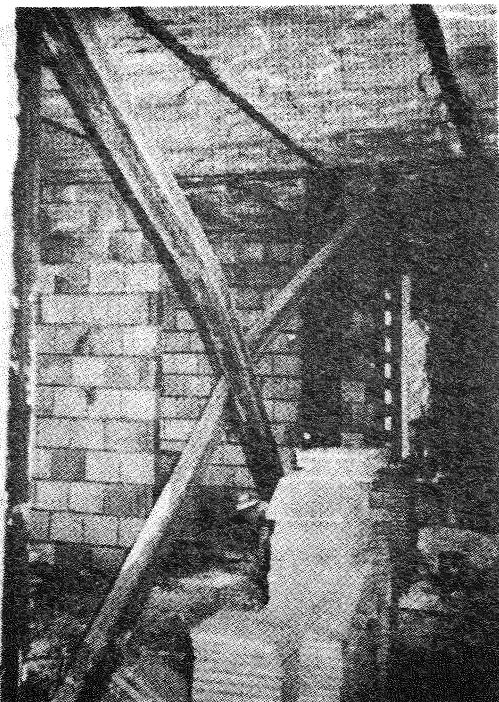
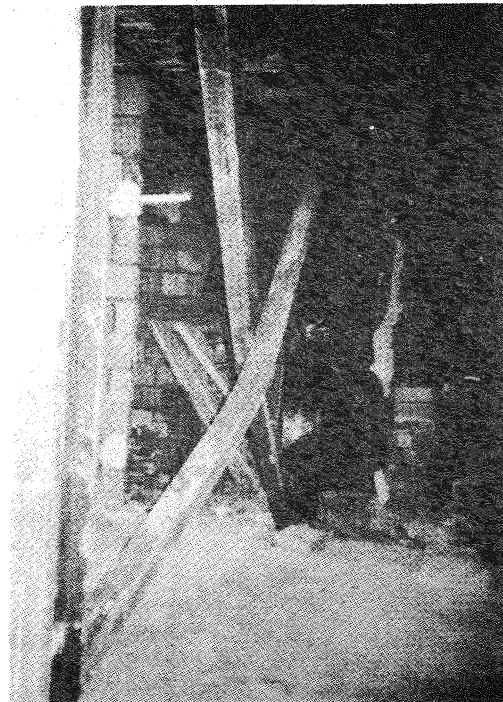
Generally, the bracing in steel frame buildings performed well and prevented the buildings from collapse or even severe damage.

**FIGURE 30: PERMANENT DEFORMATION IN THE DIAGONAL BRACING OF THIS EIGHT STOREY STEEL FRAME BUILDING UNDER CONSTRUCTION.**

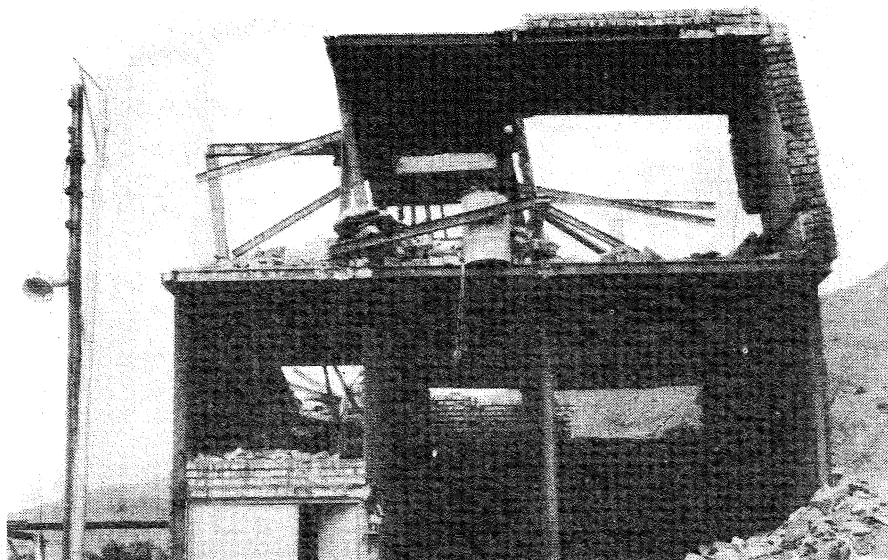
**FIGURE 31: TWO DIFFERENT LOAD BEARING SYSTEMS WERE USED IN THIS BUILDING IN HARZEVIL: THE FIRST STOREY IS A STEEL FRAME WITH INFILLED WALLS WHILE THE SECOND STOREY CONSISTS OF TWO BEARING WALLS ON THE SIDES WITH STEEL COLUMNS IN THE MIDDLE. THE RESULT HAS BEEN TILTING OF THE SIDE WALLS AND PARTIAL COLLAPSE OF THE SECOND STOREY.**

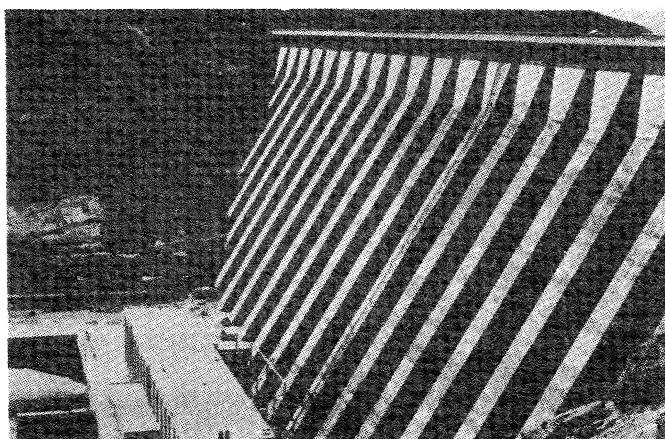
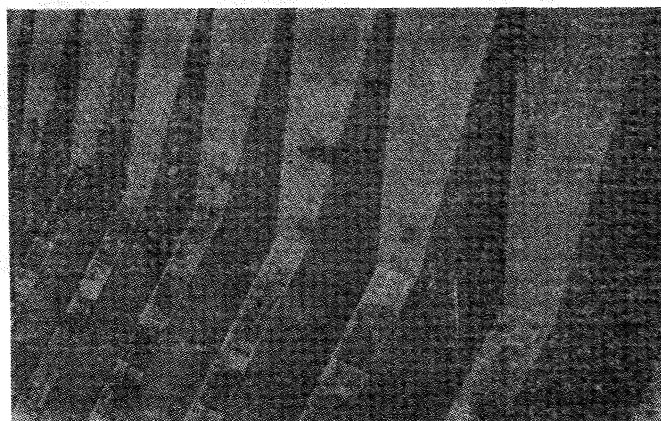
Fortunately the dam remained stable though several horizontal and diagonal (repairable) cracks developed at the top of some of the buttresses. Part of the parapet wall in the crest has been tilted in the downstream direction.

**FIGURE 32: SEFRIDRUD DAM LOCATED ABOUT 300 M FROM THE EARTHQUAKE FAULT (TOP) WITH A CLOSE UP VIEW OF CRACKS IN THE BUTTRESSES. THIS DAM SUSTAINED GENERAL STABILITY AND OPERATIONABILITY AFTER THE 20 JUNE 1990 EARTHQUAKE. SOME HORIZONTAL AND DIAGONAL CRACKS DEVELOPED AT THE TOP (ABOUT 14 M FROM THE TOP) WHICH ARE REPAIRABLE.**

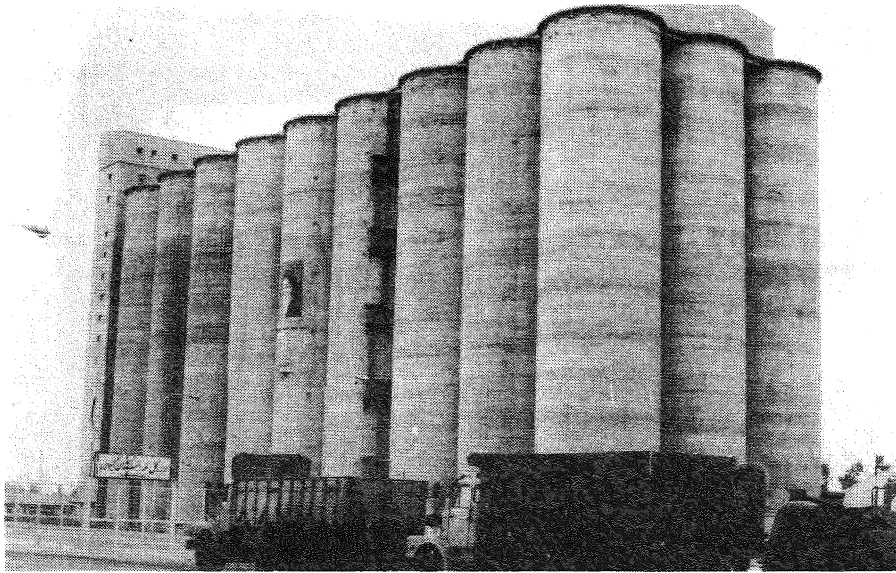
FIGURE 33: THIS 120,000 TON SILO IN SARAVAN NEAR RASHT SUFFERED NO DAMAGE.
