## An Immediate and Preliminary Report on THE MANJIL, IRAN EARTHQUAKE OF 20 JUNE 1990

A. A. Moinfar<sup>1</sup> and A. Naderzadeh<sup>1</sup>

**Editorial Note:** This article is based on a brief English version of a fuller report by the authors originally published as Publication No. 119, July 1990 of the Building and Housing Research Centre.

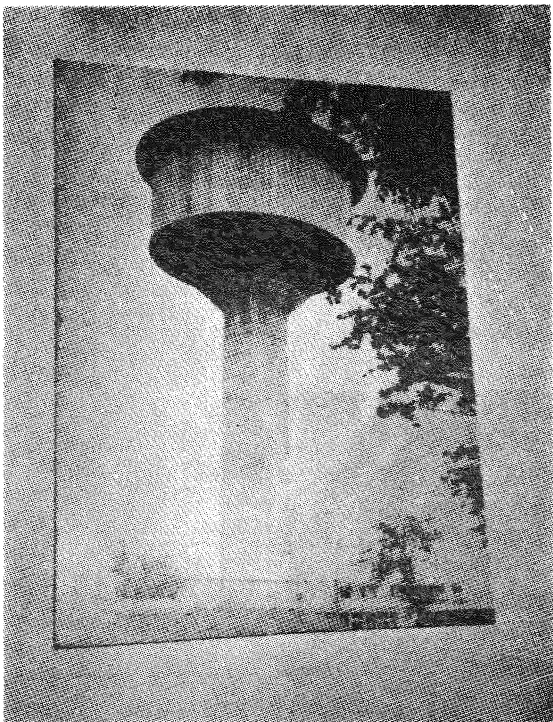
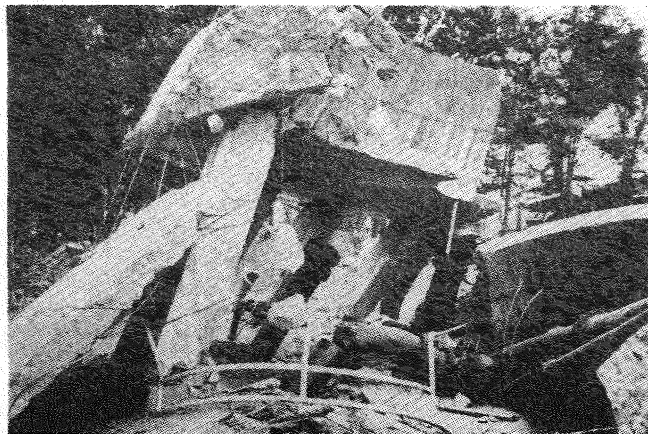
Another important structure which collapsed due to the earthquake was the 1500 m<sup>3</sup> water tower in Rasht which was built over 20 years ago (Figure 34). This tower consisted of a reinforced concrete shaft 6 m in diameter and 30 cm thick supporting a 10.30 m high prestressed concrete tank. The top of the tower was 46.50 m above the ground. There was about 1000 m<sup>3</sup> water in the tank at the time the earthquake occurred. The tower overturned in the earthquake.

FIGURE 34: A 1500 M<sup>3</sup> WATER TOWER (46 M HIGH) BEFORE THE EARTHQUAKE (LEFT) AND AFTER (RIGHT).

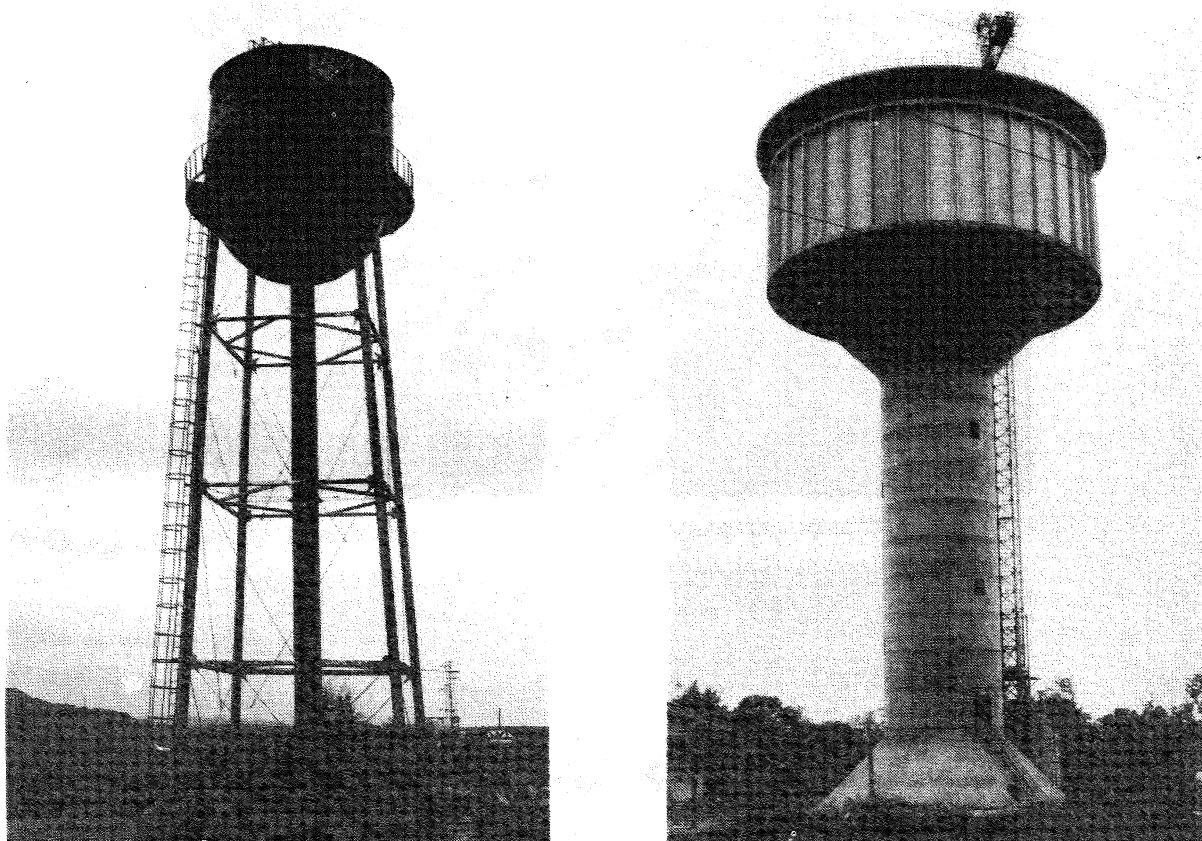
A steel water tower in Manjil behaved well and damage was limited to the bracings (Figure 35).

**FIGURE 35: WATER TOWER IN MANJIL. THE DIAGONAL BRACINGS WERE FRACTURED BY THE EARTHQUAKE.**

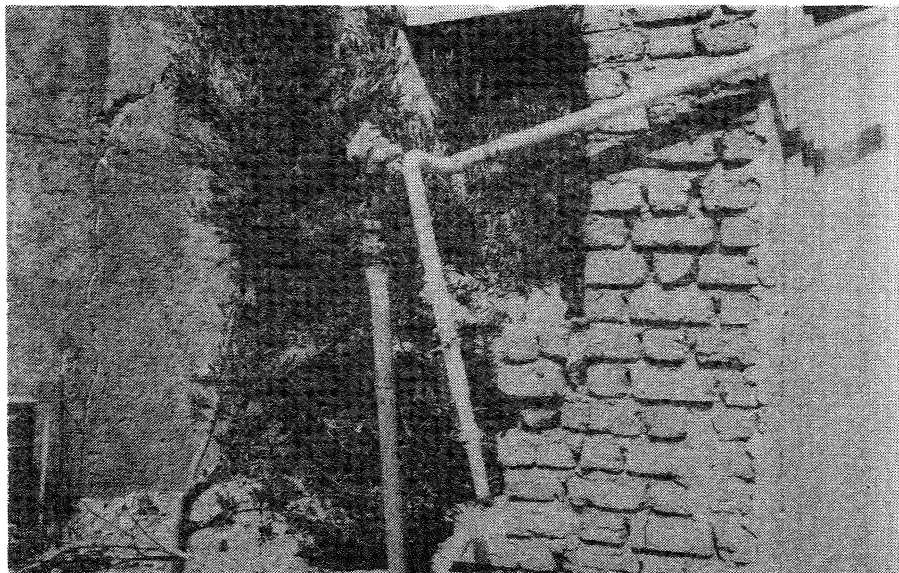
**FIGURE 37: DAMAGE TO A GAS PIPE IN A BUILDING IN MANJIL.**

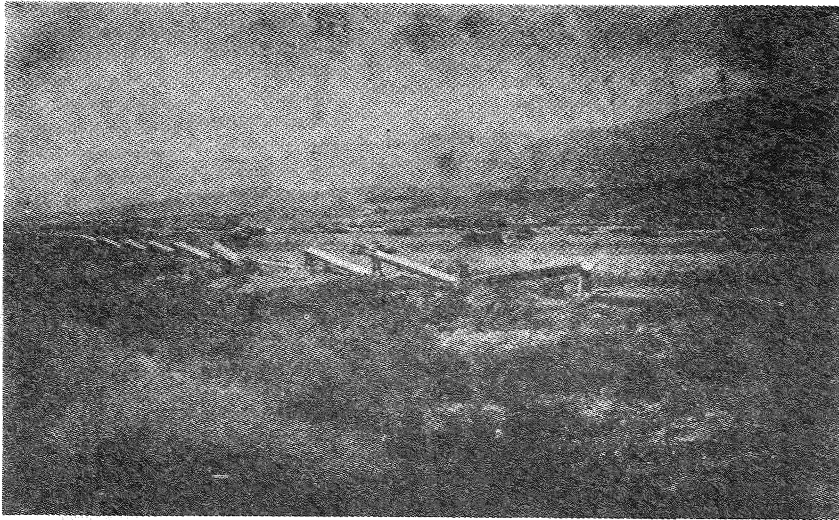
FIGURE 38: FALLEN PREFABRICATED IRRIGATION CANALS NEAR GILVAN.

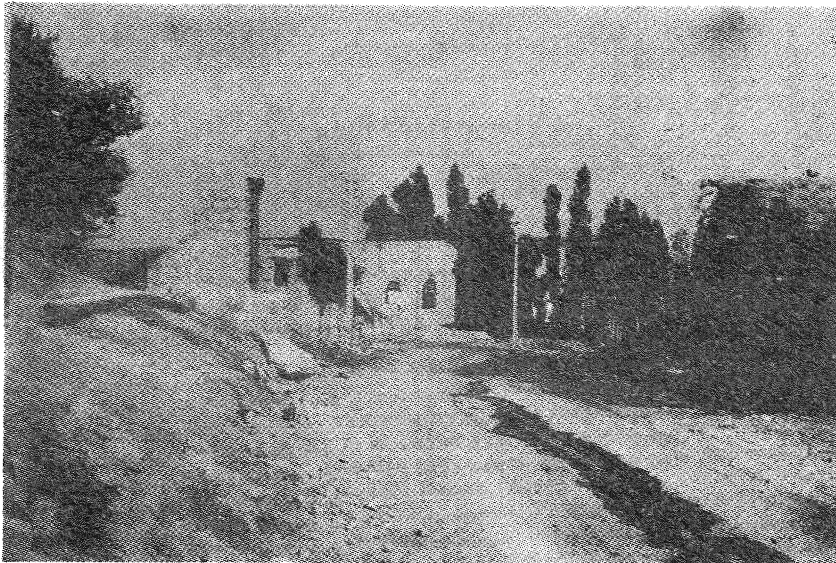
FIGURE 39: A BROKEN VILLAGE WATER PIPE CAUSED A DISRUPTION TO IRRIGATION.

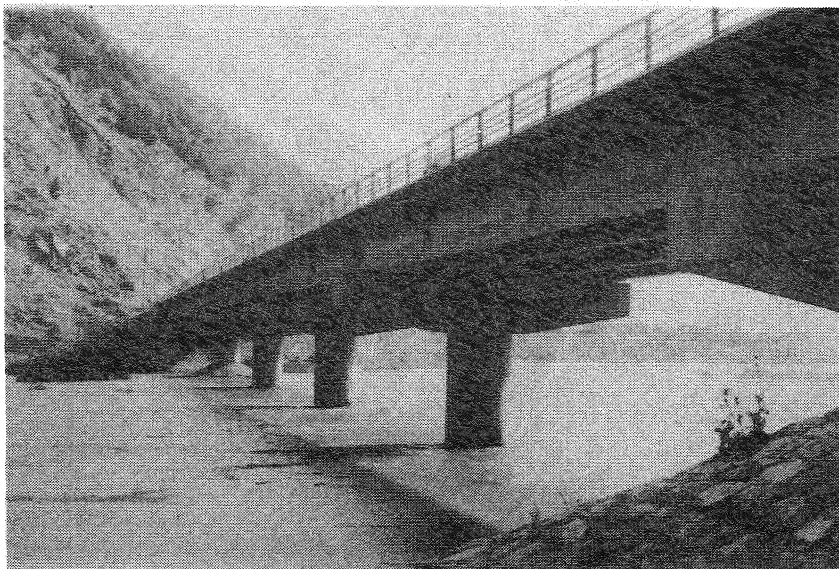
FIGURE 40: RUDBAR BRIDGE WHICH REMAINED OPERATIONAL AFTER THE EARTHQUAKE.

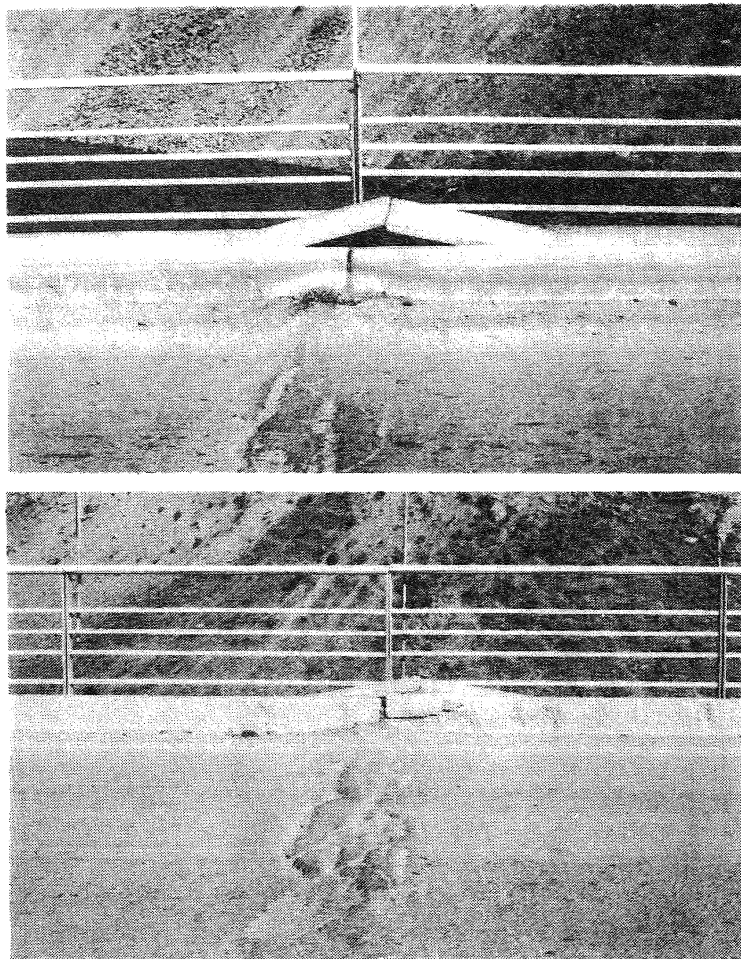
**FIGURE 41: COMPRESSION FAILURE IN THE DECK OF THE RUDBAR BRIDGE DIRECTLY ABOVE THE PIERS.**

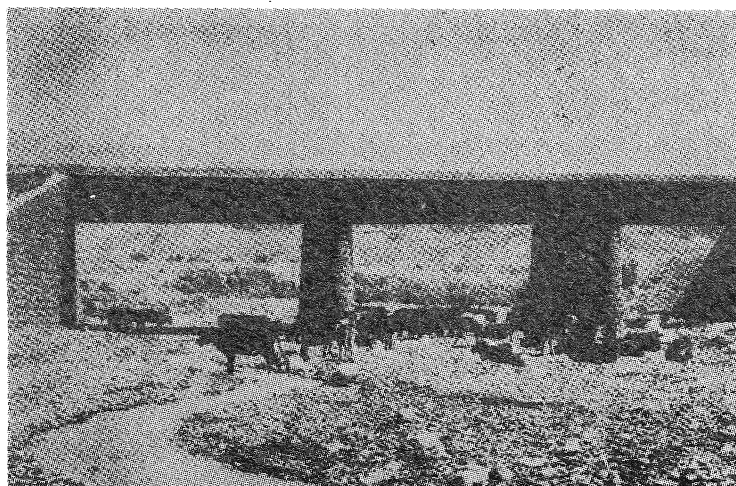
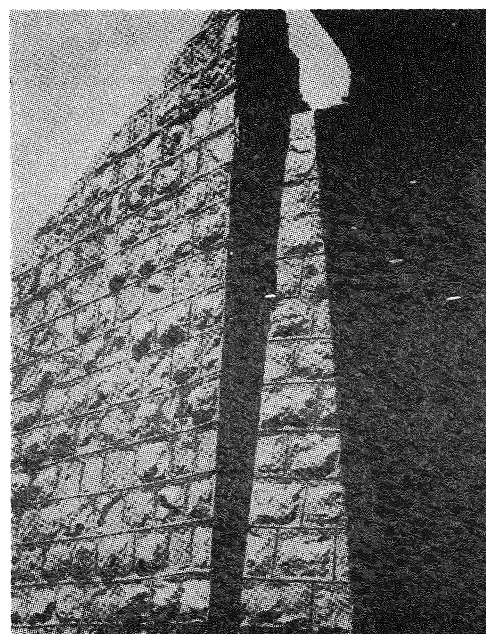
**FIGURE 42: THIS BRIDGE ON THE ROAD FROM MANJIL TO GILVAN WAS UNDAMAGED, THOUGH AN ABUTMENT RETAINING WALL HAS UNDERGONE SOME MOVEMENT.**
