THE LAKE COLERIDGE EARTHQUAKES OF 1946

George Eiby

SUMMARY

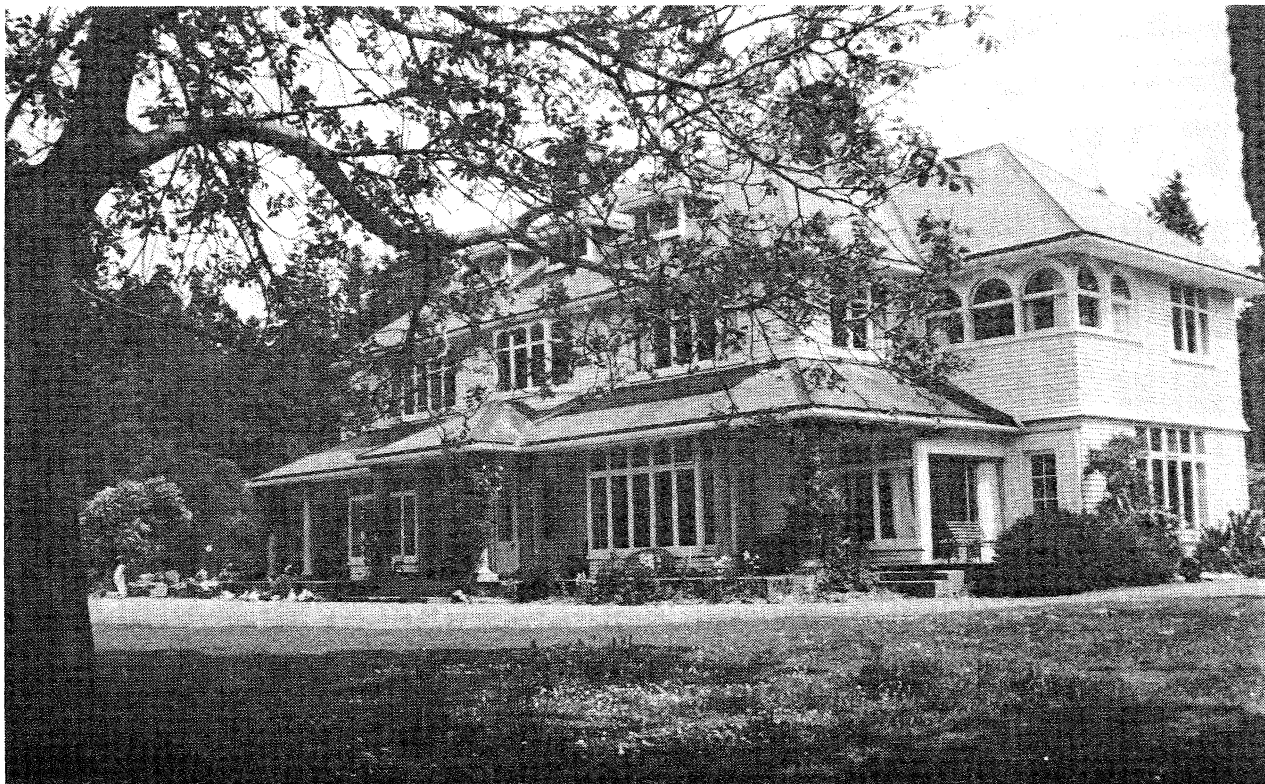
Snowdon (Figure 4)

FIGURE 4. THE HOMESTEAD AT SNOWDON. CHIMNEYS FELL, AND THE ORNAMENTAL COLUMNS OF THE VERANDA WERE RACKED SIDWAYS, BUT THERE WAS LITTLE STRUCTURAL DAMAGE.

Chimneys fell in on themselves, and brickwork around the cooking range was damaged, but most damage was to plaster and not structural. This was described by Baird, but part of his description and his analysis of the causes is questionable. The repairs are still visible.

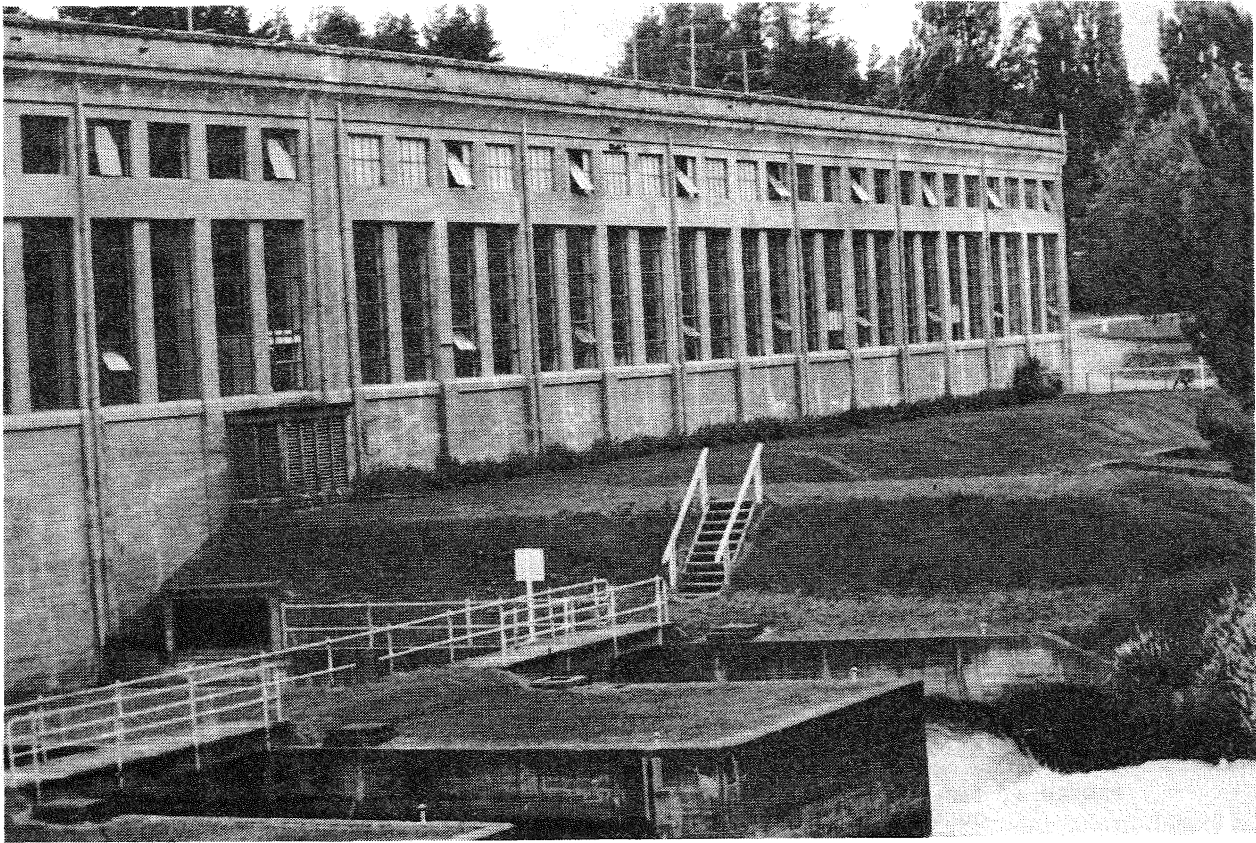
FIGURE 5. LAKE COLERIDGE HYDROELECTRIC POWER STATION.

This reinforced concrete building is in two sections of roughly equal size (Figures 5 and 6). One was part of the original construction in 1914, and the other was added in the late 1920s. The two parts of the turbine hall have the same roof line and wall alignment, but the level of the floors differs by two or three metres. Damage occurred where the two sections join, and at the junction with office and storage space to one side of the older portion. About 70 window panes were broken. These are old metal-framed windows about half a metre square, and spontaneous breakages and damage by wind are apparently fairly common. The concrete walls below the windows show many shrinkage or settlement cracks. There is nothing obviously tying the old and new sections together, and signs of relative movement in the past are apparent.

Damage to the electrical equipment does not appear to have been serious, though a power surge accompanied the earthquake and caused the breakers to trip. Pipelines were found to have moved a few inches. Twisted telephone lines had to be untangled, and a broken transformer bushing replaced.

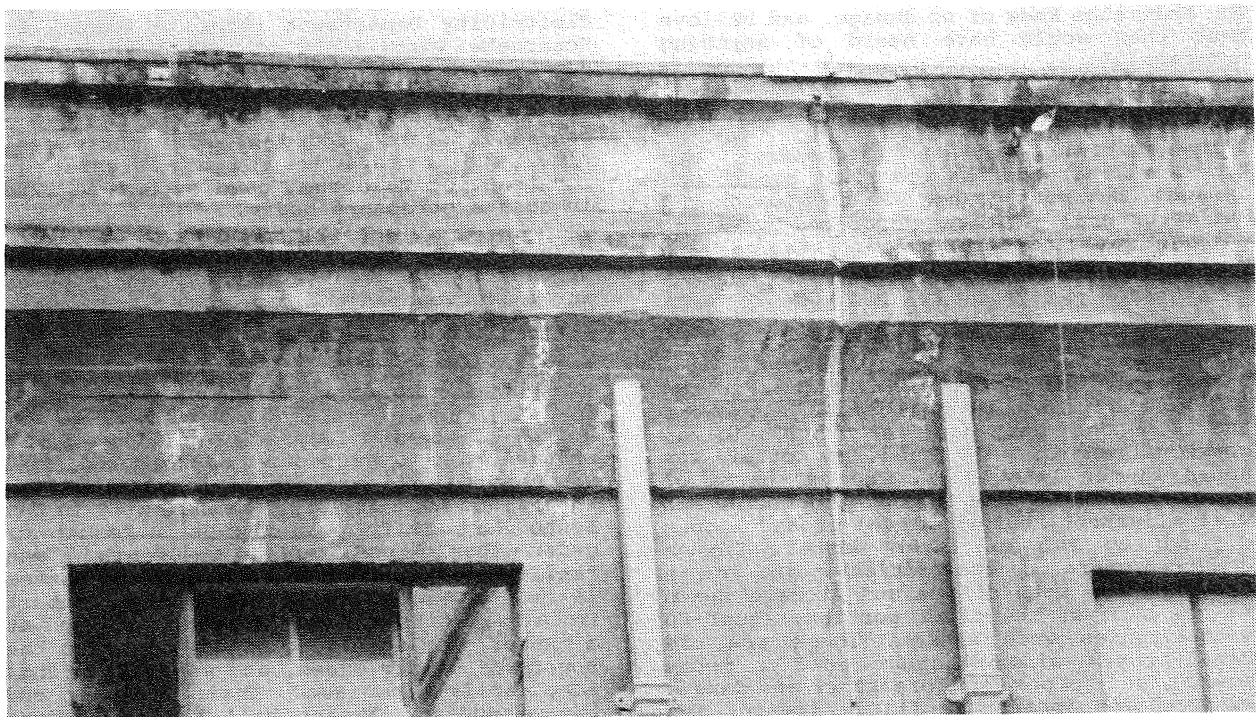
FIGURE 6. DETAIL OF THE JUNCTION BETWEEN THE OLD AND NEW PARTS OF THE POWER STATION.
