EFFECT OF THE EDGE CUMBE EARTHQUAKE ON MECHANICAL AND PROCESS EQUIPMENT AT THE TASMAN MILL

by W. C. Hodge¹ and M. Macfarlane²

SUMMARY

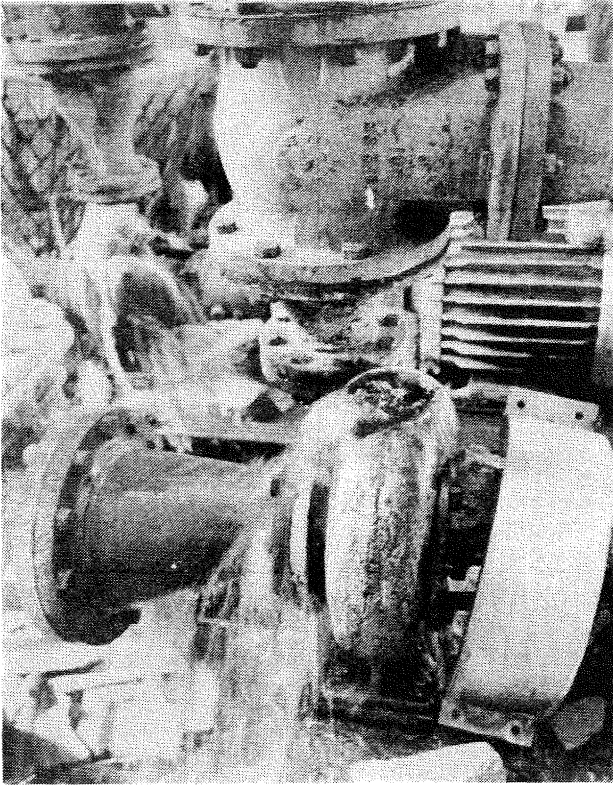
FIGURE 3. PUMPS WITH BROKEN CASTINGS

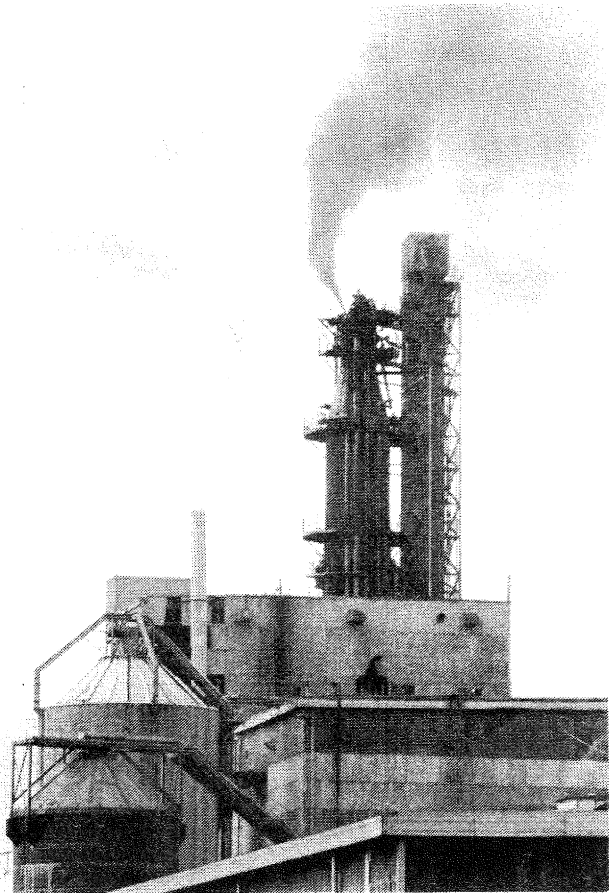
FIGURE 4. BROKEN PIPE ON DIGESTER

some sixty metres high. The crane collapse was the result of failure of the holding down bolts. Beca, Carter [2] in a private study for Tasman showed that these bolts just reached the point of failure with the peak accelerations at the top of the digester which they estimated could have been as high as 3.0g. However the digester shell stresses did not exceed the design conditions. The major process impact here was the loss of black liquor from a broken pipe (see Figure 4).

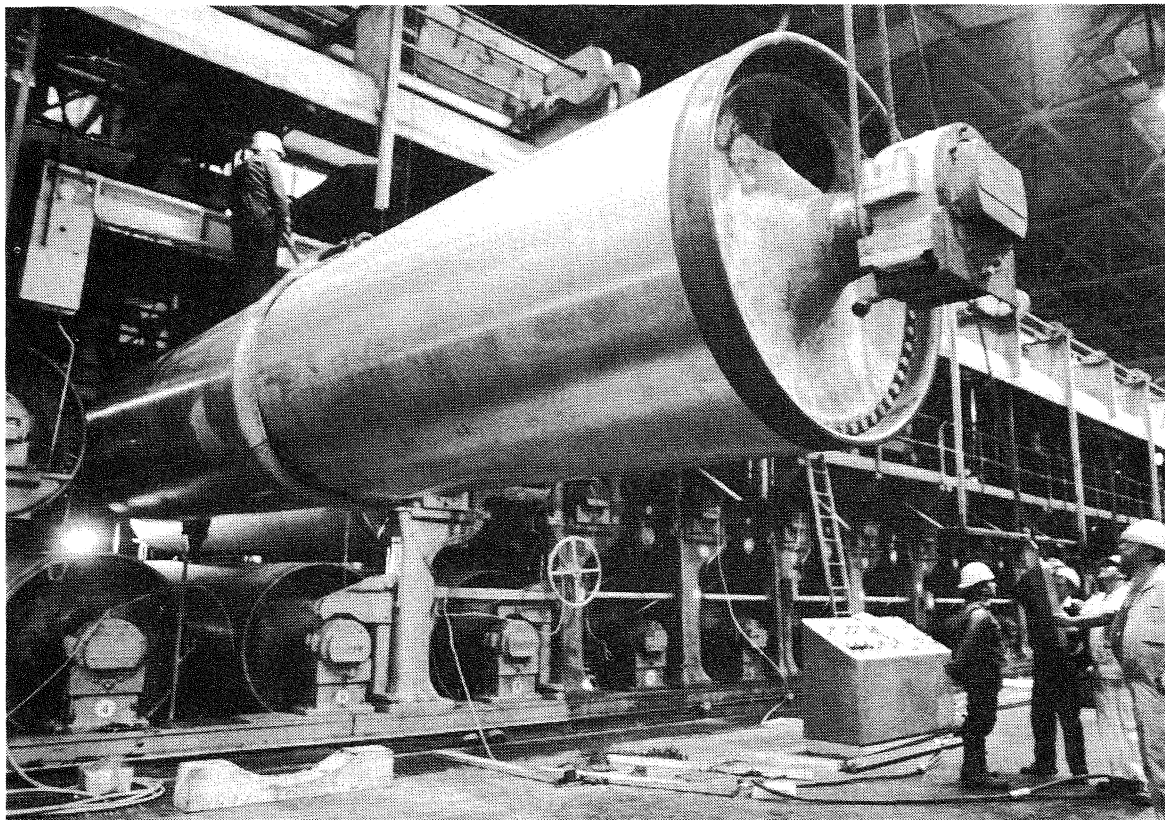
FIGURE 5. REPLACING DRYER CYLINDER ON NO. 2 MACHINE

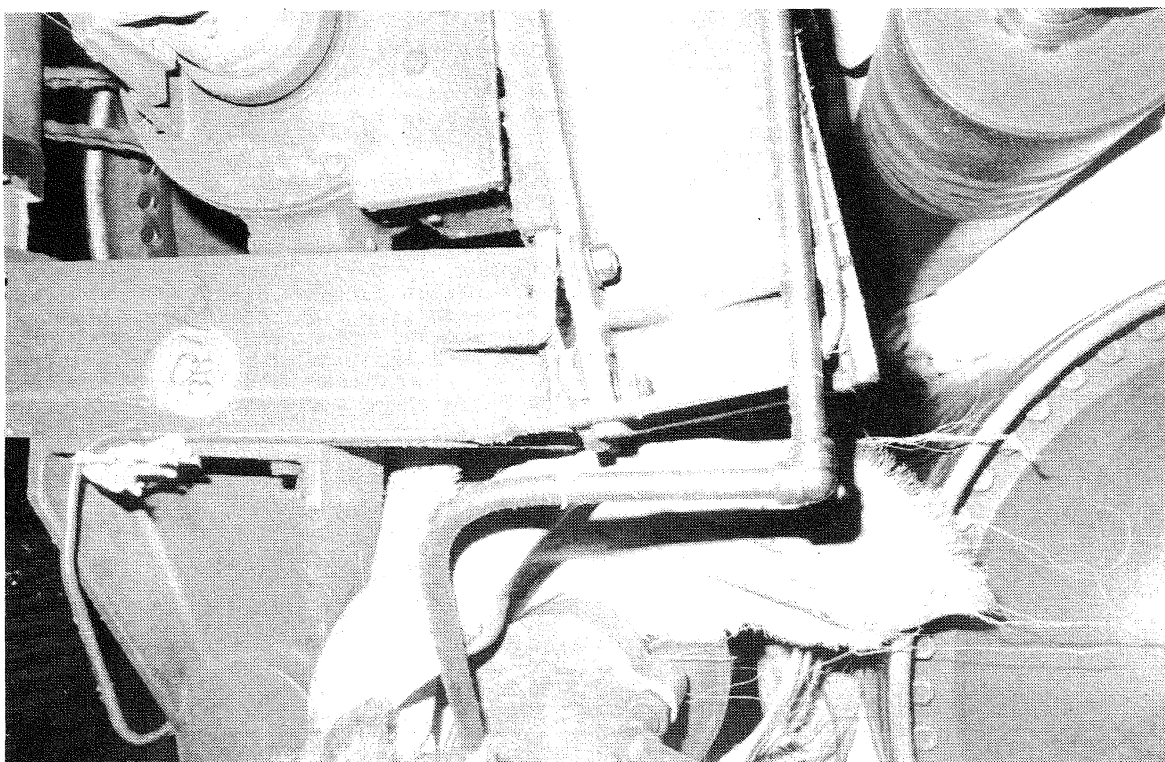
FIGURE 6. NO.3 MACHINE PART DRYER FRAMING

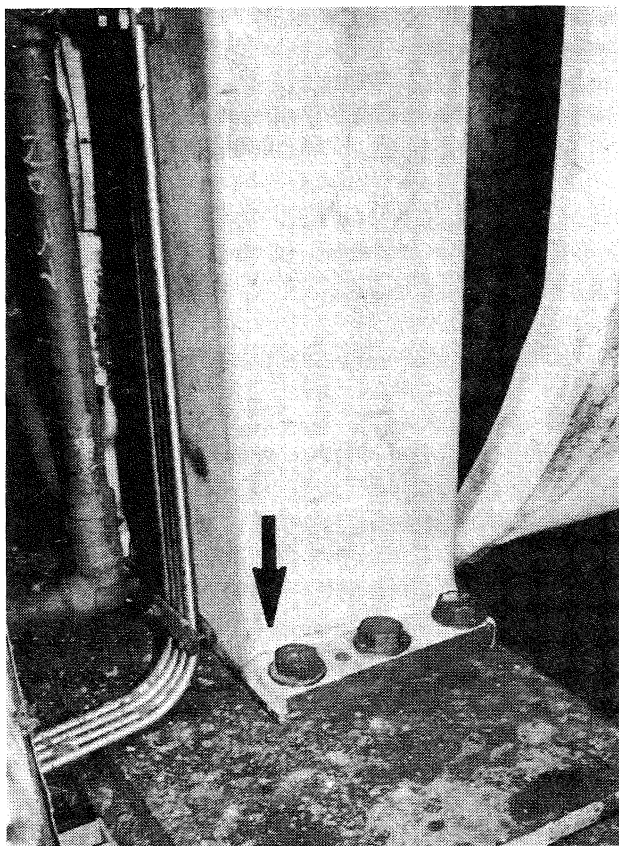
Virtually every machine column on the front side drivers failed at the sole plate level, most gearcases on the backside continuous gear train failed and all guide and stretch roll housings were damaged to some degree.

FIGURE 8. COLUMN BASE FAILURES NO.3 M/C DRYERS (FRONTSIDE).

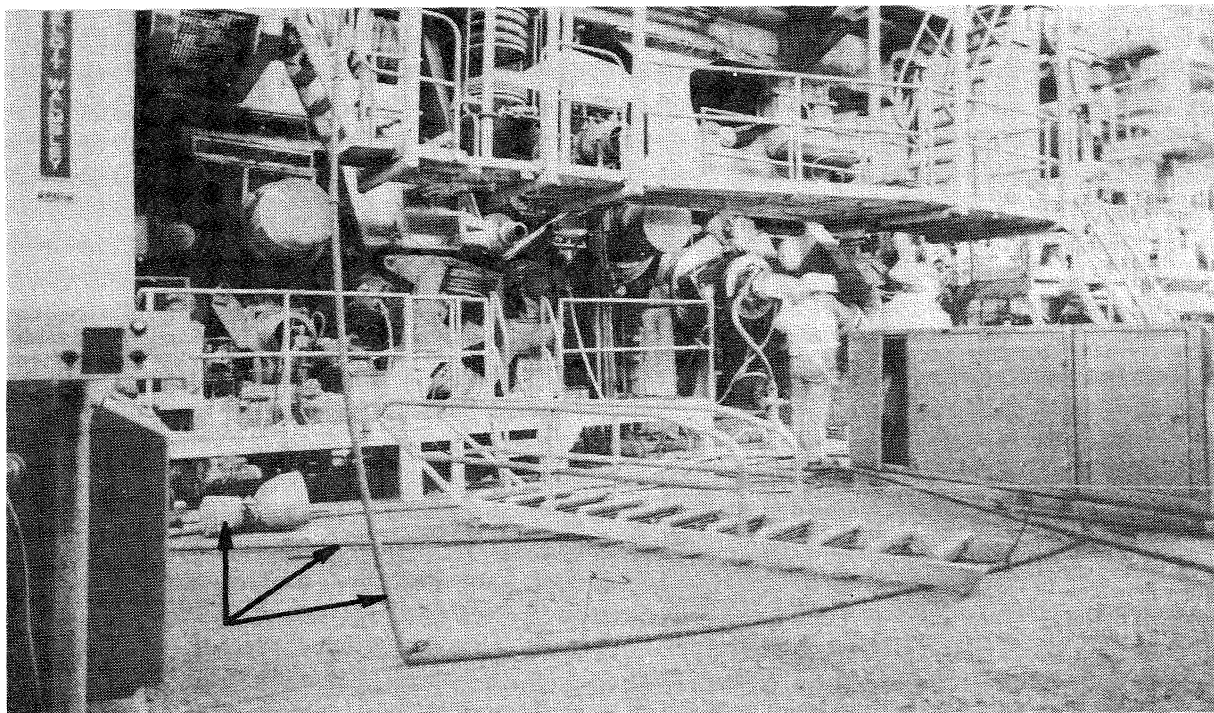
Several areas suffered failures of fire sprinkler systems as shown in Figure 9, a particularly sorry state of affairs given the compulsory nature of these systems for insurance, the limited purchasing opportunities for such systems and the very high probability that the time of greatest need could be after an earthquake. Poor fixing details, lack of piping flexibility, and high risk joint details were important factors in these failures.

Also visible in the same figure are some light fittings on the floor, they were particularly dangerous, having a weight of around fifty kilograms, many fell as a result of suspension chains failing during the violent shaking.

FIGURE 9. FALLEN SPRINKLER PIPES AND LIGHT FITTINGS

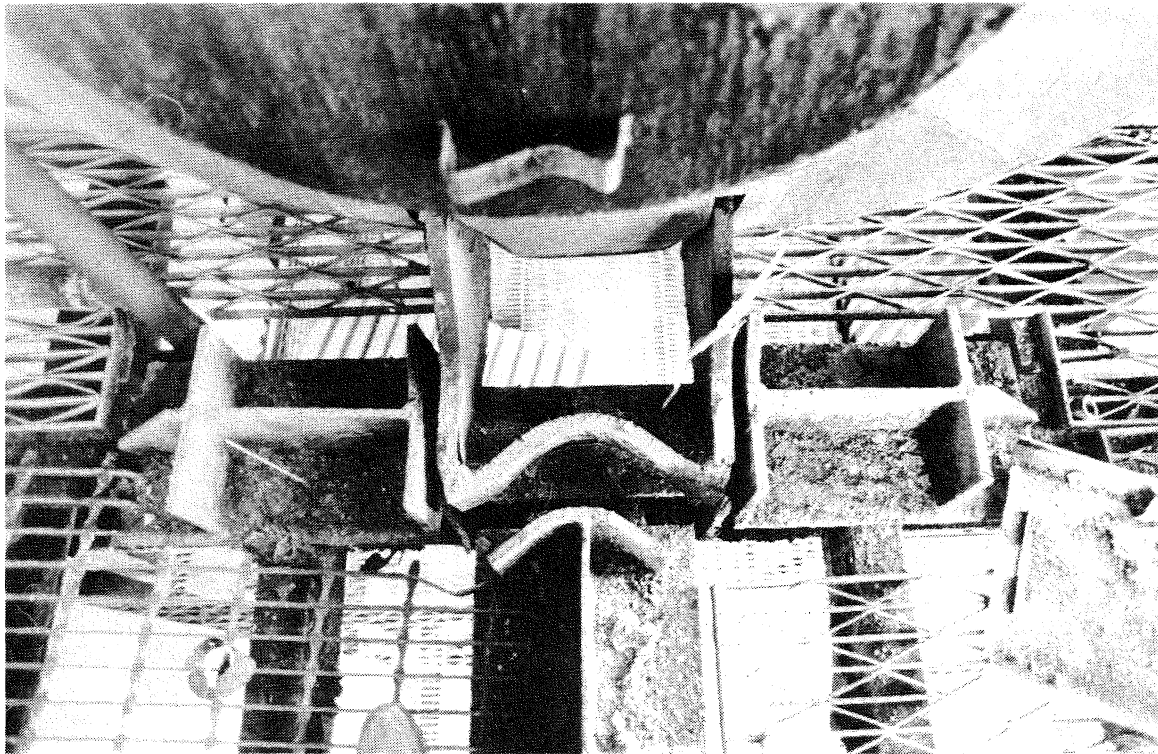
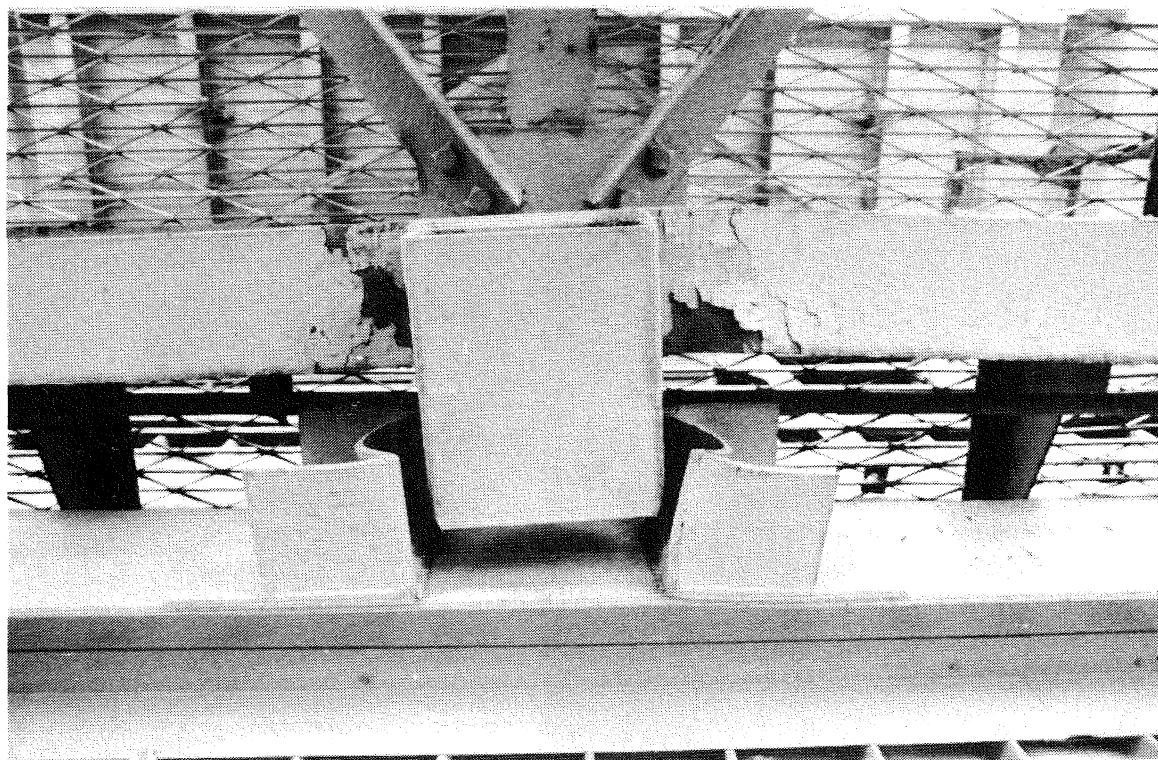
Many of the earthquake stops on No.2 Recovery Boiler collapsed but fulfilled their intended role, the only significant damage, apart from some structural parts, in this unit occurred in the economiser/backside generating bank where a few tubes and economiser baffles failed. Some outlet ducting on this unit required replacement expansion joints. Outlet

FIGURE 10. COLLAPSED EARTHQUAKE STOP - NO.2 RECOVERY UNIT

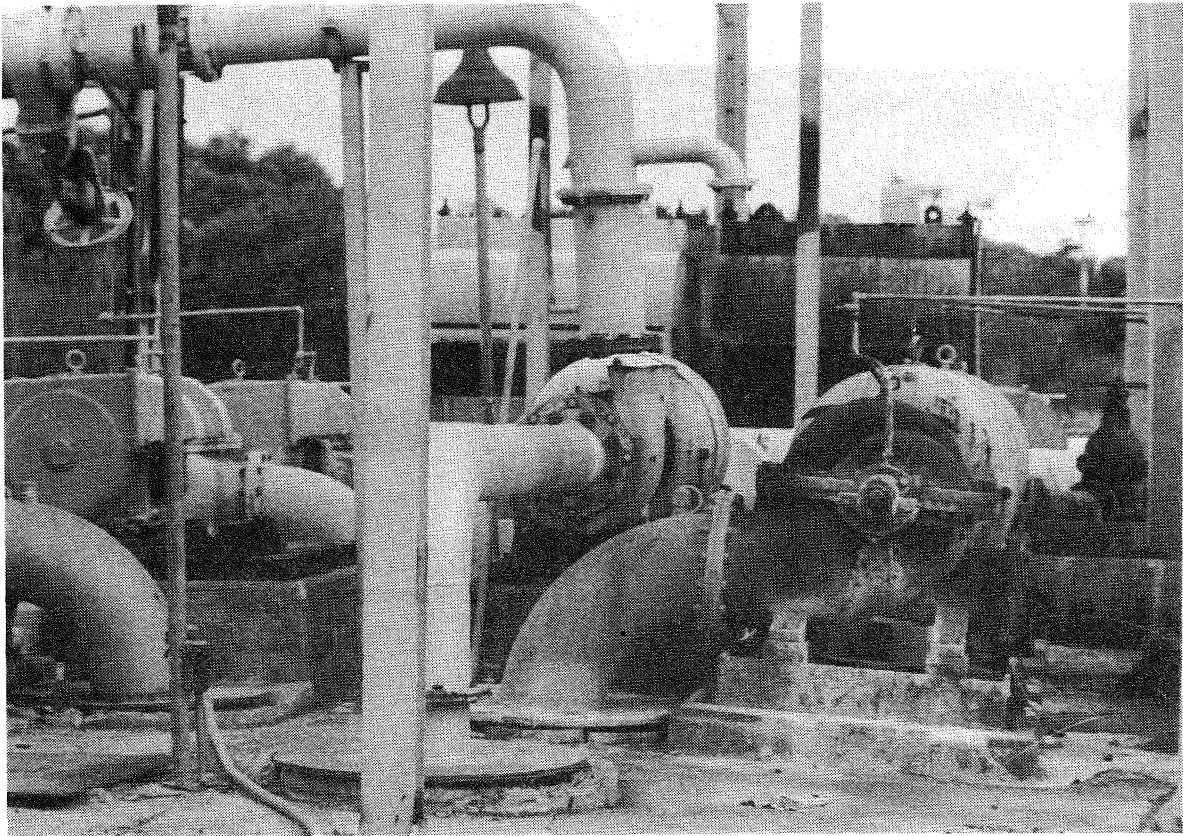
The raw water intake and pumping station built at the time of the original mill construction was badly damaged by ground movement resulting in tilting of the ground level concrete slab supporting the pump/motor rafts together with causing damage to underground pipes.

FIGURE 11. RAW WATER PUMPS SLAB TILTING

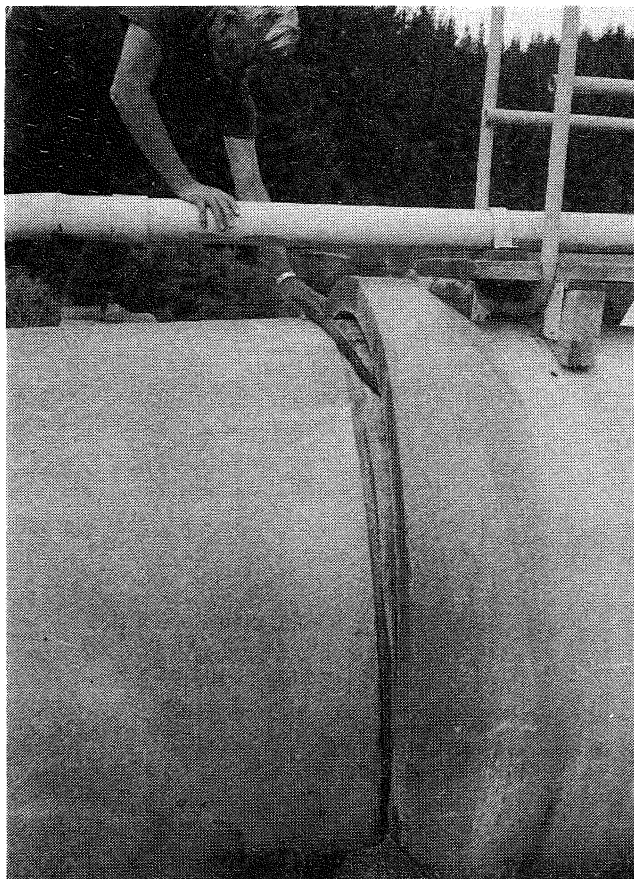
Damage from subsidence and ground movement opened up joints on the main effluent line and many of the underground process sewers. There was some slight tilting of the clarifier and remedial action is yet to be decided.

FIGURE 12. EFFLUENT LINE DAMAGE
