LIQUEFACATION IN THE BULLER REGION IN THE 1929 AND 1968 EARTHQUAKES

J. B. Berrill¹, V. C. Bienvenu² and M. W. Callaghan³

This article describes the results of a search for sites of liquefaction in the 1929 M=7.6 Murchison and the 1968, M=7.1 Inangahua earthquakes in the Buller region of New Zealand. Evidence of liquefaction was found for nine sites in each earthquake; two sites were common to both events. Widespread ejection of sand occurred in the epicentral regions of both earthquakes. Liquefaction was more sporadic at larger epicentral distances, except in the North Beach area of Westport, the most distant 1968 site, where sand boils occurred over several hectares, together with the toppling of utility poles and some lateral mass movement. This area corresponded to the very young beach sands deposited since extension of the Westport harbour breakwaters towards the end of last century. Liquefaction was much less common in the river-lain sands in the same vicinity.

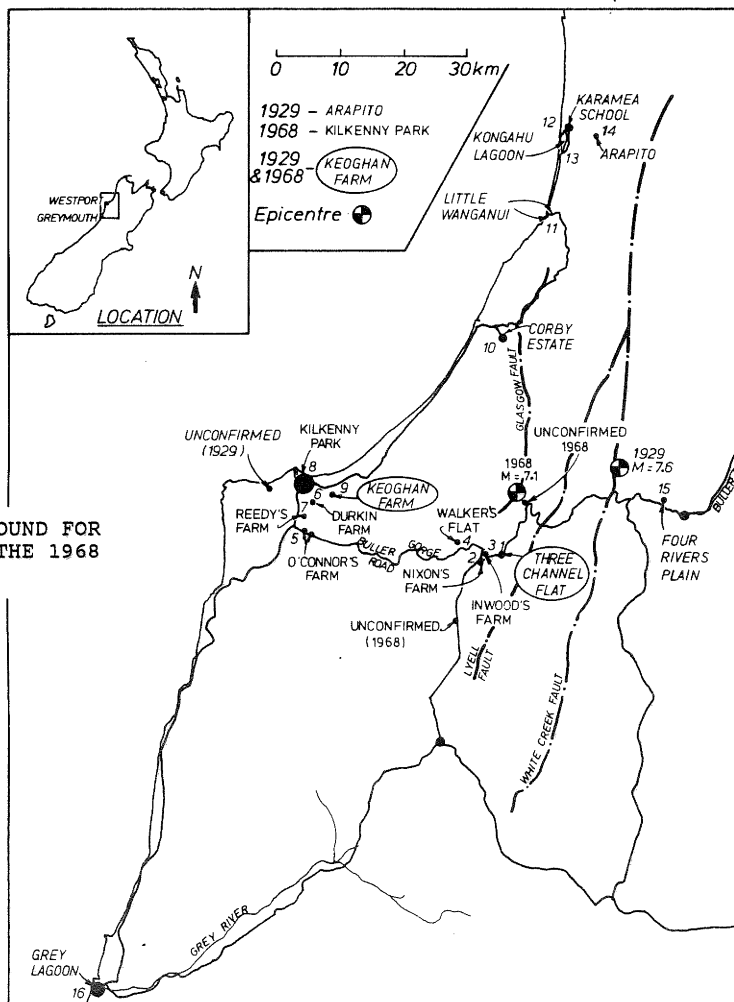
Figure 2 shows the sites of liquefaction that have been positively identified. These sites are listed in Table 1 together with epicentral distances and notes giving the type of evidence found. All sites shown are on level or near level ground.

FIGURE 2: SITES OF LIQUEFACTION FOUND FOR THE 1929 MURCHISON AND THE 1968 INANGAHUA EARTHQUAKES.

patches that may be ejected sand beside the Inangahua-Reefton road about 10 km south of Inangahua Junction. This land was owned by a Mr McLelland at the time of the earthquake, but he could not be traced and, as for the two other cases, no eyewitness confirmation of liquefaction could be found. These sites are marked in Figure 2.

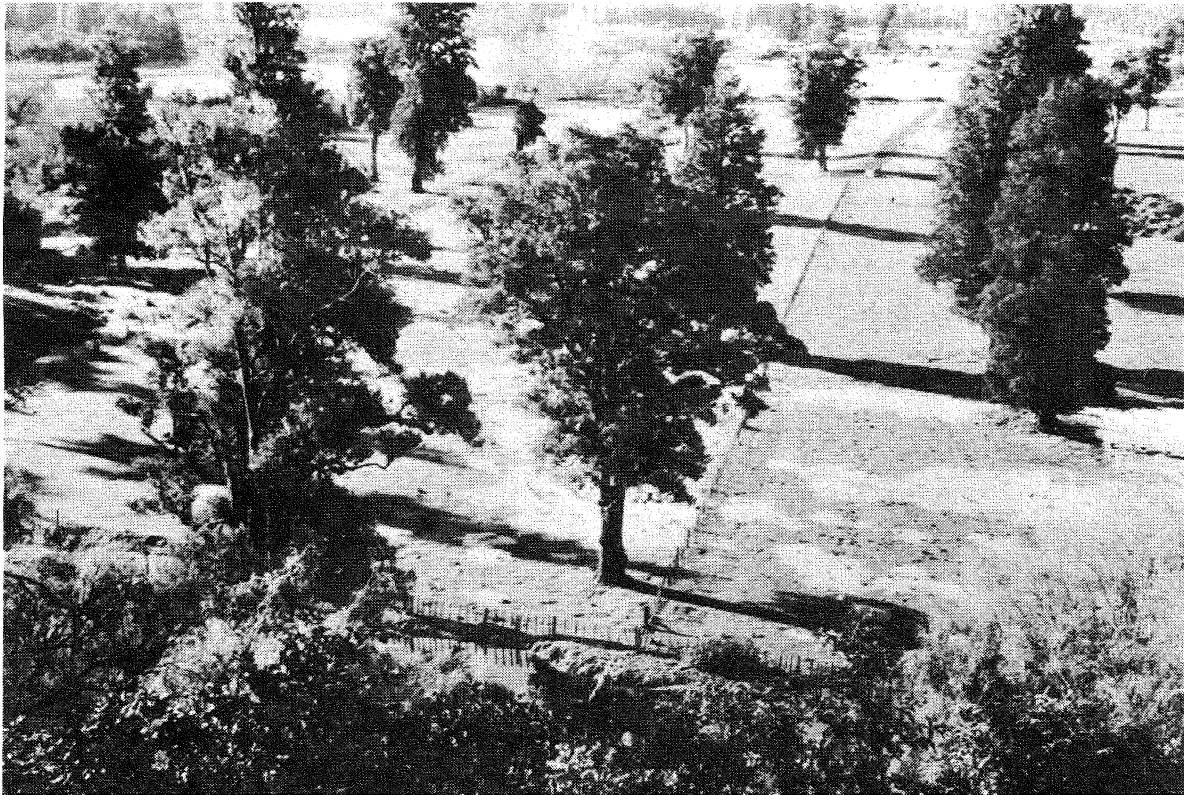
Extensive ejection of sand was observed at Three Channel Flat following the 1968 earthquake. The flat comprises a system of low terraces of Recent alluvium. The photograph shown in Figure 4 was taken on the day after the earthquake. The present owner of the land, Mr Warren Inwood, also remembers seeing the ejected sand, although he did not own the land himself at the time. The extent of sand ejection is clear from Figure 5, a vertical aerial photograph taken 5 days after the earthquake.

FIGURE 4: THREE CHANNEL FLAT, LOOKING NORTH FROM DEE HILL, THE DAY FOLLOWING THE 1968 EARTHQUAKE. NOTE THE EJECTED SAND AND VENTS VISIBLE IN THE FOREGROUND. (PHOTO: M. CALLAGHAN).

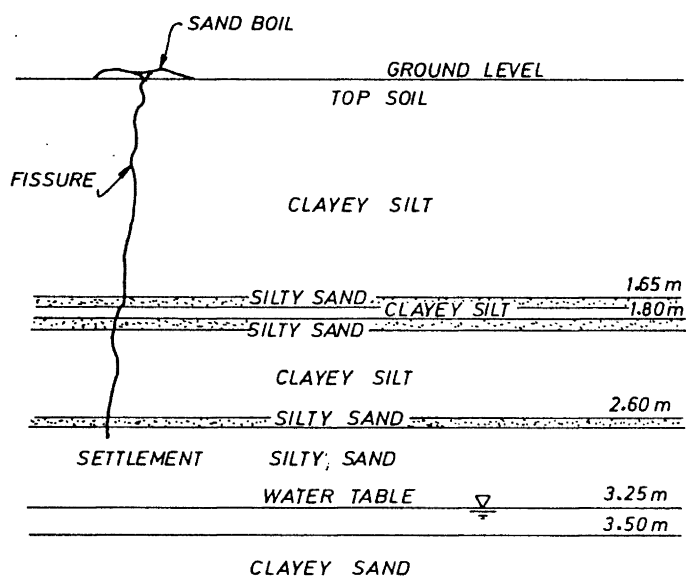
Dodd and Dunlop (Dodd, 1970; Dunlop, 1968) investigated sand boils at the south west of the flats with auger borings and sieve analysis. The log of their boring, starting from the bottom of a recently excavated trench, is shown in Figure 6; grain size distributions of the ejected and subsurface sand strata are shown in Figure 7. Note the similarity of the sand gradings. Presumably the ejected sand came from the lower layer, below the water table.

FIGURE 6: LOG OF TRENCH AND AUGER BORING BY DODD AND DUNLOP IN AUGUST 1968.

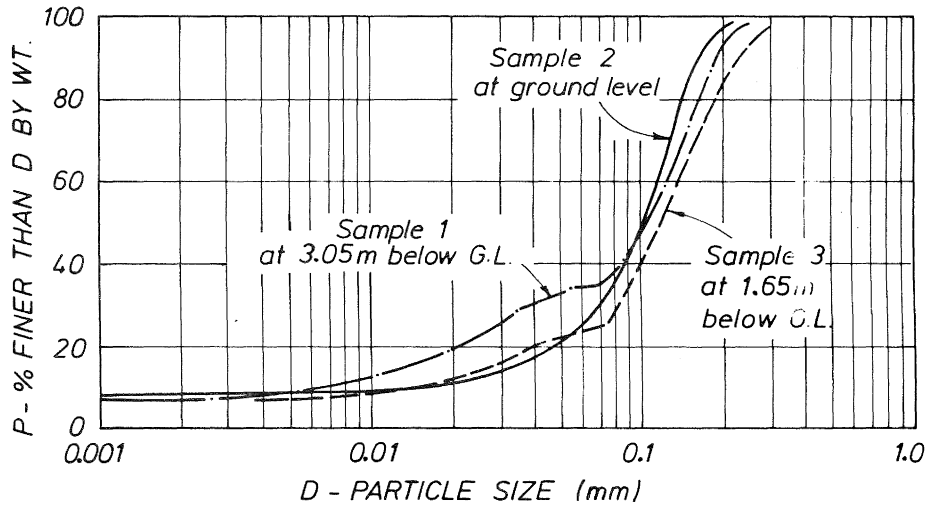
FIGURE 7: PARTICLE SIZE DISTRIBUTION OF SAMPLES TAKEN FROM BORING SHOWN IN FIGURE 6.

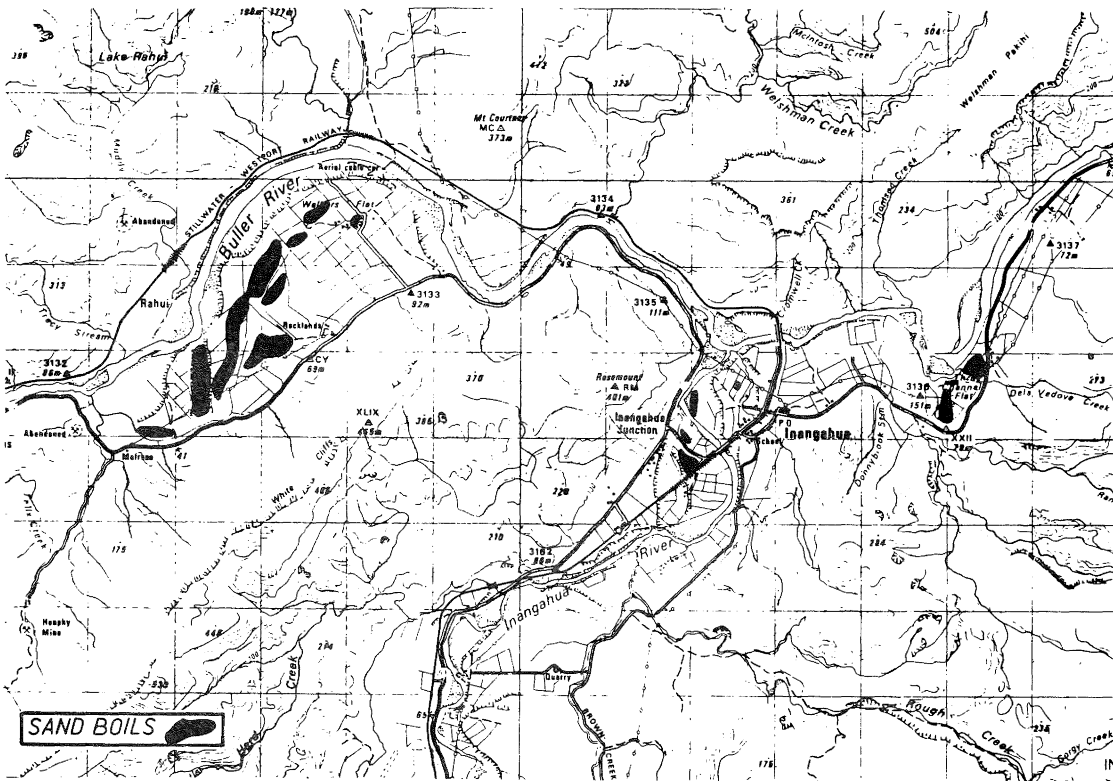
Aerial photographs from runs C and D of the 1968 post earthquake photography show ejected sand over a large part of Walkers Flat. Figure 8 shows the extent of the 1968 sand boils.

FIGURE 8: LOCATION OF EJECTED SAND SHOWING IN THE 1968 AERIAL PHOTOGRAPHS AT SITES NEAR INANGAHUA.

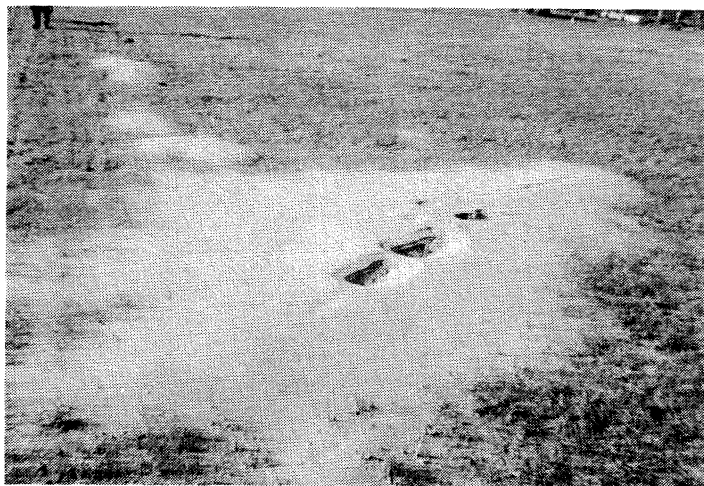
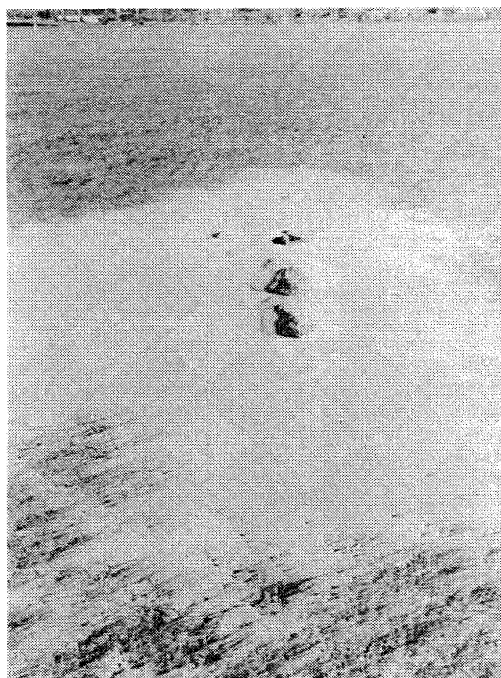
The eyewitness accounts and photographs taken near Mr G. Meddows' farmhouse at the east end of the flat are of particular interest. The photographs in Figure 9 show sand boils in the paddock immediately to the north of the farmhouse. Mr Meddows remembers sand and water being ejected from vents in the vicinity of the farmhouse and cowshed during some aftershocks as well as the main shock. But he did not notice any sand ejection in the area following the 1962 Westport earthquake sequence.

FIGURE 9A: SAND BOILS IN THE "BULL Paddock" MEDDOWS' FARM AT NORTHEAST END OF WALKERS FLAT, MAY 1968.

FIGURE 9B: DIFFERENT VIEW OF BOIL ABOVE. (PHOTOS: MRS WAYNE MEDDOWS, MR G. MEDDOWS).

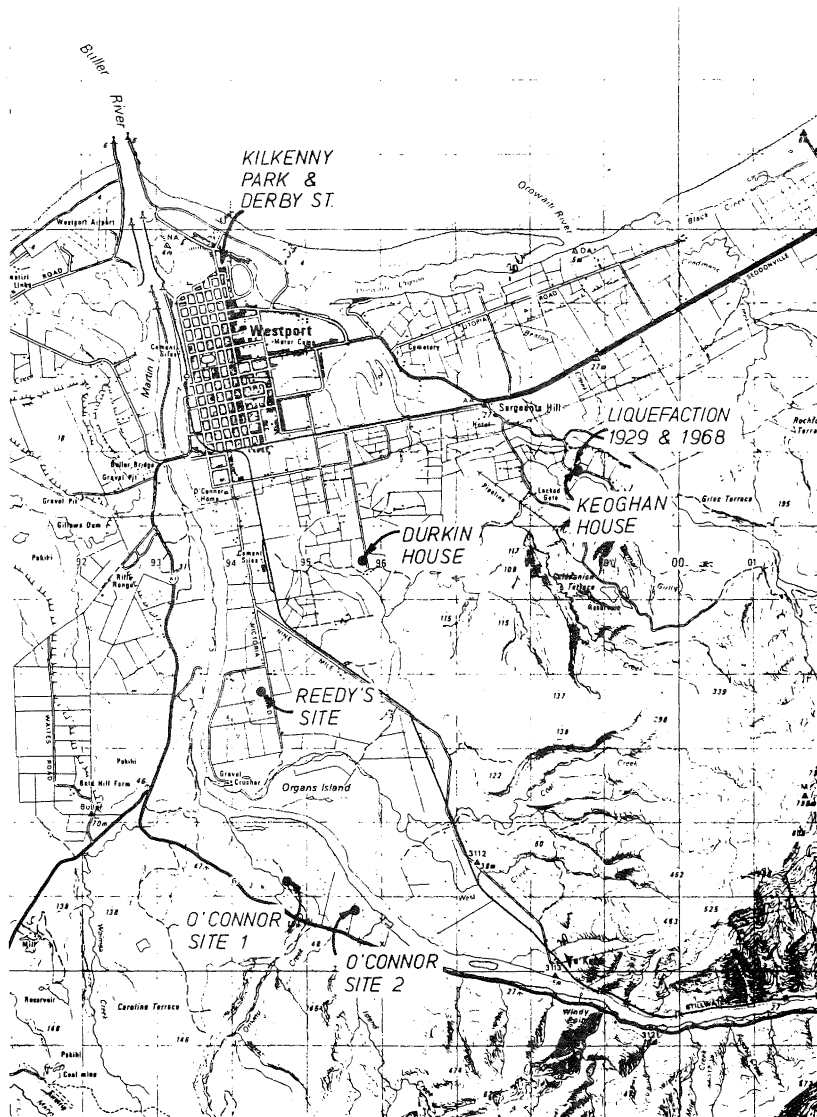
FIGURE 10: SITES NEAR WESTPORT.

Mr Noel Keoghan's farm is situated on the banks of the Orowaiti River, south east of Sergeants Hill. His house is marked on Figure 10. Mr Keoghan observed sand boils in the paddocks to the north of his house following the 1929 earthquake and again in 1968.

Both sites are marked on Figure 10.

Mr James Durkin observed the ejection of sand in the backyard of his house (now occupied by his son Michael) on Excelsior Road. Mr Durkin was not sure whether this occurred in 1962 or 1968. However, Mr O'Connor, who first told us of this site, implied it occurred in 1968. The house is marked in Figure 10.

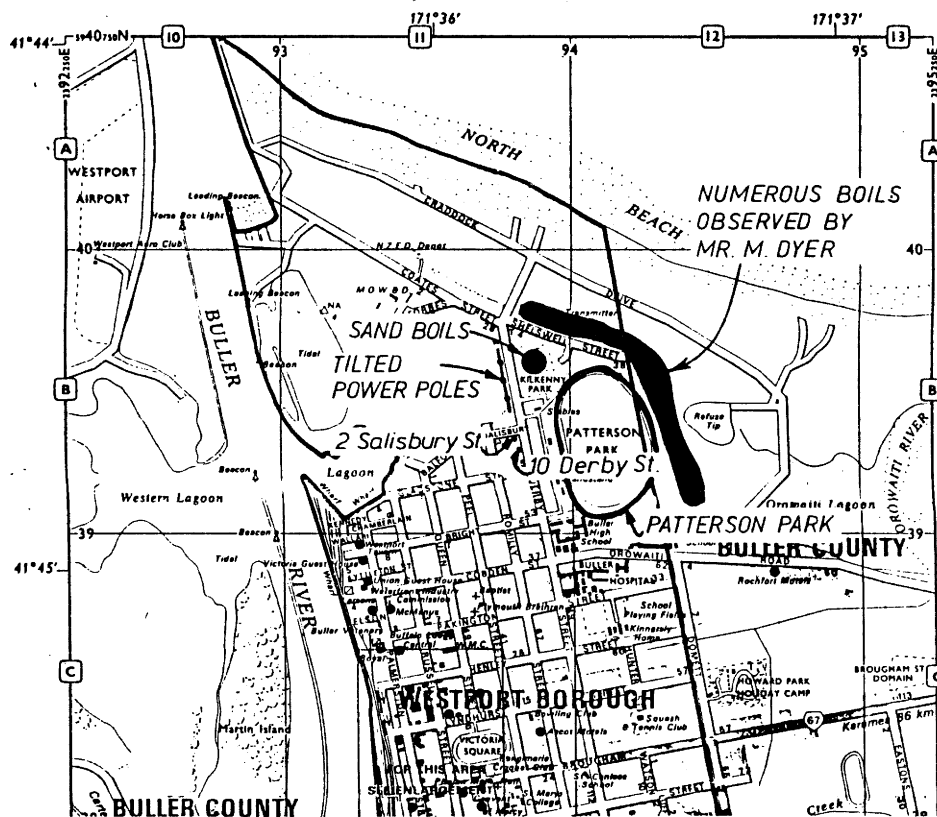
Mr M. Dyer remembers seeing numerous sand boils in the paddocks immediately north of Shelswell St and over the land to the west of Patterson Park south of Orawaiti Road, as shown in Figure 11. He also remembers boils along the east side of Derby St at Kilkenny Park. Several other eyewitnesses reported sand and water boiling from the ground in Kilkenny Park; these include Mrs McDonald of Morgan's Lane, and Mr and Mrs Bill Gaynor and Mrs Naylor of Shelswell Street, whose properties back onto Kilkenny Park. They do not remember seeing anything similar in 1962, but Mrs

Also, cracks opened in the ground passing through the Gaynors' house at 14 Shelswell Street and others on the south side of Shelswell Street. The cracks were roughly parallel to Shelswell St, (and to the nearby beach) and were of the order of a few hundred millimetres wide. Mr Gaynor, employed by the Westport Borough Council at the time, remembers having to add 1.2m of pipe to reconnect the broken water main running approximately north-south along Derby St, near Kilkenny Park. Taken together with the cracking, the broken water main suggests that a large mass of surficial soil had moved towards the coast on a layer of liquefied sand.

FIGURE 11: AREAS OF LIQUEFACTION IN 1968 IN THE KILKENNY PARK-NORTH BEACH AREA OF WESTPORT.

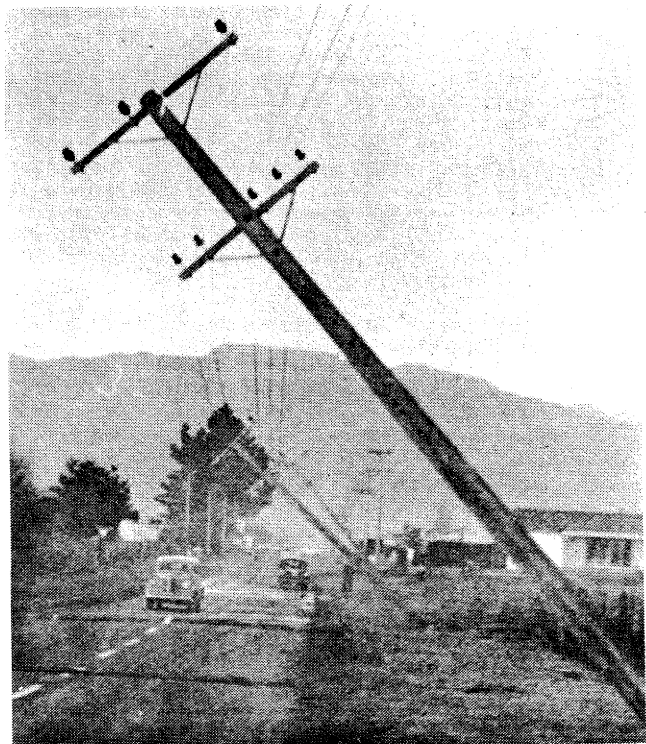
FIGURE 12: DERBY ST, WESTPORT, LOOKING SOUTH FROM KILKENNY PARK.

Figure 12 shows tilted electric power poles on the west side of Derby St adjacent to Kilkenny Park, also pointing to liquefaction at a shallow depth.

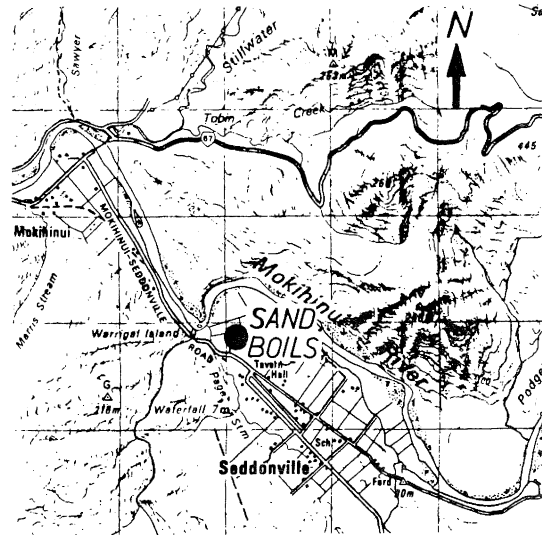
Mrs Corby remembers seeing sand boils on the Mohikinui River terraces between the Corby homestead and the Seddonville road. She could not locate the boils precisely, after 57 years, but they were in the area shown in Figure 13.

FIGURE 13: APPROXIMATE LOCATION OF SAND BOILS SEEN AFTER THE 1929 EARTHQUAKE.

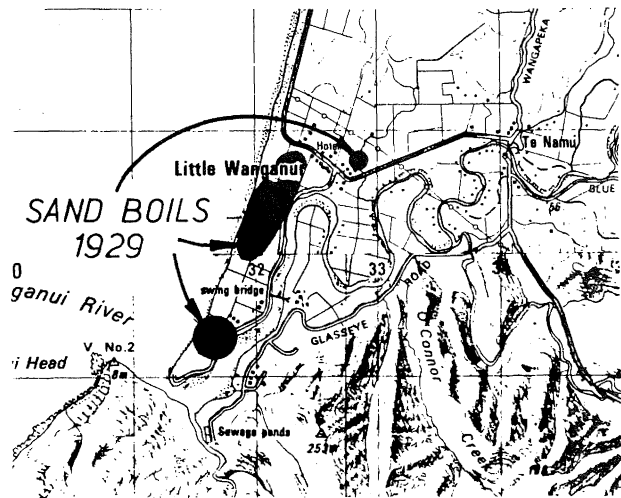
Mr and Mrs R. Duncan of Little Wanganui can both remember seeing sand boils following the 1929 earthquake, at the approximate locations shown in Figure 14.

FIGURE 14: APPROXIMATE LOCATION OF SAND BOILS SEEN NEAR LITTLE WANGANUI IN 1929.

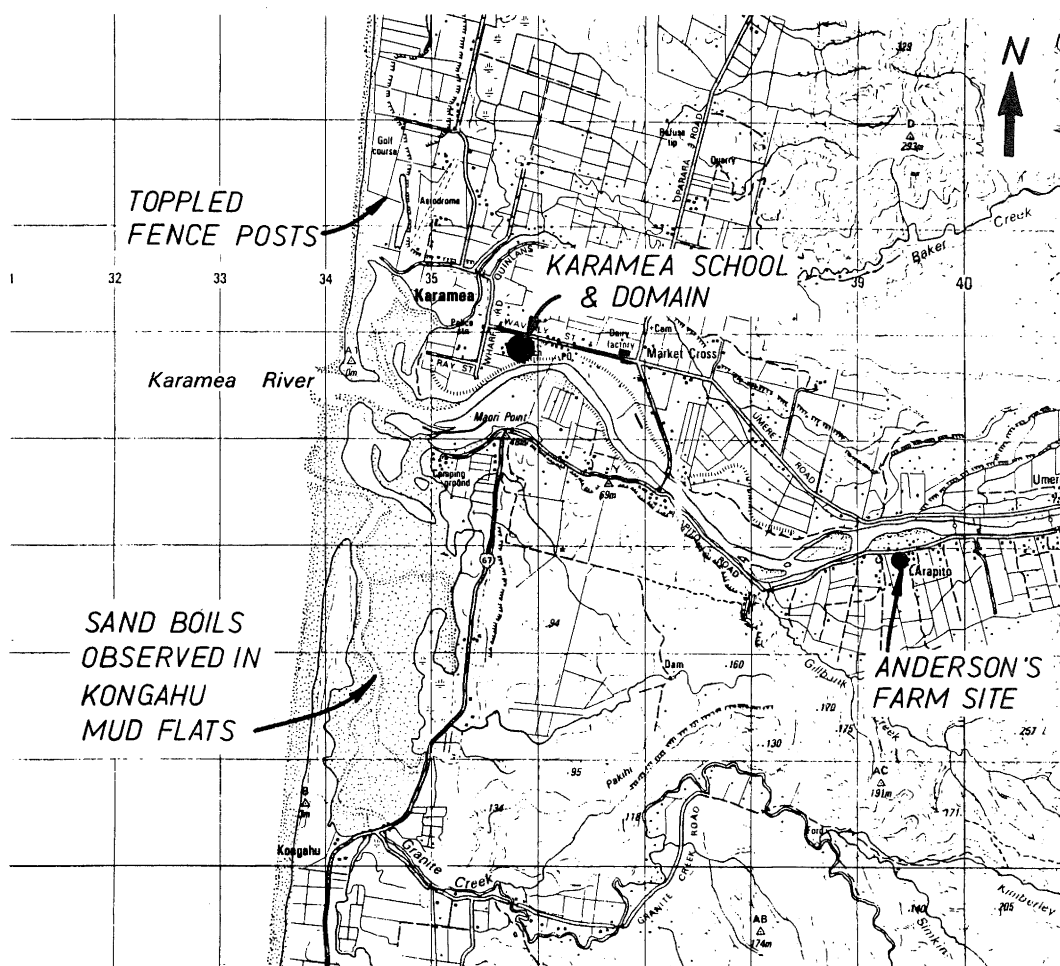
The most frequently commented-on site was the Karamea School and the adjacent Domain sports field, shown in Figure 15. The 1929 earthquake occurred during school hours and many of the elder present-day residents of the district were then at school. Three eyewitnesses independently referred us to a site immediately in front of the old school building, where sand and some gravel was ejected. An auger boring made at the school in May 1987 (Bienvenu, 1988) found a gravelly coarse sand, answering the general description of the ejecta, from a depth of about 2 to 3m and overlain by silts and clays. The water table was at a depth of 2.2m in May 1987.

Although he was away from Karamea at the time, Mr Karl Jones clearly remembers his grandfather describing sand boils erupting around him in the estuary between Kongahu and Maori Point, where he was fishing at the time. The rough location is shown in Figure 15.

As well as remembering sand ejection in the school grounds, Mr Johnson also recalls a line of fence posts toppled just to the west of the pond between the aerodrome and the coast, immediately south of the present golf course. The approximate location is shown in Figure 15.

FIGURE 15: SITES OF LIQUEFACTION IDENTIFIED IN THE KARAMEA DISTRICT FOR THE 1929 EARTHQUAKE.

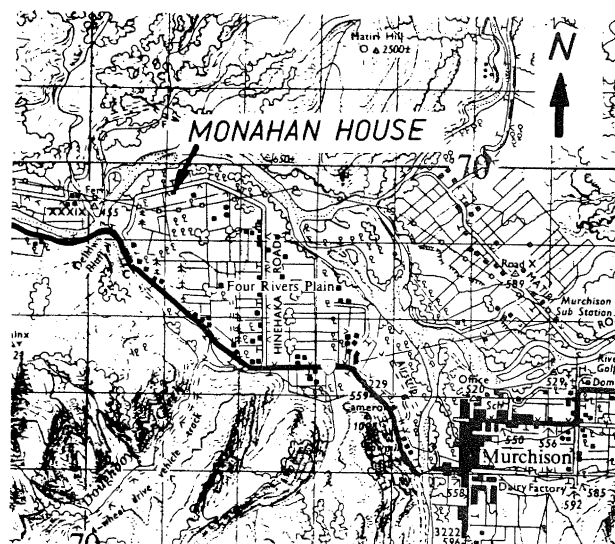
Mr T. Monahan remembers seeing sand boils distributed over the flat land around his house at Four Rivers Plain west of Murchison, and seeing isolated sand boils over most of the Four River Plain area after the 1929 earthquake. The Monahan's house and Four Rivers Plain are shown in Figure 16.

FIGURE 16: THE FOUR RIVERS PLAIN AREA WHERE PERVASIVE SAND EJECTION WAS OBSERVED IN 1929.

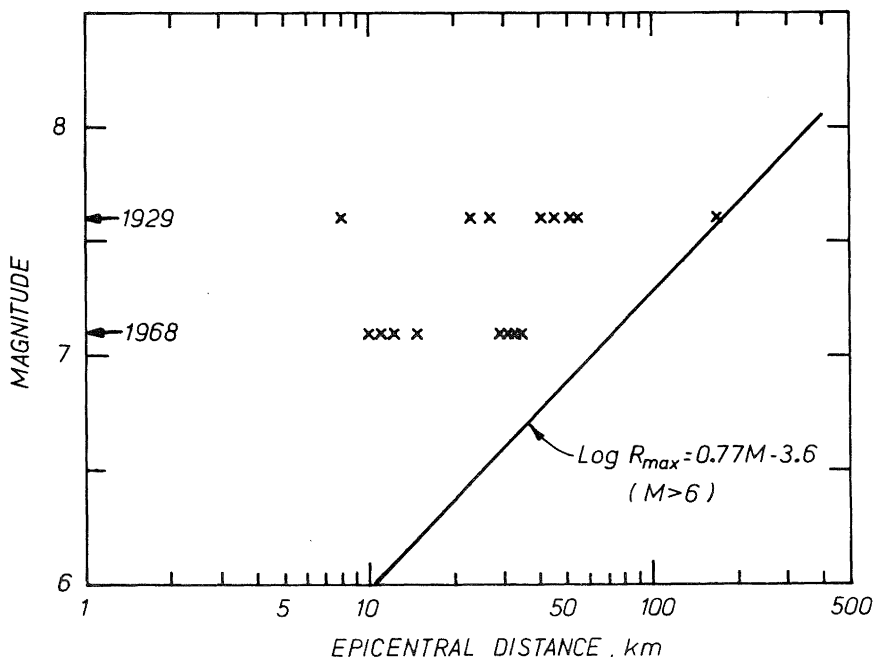
The 18 cases of liquefaction found in the Buller region are plotted on a magnitude-distance diagram in Figure 17, together with the Kuribayashi and Tatsuoka (1977) upper bound relationship for distance R_{max} to site of furthest liquefaction.

For the 1968 data, it is seen that liquefaction might have been expected at greater distances, especially towards the south, since the epicentre was at the northern end of the rupture surface. Enquiries were made of residents in the Reefton-Ikamatua area, but no further cases were found.

FIGURE 17: MAGNITUDE-DISTANCE PLOT OF THE 1929 AND 1968 SITES.
