IMPACTS OF THE 14TH NOVEMBER 2016 KAIKŌURA EARTHQUAKE ON THREE WATERS SYSTEMS IN WELLINGTON, MARLBOROUGH AND KAIKŌURA, NEW ZEALAND: PRELIMINARY OBSERVATIONS

ABSTRACT

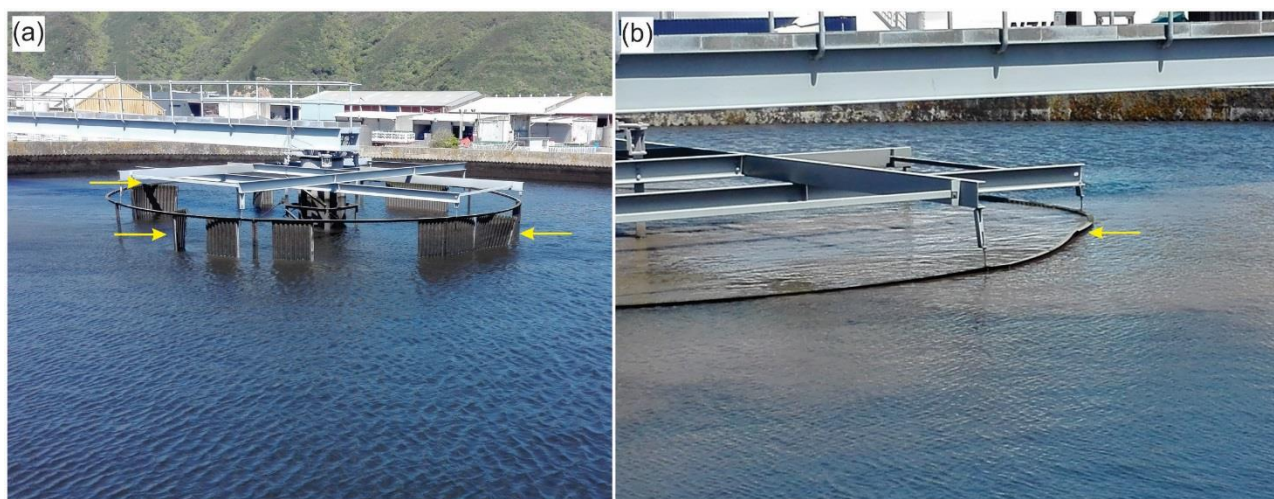
The four wastewater treatment plants in Wellington region are. Moa Point (Wellington), Seaview (Upper Hutt and Lower Hutt; see Figure 1a for location), Porirua and Western (Karori). In the Seaview and Porirua treatment plants, water seiching in the secondary clarifier tanks damaged the stilling well curtains and their holding rings that baffle mixed liquor influent to aid settling (Figure 2).

Figure 2. Damage at the Seaview Waste Treatment Plant. See Figure 1a for location. (a) Displaced curtain panels in the stilling well in one of the Seaview treatment plant clarifiers. (b) Damaged ring that holds the curtains of the stilling well in one of the Seaview treatment plant clarifiers (Photos: Hutt Valley Water Services Ltd).

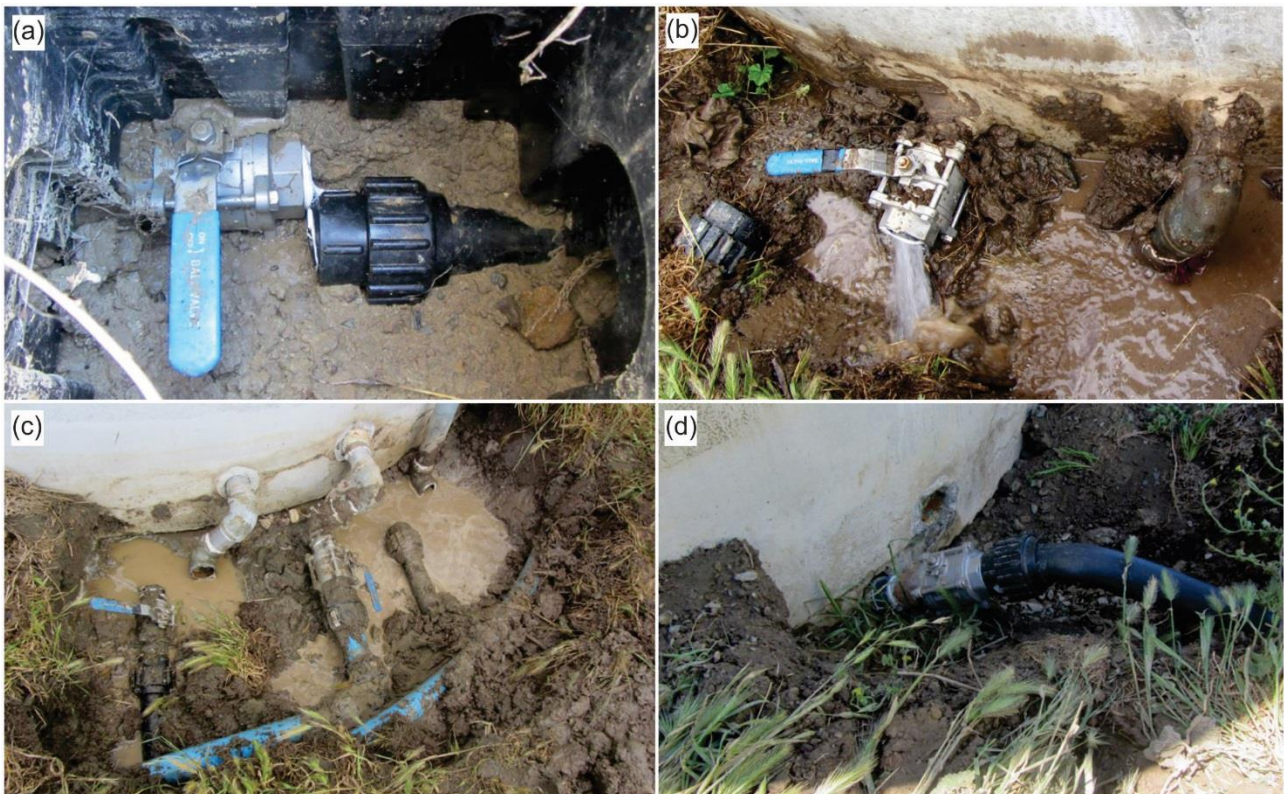
Figure 5. (a) Blind River Tanks. Failure failed threaded fitting due to horizontal displacement. (b) Flaxbourne, failed threaded fitting (Photo: Marlborough District Council). (c) Flaxbourne, failed threaded fitting and rotated galvanized pipe. The pipes rotated due to lateral ground movement. The seal around the pipes into the tanks has been compromised by the movement (Photo: Marlborough District Council). (d) Wheelers Hill. Pipe pulled out of tank wall due to relative displacement (Photo: Marlborough District Council). See Figure 1 for locations.

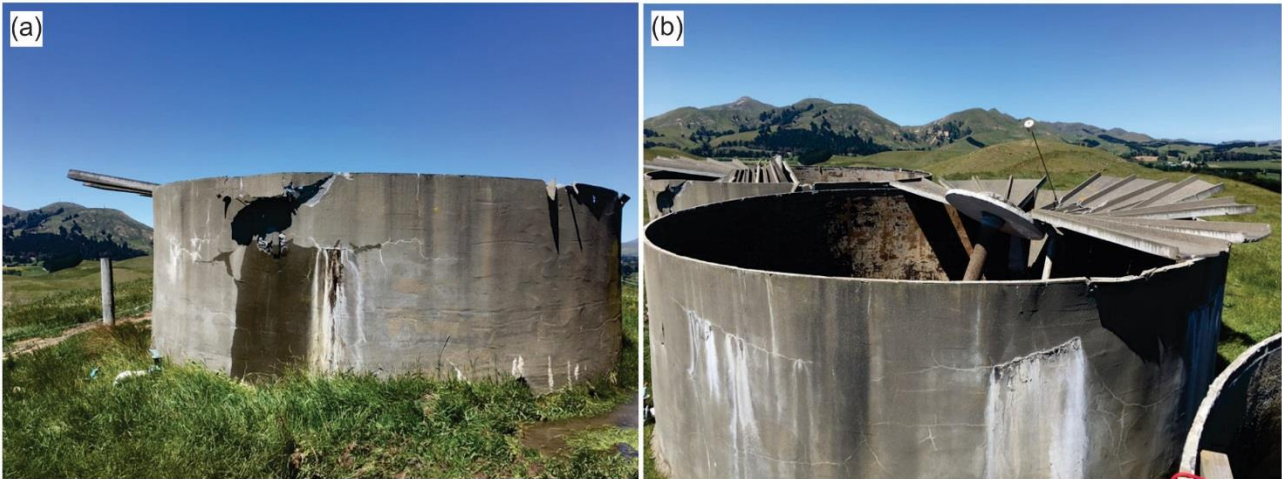
Figure 6. Ferrocement tanks at Ward, installed in the 1950s. (a) The thin ferrocement walls have failed and the segmented roof has collapsed (Photo: Marlborough District Council). (b) The segmented roof and the central pillar have collapsed (Photo: Marlborough District Council).

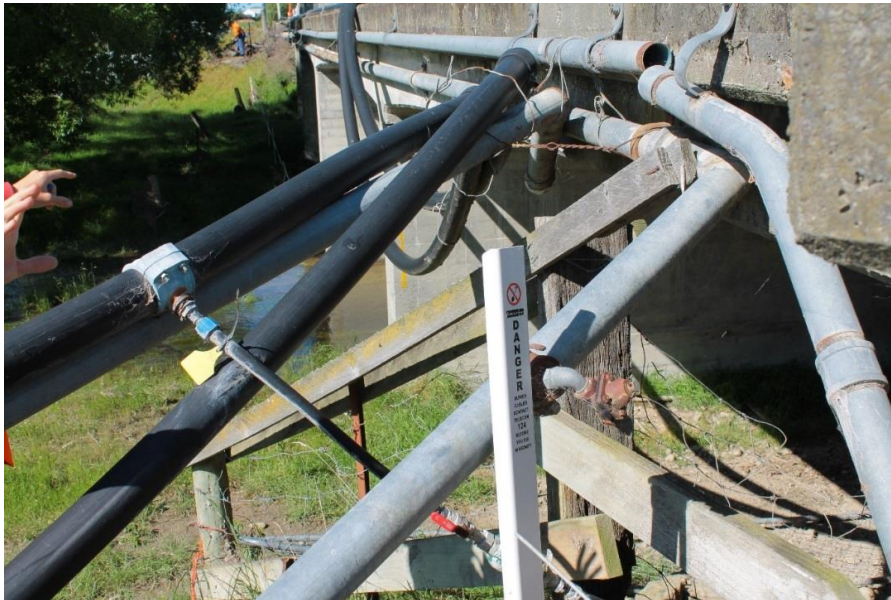
In addition to the Elizabeth Street footbridge in Blenheim, damage occurred at several other pipe service bridges across the region. For example, pipelines between relatively rigid bridge abutments and the ground were damaged as observed at the Needles Creek bridge site along State Highway 1, north of

Ward (Figure 7). Observed damage where pipes connect to bridges and other structures suggest more flexibility of the pipeline system would be important. A water supply well pump in Ward failed when movement of the water supply well relative to the nearby pump house resulted in the hold down bolts pulling out of the concrete base and displacement of the pump despite the presence of a rubber bellows joint. While this had caused an outage, it was believed that this had prevented failure of the pump itself (Figure 8).

Figure 7. East side of the Needles Creek Bridge north of Ward on the SH1, viewed from the north. Original freshwater pipelines have failed and been replaced temporarily with ductile pipes (in black) (Photo: X. Bellagamba).

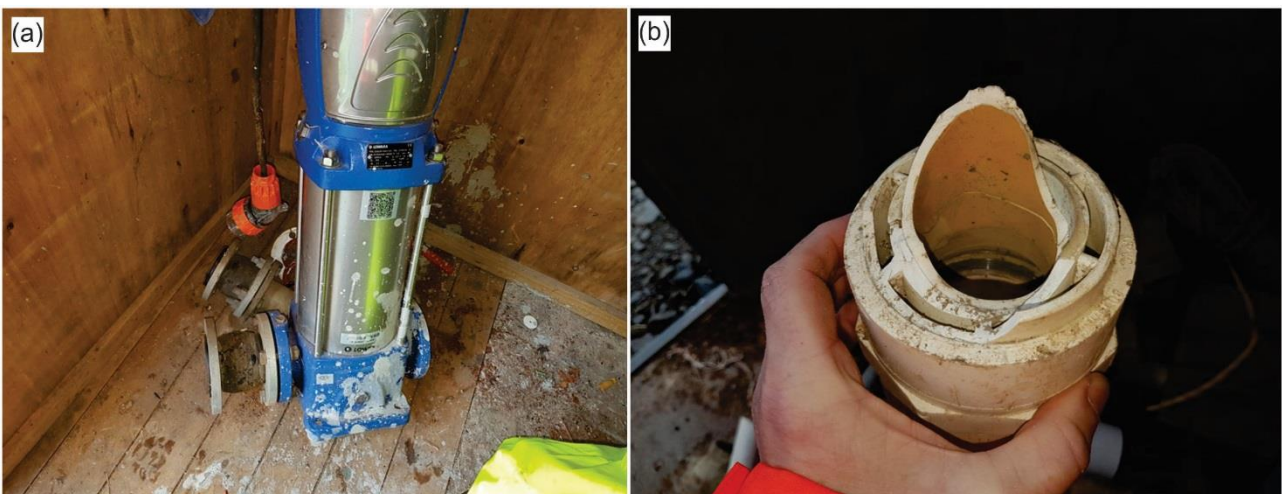
Figure 8. (a) Grundfos pump in pump house at Ward. When the water supply well was displaced, the galvanized steel pipework pulled on the pump. The bolts holding the pump to the concrete slab then failed, causing the pump to topple. (b) Failed PVC pipework from the Taimate water supply well near Ward. The pump house building slid on its base, causing the water supply well pipework to fail.

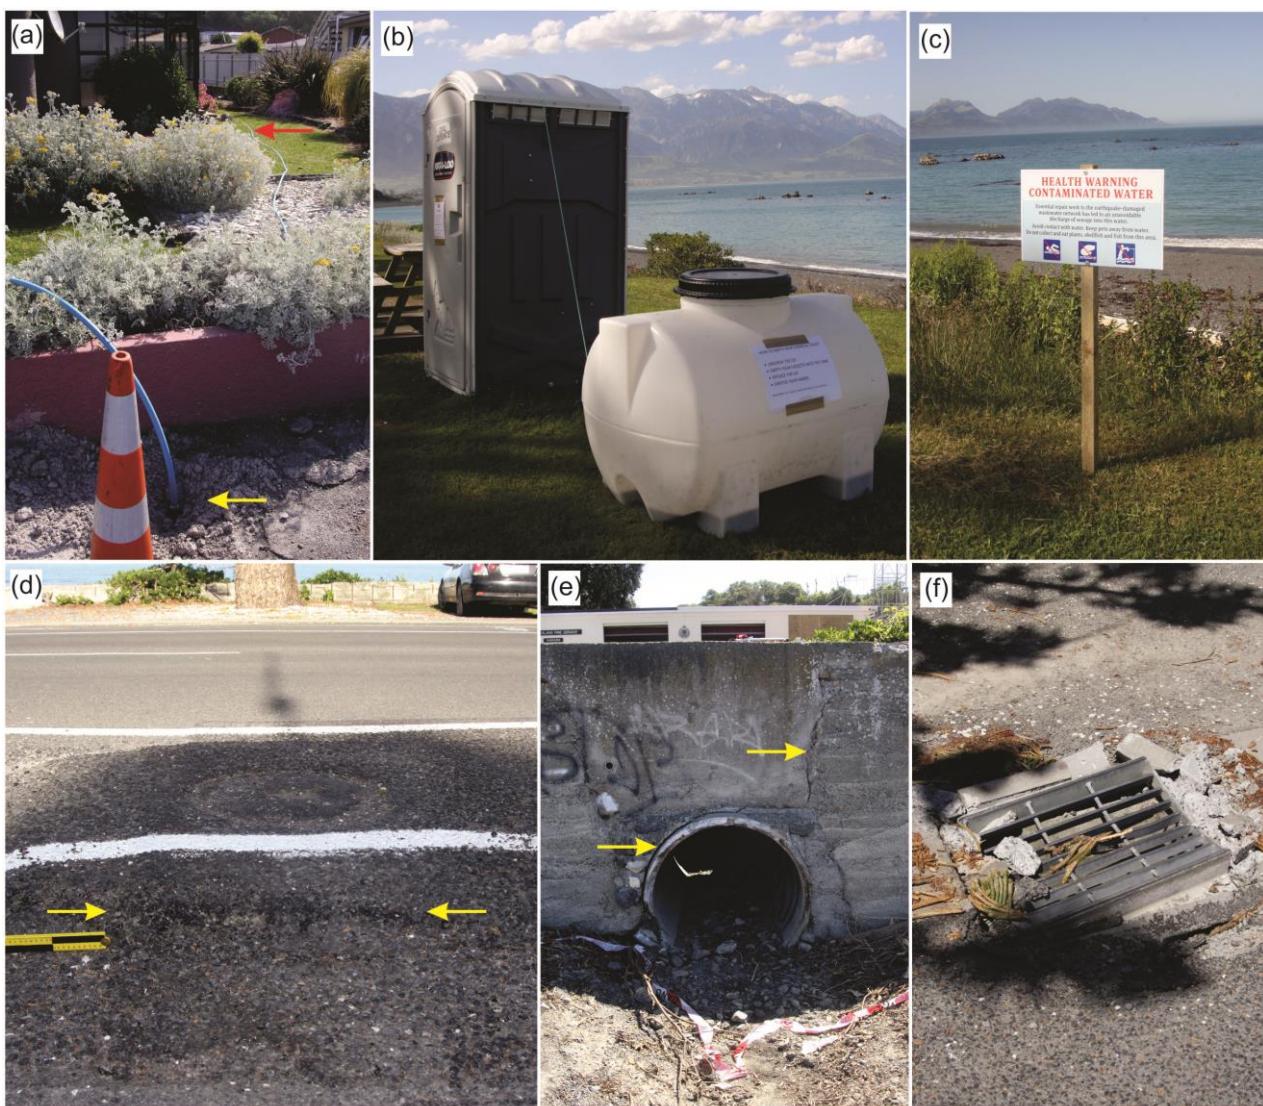
Wastewater pipes experienced significant damage, compromising most of the system that is reticulated to the treatment plant north of Kaikōura township. As a result residents were advised to use available portaloos already present in Kaikōura, or to use buckets or holes dug in gardens to dispose of human waste. On November 18th chemical toilets were delivered by the New Zealand Defence Force to be distributed to all households in Kaikōura, although the necessary supply of chemical solution for them was delayed by 2-3 days. Residents were informed of chemical toilet dump station locations (Figure 9b). Portaloos were also distributed

Figure 9. Three waters impacts along The Esplanade, Kaikōura. (a) Temporary overlanding of domestic water supply from the street connection (yellow arrow) to the house's kitchen area (red arrow). (b) Portaloos (left) and chemical toilet dump station (right). (c) Contaminated water warning, discouraging swimming, fishing and shellfish collection. (d) Differential manhole movement of ~3 cm (arrows). (e) Cracking in retaining wall (arrows) surrounding stormwater culvert. (f) Damaged concrete gutter due to impact by steel stormwater grate. (Photos: M.W. Hughes).

There was little physical manifestation of system damage along roadways, although at least one manhole was noted to have experienced slight differential movement through the 14th November event (Figure 9d). Pipe condition assessments via CCTV were occurring from the days after the event, supported by experience and expertise gained from condition assessments conducted in Christchurch through the 2010-2011 CES [21].
