THE SEPTEMBER 1985 MEXICO EARTHQUAKE

PRELIMINARY REPORT OF THE NEW ZEALAND RECONNAISSANCE TEAM

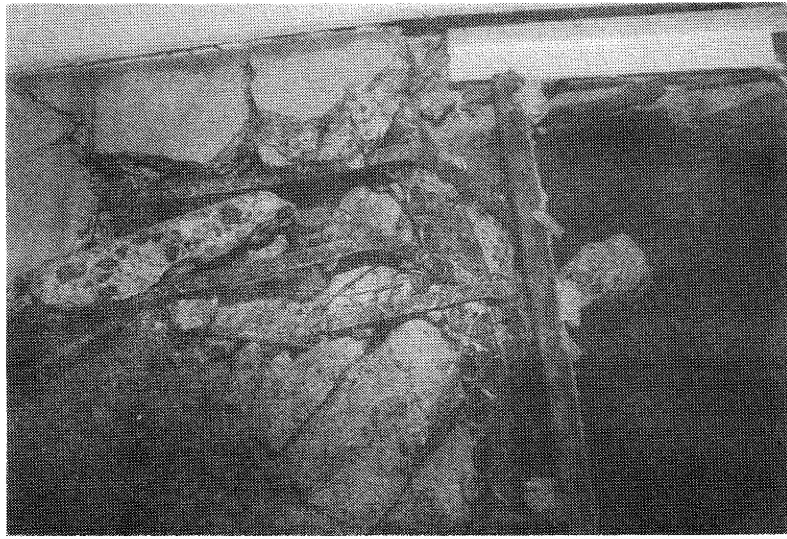
Numerous instances of complete disintegration of reinforced concrete columns were evident, due to the opening up of column ties and loss of confinement as a result of removal of concrete cover due to hinging or shear and the unfolding of 90° hooks to ties. As a result, longitudinal bars buckled, core concrete fractured and the gravity load carrying capacity at the column was lost (Fig. 5). In beams, similar effects were observed in 'hinge' regions. The use of 90° hooks to column ties and stirrups rather than 135° hooks appears to be almost universal in Mexico. Several examples of apparent compression failure in columns were also observed. Fig. 6 illustrates one example of beam column joint failures leading to partial collapse of a reinforced concrete office building and Figs. 7 and 8 show damage resulting from apparent column failures.

Figure 5 Opening of 90° hooks to column ties.

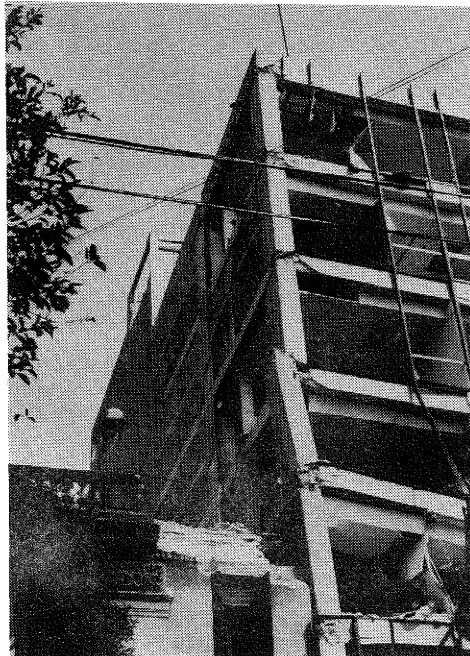
Figure 6 Building on Calle de Tanala which has suffered severe beam/column joint failures.

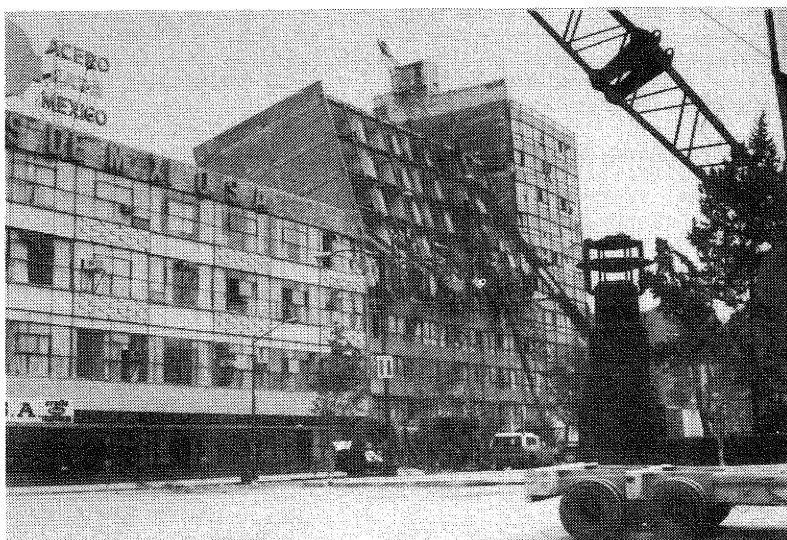
Figure 7 Collapse of the Hotel de Carlo due to Column failure at rear.

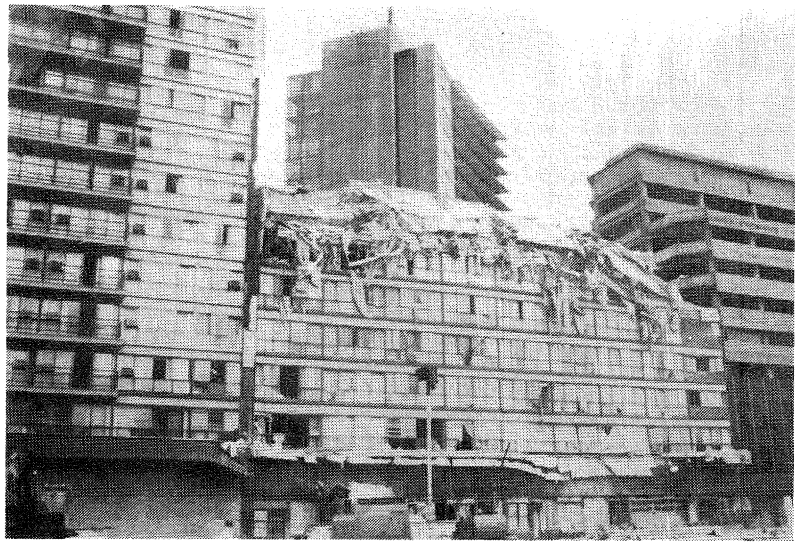
Figure 8 Upper storey collapse in the Continental Hotel.

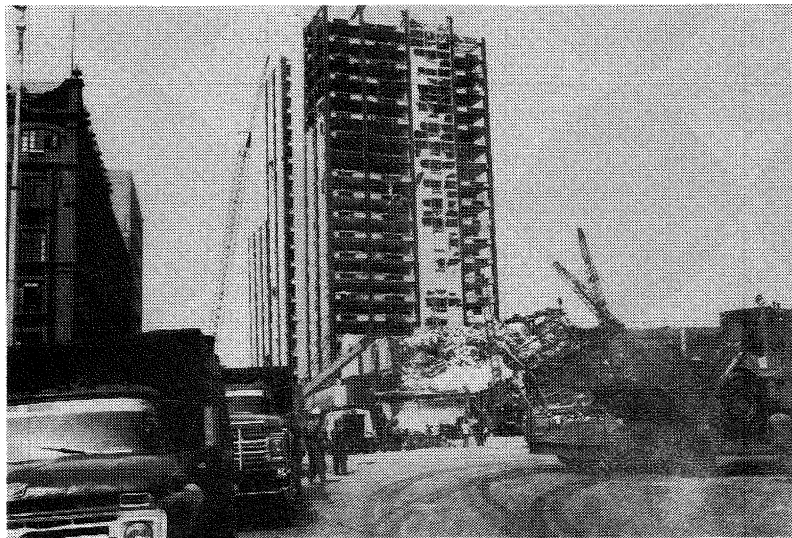
One of the most spectacular failures in Mexico City was the collapse of one of the Pino Suarez Towers. Prior to the earthquake, this complex consisted of five buildings in a row. The end two were of 14 storeys and the central three of 20 storeys. The columns were box sections fabricated from steel plate and the beams were truss members. In the short direction (2 bays) lateral resistance was provided by frame action between the beams and the columns. In the long direction (4 bays) "K-bracing" had been provided in one bay. Failure occurred at the third floor level (immediately above the podium), the mode being local buckling in the flanges of the column assisted, perhaps, by weld

failure, resulting in complete collapse of one of the 20 storey towers on to the adjacent 14 storey structure. Severe hinging was also observed in the long direction in the beams where the infill panels had braced part of the beam span forcing it to behave as a short coupling beam. Fig. 9 shows the remaining towers with the collapsed structures, partially removed, in the foreground. Figs. 10 and 11 show local buckling in column plates and instances of weld failure and lack of fusion of fillet welds to a diaphragm plate at a beam column joint.

Figure 9 Pino Suarez Towers during clean-up operations. In foreground, debris from 20 storey tower which collapsed over adjacent 14 storey building.

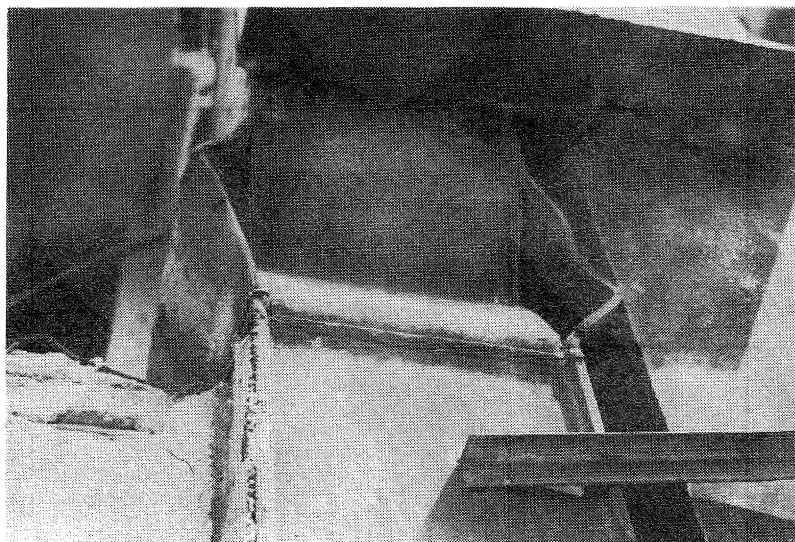
Figure 10 Local buckling in steel box columns—Pino Suarez Tower, still standing but with 1.2m lean.

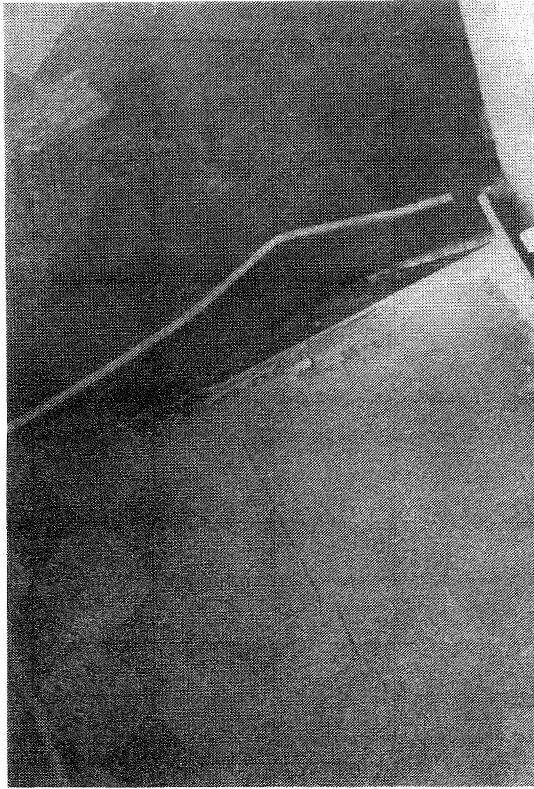
Figure 11 Lack of fusion in fillet weld to a diaphragm plate in the steel box columns—Pino Suarez Tower, collapsed 20 storeys.

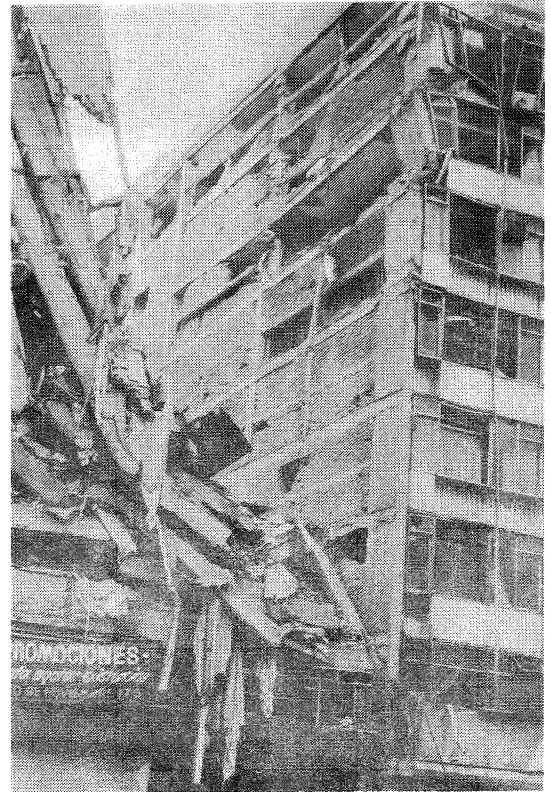
Provision of a seismic separation gap between adjacent structures, particularly in the case of newer construction, was common. However, in many instances the clearance was inadequate and impact occurred. The consequences of impact was especially severe when floors were at different heights, so that the floors of one structure struck the columns of its neighbour. One such example is shown in Fig. 12. In some instances it was the intent of the designer to provide a seismic gap. However, a lapse in quality control either during construction or subsequent to completion meant that the gap was not maintained. For example, several cases were observed where formwork had been left in place effectively nullifying the gap. Appropriate flashing of the gap adequately to prevent the accumulation of debris in the clearance during the working life of the facility had not been installed in other instances.

Figure 12 An example of pounding between neighbouring structures with floors at different elevations.

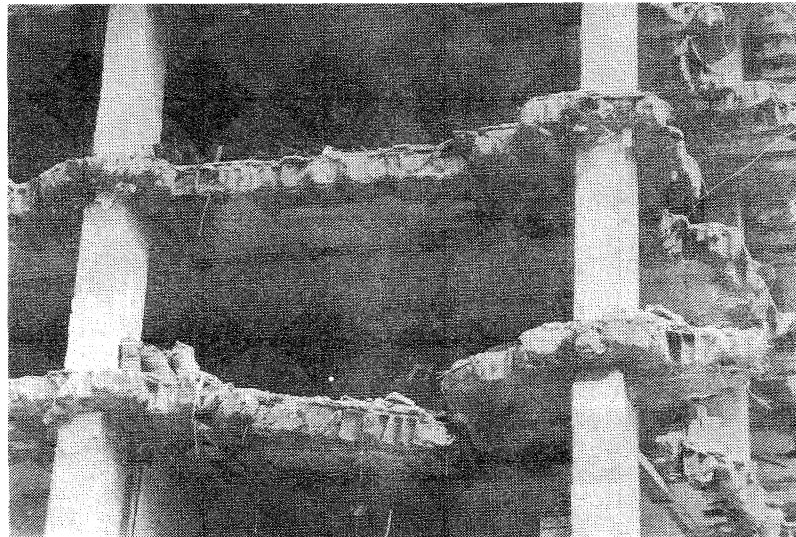
Several failures due to inadequate shear capacity in flat slabs adjacent to columns were observed. The waffle slab in various forms is a common slab type used in Mexico City. A typical failure in a partially collapsed building is shown in Fig. 13. Fig. 14 shows an example of a collapse of an eleven storey flat slab structure. The columns remain standing, but separated from the slabs they once supported by shear failures in the junction between slab and column.

Figure 13 Flat slab-column joint failures, Public Water Supply building.

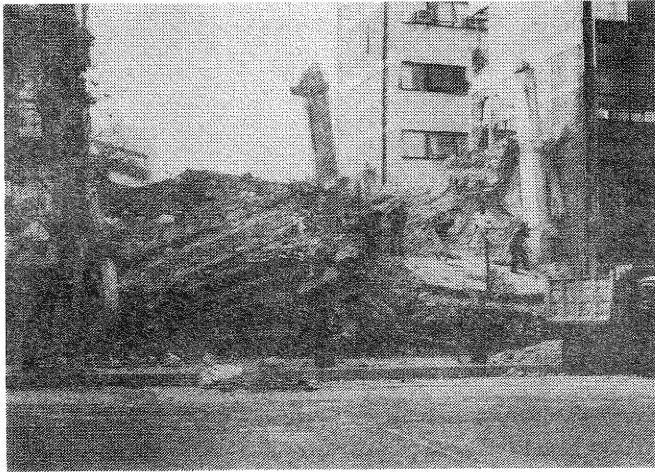
Figure 14 Flat slab failure in an eleven storey structure on Av. Oaxaca.

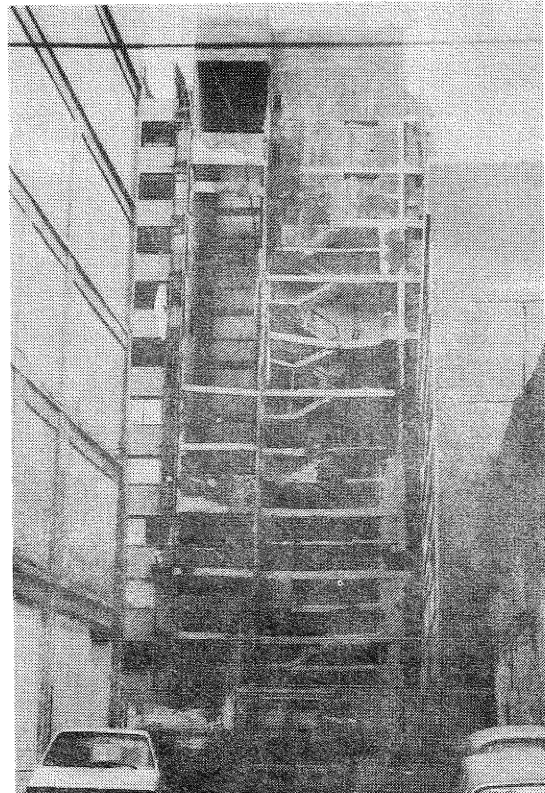
Insitu concrete stairs are usual, but steel is also found. There was usually no positive separation at floor landings and damage had occurred in many cases as a result of this (Fig. 16). Even where structural damage to stairs was slight, architectural finishes were damaged where movement had occurred between the stairs and adjacent elements.

Figure 16 Damage to stair tower and hinging in strings due to non-separation.

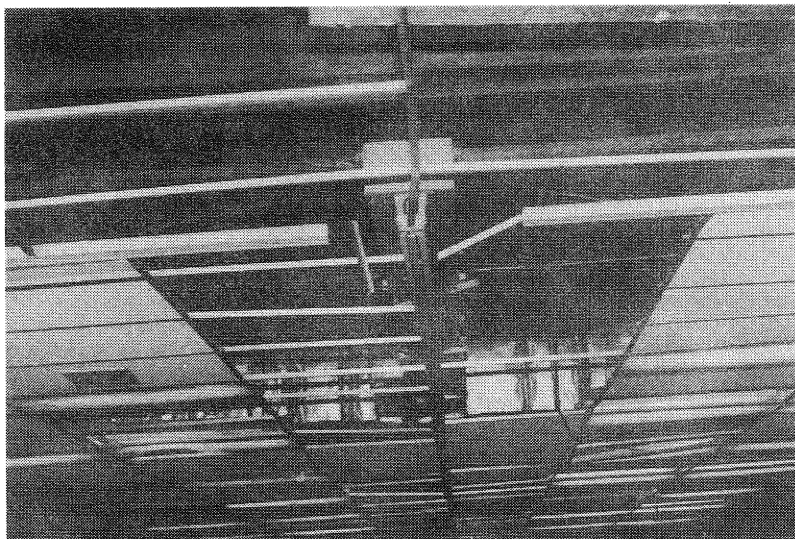
- By collapse of the adjoining or supporting structure.
- By damage to panels and/or rails that had been restrained by the adjacent elements.
- By panels falling out, although damage to the rail system was slight. This was common. (Fig. 15).

Figure 15 Damage to suspended ceiling system.

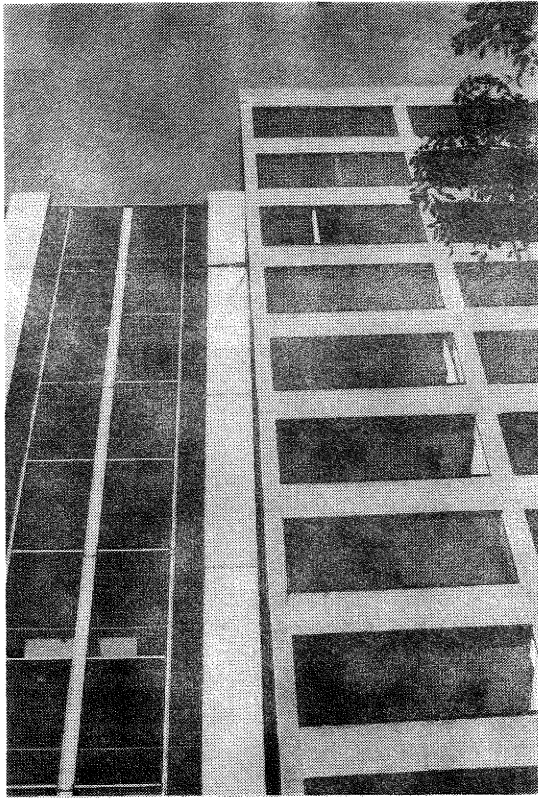
Damage to windows systems, and particularly to glazing, was widespread in the severe damage zone (Fig. 17) but there were also many anomalous situations in which glazed curtain walls were undamaged or only slightly damaged, despite apparent deficiencies in the structural form of the building.

Figure 17 Damaged glazing system.

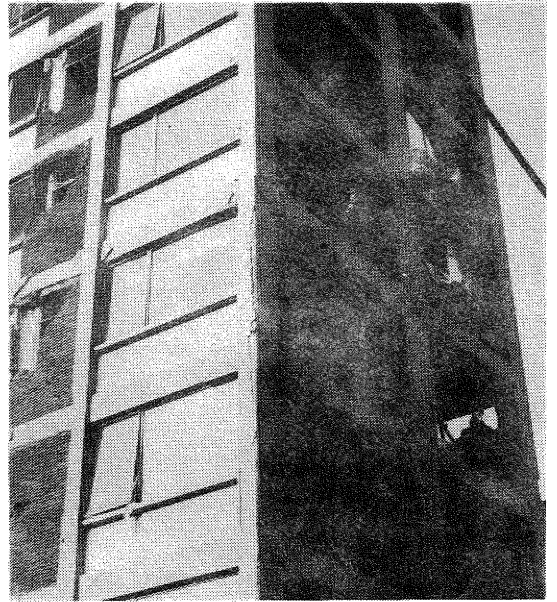
Figure 18 Damaged brick infill panels.

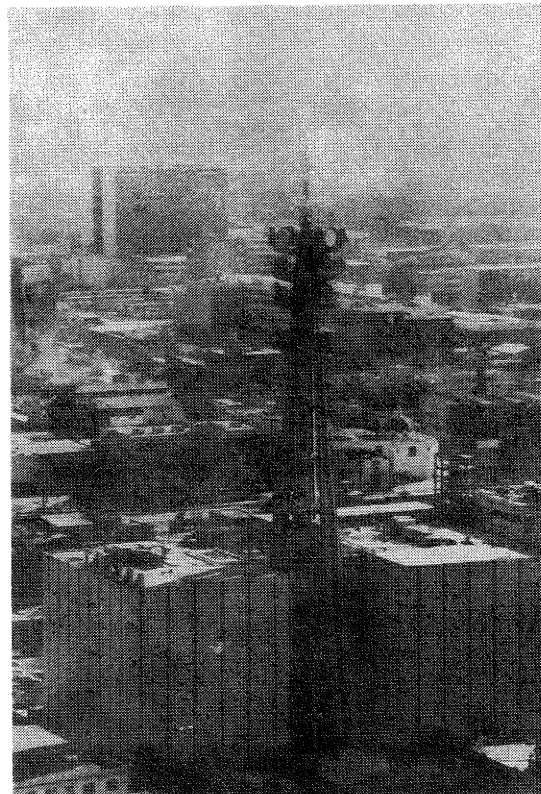
Figure 19 Telecommunications tower, Mexico City.

The reinforced concrete tele-communications tower at the central telephone exchange suffered some damage to upper coupling beams (Fig. 19) and to the covered walkways to adjacent buildings. The tower appears to be plumb and is still in use. It is not known whether the microwave antennae were damaged or needed to be realigned.

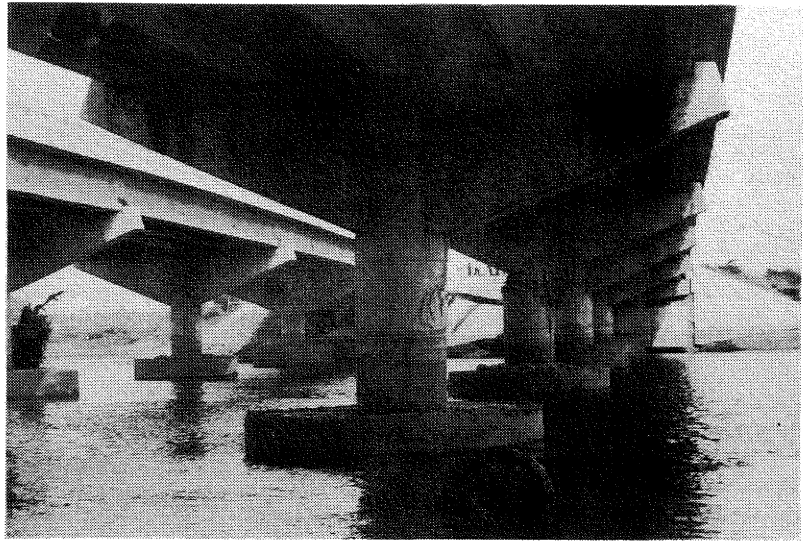
The twin bridges on the Rio Balsas are reinforced concrete, with single stem piers and with 5 prestressed concrete simply supported spans. A number of the piers suffered major damage due to hinging and loss of confinement (Fig. 20). The bridge showed evidence of longitudinal movement, and damage to the lugs restraining the spans transversely. In addition, the approach fills had settled and suffered tension cracking longitudinally. The damage was sufficient to close one bridge to vehicles while only one unladen vehicle per time was permitted on the other.

Figure 20 Bridge pier damage.

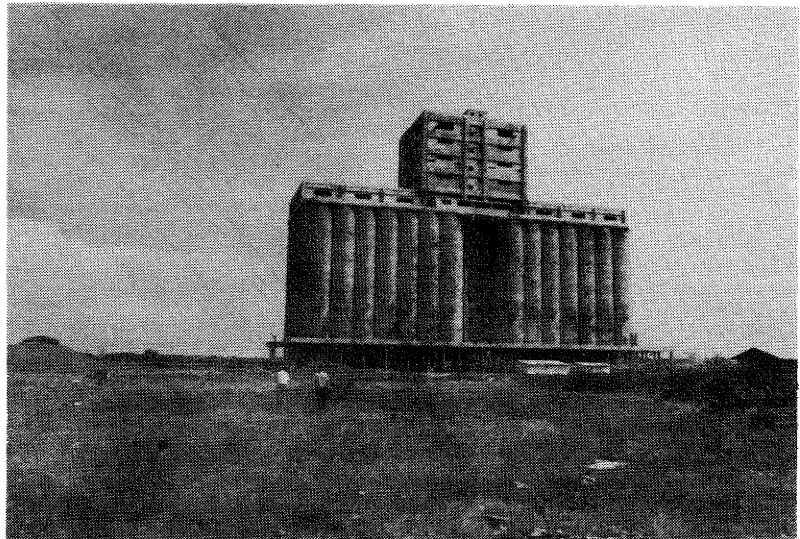
Figure 21 The structure on the grain silo has lost its lowest storey.

the silos partially collapsed and lost a complete storey due to column shear failure (Fig. 21). In addition, the reinforced concrete conveyor support structure to the grain unloading facility on the adjacent wharf collapsed. Collapse appeared to start at the free end (Fig. 22) due to inadequate anchorage of the column bars into the wharf deck. The twisting caused torsion cracking of the spine beam and failures of the beam at cut outs in the slab. Failures of the cantilever columns in some cases involved complete disintegration due to inadequate column ties and the use of 90° hooks. The large structural steel mobile grain elevator on the wharf was restrained by angles welded to the rail but was undamaged.

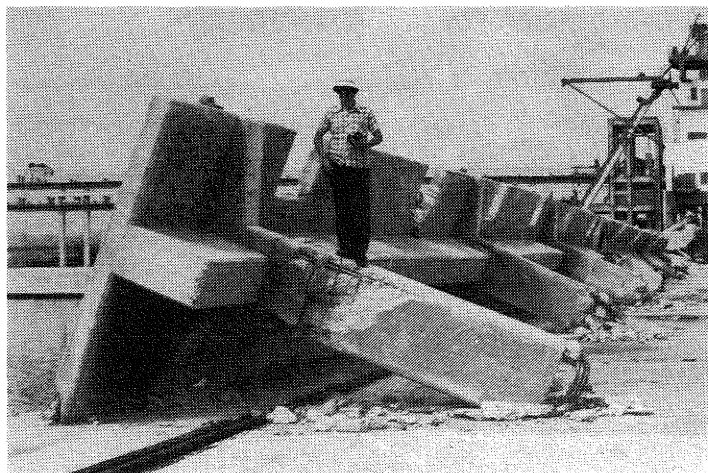
Figure 22 Collapse of conveyor support structure.

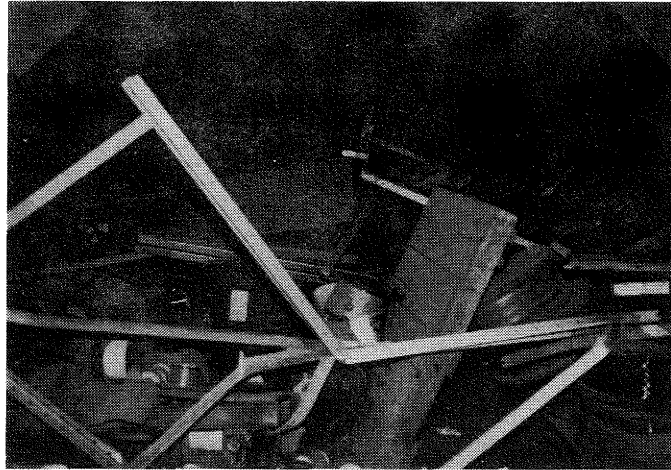
Figure 23 Collapsed storage rack.

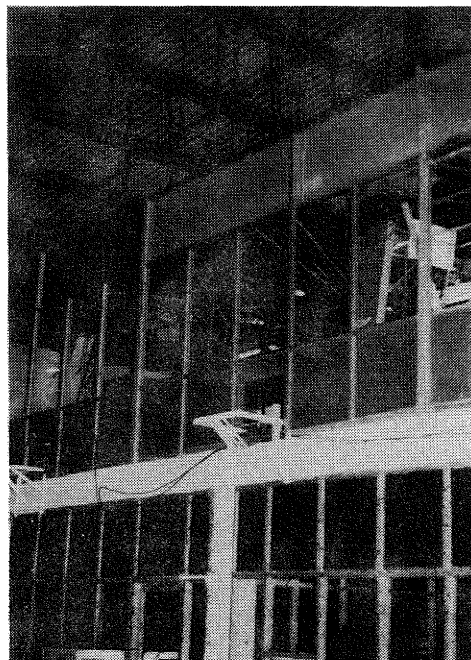
Figure 24 Damaged warehouse offices.

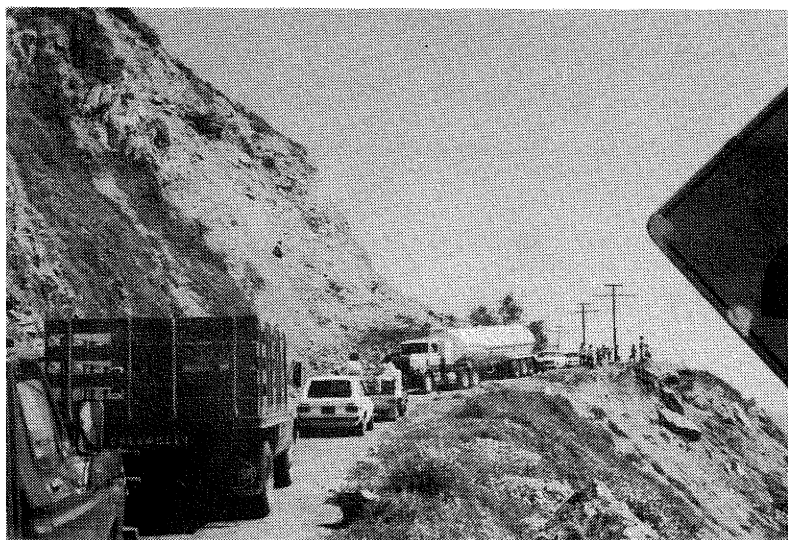
Figure 25 Rock slide on Highway 200.

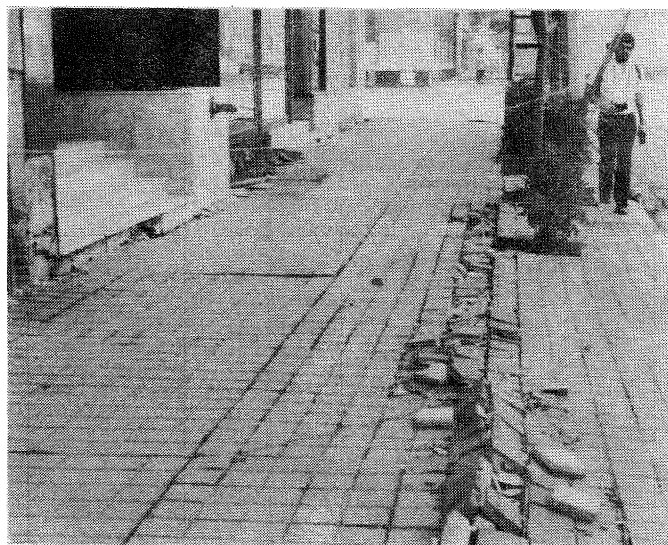
- Uplift of the foundation slab or pile cap combined with settlement of the ground surrounding piled structures. Relative displacements were generally 150 - 200 mm. Slender structures were the worst affected.
- One case of complete pile pull-out with resulting building over-turning was reported.
- Buckling of ground slabs, pavements, etc. as evidence of relative displacements of buildings at ground level. (Fig. 26).

Figure 26 Compression buckling of pavement.

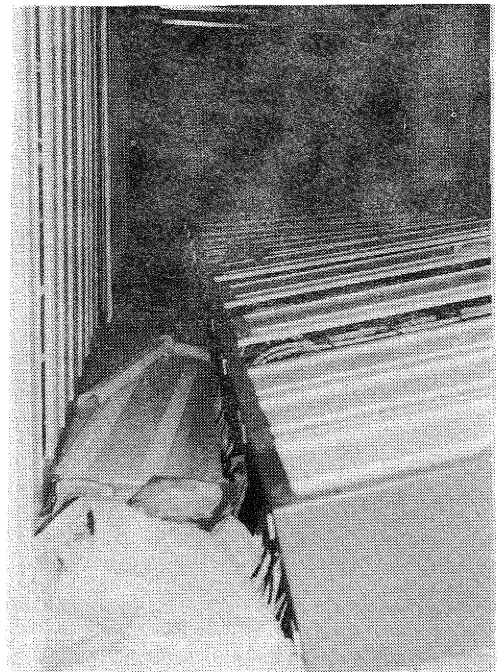
Figure 27 Overturned switch cabinets.
