## INELASTIC ANALYSIS OF THE IMPERIAL COUNTY SERVICES BUILDING

### Summary:

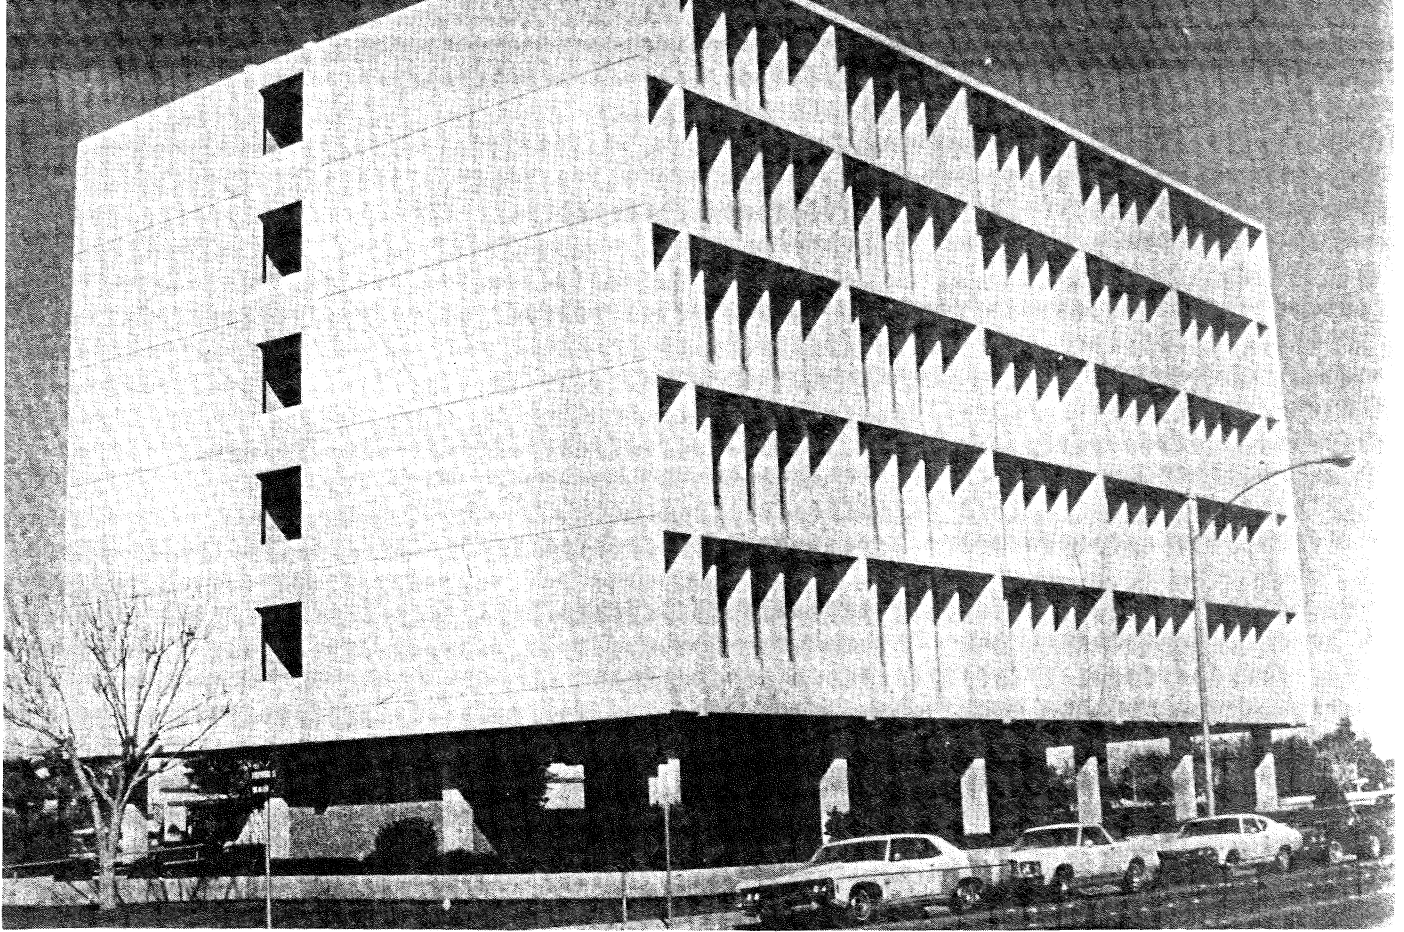
FIGURE 1 : Imperial County Services Building - view looking Northeast

Failure of the ICSB in the October 1979 earthquake occurred catastrophically in the columns at the east end of the building. From the initial examinations, it appeared that the four free-standing columns at the east end of the building had failed by overturning since the outer pair of columns showed more distress than the inner. At the same time, the end shear wall, the floor diaphragm and the inner shear wall showed no apparent sign of shear distress.

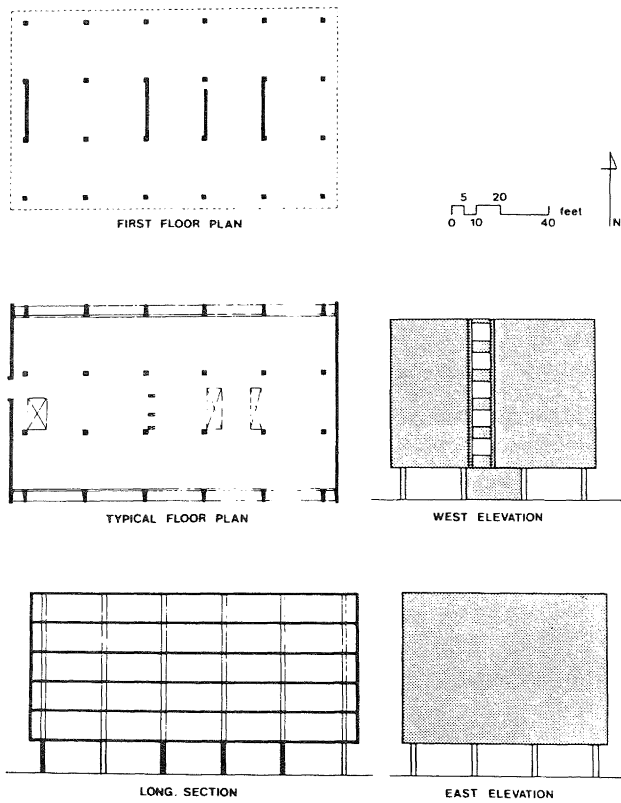
FIGURE 2 : Plan and elevation views of ICSB

Superficially, the ICSB appears to be a simple, rectangular and symmetrical structure and as such one would expect the four corner columns to react in a symmetrical fashion. However, the floor plans and longitudinal section shown in figure 2 indicate that the ground floor shear walls are not symmetrically distributed. It can be seen that at the west end, the shear wall from roof to first floor is offset some 1½m horizontally at the first floor level before continuing to the foundations (in the centre bay only). At the east end, a similar shear wall stops at the first

The situation at the east end represents a classic case of shear wall discontinuity where an abrupt change of strength and stiffness occurs at a point where the shear wall terminates at the first floor. The vertical loads (from the overturning of the shear wall) must be taken down to the ground through the four slightly offset columns while the shear forces from it must be transferred to the smaller shear wall in the adjacent bay in the manner indicated schematically in figure 3. At the west end, the stiff ground level shear wall beneath the upper wall prevents large axial forces from being carried by the columns. While there is a 1½m "kink" in the load path from the upper portion of the west wall to the ground floor portion, compared to the east end it is more nearly a continuous wall.

From figures 2 and 3 it can be seen that in effect, the east end of the building at the ground floor level is more flexible than the west end and it could be expected that in an earthquake the ground level columns at the east end would resist some of the horizontal load from the shear wall above. Coupled with this, it can be seen from figure 4 that the lateral ties to the longitudinal steel were more closely spaced at the bottoms of the columns where plastic hinge formation was most likely to occur. However, a concrete ground slab was poured on the soil layer above the footings at about the same level as the point where the spacing of the lateral ties was reduced. Failure in the east end columns occurred about the slab level and it seems that this failure was caused by the formation of plastic hinges at this level together with the effect of the large cyclic axial force variations in the two outer columns on column line G (in the transverse direction) contributing to their degradation in strength and stiffness.

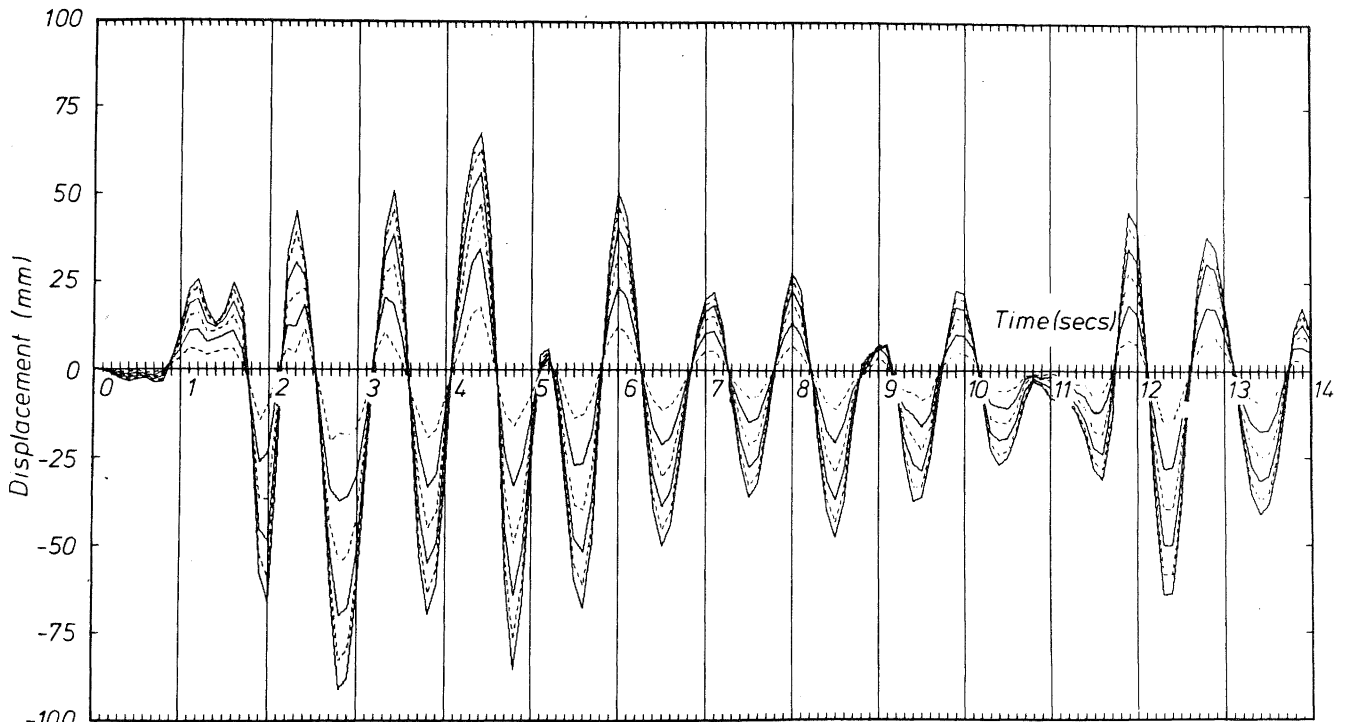
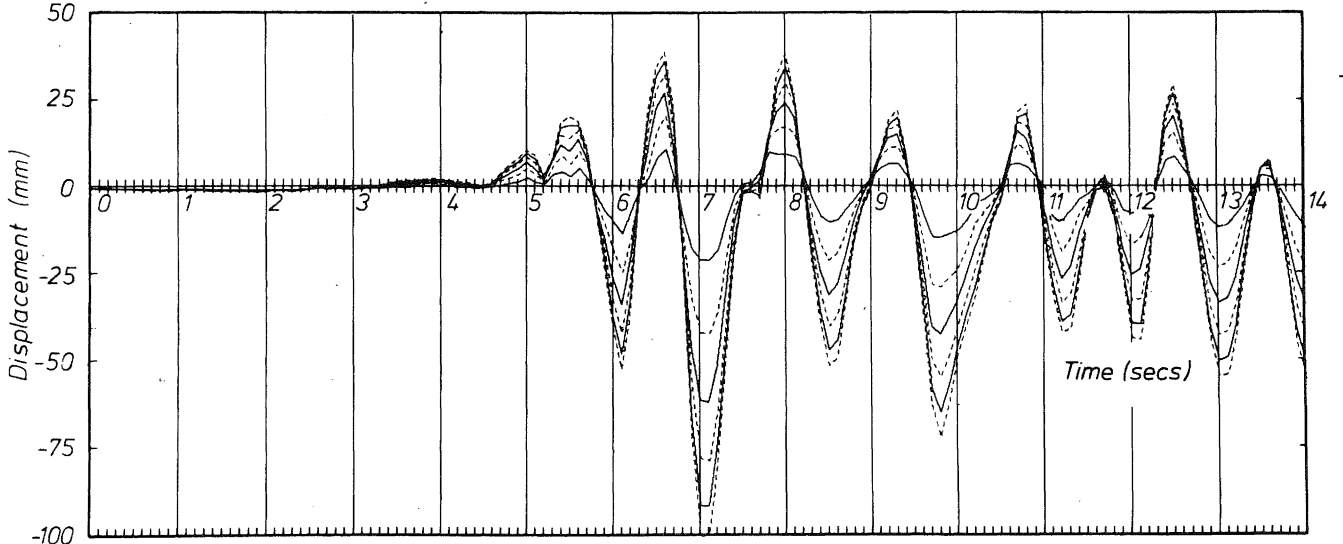
FIGURE 11 : Displacement time-history plots for inelastic analyses using 1940 (top) and 1979 (bottom) EW earthquake records

Under the 1940 and 1979 free field earthquake records, the deflection at the roof level was found to be 93.0mm and 95.5mm respectively while under the recorded 1979 ground floor motion the roof deflection was 103.4mm. Comparing the time-history plots for the 1979 free field and ground floor records, it was found that the displacement variations were very similar for both records even though the ground floor record had larger peak accelerations than the free field record. Displacement time-history plots from the 1940 and 1979 records are shown in Figure 11.

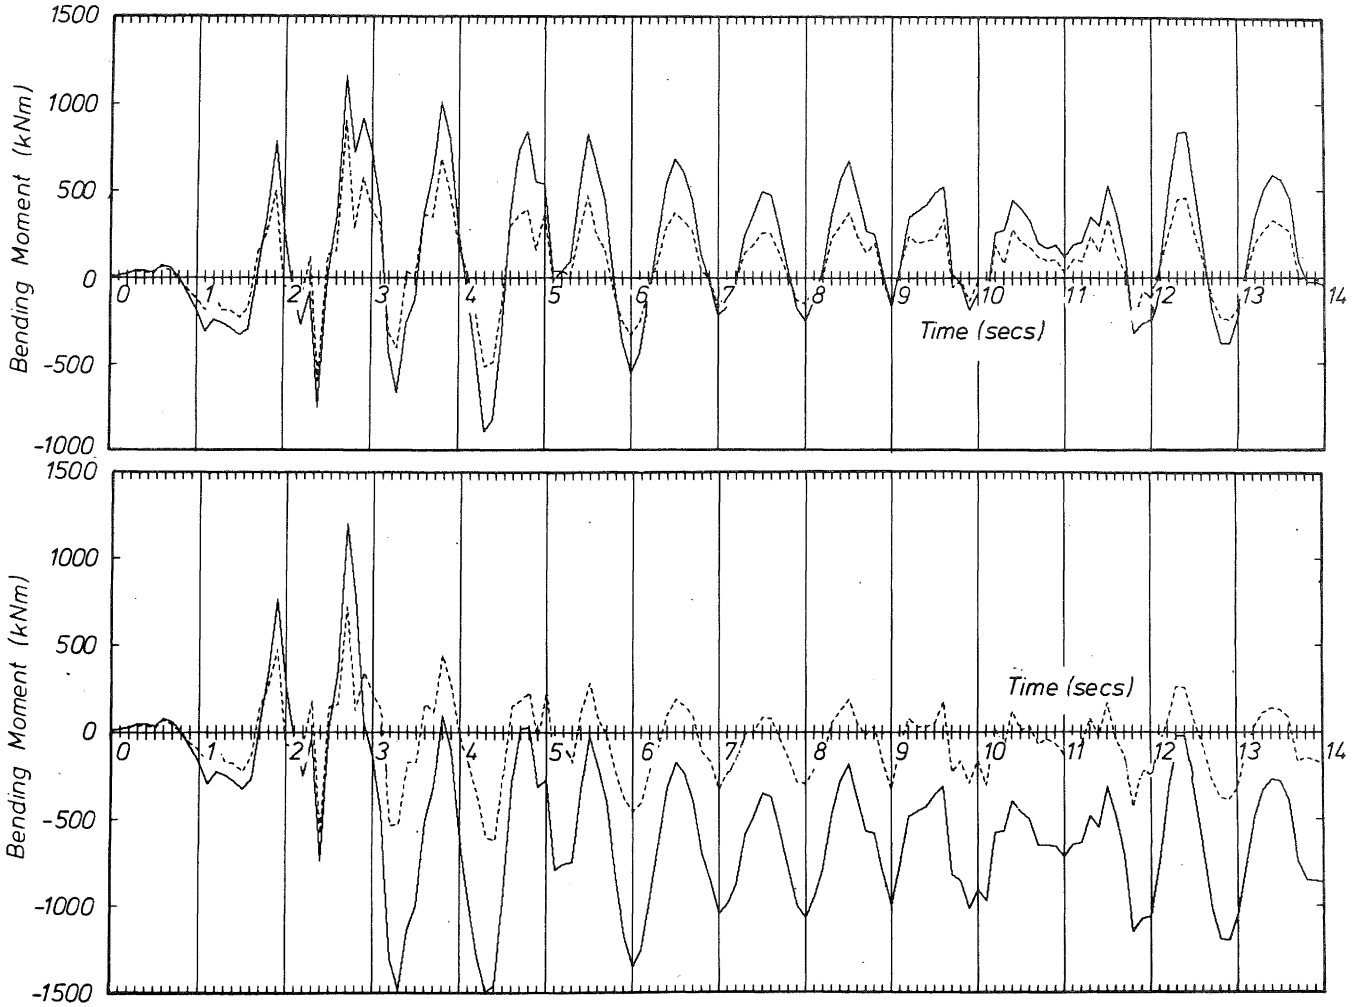
FIGURE 12 : Bending moment time-history plots for outermost column in exterior (top) and interior (bottom) frames under 1940 El Centro record

Time history-plots for the column bending moments at the top (dashed line) and bottom (solid line) in the end columns of the exterior and interior frames are shown in Figures 12 and 13. For both earthquakes, it can be seen that the behaviour of the end columns of the two frames are slightly different. In the case of the exterior frame under the 1940 earthquake, the bending moments at the top and bottom of the columns both alternate in direction in a similar way. For the interior frame, the moment at the bottom of the column maintains the same direction after first few reversals but the top moment continues to alternate in direction. The 1979 earthquake produces moments in the end columns of both frames that fluctuate in direction though the moments at the bottom of the column in the external frame do show some drift. Diagrams showing the plastic hinge formation and floor deflection profiles at various times through the 1979 free field earthquake record are shown in Figure 14.

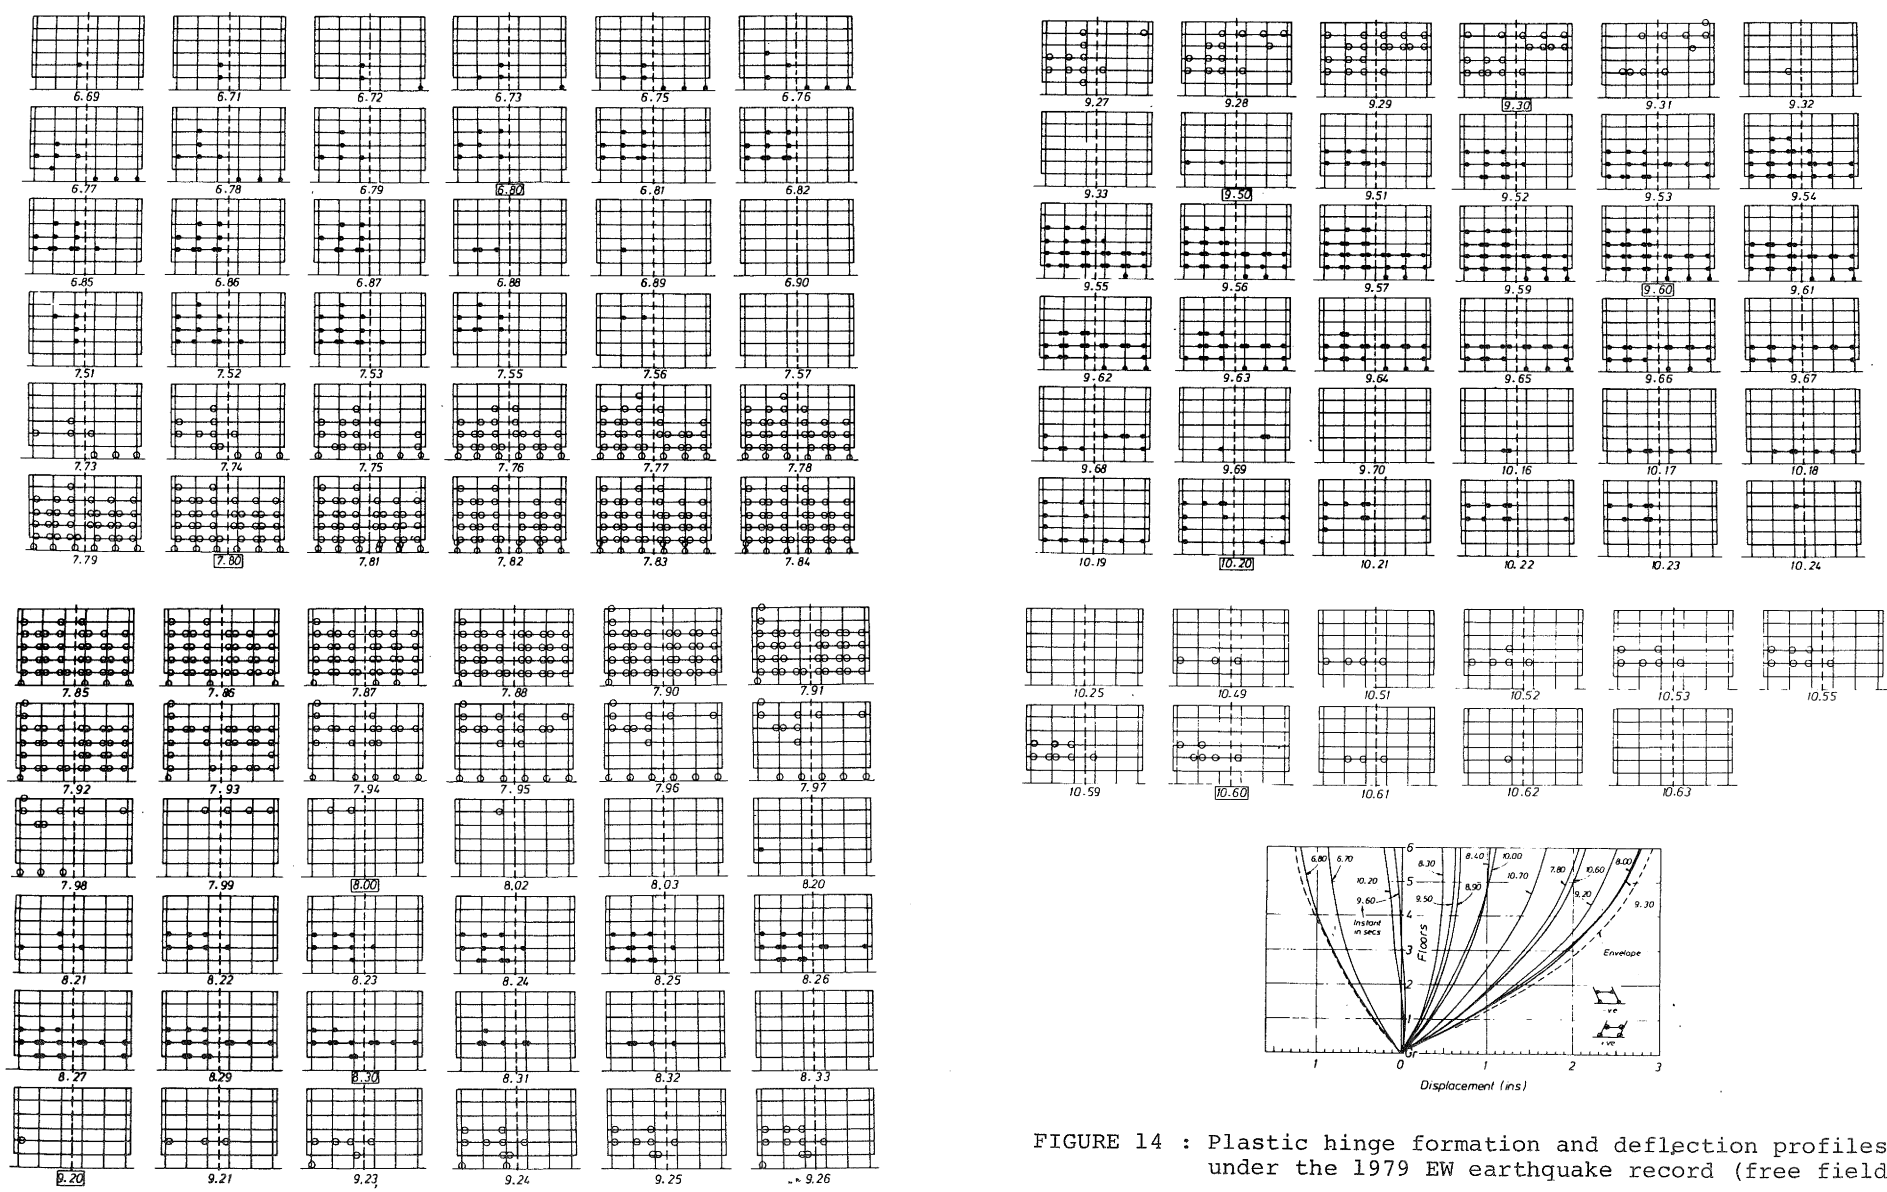
FIGURE 14 : Plastic hinge formation and deflection profiles under the 1999 EW earthquake record (free field)

columns of both interior and exterior frames was found to be low being a maximum of 3.1 under the 1940 earthquake record, 1.8 under the 1979 earthquake record, 1.6 under the 1979 ground floor (trace 13) record. The girder ductility demand was a maximum of 4.4 under the 1940 earthquake record and 4.7 and 5.0 under the 1979 free field and ground floor records, respectively.

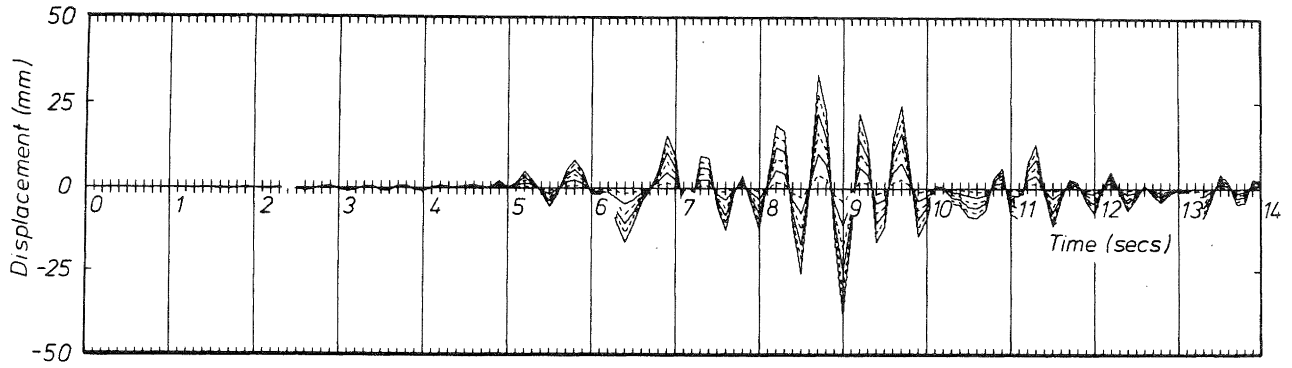
FIGURE 15 : Displacement time history for the transverse (i.e. NS) frame at East end under the 1979 NS "free field" earthquake record

Under the 1979 north-south free field earthquake record, the maximum displacement at the roof level was found to be 35.6mm, occurring just after the earthquake peak that occurred slightly before 9 seconds (see Figure 15). Plastic hinge formation was very limited and occurred only in the two outer columns during the period from 8.6 to 9.1 seconds. Associated with the yielding at the plastic hinges that occurred at the top and bottom of the outer columns was a very brief period of tensile axial yielding of each column. It can be seen from Figure 16 that as each outer column yields in tension the compression in the column at the other end of the frame increases to about half the compression yield of the column.

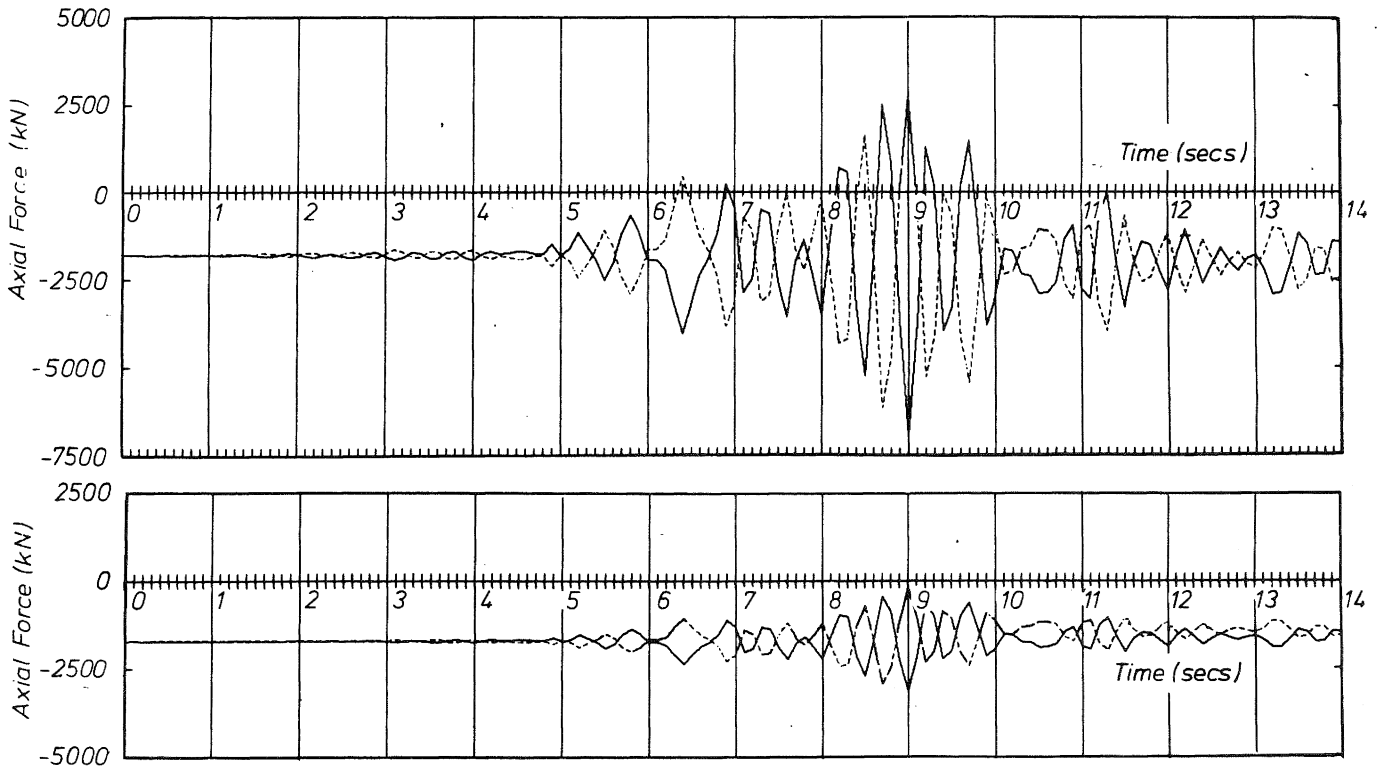
FIGURE 16 : Axial load time-history plots for East end transverse frame under 1979 NS component for outer (bottom) and inner (top) columns

This discrepancy is probably caused by the fact that the earthquake had components along and across the building of similar magnitude, thus producing significant interaction between the forces in the two directions. Normally, as suggested by building codes, buildings with at least one axis of symmetry can be analysed separately for their seismic behaviour in directions along and across the building. It was mentioned earlier that the arrangement of shear walls and frame at the East end of the building (see Figure 3) is such that the overturning moment from the wall can only be resisted by the development of tension and compression forces in the outer columns of the frame. The variation with time of these axial forces when resisting the transverse component of the 1979 earthquake can be seen in Figure 16 and is quite large during the period from 8 to 10 seconds.

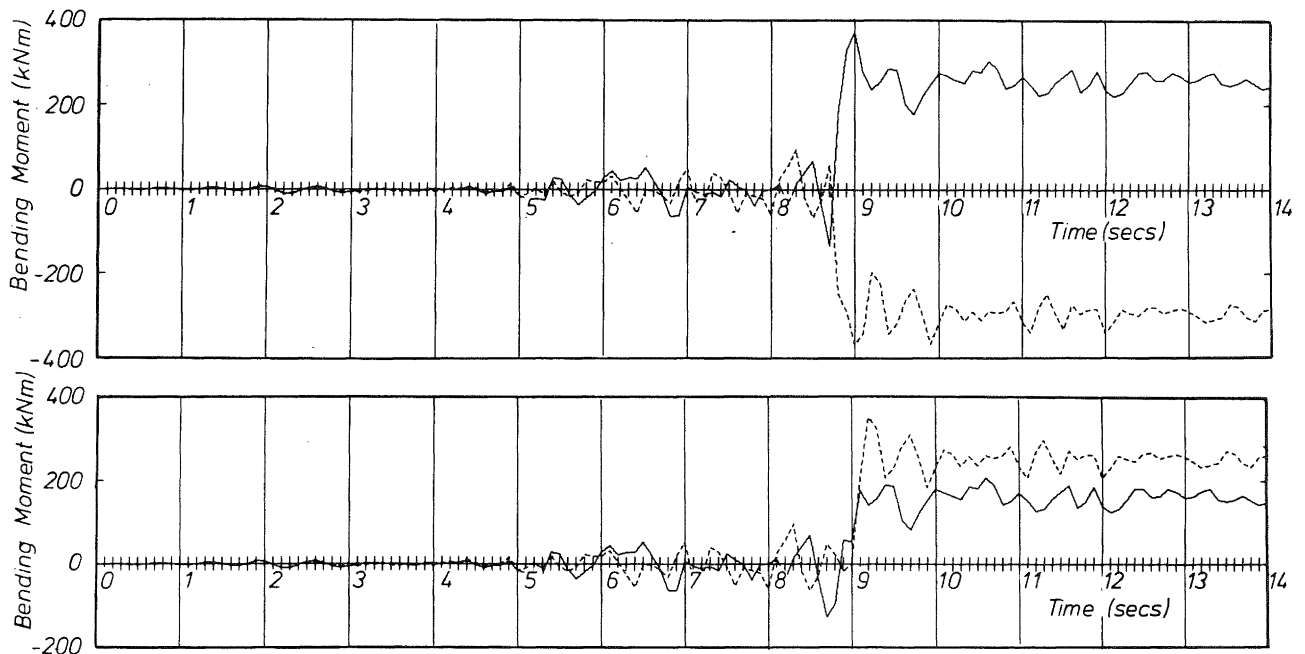
FIGURE 17 : Bending moment time-history plots for East end transverse frame under 1979 NS component for outer (top) and inner (bottom) columns

Time-history plots for the column bending moments at the top (dashed line) and the bottom (solid line) in the ground floor columns are shown in Figure 17.

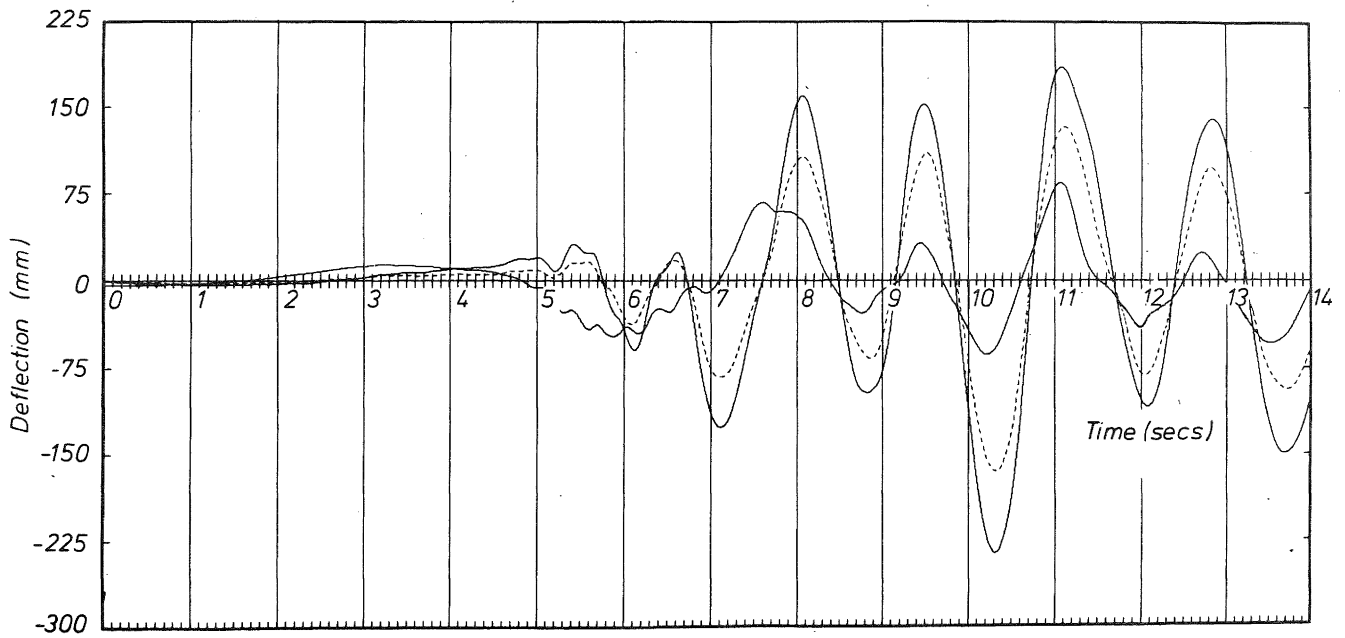
FIGURE 18 : Longitudinal (EW) deflection of ICSB relative to the ground at roof and 3rd and 1st floors

Figure 18 shows the time-history plot for the longitudinal deflection of the ICSB at the roof and floors 4 and 2, as determined from the strong motion accelerographs 4, 5 and 6 (Fig. 5) relative to the ground motion recorded by instrument 13. It can be seen from Figure 11 that these deflections are not very well predicted by the analytical results, though there are similarities up to a time of 8 seconds or so but the large roof displacement (exceeding 230mm or 9 inches) that occurred just after 10 seconds is not shown by the inelastic analysis.

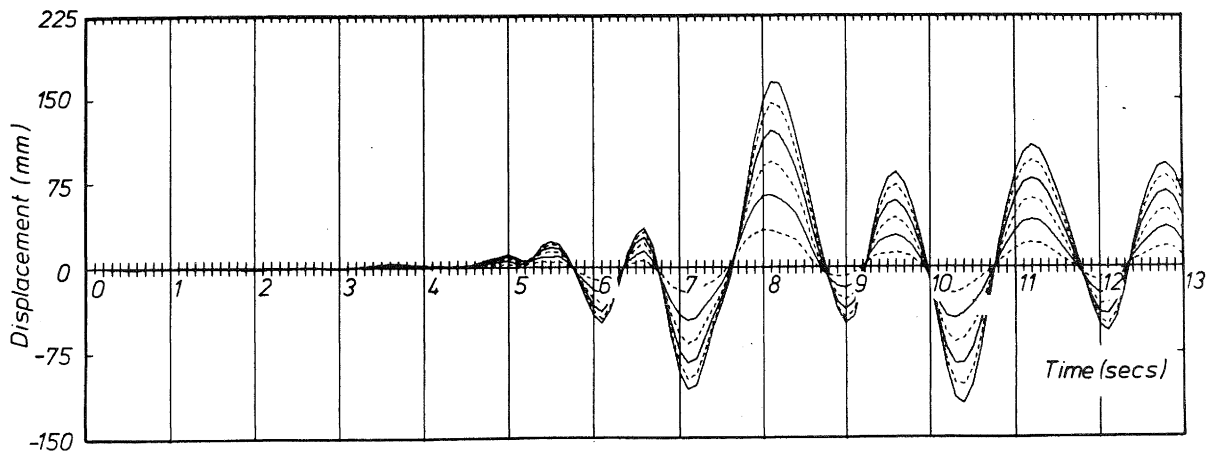
FIGURE 19 : Longitudinal deflection time histories obtained using the 1979 EW record with degrading stiffness and pinching of the concrete hysteresis curves

In an endeavour to obtain better agreement with the measured deflections, the analysis of the longitudinal frames was repeated using the 1979 free field earthquake but modelling the inelastic beam and column behaviour by a model that incorporates the pinching that occurs in the hysteresis loops for reinforced concrete members rather than by the simpler, but less accurate, bilinear model. The displacement results obtained using this model are shown in figure 19. Comparing this with figure 18 it can be seen that the large peak displacement that occurs at about 8 seconds is predicted quite accurately but subsequent peaks are not as large and the peak between 10 and 11 seconds is not as well predicted by the computer analysis, though all the peaks in figure 19 do occur at the same time as the corresponding peaks in figure 18.

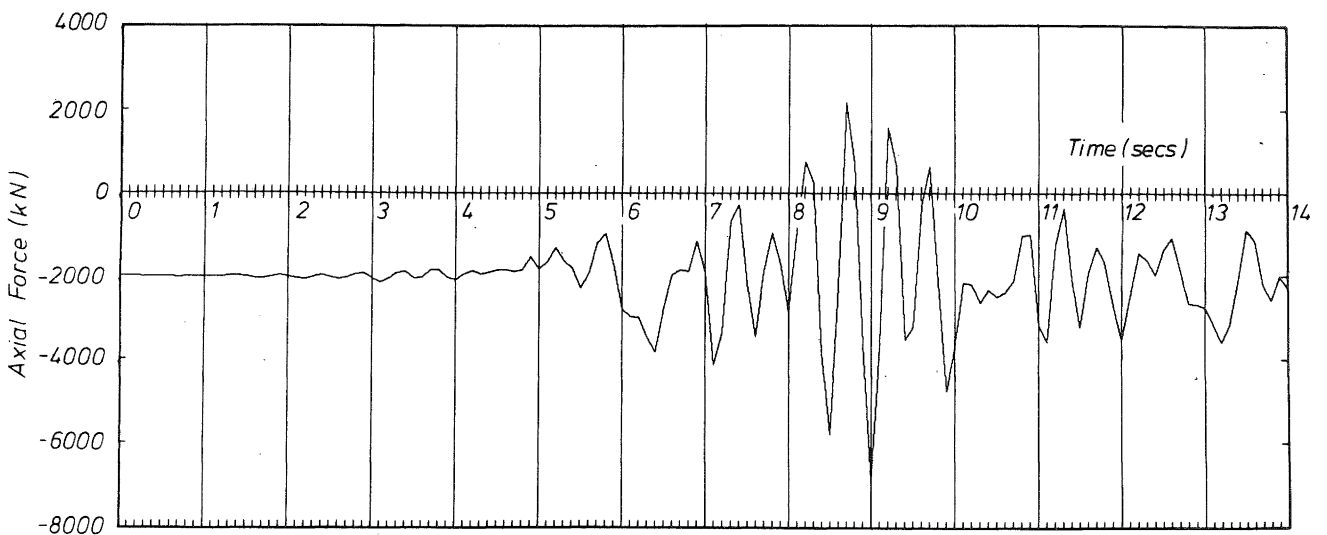
FIGURE 20 : Axial force in a corner column at the East end caused by longitudinal and transverse earthquake components for 1979 record

quake period and when combined with the longitudinal bending moments will mean that the neutral axes in the columns are continually shifting in position and orientation. The variation in the axial force in a corner column from the simultaneous seismic effects in both longitudinal and transverse directions is illustrated in figure 20.

However, the effect of the North-South component of the earthquake together with the unfortunate placing of the ground level slab above the detailed column hinge reinforcing probably led to the failure of the corner columns.
