## 2. REDEVELOPMENT OF THE NORMAL SCHOOL CRANMER SQUARE, CHRISTCHURCH

G.K. Wilby\*

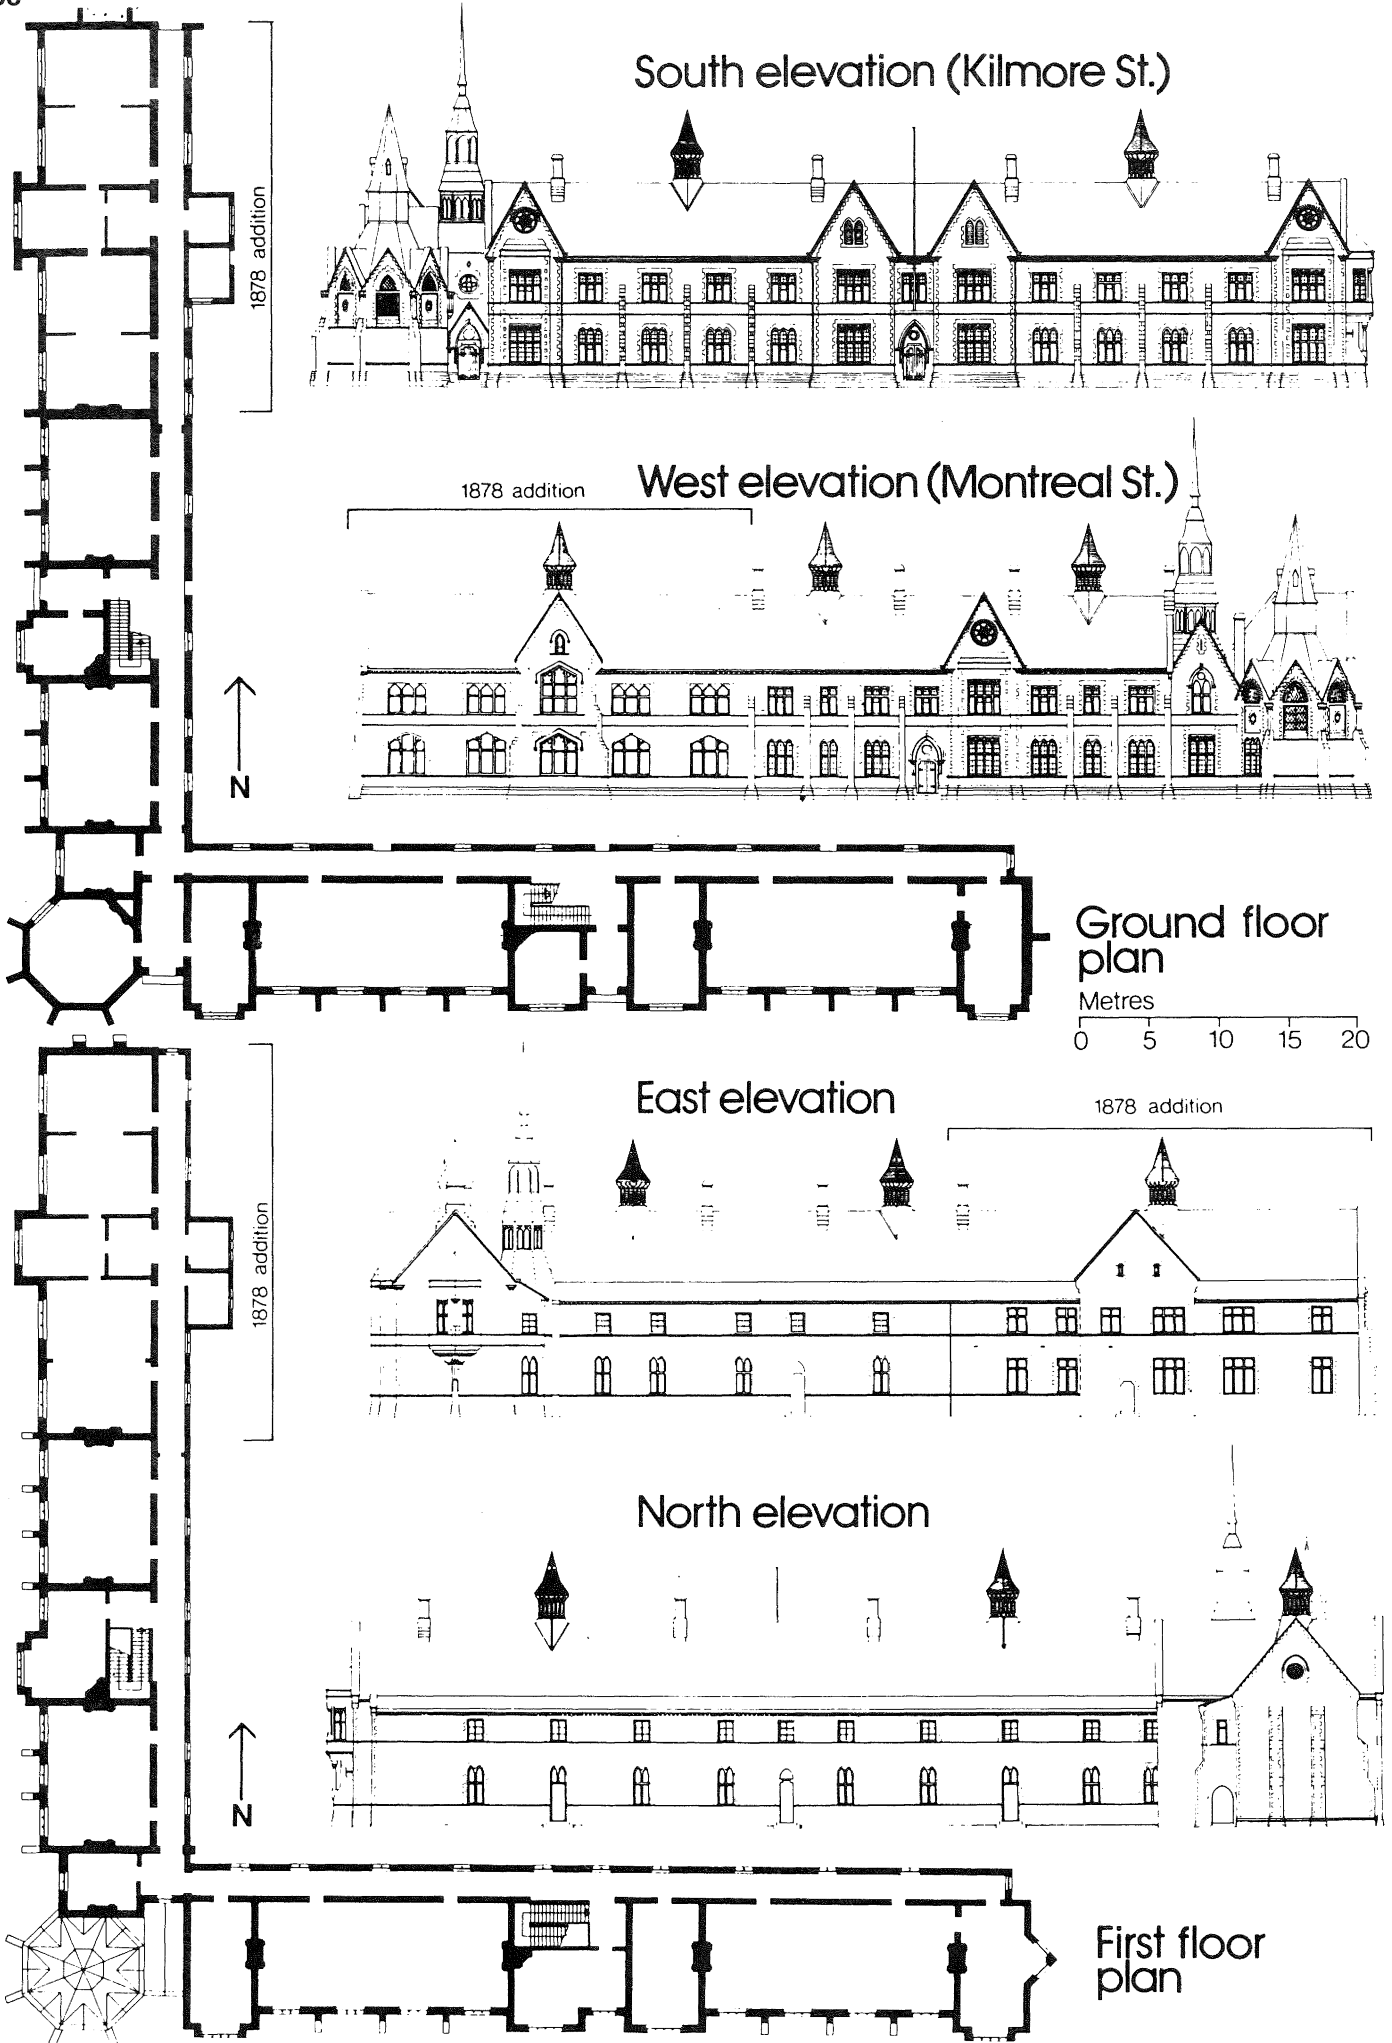
Figure 1

The school is a two storey L-shaped structure, with wings facing Kilmore and Montreal Streets, and with a single storey octagonal shaped building at the junction. (See Fig. 1). The total area of the buildings prior to conversion was 2880 m<sup>2</sup>.

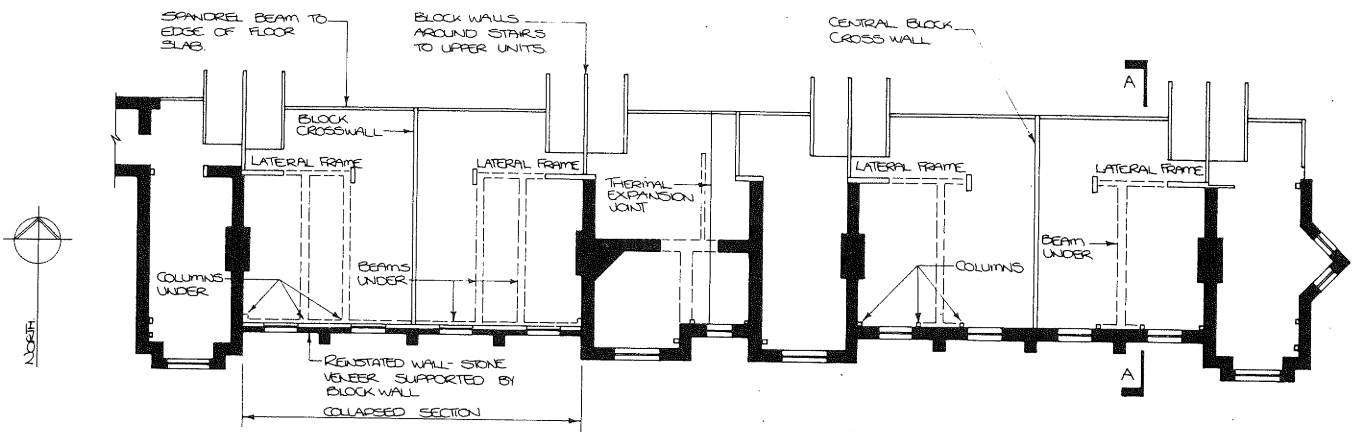
FIGURE 2

KILMORE STREET WING : FIRST FLOOR

Reinforced concrete lateral load resisting frames were constructed along the line of the inner of the two stone walls that were demolished (see Fig. 2 & 4). These, together with the existing stone walls facing the street, gave adequate seismic resistance along the wings. Lateral load resistance across the wings was provided by the existing stone cross walls. Concrete block cross walls were also built at the centre of the large classrooms to give added seismic resistance and to provide separation between Units.

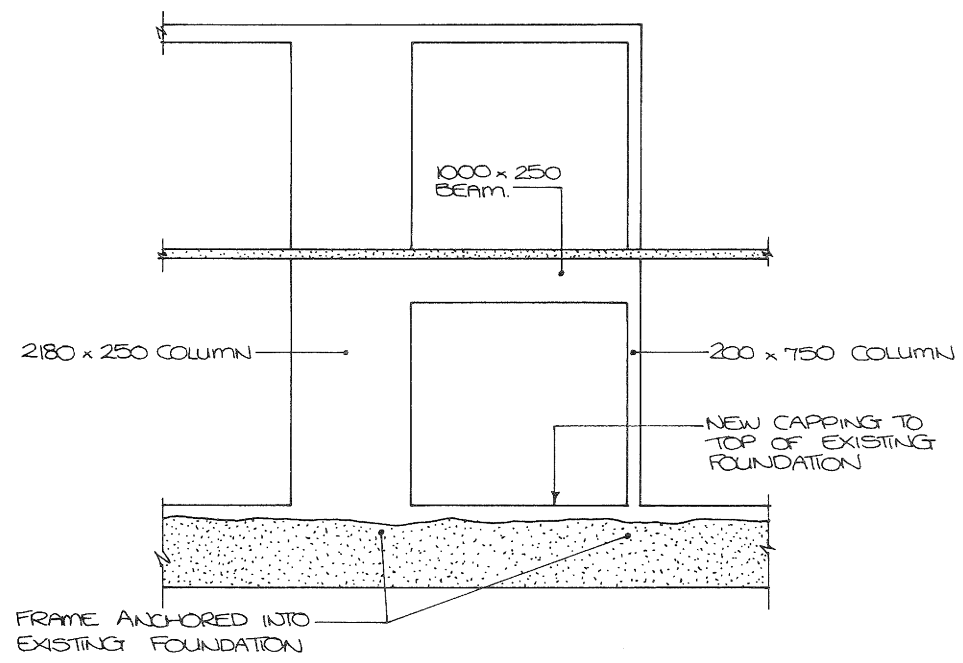
FIGURE 4.

TYPICAL LATERAL FRAME

Reinforced concrete lateral load resisting frames were constructed along the line of the inner of the two stone walls that were demolished. The frames (see Fig.4) were of the half-frame and post type, a configuration chosen primarily to suit the architectural constraints. The frames were founded on the existing concrete foundations which had been cut back and reinforced to provide some hogging moment capacity.
