# DAMAGE TO RAILWAY TRACK

\*W. J. H. Duckworth

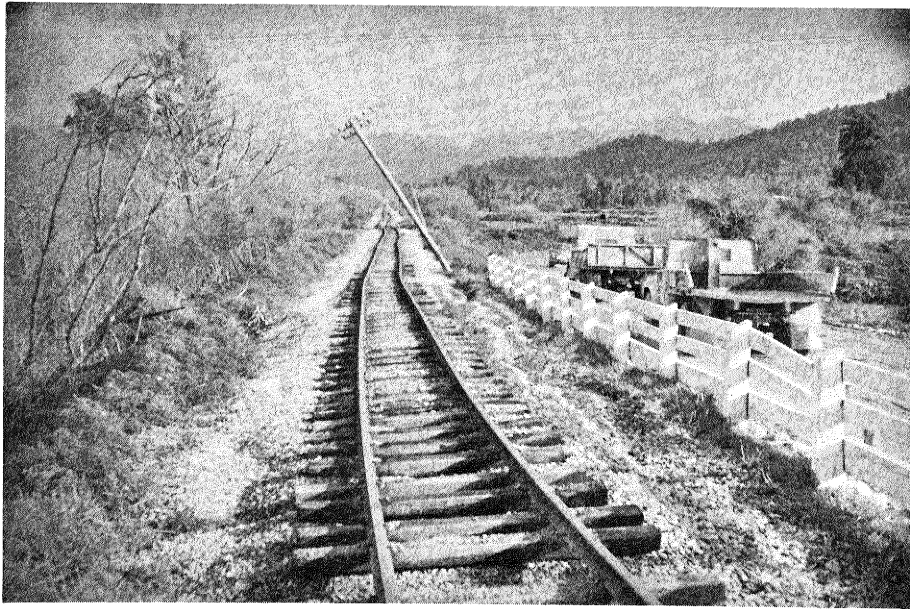
Thirdly the track was pushed out of line for practically the whole 60 mile length of the main effected area.

Fig. 1. Track out of line at Inangahua

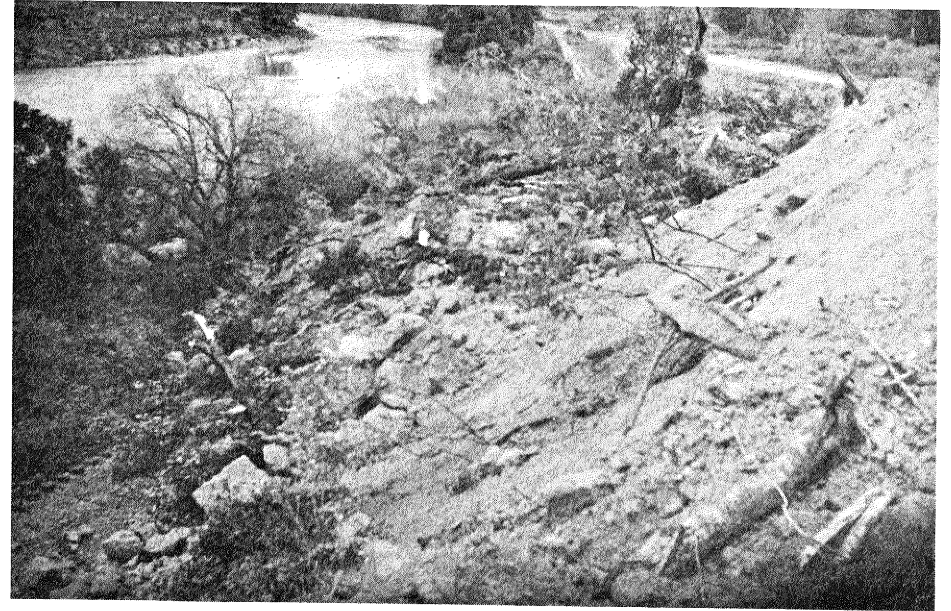
Firstly where the track was in cuttings or sidlings the sides gave way and slip material including trees and boulders 100 tons or more in size covered the track. Where this happened the track was in some places severely damaged and had to be rebuilt after the slips had been cleared.

Fig. 3. Slip near Oweka

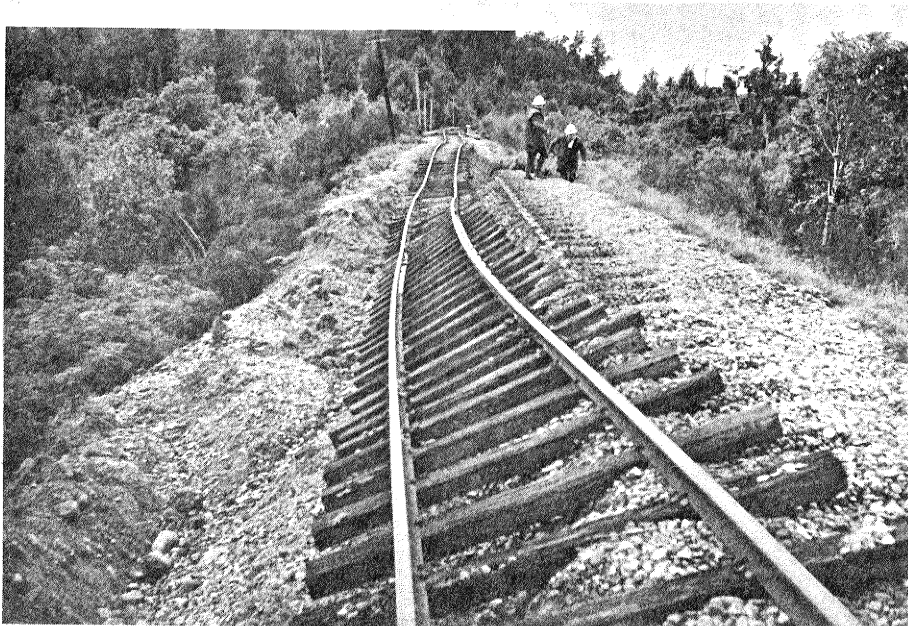
The second type of damage occurred where the track was laid on embankments - these subsided or slipped away leaving the trace suspended.

Fig. 2. Track subsidence near Rahu

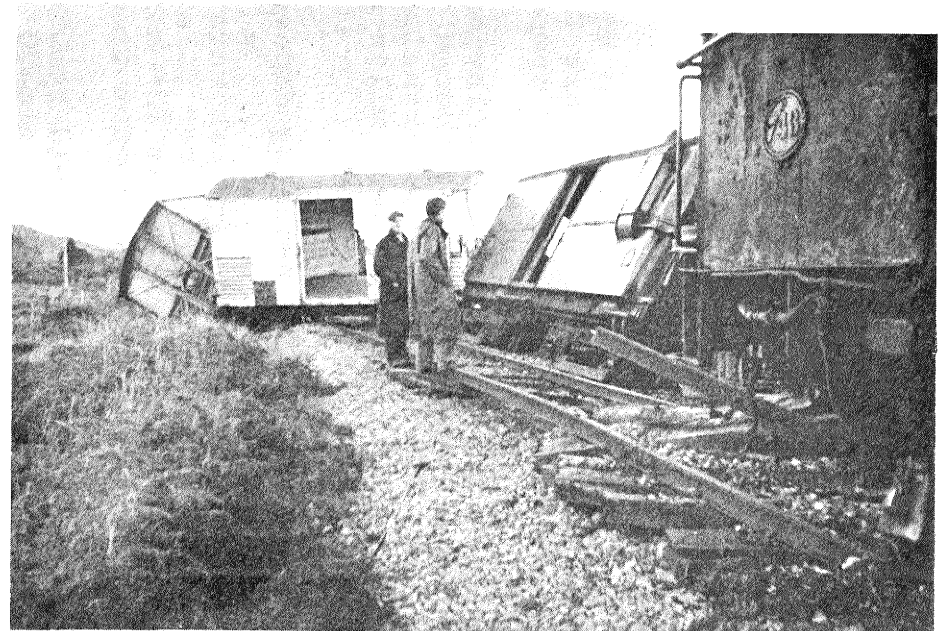
Fig. 4. Moving train derailed near Rotokohu
