DAMAGE IN NELSON AND MURCHISON

R. L. Sanders* and G. A. Toynbee**

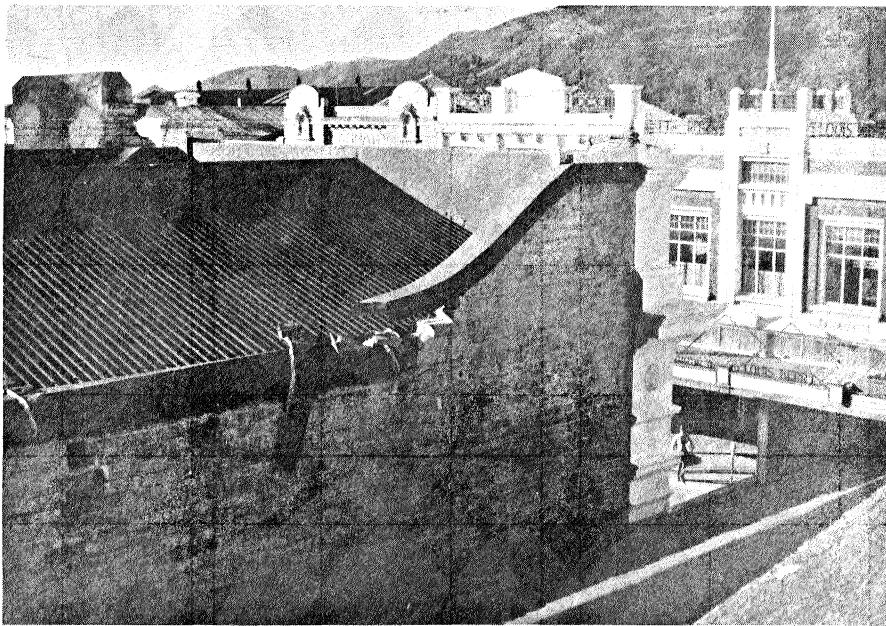
A number of parapets were cracked and horizontal displacements on mortar of up to 2 inches were noted. Instances of bricks falling were isolated.

Fig. 1 Damaged Parapet to unreinforced Masonry building - parapet partly removed.

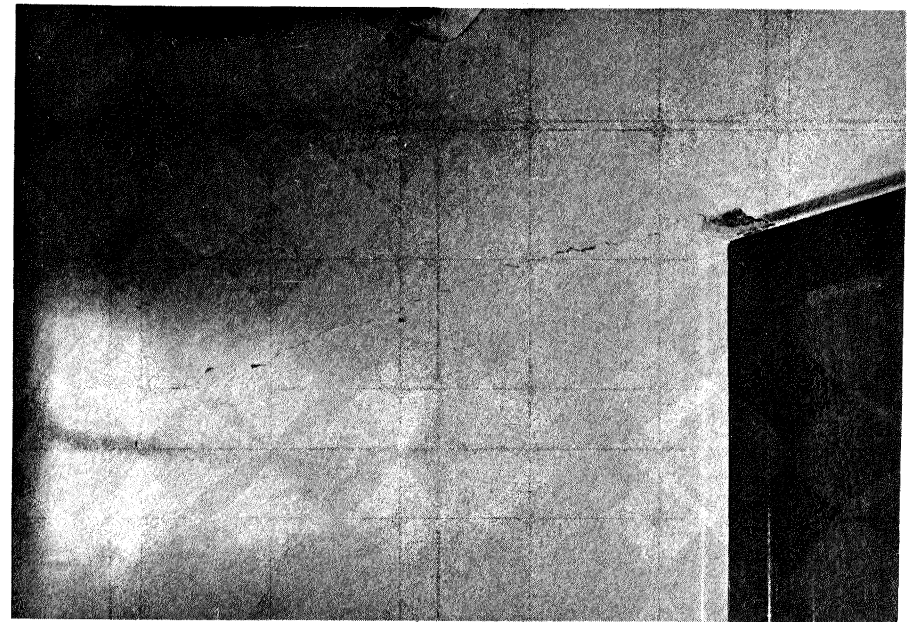
The predominant form of cracking in modern reinforced concrete construction has been movement on horizontal construction joints. Buildings with 6" centrally reinforced panel walls have developed vertical flexural cracks about mid-span. Cracks of this type may also occur in and extend through narrow beams.

Fig. 3 Reinforced concrete wall showing movement on construction joint.

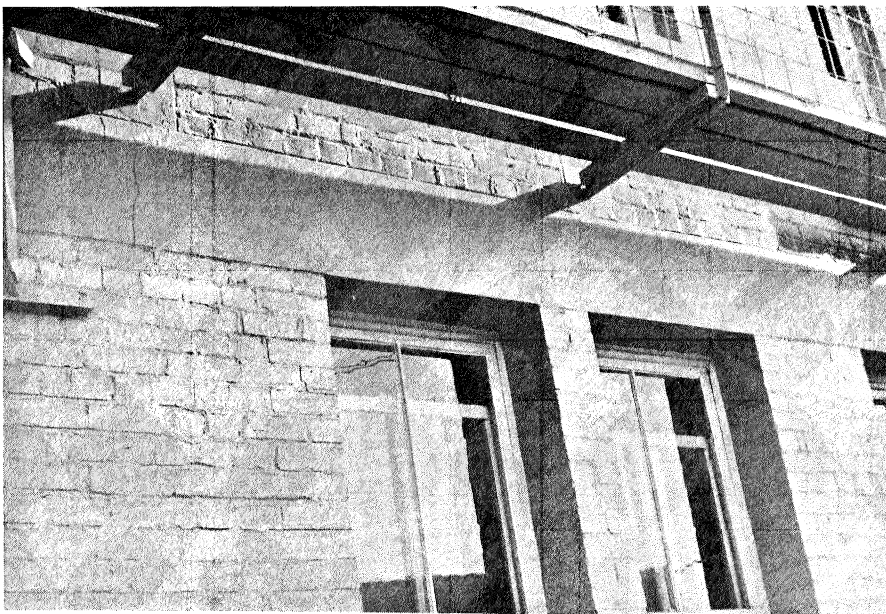
Fig. 2 Unreinforced concrete and masonry construction showing cracking of walls.

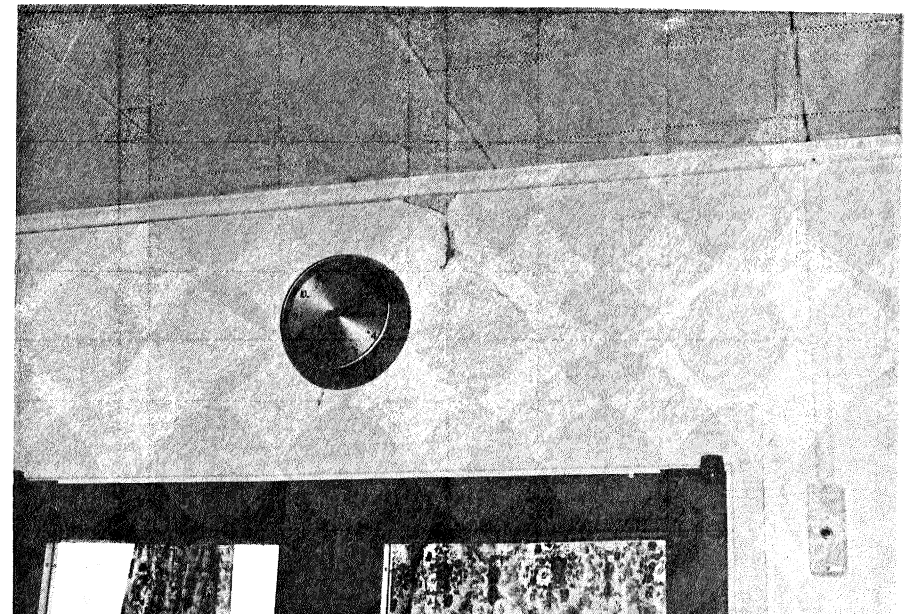
Flexural cracks in the form of an inverted Y with the vertical leg at mid panel have developed in walls pierced by windows at higher levels. These panel walls have been centrally reinforced with trim rods round openings.

Fig. 4 Reinforced concrete shear wall showing crack pattern over large opening.
