CHARACTERISATION OF TRANSPORT RESILIENCE AND MEASURES TO ENHANCE RESILIENCE IN THE RECOVERY AFTER THE 2016 KAIKŌURA EARTHQUAKE

Dougal Mason¹ and Pathmanathan Brabhaharan²

ABSTRACT

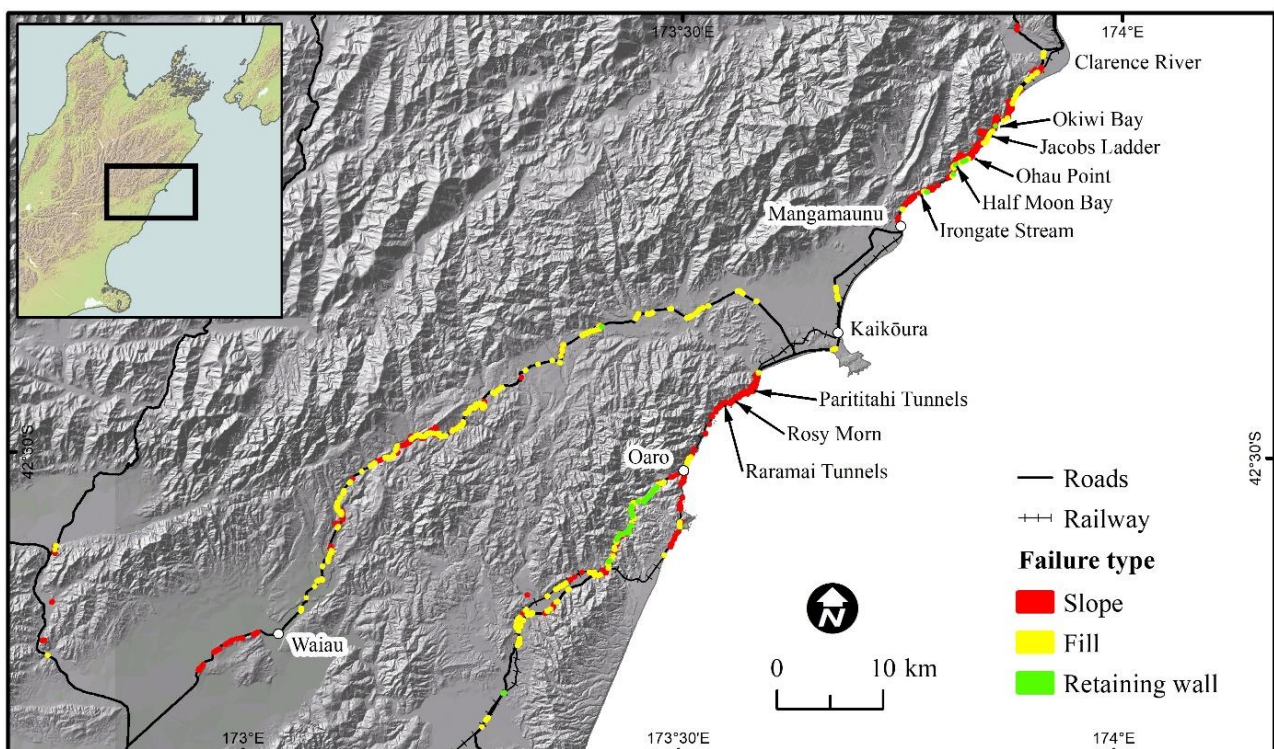
the transport infrastructure in the earthquake [21]. The locations of mapped slope failures along the road and rail corridors are shown in Figure 6 [22]. Over 1500 sites were damaged along the road network, including 200 sites on SH1 between Clarence River and Cheviot that involved landslides and damage to bridges, road pavement, embankments, tunnels, culverts and road safety barriers and signage. Over 950 sites were damaged on the MNL, including tracks, slopes, embankments, tunnels, bridges, culverts and communications systems [23].

Figure 6: Locations of earthworks slope failures along the road and rail corridors in the Kaikōura earthquake.

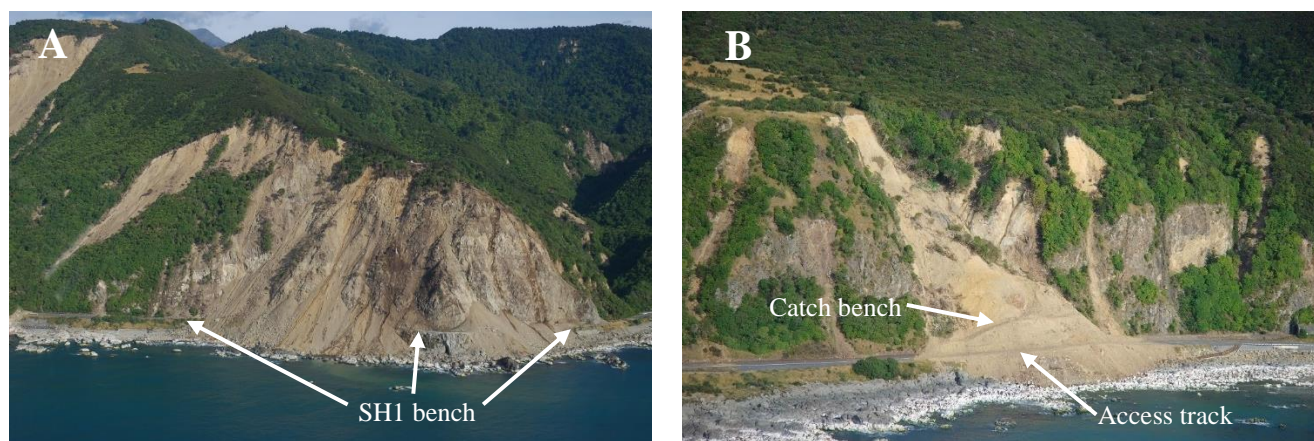
Figure 7: Examples of major landslides north of Kaikōura (see Figure 6 for locations). (A) Coalescing debris avalanches burying the SH1 road bench at Slip ‘P6’ at Ohau Point. The MNL rail line is situated in a tunnel through the hill. (B) Rock slide burying the road and rail corridors at Slip ‘P8’ in Okiwi Bay, with a 4WD access track and temporary rock fall bench constructed across the toe of the slip debris.

North of Kaikōura, the road and rail corridors were blocked by 10 major landslides on cuts and natural hillslopes extending 50 m to 100 m or more above the transport corridor (Figure 7A). These landslides were characterised by large volumes of debris and rock fall that completely buried the transport corridors. This resulted in prolonged closures due to the unstable nature of the debris, the presence of disrupted rock masses along the slopes and the safety risk posed by rock fall. These made reconstruction efforts more difficult, and involved a much longer duration for clearing of debris as it required sluicing, roped access scaling and careful formation of access tracks before debris could be cleared safely.

By March 2017, 4WD access tracks for construction plant had been built around the base of 8 of the 10 major slips (Figure 7B). The road corridor remained blocked by a major landslide at Ohau Point until August 2017, 9 months after the earthquake, when a construction access track was cleared around the base of the slip. The MNL reopened for freight trains in September 2017, and SH1 reopened for public access on 15 December 2017, during daylight hours only and with lengthy unsealed single lane sections, speed restrictions and stop-go traffic management. Construction work continued on the rail and road corridors after reopening, with 24-hour operation of the road recommencing in April 2018 and passenger trains resuming in December 2018.

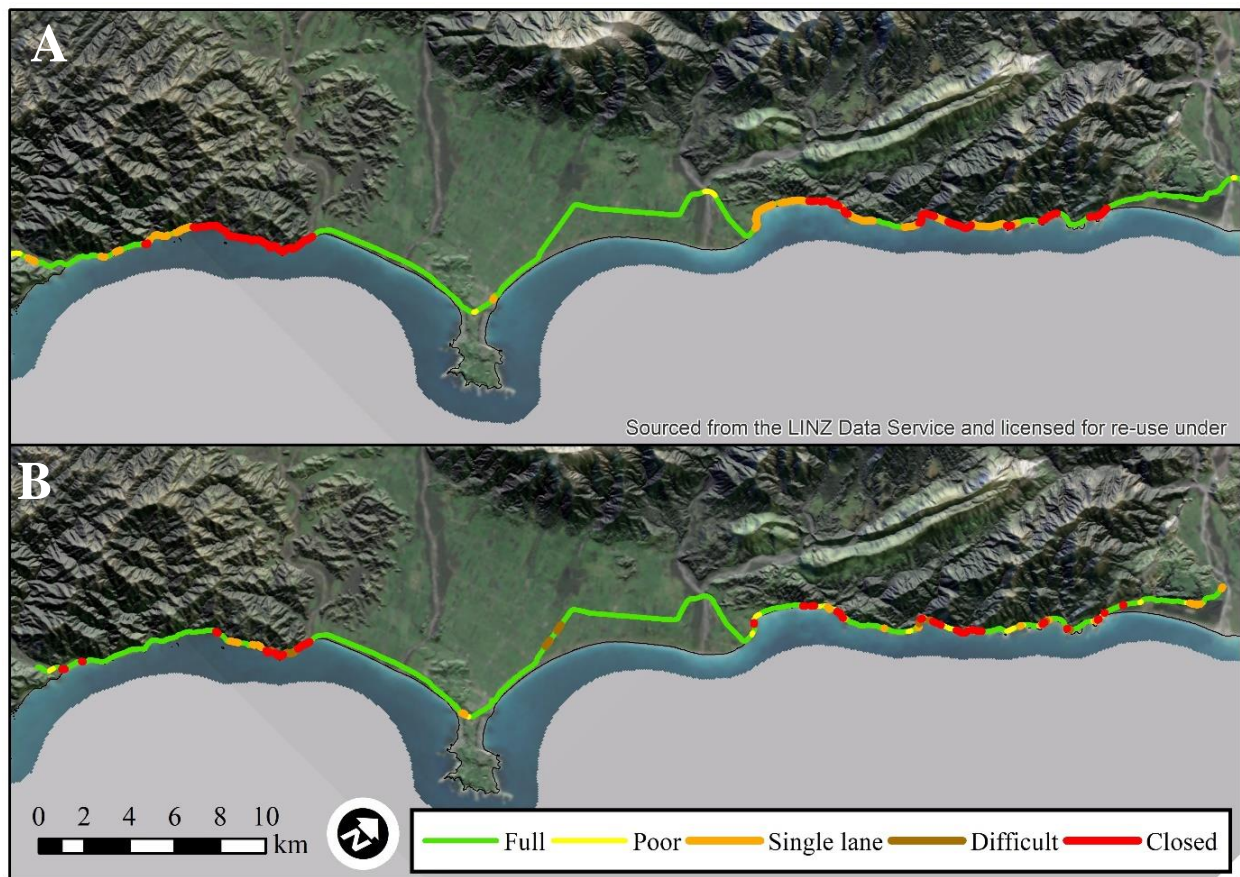
The vulnerabilities identified in the 2001 resilience study as well as the 2016 national state highway resilience study were distinctively demonstrated in the Kaikōura earthquake, particularly the hazard posed by strong ground shaking and coseismic landslides. As seen in Figure 8, the observed availability of the state highway following the earthquake generally ties in with that assessed in the 2001 study. The route was closed over most of the coastal sections of the highway, predominantly due to inundation of the road platform by large volumes of landslide debris. However, not every section assessed as vulnerable to damage was closed in the earthquake event. The pre-earthquake studies assessed the level of damage and outage for a large magnitude earthquake (with a nominal return period of ~1/1000 years) that did not relate to a specific earthquake scenario such as rupture of a particular fault. Instead these studies assumed a consistent and high level of ground shaking along the whole study corridor. As a result, sections of steep hillslopes in close proximity to the road corridor were grouped together as being vulnerable to closure or reduction to single lane. Conversely, ground shaking in the Kaikōura earthquake varied considerably along the coastal corridor, depending on the local ground conditions, distance from the epicentre and fault ruptures, and topographic amplification and rupture directivity effects. Consequently, some sections identified as being vulnerable to closure in the 2001 study did not get damaged in the 2016 earthquake due to lower levels of ground shaking than assumed in the resilience

Figure 8: Comparison of the mapped resilience of the coastal section of State Highway 1 through Kaikōura with the actual performance of the corridor in the 2016 Kaikōura earthquake. (A) Assessed availability state for ~1,000 year RP earthquake [1]. (B) Observed road availability following the 2016 Kaikōura earthquake [24].

assessment. In other sections where vulnerable hillslopes were affected by landsliding, the full length of hillslope did not fail, with closure of the road only at discrete locations. Failure of the full length of hillslopes would not be expected in any one specific event.

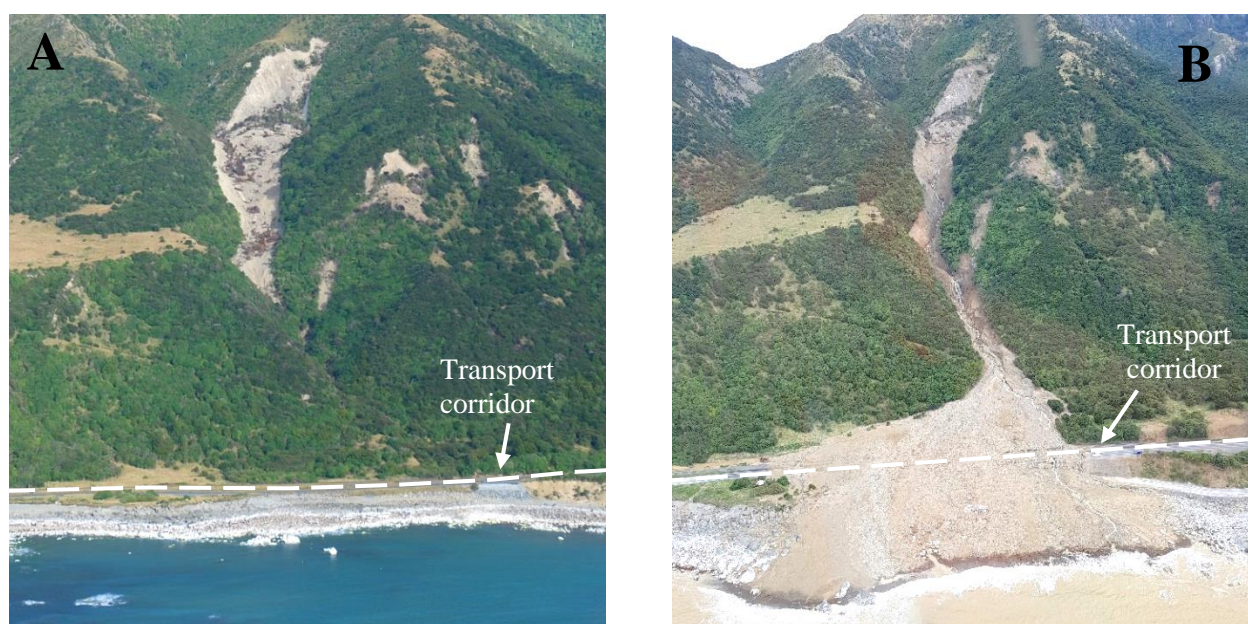
Slope failures (landslides and embankment failures) caused the most damage and disruption to the transportation infrastructure in the Kaikōura earthquake [26]. In addition to the areas where coseismic landslides resulted in damage to the transport corridor, many areas of hillside and ridge cracking occurred during the earthquake without causing landslides. In other areas, landslides were initiated but the debris was retained on the hillslopes or in gullies above the transport corridor. Following the earthquake, a number of failures developed in response to heavy rainstorms, including re-mobilisation of existing landslide debris fans into debris flows (Figure 9), and landslides or debris flows from slopes that had been cracked or damaged in the earthquake (Figure 10).

Figure 9: Examples of post-earthquake debris flow at Jacobs Ladder, north of Kaikōura (locations are shown in Figure 6). (A) Debris fan from earthquake-induced landslide retained in a gully above the transport corridor (January 2017). (B) Complete burial of the transport corridor by debris flows triggered during ex-Tropical Cyclone Gita (February 2018).

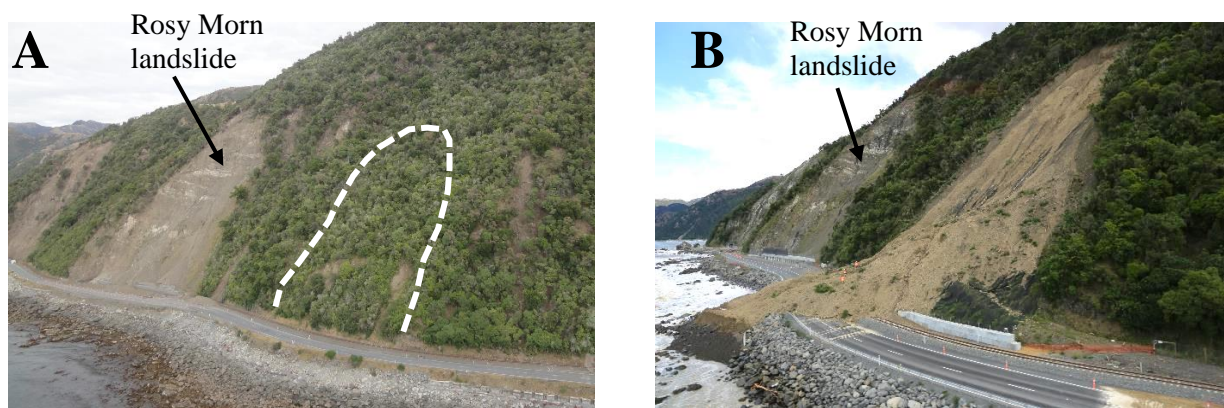
Figure 10: Examples of post-earthquake slope failure at Rosy Morn, south of Kaikoura. (A) Photo of the earthquake-induced landslide at Rosy Morn (February 2017). The adjacent slope (dashed line) did not fail in the earthquake. (B) Failure of the hillslope adjacent to the Rosy Morn landslide as a result of heavy rainfall during ex-cyclones Debbie and Cook in April 2017 and Gita in February 2018.

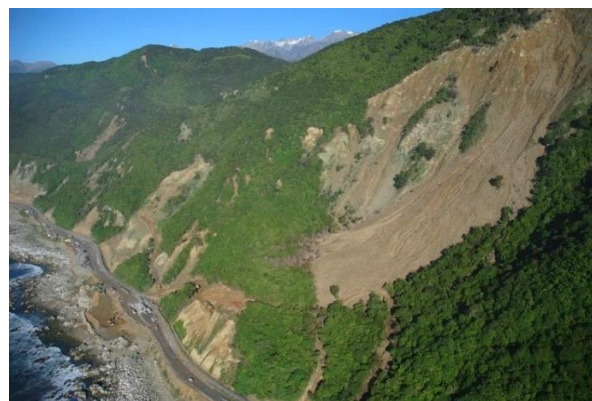
The resilience assessment showed that significant clusters of potential long duration outage could occur at the steep hillside sections along the coastal corridor, particularly around the areas of heavy damage from the Kaikōura earthquake (e.g. Figure 11).

Figure 11: Examples of earthquake-damaged hillslopes in Half Moon Bay, north of Kaikōura, assessed as highly vulnerable to future failure in earthquake or rainfall events (see Figure 6 for location).
