# SEISMIC PERFORMANCE OF REINFORCED CONCRETE BUILDINGS IN THE SEPTEMBER 2010 DARFIELD (CANTERBURY) EARTHQUAKE

## SUMMARY

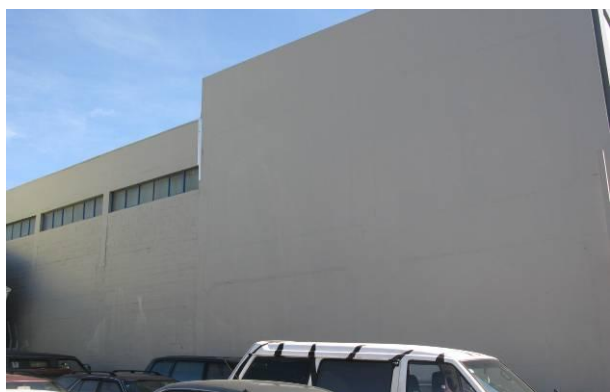
Figure 4 shows an example of a typical low-rise 1950s-60s RC frame with concrete blocks masonry infill walls. Separation cracks between the structural frames and the infill walls were observed. No diagonal shear or horizontal-sliding cracks were observed in the masonry infill walls. Flexural cracks were observed in several beams and columns.

**Figure 4:** *Low-rise pre-1970s RC frames with masonry infills. Separation cracks of the infills and RC frame were observed. (Photo credit: Weng Y. Kam).*

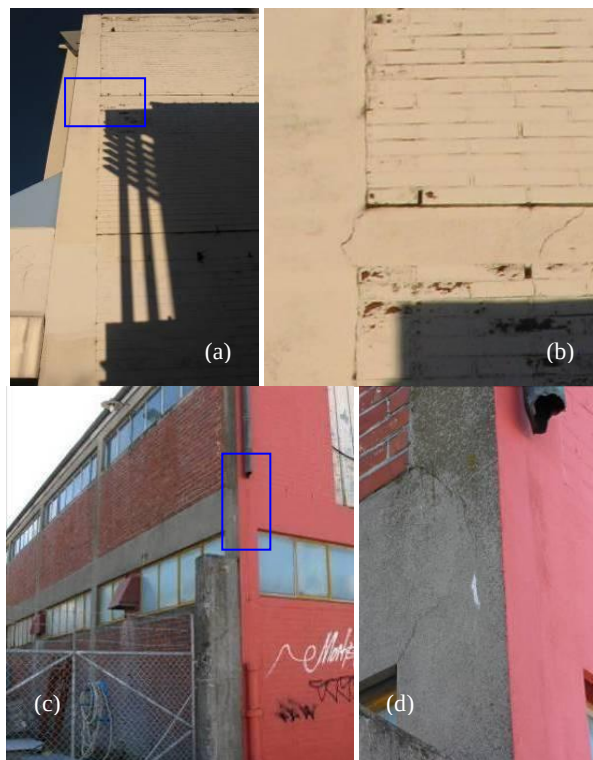
Figure 5 shows two more examples of low-rise RC buildings with more noticeable damage in the structural frame elements. Figure 5a-b shows a three storey RC frame building with clay brick infill walls in the perimeter frame, built in the 1950s-60s. Flexural cracks at the beam ends and diagonal cracks on the masonry were observed. Figure 5c-d presents an example of low-rise RC frames with observable joint shear cracking.

**Figure 5:** *Visible residual cracks in the beam, column and joint elements in low-rise pre-1970s RC frames with masonry infills. (Photo credit: Weng Y. Kam).*

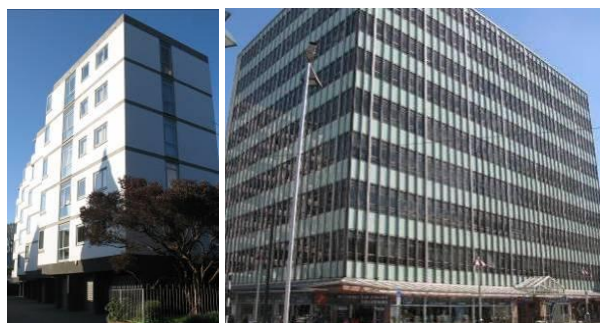
The data presented in Figure 2 and collected in the post-earthquake survey lists about 25 to 30 mid- to high-rise pre-1970s RC buildings in Christchurch. Many of these structures suffered very little to minor damage. Figure 6 shows two examples of RC buildings built in the 1960s that have shown no visible structural damage.

**Figure 6:** *Mid-rise pre-1970s RC buildings with no apparent damage. (Photo Credit: Weng Y. Kam).*

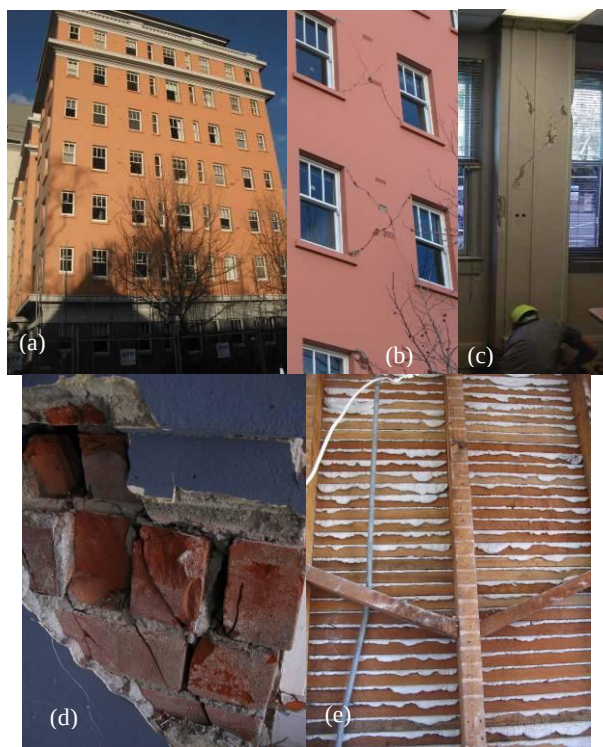
Figure 7 shows the St Elmo's Court building, a heritage-listed 1930 art-deco styled seven storey former apartment block. It has a series of gravity-designed RC frames coupled with 150 mm thick RC staircase core walls. The core walls had minor diagonal and flexural cracks up its elevation. The columns varied in size up the elevation, with typical sizes of 22"-18"-15" (560 mm – 460 mm – 380 mm) squares. One of the exterior columns had a clear shear failure (Figure 7c). Horizontal cracks along the floor level and below the beam soffits were observed in most storeys, indicative of inter-storey deformation.

There is a double-width solid-clay bricks veneer along the perimeter frames. Shear diagonal cracks were observed on the larger exterior panels (Figure 7b). A closer inspection revealed good concrete mortar quality on the infill walls. The failure on the infill walls were predominantly the fracture of solid-clay bricks (Figure 7d). Most of the interior brick infill walls had been removed during a refurbishment in 1980s. Interestingly, some of the preserved original 1930 plastered timber infill panels show no apparent damage (Figure 7e).

**Figure 7:** *St Elmo Courts seven storeys RC buildings. Shear cracks observed in the masonry infills and column. (Photo Credit: Weng Y. Kam and Stefano Pampanin - (c)).*

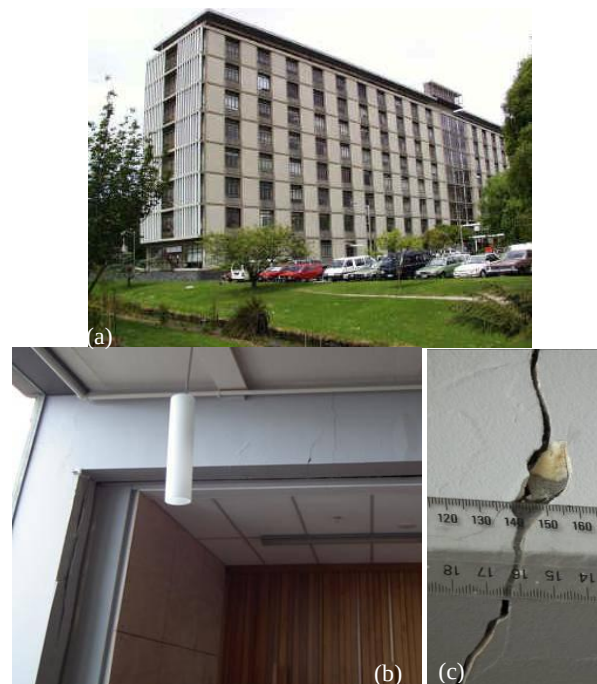
Figure 8a shows an eight storeys RC frame-wall building built from 1962 to 1966 at the University of Canterbury Ilam campus. The building has a rectangular plan with a large aspect ratio. The RC frames in the weaker direction were damaged. Cracks in the beams and walls were observed. For example, in the top floor, beam residual cracks up to 5 mm

wide indicated significant yielding of steel reinforcement, (Figure 8b-c). The building also experienced significant non-structural damage including wall partitions cracking, ceiling damage, broken windows, damage at seismic separation, and toppling of containers containing chemicals (e.g. paraffin oil).

**Figure 8:** *Beam plastic hinge of 1960s mid-rise RC building. (Photo Credit: Rajesh Dhakal).*

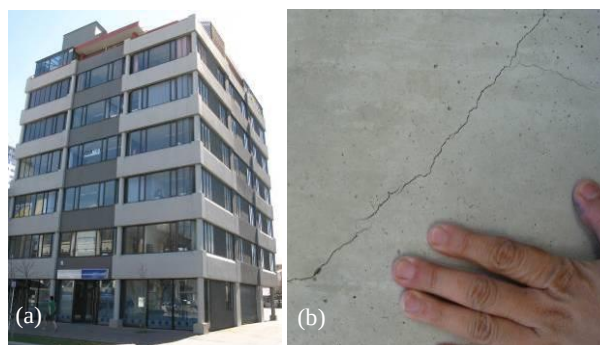
In several mid-rise RC buildings with cast-in-situ shear walls, diagonal and horizontal cracks were observed in the thick RC shear walls. Figure 9b shows an example of such minor damage, observed in a five storeys building with heavy shear wall lateral system.

**Figure 9:** *a) Modern mid-rise RC frames building; b) Shear diagonal cracks on modern thick shear walls. (Photo credit: Weng Y. Kam).*

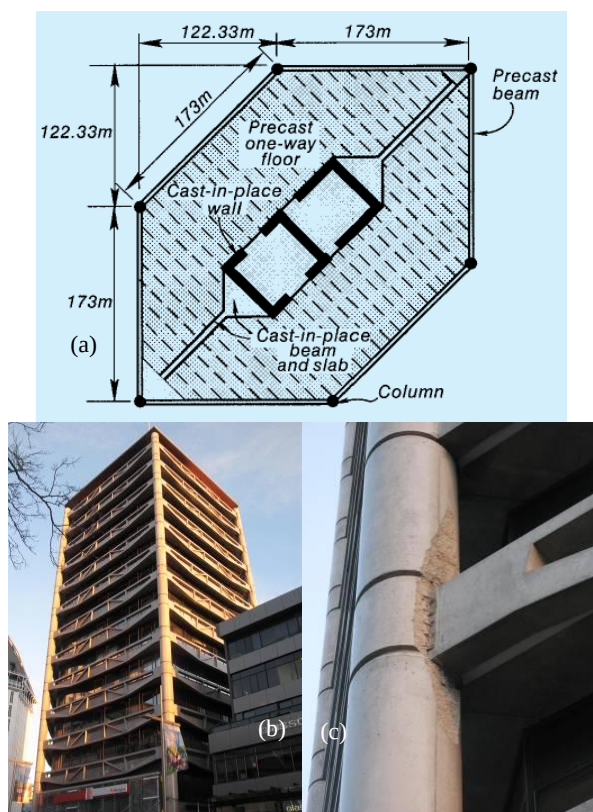
Figure 10 shows a fourteen storey commercial building with RC shear walls around the staircase/escalator core, with coupled-link beams to the frame systems. The perimeter frame was designed primarily for gravity loading only. Evidences of concrete spalling, exposing column and beam reinforcement, were observed in many beam-column connections throughout the building elevation.

**Figure 10:** Fourteen storeys RC core walls building with perimeter gravity frames: a) Structural layout [16]; b) Damaged gravity frame. (Photo credit: Weng Y. Kam).

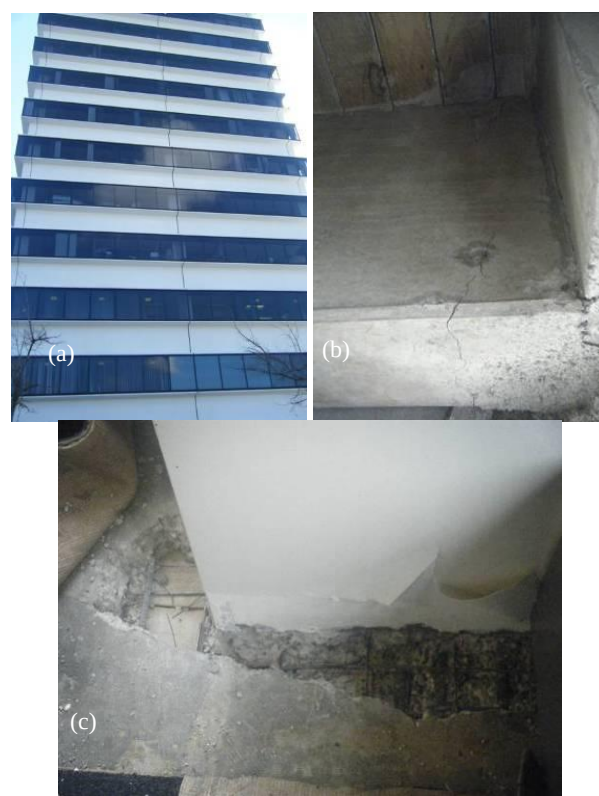
Figure 11 shows an example of a twelve storey two-way RC frame building, built in the 1980s. The building was initially green-tagged but was subsequently yellow-tagged and evacuated following an aftershock three days after the main event. Cracks on the main structural elements grew larger with each of the numerous moderate aftershocks ( $M_w = 4.5-5.4$ ).

Indications of plastic hinges in the beams at the exterior bays were evident in the second to seventh storey. The yielding of the reinforcing bars was up to three times the yield strains, estimated from the 3-4 mm wide residual crack width. Cracks ran throughout the depth of the beam suggesting yielding of both the top and bottom bars.

The yielded beams were part of the frames in the north-south (NS) direction, suggesting that the shaking was dominated by the NS component. The plastic hinges existed only in the outermost bay; in the inner bays the beams had fine cracks but not to a level that would suggest yielding of reinforcing bars.

The building had prestressed precast concrete double-tee units spanning in the NS direction parallel to the damaged frames. Cracks between the precast floor units and the transverse beams (east-west) indicated some level of beam elongation effects from the plastic hinges.

**Figure 11:** Twelve storey RC frame building beam plastic hinges. (Photo credit: Rajesh Dhakal).

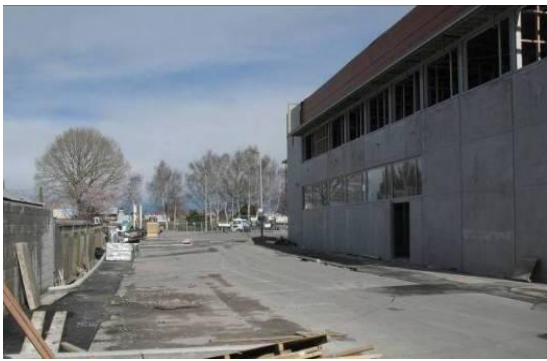
Many of these tilt-up panel buildings were damaged by liquefaction failure. Figure 12 shows a supermarket building in the Kaiapoi town (17 km north of Christchurch City), that is scheduled to be demolished due to liquefaction damage. It consists of tilt-up precast concrete panels and portal steel frames, founded on flat RC slab on-grade.

**Figure 12:** A tilt-up precast concrete with steel portal frames supermarket to be demolished due to differential ground settlement from liquefaction. (Photo credit: Weng Y. Kam).

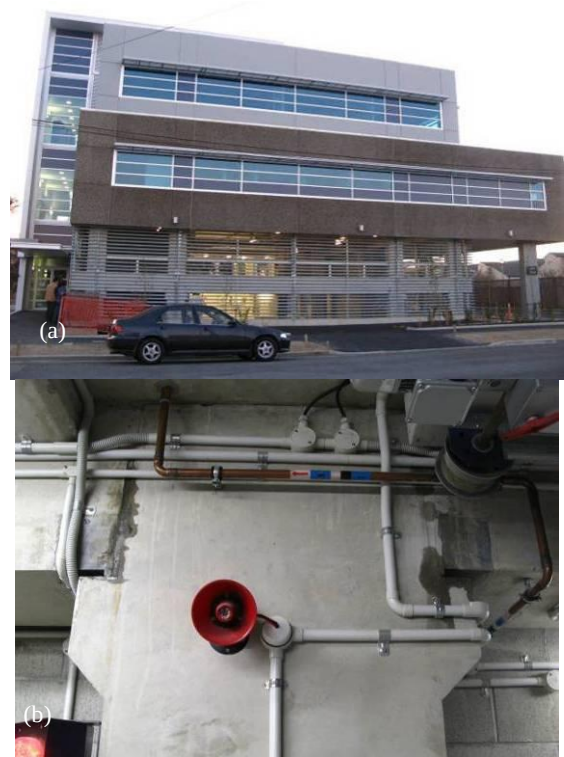
The post-tensioned frames and coupled walls were expectedly undamaged. Vertical cracks along the grout pad at the beam-column interface suggested that the 'rocking' mechanism of the frame system was indeed activated. However no residual crack width was noticeable in the beam-plastic hinge, due to the designed re-centering action of the unbonded post-tensioned tendons. Several of the gravity corbels had hairline to 0.5 mm cracks confirming a not-negligible rotation-induced compression force (plus seismic shear) on these corbels. Hairline cracks were also observed in the secondary transverse gravity frame in the EW direction. Negligible non-structural (one single glass panel) and content damage was reported.

**Figure 13:** Self-centring precast concrete system implemented for a newly constructed private hospital facility. (Photo credit: Weng Y. Kam).

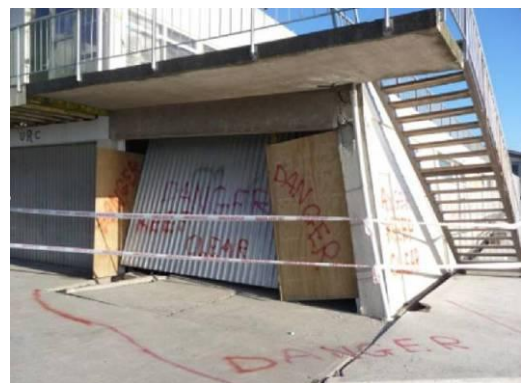
Figure 14 shows an example of a two storey RC building constructed in the mid 1960s along the Avon River. This building had sustained significant damage because of lateral spreading of the soil under the foundations of the columns. The column line adjacent to the river was the only column line with apparent soil movement. Most damage was concentrated in the beam-column joints.

**Figure 14:** Lateral spreading and liquefaction induced displacement demand resulting in beam-column joint failure. (Photo credit: Charles Roeder).

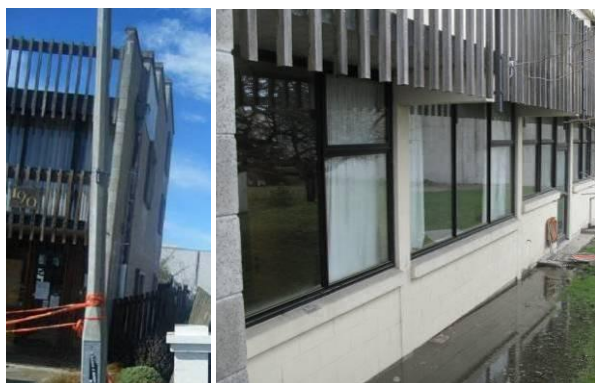
In Figure 15, severe differential settlement (up to 300 mm at the south end) resulted in significant tilting of the three storey RC frames superstructure. No damage was observed on the superstructure from exterior inspection.

**Figure 15:** *Liquefaction failure-induced tilting and differential settlement of a three storeys RC frames building built in 1978 at Kaiapoi. (Photo credit: left: Rajesh Dhakal, right: Weng Y. Kam).*

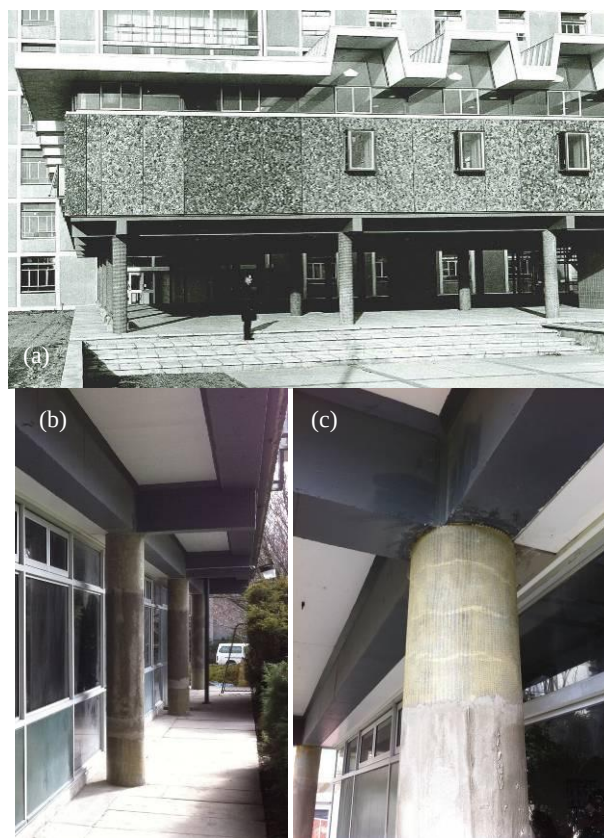
After the earthquake, flexural cracks were observed in the plastic hinge regions within the FRP wrapping. The columns effectively formed top and bottom flexural hinges as the lateral resisting mechanism. No noticeable residual deformation of the building was noted.

**Figure 16:** *Column retrofit using FRP jacketing for the two storeys Sciences library building. (Photo credit: a) UoCanterbury archives, b-c) Grant Wilkinson of Ruamoko Solutions).*

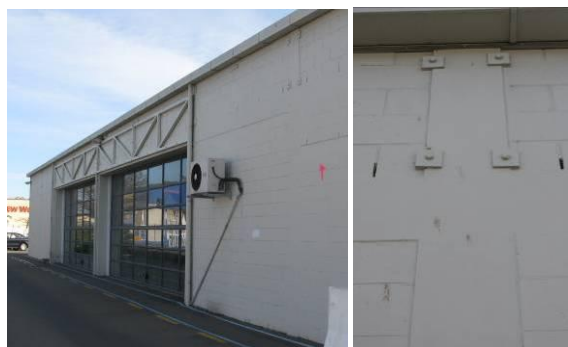
Figure 17 shows attempts to secure the brick wall parapets on a single storey 1950s-era infilled RC frame building. While none of the parapet failed during the 4<sup>th</sup> September earthquake, growing cracks along the infill panels and interior damages from the aftershocks resulted in the closure and 'red-tagging' of the structure (an emergency medical facility) five days after the main event.

**Figure 17:** *Infill walls parapet retrofit for infilled RC frames (Photo credit: Weng Y. Kam).*

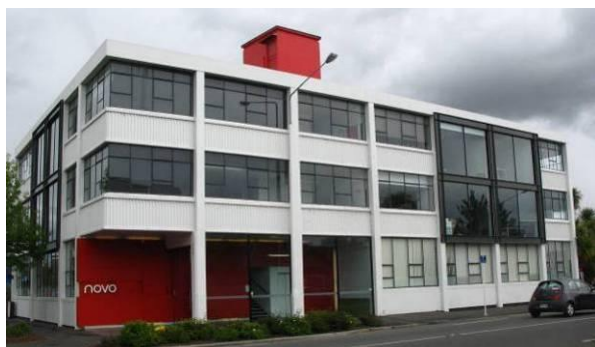
Figure 18 shows another successful retrofit example of a 1950s three storey RC frame building with non-ductile detailing. The seismic retrofit strategy involves global strengthening by additional RC shear walls and local ductility capacity upgrading by confining the as-built non-ductile columns with FRP wraps. The building performed very well during the earthquake. No structural or non-structural damage was observed from an exterior-only inspection.

**Figure 18:** Seismic retrofit of non-ductile RC frames with FRP jacketing of the columns and with additional new shear walls. (Photo credit: Weng Y. Kam).

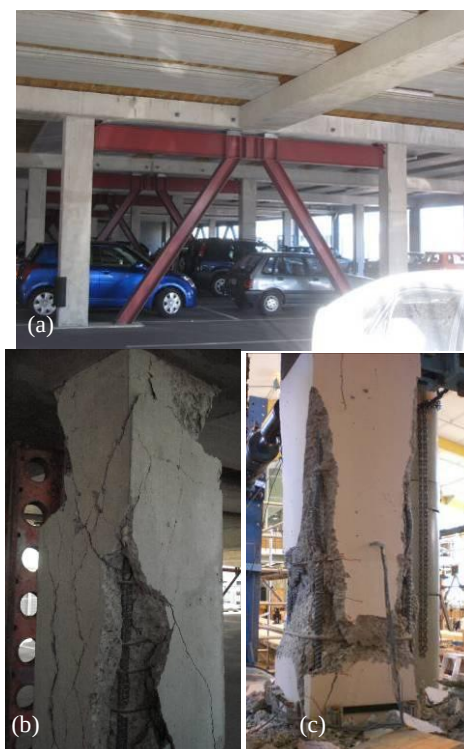
heavily damaged with a bi-directional shear-flexural failure as shown Figure 19b. As steel K-braces were used in both directions, these columns were designed pre-dominantly for gravity loading. Damage to these columns indicates that the type and level of drift demand was underestimated.

**Figure 19:** Gravity column failure at car-park structure and similar observation in the laboratory testing by Boys et al. [21]. (Photo credit: top and left: Stefano Pampanin; right: Alistair Boys).

Interestingly, only the top floor columns of the building shown in Figure 19a-b were damaged. The damaged columns were possibly damaged with the displacement demand amplification due to the torsional deformation of the top floor. The top floor was intended to be torsionally-restrained by a ramp to the top floor, which was left unfinished. Further investigation of this structure is required to clearly understand the cause of the column failure.

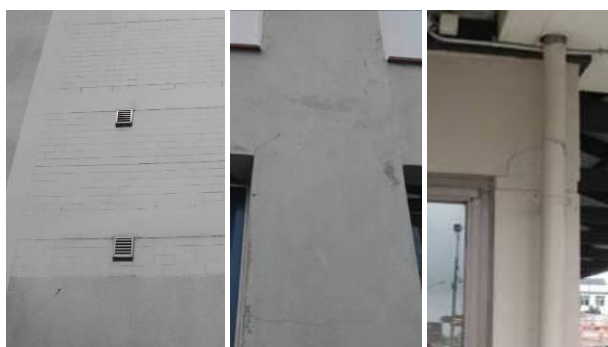
Signs of incipient, but not yet fully developed, brittle failure modes within the pre-1970s RC frame buildings are also observed in many of these buildings. Figure 5 and Figure 20 present some examples of lightly reinforced beam-column joints and columns with signs of inelastic deformation during this event. Residual joint crack widths of 2-3 mm were measured in some buildings, indicating frame distortion of up to 0.75 to 1.0% inter-storey drift (based on the authors' laboratory test experience).

**Figure 20:** Visible residual cracks in the infills, column and joints (Photo credit: Weng Y. Kam).

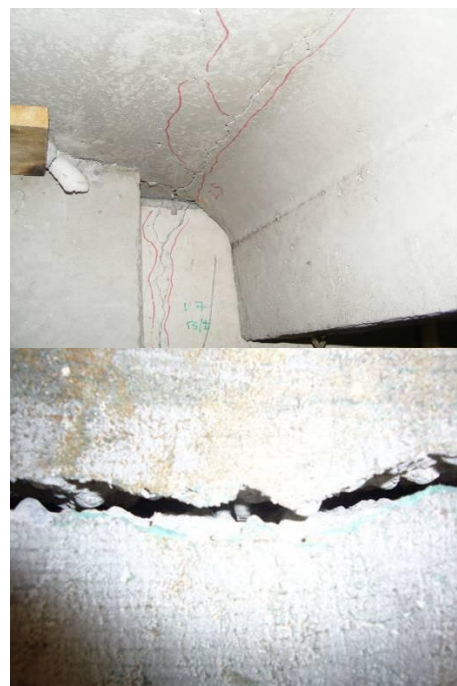
Several instances of wide cracks on precast concrete flooring units (T-beams) and along the transverse beam and floorings unit suggest that beam elongation up to 5-10 mm could have occurred in these buildings. Figure 21 shows some examples of this type of damage in modern high-rise building. Slab mesh fracture was observed in floor topping close to the beam plastic hinges. In some instances, slab-wall connections fractured along one whole side of a building.

Wide cracks were observed in beams suggesting yielding of reinforcing bars and formation of plastic hinges. Residual cracks in these beams indicate that the elongation of the beam. The overall elongation of the beams can be estimated by adding the residual crack widths in the beams. In several cases, it was more than 5 mm elongation at a beam-column joint. As expected, the elongation of beams in a seismic frame created tension in the connection between the precast floors to transverse beams. This mechanism resulted in wide cracks in the precast floor transverse to beam interfaces, as seen in Figure 21b.

**Figure 21:** a) Cracks along the T-beam flooring unit perpendicular to the hinging beam; b) Beam-elongation induced slab mesh fracture. (Photo credit: John Hare of Holmes Consulting).

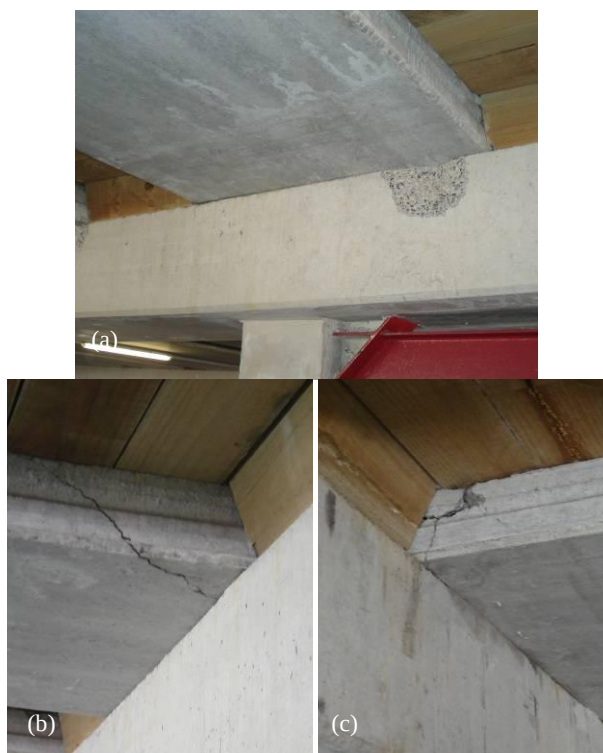
A few instances of such incipient hollowcore failure mechanisms are shown in Figure 22: a) spalling of the concrete at the edge seating support, b) shear cracking of the hollowcore unit and c) damage in the negative moment region with signs of topping delamination. This damage suggests a number of possible failure mechanisms, including the loss of end seating support and flexural-shear failure of the hollowcore.

**Figure 22:** *Precast hollowcore floor and seating damages. (Photo credit: Stefano Pampanin).*

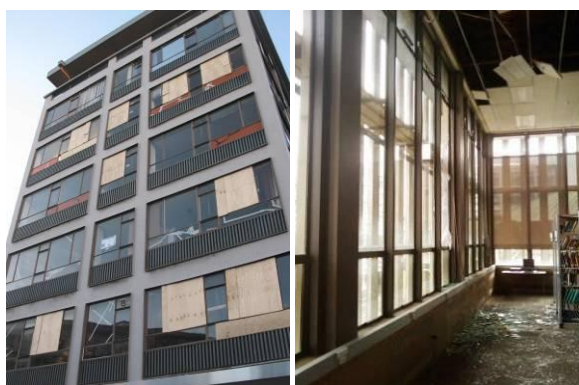
**Figure 23:** *Non-structural glass glazing and ceiling damages on RC frames built in the 1950s and 1970s. (Photo credit: left: Weng Y. Kam and right: NZSEE Clearinghouse).*

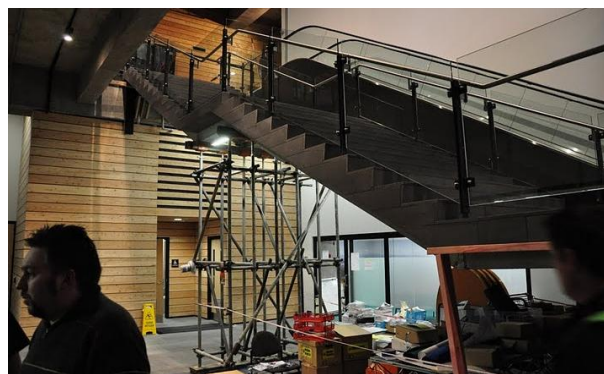
**Figure 24:** *Stairways interaction with lateral systems resulting in non-structural damage. (Photo credit: Fred M. Turner).*
