# THE "EJE CAFETERO" EARTHQUAKE, COLOMBIA OF JANUARY 25 1999

J.I. Restrepo<sup>1</sup> and H.A. Cowan<sup>2</sup>

This paper summarises the main findings of a reconnaissance team to the region organised by the New Zealand Society for Earthquake Engineering.

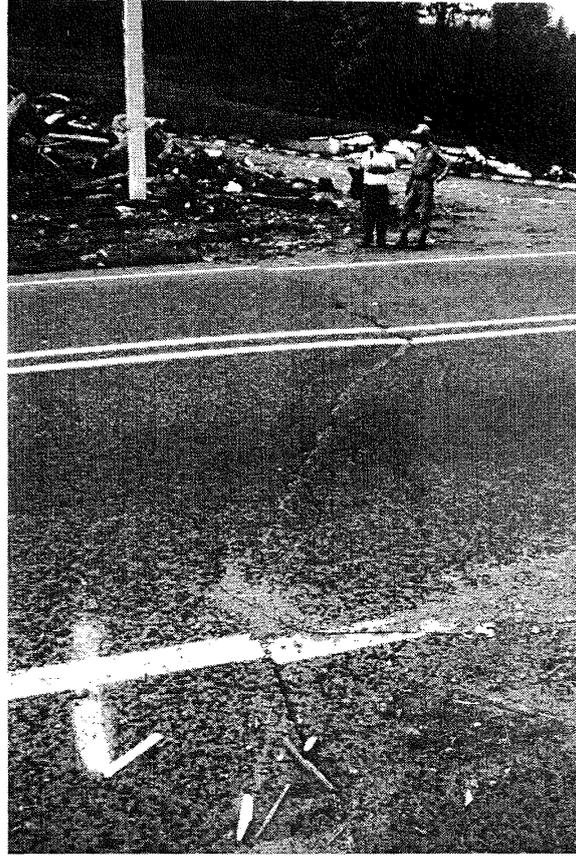
*Figure 4: Right-lateral displacements at a road margin near the town of Barcelona.*

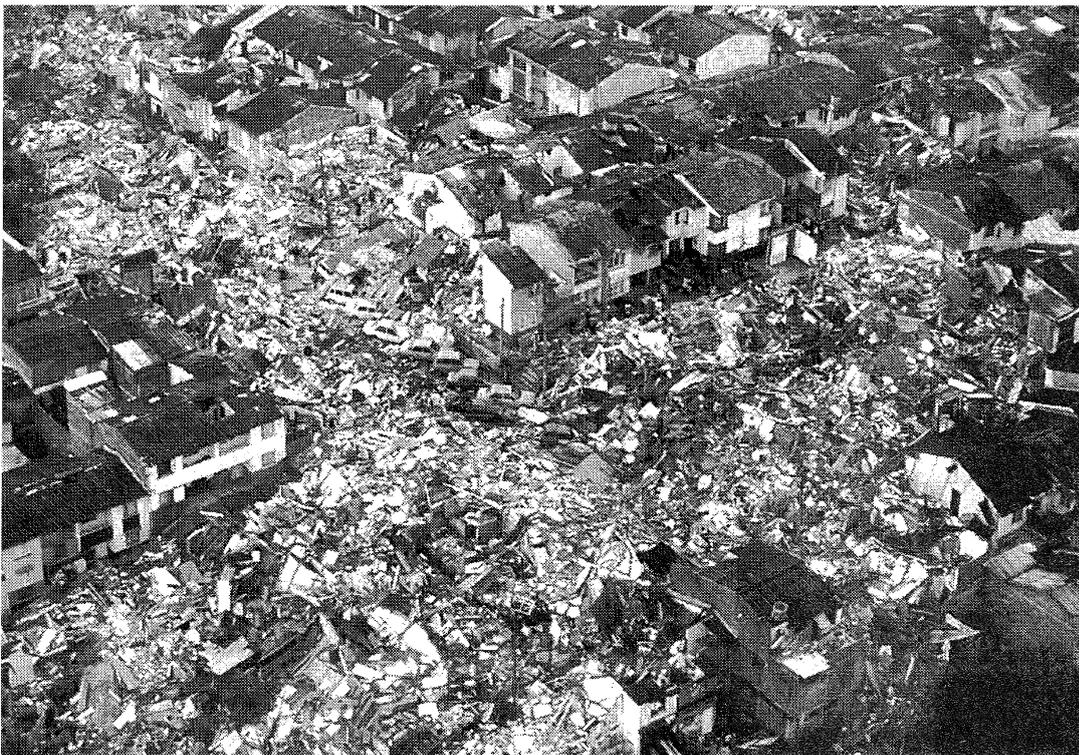
The response of the shallow soil deposits combined with topographical effects played an important role in the ground response in Armenia and Pereira. Clear evidence of this was the very different damage pattern observed between the northern and the southern parts of Armenia (Figure 8). The southwest part of Armenia has deep gullies with urban development on the ridges. In contrast, the topography in the northern part of the city is characterised by broad ridges and fewer stream gullies. Nueva Brasilia, a development of mainly two storey houses and four storey buildings located in the Southeast part of Armenia, suffered partial or total collapse of 90% of the dwellings (Figure 8). Figure 9 illustrates damage in dwellings in this part of the city.

Figure 9: Collapsed houses on a ridge, Nueva Brasilia, Armenia (Courtesy of El Colombiano).

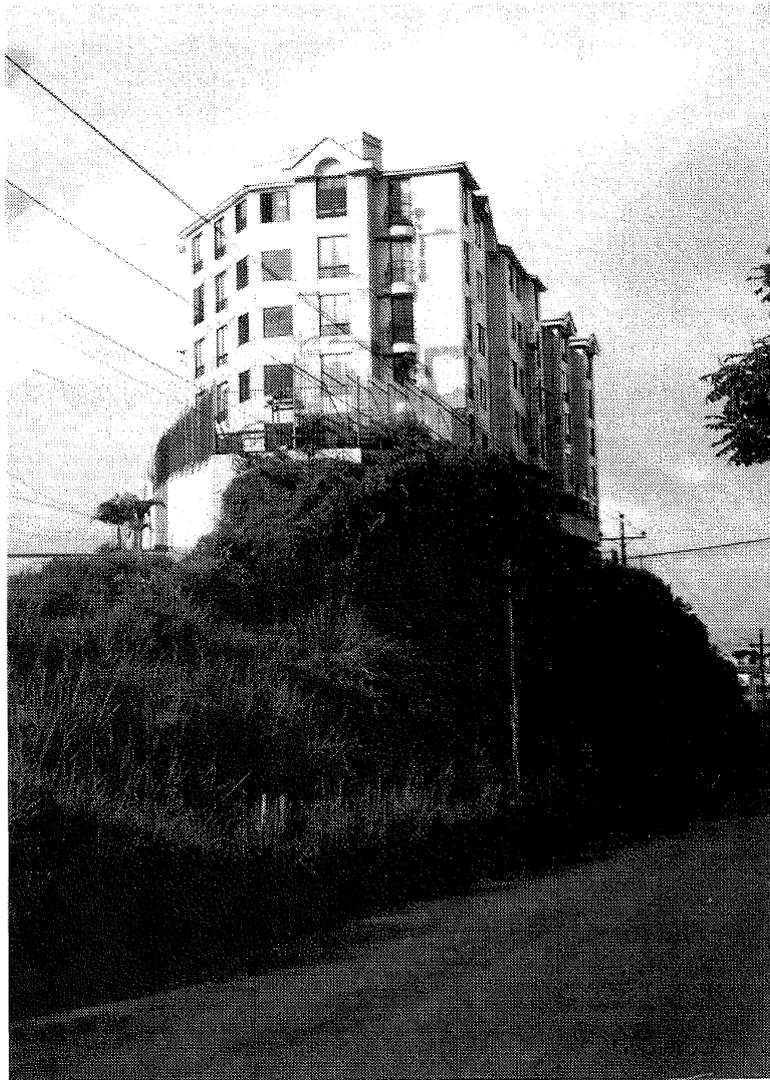
It is customary in this part of Colombia to cut steep slopes for roading when the soil is of volcanic origin. For example, the building shown in Figure 10 experienced appreciable non-structural damage to its façade despite being located in the northern part of the city, where damage was relatively light. We inferred the abrupt change in topography affected the ground response at this and other sites. Lateral spreading was also observed around the crest of some ridges in rural areas south of Armenia (Figure 11). As the rainy season was persistent in February 1999, water penetrated the ground cracks and triggered many slides in the days and weeks following the earthquake. Many small earthquake-triggered landslides were common around the epicentral region and also along the main east-west trunk road across the Central Cordillera between Armenia and Bogotá (Figure 1).

**Figure 10:** *Steep road cuts with buildings built on the crest. Note the damage to the façade of the building.*

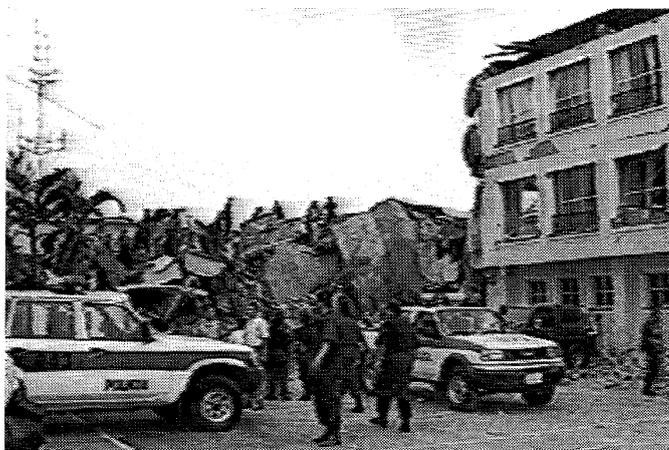
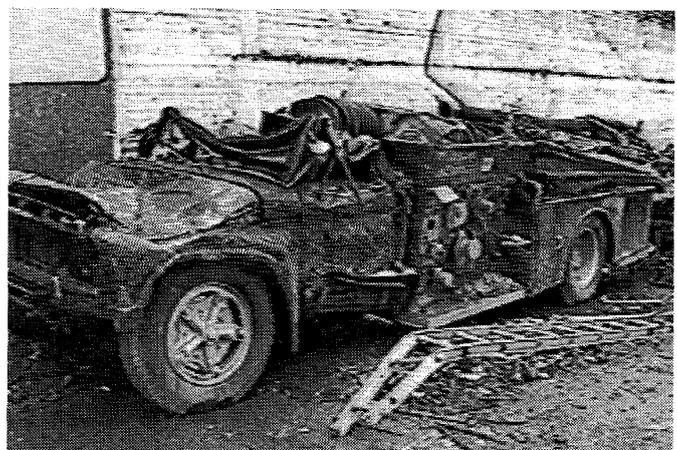
(a). *Police Headquarters*

(b). *Fire brigade truck in the collapsed headquarters*

**Figure 22:** *Impaired critical elements in the emergency response in Armenia. (Courtesy of the Colombian Civil Defense).*

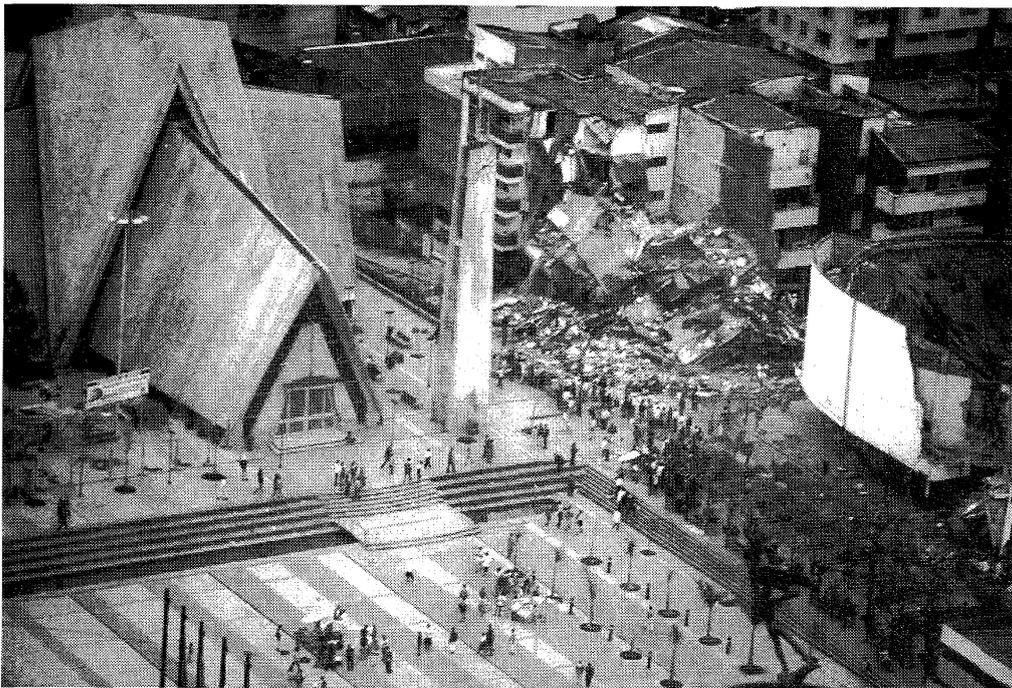
Figure 23: View of Plaza de Bolivar in Armenia showing collapsed corner buildings. Theatre Bolivar is at the right hand side. (Courtesy of El Colombiano).

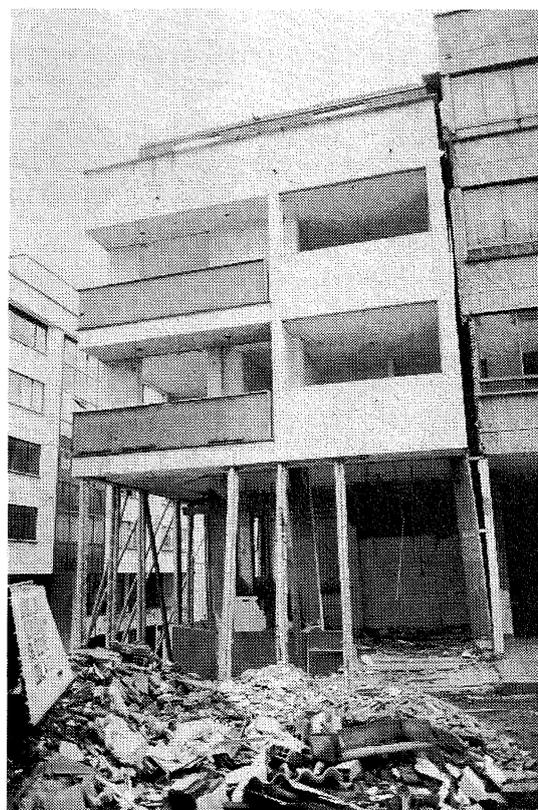
**Figure 24:** *Excessively displaced corner building in Pereira.*

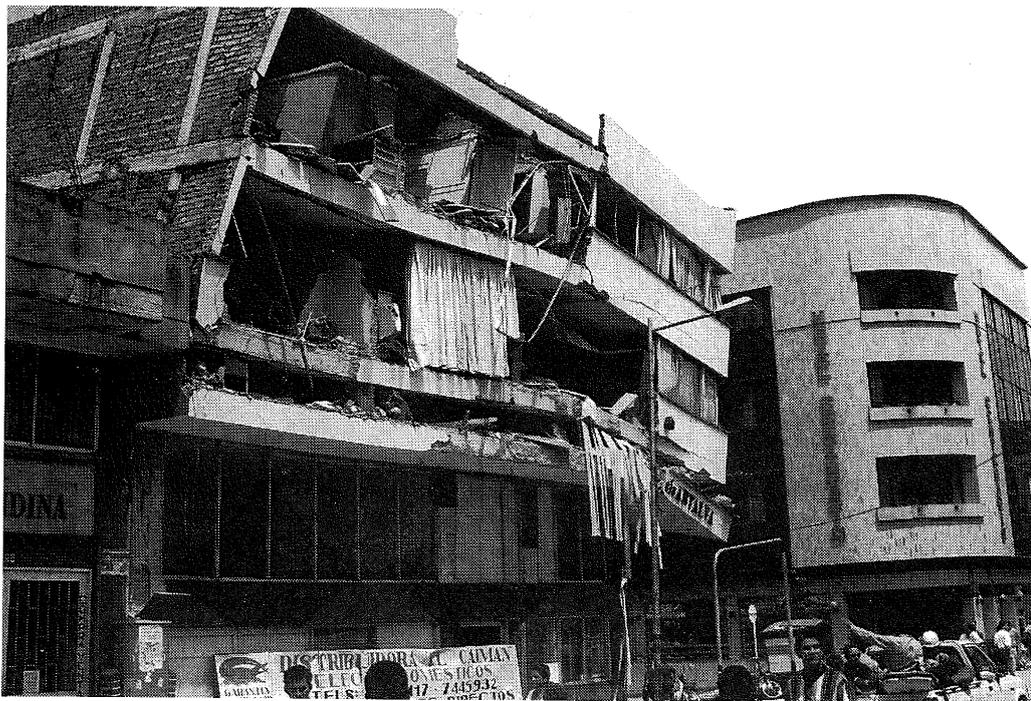
(a). *Intermediate soft storey mechanism in Artalva Courts, Armenia, caused by the collapse of the infill walls. (Courtesy of E Castrillon).*

**Figure 25:** *Poor behaviour of buildings with unreinforced masonry infilled frames.*

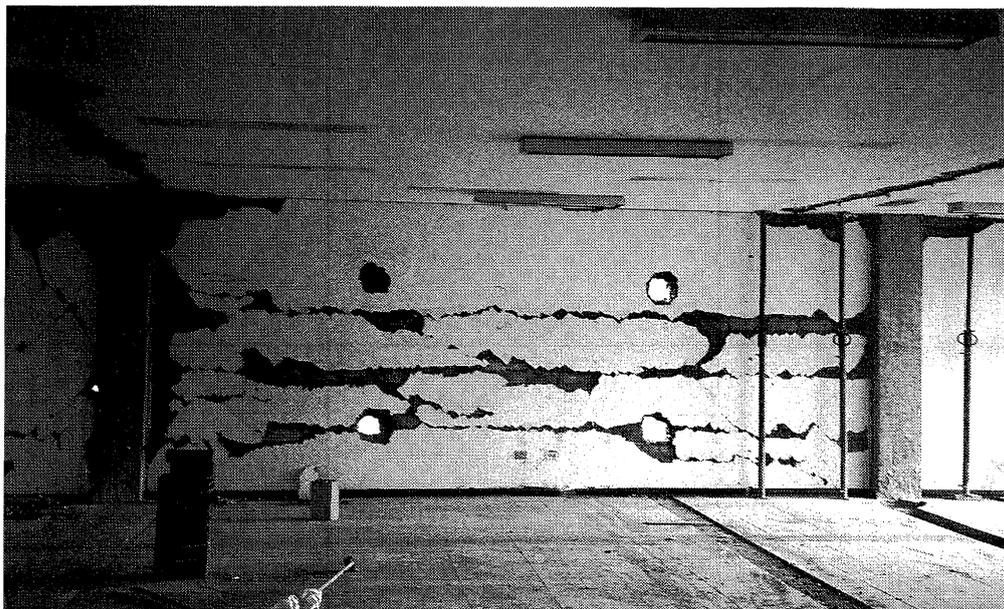
(b). *Extensive damage to an infill masonry wall in Pereira.*

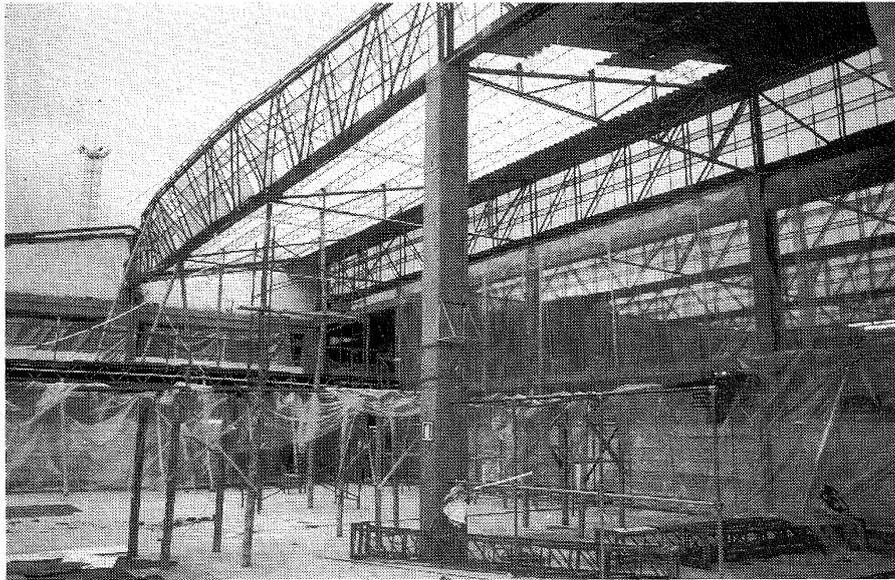
*Figure 27: Lateral buckling of a structural steel roof truss in Nicol Industries.*

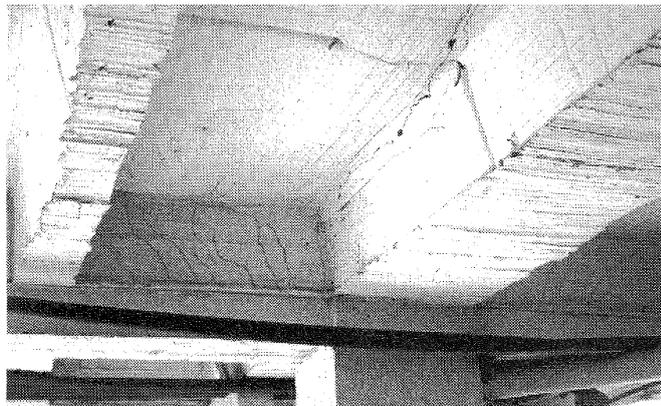
*Figure 28: Positive and negative plastic hinges in a gravity dominated beam of a reinforced concrete frame (Veraneros Courts).*

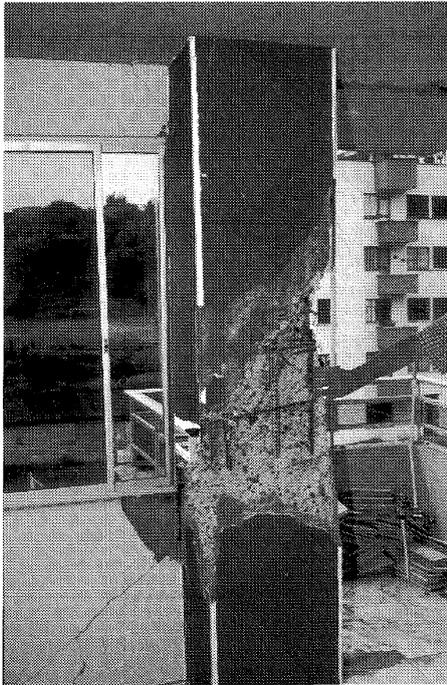
(a). *Short column induced by the presence of an infill wall.*

**Figure 29:** *Damage due to lack of deformation compatibility.*

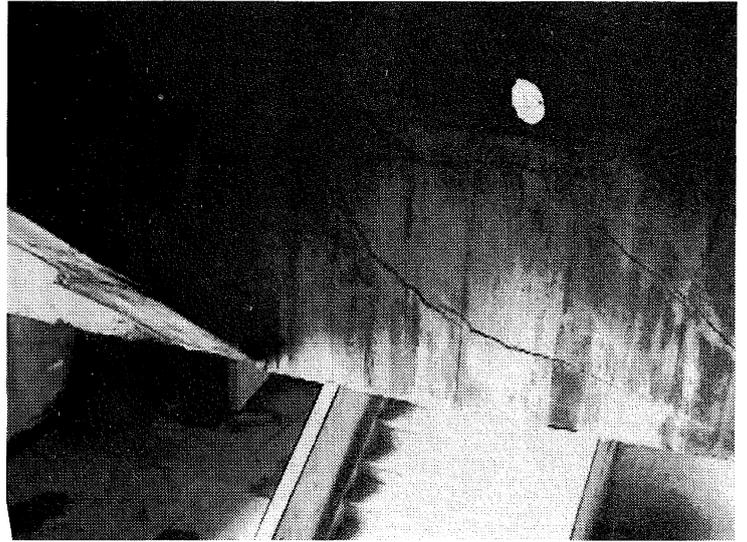
(b). *Large torsional cracks due to the interstorey restraint caused by a staircase. Hernan Ramirez Villegas Sports Stadium, Pereira.*

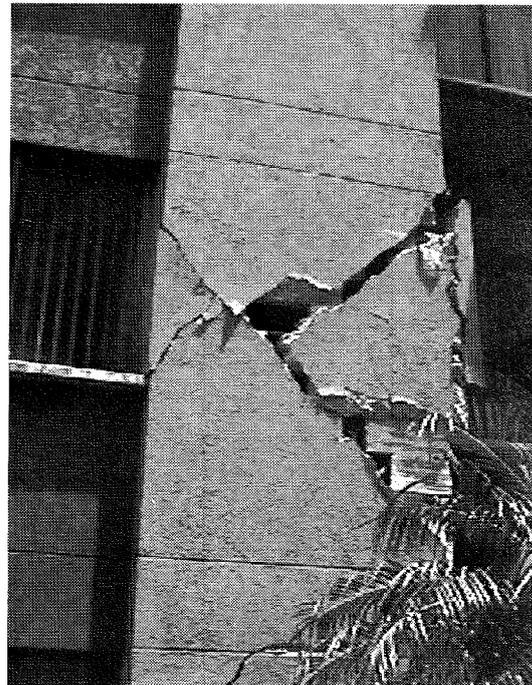
(c). *Non-structural damage to a clay brick façade.*

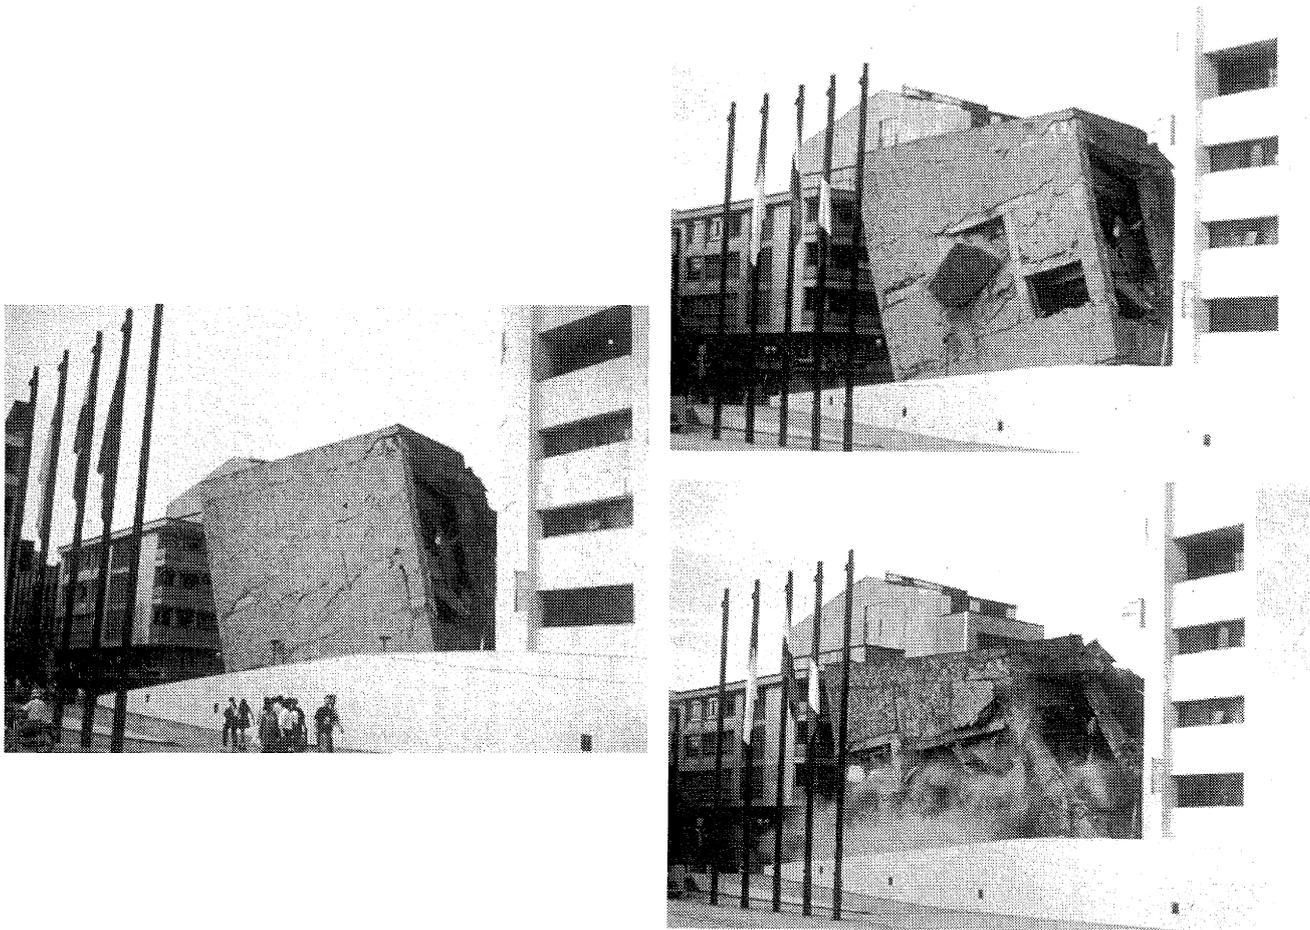
(a). Immediately after the main event.

(b). Building collapse during the 5:40 pm aftershock.

Figure 32: Quindío council chambers. (Courtesy of Quiceno Bro.).
