EARTHQUAKE RISK (PRONE) BUILDINGS – THE GISBORNE EXPERIENCE

J. D. Wells ¹

This paper was presented at the 1996 NZNSEE Technical Conference.

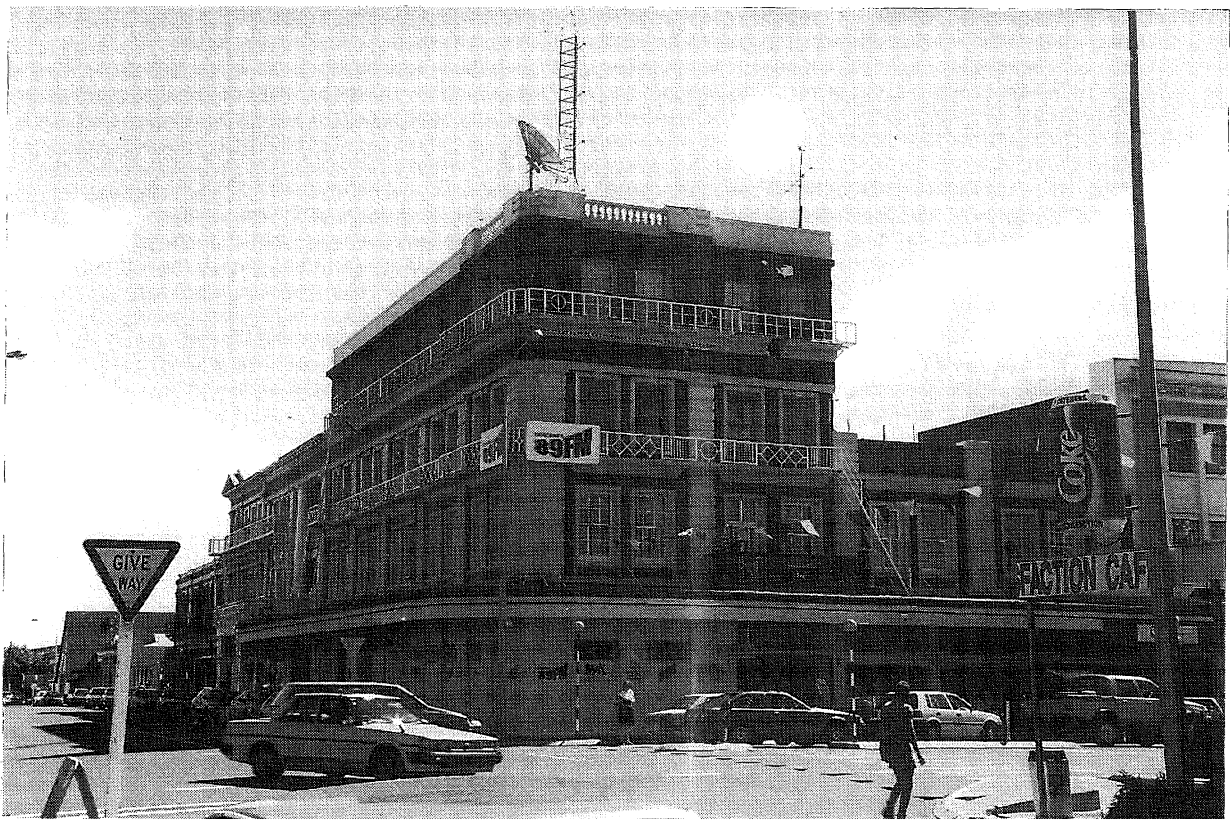
FIGURE 1 MASONIC HOTEL (built 1900-1929). First building assessed in Gisborne (1982); comprises 5 building complex; major strengthening after 1966 Gisborne earthquake

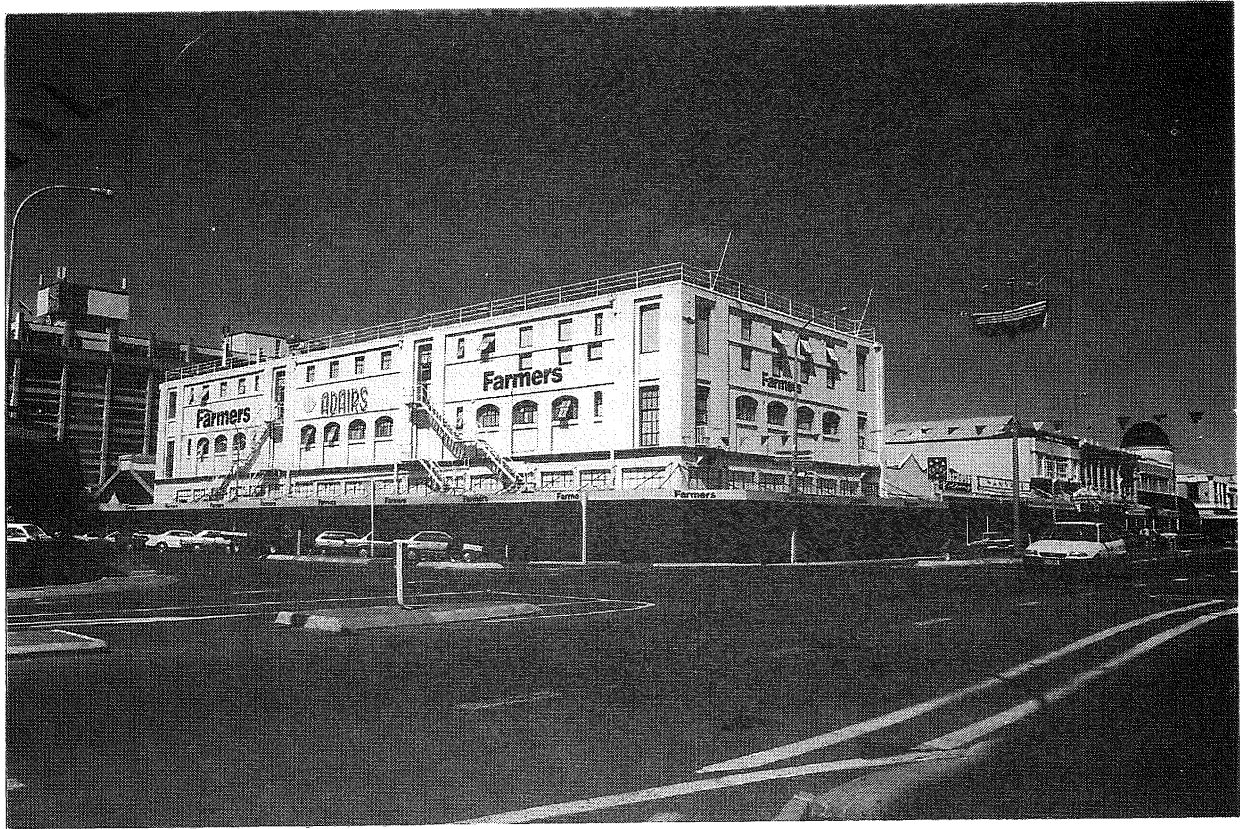
FIGURE 2 FARMERS/ADAIRS (built 1923-29). Major strengthening after 1966 earthquake; further strengthened during 1993 refurbishment on take-over by Farmers

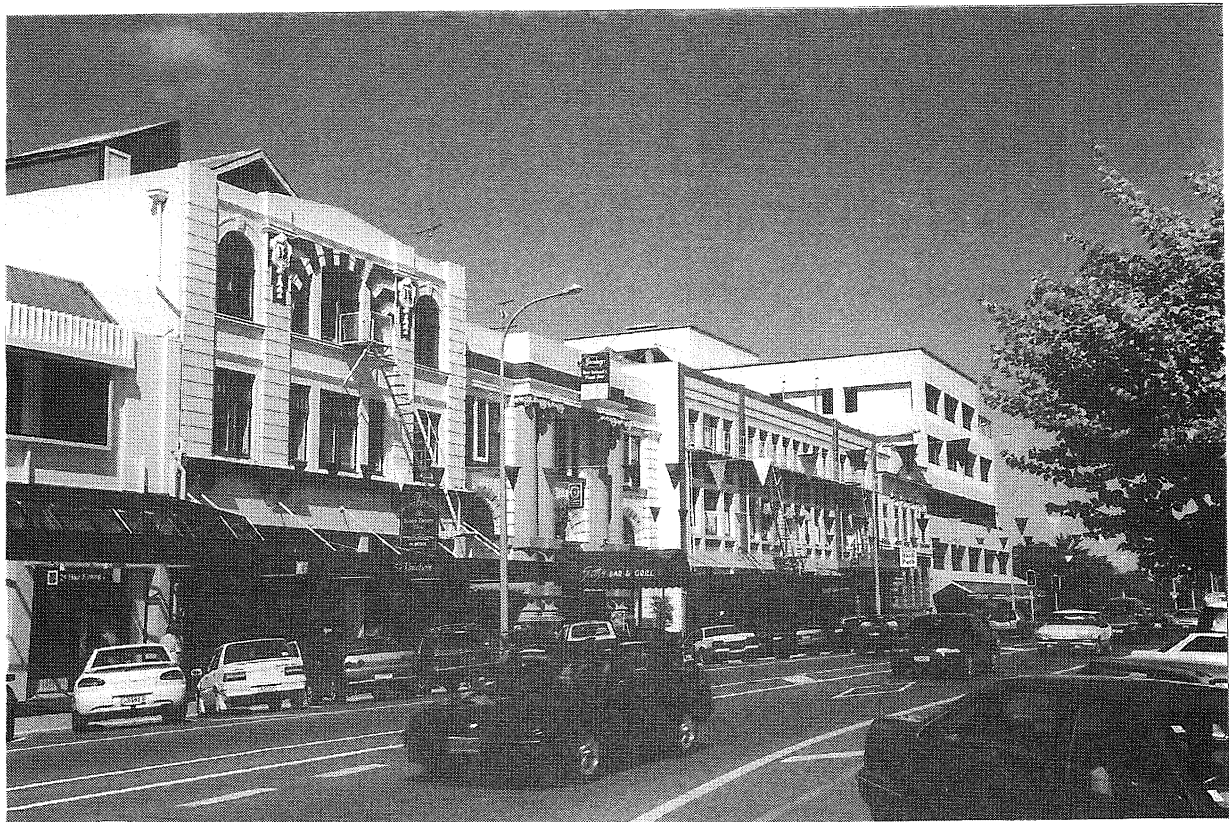
FIGURE 3 GLADSTONE ROAD HISTORIC PRECINCT (built 1909-1916). Category II Historic Places Trust classification; 4 ERB's no EPB's; Eastern Co-op building (No. 9-11) second from far end, adjacent to Quay Pt bldg (1988)

It was at the time of developing these policies in response to the apparent (and now confirmed) legal meaning of Section 66 of the Building Act 1991, that the controversy over No. 9-11 Gladstone Road arose, the ex Eastern Co-op Building Society building. Early in 1994 a verbal opinion had been given that the building was an **ERB**, based on a preliminary inspection and the assumption that the provisions of Section 624 of the LGA had been re-embodied in Section 66 of the Building Act 1991. This enquiry sparked an in-depth investigation of the wording of Section 66 and the development of the above policy changes prior to advising the owner that the building was then not considered to be an **EPB**. Rather than causing the owner some relief as would normally be the case, this reversal became the subject of an appeal to the Planning Tribunal [4], 14 & 15 August 1995, as the owner wished to use the ERB classification as a lever to enable him to demolish the building against a Preservation Order on the building as part of an "Historic Precinct". The EPB classification and Preservation Order were both upheld.
