## A NOTE ON THE ARTHUR'S PASS EARTHQUAKE 18 JUNE 1994

J.B. Berrill<sup>1,2</sup>, K.J. McManus<sup>1,3</sup> and G.H. Clarke<sup>1</sup>

The M6.3, 18 June 1994 Arthur's Pass earthquake was notable for the strength of shaking recorded at Arthur's Pass Township and for the little damage it caused to bridges and houses. Bridges, the only major man-made structures in the epicentral region except the rail tunnel, survived with only superficial damage, probably because of their dense foundation soils.

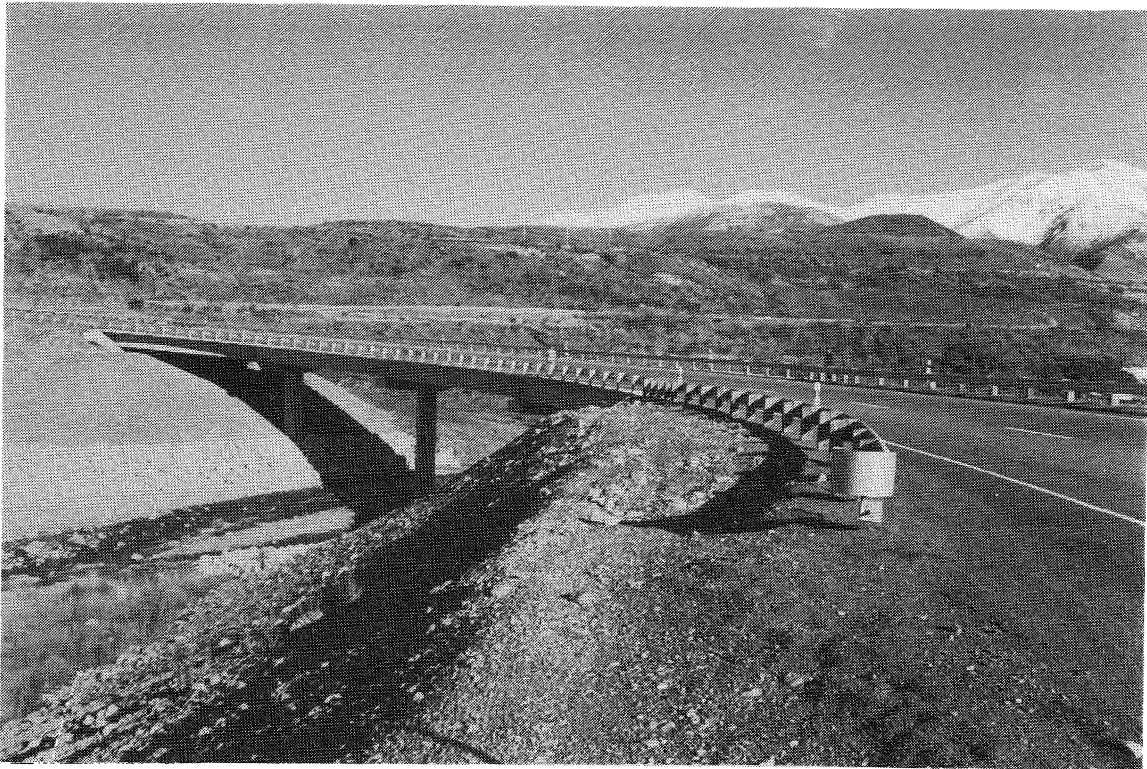
At the Broken River bridge (Figure 1), constructed in 1992, there was minor spalling of the south-most beam at the east abutment, presumable where it had lightly struck the abutment. Grout had spalled away from around the base of the rubber bearing pads at two of four beams at the east abutment (Figure 2) and at the northern pad at the west abutment. The expansion joint at the east abutment appeared to be quite compressed. At the west abutment, the joint had opened by about 10 mm, suggesting that the superstructure had been permanently displaced by that amount to the east. Distortion in the rubber bearing pads at the west abutment is consistent with such movement (Figure 3) as is displacement of the west abutment (Figure 4).

*FIGURE 1 Broken River highway bridge looking East*

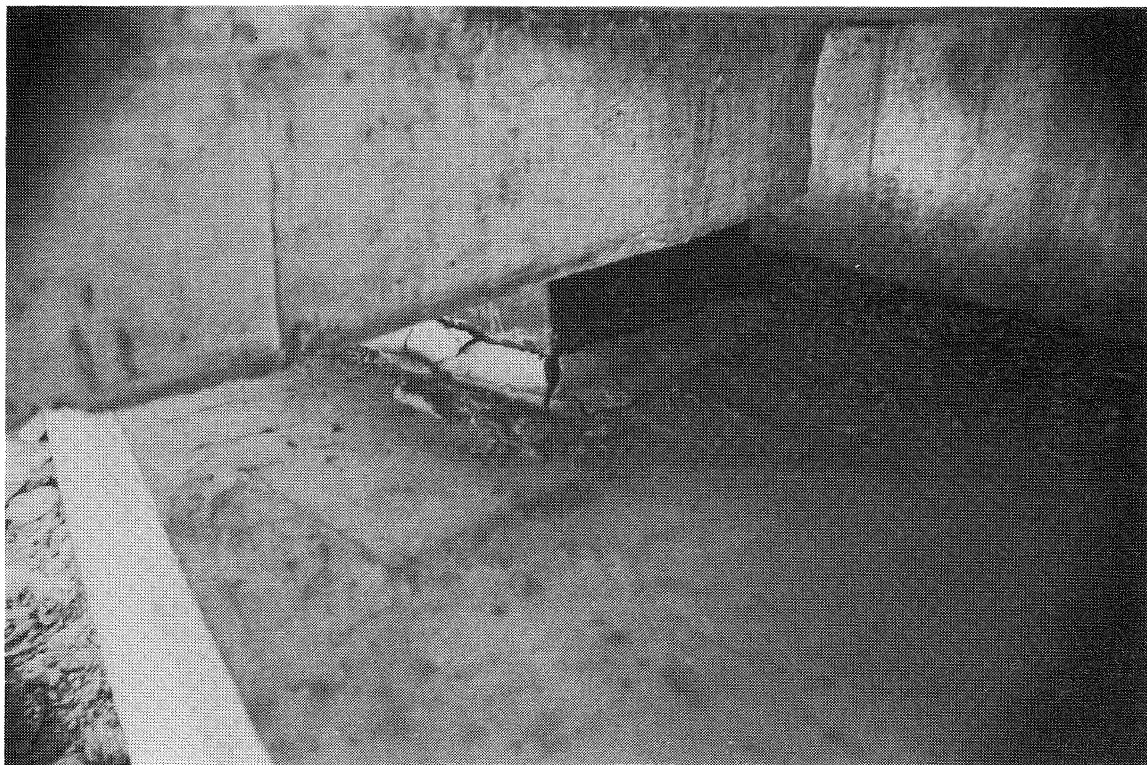
*FIGURE 2 Broken River highway bridge, showing inner bearing at eastern abutment*

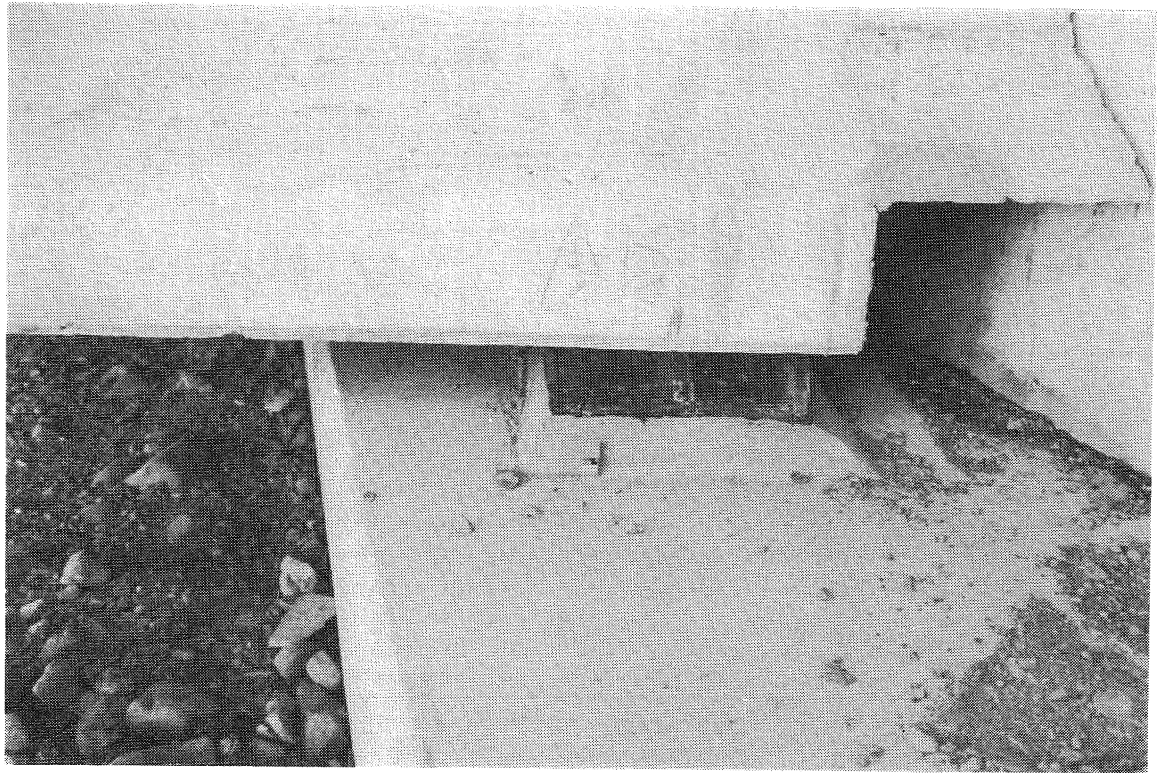
**FIGURE 3** *Western abutment, Broken River bridge, showing permanent distortion left in rubber bearing*

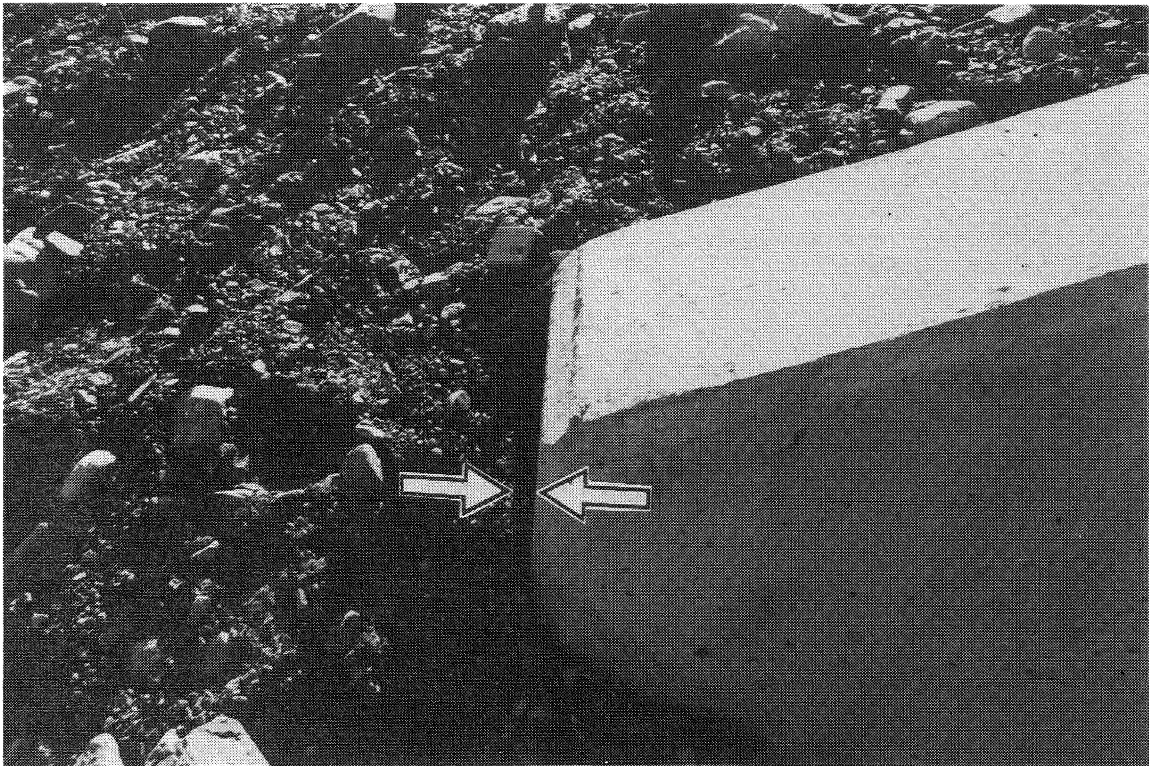
**FIGURE 4** *Western abutment, Broken River bridge, showing relative movement between ground and abutment*

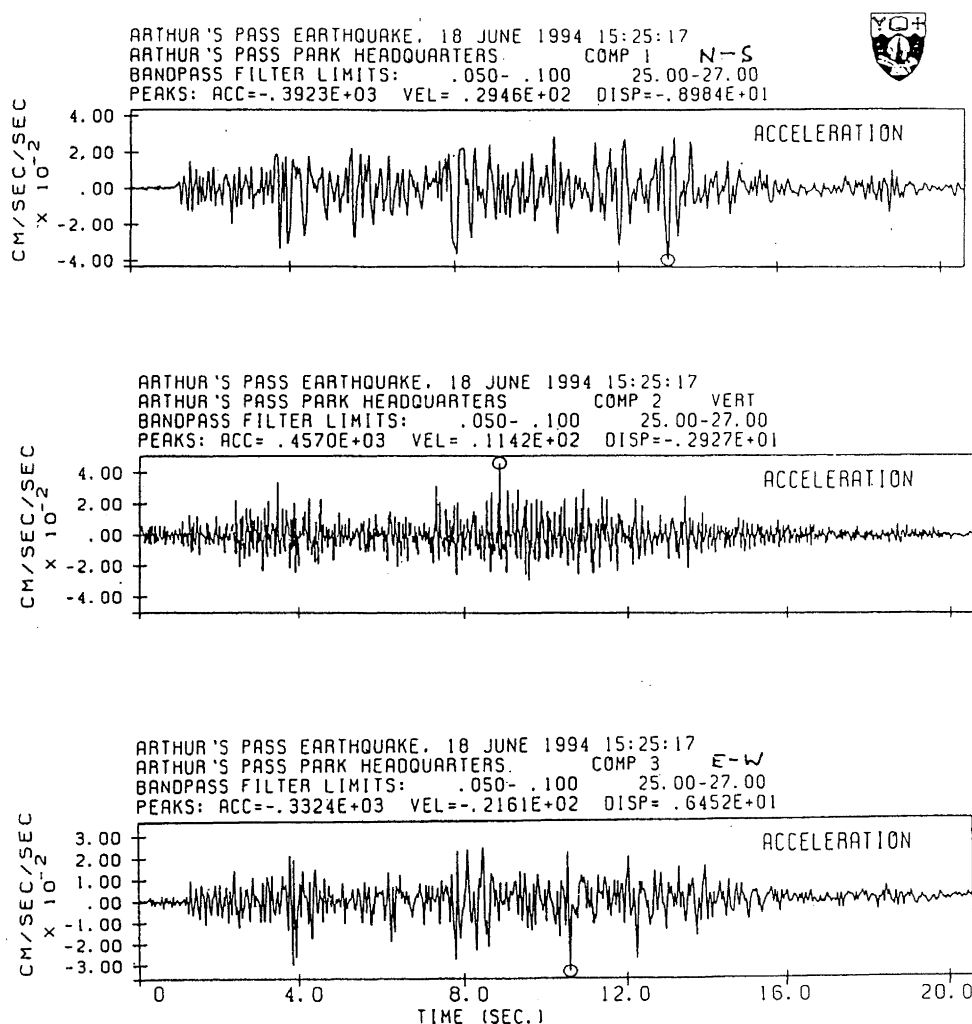
Sciences (IGNS), and 2 from instruments owned by the University of Canterbury. In addition, seven records were made on peak-recording scratch-plate (SP) instruments of the IGNS. Records from the University's instrument at Arthur's Pass are reproduced in Figure 5. Peak accelerations from the IGNS instruments are listed in Table 1.

The motions recorded at Arthur's Pass by the University's instrument in the Park Headquarters building, and the IGNS instrument about 300 m down the valley at the Police Station are amongst the strongest recorded in New Zealand. Response spectra from the horizontal components of the Park Headquarters recording are shown in Figure 6.

FIGURE 5 Accelerogram from Park Headquarters building, Arthur's Pass

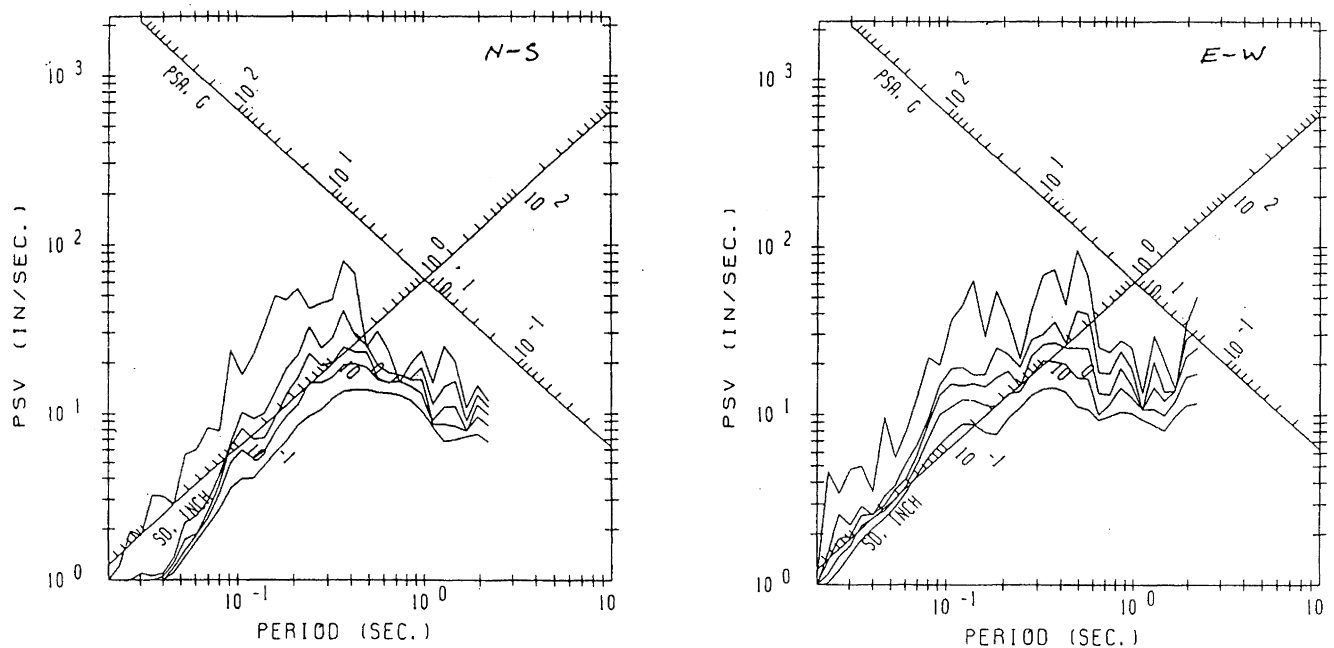
**FIGURE 6 Pseudo velocity response spectra for the two horizontal components of motion.  
Damping values are 0, 2, 5, 10 and 20 percent**

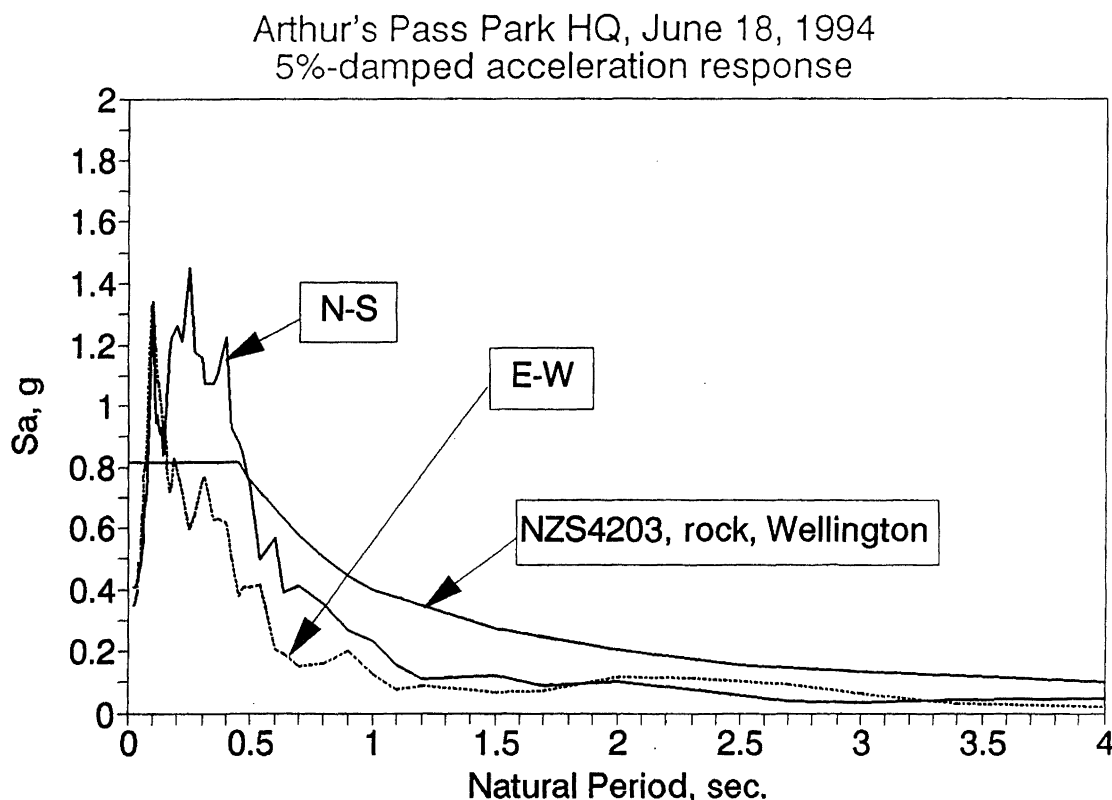
The 5 percent damped acceleration response spectra are compared with the current New Zealand *design spectrum* from NZS4203 for the most severe zone in Figure 7. For this comparison, a *structural performance factor* of 1.0 was employed. Cross spectra between the June 18th record and previous records from the site have dominant peaks at 0.20 seconds, suggesting a site period of that value, which places the site in the stiff soil or rock category. Hence the *rock* spectrum values are used. Note that the N-S component exceeds the NZS4203 spectrum by 40 to 50 percent over quite a broad band, from 0.08 to 0.5 seconds.

**FIGURE 7** Comparison of Arthur's Pass spectra with current NZ code spectrum, for main seismic region (eg, Wellington)
