NORTHRIDGE EARTHQUAKE RECONNAISSANCE REPORT

Report of the NZNSEE Reconnaissance Team on the
17 January 1994 Northridge, Los Angeles Earthquake

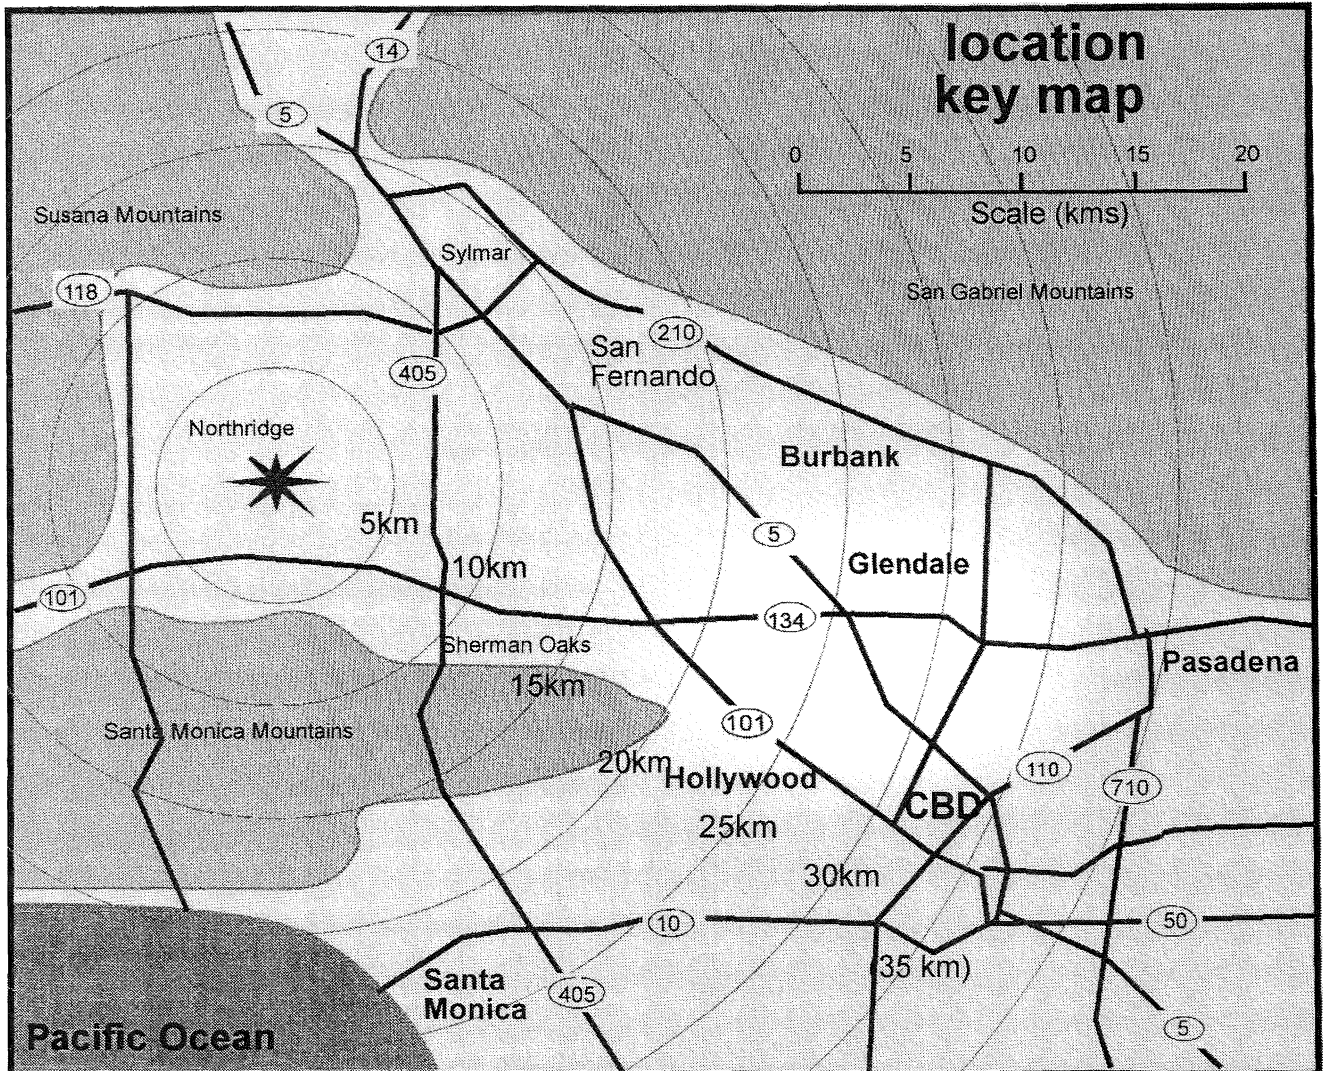
FIGURE 1.1 Northridge Location Map

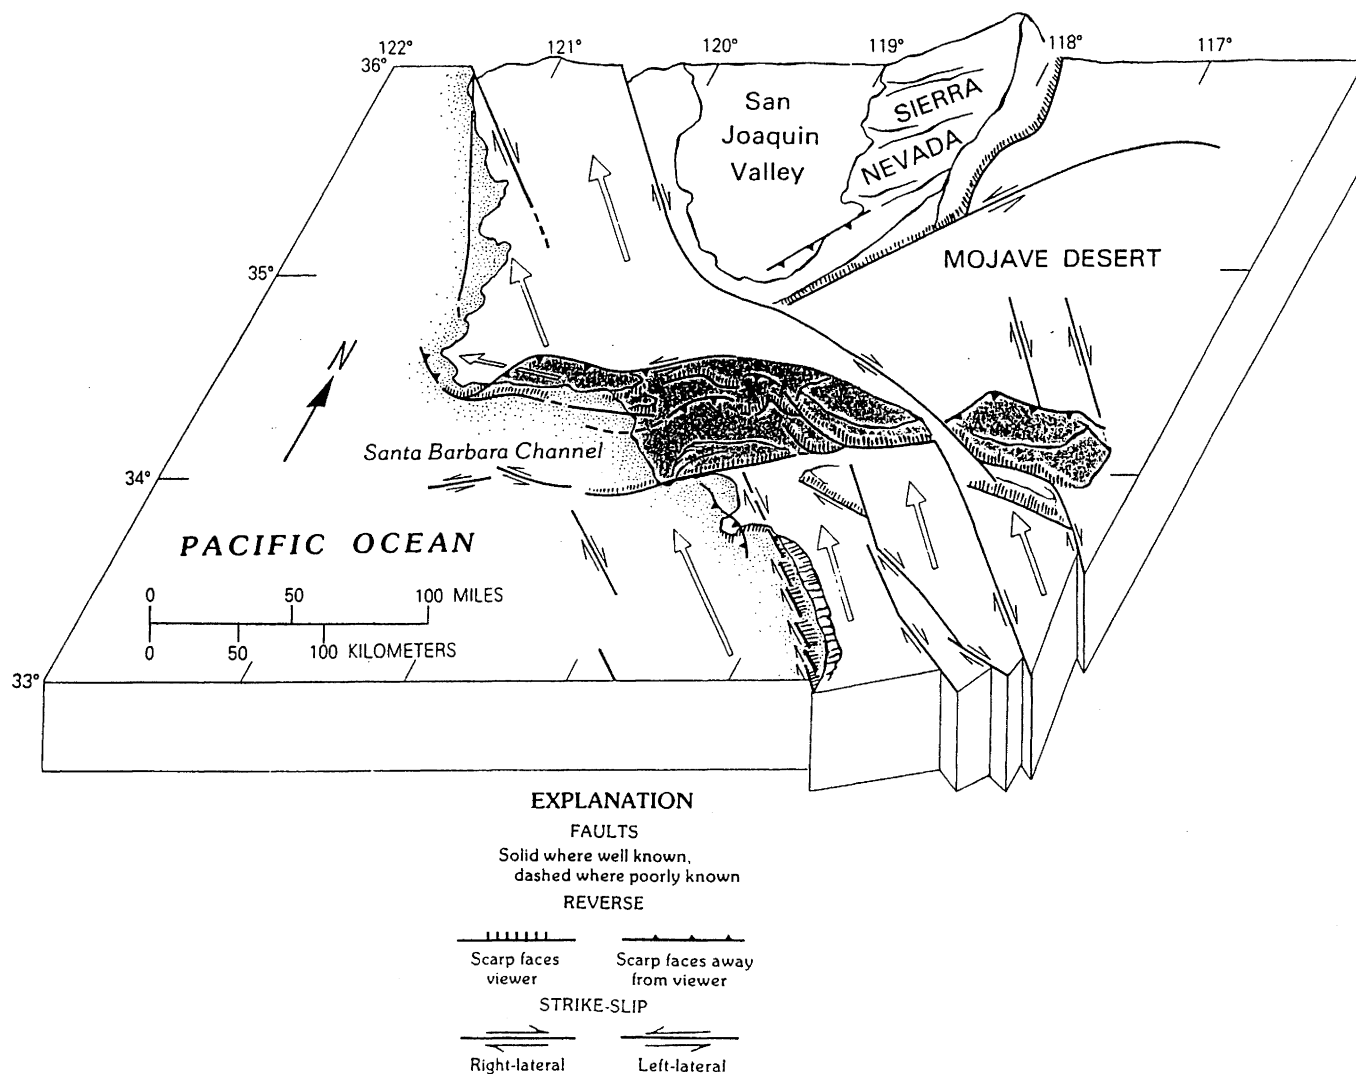
FIGURE 3.1. Relative motions of the Pacific and North American plates in the vicinity of Los Angeles. The "Big Bend" of the San Andreas fault north of Los Angeles causes the Pacific Plate to collide with the North American Plate rather than to slide past it in this region, producing compression associated with the Transverse Ranges (shaded) to the north of Los Angeles and the occurrence of reverse faulting earthquakes [from Yerkes(1985)].

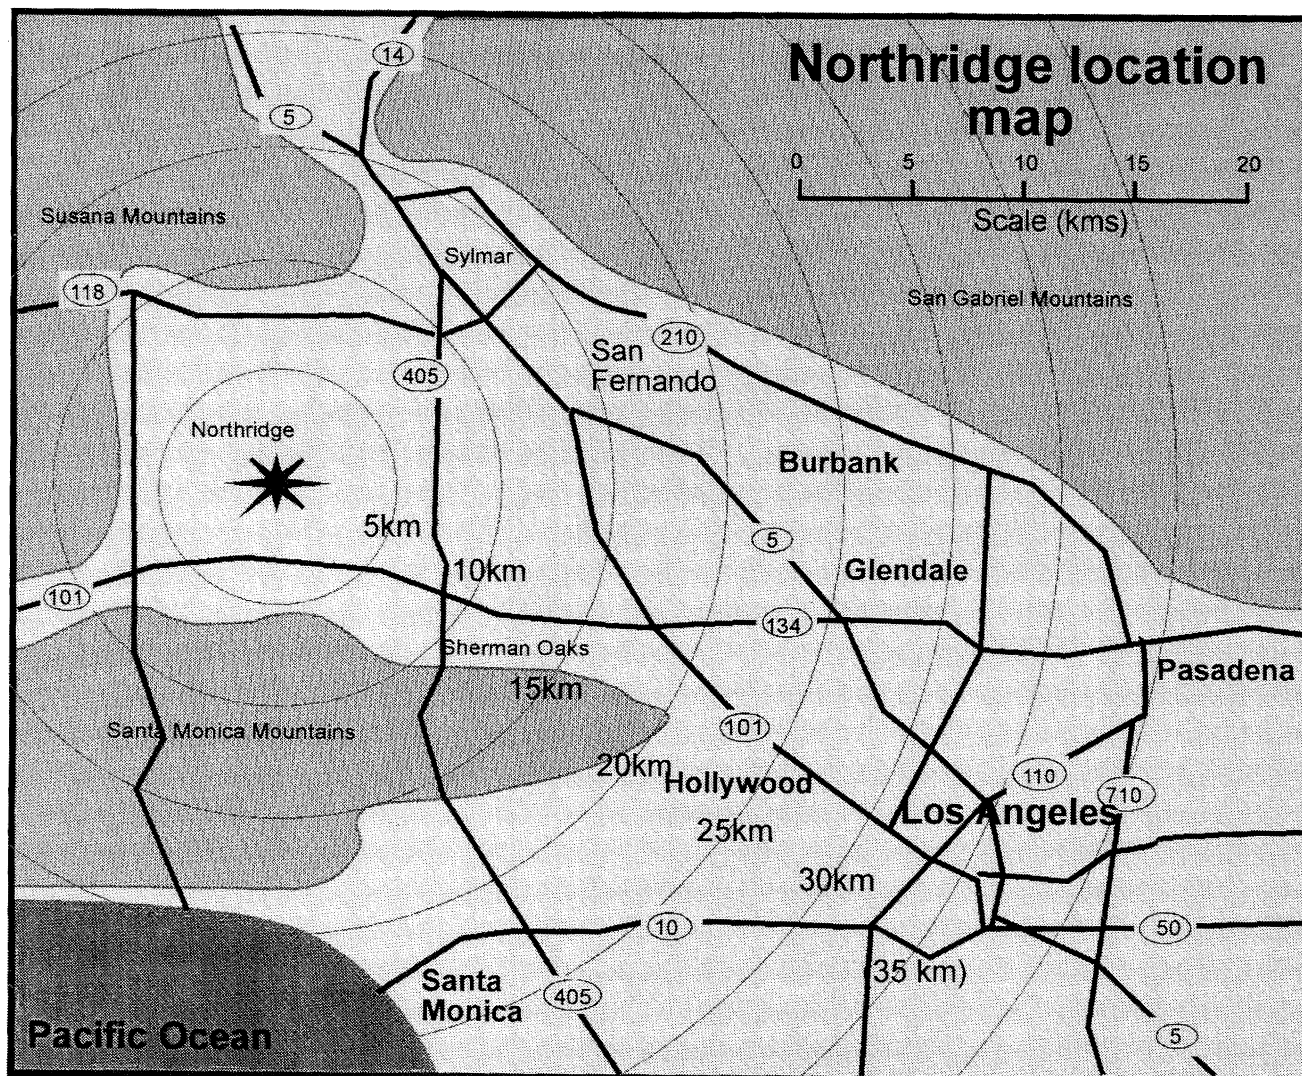
FIGURE 3.2. Map of the Los Angeles region, showing localities affected by the Northridge earthquake. The epicentre was near the boundary of Northridge and Reseda, in the centre of the San Fernando Valley which is bounded by the Santa Monica Mountains to the south, the Santa Susana Mountains to the north and the San Gabriel Mountains to the north-east. The fault rupture surface extended north-east towards Sylmar from beneath the epicentre.

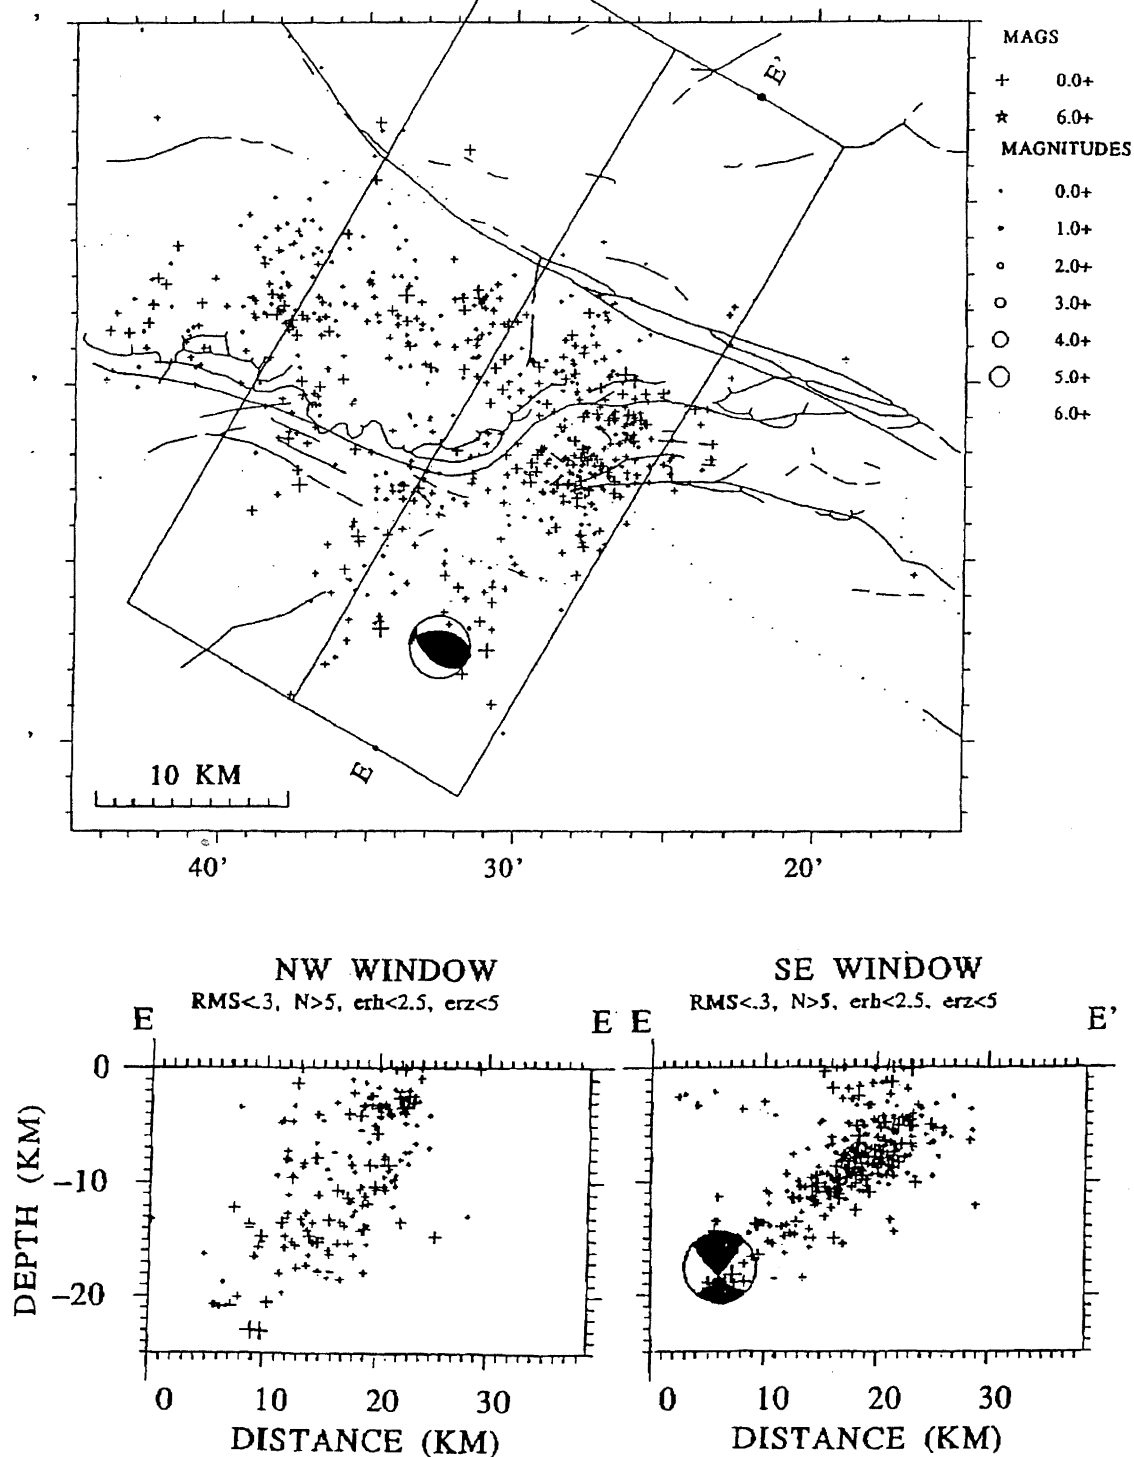
FIGURE 3.3. Locations of the Northridge mainshock and aftershocks in plan and section views. Note the concentration of aftershocks in the SE window dipping up from the mainshock focus at 18 km depth and terminating at about 5 km depth indicating the location of the rupture plane, contrasting with the more diffuse spread of locations in the NW window. (From CUBE report).

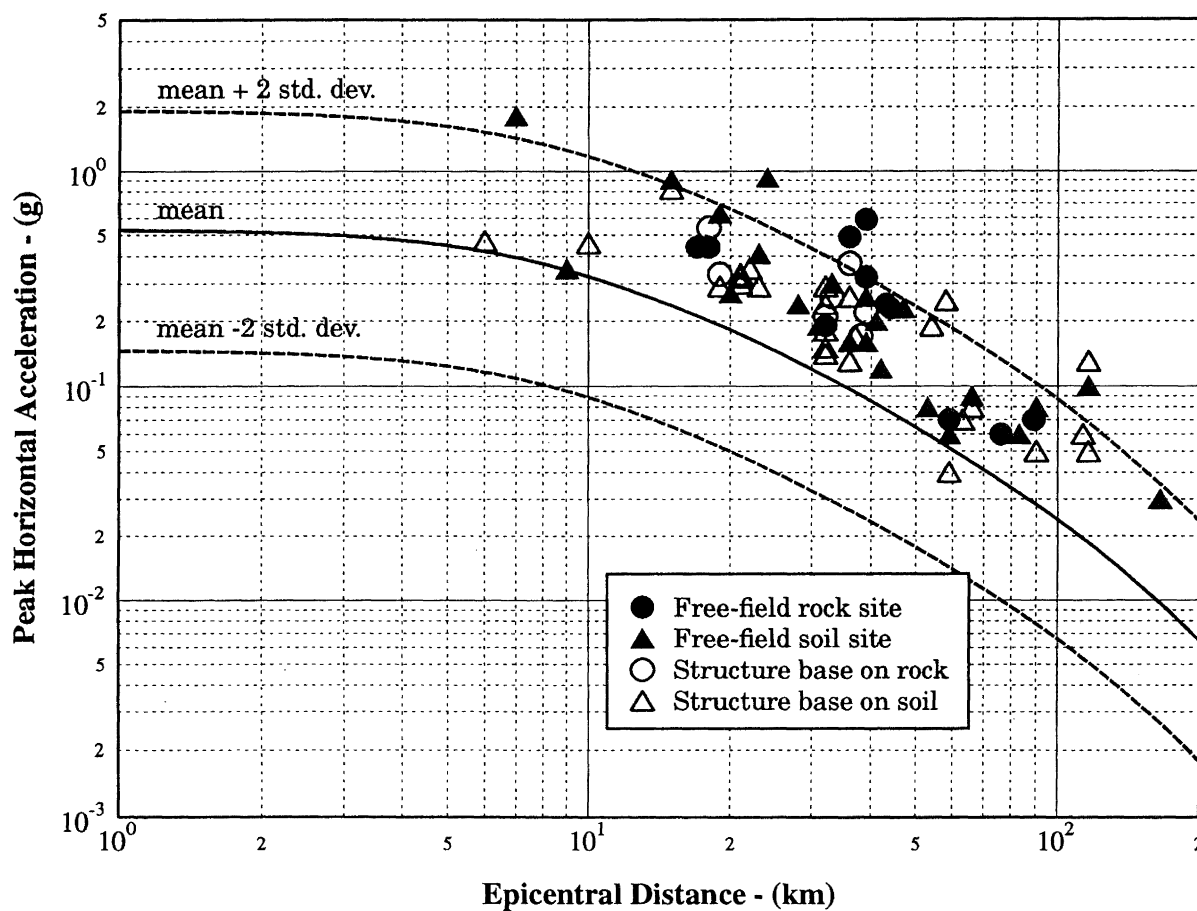
FIGURE 3.4. Peak accelerations of the stronger horizontal component of records from the Northridge earthquake plotted as a function of epicentral distance, compared with the mean and mean ± 2 standard deviation curves predicted by the Joyner and Boore [1988] attenuation relation. Data from CSMIP Fifth Quick Report.

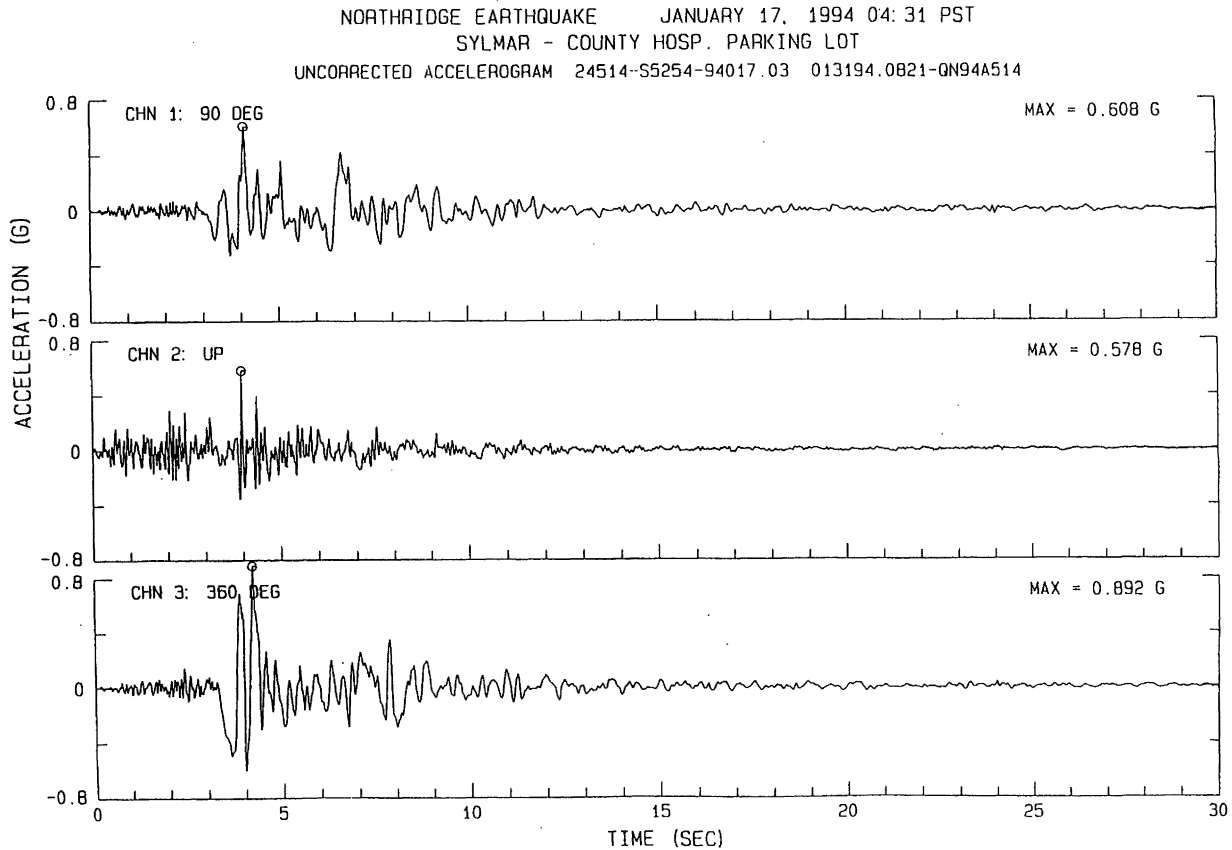
FIGURE 4.2. The three components of the CSMIP near-source acceleration record from the "free-field" Parking Lot site at the County Hospital at Sylmar. Note the strong pulse at the start of the S-wave about 3 seconds after triggering. This pulse was characteristic of the records from the near-source northern stations. [From Darragh et al., 1994a].

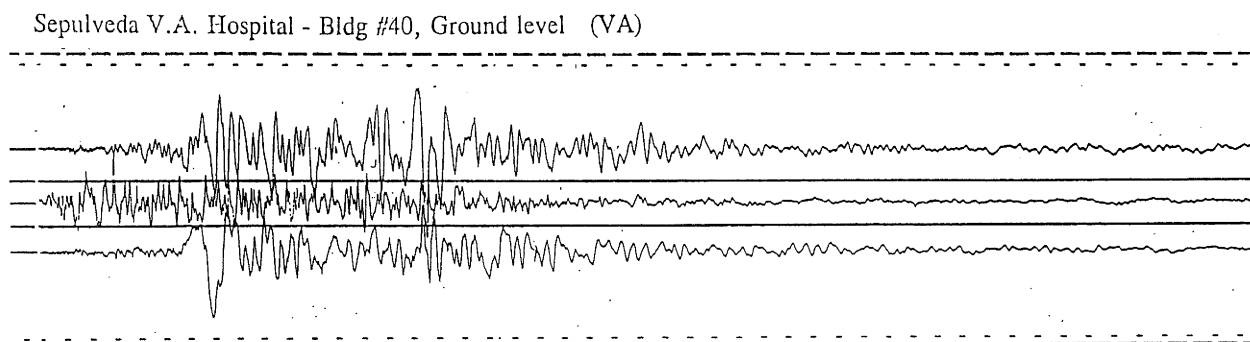
FIGURE 4.6. *The Sepulveda V.A. Hospital record from above the rupture plane, showing a strong broad pulse at the start of the S-wave, followed by very strong peak accelerations of about 0.9g [from USGS, Porcella et al., 1994]. (Published with permission of USGS, with acknowledgement to instrument owners U.S. Department of Veterans Affairs).*

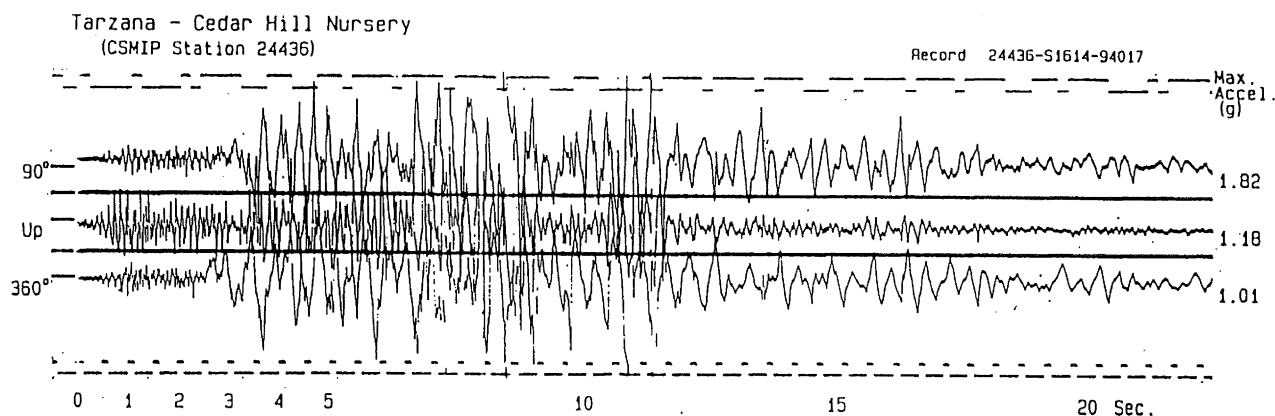
FIGURE 4.7. *The exceptionally strong accelerations recorded at the Tarzana Cedar Hill nursery, exceeding 1g for many cycles in all 3 components. An apparent lack of major damage in the surrounding area, together with high accelerations at this site in the 1987 Whittier earthquake, suggest a highly localised site effect. It is understood that CDMG and USGS were to conduct extensive site investigations following the Northridge earthquake. [From CSMIP Third Quick Report, as reproduced by Moehle (ed.), 1994].*

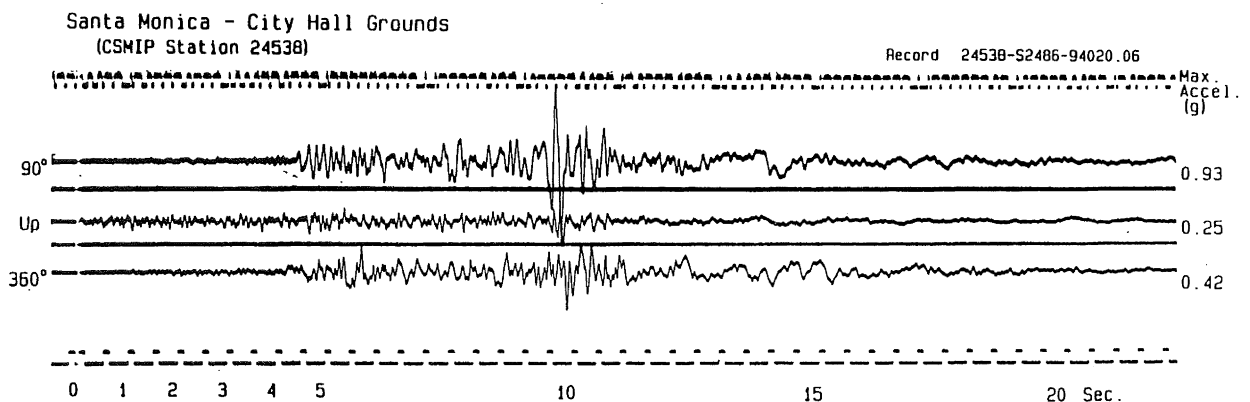
FIGURE 4.8. The CSMIP record from the grounds of the Santa Monica City Hall. Note the strong short-duration pulse in the 90° component associated with the 0.93g PGA, superimposed on many cycles of motion with amplitudes of about 0.3g. (From CSMIP Fourth Quick Report).

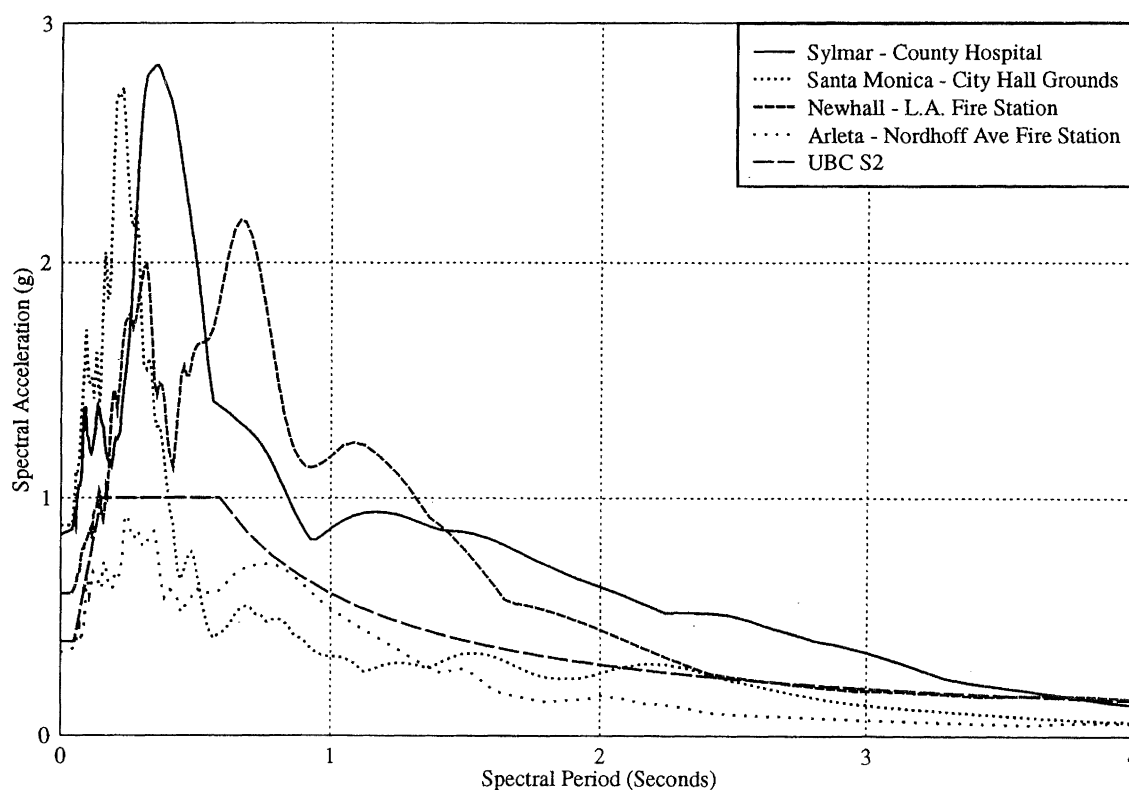
FIGURE 4.9. The four spectra presented by Krawinkler [1994] for some of the more notable strong-motion records from the Northridge earthquake. All spectra are for the stronger horizontal component, which except at Arleta was considerably stronger than the other component shown in Figure 4.10. The Sylmar and Newhall spectra exceed the UBC S2 spectrum at all periods, but the Santa Monica spectrum generally exceeds the code curve only at short periods (less than 0.4s), and the Arleta spectrum falls below the code spectrum at all periods. (Plotted from CSMIP data).

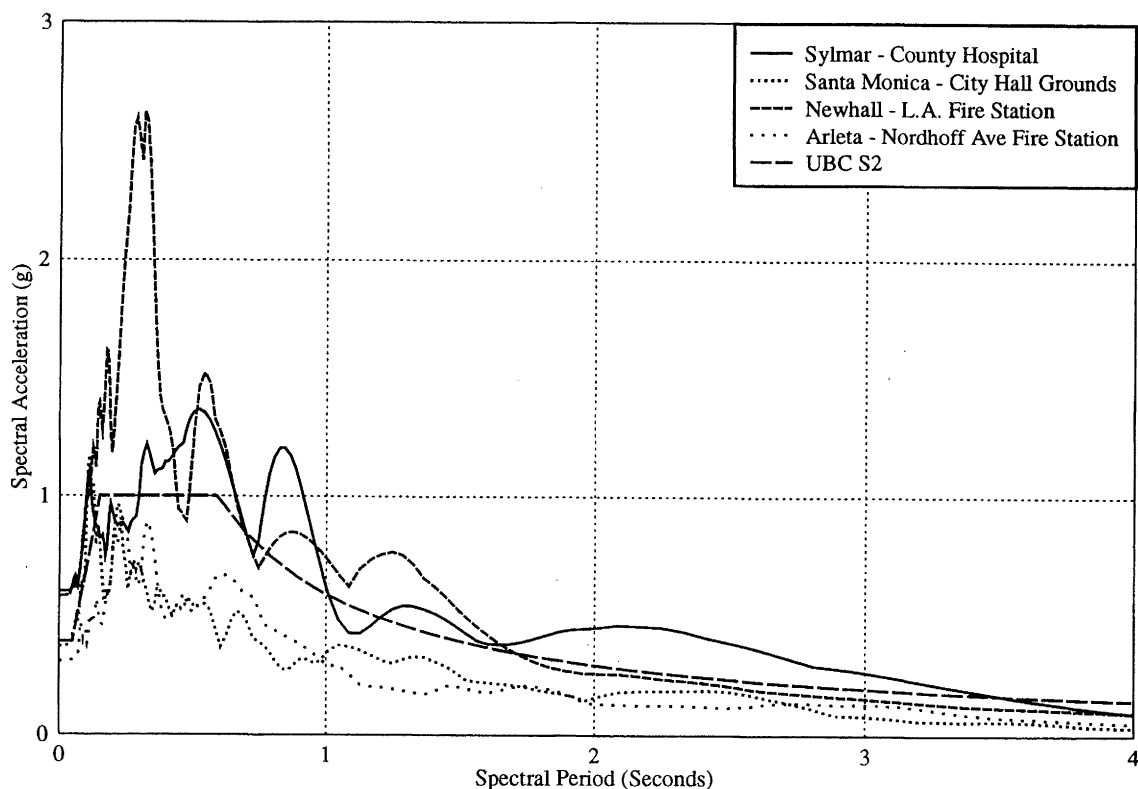
FIGURE 4.10. The spectra for the weaker horizontal component of the records shown in Figure 4.9. The spectra of the weaker Santa Monica and Arleta components generally lie below the code S2 curve, and the weaker component grossly exceeds the code curve only for Newhall, and then only at short periods. (Plotted from CSMIP data).

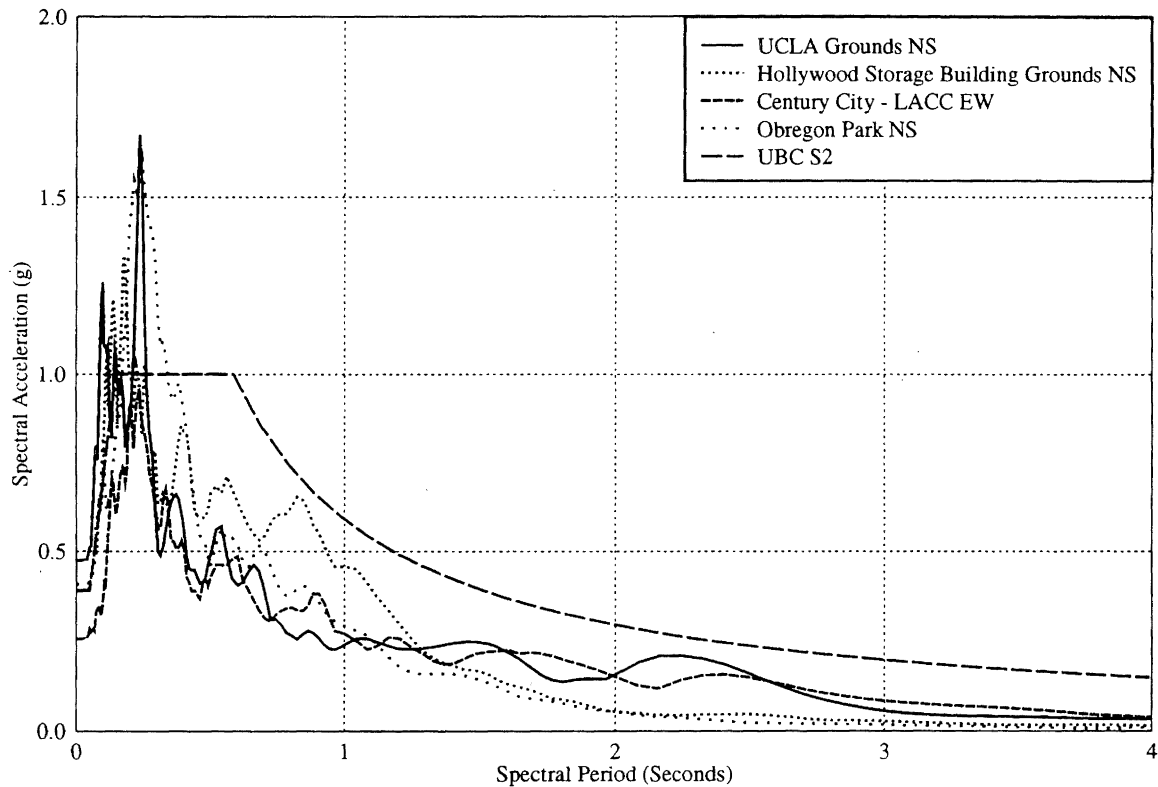
FIGURE 4.12. Spectra of the stronger components of records from the Los Angeles Basin, south of the Santa Monica Mountains. Note that they are peaked at short period, and lie below the code curve for periods greater than about 0.4s. The Northridge earthquake generally produced less than code-level motions south of the Santa Monica Mountains. (Plotted from CSMIP data).

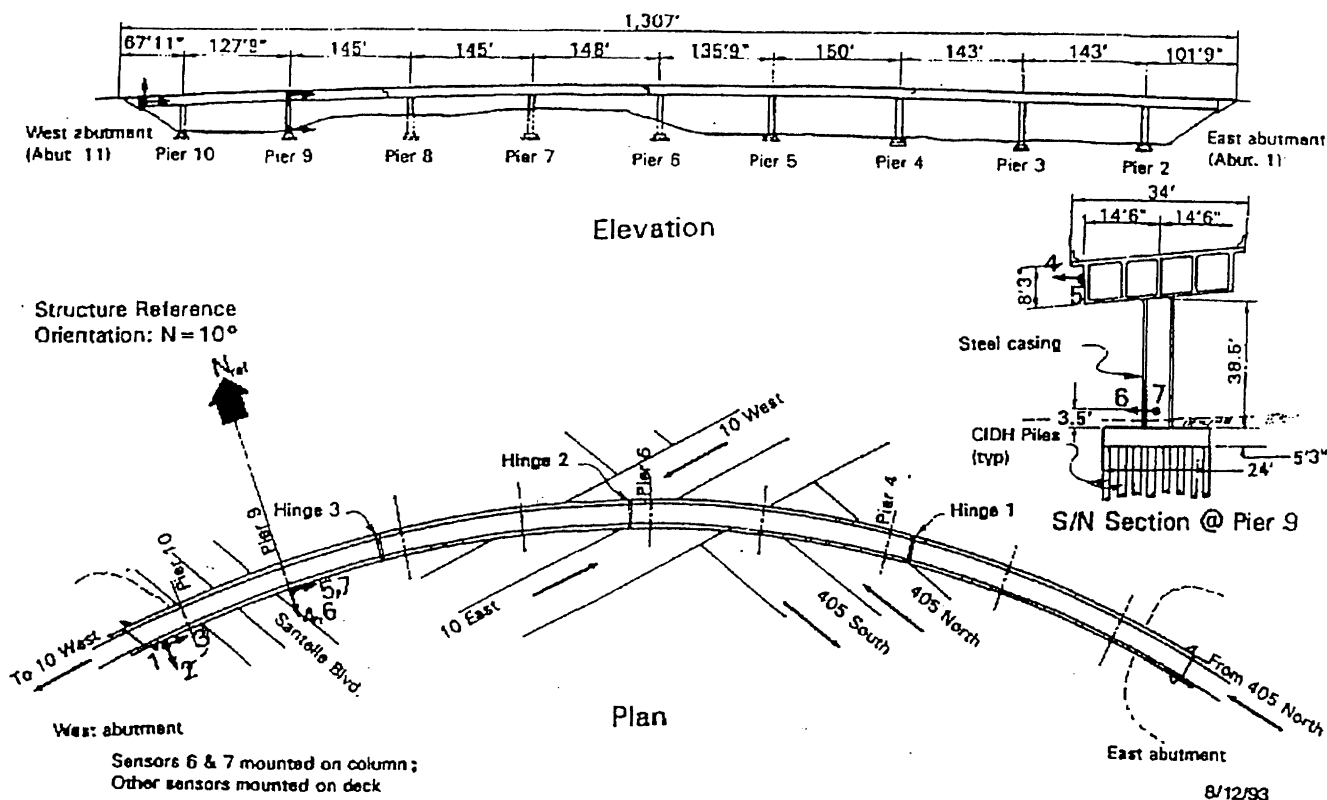
Los Angeles - I10/405 Interchange Bridge
(CSMIP Station 24670)

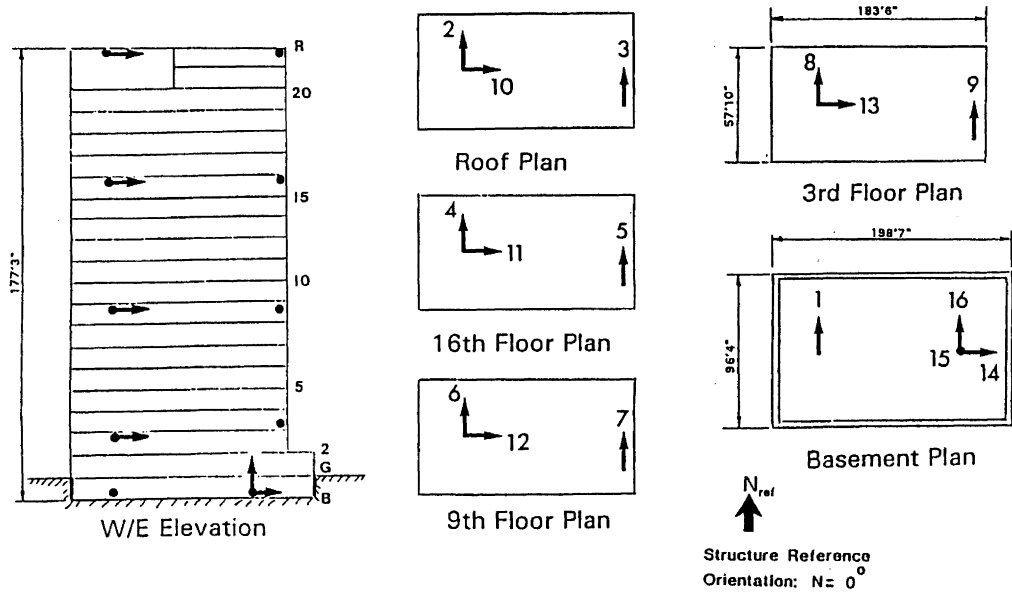
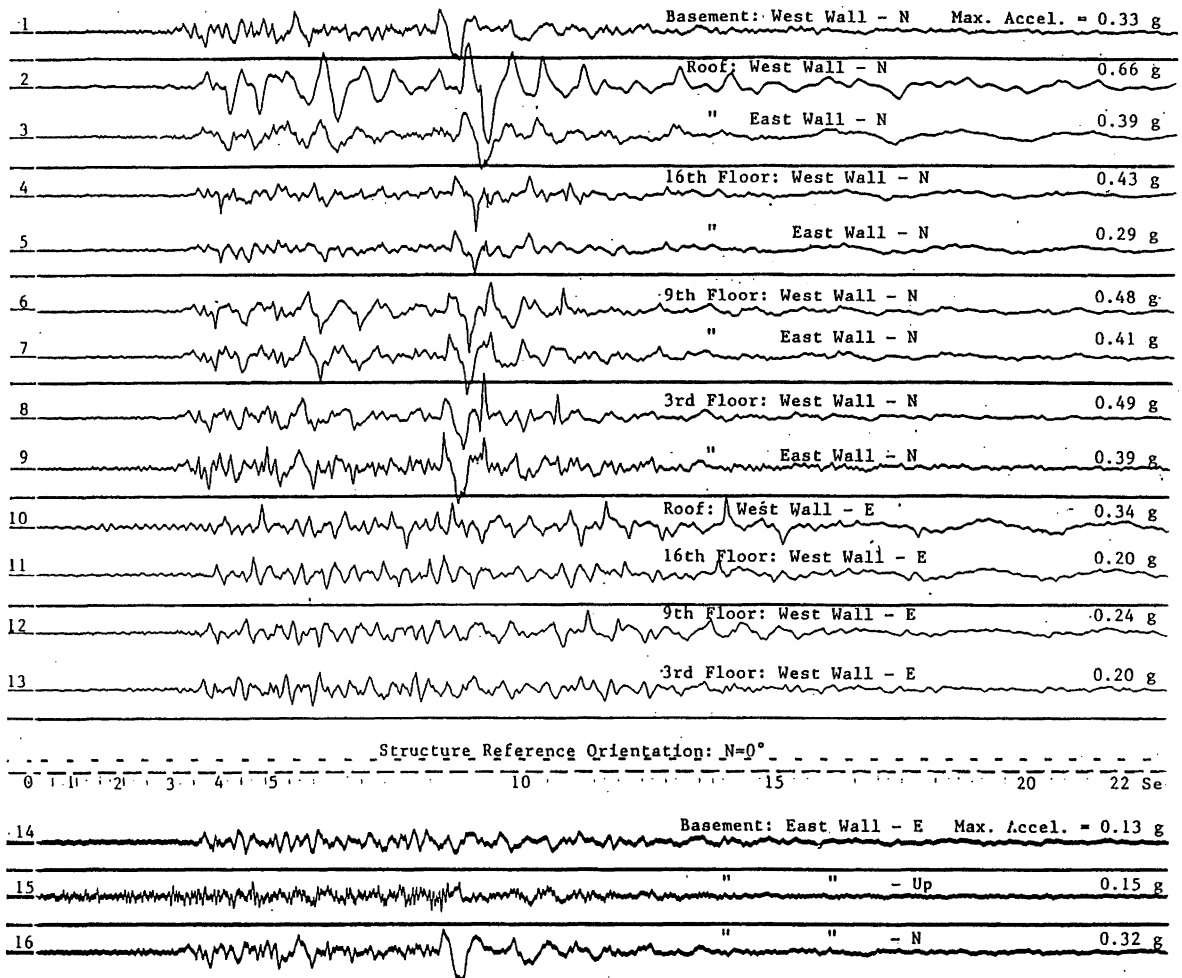
FIGURE 4.14. Basement and response records from the Sheraton-Universal Hotel (CSMIP). Note that the strong north-south pulse at 9 seconds after triggering in the basement record associated with the sub-event is propagated throughout the structure, with considerable amplification in the upper storeys. Also, the responses are stronger near the west wall than near the east wall, presumably because of torsional response. [From Shakal et al., 1994a].

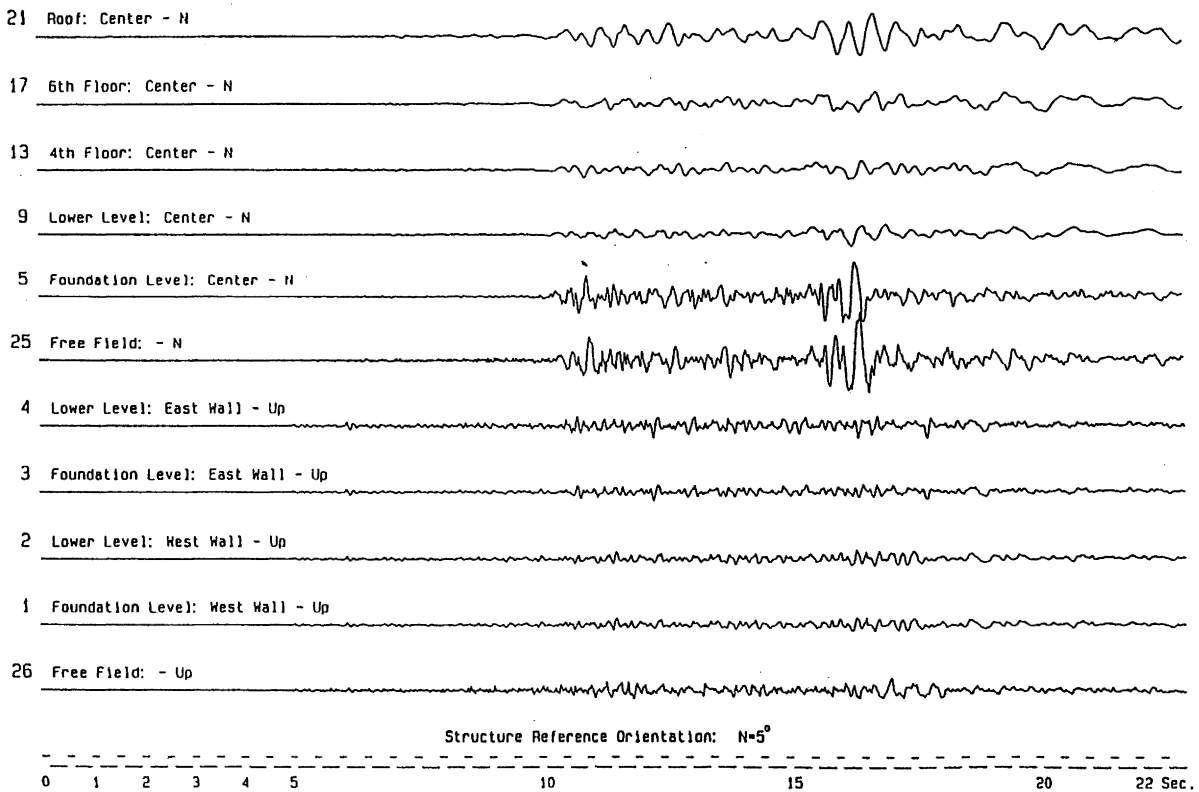
FIGURE 4.15. CSMIP records from the highly irregular base-isolated USC Hospital, showing the response to the strongest excitation recorded in a base-isolated structure. The records demonstrated that the isolation system functioned as expected, with a reduction of the basement acceleration from 0.37g to 0.13g across the isolator layer, with this level of response being maintained up the structure apart from amplification at the change of section in the top two levels. [From Shakal et al., 1994a].

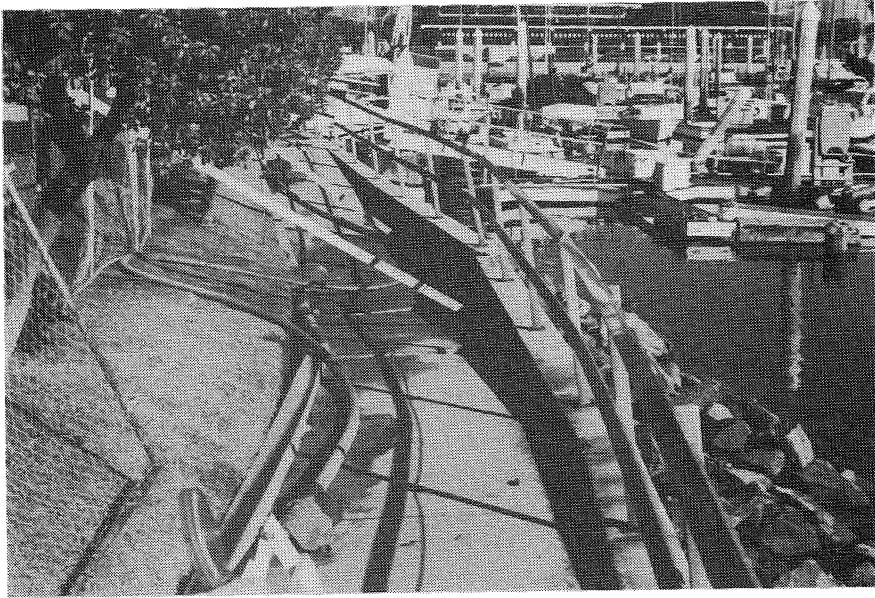
FIGURE 5.1. *Lateral spreading at Kings Harbour.*

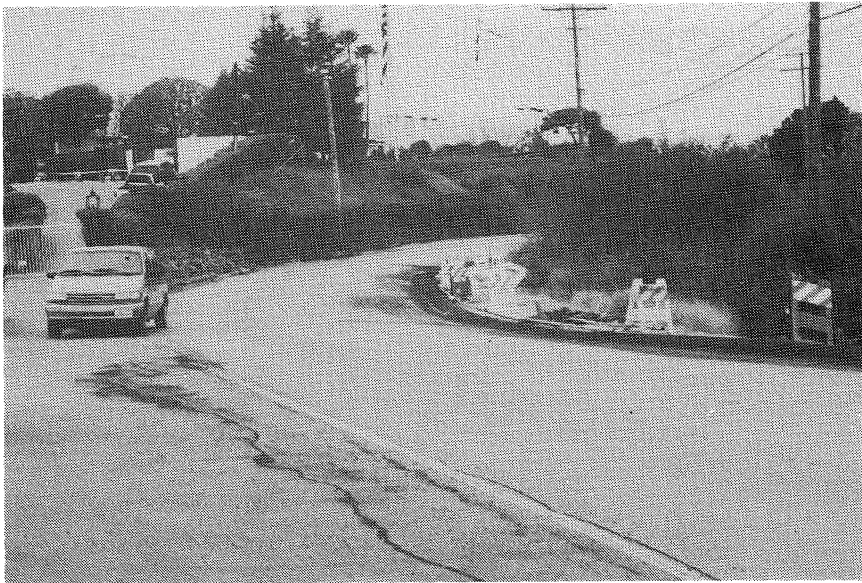
FIGURE 5.2. *Road surface cracking at a potential landslide at Mulholland Drive, Sherman Oaks.*

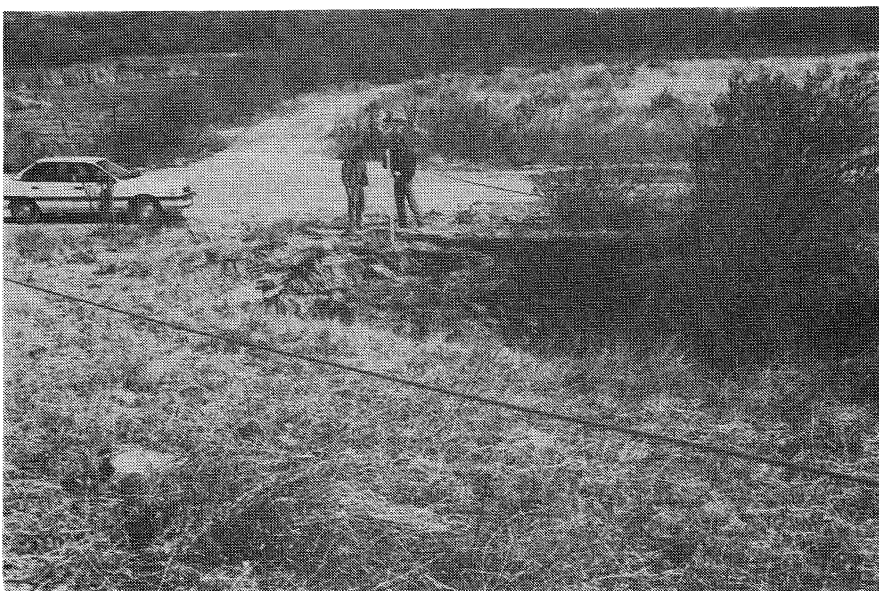
FIGURE 5.3. *Large sink hole at the Van Norman Reservoir Complex.*

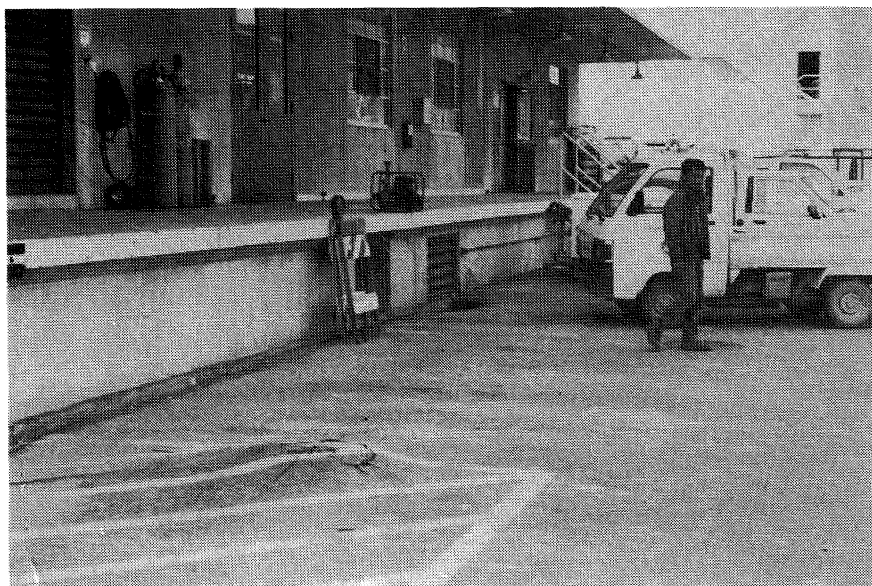
FIGURE 5.5. *Settlement adjacent to the control building, Jensen Filtration plant.*

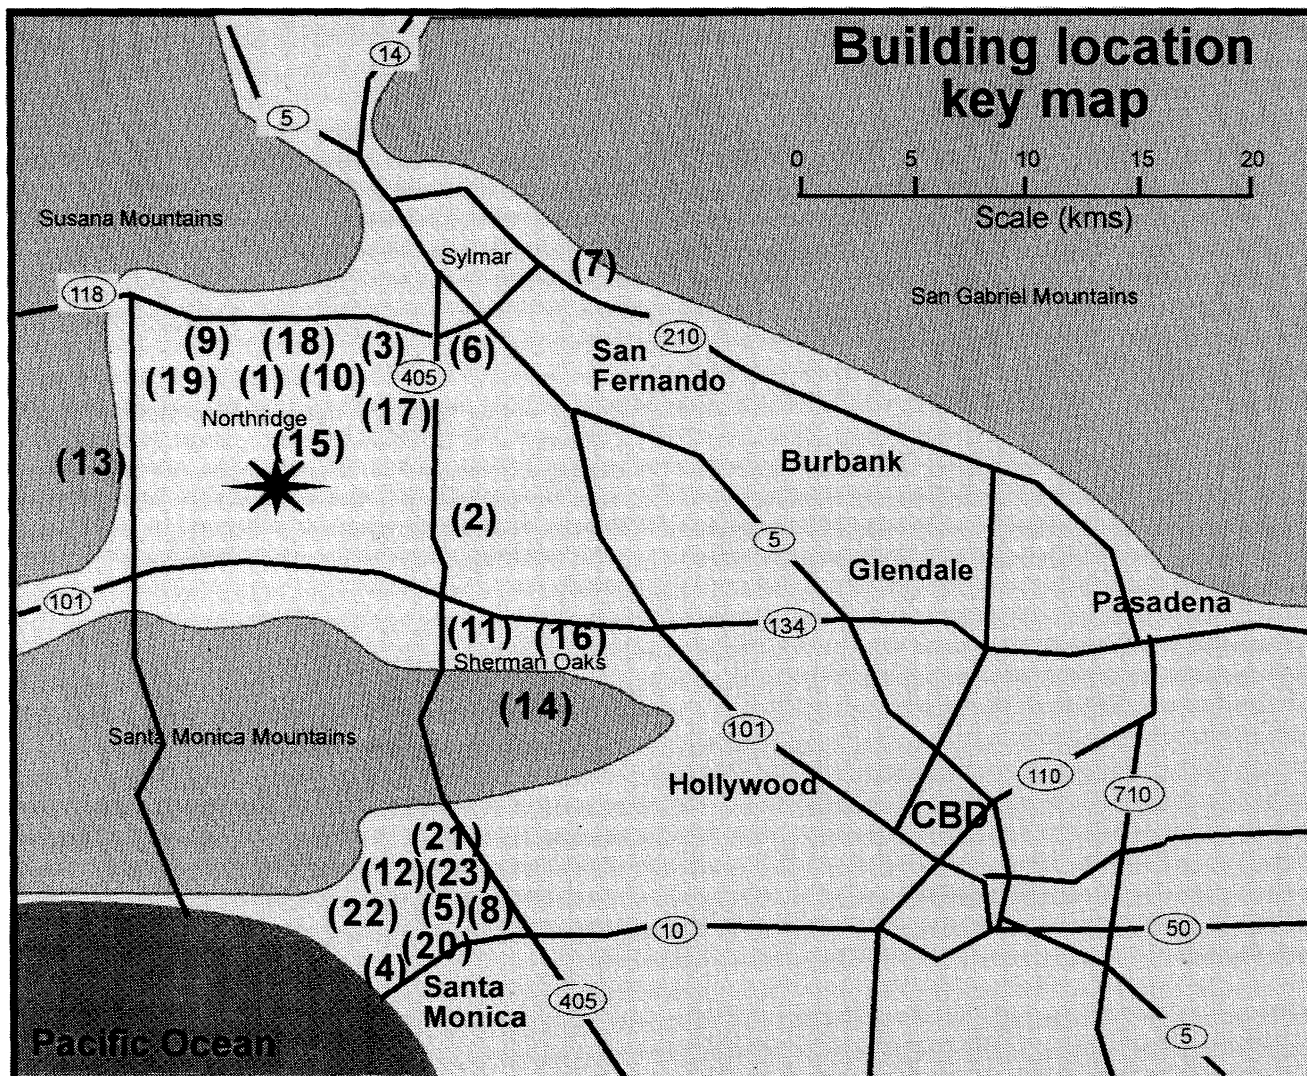
FIGURE 6.1. Key to the location of damaged structures described in the text.

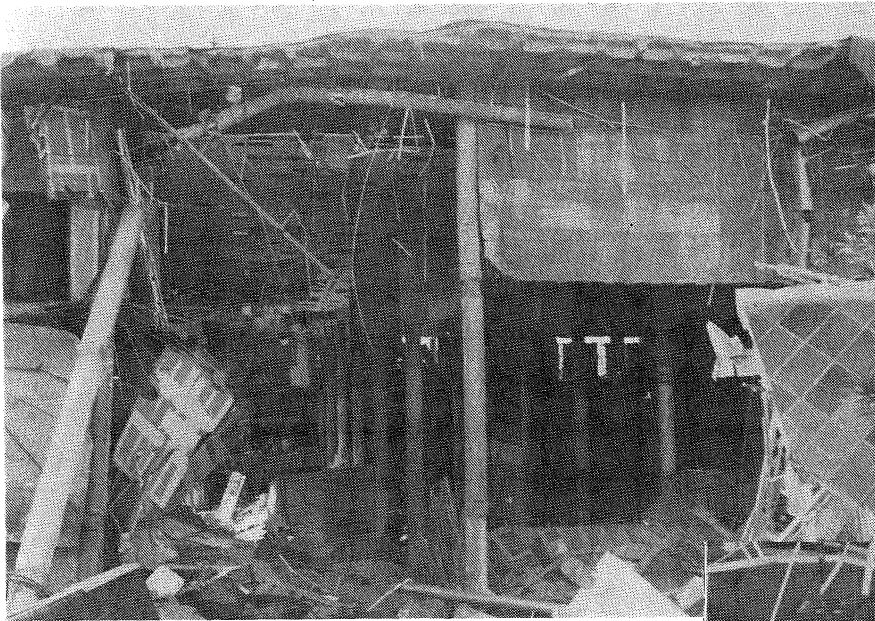
FIGURE 6.2. *Bullocks Department Store, Northridge. A forest of columns remains after the punching shear failure of all the floors. Note the waffle slab roof is still in place.*

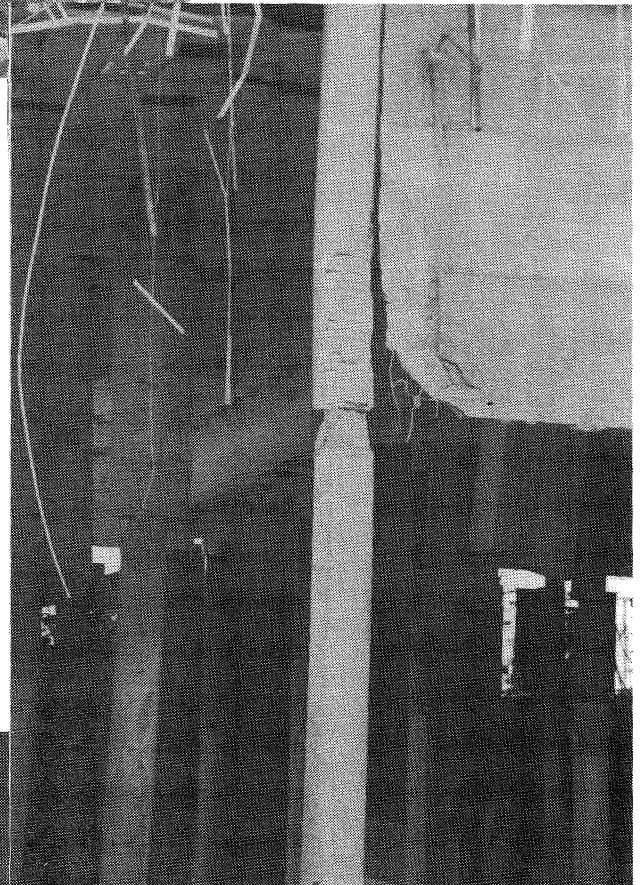
FIGURE 6.3. *Bullocks Department Store, Northridge. A closer view of the floor-to-column junction. No reinforcement or shear-heads were observed extending from the column to the floor slab.*

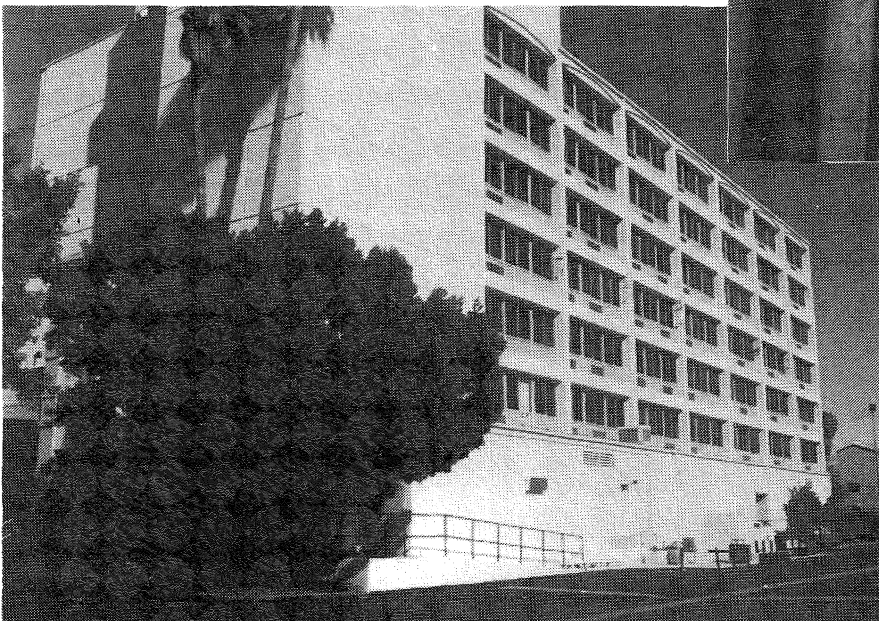
FIGURE 6.4. *Holiday Inn, Van Nuys. Looking from the south-west.*
