NORTHRIDGE EARTHQUAKE RECONNAISSANCE REPORT

Report of the NZNSEE Reconnaissance Team on the
17 January 1994 Northridge, Los Angeles Earthquake

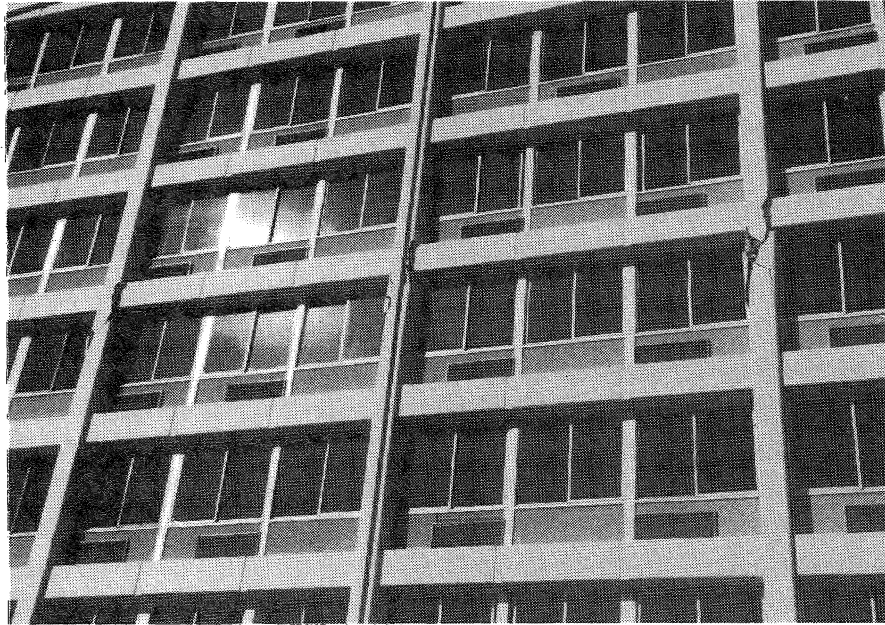
FIGURE 6.6. *Holiday Inn, Van Nuys. South side, showing damage zones at Level 4.*

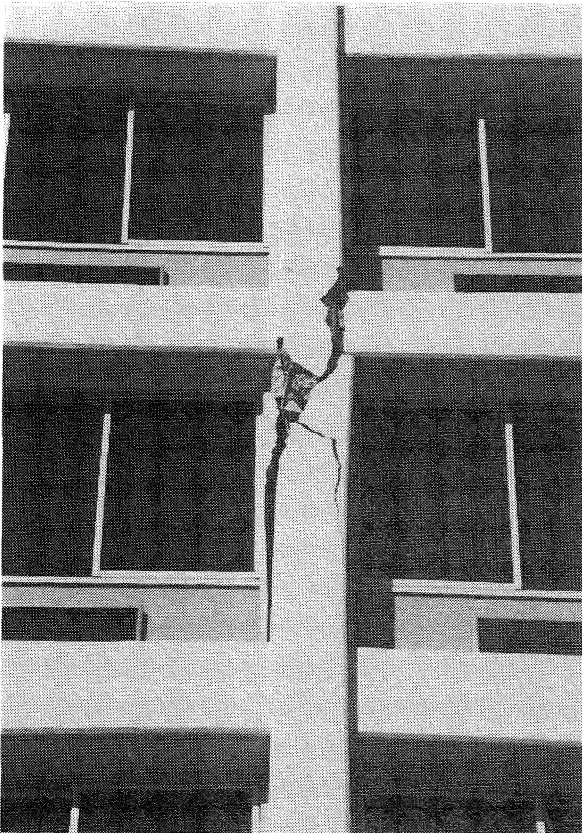
FIGURE 6.7. *Holiday Inn, Van Nuys. Close-up of the damage zones at Level 4, south side.*

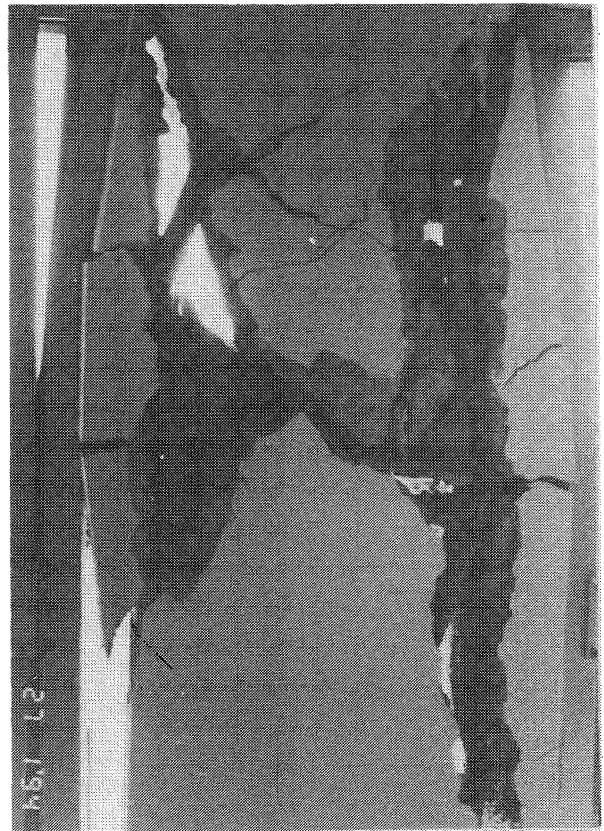
FIGURE 6.8. *Holiday Inn, Van Nuys. Interior view of a damaged column as seen from Level 3.*

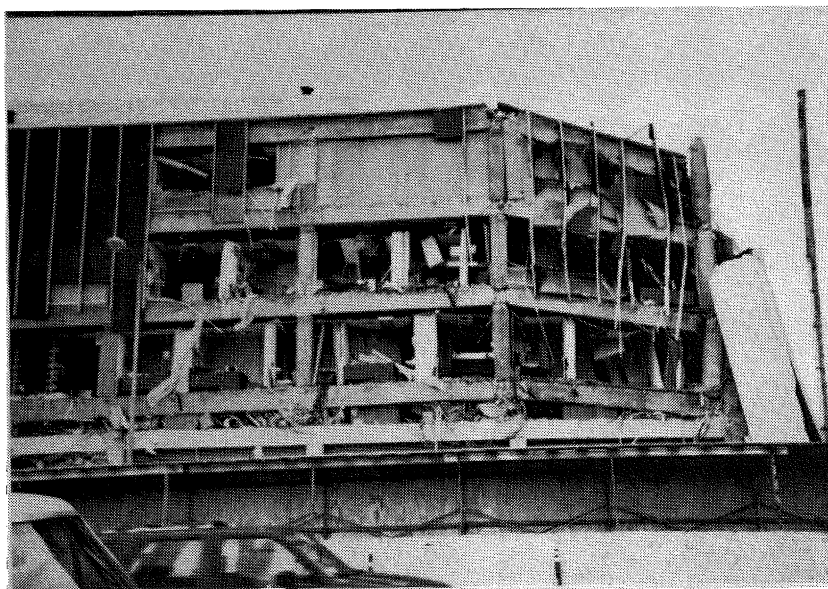
FIGURE 6.9. *Kaiser Permanente, Northridge. View of long elevation of the building.*

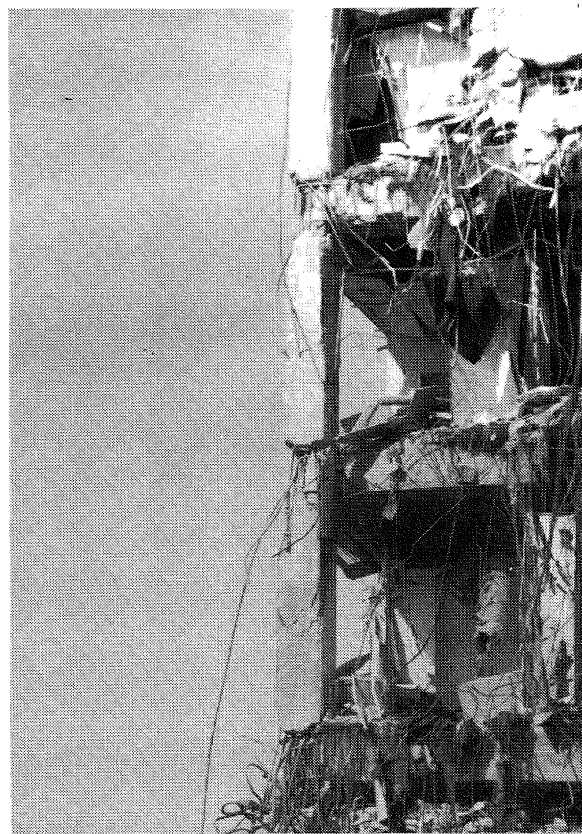
FIGURE 6.10. *Kaiser Permanente, Northridge. Completely destroyed columns of Level 2 and damaged beam-column joints above.*

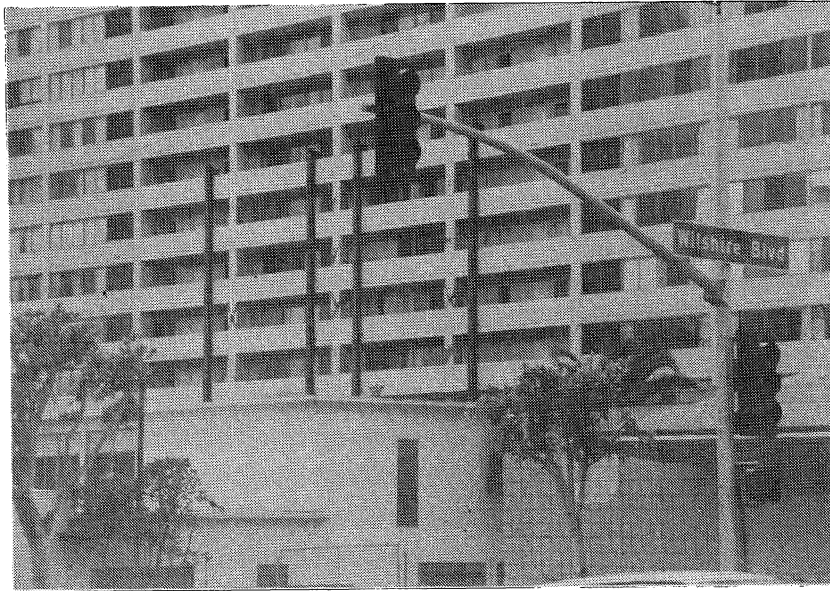
FIGURE 6.11. Champaign Tower, Santa Monica. View of east elevation of the building. Note: the extensive damage to the columns of this face.

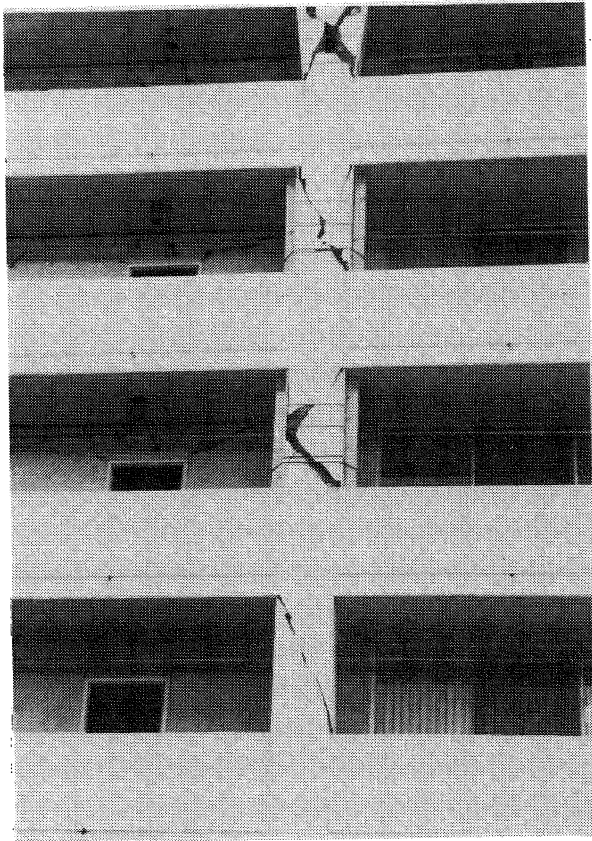
FIGURE 6.12. Champaign Tower, Santa Monica. Close view of the failed columns.

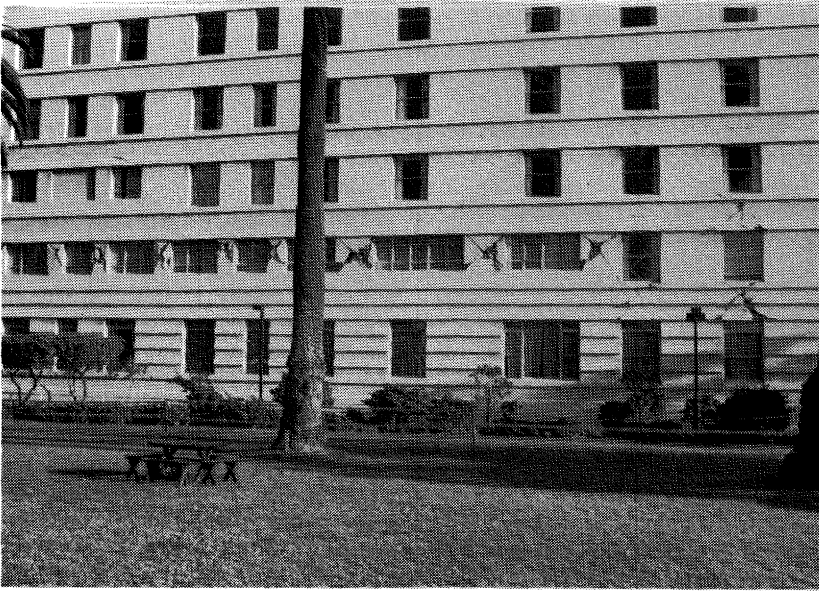
FIGURE 6.13. *St Johns Hospital, Santa Monica. Elevation of the North Wing. Note: the damage to the second floor piers.*

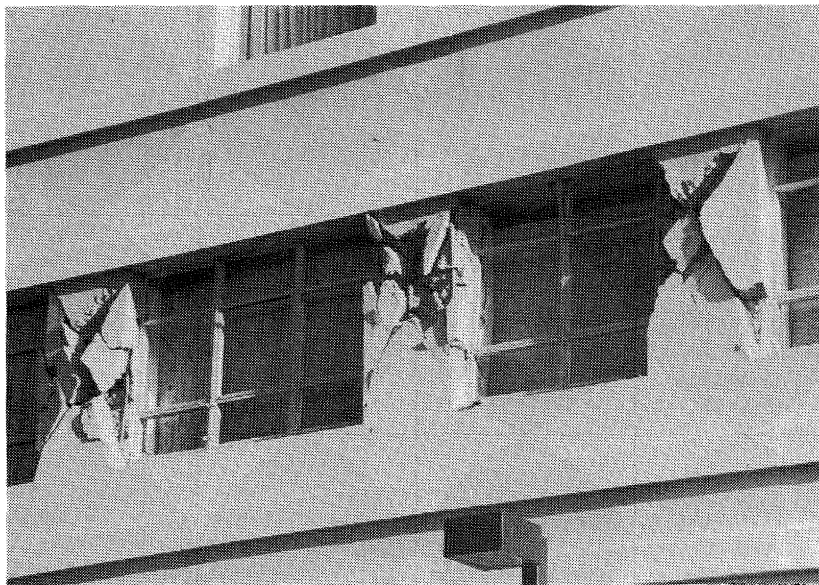
FIGURE 6.14. *St Johns Hospital, Santa Monica. Close view of the failed piers (second floor, North Wing).*

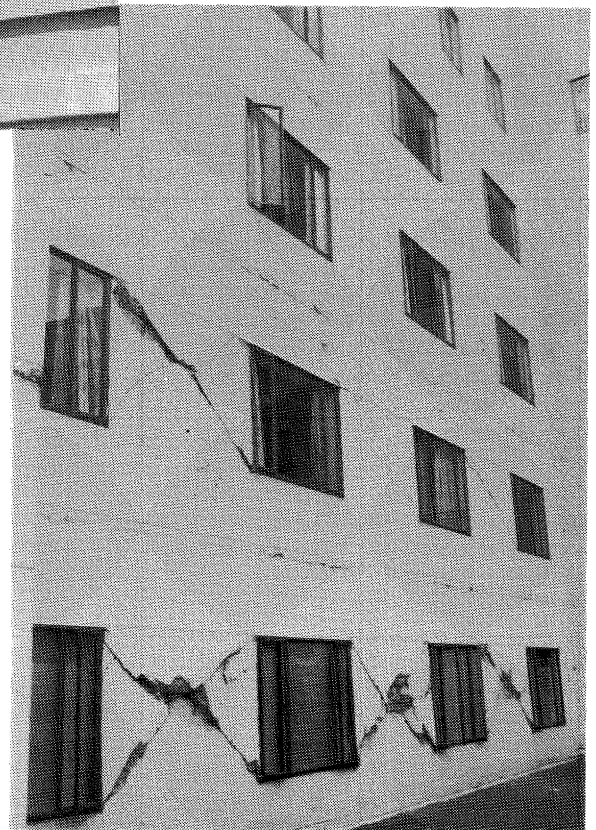
FIGURE 6.15. *St Johns Hospital, Santa Monica. Elevation of the north-east side of the South Wing.*

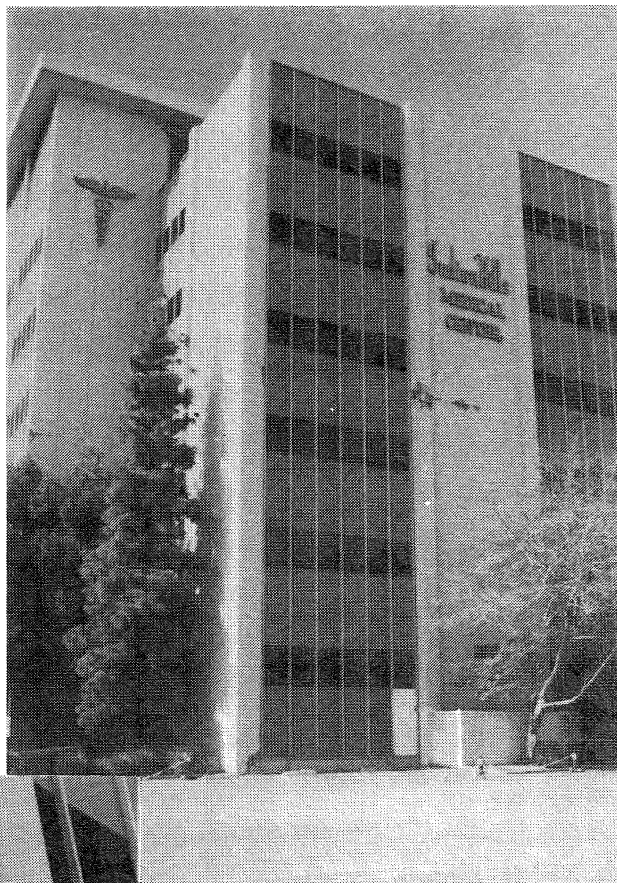
FIGURE 6.16. Indian Hills Medical Center. South Western Elevation.

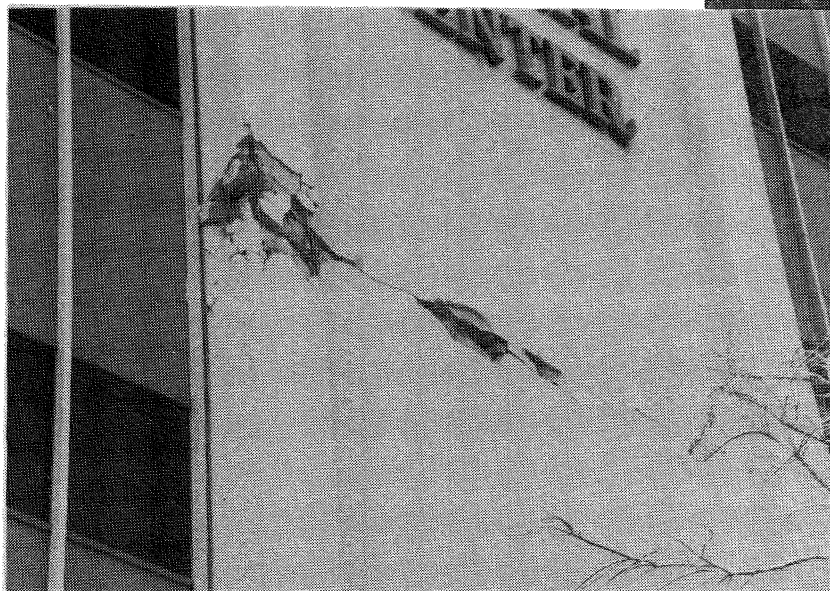
FIGURE 6.17. Indian Hills Medical Center. Failed lap splice in the end zone of the east wall and horizontal construction joint damage.

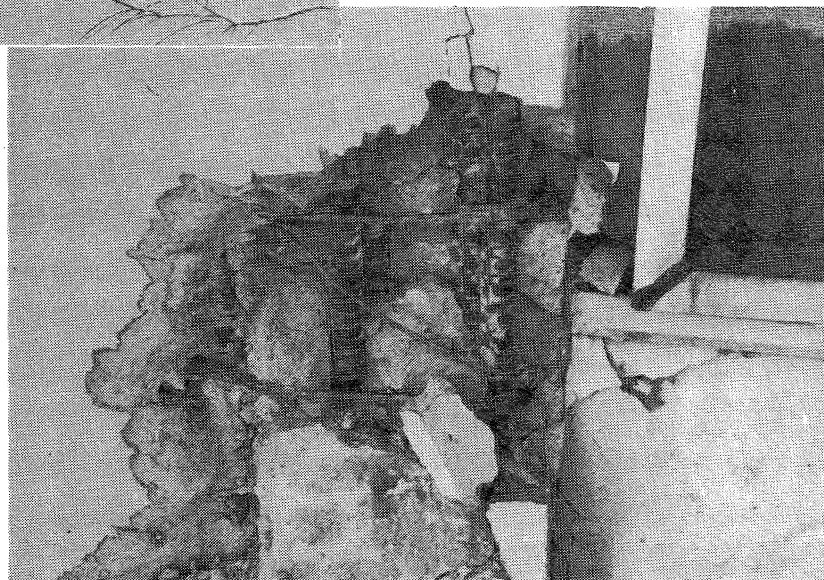
FIGURE 6.18. Indian Hills Medical Center. Close-up of failed lap splice, at the base, in the end zone of the east wall.

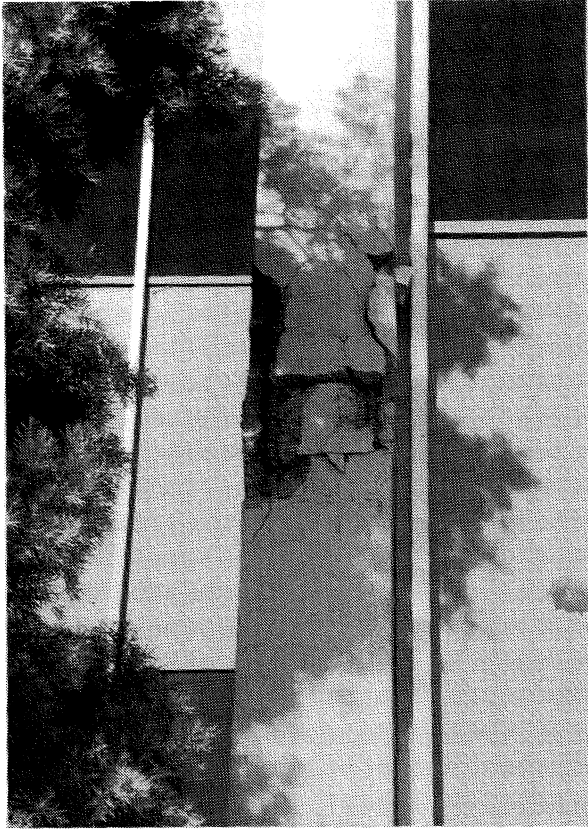
FIGURE 6.19. *Indian Hills Medical Center. Failed lap splice in the end zone of south-west wall.*

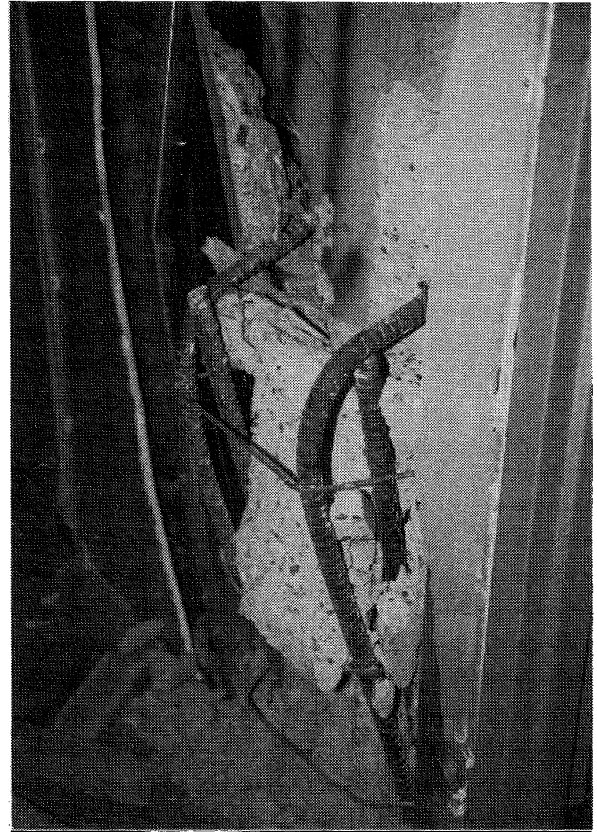
FIGURE 6.20. *Indian Hills Medical Center. Failed lap splice at the base of an interior column.*

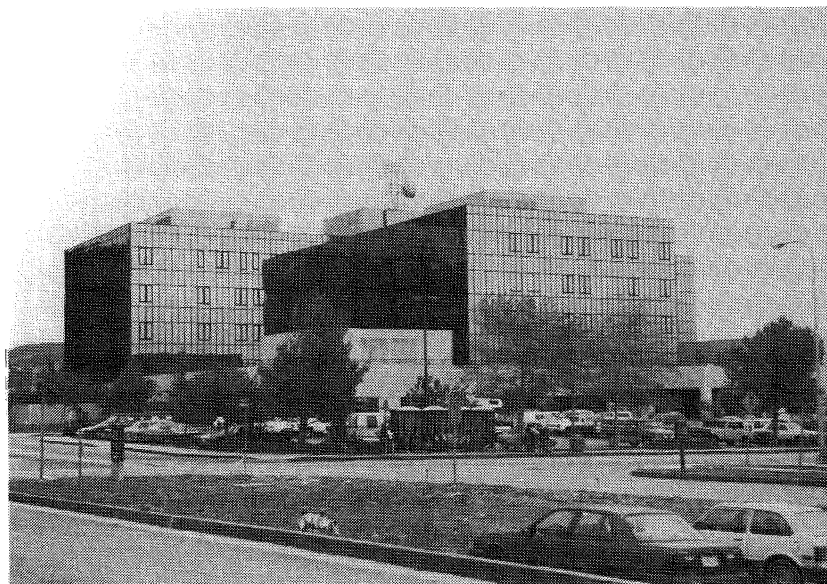
FIGURE 6.21. *Olive View Hospital (i.e. County Hospital at Sylmar).*

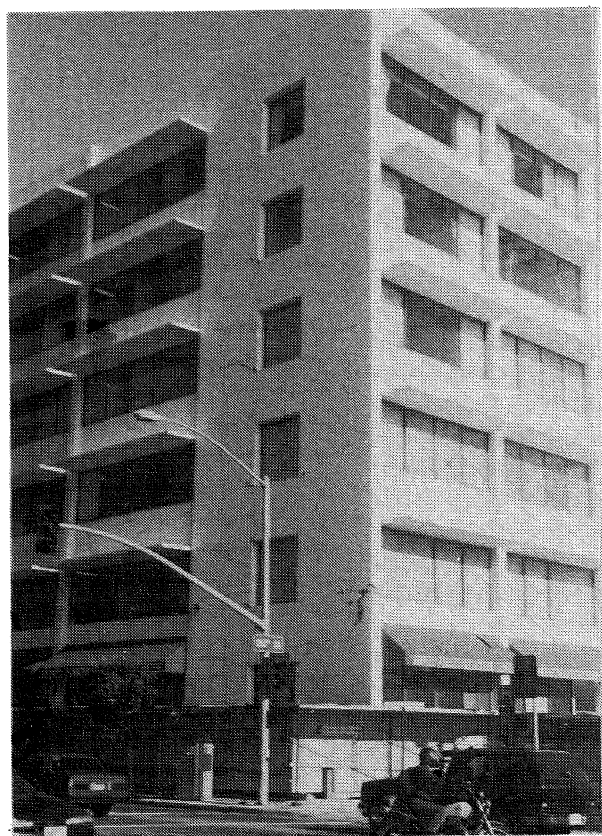
FIGURE 6.22. 2020 Santa Monica Boulevard.

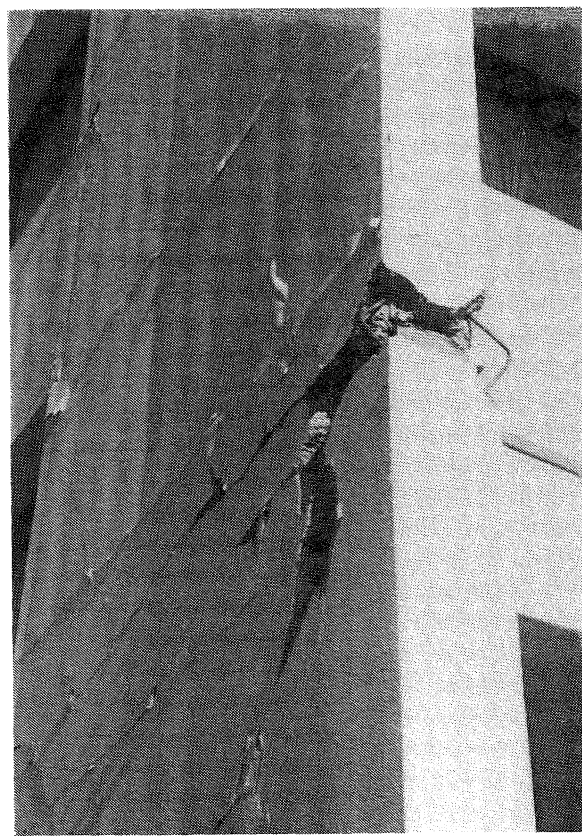
FIGURE 6.23. 2020 Santa Monica Boulevard. Close up of spalled end zone of the north west wall.

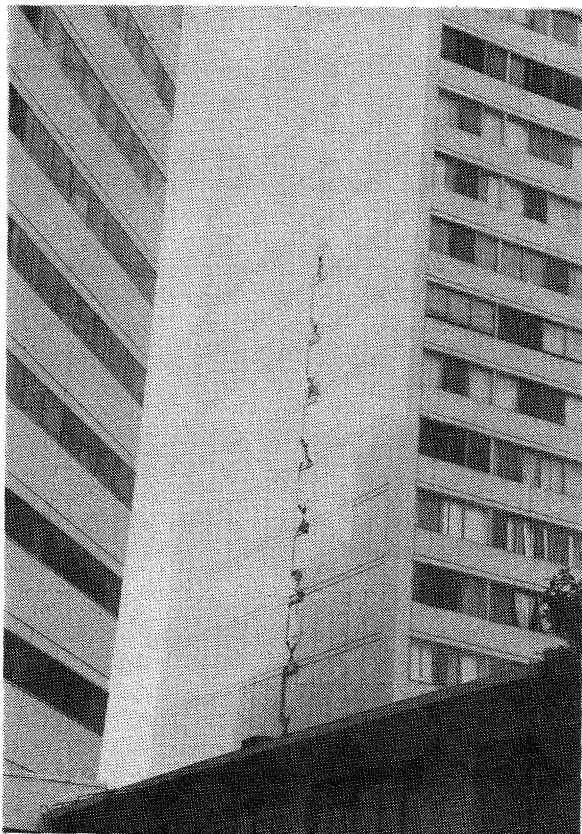
FIGURE 6.24. *Champaign Tower, Santa Monica. South coupled wall.*

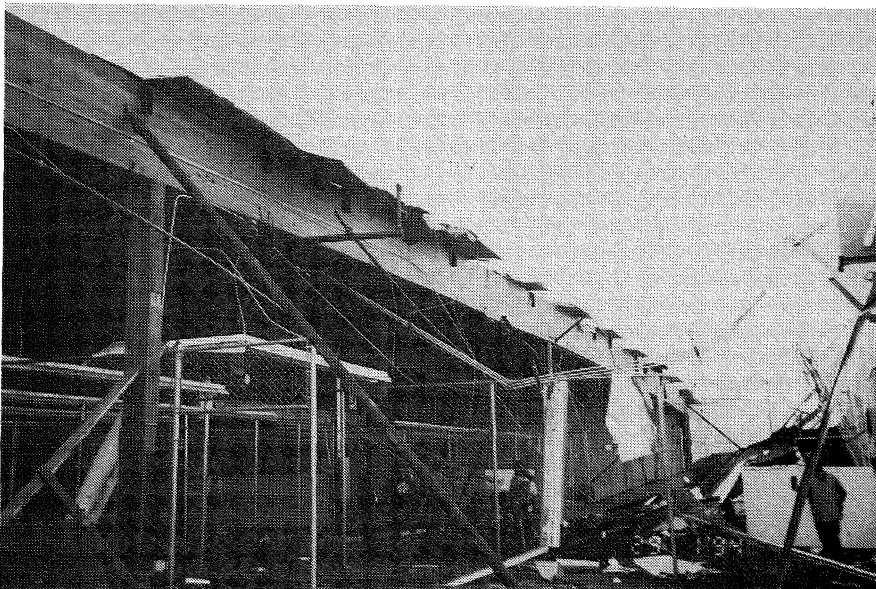
FIGURE 6.28. *De Soto Drive Warehouses. Glulam portals with rafter hangers and ties prevented spread at one end only.*

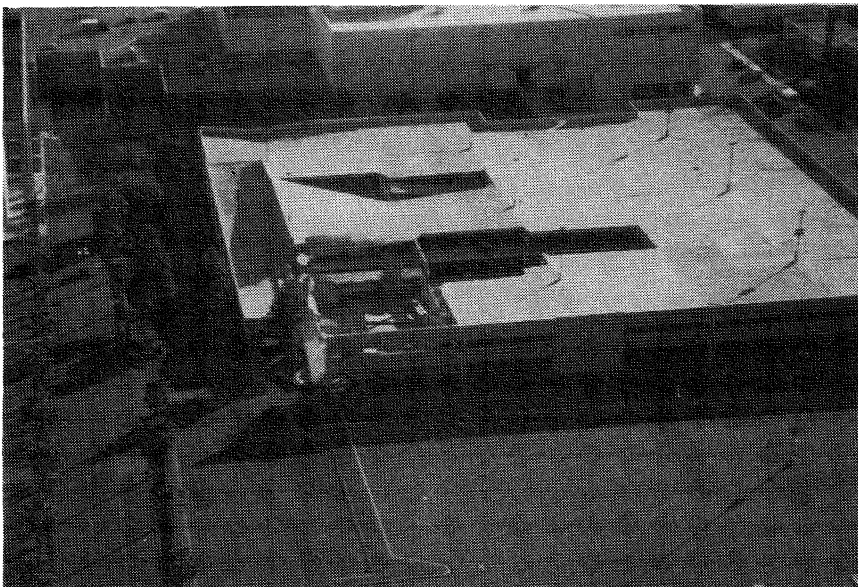
FIGURE 6.29. Sections of precast slab collapsed, in this car park, due to loss of seating because supporting columns of the interior gravity frame failed.

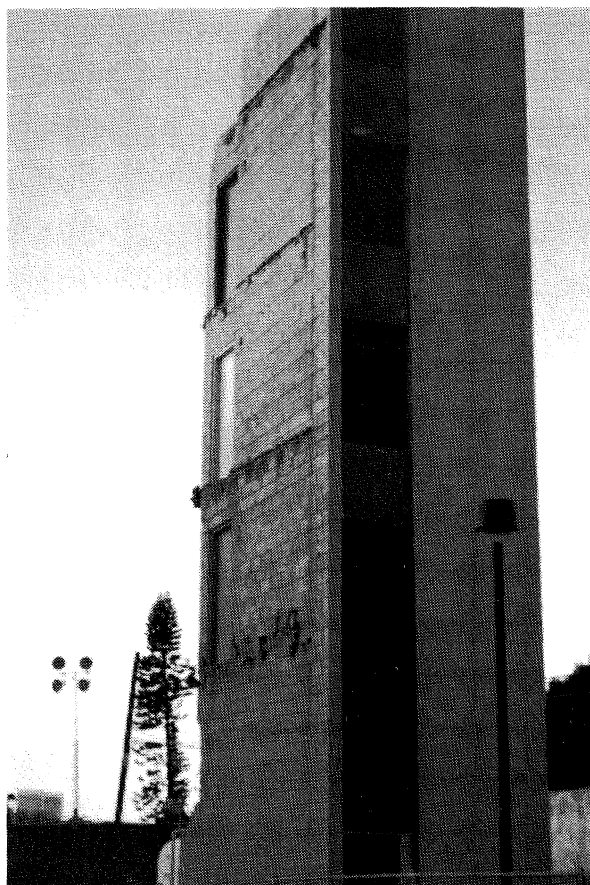
FIGURE 6.30. Car park access tower remains while the building has collapsed.

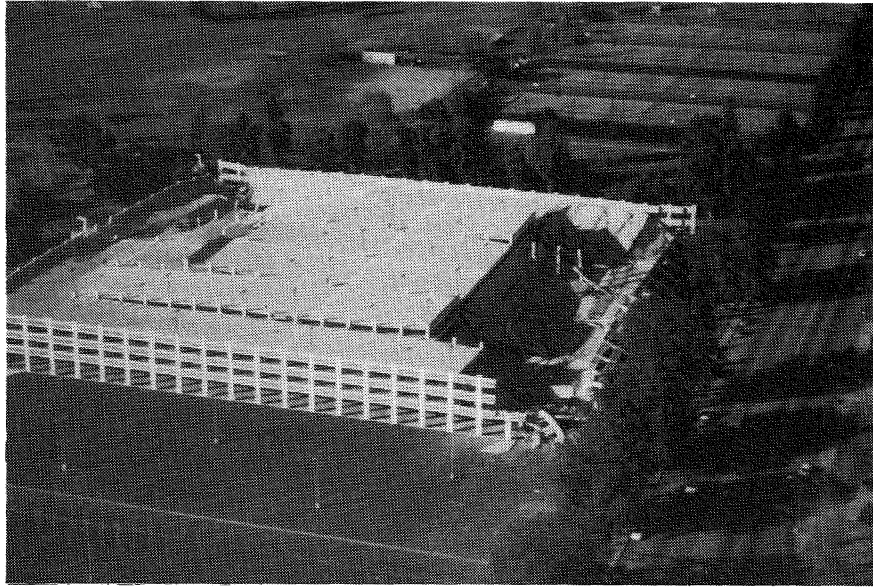
FIGURE 6.31. California State University Car Park. Aerial View showing eastern and N/W corner collapse.

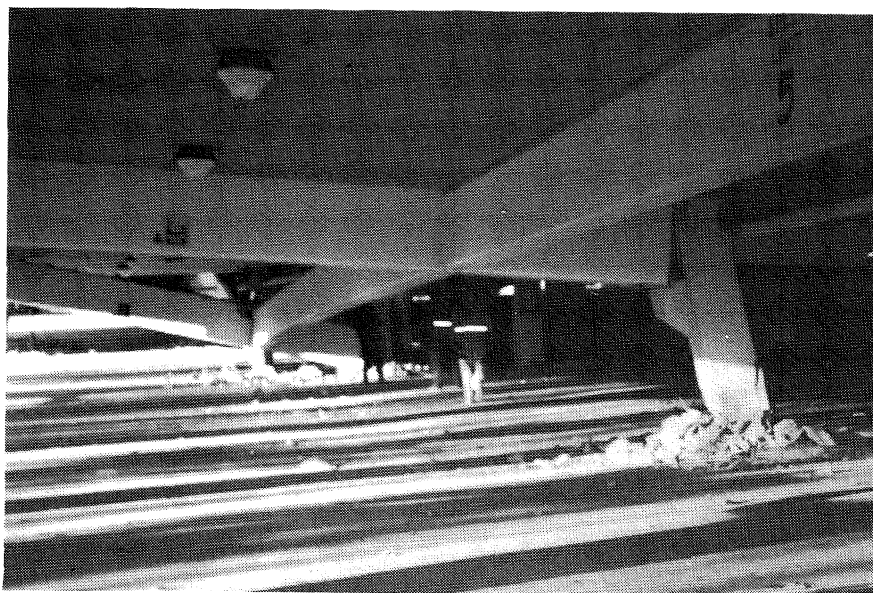
FIGURE 6.35. California State University Car Park. Internal Column Base Failures with beams slipping from their supporting corbels.

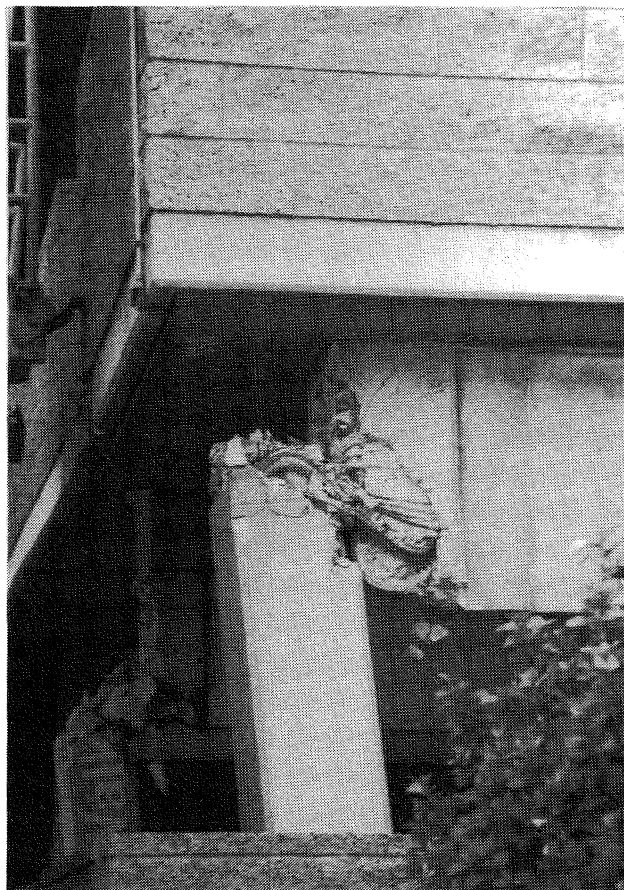
FIGURE 6.36. Sherman Oaks Galleria Car Park (south). Exterior column at ground level.

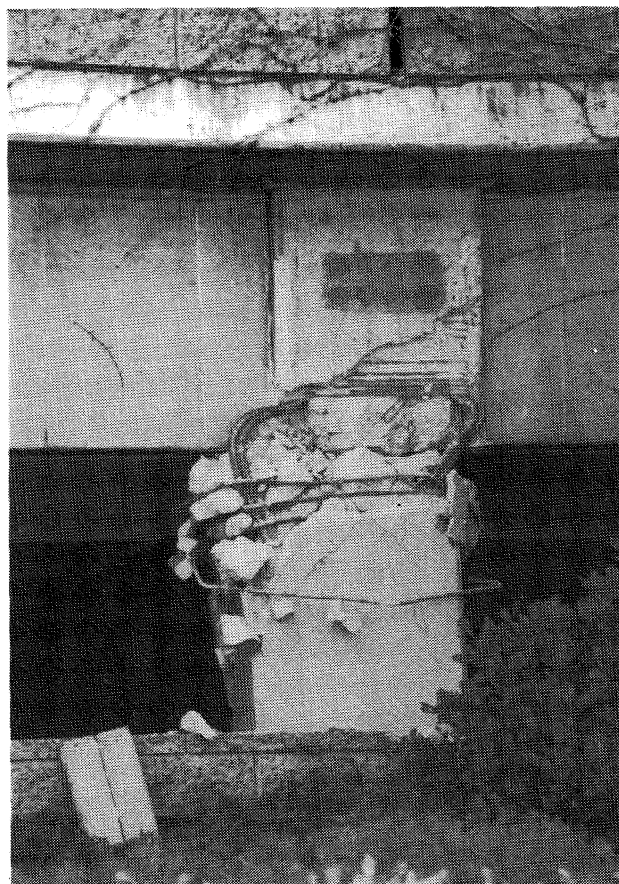
FIGURE 6.37. Sherman Oaks Galleria Car Park (south). Perimeter column at ground level.

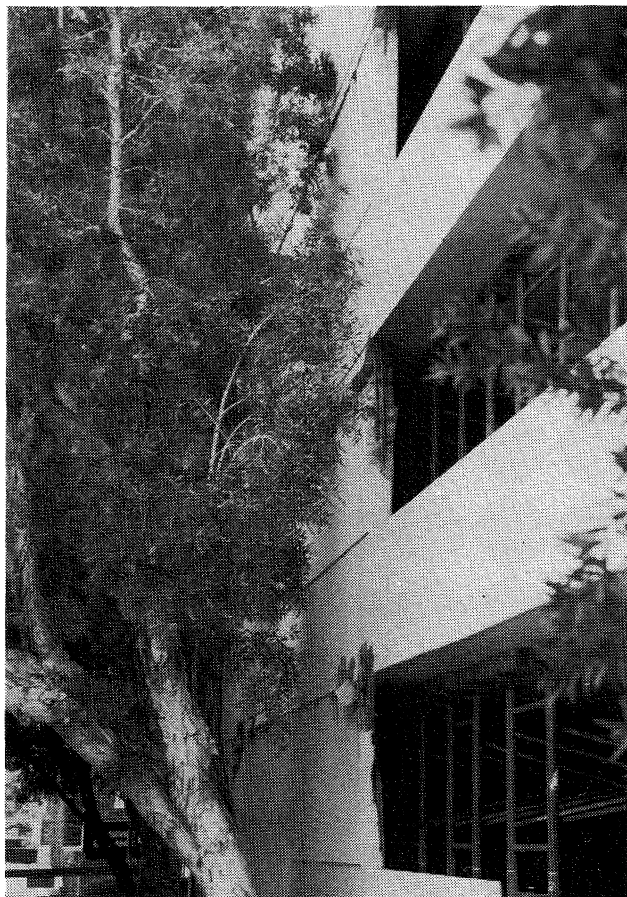
FIGURE 6.38. *St Johns Hospital, Santa Monica. Car Park (west). View of the northern end. Note the damage to the shear walls (3 levels).*

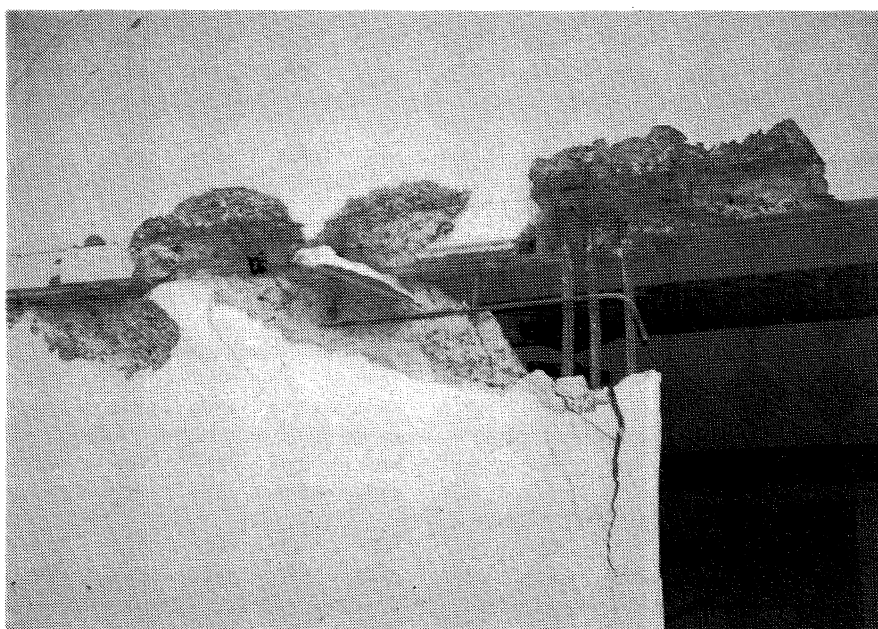
FIGURE 6.39. *St Johns Hospital, Santa Monica. Car Park (west). Close up of the end region of the lowest wall.*

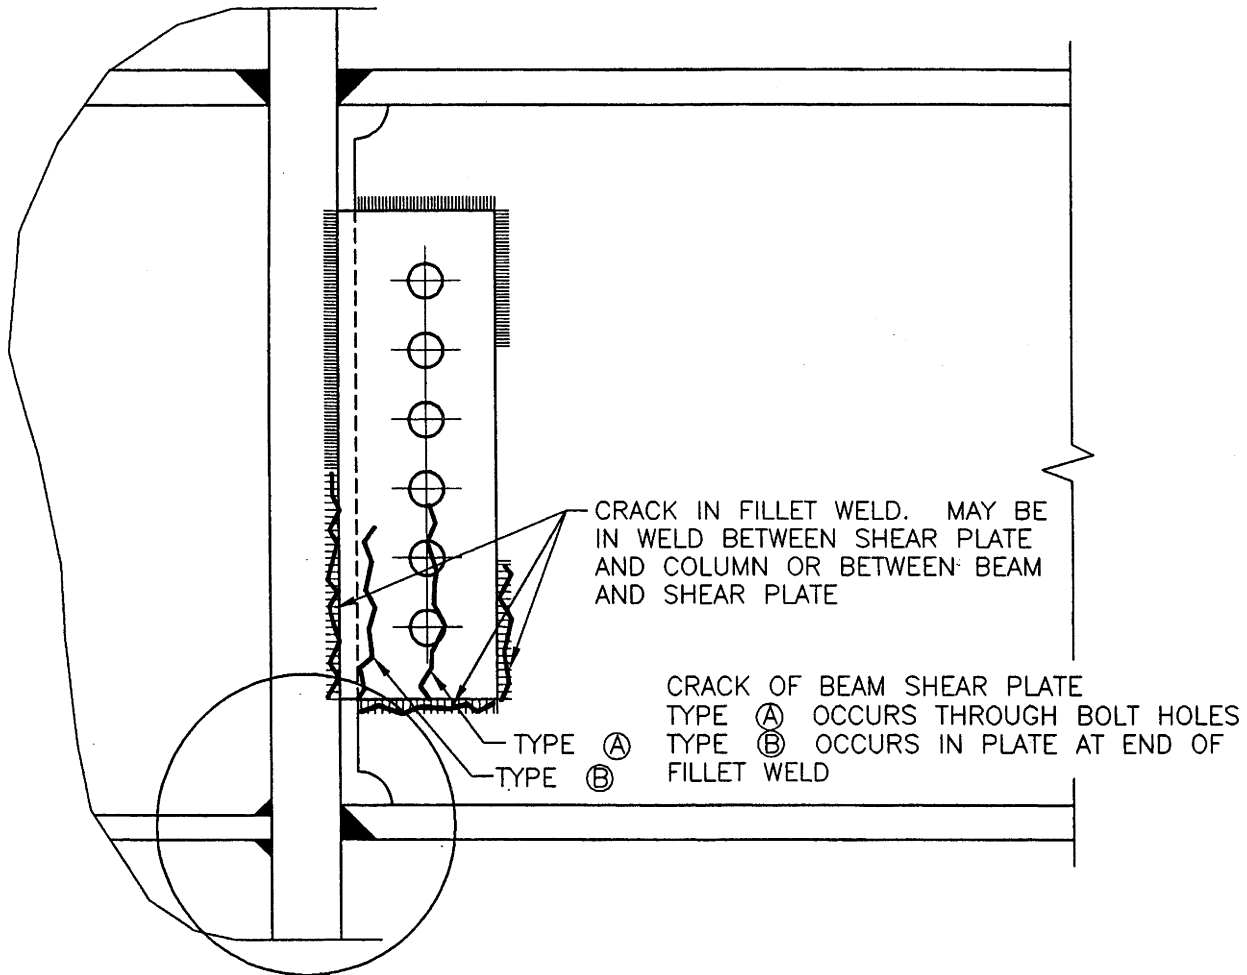
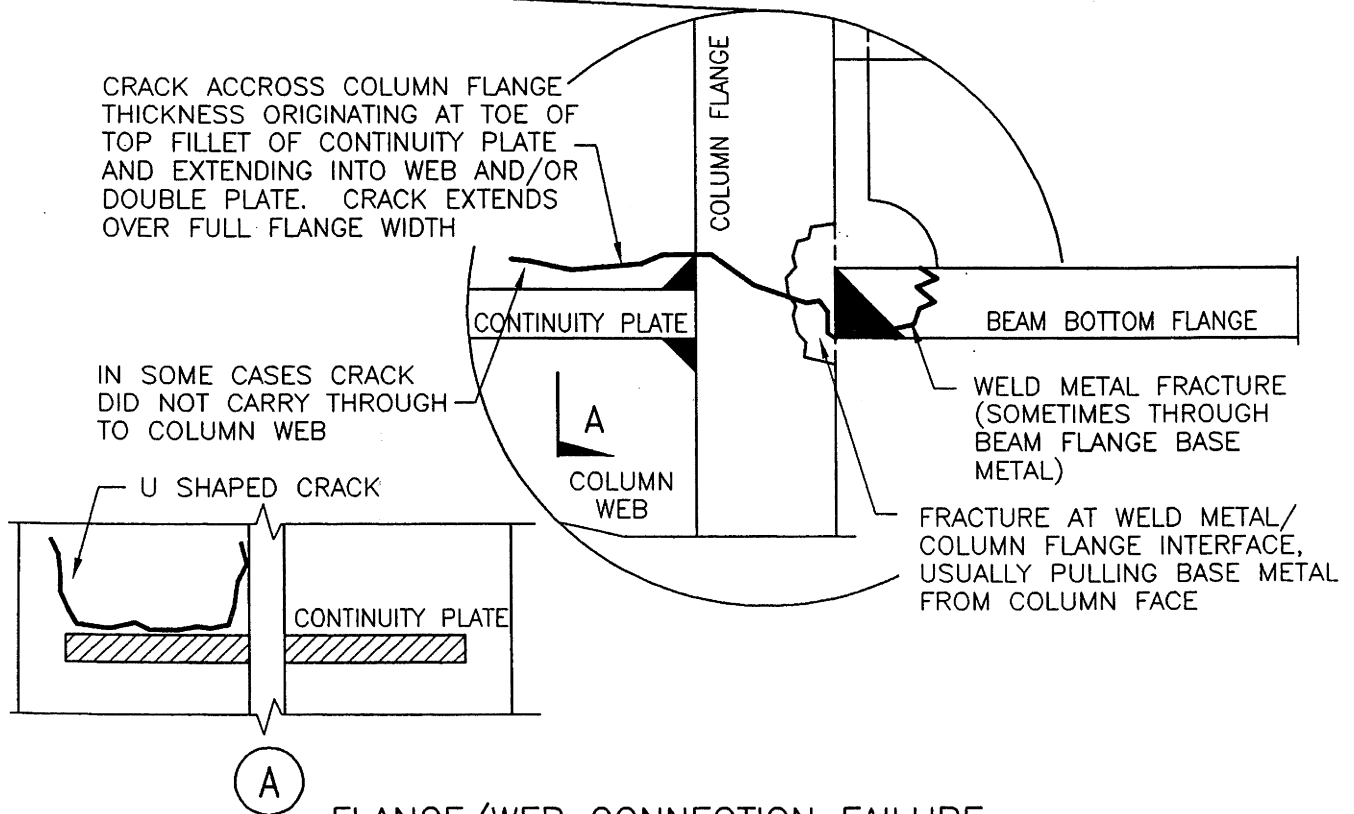
FLANGE/WEB CONNECTION FAILURE
 NOT TO SCALE

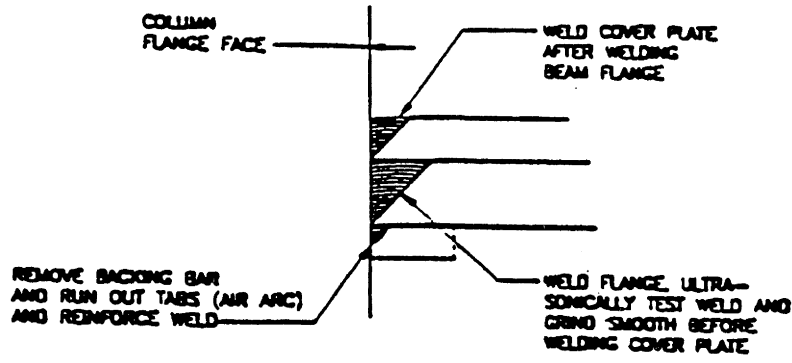
FIGURE 6.40. Typical flange/web connection failure.

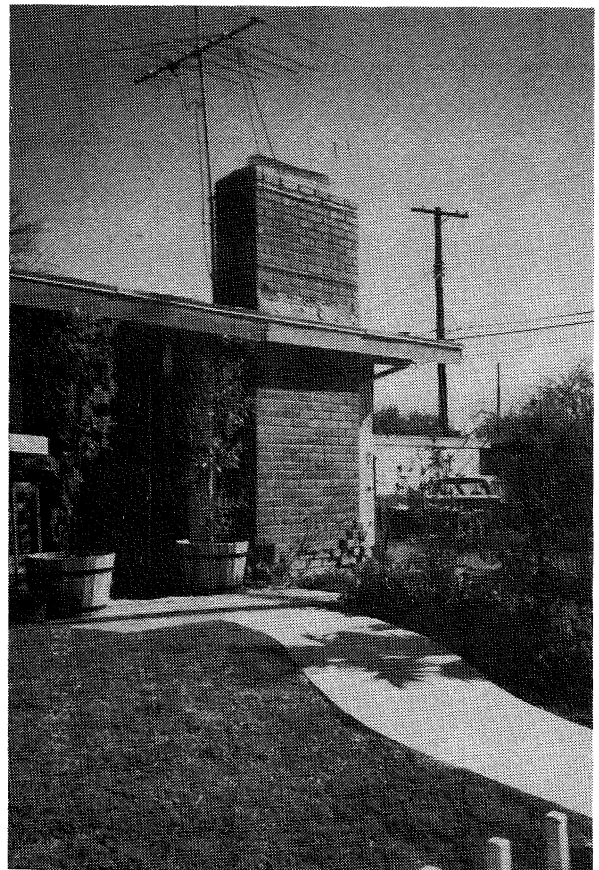
FIGURE 6.43 Masonry chimneys were commonly damaged either at their breast or foundation (13).

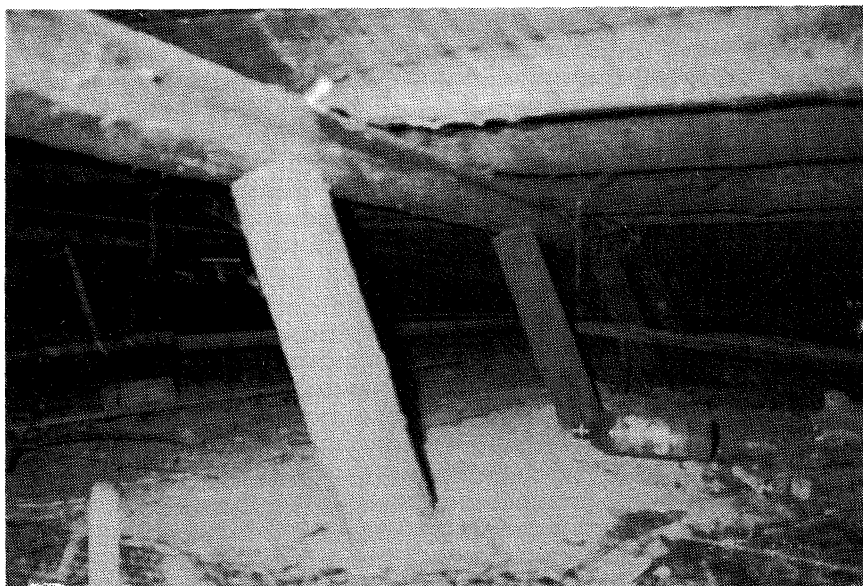
FIGURE 6.44. *Unbraced pile collapse through sideways.*

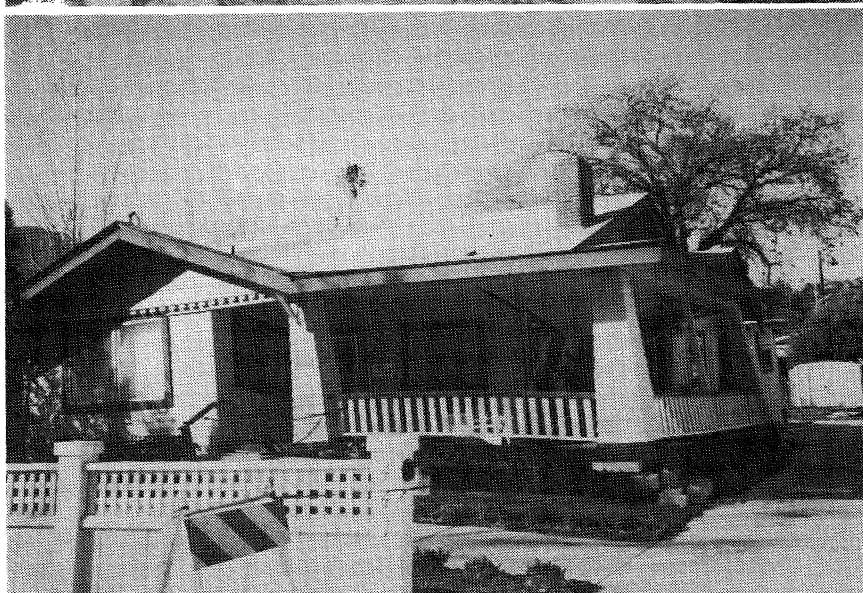
FIGURE 6.45. *Short piles without bracing were not common but performed poorly at Fillmore (25 miles north west of epicentre).*

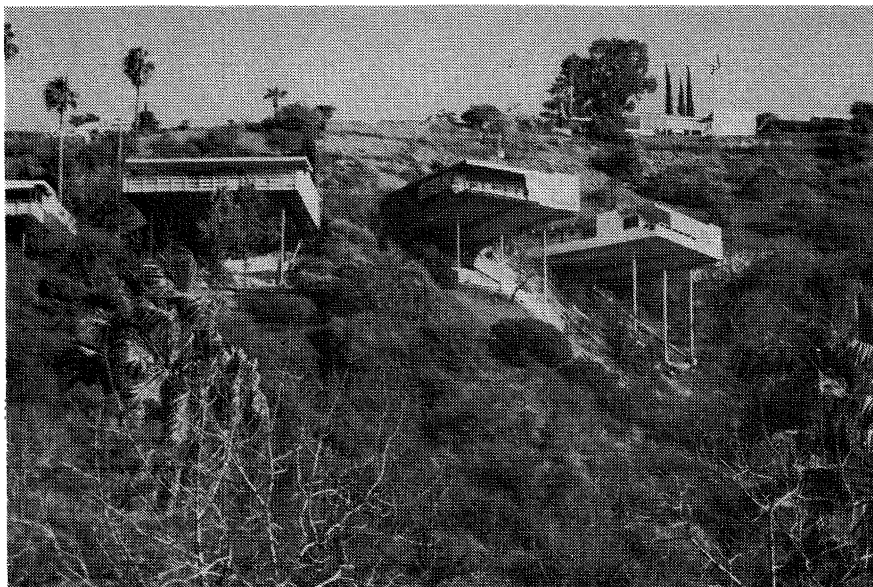
FIGURE 6.47. *Sherman Oaks House separated from Ribbon Plate and collapsed down slope.*

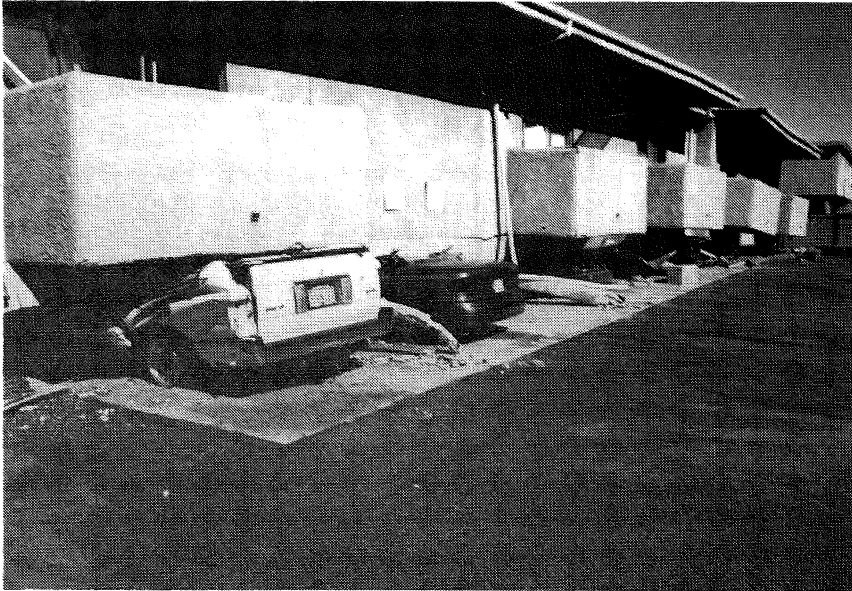
FIGURE 6.48. Dingbat collapse with stucco covered steel pipe columns (15).

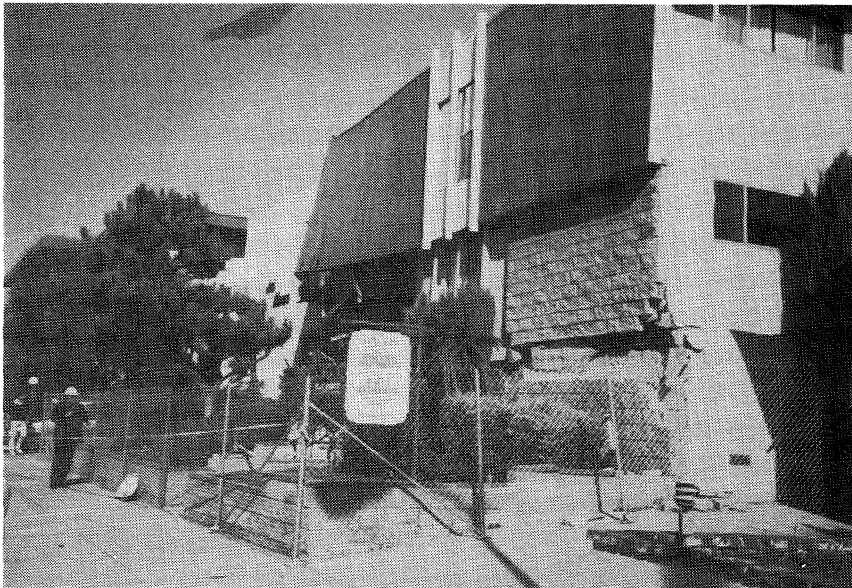
FIGURE 6.49. Apartment block partial collapse over garage while remaining section stands although stucco is severely damaged, being torn at the entrance-way (16).

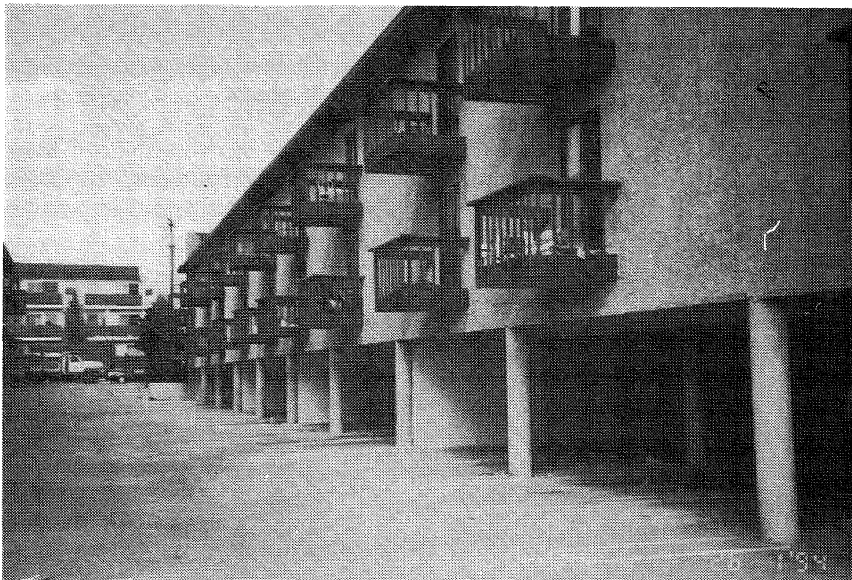
FIGURE 6.50. Concrete support columns damaged but survived (17).

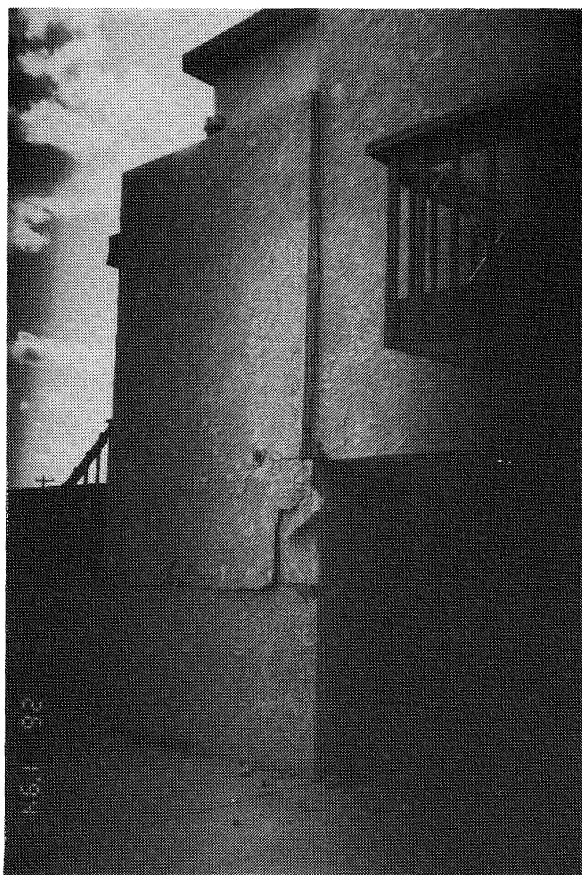
FIGURE 6.51. End wall of same apartment severely damaged stucco 'shear wall' .

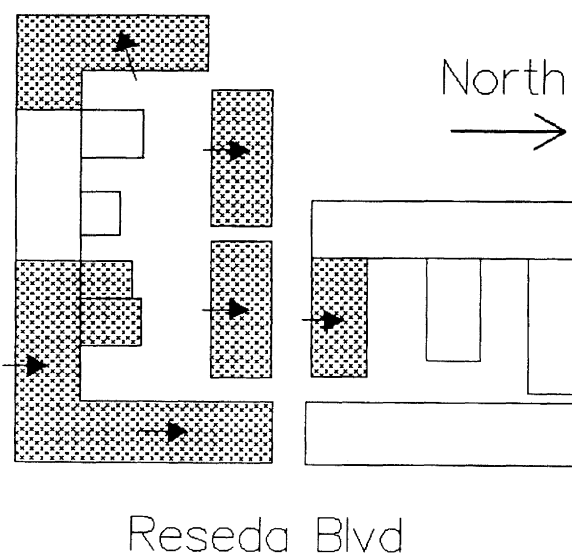
FIGURE 6.52. Meadows Apartment. Base Plan. Where the shaded buildings collapsed in the direction indicated by the arrows (18).

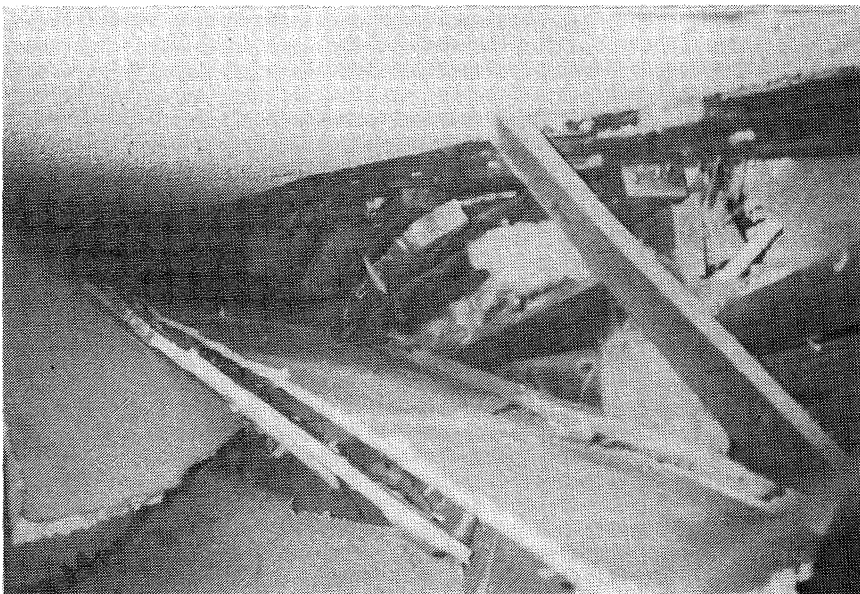
FIGURE 6.55. Meadows Apartments. The 600 mm crawl-space between ground floor and ceiling. Wall linings have become detached and diagonal timber bracing has fractured.
