NORTHRIDGE EARTHQUAKE RECONNAISSANCE REPORT

Report of the NZNSEE Reconnaissance Team on the
17 January 1994 Northridge, Los Angeles Earthquake

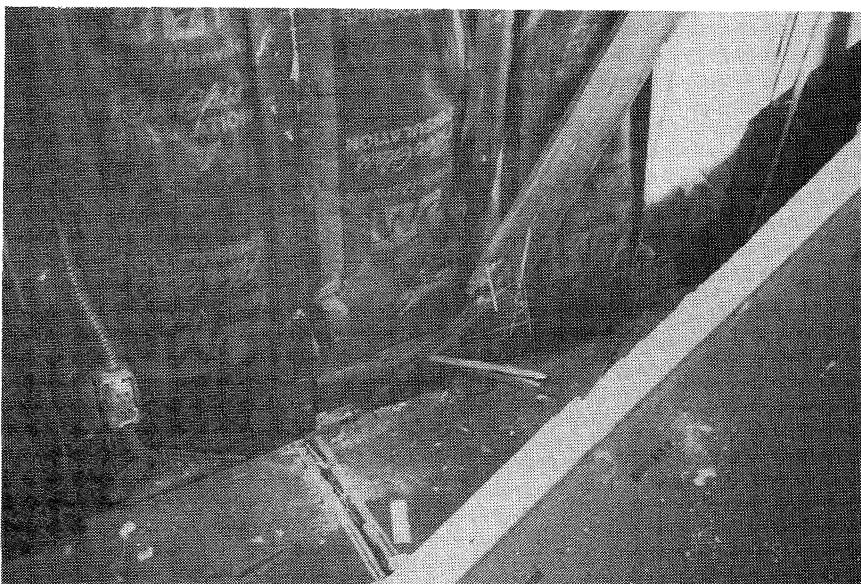
FIGURE 6.56. Meadows Apartments. Cut-in diagonal timber braces failed in compression.

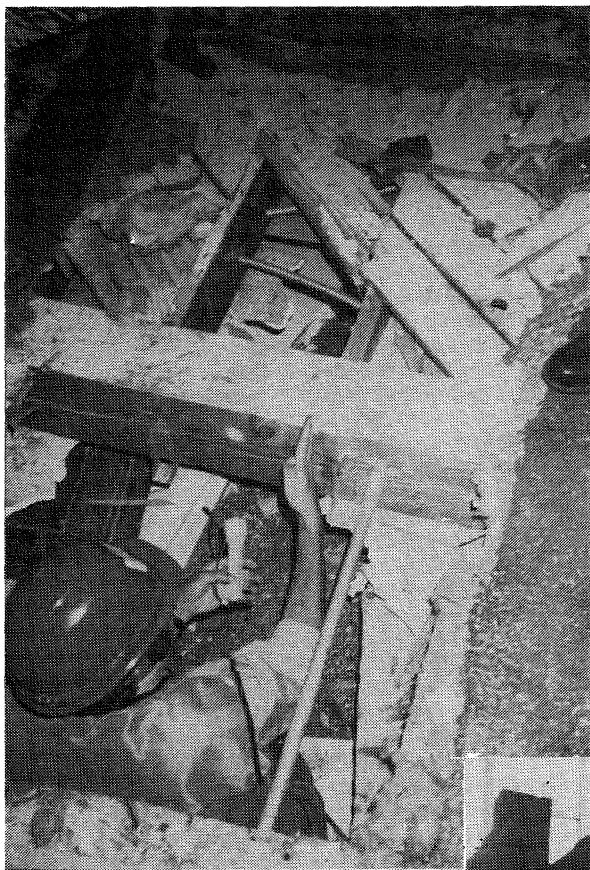
FIGURE 6.57. *Meadows Apartments. Evacuation holes cut through the first floor show the floor construction with light-weight concrete topping over diagonal planks with timber joist hanger supports.*

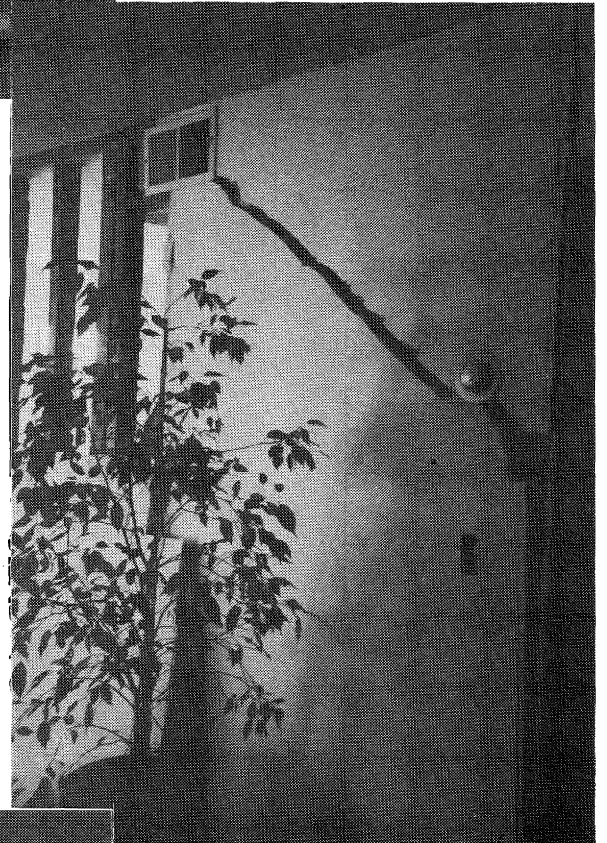
FIGURE 6.61. *Meadows Apartments. High shear was induced as the linings became wedged between protrusions with sheet shear ruptures resulting.*

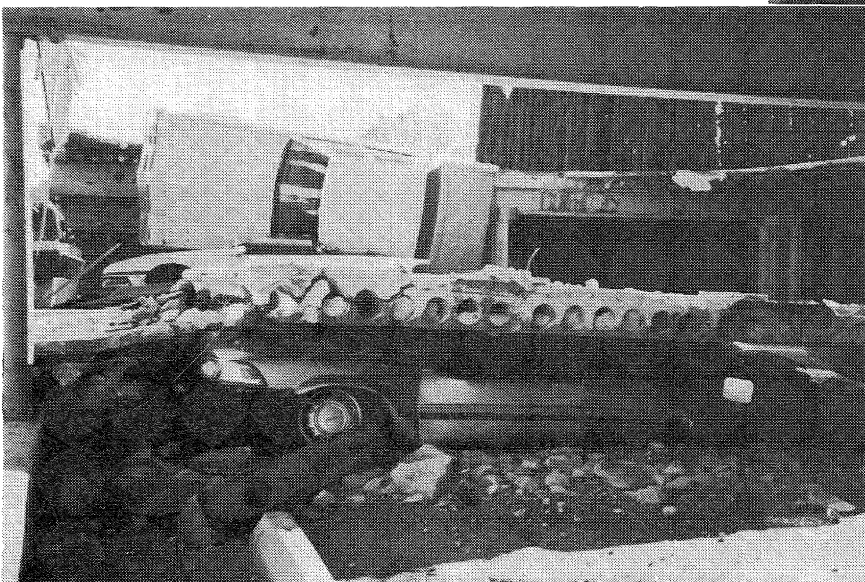
the top flange of the RSJ at approximately 600 ctrs, and to bend these bars alternate directions and cast them into the topping slab. The shift of the slab had fractured the splice bars at their weld to the top flange of the UB (Figure 6.63). At the line of failure, the topping reinforcing did not appear to extend far into the failed topping concrete (approx 100 mm). At the rear, where the reinforcing extended further beyond the joint, an area (800 mm triangular) of the topping remained suspended. Elsewhere the prestressed panels separated from the topping and collapsed.

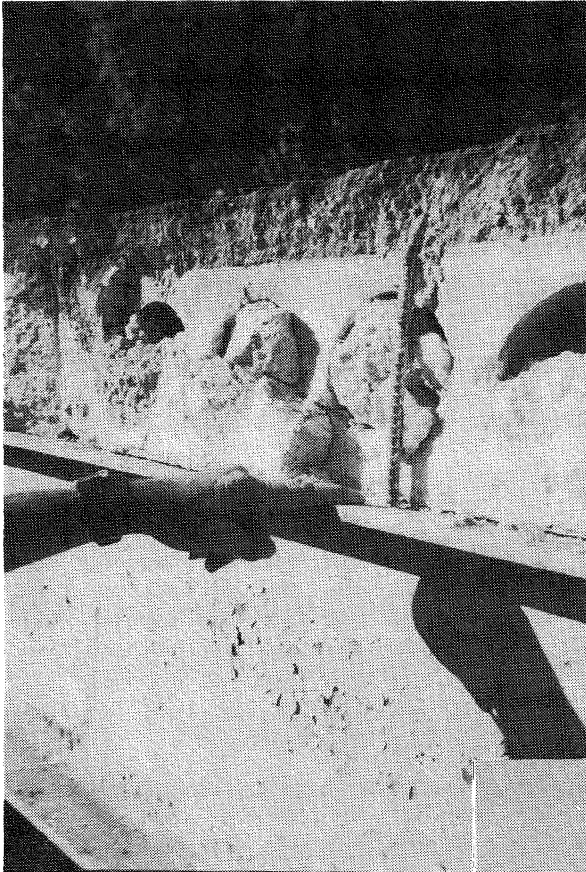
FIGURE 6.63. Meadows Apartments. Detail of shear connection between beam and slab (Note shear failure of 1/2 inch bar at the butt weld to beam).

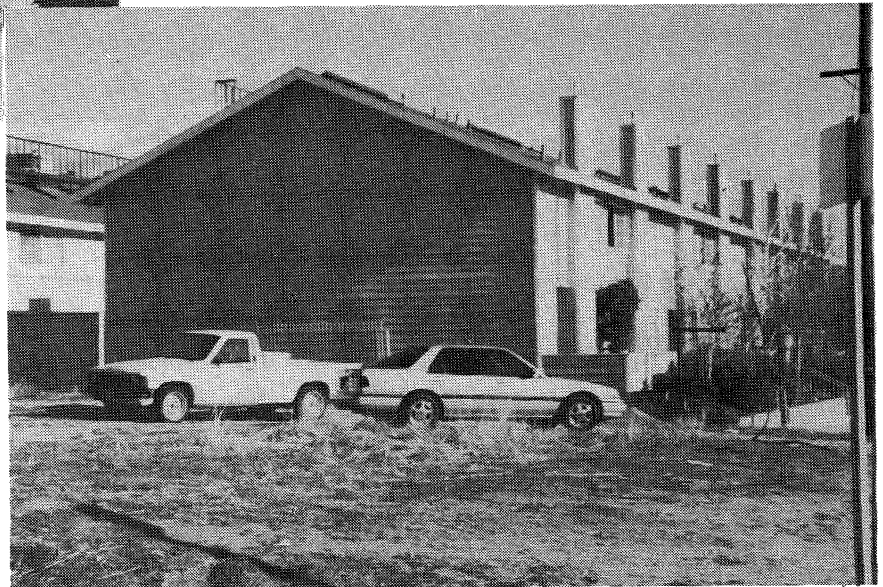
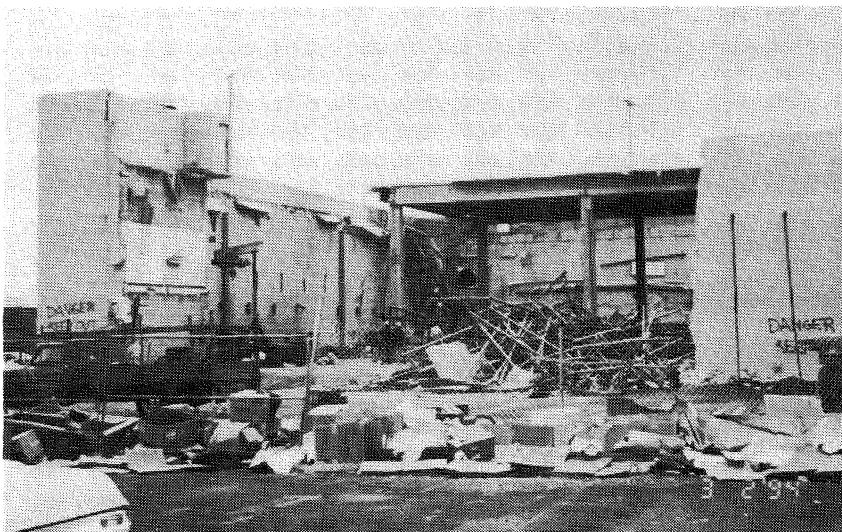
FIGURE 6.65. Masonry Walled Warehouse & Carpark collapsed as the roof diaphragm connections to the wall system failed through a lack of shear reinforcing (19).

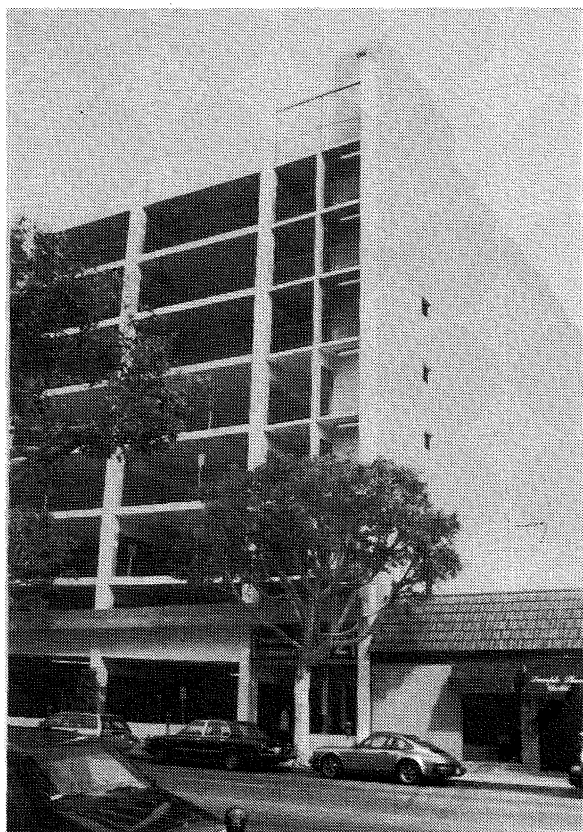
FIGURE 6.66. Carpark building, Santa Monica with little noticeable damage to reinforced concrete masonry walls (20).

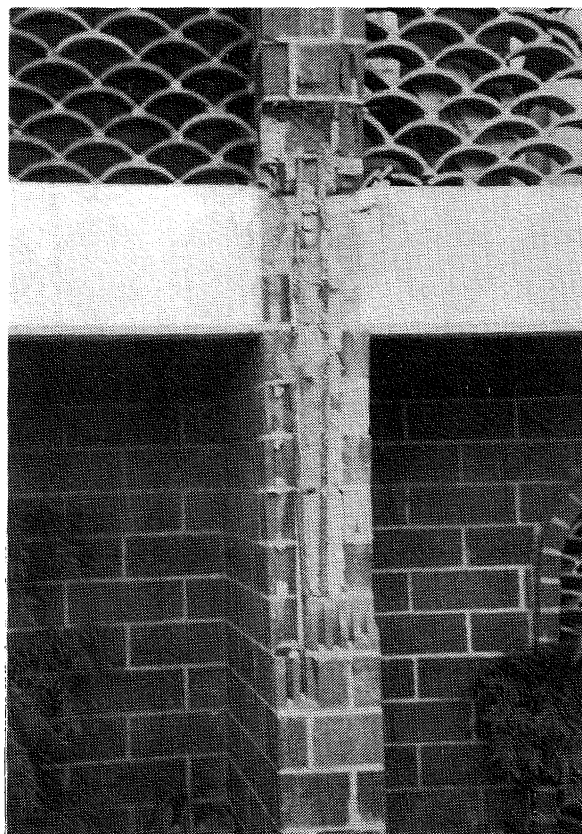
FIGURE 6.68. Berkeley East Convalescent Home. Brick Masonry end veneers shed from shear wall.

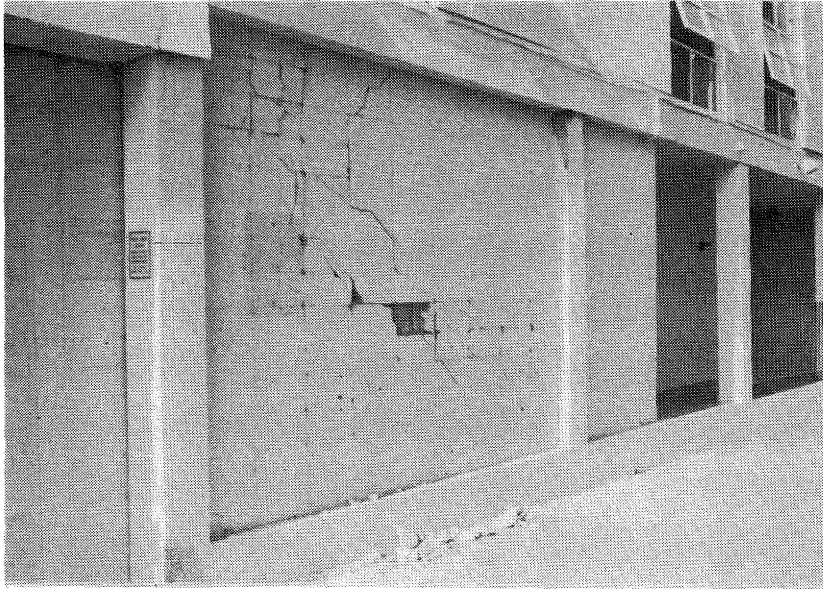
FIGURE 6.69. A hostel facility to the west of St Johns Hospital which exhibited classic diagonal cracking.

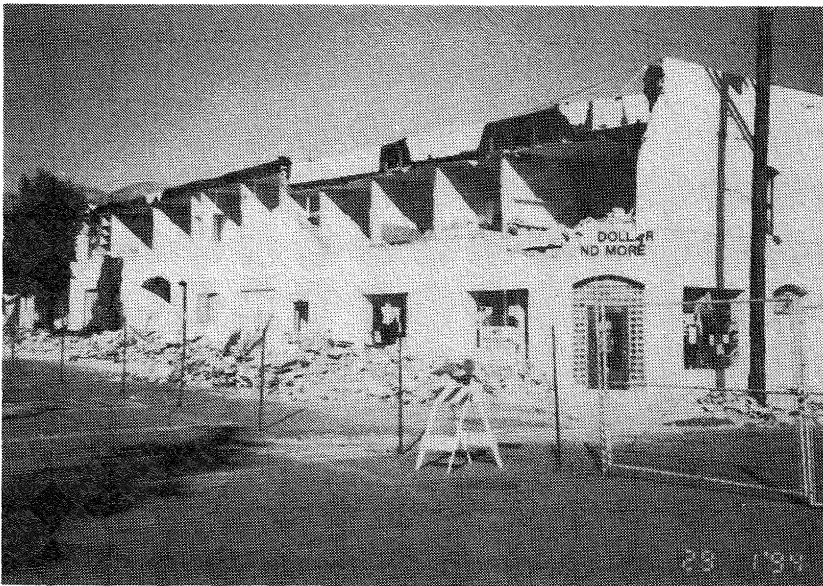
FIGURE 6.70. Unreinforced masonry structures at Fillmore, 25 miles north west of the epicentre.

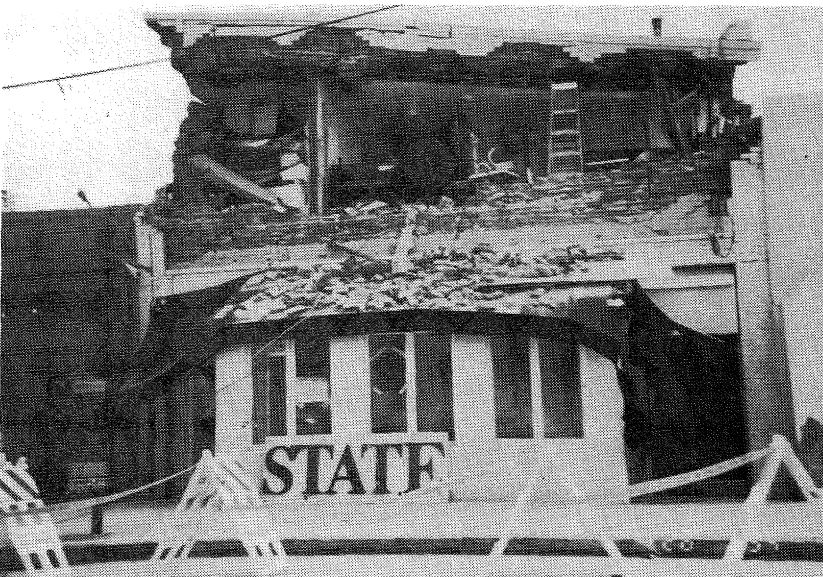
FIGURE 6.71. Unreinforced masonry structures at Santa Monica, Several small retail outlets experienced similar damage (22).

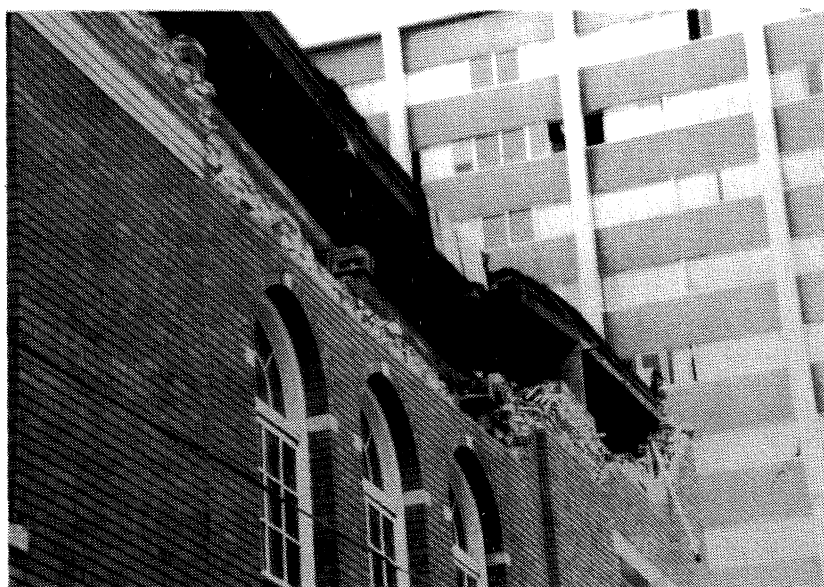
FIGURE 6.72. First Christian Church of Santa Monica (23).

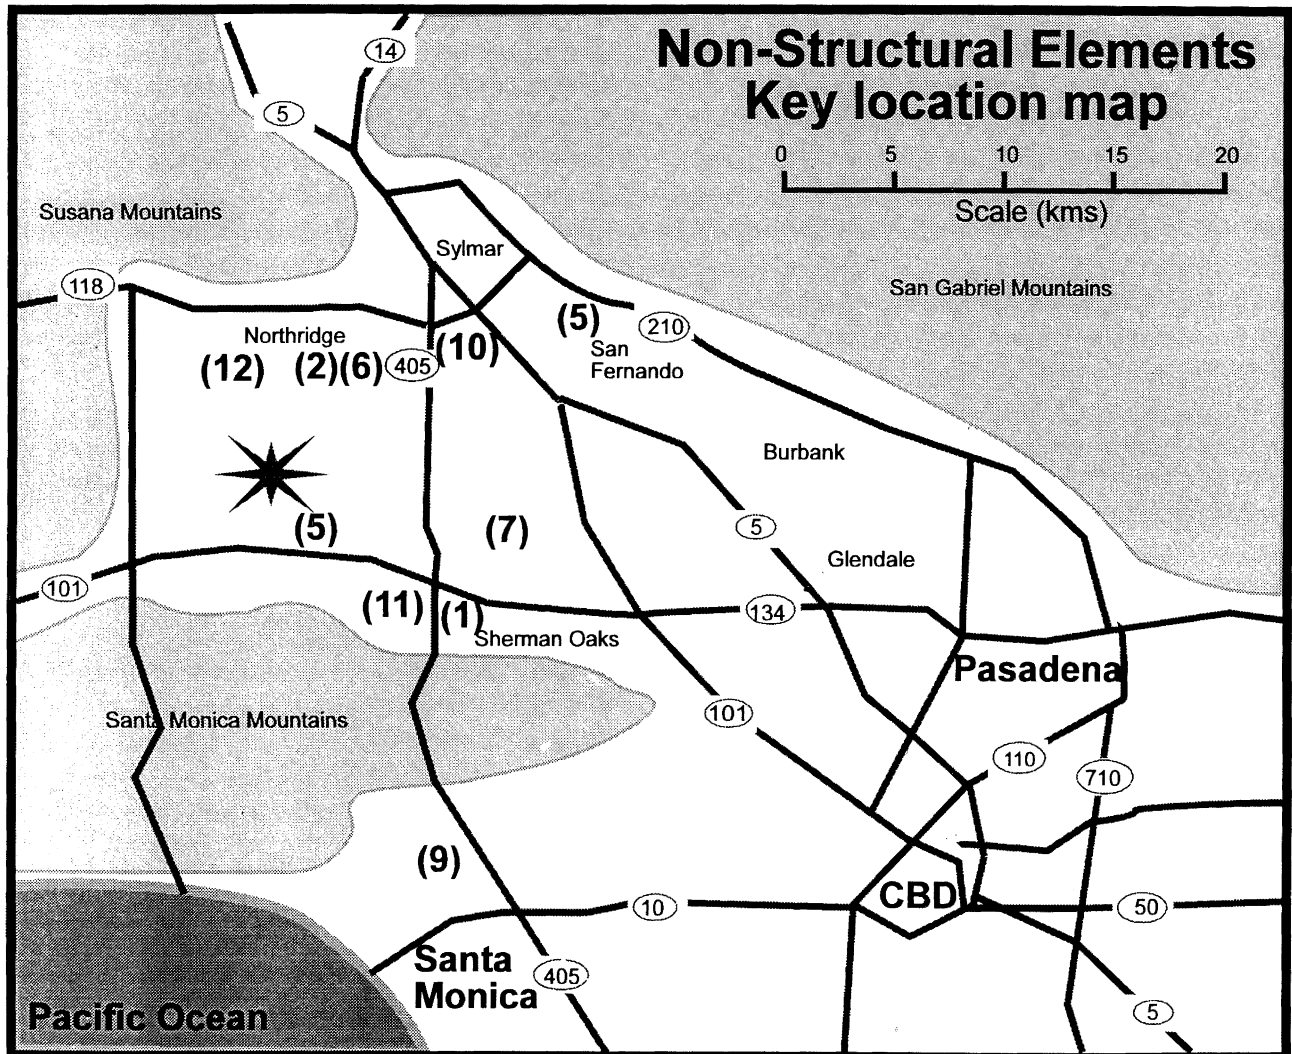
FIGURE 7.1 Key to the location of buildings where damage occurred to non-structural elements as described in the text.

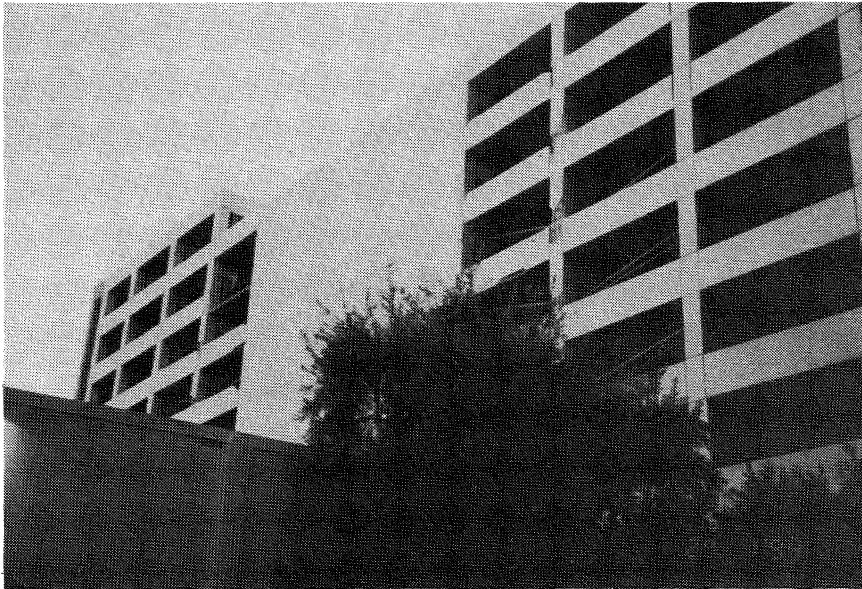
FIGURE 7.2 Precast panel damage (with one collapse) of carpark building (2) consequential to inadequate panel/column clearances.

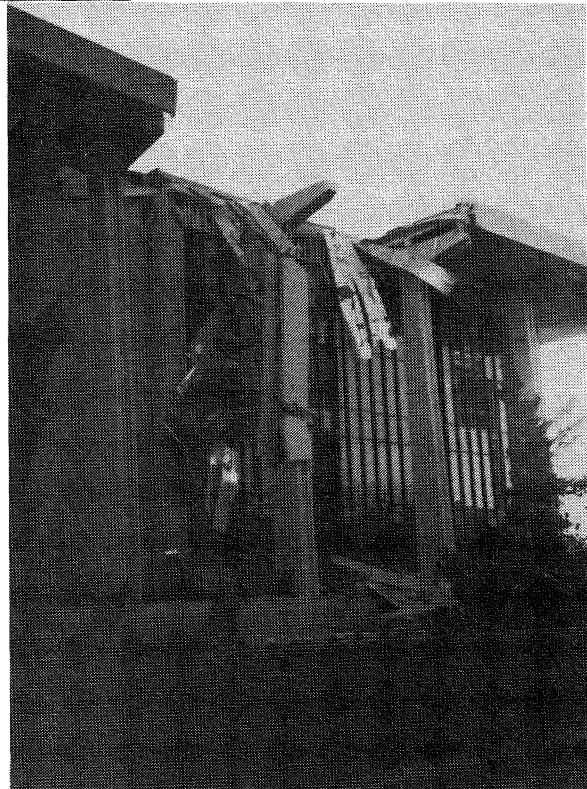
of the panes were broken) was observed within the west extension to the library where the internal floors hammered into curtain walling. It was reported that the library shelving performed well although the robotics book retrieval system used within the library is understood to have damaged.

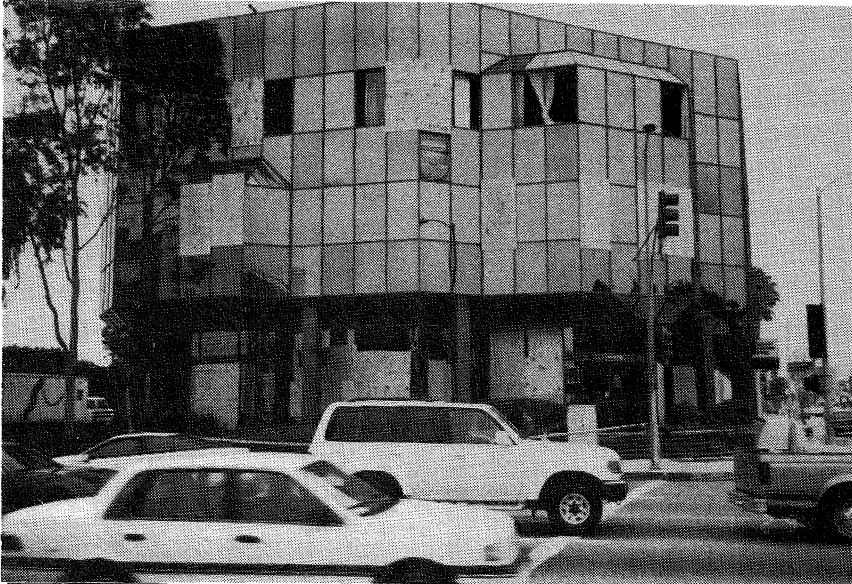
FIGURE 7.4 *Medium rise office Block (4). Several glazing panels damaged particularly at changes facade plane.*

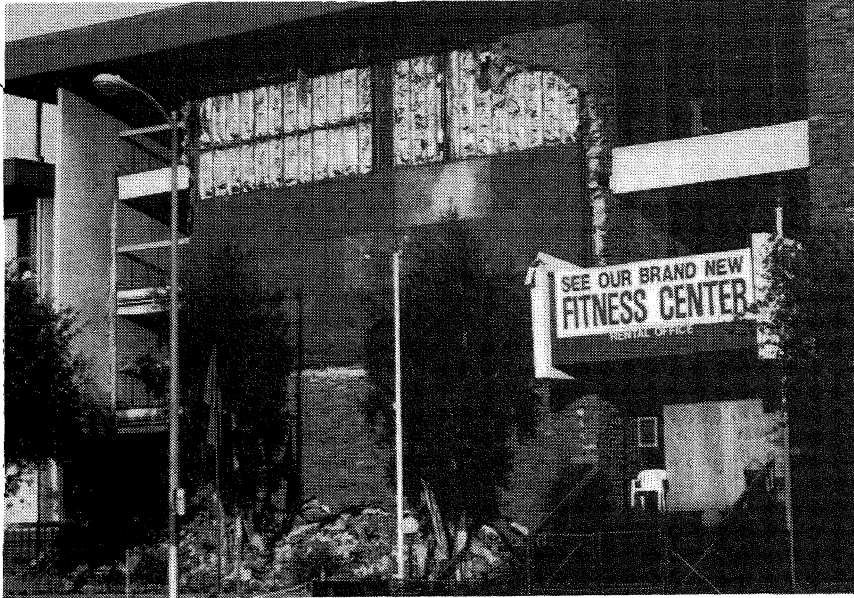
FIGURE 7.5 *Woodman Ave Apartments (5). Three storey stucco facade with stone facing which separated from the support framing and ply bracing sheets*

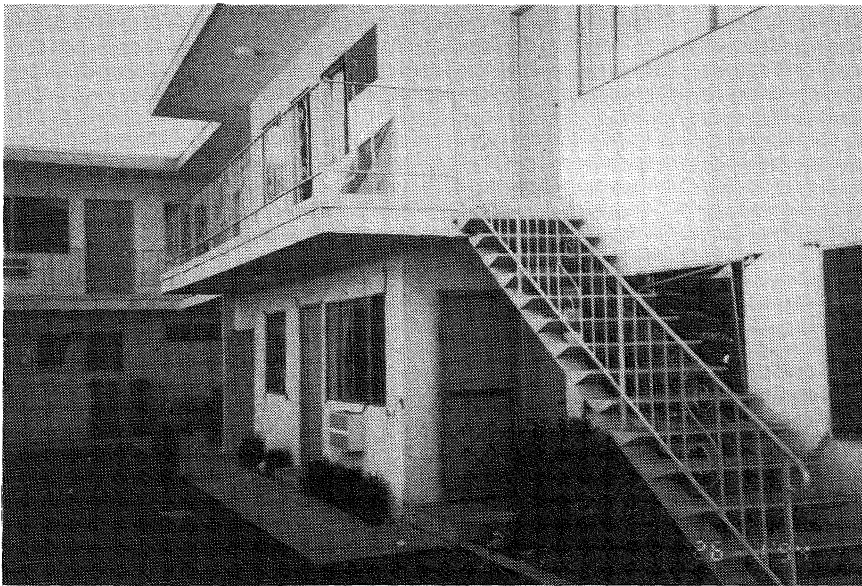
FIGURE 7.6 *Olive View Apartments (6). Typical stucco damage to two storey residential units with cracking to lintels and parapets and periodic loss of windows and glass breakage.*

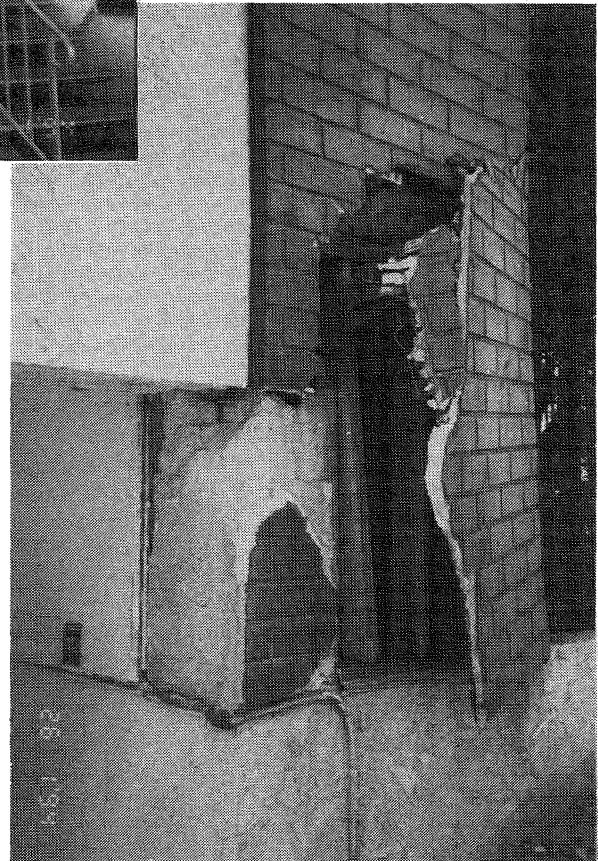
FIGURE 7.7 *Prairie St. Apartments (7). Stucco facade with impressed brick finish severely damaged and separated from support framing.*

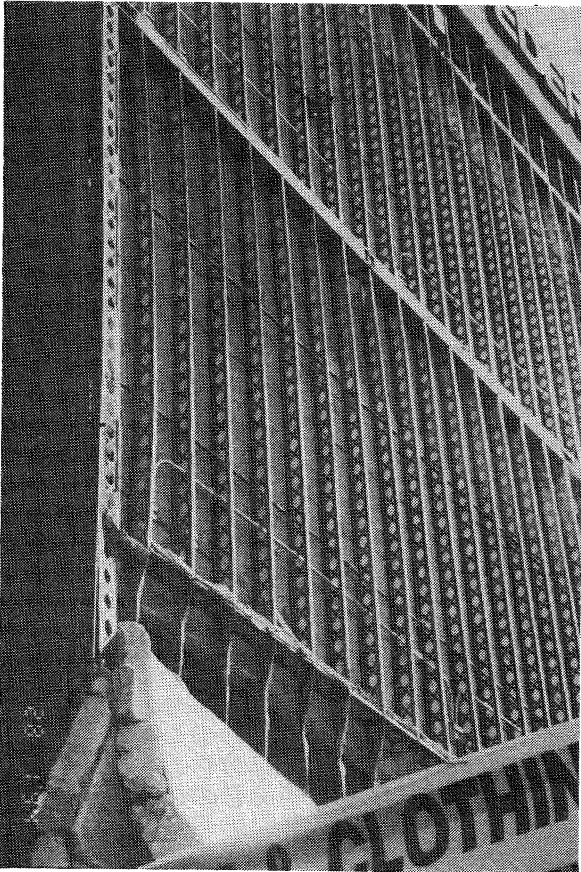
FIGURE 7.8 *Glendale Federal Bank Building, Sherman Oaks (8). The upper two storeys of stucco facade was shed from both ends of this building with significant consequential damage the roofs of neighbouring properties.*

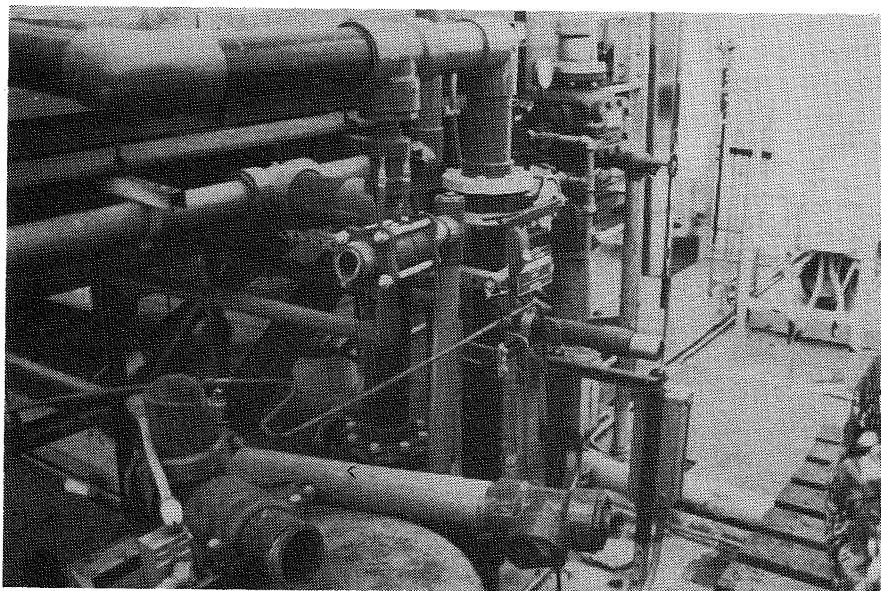
FIGURE 7.9 St Johns Hospital (9). Air conditioning plant pipework fractures at junctions and changes in direction.

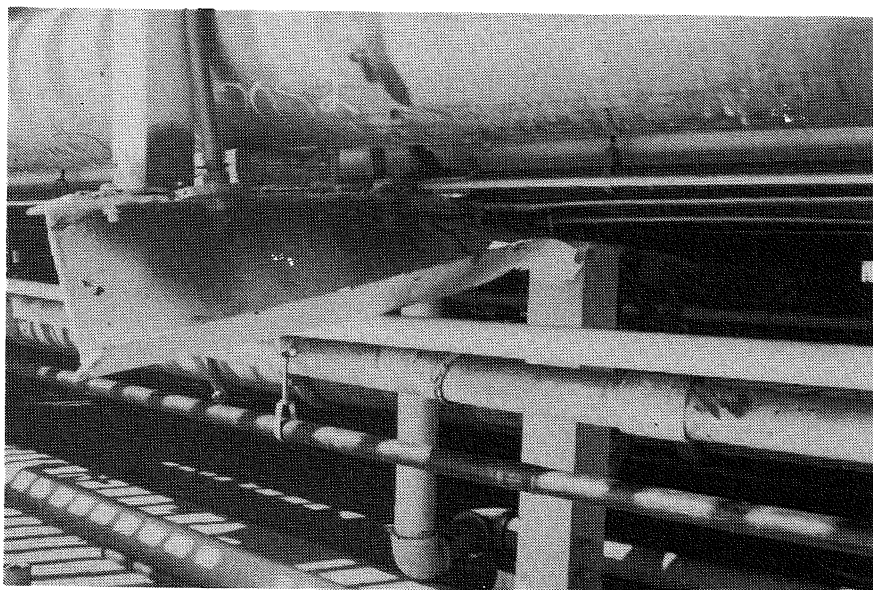
FIGURE 7.10 St Johns Hospital (9). Pipe rack supports experienced torsional failure due to insufficient longitudinal bracing

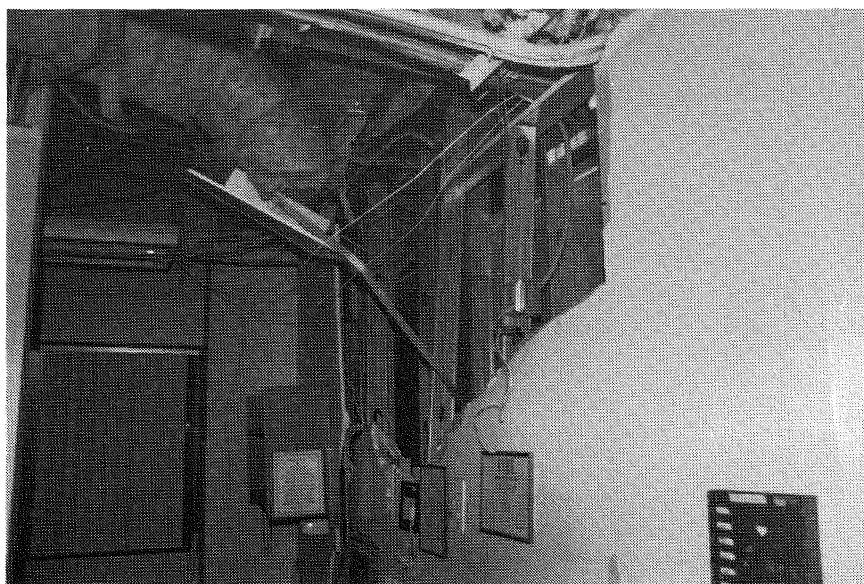
FIGURE 7.11 Holy Cross Hospital (10). Damage to the lift shaft following derailment of the lift car

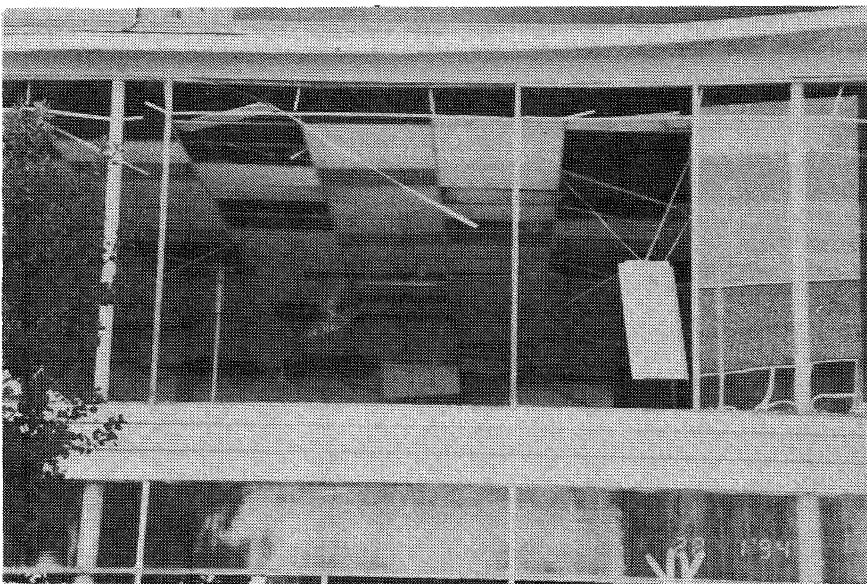
FIGURE 7.12 Retail outlet, Sherman Oaks (11). Suspended ceiling tiles and associated light and air-conditioning vents commonly fell from suspension grids.

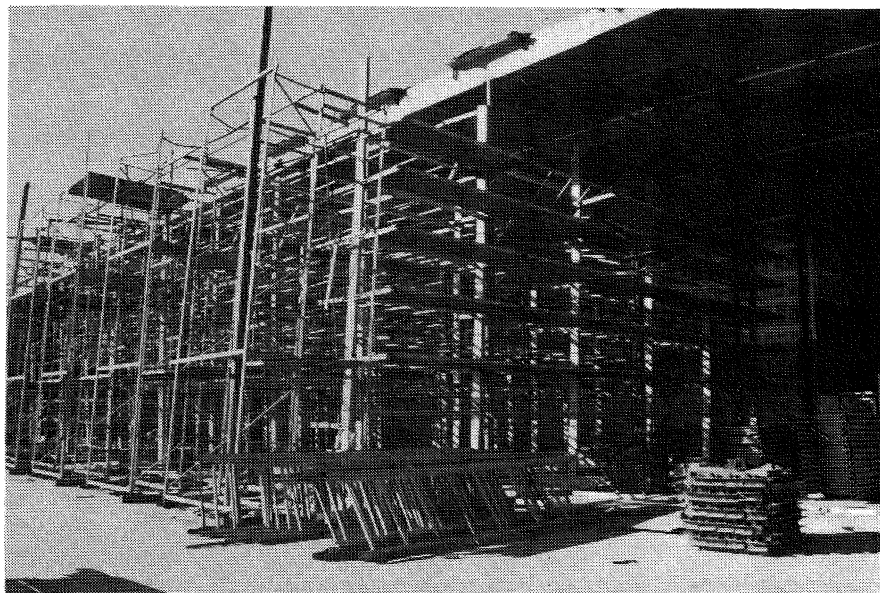
FIGURE 7.13 *Levitz Furniture Warehouse (12). Many of these 7 m high furniture storage shelves failed as cross bracing connections failed and support walls collapsed*

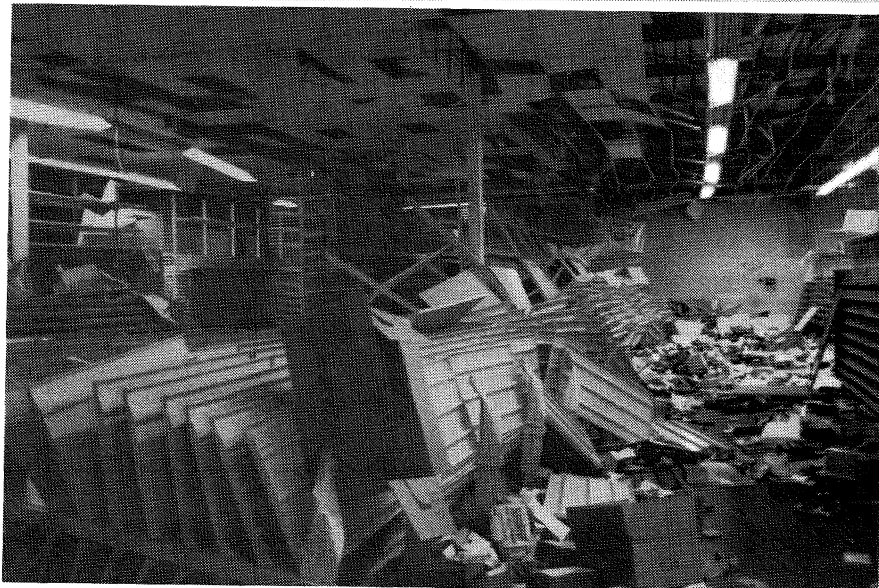
FIGURE 7.14 *Sportsmart Sporting Goods Supermarket (12). Display shelves up to 3.6 m high collapsed across their aisles through upright to base connection failure.*

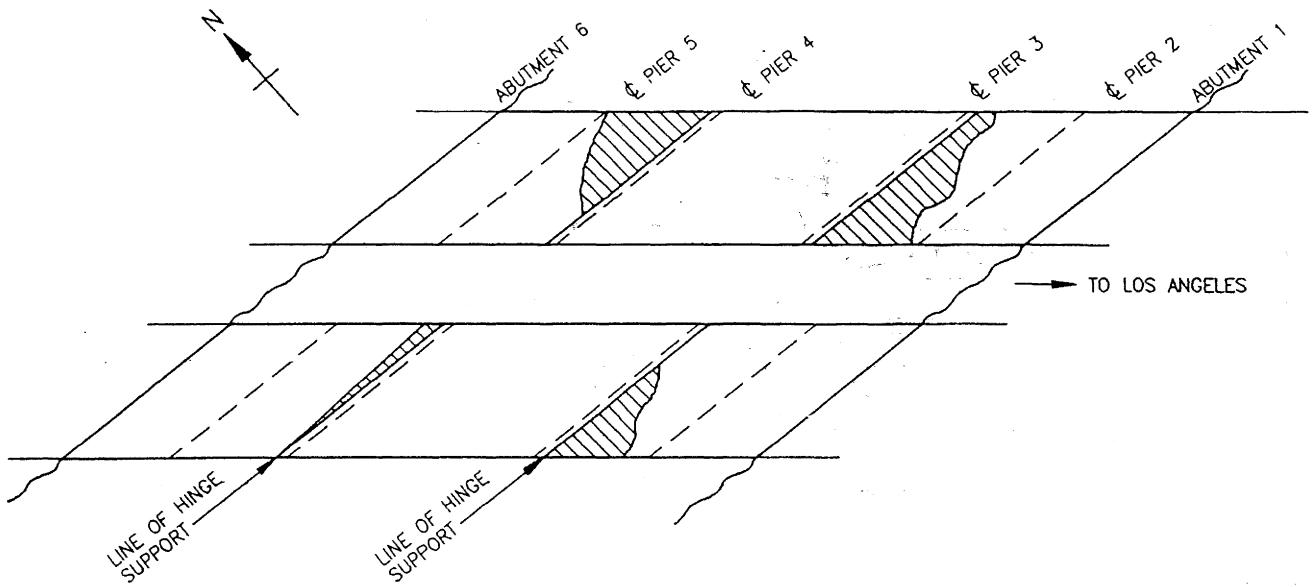
FIGURE 8.2. Plan showing areas of damage to the Gavin Canyon bridge.

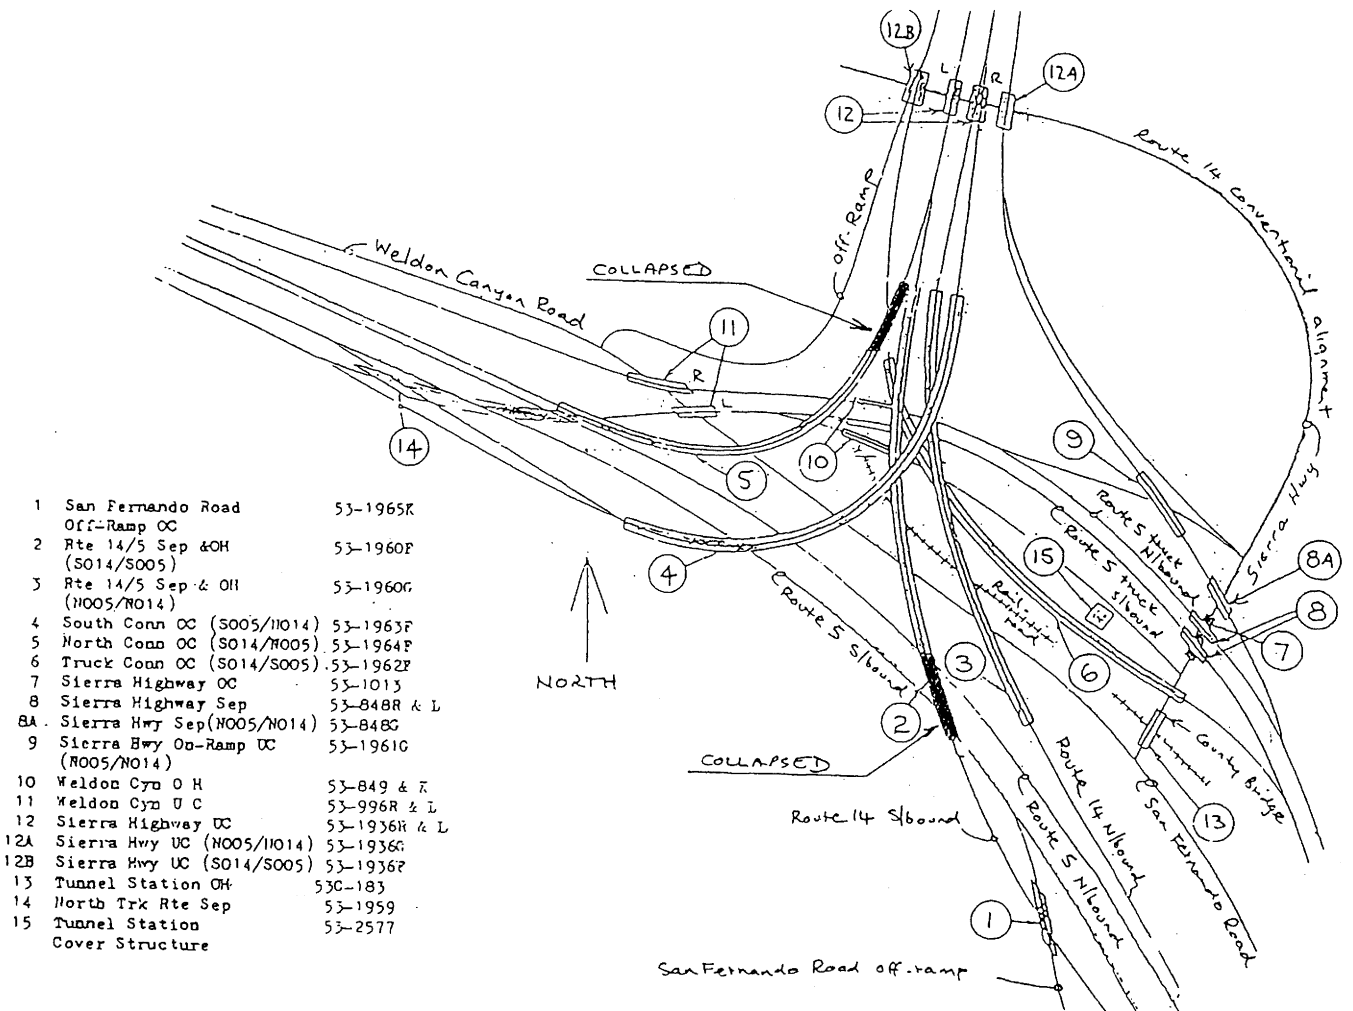
FIGURE 8.3. Sketch plan showing the layout of the interchange of Freeways 5 and 14. From Reference 1.

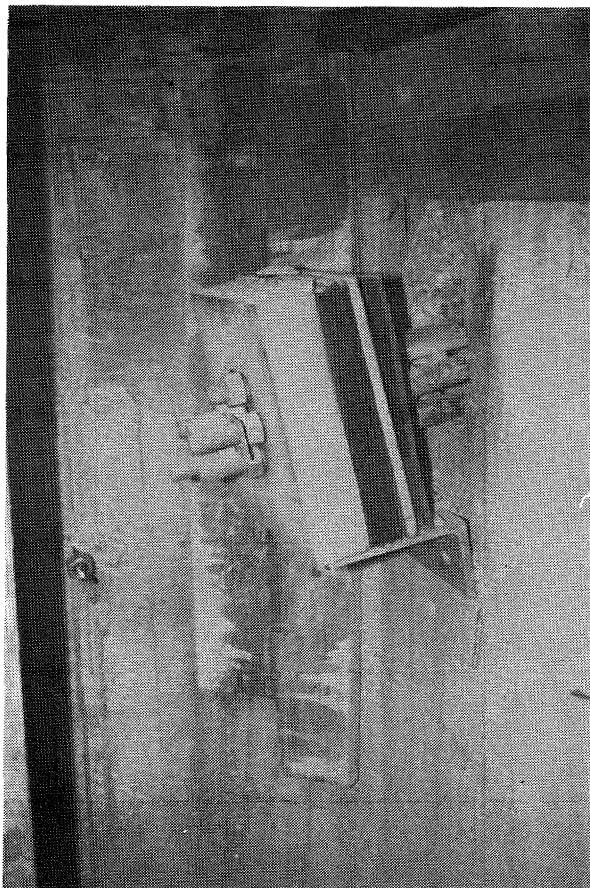
FIGURE 8.4. Interchange of Freeways 5 and 14, Structure 4, Hinge 3 - restrainer cables stretched 60 mm.

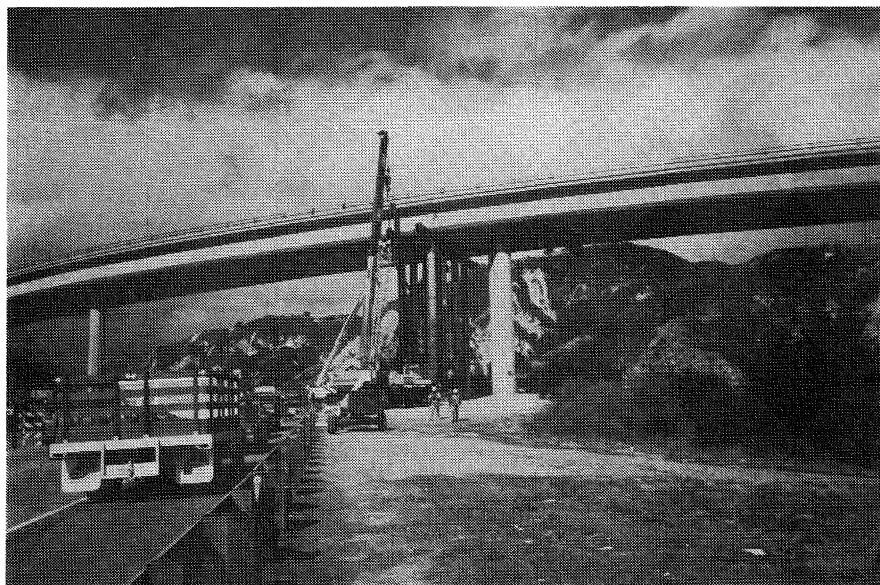
FIGURE 8.5. Interchange of Freeways 5 and 14, Structure 4, Hinge 3 - damaged hinge during shoring.

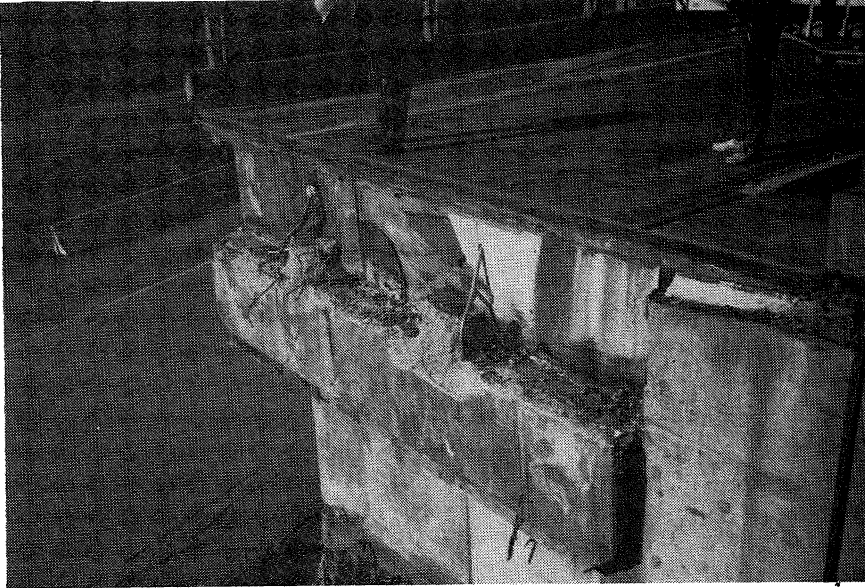
FIGURE 8.6. *Interchange of Freeways 5 and 14, Structure 5, north abutment seat.*

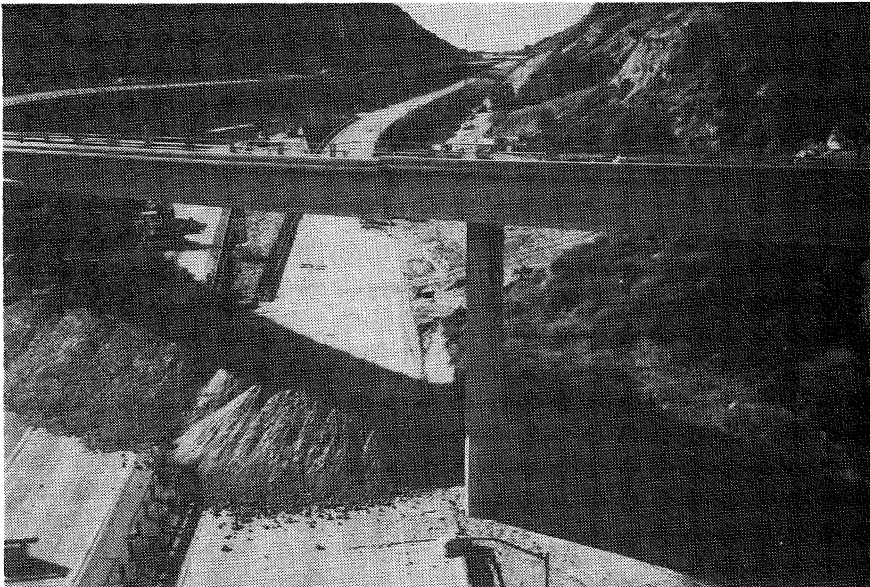
FIGURE 8.7. *Interchange of Freeways 5 and 14, Structure 5, Hinge 2 showing large horizontal and vertical residual displacement at 350 mm hinge seat.*

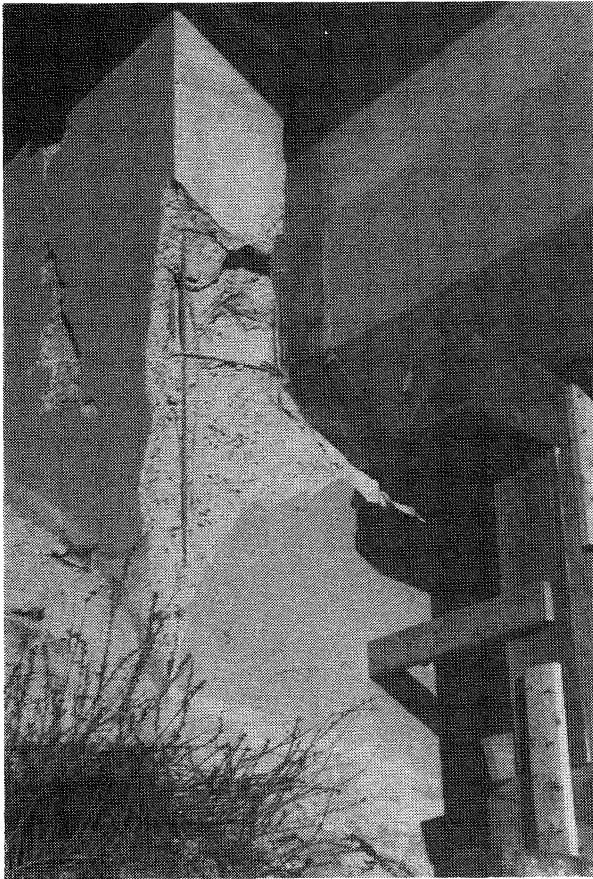
FIGURE 8.8. Interchange of Freeways 5 and 210, eastern abutment showing damaged shear keys and residual box girder displacements of 150 mm horizontal and 100 mm vertical.

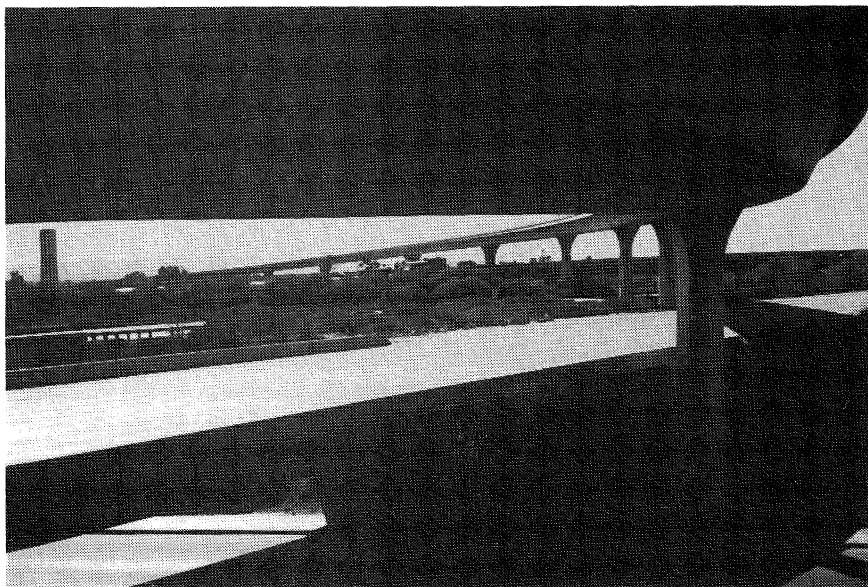
FIGURE 8.9. 510 metre long overcrossing linking Freeways 118 westbound and 5 southbound.

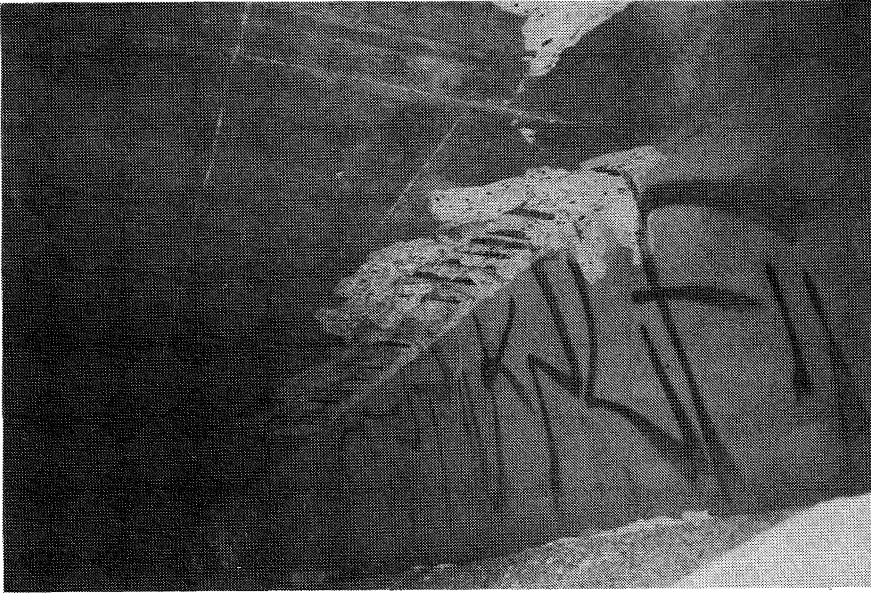
FIGURE 8.10. *San Fernando Road undercrossing of Freeway 118, east abutment - spalled concrete at abutment/soffit interface.*

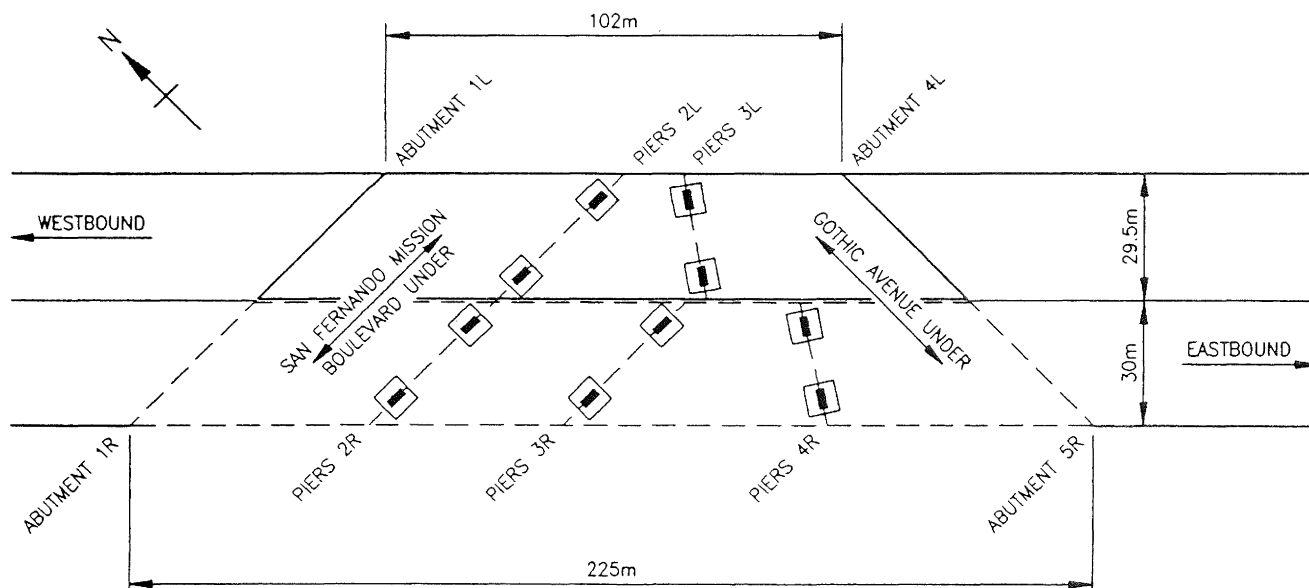
FIGURE 8.11. Sketch plan of the layout of the bridges across Mission Boulevard and Gothic Avenue.

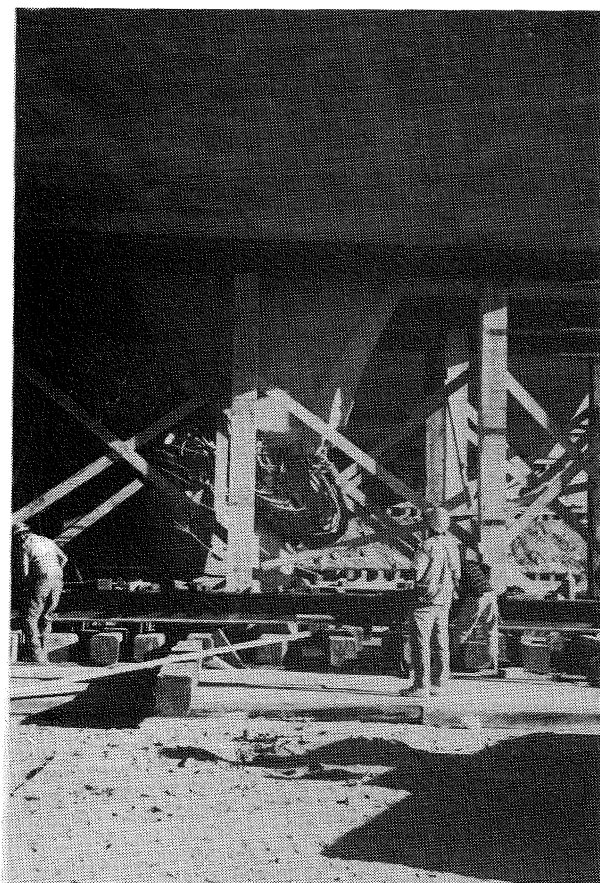
FIGURE 8.12. Mission Boulevard/Gothic Avenue undercrossing of westbound Freeway 118 structure, column 3LR showing flexural plastic hinge failure.
