NORTHRIDGE EARTHQUAKE RECONNAISSANCE REPORT

Report of the NZNSEE Reconnaissance Team on the
17 January 1994 Northridge, Los Angeles Earthquake

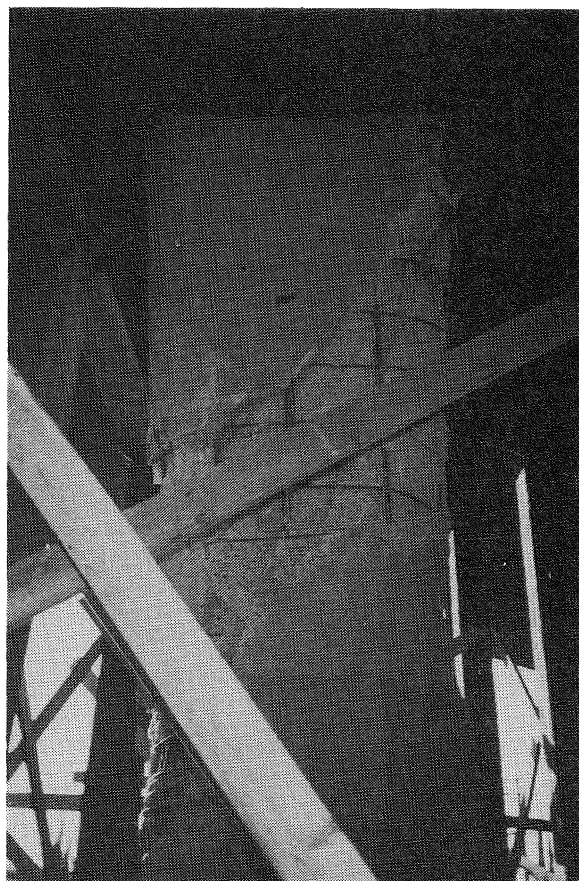
FIGURE 8.13. Mission Boulevard/Gothic Avenue undercrossing of westbound Freeway 118 structure, column 2LR showing concrete spalled over length of column flare, and shear cracking.

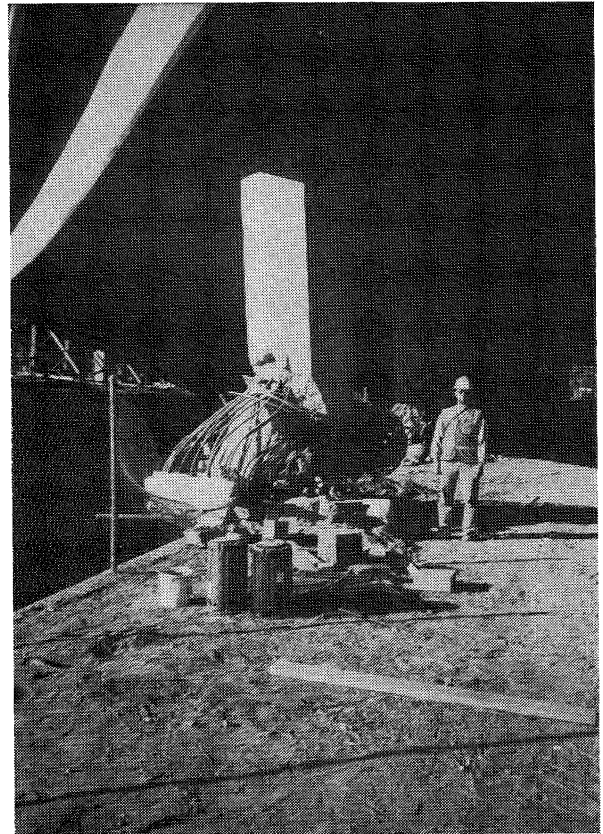
FIGURE 8.14. Bull Creek Canyon Channel Bridge on Freeway 118 - failure of columns at top of channel wall.

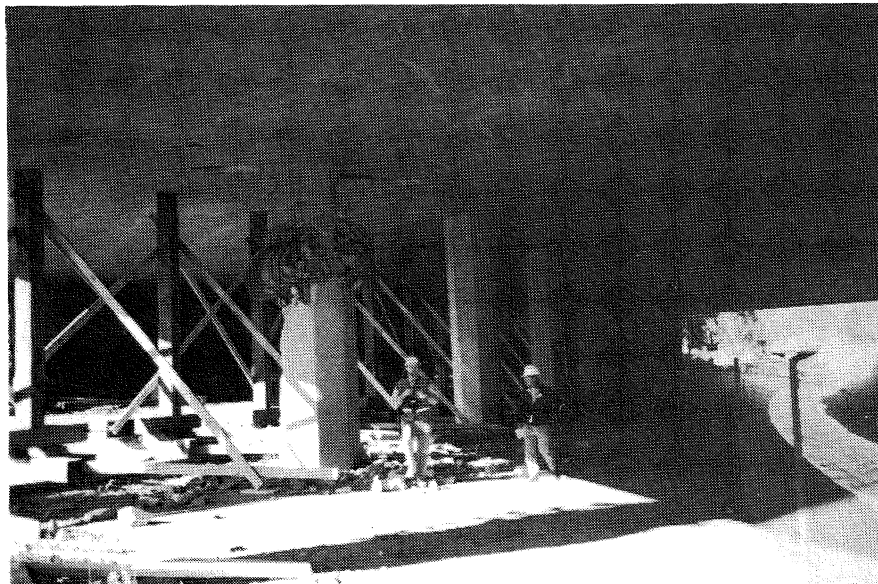
FIGURE 8.15. Bull Creek Canyon Channel Bridge on Freeway 118 - failure of columns below closely confined length below superstructure soffit.

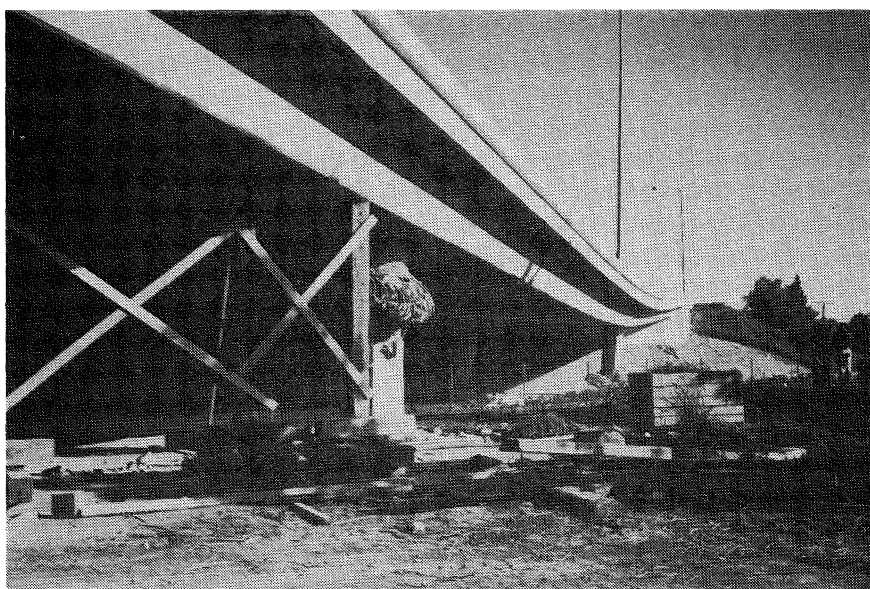
FIGURE 8.16. Bull Creek Canyon Channel Bridge on Freeway 118 - view along eastbound bridge showing 1.7 metre vertical displacement.

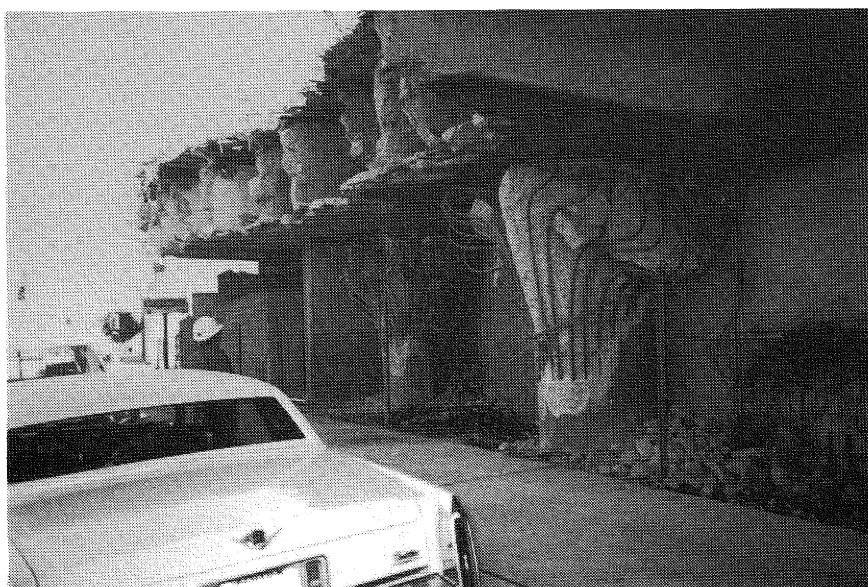
FIGURE 8.19. *La Cienega/Venice Boulevards undercrossings of Freeway 10 - damaged columns at La Cienega Boulevard.*

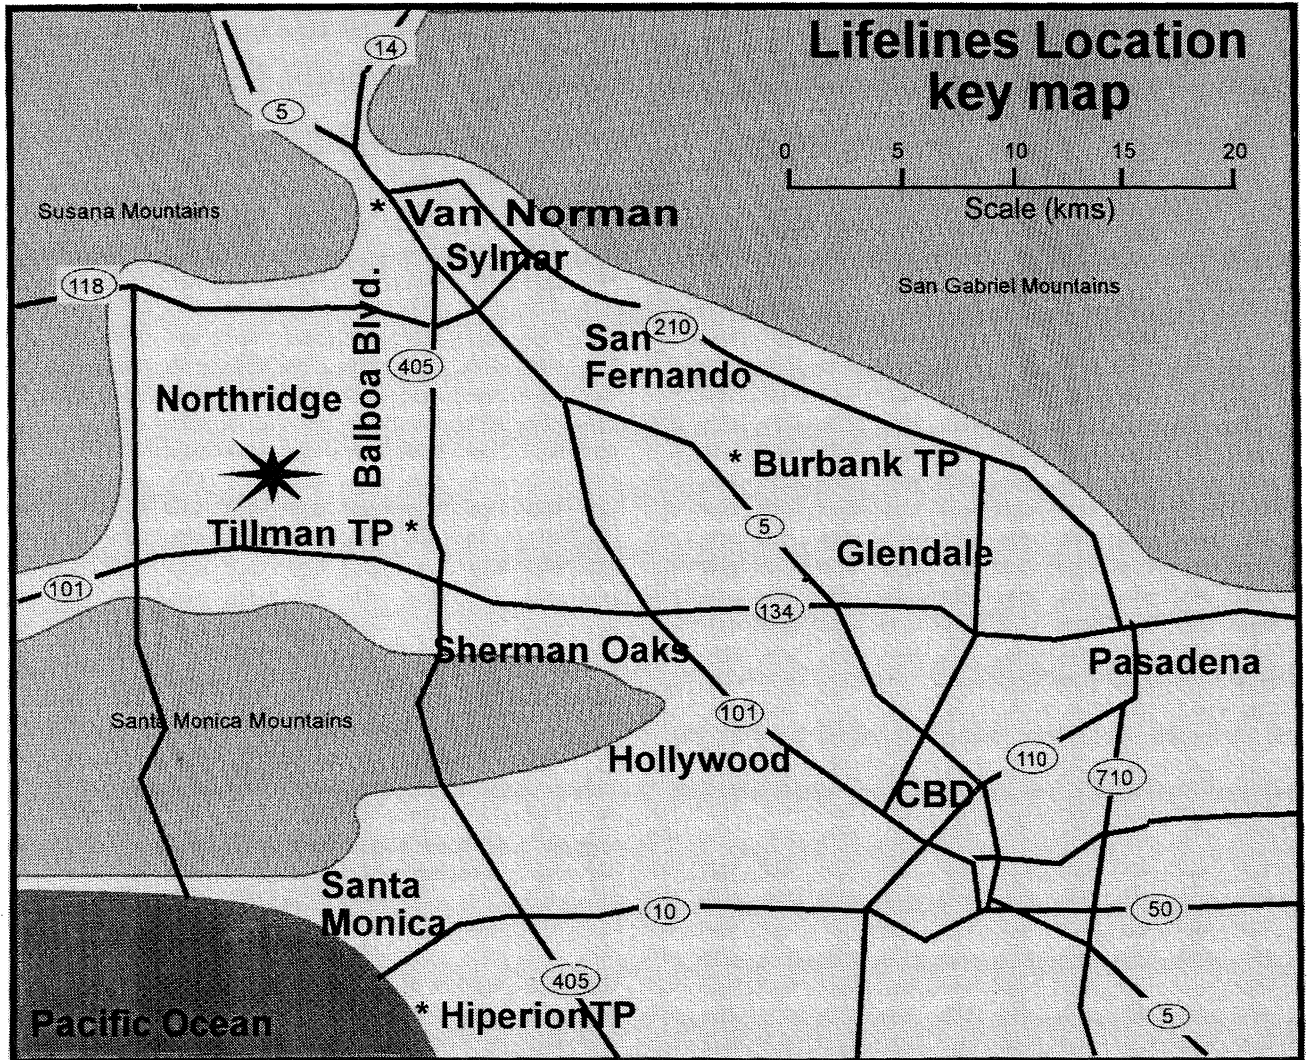
FIGURE 9.1 Location Map for Lifelines in the Los Angeles Area.

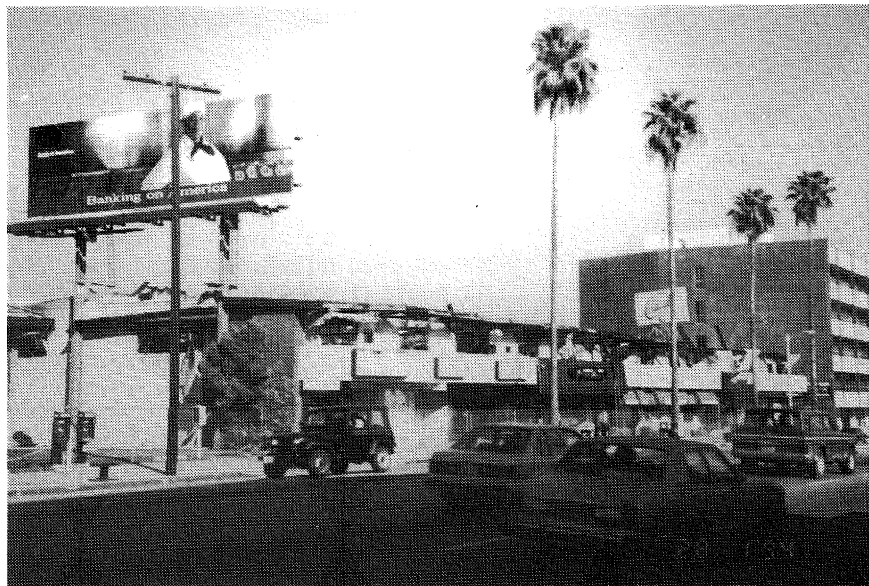
FIGURE 10.1. Several tenancies were burnt out as fire spread along the upper floor of this retailing complex. The fire outbreak coincided with restoration of power to the area several hours after the quake.

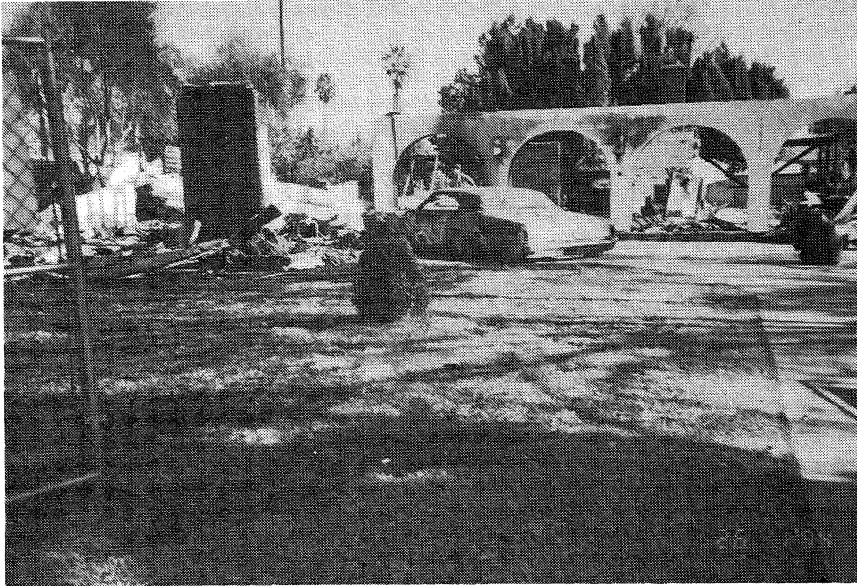
FIGURE 10.2. Gas leak initiated fire consumed this house within 20 minutes of the earthquake. It spread to and consumed an adjacent home before burning itself out (see also Figure 10.3).

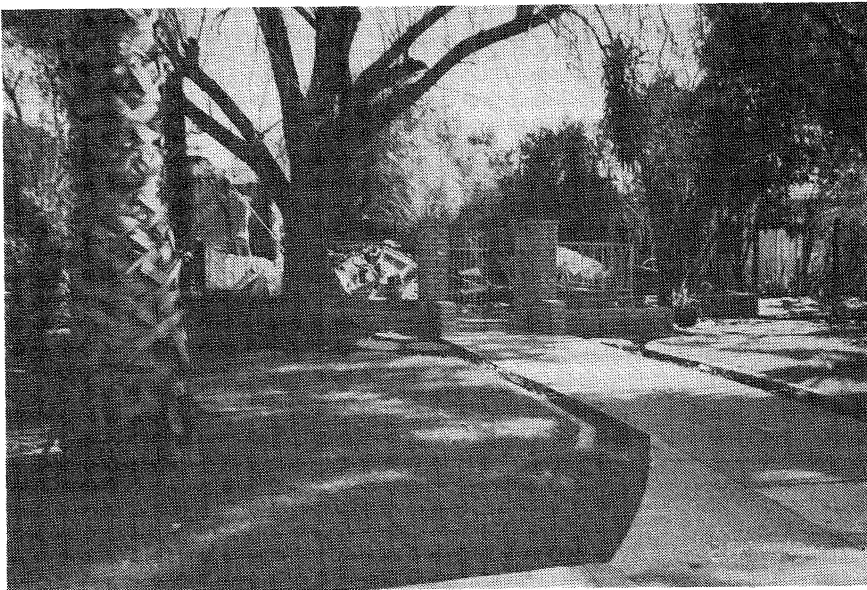
FIGURE 10.3. This house burned as fire spread from its neighbour. All water pressure was low to this area.

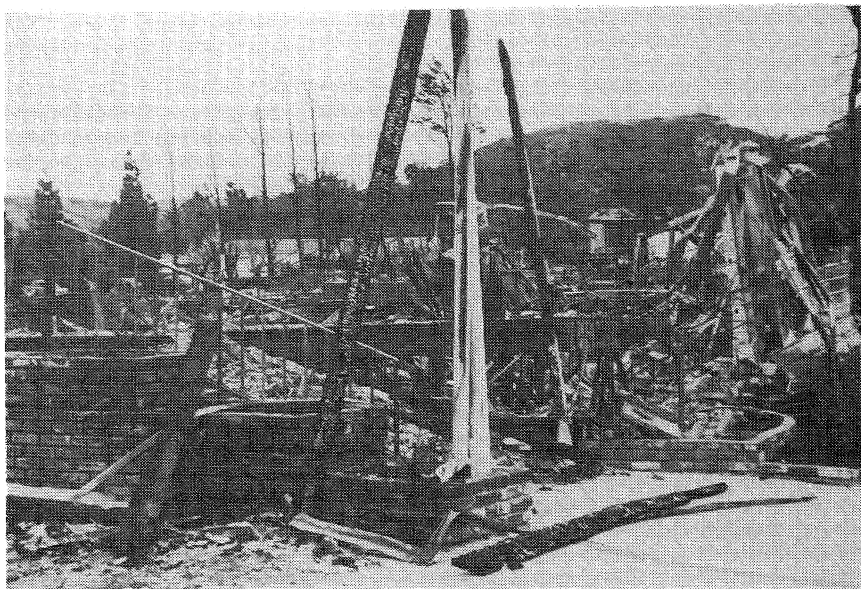
FIGURE 10.4. Widespread fire related damage occurred within manufactured home estates.
