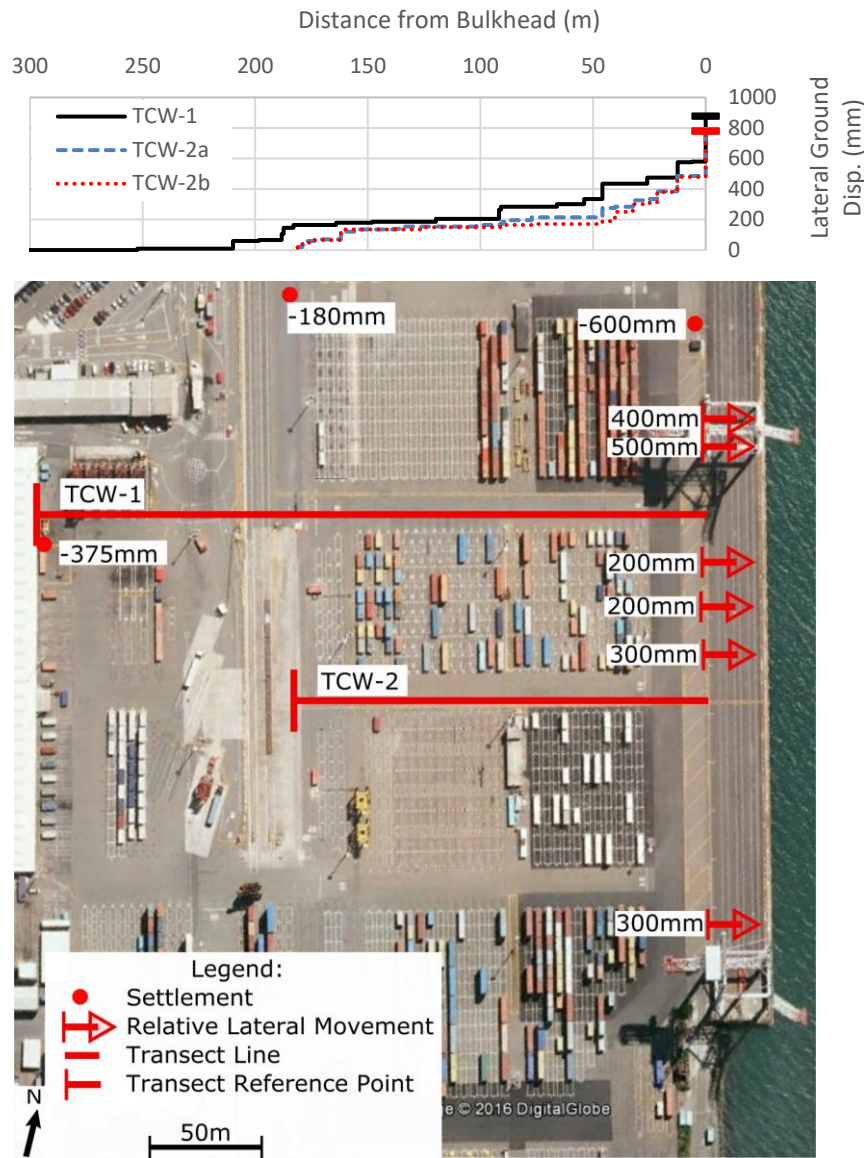
Figure 15: Location of west-to-east transects for lateral spreading measurements towards Thorndon Wharf during inspections. Plots at the top show cumulative lateral ground displacement versus horizontal distance from the bulkhead (Base image from Google Earth™).

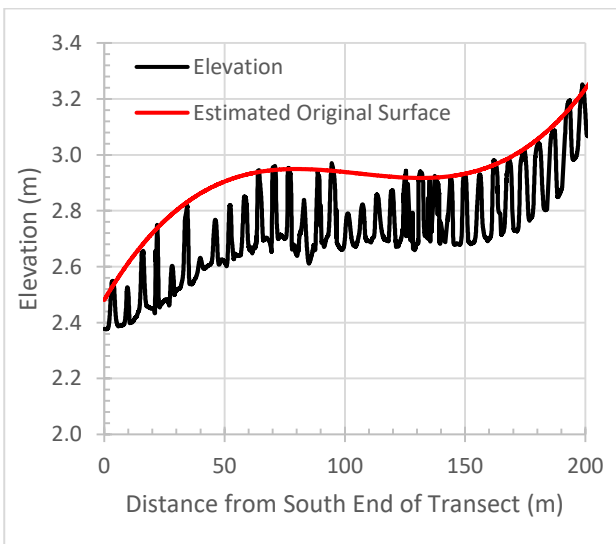
Figure 17 shows a cross-section (LT1) extracted from the LiDAR data that was obtained on the west edge of the road immediately west of Building S37. The peaks in this plot indicate locations of the buried piles whereas the lower portions show the magnitude of settlement of the pavement surface around those piles. In absence of detailed survey data prior to the event, the original surface was estimated by fitting a 3rd order polynomial ($R^2 = 0.99$) to the tops of piles showing higher elevations in the local area. Using this assumption, a differential settlement of the ground (settlement of the ground relative to the ground surface covering the tops of the piles) in this area was estimated to be on the order of 200 mm to 300 mm. LiDAR surveying data on the performance of wharves and buildings are presented in the subsequent sections.

Figure 17: Post-earthquake elevations for transect (LT1) along west side of roadway west of S37; the red line represents the estimated pre-elevation surface.

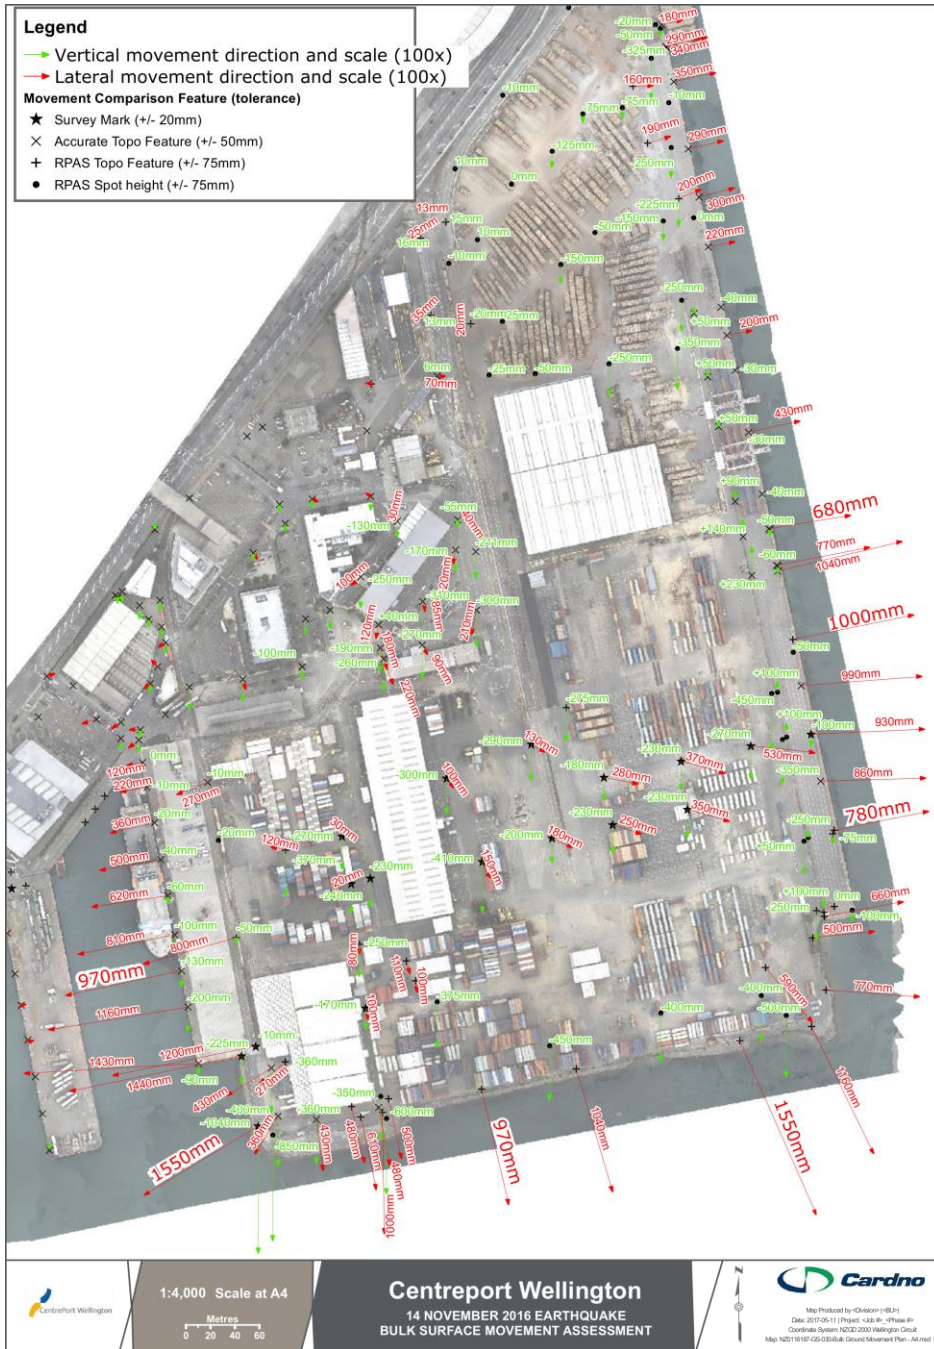
As described previously, widespread liquefaction of the Thorndon Reclamation was accompanied with settlement of the fill and lateral spreading towards Thorndon Wharf. Ground survey measurements indicate that the lateral spreading displacements at the edge of the fill (bulkhead) reached about 0.8 m to 1.0 m, relative to the respective reference points. Cardno performed an aerial unmanned aircraft systems (UAS) survey of the port that captured vertical settlement and lateral movement (Figure 19). The magnitude of lateral spreading displacement and ground settlement from the UAS survey are

Figure 19: Displacements measured from an aerial UAS survey of Thorndon Reclamation and Wharf (performed by Cardno).

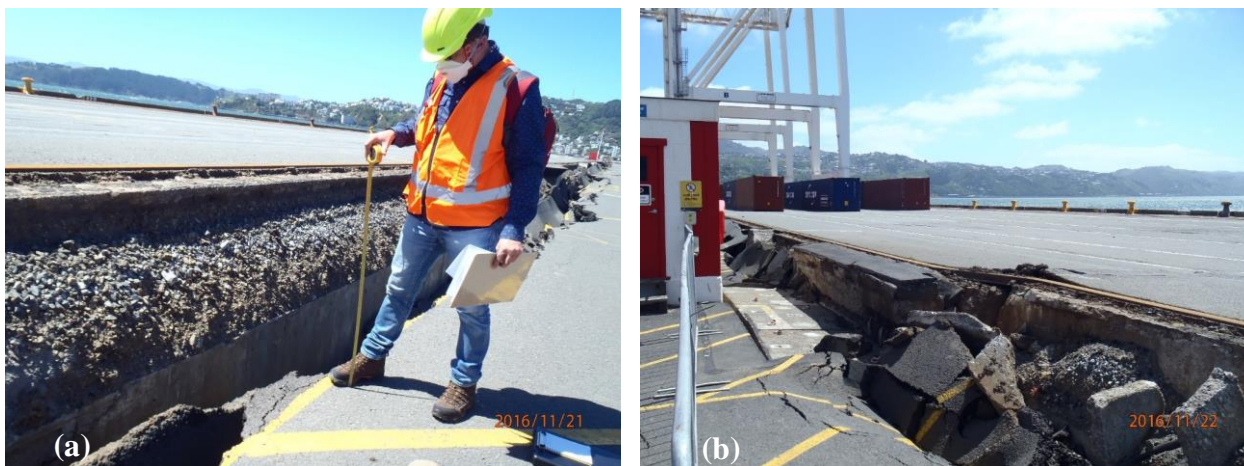
Figure 20: (a) Looking south along Thorndon Wharf bulkhead at approximately STA 240. Approximately 600 mm of ground settlement was measured relative to pile-supported wharf. (S41.278250° E174.789205°, taken at 1124 hrs on 21NOV16); and (b) Looking north along Thorndon Wharf bulkhead at approximately STA 280. Approximately 600 mm of ground settlement was measured relative to pile-supported wharf. (S41.277743° E174.789236°, taken on 22NOV16).

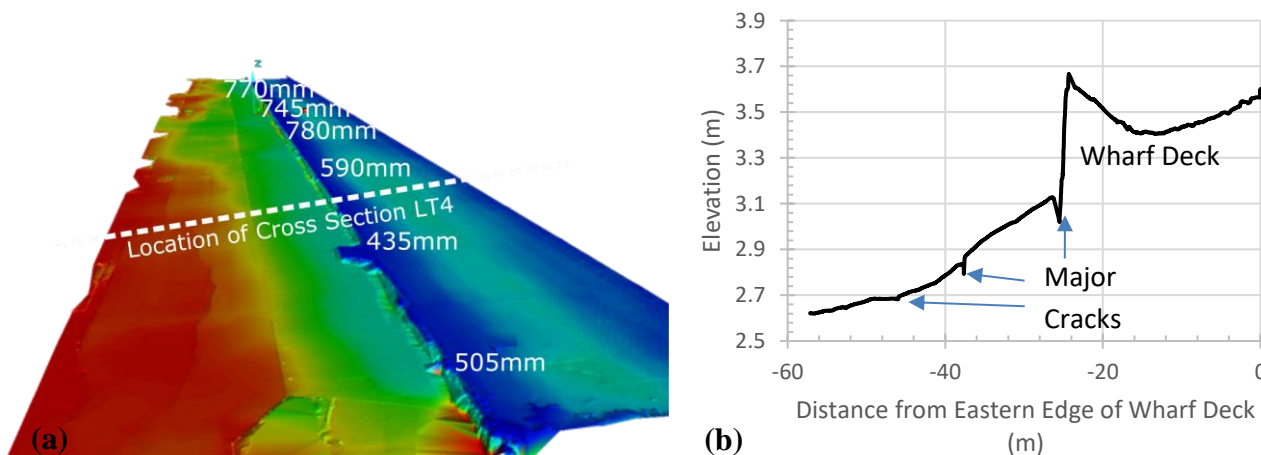
The lateral thrust from the displaced fill pushed the inland piles of the wharf towards the sea, causing tilt of the wharf. The crane rail tilted 2.5° down towards the sea at TWC-1 and 1° down towards the sea at TWC-2 (see Figure 15 for transect locations). Lateral seaward movement measurements of the bulkhead relative to the ground immediately inland range from 200 to 500 mm. These estimates are based on surface observations of asphalt cover movement, which do not necessarily represent movement of the underlying soil beneath the asphalt. In fact, at this interface zone of large horizontal and vertical offsets between the fill and wharf, cavities were apparent immediately below the distorted asphalt cover. Figure 20 shows the vertical offset created between the pile-supported wharf and reclaimed fill behind the wharf. Deformation of the Thorndon Wharf was also captured in the LiDAR survey (see Figure 21).

Figure 21: (a) Perspective view of the LiDAR DEM of the eastern section of the port looking northward including the Thorndon Wharf and surrounding fill area coloured by elevation to highlight discontinuities from cracks. Elevation ranges from approximately 2.60 m (red) to 3.60 m (dark blue). Differential settlements between the wharf and reclaimed land are identified. (b) Elevation profile for cross section LT4 across Thorndon Wharf and inland fill.

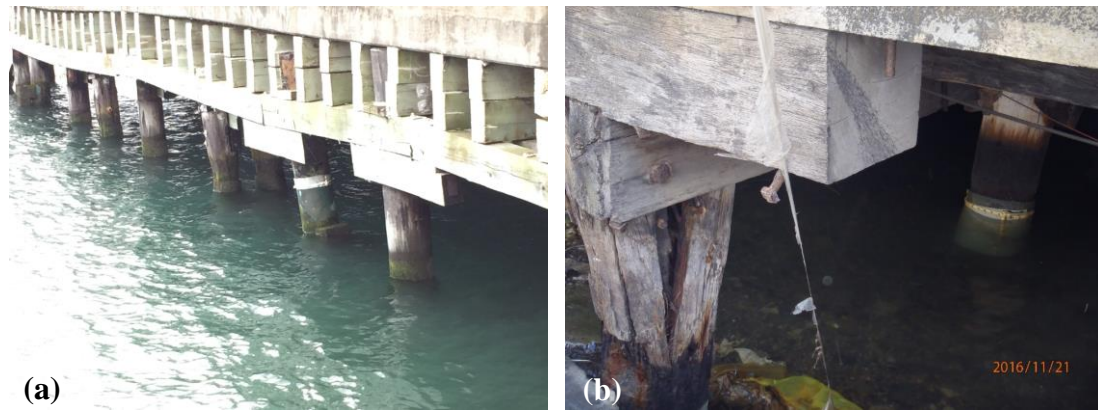
Westward movement of the structure is visible in Figure 22a, in which the southern bent of piles leans to the west. The inland timber piles split due to seaward lateral movement of the deck relative to this row of piles (Fig. 22b). Vertical warping of the wharf deck is shown in the LiDAR DEM (Fig. 23a). The wharf deck exhibits significant concavity (downward) as observed in the cross section plotted on Figure 23b. Differential settlement between the wharf and adjacent ground range from 475 mm to 630 mm, as measured from the LiDAR-derived DEM.

Figure 22: (a) Looking west along southern end of King's Wharf showing westward tilt of piles ($S41.281281^{\circ} W174.784097^{\circ}$, taken on 17NOV16), and (b) looking under King's Wharf at an inland bulkhead pile; timber pile is split from lateral movement of the deck relative to the pile. ($S41.280900^{\circ} E174.784375^{\circ}$, taken on 21NOV16).

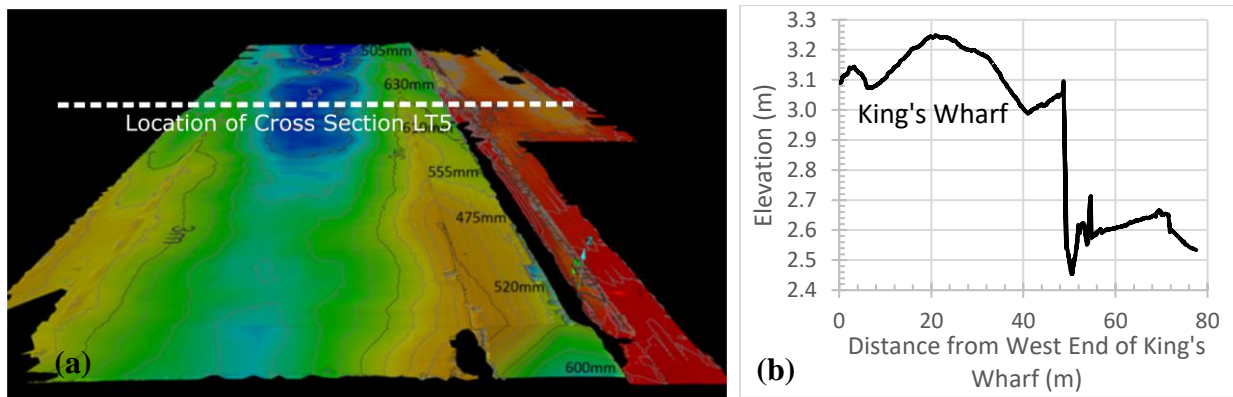
Figure 23: (a) LiDAR derived DEM (looking northward) of the pile-supported King's Wharf showing measurements of differential settlement between the wharf and the adjacent ground. Elevation ranges from approximately 2.50 m (red) to 3.30 m (dark blue). (b) Cross section LT5 taken across King's Wharf and the adjacent ground.

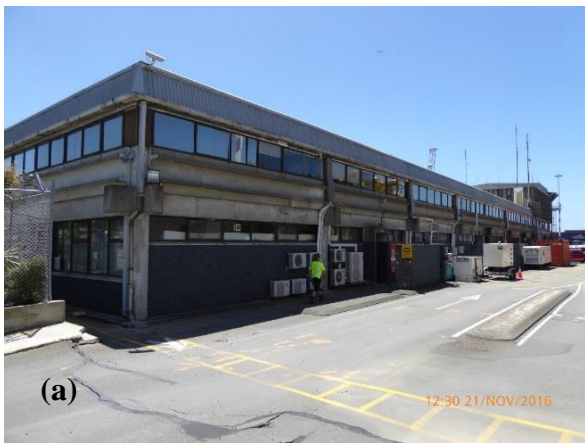
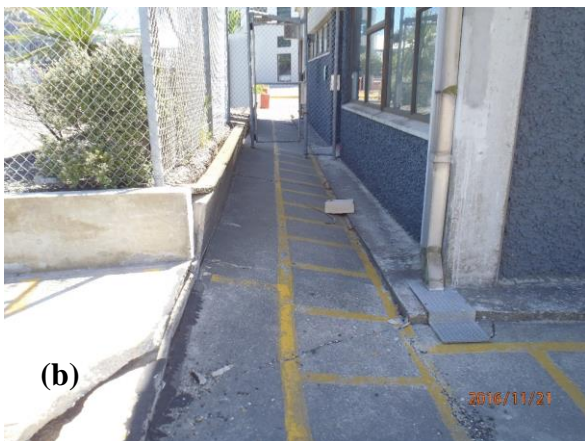
The CPH building ($S41.27829^{\circ} E174.78618^{\circ}$, see Figure 24) is founded on reinforced concrete (RC) spread footings connected with RC grade beams (Figure 25a). There were no apparent signs of structural distress, and the building was operational at the time of the reconnaissance in late November 2016. The building and immediately surrounding fill settled relatively uniformly. Settlement appeared to be more or less uniform across the building footprint, as there were no apparent signs of relative movement or tilt of the ground floor of the CPH building from the visual investigation. However, a preliminary analysis of the LiDAR scans indicate a slight tilt (i.e., of 0.105 degrees) in the large operations room on the east end of the building. Ground a few meters to the west of the CPH building did not appear to settle significantly, because it was supported by the buried precast seawall that ran along the bulkhead of the partially demolished Pipitea Wharf, which minimized liquefaction-induced settlement of the ground above it. The building and fill settled approximately 230 to 260 mm relative to the elevated ground supported on the seawall (Figure 25b).

Figure 25: (a) Uniform settlement of CPH building which is founded on shallow foundations that apparently displaced downward the same amount as the surrounding fill. This photo is looking northeast at the southwest corner of the building. (S41.278395° E174.785639°, taken on 21NOV16). (b) Uniform settlement (230–260 mm) of the building relative to ground supported on the buried precast seawall that ran parallel to the bulkhead of partially demolished Pipitea Wharf. Looking north along western wall of CPH building. The perimeter walkway slopes down towards the building at 11 degrees over 1.35 meters. (S41.278395° E174.785639°, taken on 22NOV16).

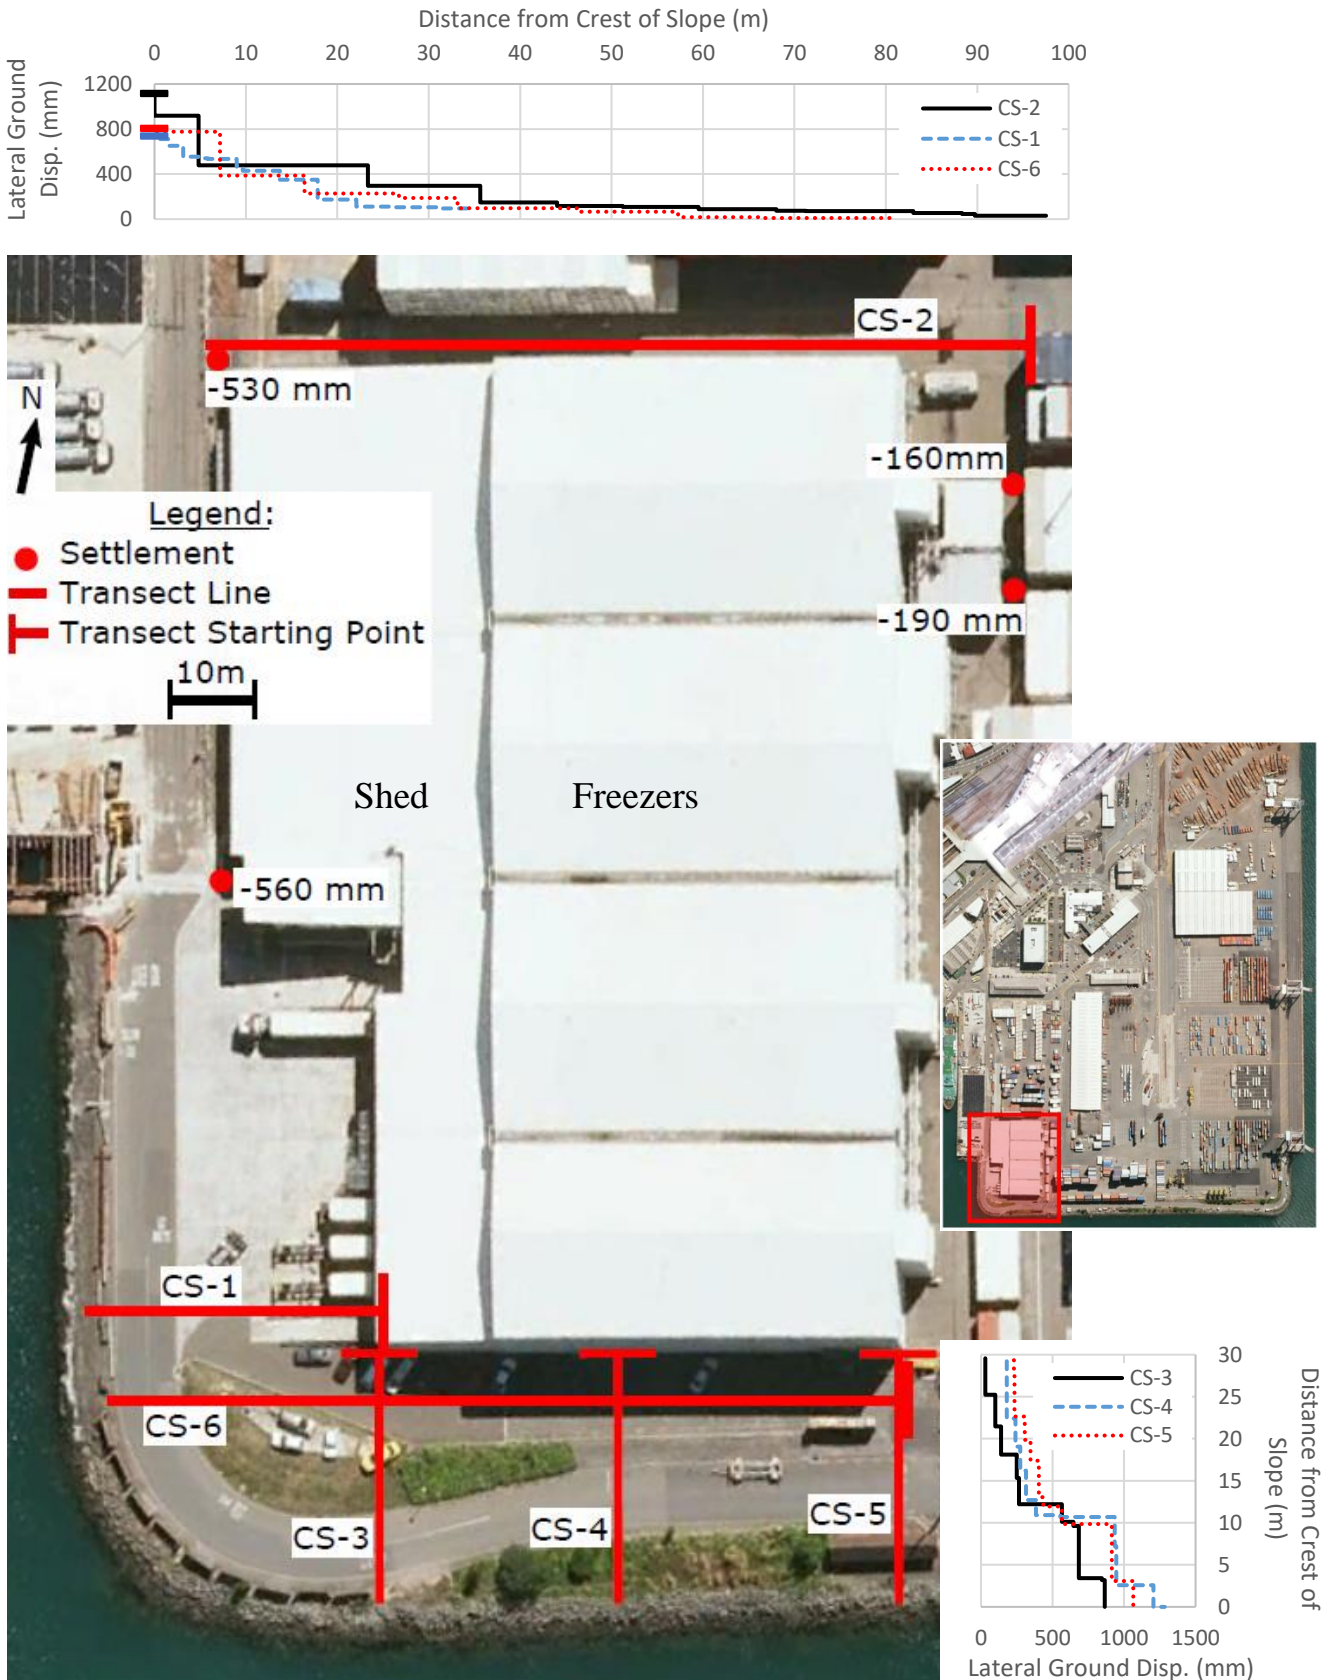
this figure are plots of cumulative lateral ground displacement as a function of distance from the crest of the waterfront slopes for each transect. They show the fill moved towards the sea (southward) approximately 0.8 to 1.3 m (relative to the reference point of measurement), at the south side of the building. The fill moved 0.8 to 1.1 m to the west. The foundations of the building were subjected to a lateral stretch of approximately 200 mm over a column span of approximately 8.8 m. This corresponds to a lateral strain of about 2.3%.

Figure 26: CS building lateral ground movement transects and vertical settlement measurement locations. Cumulative ground displacement versus distance from crest of slope are provided in the inset plots. Note that the crest of slope is further east at CS-2 than at CS-1 and CS-6, therefore, displacement plots do not perfectly align with satellite image for CS-2. Settlement measurements to the northeast are relative to the building which also settled.

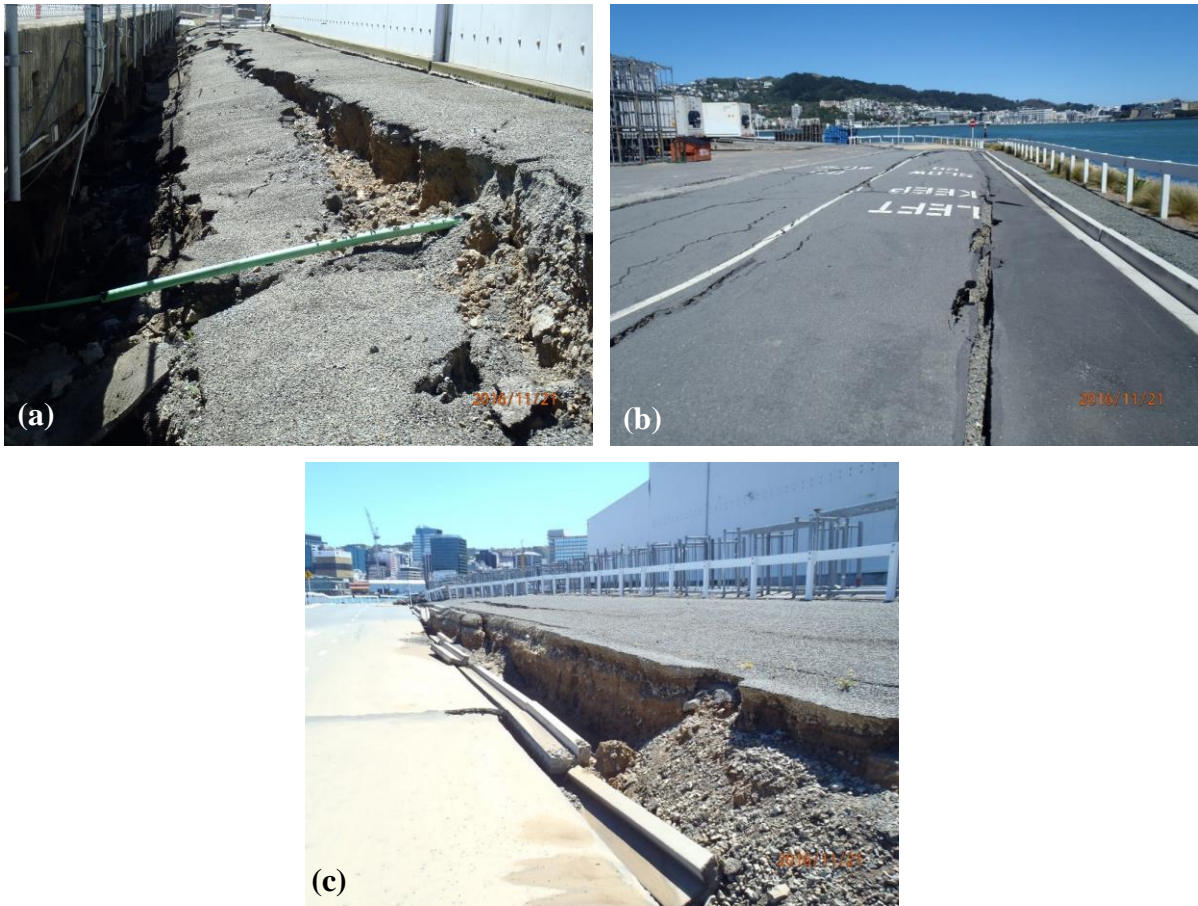
Gravelly liquefaction ejecta was observed around the building. Figure 27a shows lateral ground movements and partial collapse of the slope at the reclamation edge along the western wall of the Shed of the CS building (which is parallel and adjacent to King's Wharf), where the ground settled approximately 530 mm relative to the King's Wharf. This part of the building is closest to the crest of the slope and it underwent the largest lateral movement. Figure 27b shows lateral movements near the crest of the western slope, and Figure 27c shows lateral spreading towards the southern slope with a consequent vertical offset of approximately 1.1 m. Significant separation between the CS building foundation and external pavement slab were observed on the south side of the building (as well as settlement and spreading of the surrounding pavement). Shallow soils beneath the pavement were exposed in large cracks and vertical offsets surrounding the building, and these soils consist of gravelly quarry-rock reclamation fill.

Figure 27: (a) Looking north along the west wall of the CS building. The ground settled approximately 530 mm relative to the pile-supported bulkhead of King's Wharf, which is shown at the left side of the photograph. (S41.280923° E174.784389°, 21NOV16); (b) Ground cracks in area west of the CS building and along the southwestern slopes of CentrePort (looking south). The CS building can be partially seen on the upper left corner of the photograph. (S41.281478° E174.784430°, 21NOV16); and (c) Approximately 1.1 m of vertical offset resulting from the southward lateral movement of the southern edge of CentrePort reclaimed land near its western side. Looking west near the southern wall of the CS building. (S41.281701° E174.785268°, 21NOV16).

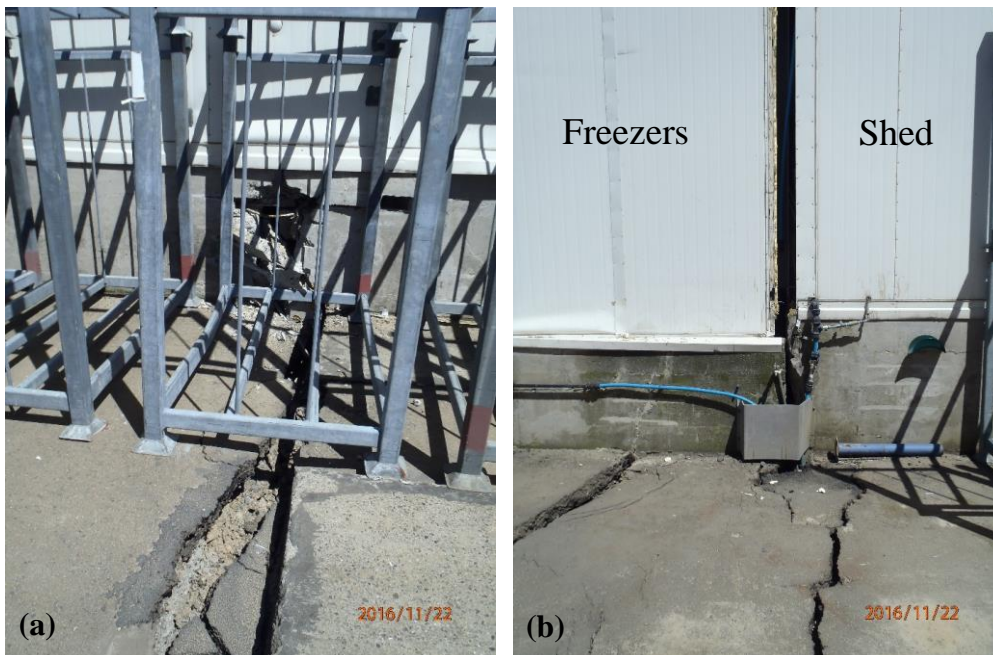
Figure 28a documents significant cracking resulting in exposure of rebar in the foundation of the CS building along the exterior northern wall. The photograph looks south at the north wall of the CS building, however, this same ground crack runs northward continuously for approximately 100 m. Crack widths and locations along the bottom of the outside walls of the CS building were also measured. Figure 29 shows results of this survey, which are consistent with the previously described lateral spreading measurements and also indicate a lateral stretch of the shallow foundation of the Shed of approximately 200 mm in the westward direction along the northern wall.

Figure 28: Cracks along the exterior north wall of CS building: (a) 180 mm crack in the foundation of the CS shed from westward lateral spreading (S41.280607° E174.784533°, 22NOV16), and (b) 150 mm of separation between the Shed and Freezers (i.e., westward/seaward movement of the Shed relative to the Freezers), (S41.280584° E174.784705°, 22NOV16).

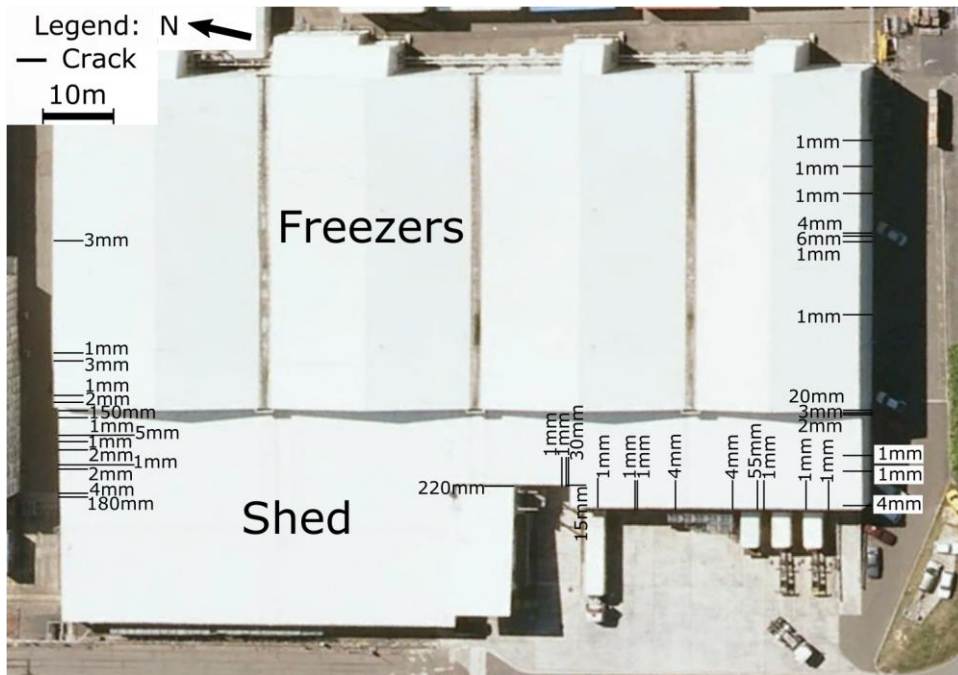
Figure 29: Location and width of lateral ground movement-induced cracks in the RC concrete walls at the base of the exterior building walls of the CS building. Crack openings are parallel to the respective wall.

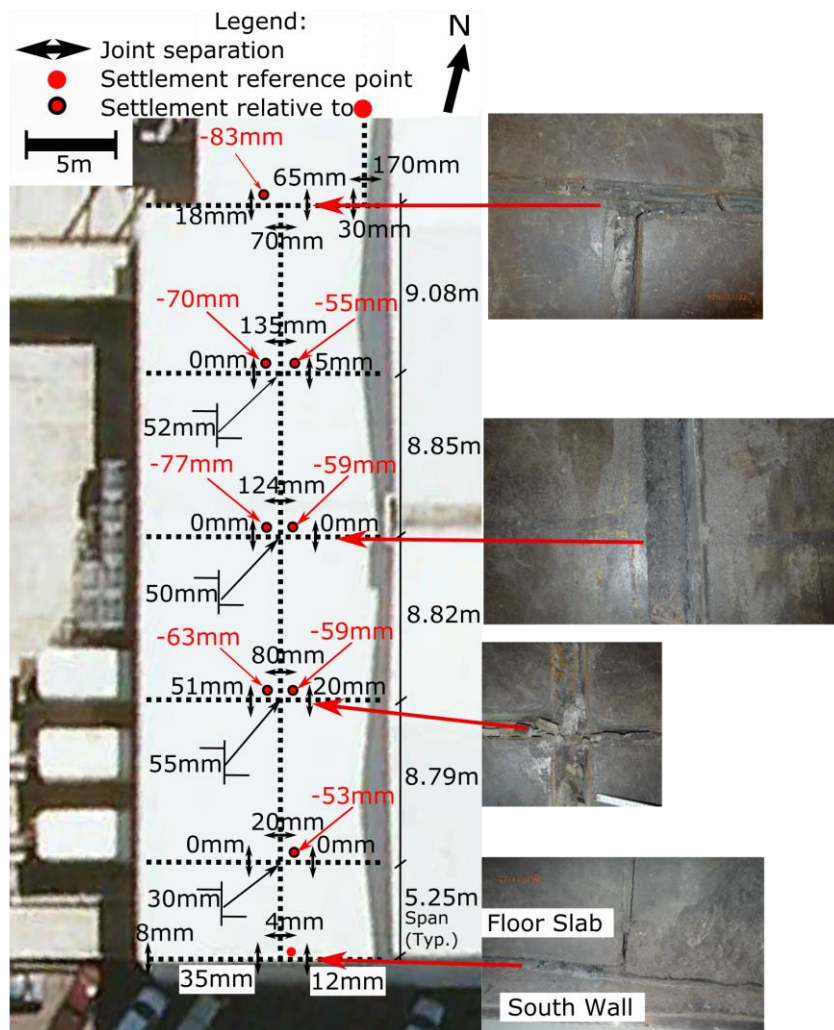
Figure 30: Southern part of Shed floor slab construction joint separation measurements. Photographs along right side of figure are of construction joints at which measurements were taken and are aligned vertically with each depicted joint. (Surveyed 22NOV16).

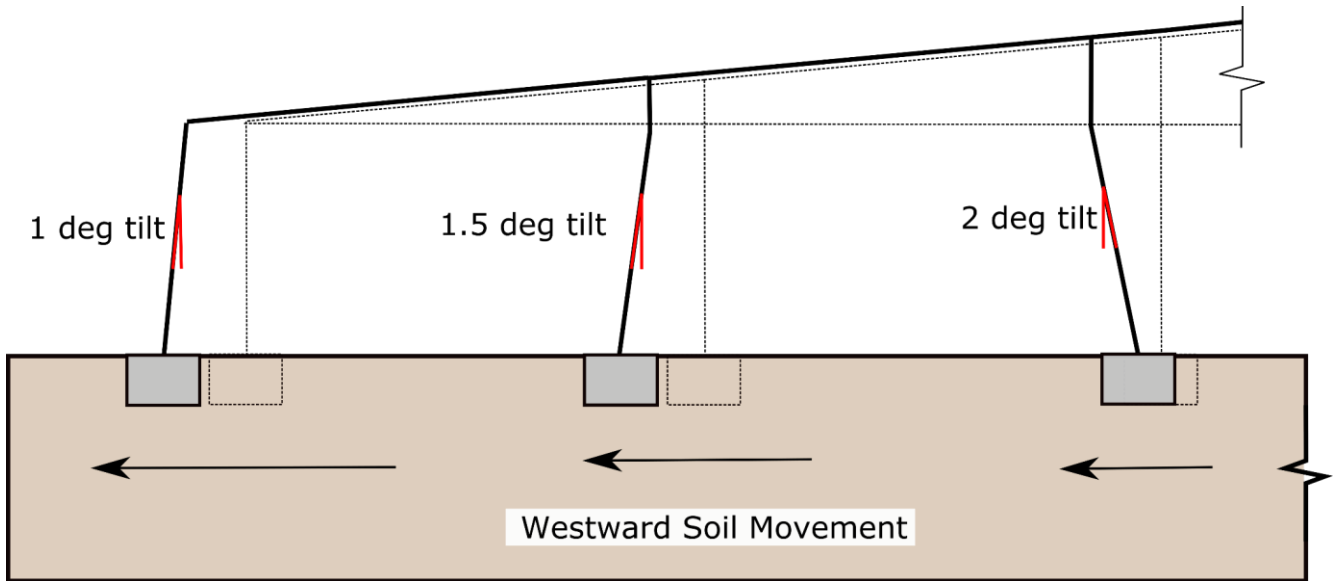
Figure 31: Schematic of deformation pattern of steel frame along the north wall of CS building (three west-most columns of the Shed; looking north from interior).

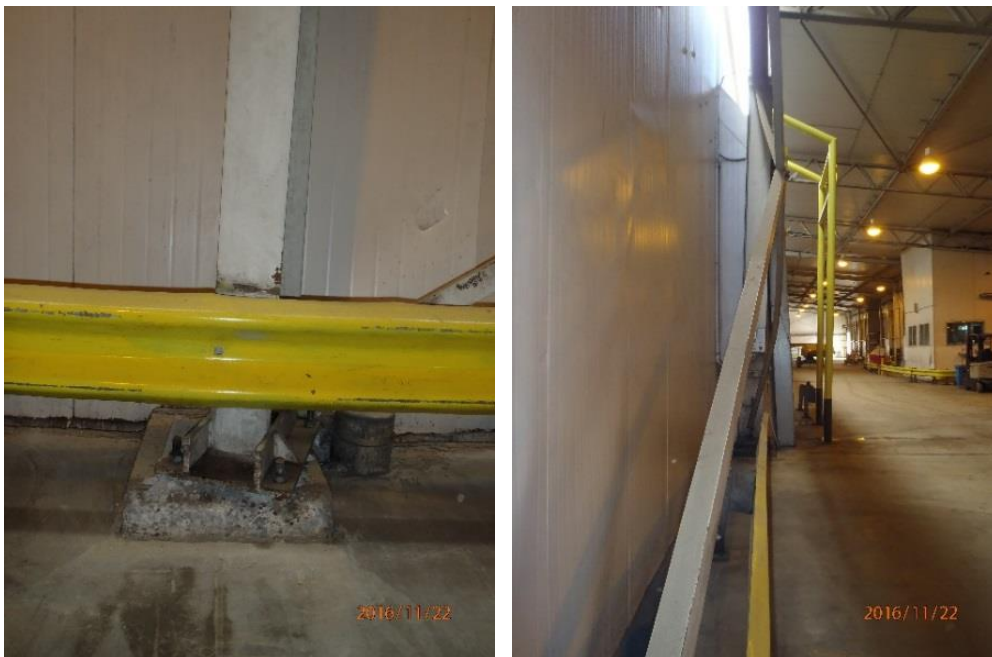
The western part of the CS building (i.e., the Shed) is a steel-frame, single-story structure with an open bay. The total span of the Shed on its north end is about twice as wide as its span width on its south end. The northwest part of the Shed is closest to the free-face of the slope and consequently experienced the largest lateral ground movement. Thus, the northern part of the Shed displaced laterally westward more than its southern end. The westward lateral movement of the north end of the building separated the Shed from the Freezers along the northern half of the building (Figure 28b). The differential lateral ground movements across the north-south length of the Shed produced deformations, cracks, and openings in the overlying foundation and structure. This deformation pattern was apparent by comparing the magnitude of building cracks along the north wall to those on the south wall (Figure 29), as well as separation of construction joints in the interior floating slab of the Shed. Measurements of construction joint separation in the slab are shown schematically in Figures 30 for the southern part of the Shed. The differential lateral ground movements across the footprint of the Shed part of the CS building were also manifested in the deformation pattern of its steel framing. This deformation pattern is shown in Figure 31, which is a schematic of the three west-most columns of the four column frame along the north wall looking north from the interior. The column span is approximately 8.7 m. In addition to the tilting of these columns along the north wall, at least two columns along the east wall of the shed were rotated at the base, causing buckling of the concentric bracing between columns (Figure 32).

Figure 32: Internal east wall in northern part of the Shed, which shows column-pedestal connection failure due to rotation of the base of the column and buckling of concentric bracing. (Approx. at S41.280939° E174.784778°, 22NOV16).

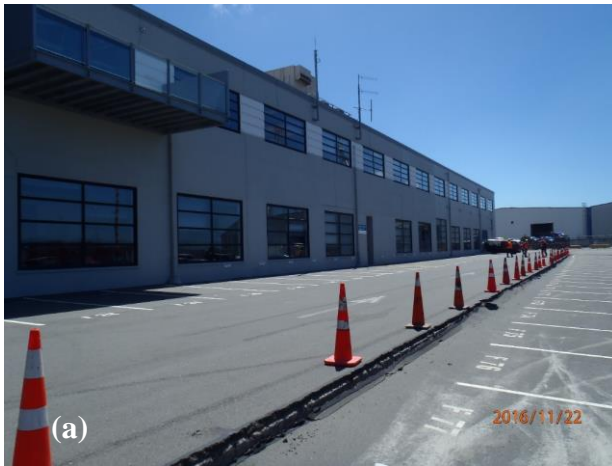
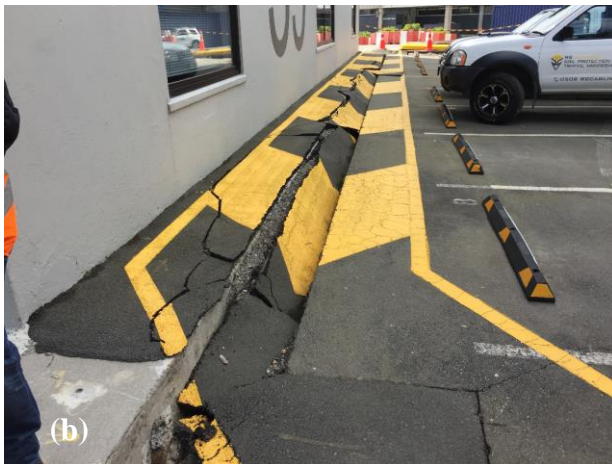
The S39 building (see Figure 24) is supported on Frankie piles. The old buried mass concrete seawall (i.e., Old Seawall) runs parallel and adjacent to the southeast wall of the building. Additionally, along the southeast wall, a segment of the historic Fryatt Quay Wharf deck (Figure 3) was left intact. The ground to the south of the seawall and wharf settled 220 mm relative to the top of the wharf deck and the pile-supported building (Fig. 33a). Approximately 100 to 190 mm of settlement was observed along the southwest wall of the building (Figure 33b). On the northwest side of the building, the ground adjacent the building settled approximately 50-100 mm relative to the building. The

Figure 33: (a) Southeast side of Building S39 and a buried segment of the Fryatt Quay Wharf deck parallel to the building. Fill to the south of the buried mass concrete seawall/wharf settled 220 mm relative to the pile-supported building and wharf deck. ($S41.277984^{\circ}$ $E174.785776^{\circ}$, 22NOV16), and (b) looking southeast along southwest wall of Building S39. Fill settled approximately 190 mm relative to pile-supported building at the northwest corner of the building (shown on lower left corner of photo), and magnitude of settlement decreased south-eastward along this wall. ($S41.277994^{\circ}$ $E174.785467^{\circ}$, 17NOV16).

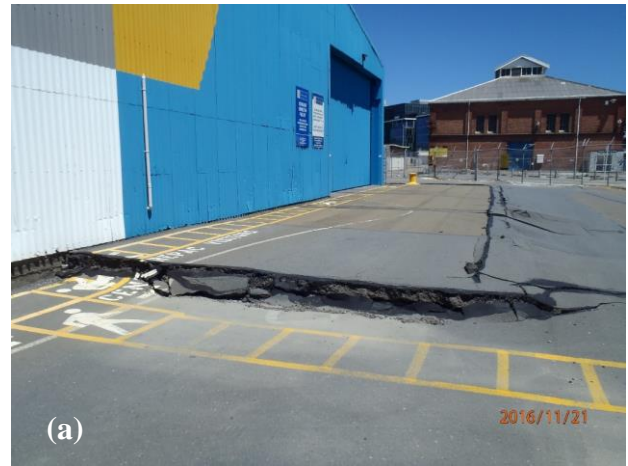
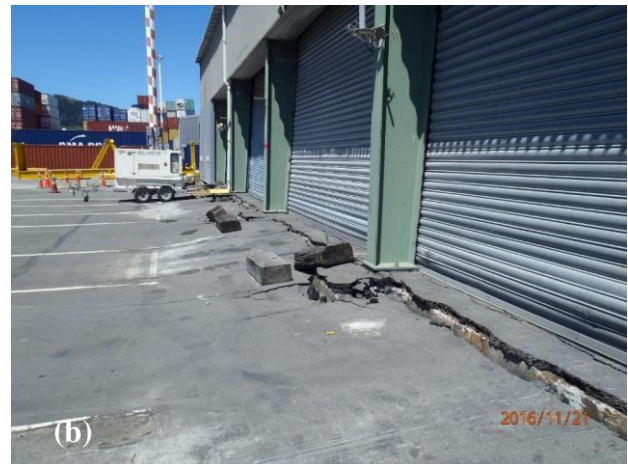
The western half of the S37 building (see Figure 24) is founded on the deck of the buried, partially demolished pile-supported Pipitea Wharf, and the east wall of the building is supported on piles. The precast seawall that formerly ran along the bulkhead of the Pipitea Wharf is now buried and runs south-to-north through about the centerline of the building. The ground floor slab not supported on piles, the old wharf deck, or the precast seawall settled up to 550 mm relative to these structures (Figure 34a; the value is based on measurement from LiDAR scan for this building). The ground settled approximately 375 mm relative to the building along the exterior of the east wall of the S37 building (Figure 34b). Approximately 16 m west of the western wall of the S37 building, a buried row of piles from the old Pipitea Wharf protruded from the ground as the surrounding fill settled approximately 300 mm relative to the piles (Figure 17).

Figure 34: (a) Looking west across north wall of Building S37. Approximately 400mm of differential settlement between ground and deck of buried, pile-supported Pipitea Wharf that supports the western side of the shed. ($S41.278571^{\circ}$ $E174.785632^{\circ}$, 21NOV16); and (b) looking south along east wall of Building S37, which shows approximately 375 mm of differential settlement between fill and pile-supported east wall of the building. ($S41.279065^{\circ}$ $E174.785787^{\circ}$, 21NOV16).

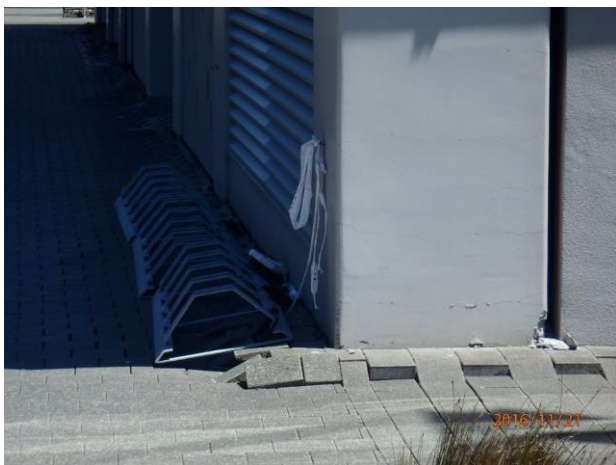
team visit though some level of distress in the ground adjacent to the building was evident. The ground settled 100 to 200 mm relative to the pile-supported building (Figure 35), in a relatively uniform fashion though some deviations from this pattern were also evident. Ground floor infill walls along the perimeter of the building were cracked in places, and the Level 1 floor slab pulled out and partially collapsed.

Figure 35: Looking west at southeast corner of the S building at which fill settled approximately 100 to 200 mm relative to pile-supported building. (S41.278285° E174.784757°, 21NOV16).

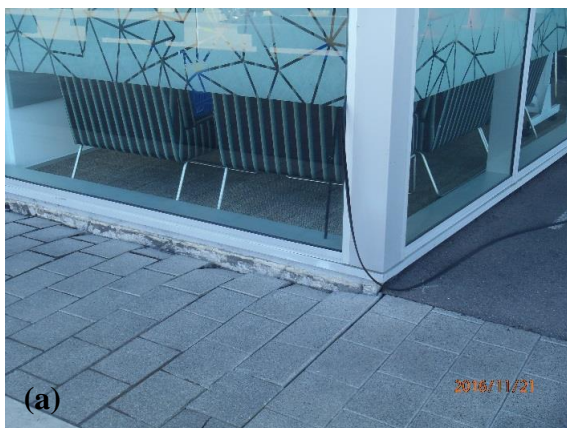
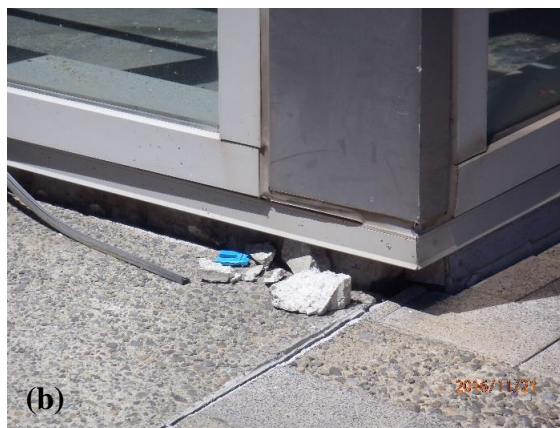
The B building (see Figure 24) is supported on piles with stone column ground improvement performed over the southeastern (seaward) half of the building footprint. The surrounding ground settled approximately 50 to 90 mm uniformly relative to the building (Figure 36). No other significant movements were observed.

Figure 36: Ground settlement relative to the pile-supported B building at: (a) the southwest corner of the building with ground improvement (S41.279767° E174.782100°, 21NOV16), and (b) northwest corner of the building without ground improvement (S41.279419° E174.781443°, 21NOV16).
