PERFORMANCE OF EARLY MASONRY, COB AND CONCRETE BUILDINGS IN THE 14 NOVEMBER 2016 KAIKOURA EARTHQUAKE

Dmytro Dizhur¹, Marta Giaretton² and Jason Ingham³

ABSTRACT

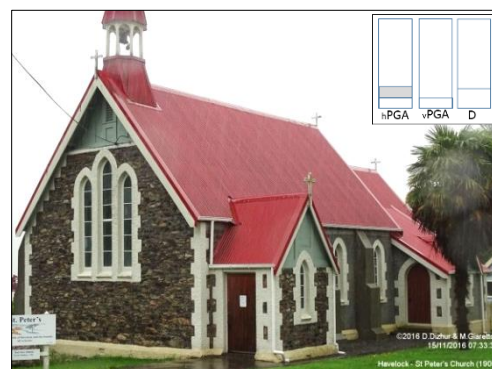
(a) St Peter's Church (1905, Heritage List #1496, likely to be seismically retrofitted)

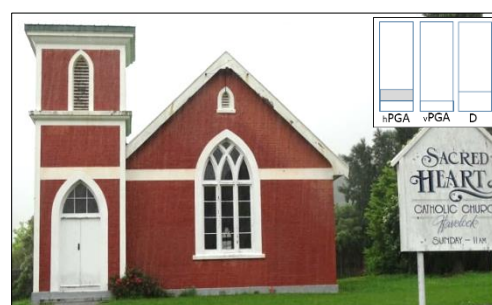
(b) The Sacred Heart Church

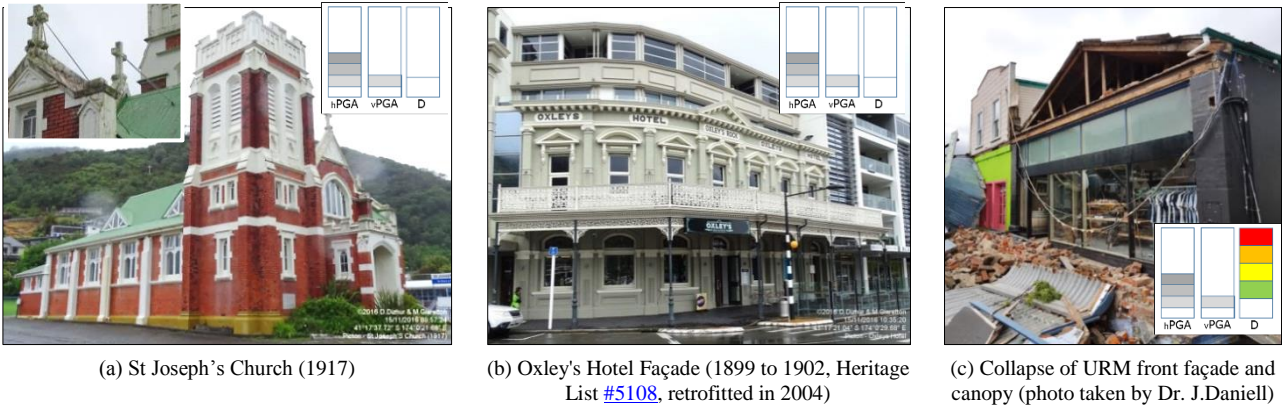
inspection of the Oxley Hotel's URM façade, see Figure 4b. Within Picton the most extensive observed damage was the collapse of a single URM gable wall from a single storey URM retail building located on the main street of Picton, leading to the collapse of a canopy, see Figure 4c.

Figure 4: Unreinforced clay brick masonry buildings in Picton (hPGA 0.262g, vPGA 0.100g – QCCS).

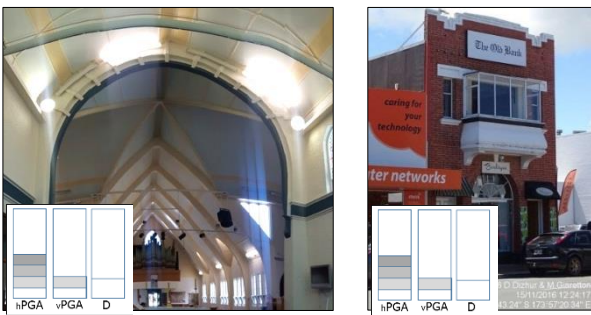
(a) The Church of Nativity (1906 and 1956, retrofitted in 1983) – internal view (b) Bank of Australasia (1926, Heritage List #9301, retrofitted)

Figure 5: Unreinforced clay brick masonry buildings in Blenheim, (hPGA 0.269g, vPGA 0.089g – MGCS).

The Bank of Australasia is a listed heritage building (#9301, see Figure 5b) and is a two-storey commercial URM building constructed in 1926 and seismically retrofitted in 2005 using steel structural members. Based on a detailed internal and

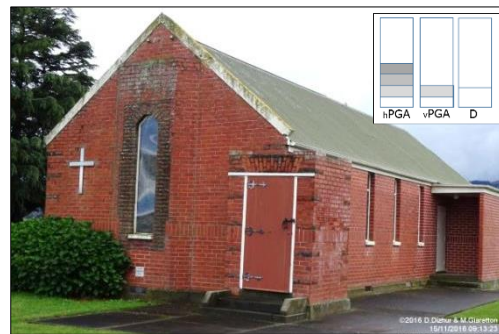
external inspection, no earthquake related damage was observed in the Bank of Australasia building. The Rapaura Community Church is in the surrounding area north of Blenheim and from an external inspection the building appeared to be clay-brick cavity masonry construction, with no earthquake related damage being identified, see Figure 6.

Figure 6: Unreinforced clay brick masonry church in Rapaura, (hPGA 0.269g, vPGA 0.089g – MGCS).

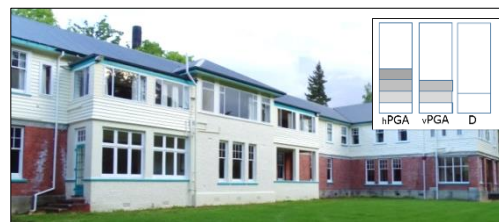
(a) Nurses' Hostel (1928-1929) with loadbearing cavity-URM walls on ground floor and timber framed walls on the upper level

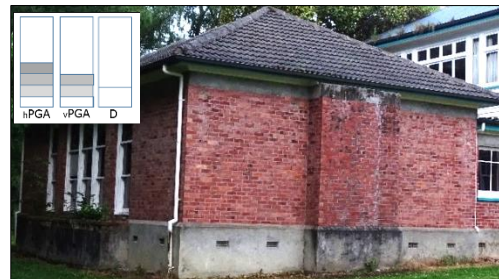
(b) Close-up of the loadbearing URM cavity-walls, Nurses' Hostel

The historic Queen Mary Hospital in Hanmer Springs (hPGA 0.263g, vPGA 0.162g – HSES) was inspected in great detail, with no identified structural damage to the URM loadbearing walls. Significant damage was only observed in the URM chimneys, reported herein in a subsequent section. The vintage hospital complex is part of the Heritage List (#7583 and #7612) and includes the Soldiers' Block (1916) and the Chisholm Ward for female patients (1926) which are two single storey timber buildings with URM chimneys, and the Nurses' Hostel (1928-29, see Figure 7) which is a two storey building with loadbearing cavity-wall clay brick masonry on the ground floor and timber weatherboards on the first floor.

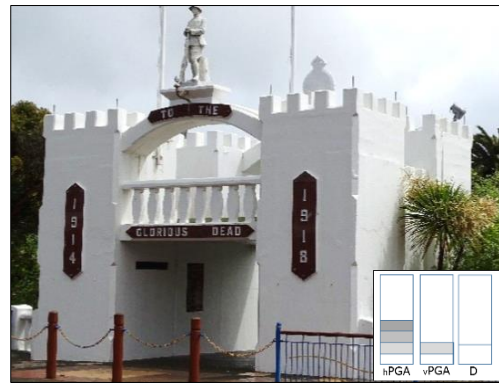
Several vintage concrete buildings and monuments were inspected in the north part of the South Island. The former Public Trust Office Building (Heritage List #1530) was constructed in 1924 in the Art Deco style with a magnificent columned façade, and was turned into a bar and hotel in 1993, see Figure 9a. The only damage suffered to this building was related to horizontal cracks localised at the perpendicular walls next to the main building entrance. The Court House (1937, Heritage List #1509) and the War Memorial and Clock Tower (1928, Heritage List #243) are thought to be reinforced concrete structures with stone facing and no damage was identified, see Figure 9b-c. The Picton War Memorial had no observed damage, even to free-standing appendages, see Figure 8.

Figure 8: Vintage concrete structures in Picton (hPGA 0.262g, vPGA 0.100g – QCCS).

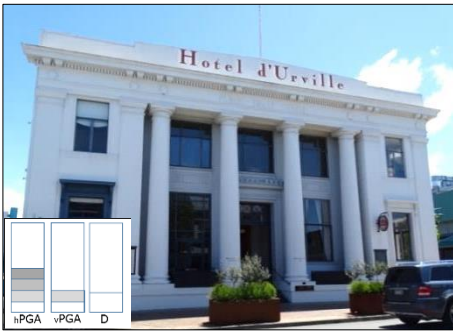
(a) Former Public Trust Office Building (1924, Heritage List #1530).

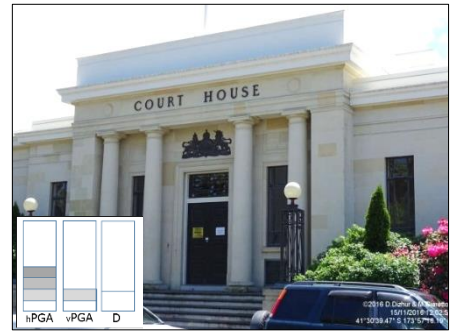
(c) Court House (1937, Heritage List #1509)

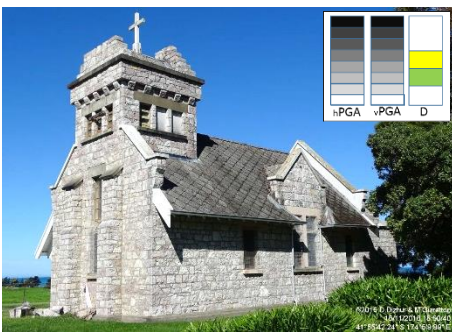
2013 Lake Grassmere earthquakes [10]. However, during the 2016 Kaikoura earthquake the horizontal and vertical accelerations recorded were 1.278g and 1.271g respectively (WDFS – Ward, 10 km North), causing the collapse of one of the parapets above the tower and diagonal cracking and shear sliding cracks along the lateral walls as shown in Figure 10.

(a) St Oswald's Church (1927)

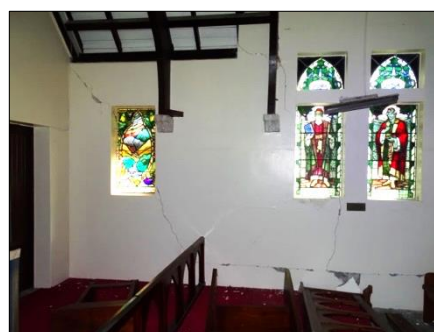
(b) Internal view with diagonal shear and shear sliding cracks

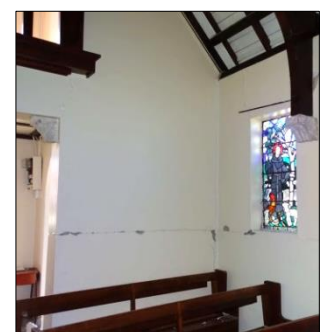
(c) Internal view with shear sliding cracks

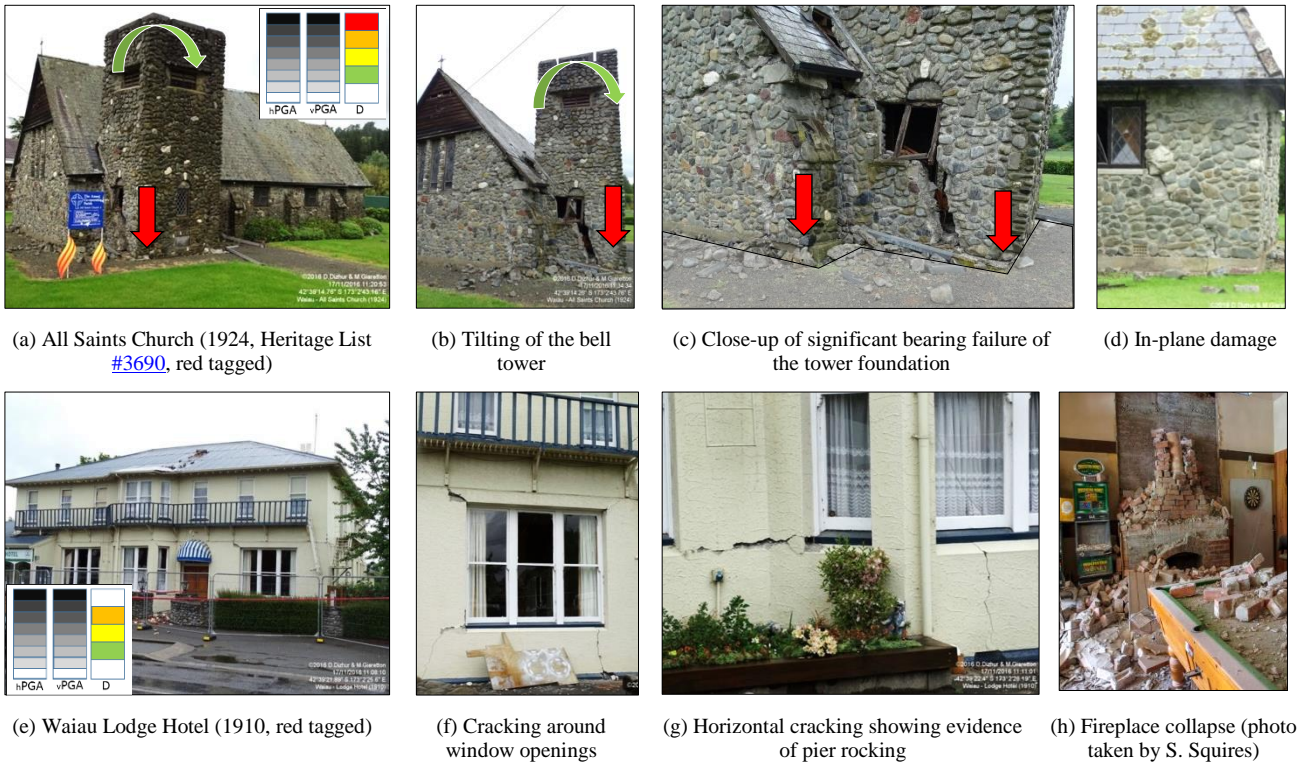
Figure 11: Vintage concrete buildings in Waiiau (hPGA 1.124g, vPGA 3.216g – WTMC).

The Waiiau Lodge Hotel is a concrete two-storey building constructed in 1910 that was severely damaged, see Figure 11e. All three URM chimneys fell through the roof, severely damaging the adjoining rooms (see Figure 11h), and in-plane diagonal cracks around openings and pier rocking damage was observed on the front and back façades (see Figure 11f-g).

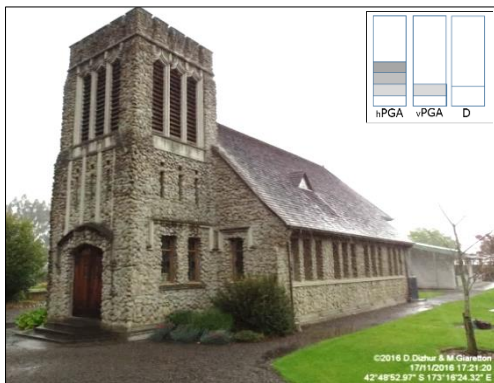
Knox Presbyterian Church in Cheviot was built in 1952 using a similar construction method as used in the All Saints Church Waiiau: stone gathered from near the Hurunui River and a lightly reinforced concrete core. Cheviot is located along State Highway 1, 17 km east of the epicentre, and the area experienced a significantly lower peak horizontal acceleration (0.288g) than in Waiiau, resulting in no visible damage being detected during a detailed external inspection of the church structure. Another vintage concrete structure that was investigated was the Old Train Tower located in Rotherham and probably constructed between 1914 and 1919 when the railway connecting Waiiau to Culverden (aka Waiiau Branch) was built. A large concrete store stands above two tall concrete portals, which experienced heavy damage at the column bases and at the beam-column joints, as shown in Figure 13. The Waiiau Branch railway closed in 1978.

Figure 12: Vintage concrete church in Cheviot (hPGA 0.288g, vPGA 0.09g – CECS).

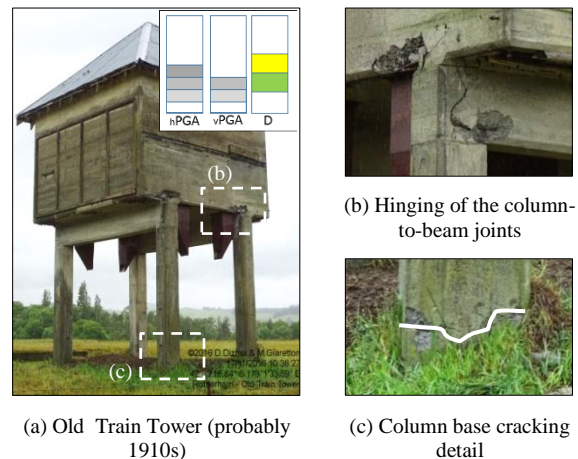
Figure 13: Vintage concrete structures in Rotherham (hPGA 0.280g).

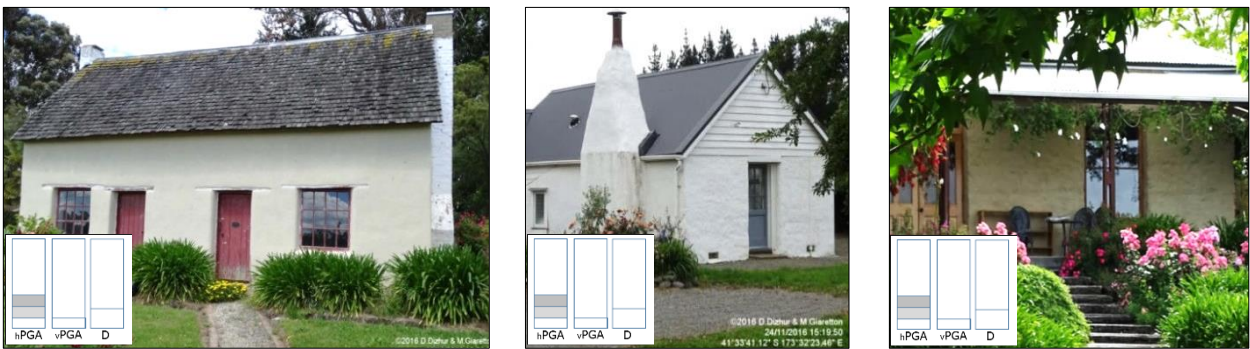
The two-storey Riverlands Cob Cottage (#1471, see Figure 14a) was constructed between 1854 and 1868 and served variously as a farm cottage, shearers’ quarters, school, a stove room, and a hay shed. The 400 mm thick walls are of a puddled clay and chopped tussock mixture reinforced with horse manure containing ‘undigested’ chaff. Restoration was undertaken between 1961 and 1965 by the Marlborough Historical Society and Historic Places Trust that included placing concrete blocks at the base of the walls which enabled the cottage to survive past earthquakes but attracted moisture

which has weakened the cob walls [18]. Strengthening of the cottage was undertaken in 2013, involving strengthening of the foundation to meet the requirements of the building code and to address the problem of rising damp, consolidation of the walls using strong lime-based plaster on both interior and exterior surfaces to protect the material, and repair and securing of the URM chimneys that were damaged during the 2013 earthquakes. No further damage was observed in the Riverlands Cob Cottage following the 2016 Kaikoura earthquake, as for the other cob houses in the area surrounding Blenheim (Wairau Valley and Renwick, see Figure 14b-c). Conversely, the Waiiau Cob Cottage museum was heavily damaged by the Kaikoura earthquake and received a red placard, see Figure 15. The cottage was built in 1866 using clay, straw and tussock (#3682) and appeared to be well preserved prior to the earthquake and to have been partially seismically strengthened. Evidence of the use of textile reinforced mortars was identified only on the south-west wall, which also presented cracks and localised detachment of the textile net. In all perimeter walls cracks were displayed around

(a) Riverlands Cob Cottage (1854-1868, Heritage List #1471) (b) Wairau Valley COB House (1860s, Heritage List #1472) (c) Renwick COB House (Heritage List #2922)

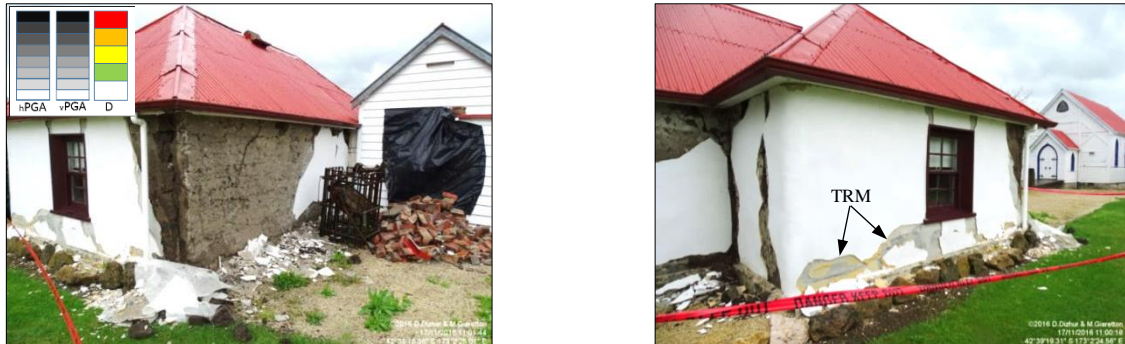
(a) Damage to the Cob Cottage museum (1866, Heritage List #3682, red tagged) (b) Evidence of Textile Reinforced Mortar (TRM) used as a retrofit intervention

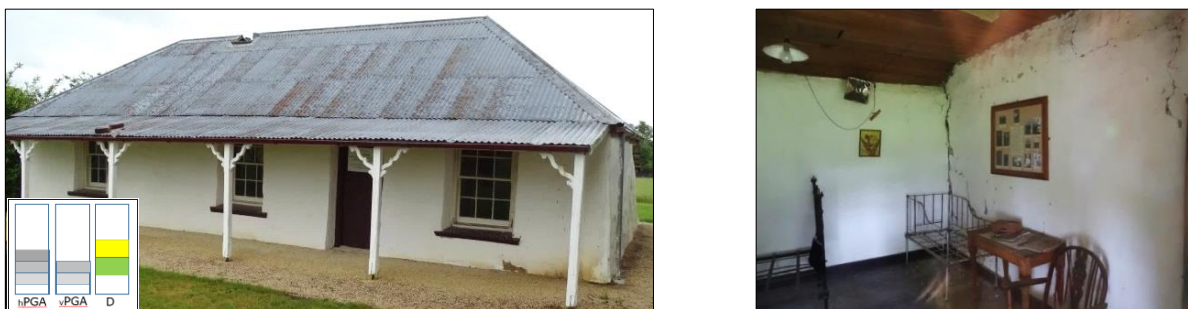
windows, roof and corners suggesting the potential initiation of an out-of-plane failure mechanism but without leading to collapse. Diagonal cracking and extensive detachment of the recent thick plaster was also observed. The URM clay brick chimneys located in the timber portion of the cottage had collapsed, see Figure 15a, while the timber church behind the cottage did not sustain any damage, see background of Figure 15b. Minor damage was also found in the Watters Cob Cottage in Rotherham, see Figure 16. The Watters cottage was originally built in 1885 (#3691) by John Watters who migrate from Ireland and lived in the building until 1961. The cottage was originally built with 500 mm thick cob walls and a thatched roof and was restored by the Hurunui District Council and New Zealand Historic Places Trust between 1991 and 1998, now being a testimony of the living conditions of many families in the late 19th century. During the 2016 Kaikoura earthquake the URM clay brick chimney collapsed (see Figure 16a) and localised cracks developed at the roof-to-wall and wall-to-wall connections, as shown in Figure 16b.

(a) Damage to the Watters Cob Cottage (1885, Heritage List #3691) (b) Internal view showing return wall separation

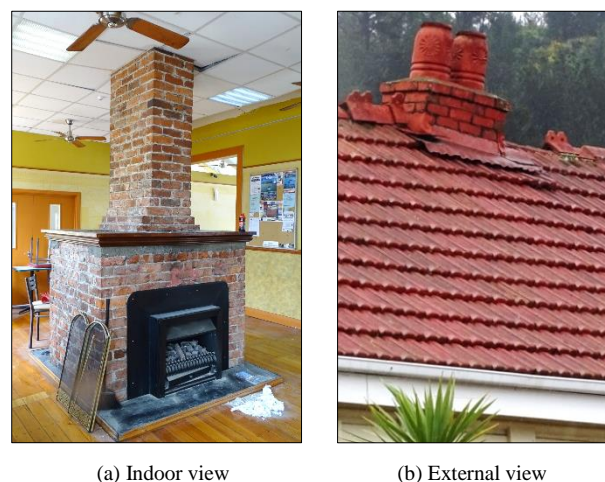
In a few cases residents were quick to remove damaged chimneys that remained standing and cover the stack, in order to eliminate the risk due to aftershocks or strong winds. At the Picton Railway Station there is a fireplace located in the middle of the timber building, where the chimney stack was cracked above the smoke chamber and had rotated, resulting in damage to the ceiling and the flashing, see Figure 17a. The roof coating around the chimney was also damaged and the free-standing chimney portion above the roof appeared to have displaced, see Figure 17b.

Figure 17: Historic URM chimney at the Picton Railway Station (1902, Heritage List #5392).

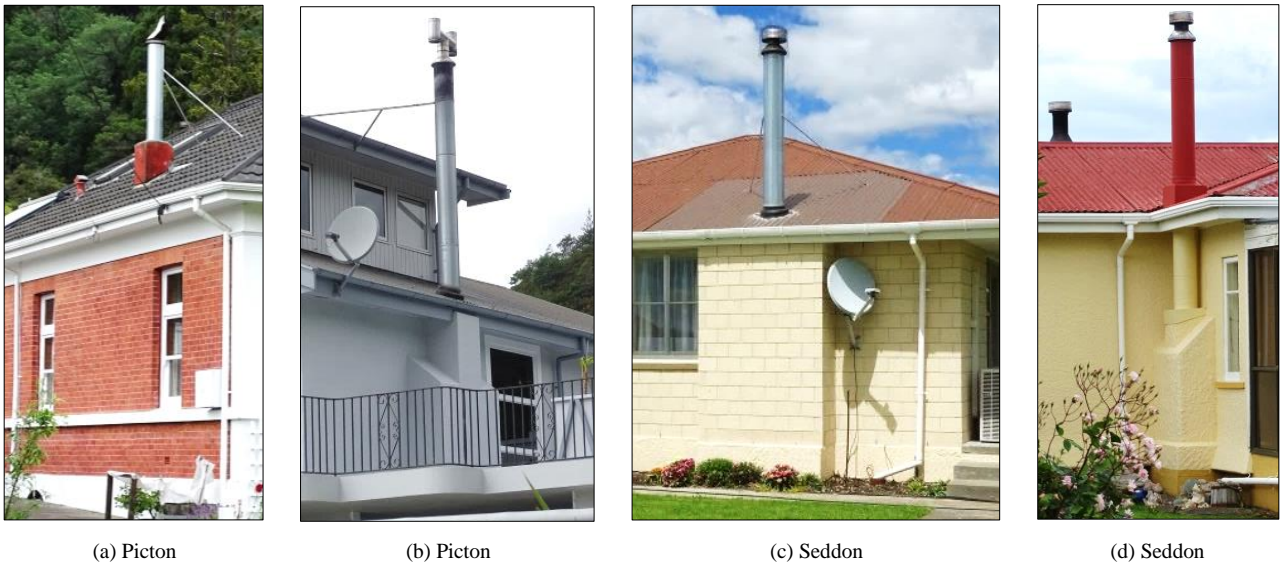
Numerous examples existed of chimney cracked at the roofline, and displaced and skewed chimney stacks after rocking due to the intense and long duration shaking, see Figure 18.

Figure 18: Examples of URM chimneys that had been removed and/or lowered to the roofline.

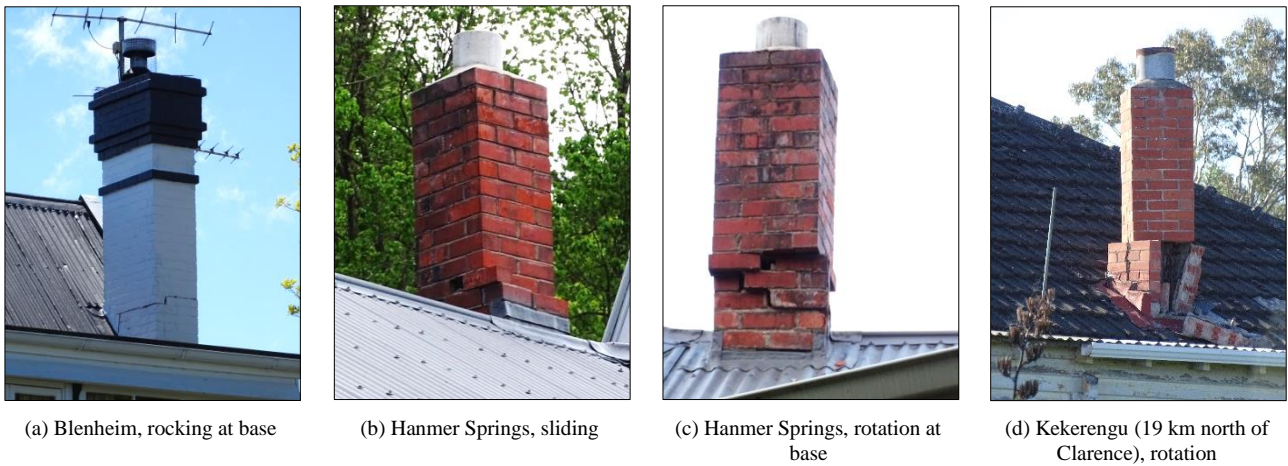
Figure 19: Examples of horizontal cracking at the chimney base with rocking (a) and sliding (b) or rotation (c, d).

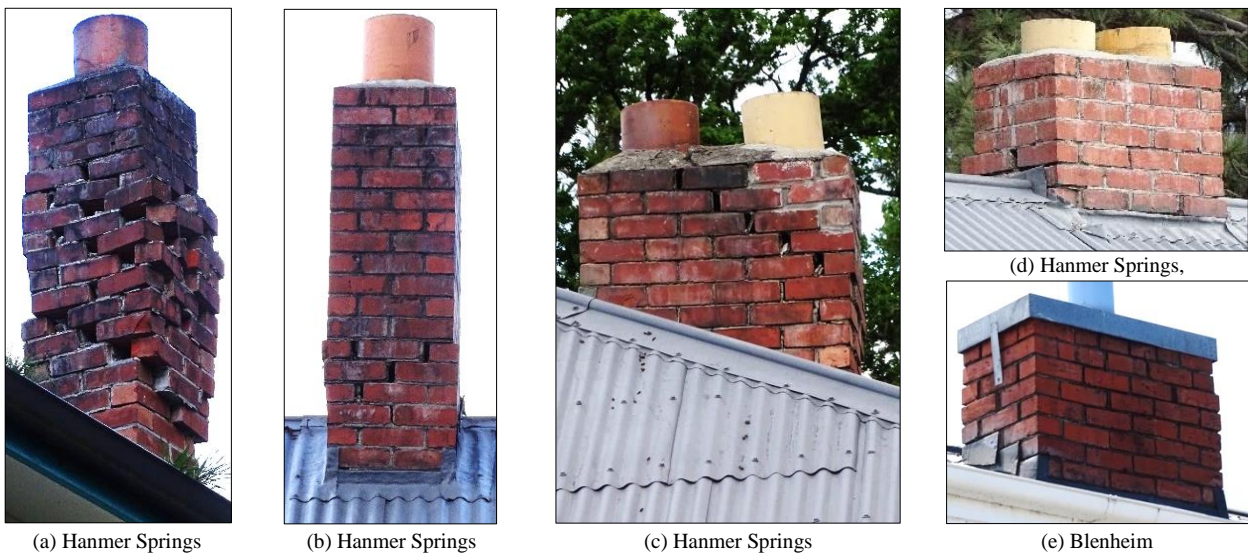
At the Queen Mary Hospital in Hanmer Springs most of the chimneys exhibited weak mortar disintegration and dislodged

bricks, resulting in badly damaged but standing URM chimneys that represented a significant falling hazard, see Figure 20. Extensive cracking and collapse of the top part of the stack occurred in an historic free-standing fireplace located in the countryside, 16 km west of Seddon, see Figure 21d. Several falling chimneys had punched through the roof, as well as a number of chimneys or chimney stacks that had toppled outside the building perimeter also being observed. Examples are illustrated in Figure 21 and Figure 22.

Figure 20: Examples of mortar disintegration and dislodged bricks for chimneys in Hanmer Springs at the historic Queen Mary Hospital and in Blenheim.

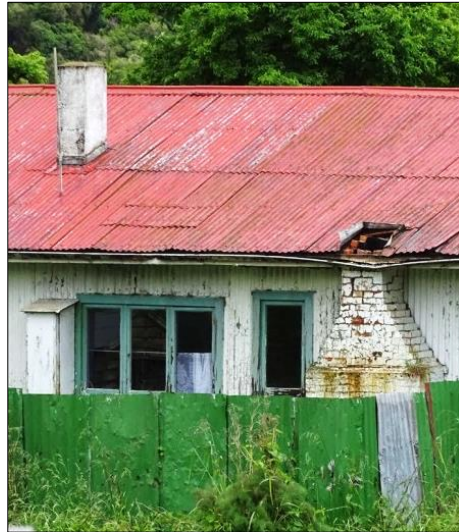
(c) Oaro

Figure 21: Examples of chimney toppling above the roofline.

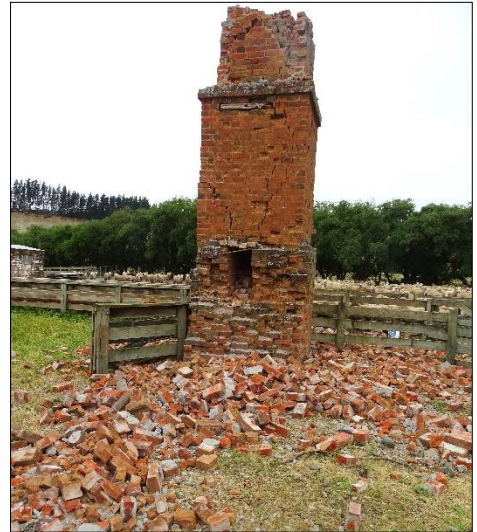
(d) Standalone historic URM chimney, located 16 km west of Seddon

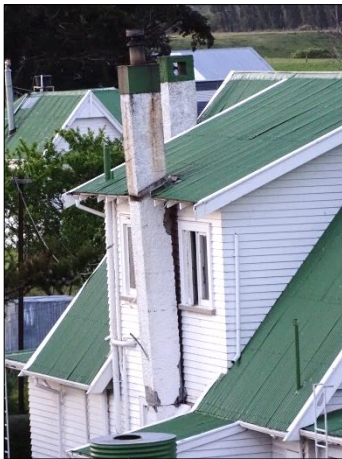
(a) Clarence

Figure 22: Examples of out-of-plane (a-c) detachment or (d-f) collapse of the chimney stack.

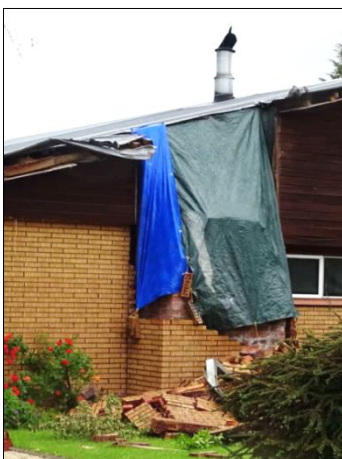
(d) Waiiau, veneer chimney

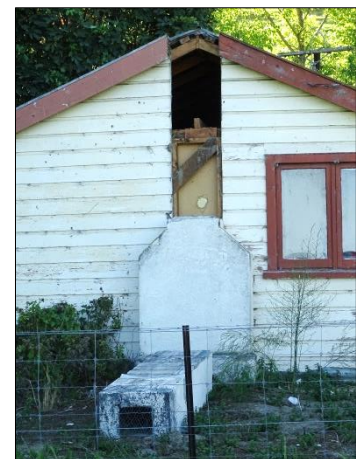
(f) Clarence, concrete stack

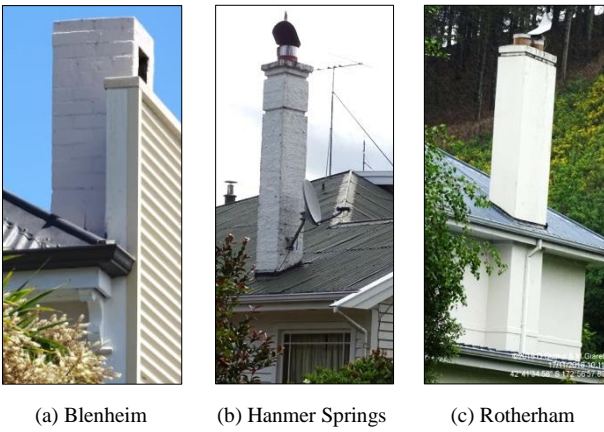
Despite the extent of damage described above and the large number of chimneys previously removed or lowered at the roofline, there were several cases of undamaged tall chimneys as shown in Figure 23.

(a) Blenheim (b) Hanmer Springs (c) Rotherham

Figure 23: Examples of tall non-damaged URM chimneys.

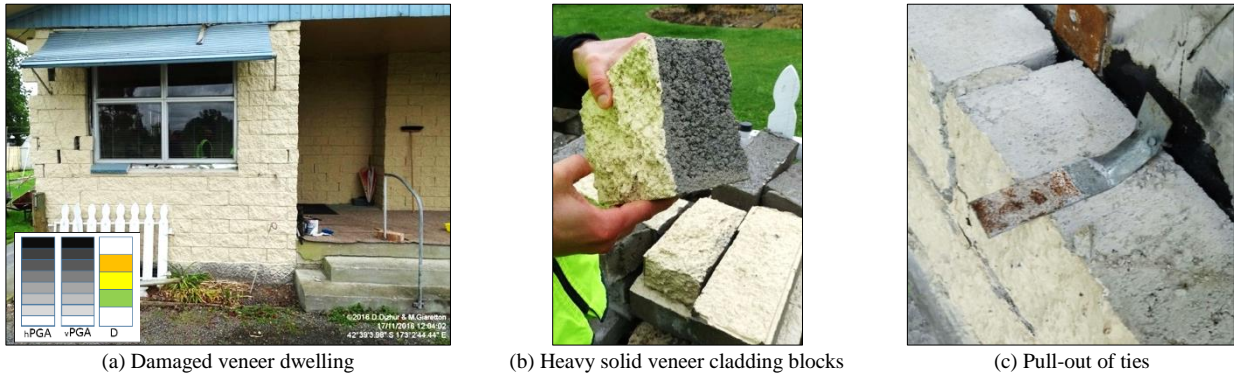
Figure 24: Significant damage to a masonry veneer dwelling in Waiau (hPGA 1.124g, vPGA 3.216g – WTMC).

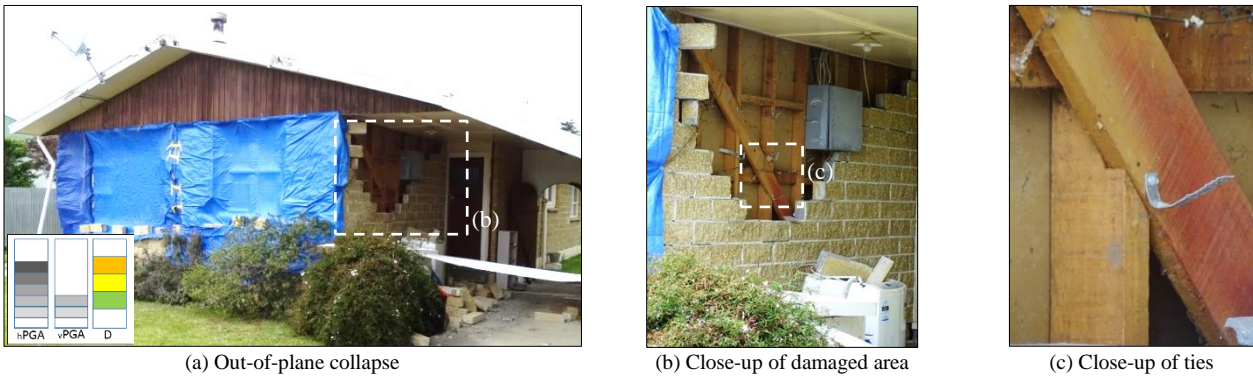
Figure 25: Out-of-plane collapse of masonry veneer in Seddon (hPGA 0.759g, vPGA 0.196g – SEDS).

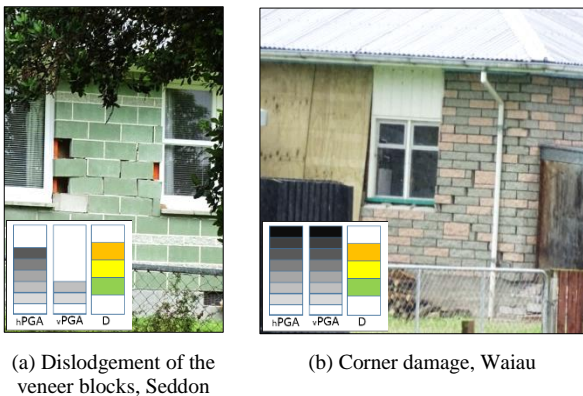
(a) Dislodgement of the veneer blocks, Seddon (b) Corner damage, Waiau

Figure 26: Examples of in-plane damage to veneer.

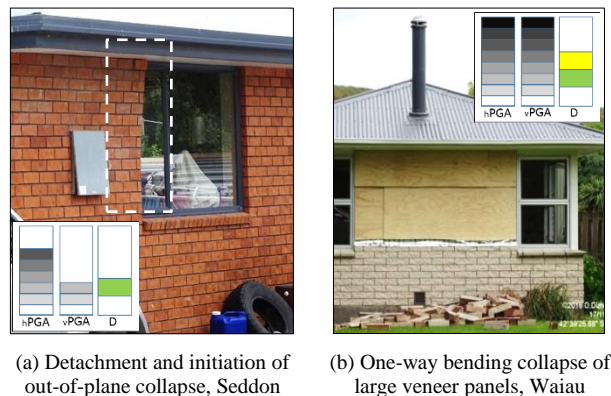
(a) Detachment and initiation of out-of-plane collapse, Seddon (b) One-way bending collapse of large veneer panels, Waiau

Figure 27: Examples of out-of-plane damage to veneer.

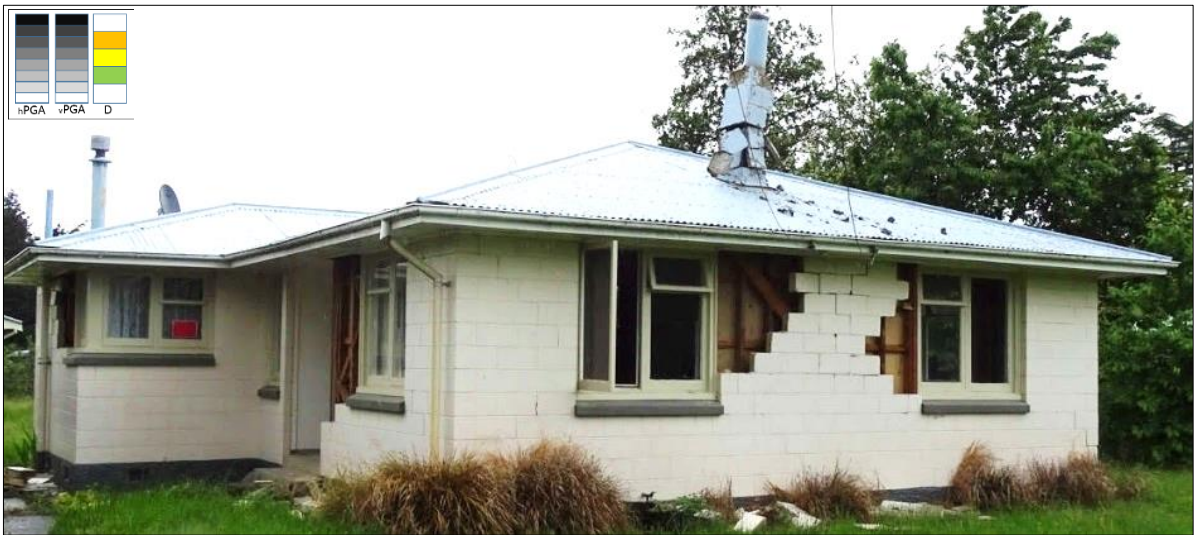
Figure 28: Examples of in-plane and out-of-plane damage to masonry veneer dwelling, Waiiau (hPGA 1.124g, vPGA 3.216g – WTMC).

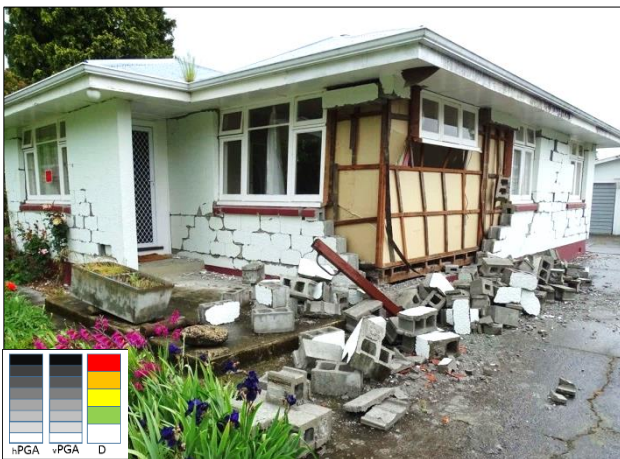
(a) Out-of-plane collapse

Figure 29: Examples of in-plane and out-of-plane damage to hollow concrete block masonry veneer dwelling, Waiiau (hPGA 1.124g, vPGA 3.216g – WTMC).

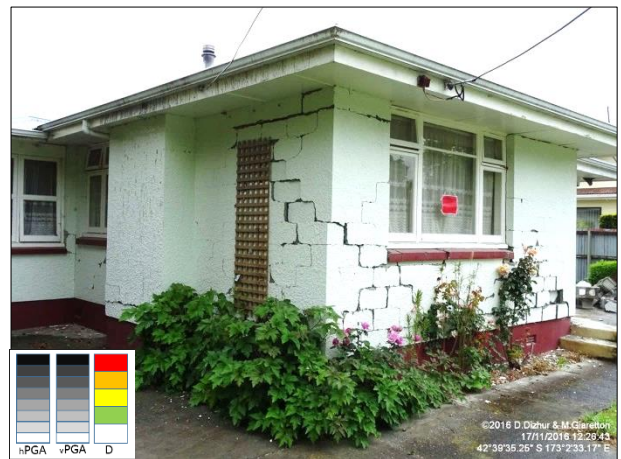
(b) Extensive cracking and dislodged blocks

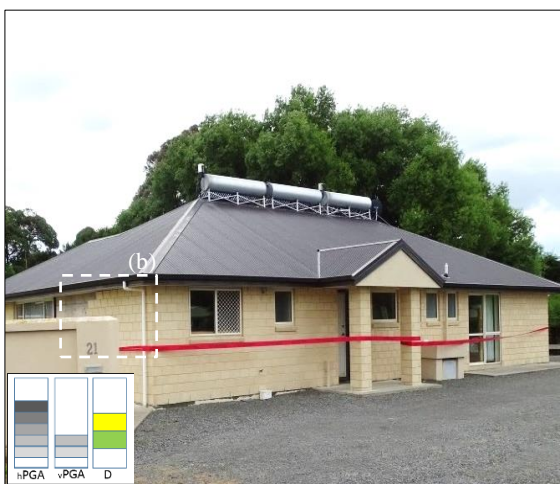
(a) Recently constructed veneer building

Figure 30: Example of damaged modern masonry veneer dwelling, Seddon (hPGA 0.759g, vPGA 0.196g – SEDS).

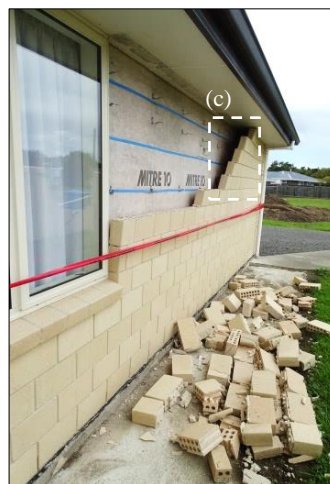
(b) Out-of-plane collapse

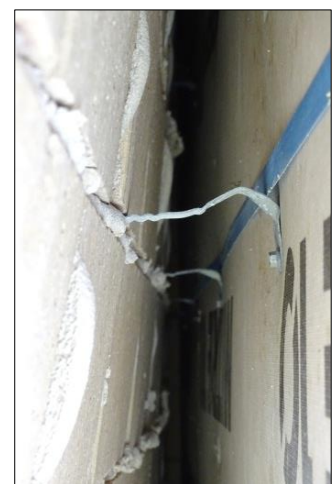
(c) Buckling of ties

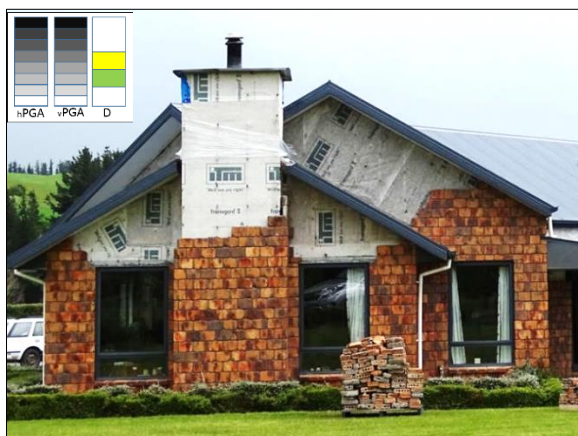
Figure 31: Example of damaged modern masonry veneer dwelling, Waiau ($hPGA$ 1.124g, $vPGA$ 3.216g – WTMC).
