3. CASHFIELDS SHOPPING CENTRE: CHRISTCHURCH

J.M. Taylor*

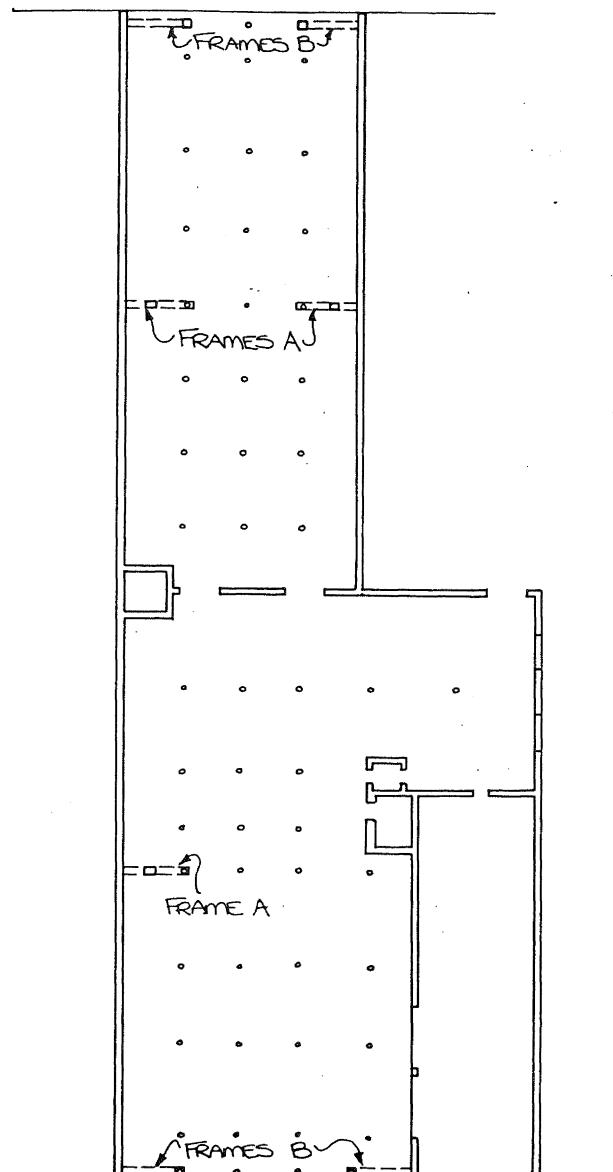
GROUND FLOOR PLAN

The general layout of the structure is shown in fig. 1. The building extends the full depth of the city block - some 101m - with width 21m (approx.) at Cashel Street, and 37m (approx.) at Lichfield Street. Storey heights are 5.5m ground to first floor, 4.8m first to second and 4.0m second floor to roof. Parapets are 1.2m high at side walls and up to 3.0m high at the street frontages.

Seven reinforced concrete half frames were constructed to provide additional lateral load capacity (see figs. 1 & 2). The location and configuration of the frames were chosen to take maximum advantage of the existing vertical load carrying elements, and to simplify construction as much as possible within the constraints of the architectural requirements.

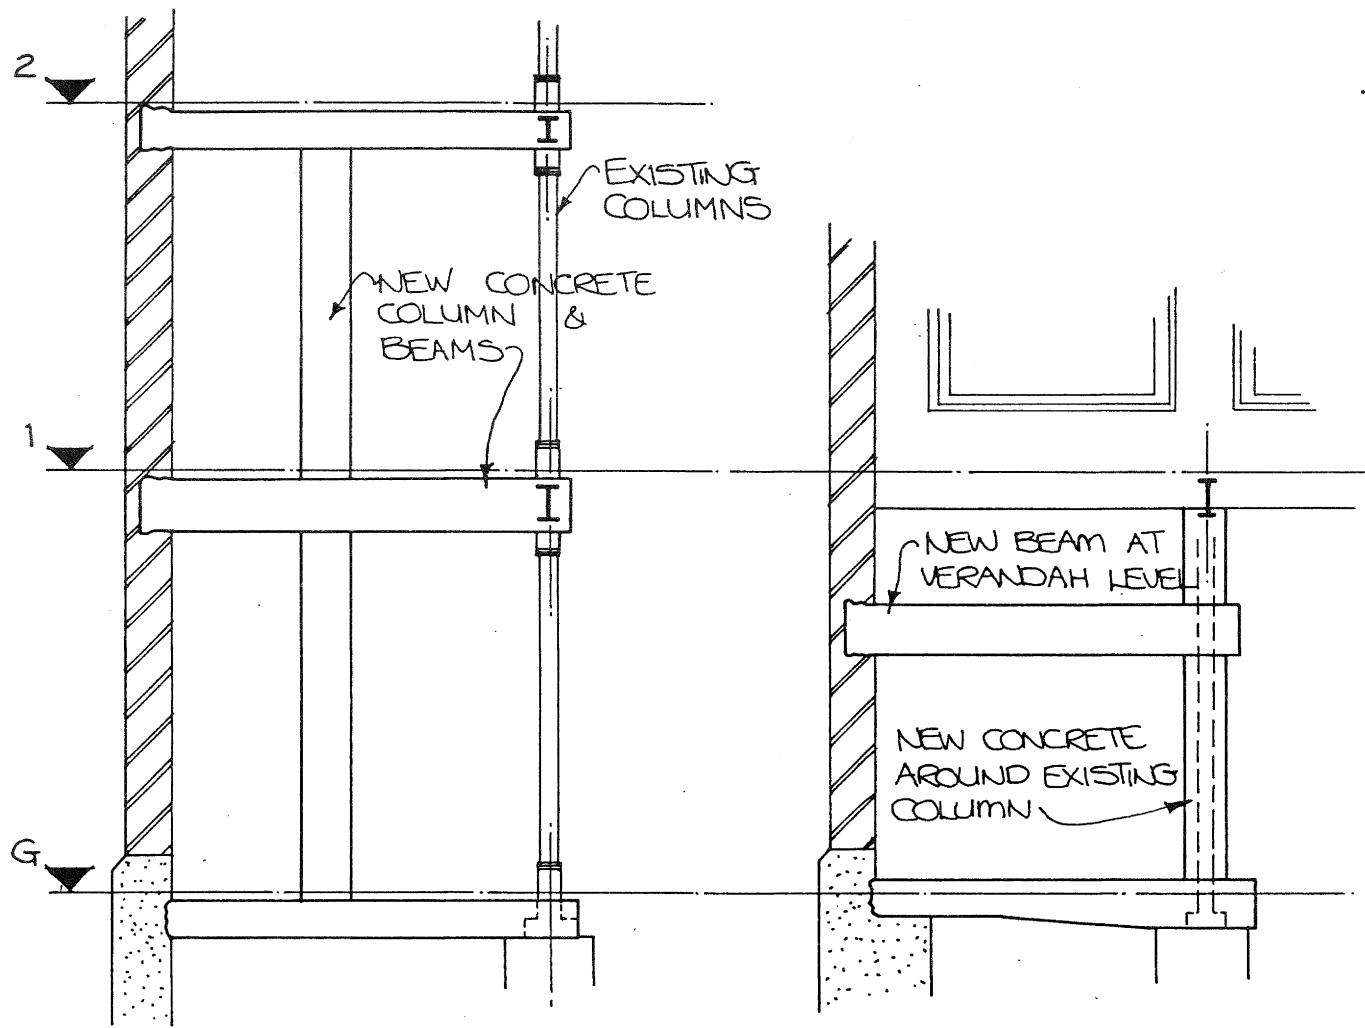
FIGURE 2

1. The absence of any lateral load resisting elements near the ends of the building.
2. The stability of the parapets, especially those on street frontages.
3. The capacity of the floor and roof diaphragms and their connections to the walls.
