**THE TAVEUNI EARTHQUAKE
FIJI
ON 17 NOVEMBER 1979**

A.W. Paterson* R.L. Williams**

Following the 17th November 1979 Taveuni earthquake, the authors were sent by the Fiji Government to inspect earthquake damage. The damage was assessed at \$0.75m. This paper is based on their reports and makes recommendations relevant to Pacific Island construction.

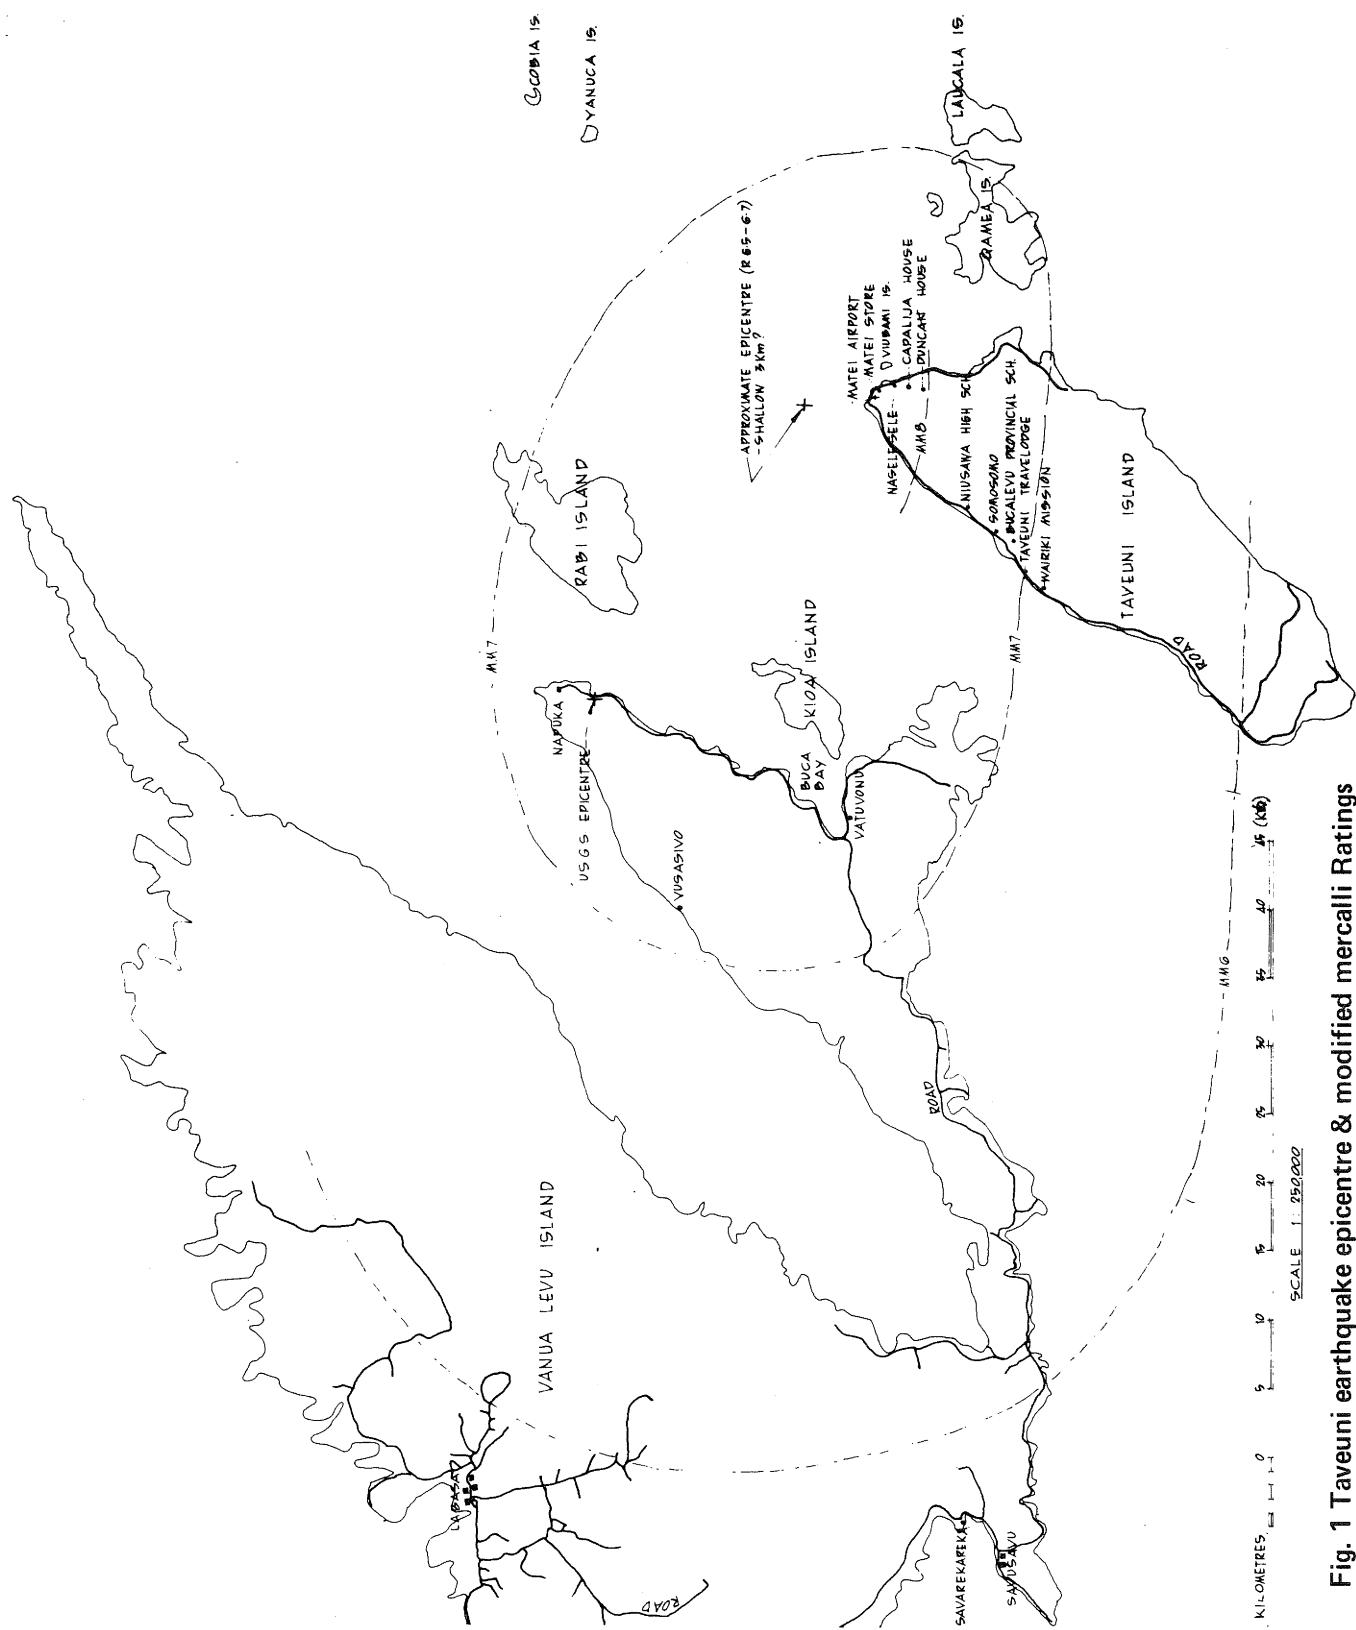
The ground motion in the Matei region was severe particularly on exposed ridges. Strong motion causing significant damage occurred for about half the length of the island and in the Buca Bay area. Figure 1 shows Modified Mercalli intensities assigned by the authors. Structural damage was not as extensive as one might have expected due to a number of factors i.e.

Fig. 1 Taveuni earthquake epicentre & modified mercalli Ratings

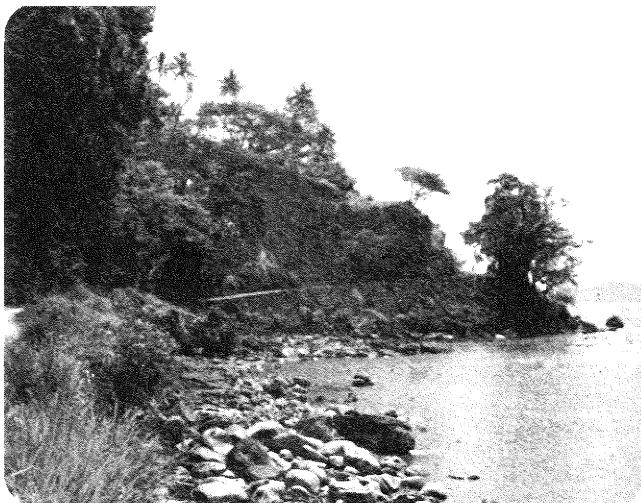
rolled down hills (figure 3), rocks over 100 tons had fallen in some islands. Most of the seaward face of the island of Viubani, off Matei slipped away (figure 4). Slipping was aggravated by early heavy rain and slipping was expected to continue as rain runs into cracks opened up by the earthquake. Slipping is not uncommon in this area because of the loose materials and steep nature of the hillsides.

Fig. 3 Slipping South of Matei

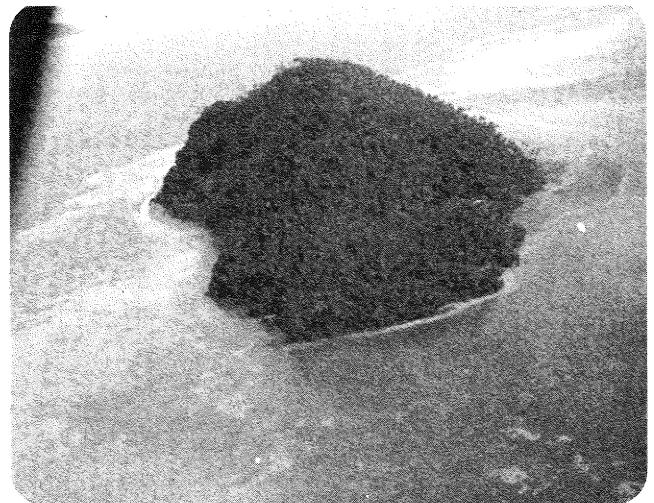
Fig. 4 Slipping on Viubani Island

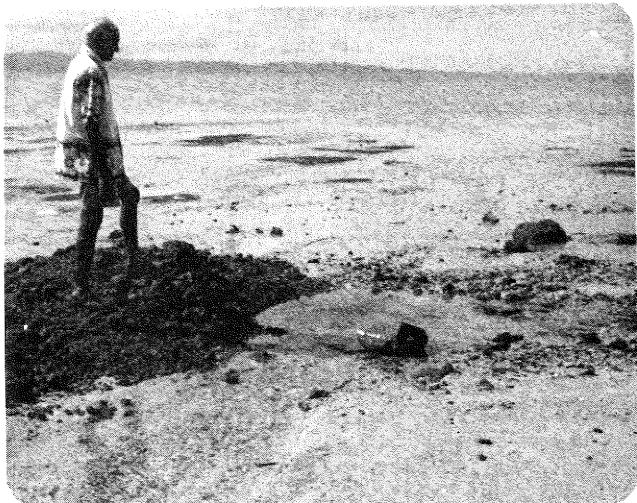
Blowholes occurred in a number of places near the epicentre. Noteable cases were at Qamea Island where water gushed out leaving holes up to 5 metres deep and flooding the playing field up to ankle depth. The area was just above sea level. Similar effects occurred as far away as Vusasivo on Vanua Levu where fine sand was ejected. The authors observed similar deep holes at Wairiki and also on the beach opposite Matei Store at Naselesele where sand and scoria had been ejected (figure 5). These latter holes were at approximately half tide and were about one metre across. They were gushing several hundred gallons a minute to clear, slightly salty water 6 days after the earthquake. It appeared that liquefaction had opened up fissures in the ground. However the water may be from natural aquifers supplemented by water squeezed out by settlement of nearby areas.

Fig. 5 Blowholes on Beach Naselesele

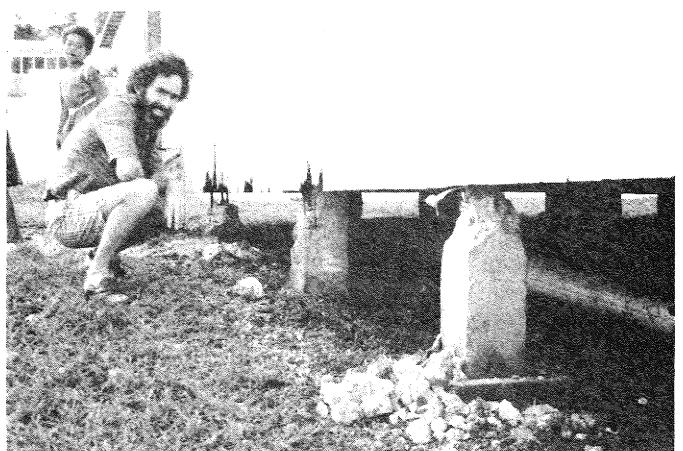
The majority of these were completely undamaged. Where damage did occur it was to the foundation. At least one building fell off its piles. Many others suffered pile damage. Some timber piles had clearly rotted, the earthquake causing final collapse. A surprisingly large number of concrete piles completely shattered (figure 6). The concrete failed in a brittle manner; the cement not bonding to the large aggregate. This appeared to be a combination of low cement ratio and dirty aggregate. The central reinforcing bars showed rusting although the outside of the piles did not indicate unsoundness. Clearly the standard of concrete piles should be upgraded.

Fig. 6. Damage to concrete House piles Niusawa High School

Timber construction was rarely damaged except for a few foundation failures. The cement content of concrete piles should be

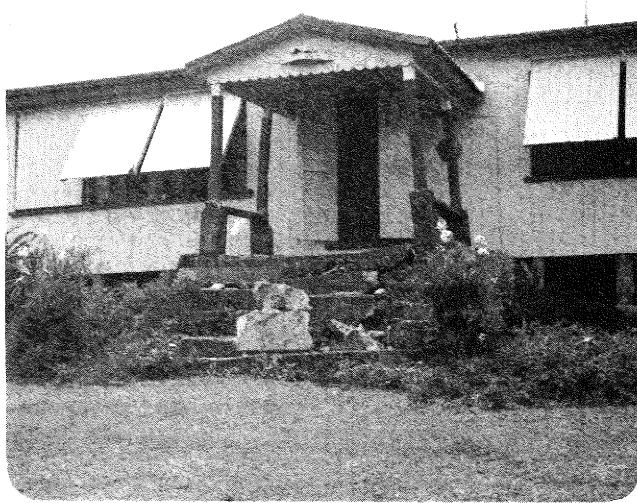
Just south east of Naselesele on the Nagasau Estate 2 houses (owned by Mr Capalija and Mr Duncan) exhibites signs of very severe shaking. Both houses were of substantial construction and about 50 years old and both were on exposed ridges. These houses had timber piles but in both cases many of the piles had been strengthened by concrete pads 500mm square at their bases. The severe shaking displaced many of the weaker piles and the stronger piles had visible signs of considerable movement. Concrete rubble floors in bathroom and verandah areas (figure 7) had completely disintegrated and out-houses had been badly damaged. The shaking had thrown all loose furniture over the rooms (figure 8) much of it over-turning and being damaged beyond repair and at least half the contents would have to be written off. Paintings were thrown off walls breaking substantial wire supports. It is estimated accelerations of 0.5g would be required to cause this type of damage.

Fig. 7 Broken terrace, Mr Duncan's House, Naselesele

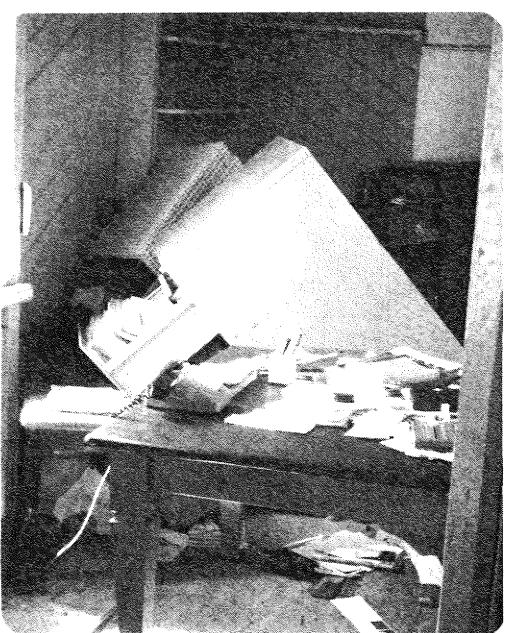
Fig. 8 Furniture overturned, Mr Capilija's House, Naselesele

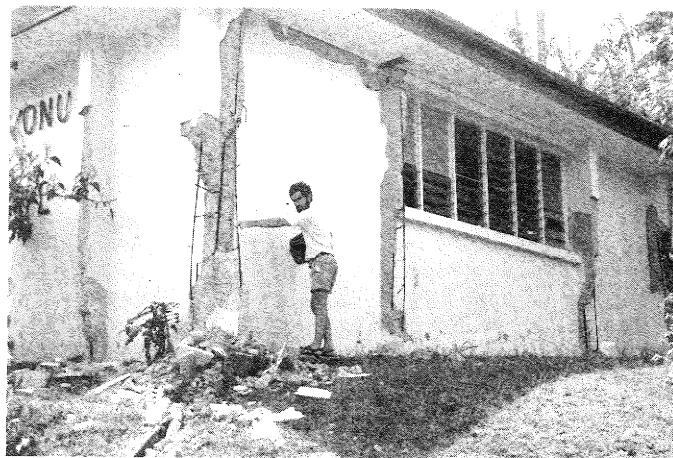
Very few buildings were built in this material. Only in 2 cases did significant damage occur. The S.D.A. Mission School suffered very serious damage to the 5 classroom reinforced concrete and masonry building (figure 9). Extensive cracking and spalling occurred throughout the building. The building occurred mainly due to poor concrete. The concrete had an excessive sand content and low cement content which has mainly been absorbed in coating the sand. This left a mix with insufficient cement to be impervious and counteract the effect of the salts. Extensive rusting of the bars has occurred further weakening the construction.

Fig. 9 5 classroom block Vatuvonu School

Since the earthquake immediate action has been taken by the Mission and within one month they had removed all walls and cast new foundations and floor slabs in high quality reinforced cement. They have replaced all walls with timber construction. The original roof was propped during reconstruction and has now been firmly bolted down. It was interesting to note that a blockwork 2 classroom block on the same site was well constructed and had only hairline cracking as a result of the earthquake.

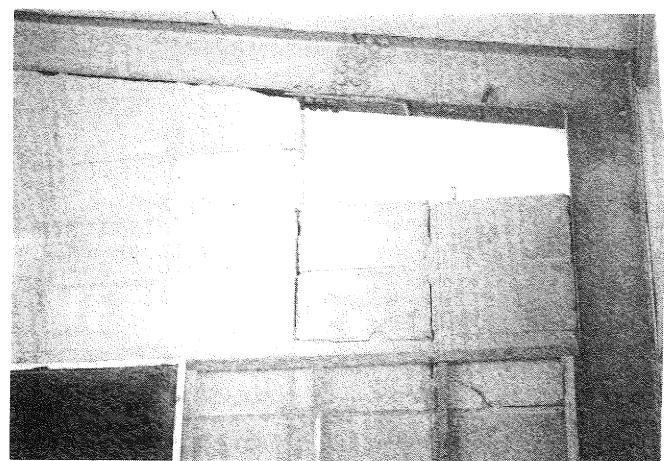
Blockwork was not extensively used in the area but probably a quarter of these building in the Taveuni and Buca Bay areas showed some signs of damage. Damage at the Niusawa Methodist High School occurred in several buildings. In the classroom block the non structural partition walls

Fig. 10 Damaged blockwork partitions - Niusawa High School

had separated from the steel portal frame (figure 10), locating bolts were torn out and stack bonding failed. This building was x-braced in the other direction.

This earthquake did not test modern Fiji construction but it was apparent that blockwork was particularly vulnerable to damage due to poor design and construction. The authors recommend all cells filled construction with 12 mm reinforcement at 600 mm centres both ways. Stack bonding of mortar joints is particularly vulnerable to damage and should be avoided. Grouting was particularly poor. A free flowing mix should be used and well compacted by rodding. Only deformed steel should be used. Laps should be at least 40 diameters because of poor bonding of grout to steel.

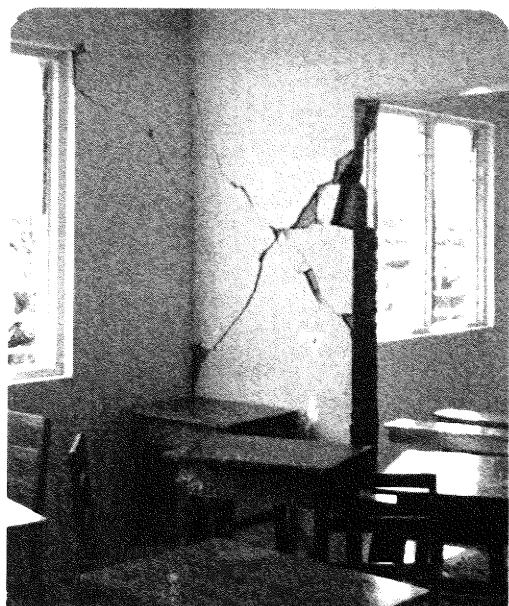
Fig. 11 Damaged Blockwork Bucalevu School

At Bucalevu Junior/Secondary School the interior wing walls between 2 classrooms showed serious cracking. One wall showed shear cracking (figure 11) while others failed due to inadequate grouting at the base (figure 12).

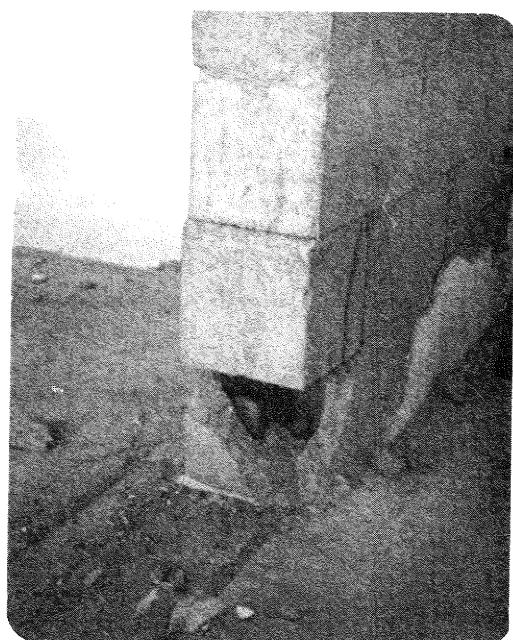
Fig. 12 UngROUTed reinforcement Bucalevu School

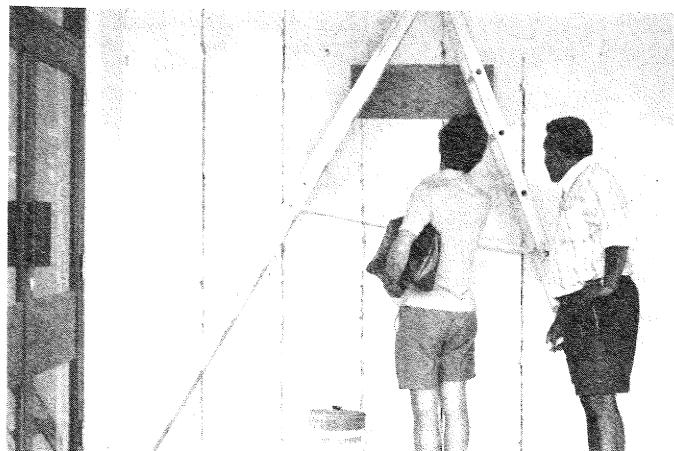
Fig. 13 Failure of stackbonded blockwork - National Bank of Fiji, Labasa

Damage that occurred remote from the epicentre in the new National Bank of Fiji in Labasa. This building had not even been opened yet it suffered damage to several of its stackbonded blockwalls (figure 13).

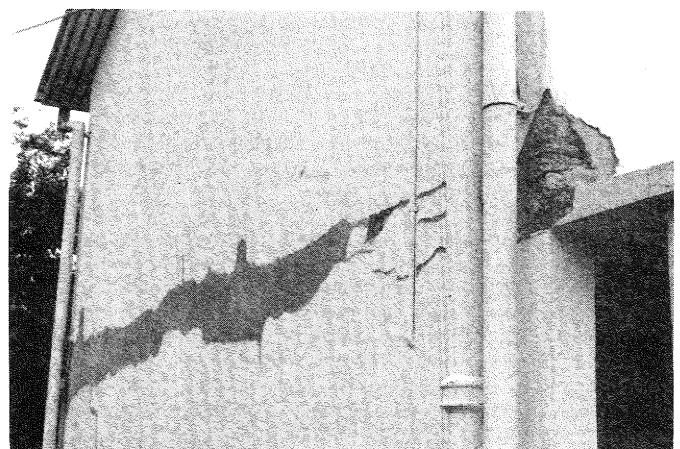
Fig. 14 Failure of standard Maisonette on damproof course

Damage also occurred at a 2 storey standard government maisonette at Labasa (figure 14). This was apparently due to a shear friction failure that occurred on an unnecessary dampproof course that had been added at first storey height.

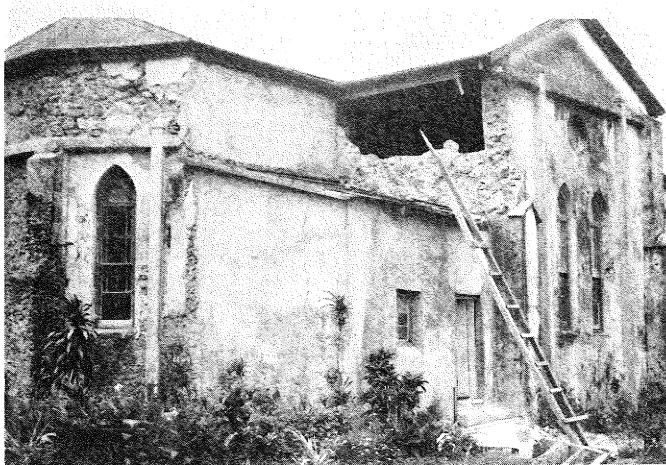
Napuka Catholic Mission - The main church, the priests house, convent, dormitory and a workshop classroom were all condemned as irreparable. All were constructed in rubble concrete. The church (figure 15) was damaged by an earthquake in 1921 and was subsequently strengthened by reinforced concrete bands and piers both inside and out. These bands, visible in the photograph do not appear to have greatly improved the earthquake resistance but do appear to have

saved the building from total collapse.

Fig. 15 Failure of rubble concrete - Napuka Catholic Church (Note Strengthening)

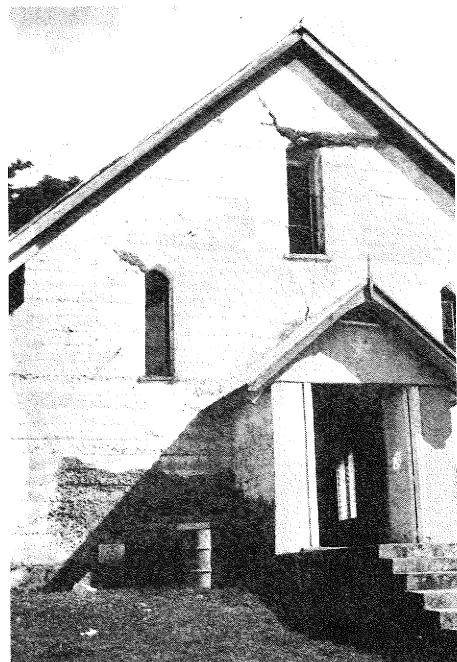
Other damage to this type of construction occurred at Savarekareka Catholic Mission House and Somosomo Methodist Church (see figure 16).

Fig. 16 Failure of rubble concrete - Somosomo Methodist Church
