DAMAGE TO CIVIL ENGINEERING STRUCTURES DUE TO THE NEAR IZU-OHSHIMA EARTHQUAKE OF JANUARY 14, 1978

Toshio Iwasaki * and Kazuhiko Kawashima **

ABSTRACT

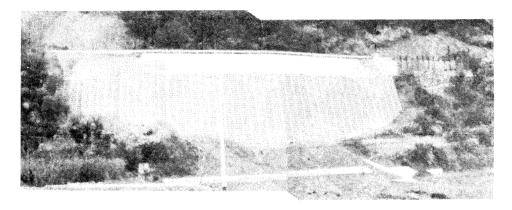
In the area hit by the earthquake there was a number of retaining walls for cut and embankment slopes. The most common of these retaining walls were made of concrete or masonry. Although some of them were damaged as shown in Fig. 14, many survived safely with minor non-structural damage such as cracks, gaps, small settlements, etc. There were several high embankments with heights of more than 10 to 20 meters in east Izu area as shown in Figs. 15 and 16. It should be noted that these high embankments showed quite a good performance against the earthquake.

FIGURE 15: PLANE VIEW OF HIGH EMBANKMENT, RETAINED BY CONCRETE FRAME,
WHICH COULD SURVIVE SAFELY AGAINST THE EARTHQUAKE, AT
NASHIMOTO AREA IN KAWAZU TOWN (SHUZENJI-SHIMODA ROUTE)

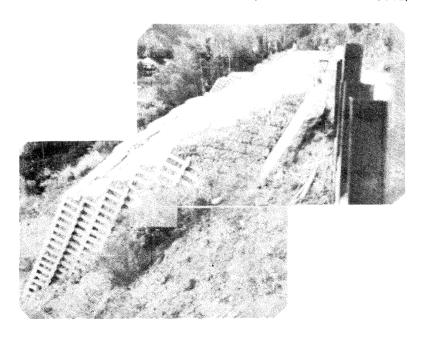
FIGURE 16: SIDE VIEW OF THE HIGH EMBANKMENT (SHUZENJI-SHIMODA ROUTE)

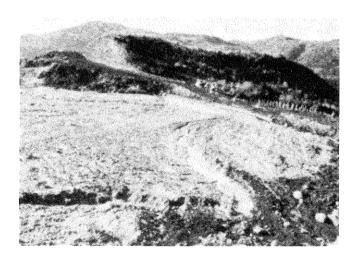
Two tailing dams for storing mining wastes were collapsed as shown in Figs. 20 and 21, and the slimes which overflowed from a damaged dam resulted in water pollution in Mochikoshi River, Kano River and Suruga Bay.

FIGURE 21: COLLAPSED first Tailings Dam and temporarily repaired Dam.

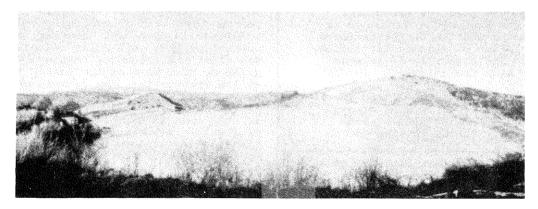
FIGURE 20: OVERALL VIEW OF COLLAPSED HOHZUKI—KAWA TAILINGS DAMS for storing mining waste — front of the photograph shows the first dam collapsed completely just after the main shocks (January 14, 1978), RIGHT HAND SIDE shows the second dam collapsed by one of after shocks at about noon in January 15, 1978, and LEFT HAND SIDE shows the third dams with no damages.
