SHAKING TABLE TESTS OF TYPICAL B-ULTRASOUND MODEL HOSPITAL ROOM IN A SIMULATION OF THE LUSHAN EARTHQUAKE

Wang Duozi¹, Dai Junwu² and Ning Xiaoqing³

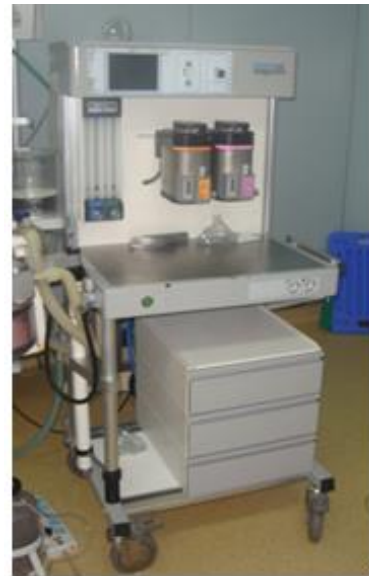
Nonstructural seismic damage to the People's Hospital in Mingshan County was severe, but the structure was left intact. Some valuable medical equipment was damaged by vibrations rather than by being knocked over. Many infilled walls shifted and cracked, and decorations on the walls and columns fell. The ceilings sustained over 2200 m^2 of damage. The fire water tank cracked and the outbound device in the elevator was damaged. The facilities sustained severe and widespread damaged that impaired the functionality of the hospital. For example, the colour Doppler ultrasound machine could not be started, and the anesthesia machine worked abnormally because of damaged pipe connections (Figure 2).

(a) Anaesthesia machine

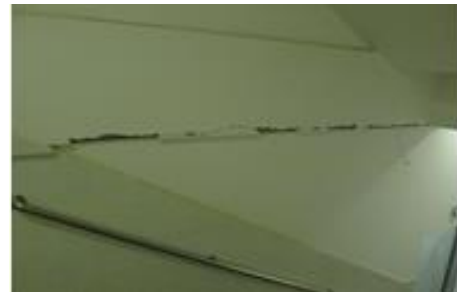
(b) Crack on the stair wall

Figure 2: Seismic damage of the outpatient of people's hospital in Mingshan county.

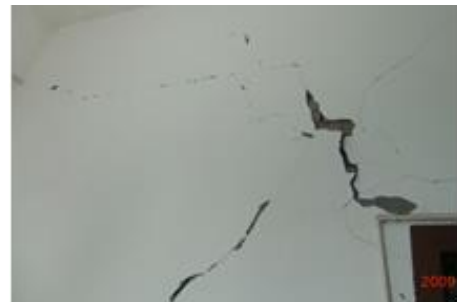
(a) Crack on the infilled wall

The Xindian Outpatient Clinic suffered moderate structural damage and visible cracks formed on many infilled walls. The decoration and architectural elements did not suffer much seismic damage. More than 100 pieces of equipment and furnishings suffered various levels of damage. These included computers, the colour Doppler ultrasound machine, and ventilators. The drug supplies were scattered across the floor (Figure 3). This is typical of the damage sustained by low rise clinics. The structure experienced slight to moderate damage and retained much of its normal function. Meanwhile, nonstructural components suffered severe damage, which can lead to interruptions in medical function, such as in the Qingren Country Clinic and Siyan County Clinic.

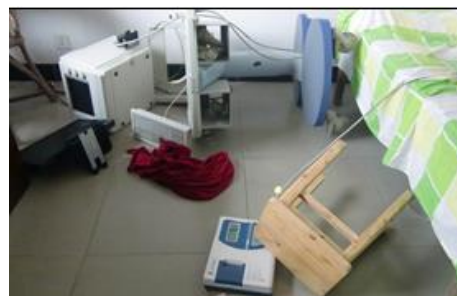
(b) The colour doppler ultrasound machine

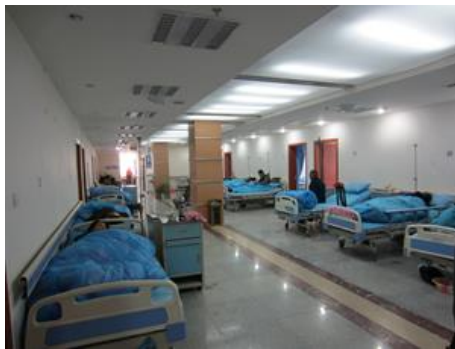
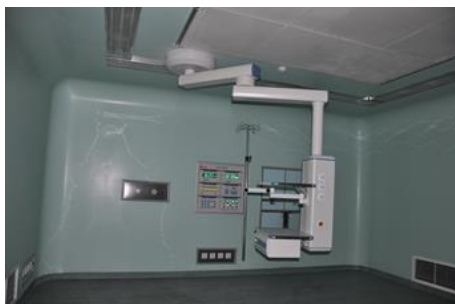
Figure 4: Situation of the new outpatient of people's hospital in Lushan county after Lushan earthquake.

The new outpatient facility had an isolation damping system, so the only seismic damage sustained was to this system, and almost all the medical and administrative equipment remained functional (Figure 4). The new outpatient facility was the only functional hospital facility after the earthquake in Lushan County, and played it an important role in emergency response.

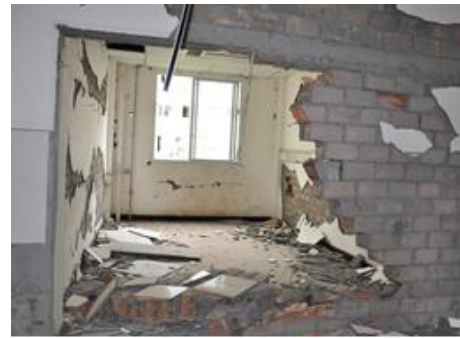
The old and new outpatient facilities are next to each other. The old outpatient facility sustained both structural and nonstructural damage, and both structures and other elements were functionally interrupted (Figure 5).

(a) Crack on the infilled wall

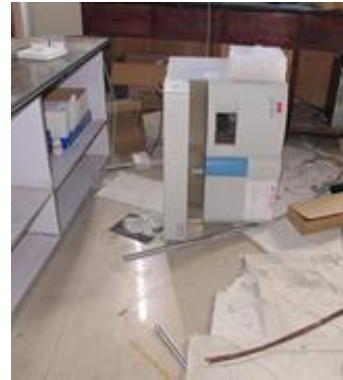
(b) Overturning of equipment

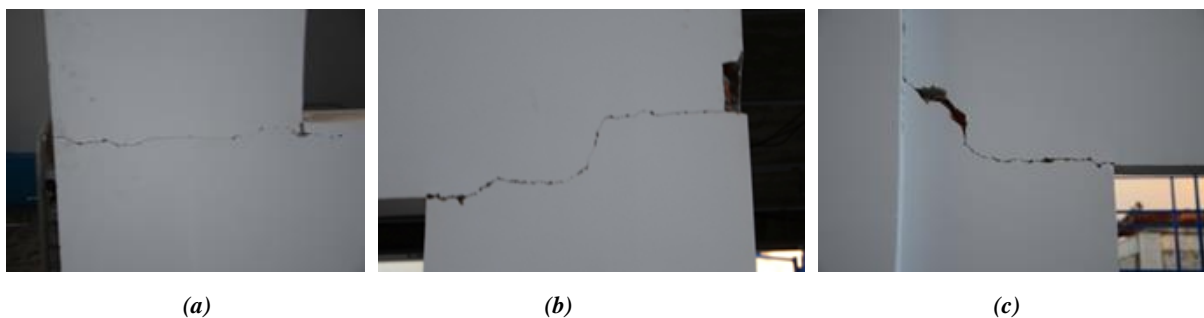
Figure 11: Cracks on the walls.

The structure itself remained almost undamaged with some minor cracks in the masonry of infilled walls (Figure 11), and the cracks appeared near windows and doors, where the infilled walls were brittle. As PGA increased, the B-ultrasound machine and the sickbed started moving randomly. The office desk, which did not have trundles also showed significant movement. The monitor on the office desk overturned after severe vibration (Figure 12). The limit of the maximum driving displacement and peak value acceleration of shaking table was as listed in Table 2. There was not enough floor displacement or floor acceleration to knock any of the furniture over (because the model was only one storey high and PGA was the peak floor acceleration for the contents).

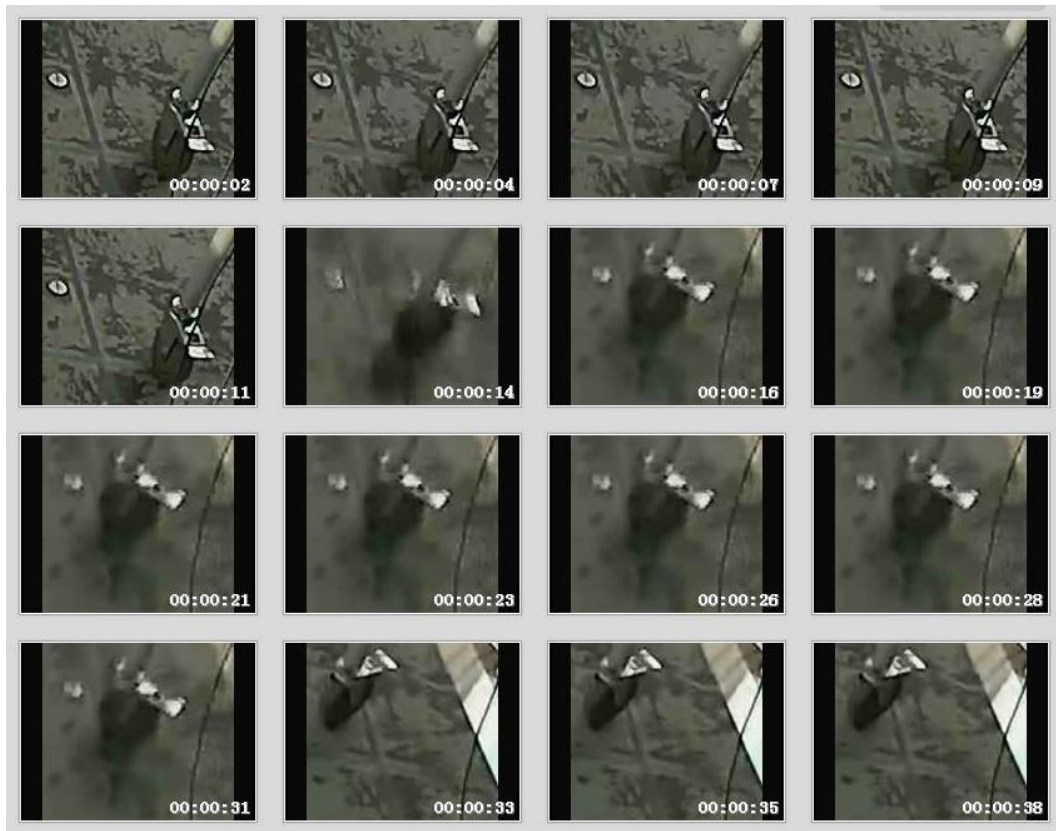
Figure 15: Snapshots from the video recordings of one trundle of sickbed.

with increased PGA and even reduced or vibrated sometimes. The coefficient of friction of the building contents without trundles was nearly ten times of that with them [12, 13]. The trundles did not rigidly connect with the main body, so they could turn freely and rapidly (Figure 15). In this way, the frictional force, which depends on the layout of trundles, plays an important role on dynamic response of the building's contents.
