# ASSESSMENT OF DAMAGE TO THE CEILINGS AND SPRINKLER DOWNPIPES OF AN INDUSTRIAL PLANT FROM THE 2012 7.6MW SÁMARA EARTHQUAKE IN COSTA RICA

Ricardo Roldán<sup>1</sup> and Alfredo González<sup>2</sup>

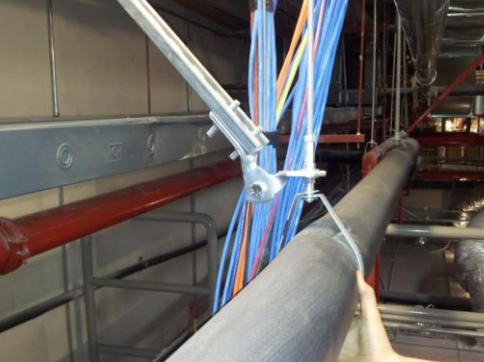
**Figure 5: Pipe bracing detail in the transverse (top) and longitudinal (bottom) directions in the as-built drawings (source: FSA Ingeniería & Arquitectura S.A.).**

Pipe supports of the type depicted in Figure 5 (top and bottom) are called for in the details. These are typical of seismic applications in Costa Rica and elsewhere. A similar detail, albeit slightly more flexible, was actually used (Figure 3). The as-built drawings do not seem to have picked up the difference, but it is not clear to the authors whether this was an oversight or that simply the difference was considered immaterial. The lateral restraint of pipes was found to generally conform to the drawings and current practice.

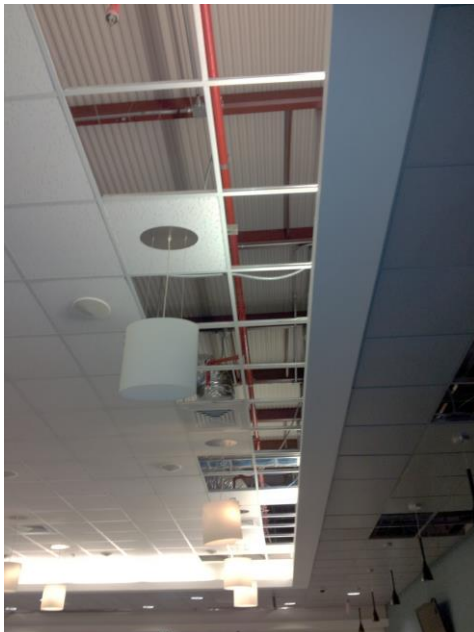
2. The lateral detachment at the ceiling-to-wall angle was not followed at the interface of the suspended ceiling with a stiffer, heavier drywall ceiling as shown in Figure 4 (top), Figure 6a and Figure 6c.

1. Buckling of tees around the perimeter (infrequent).
2. Falling of tiles around the perimeter (very frequent). Around 25% of total area was damaged. Fortunately, no one was injured due to falling tiles.
3. Enlargement of the hole for sprinkler heads in ceiling tiles (frequent): during the earthquake, the sprinkler heads bore into the ceiling tiles and enlarged the originally circular perforation, rendering it oblong. The enlargement was several centimetres long, and was observed in groups rather than isolated cases, but not generalized. This leads us to conclude that the relative movement between the pipe and the ceiling is related to the local solution adopted for the pipe and ceiling bracing rather than with system behaviour.

**Figure 6: Ceiling damage. (a) Fallen tiles around the perimeter between suspended ceiling and rigid, heavier drywall soffit, and at the perimeter between metallic pan tiles and wall (cafeteria). (b) Loosened (fallen elsewhere) tiles as a result of relative movement of first tee parallel to wall and wall angle at moving support detail where the perpendicular tee is not fixed to the wall angle (offices). (c) Fallen tiles around interior drywall feature. Note that the feature is rigidly braced to the structure above. (d) Tile damaged as the downpipe supporting the sprinkler head enlarged the penetration hole (seen from above). Recent water damage can be seen as a result of a leaking connection above.**

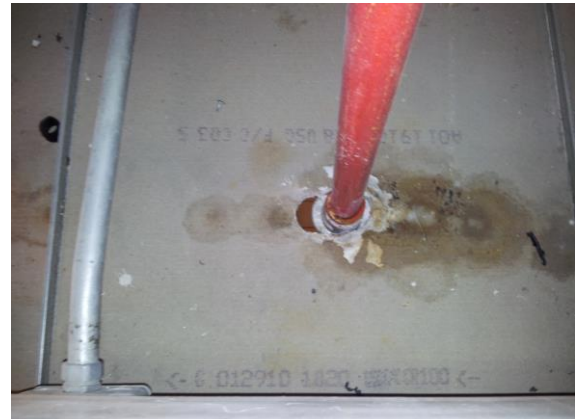
(d)

4. Leaking downpipes (two cases): this is the last portion of pipe leading to the sprinkler head at its lower end. The relative displacement was large enough to break the connection at the top of the downpipe. A mechanical engineering consultant analysed the broken pipe and determined that a premature failure occurred as a result of an inadequate threading technique.
