# STRENGTHENING HERITAGE TUNNELS TO ENHANCE THE RESILIENCE OF WELLINGTON'S TRANSPORT NETWORK

## ABSTRACT

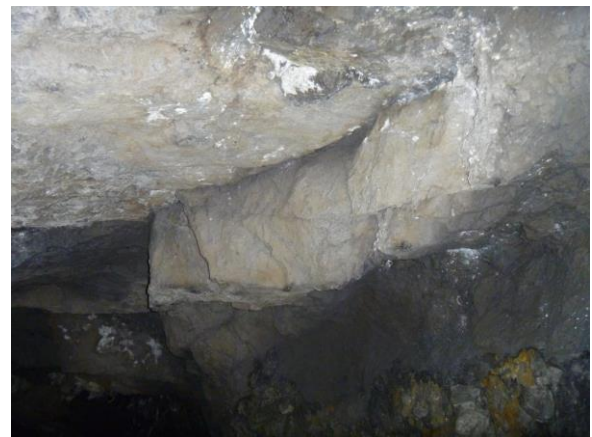
in tunnels and on slopes around Wellington. A characteristic wedge failure observed on the roof of the unlined Orongorongo water supply tunnel in Wainuiomata, which is formed in Wellington Greywacke is shown in Figure 8.

**Figure 8: Wedge failure mechanism observed on the roof of Orongorongo water supply tunnel in the Wellington Region.**

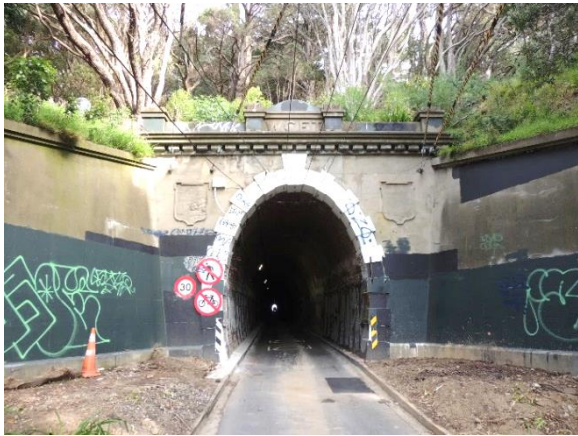
The tunnel portals are more prone to damage under earthquake loading. The portals and side or wing walls of the tunnels discussed in this paper are generally unreinforced retaining walls (or lightly reinforced in the case of Northland tunnel), see Figure 9.

**Figure 9: Hataitai Bus tunnel west portal, parapet and wing walls (before the strengthening works).**

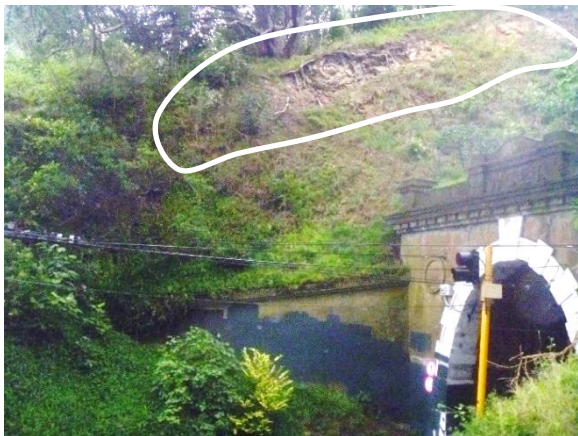
**Figure 10: Rockfall hazard from slope above the east portal of the Hataitai Bus tunnel (rockfall source shown in white).**

Rockfall hazard was identified on the slopes above the eastern portal, causing a maintenance issue and safety risk for the road and tunnel users. The source of the rockfall above the portal is shown in Figure 10. Rockfall was generated by unfavourably oriented rock defects, forming rock blocks that became loose

with time and failed under static conditions, exacerbated by rainfall events. The risk to road users under small, frequent events was assessed as minor and consisted more of a nuisance and maintenance issue. The risk under severe storm and earthquake events was, however, assessed as high. Rock fall protection measures were implemented, comprising a high strength steel wire mesh (nominally 1770 N/mm<sup>2</sup>), single twisted into rhomboidal mesh, fixed on the slope with a 3.0 x 3.0 metre pattern of 4-metre-long rock bolts, see Figure 11.

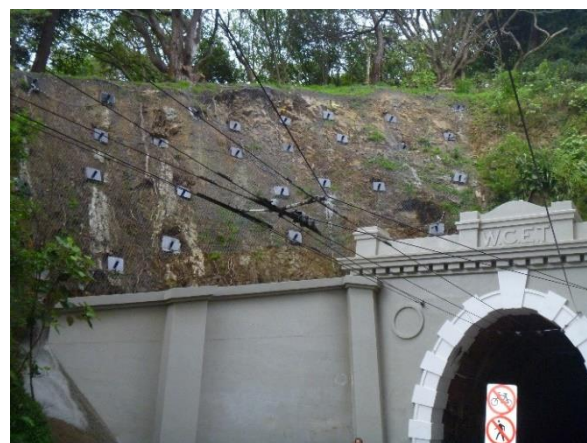
*Figure 11: Rockfall protection mesh installed above the Hataitai end portal. View of the finished portal walls.*

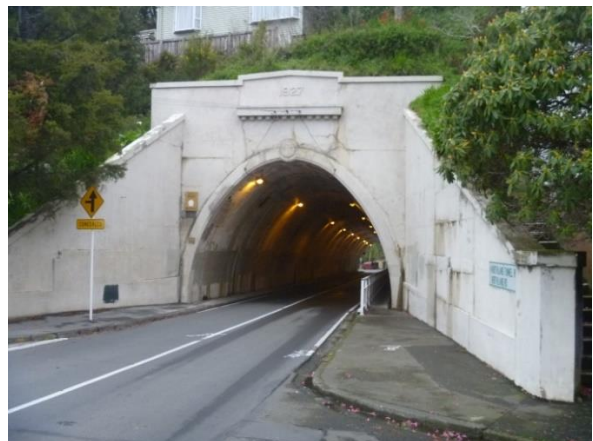
Figure 14: North portal of Northland tunnel (photograph taken before the strengthening works).

The assessment of the seismic behaviour of the portals concluded that the portal walls and wing walls were marginally stable for the 25-year serviceability limit state (SLS) event and the 100-year event. The walls could be prone to overturning for the 250-year event but based on the assessed displacements the damage expected would be easily repairable. Large and unacceptable displacements or failure in sliding and /or overturning of the portal walls could be expected in the 500-year event and the ultimate limit state level (ULS) earthquake event or larger (i.e., 1000-year or larger).

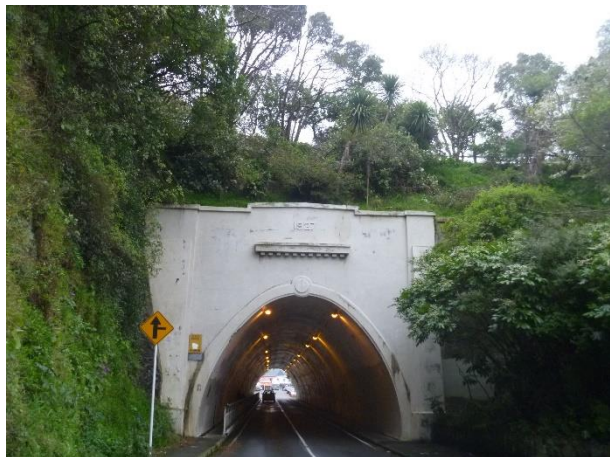
The southern portal of the Northland tunnel is constructed in a cut slope, which at the west (left) side of the portal is up to 15 m high (Figure 16). The slope is excavated in rock, at a steep angle of 70 to 75 degrees. This slope has generally performed satisfactorily since the construction of the tunnel, without major instability or rockfall issues reported, but due to its height and steepness and the proximity to the tunnel portals, its stability was included in the assessment.

**Figure 16: View of the south portal of Northland tunnel. 10 m to 15 m high and steep rock slope at the left-hand side of the portal (photograph before the strengthening works).**

The assessment concluded that there were unfavourably oriented defects present on the slope that could cause planar / wedge type of failures and rockfall hazard to the users of the tunnel. These failures would not affect the tunnel. Failures of sufficient size, enough to block part of or one lane of road were more likely under a 500-year seismic event. It was considered that these failures could not cause damage to the tunnel, while partial blocking of the road could be quickly cleared after a seismic event. As a result, such failures are acceptable from a resilience perspective. No stabilisation measures were considered necessary based on the condition of the slope at the time of the assessment.

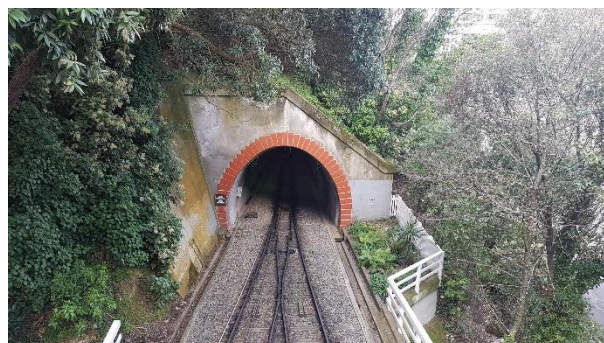
Figure 29: Upper section of middle tunnel near steep slope.

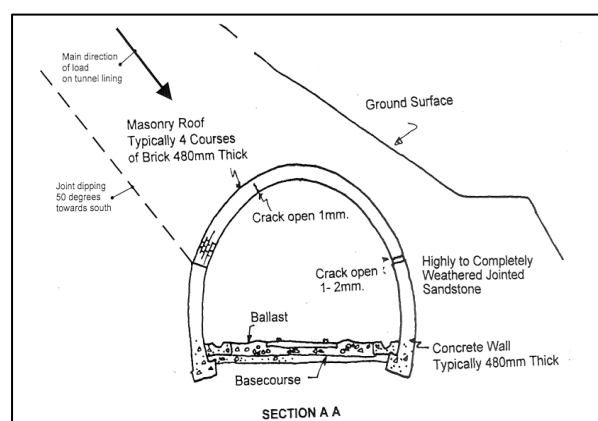
Evidence of distress of the lining of the upper 40 m length of the Middle tunnel was observed in late 1990's. This consisted of longitudinal cracking of the lining for a length of about 40 m from the upper portal observed at two locations of the tunnel section, at about 11 and 2 o'clock (see Figure 30).

Figure 30: Sketch of the cracking of the lining along the upper 40 m of the Middle tunnel [34].

The cracking was attributed to asymmetric loading of the tunnel barrel due to its proximity to the slope and potential occasional slope movements (creep). Based on the analysis carried out at the time, it was concluded that the available rock wall at the south side of the tunnel could potentially resist the horizontal loading applied by the uphill slope movements, provided there were no unfavourably oriented rock defects which could cause the rock wall to creep or fail. The slope movement and consequent cracking of the tunnel lining had occurred under static or low to moderate earthquake loading [34].

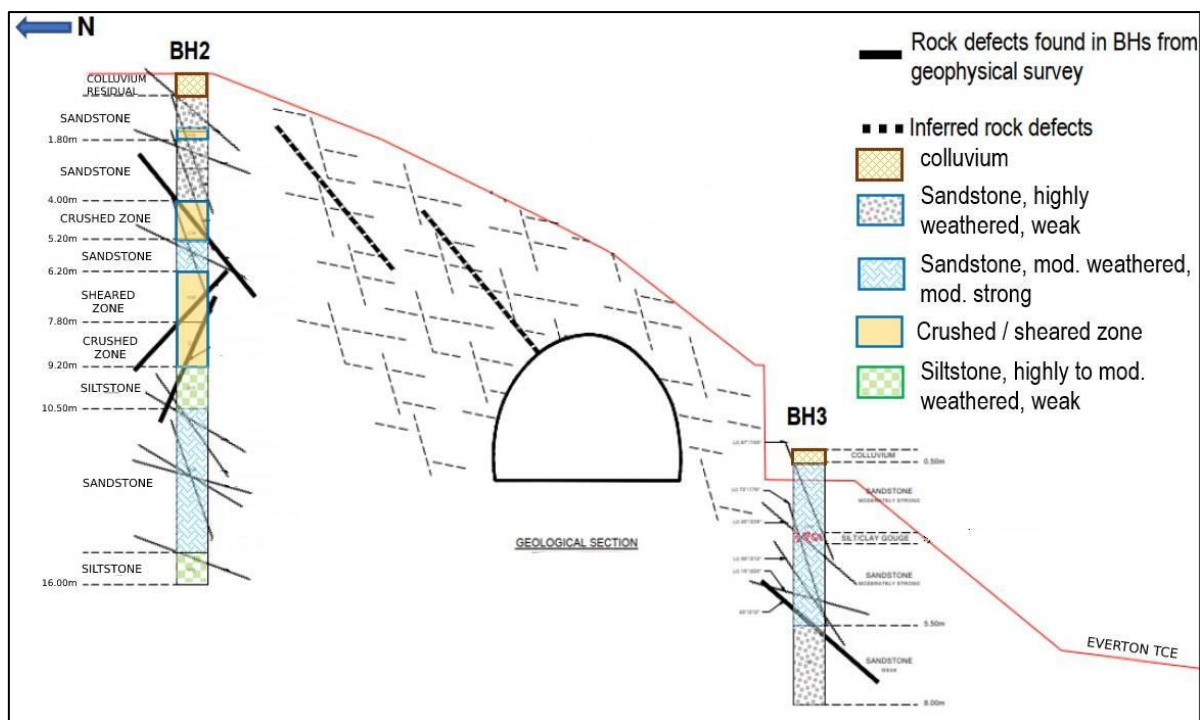
The investigations confirmed the initial assessment [34] that inferred the potential presence of poor-quality rock mass and unfavourably oriented rock defects, which exacerbate the slope movements and the effects of asymmetric loading on the tunnel (see Figure 32).

Figure 32: Interpretation of ground model and rock defects affecting the upper 40 m of the Cable Car middle tunnel.

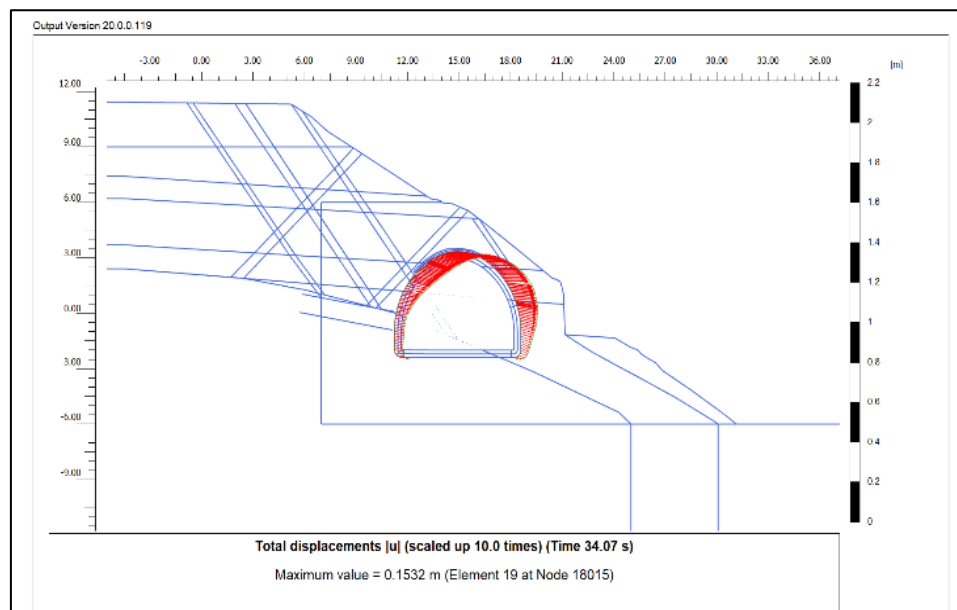
Failure of the slope is expected for events larger than the 1:500-year event, and this will make the tunnel barrel more vulnerable to subsequent earthquakes or aftershocks. Collapse of parts of the tunnel along this section could occur in this case, especially if the portal is damaged substantially.

**Figure 33: Deformation pattern of tunnel section and of the slope associated with the tunnel under the 1: 1000-year earthquake event, from Plaxis analysis.**

The earthquake performance of the upper 40 m long section of the Middle tunnel could be enhanced by strengthening the slope above and south of the tunnel with rock anchors. Further strengthening of the tunnel barrel was not considered necessary. The tunnel lining provides sufficient strength to the tunnel barrel, provided that the slope above and at the south side of the tunnel are protected from substantial deformation or failure.

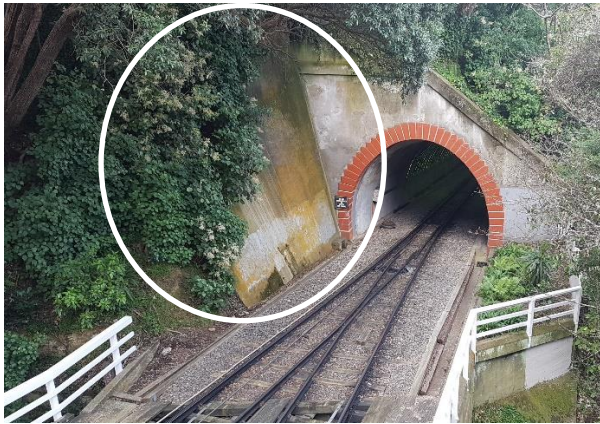
A slope about 15 m high at the north side of the upper portal is protected by an unreinforced concrete facing about 250 mm to 300 mm in thickness (Figure 34). The facing was possibly constructed to address relatively shallow failures during or in the early years after construction of the cable car line.

**Figure 34: Unreinforced concrete facing on the slope face at the north side of the upper portal of the middle tunnel.**

The presence of unfavourably oriented defects has been confirmed from the site investigations above the slope. The stability of the slope under seismic loading has been checked using the RocScience Slide 2018 software for different levels of earthquake shaking. The modes of failure that have been examined include failure through the rock mass, defect-controlled failures (formed by combination of the unfavourably oriented defects) and combined defect and rock mass failures.
